**SUBJECT:** Isoxaflutole 2-year Tile Drain study, New Holland, Ohio

This memorandum provides EFED's analysis of the study results from a tile drain study with isoxaflutole in New Holland, Ohio. A list of the quarterly status reports covered by this memo is given in Table 1.

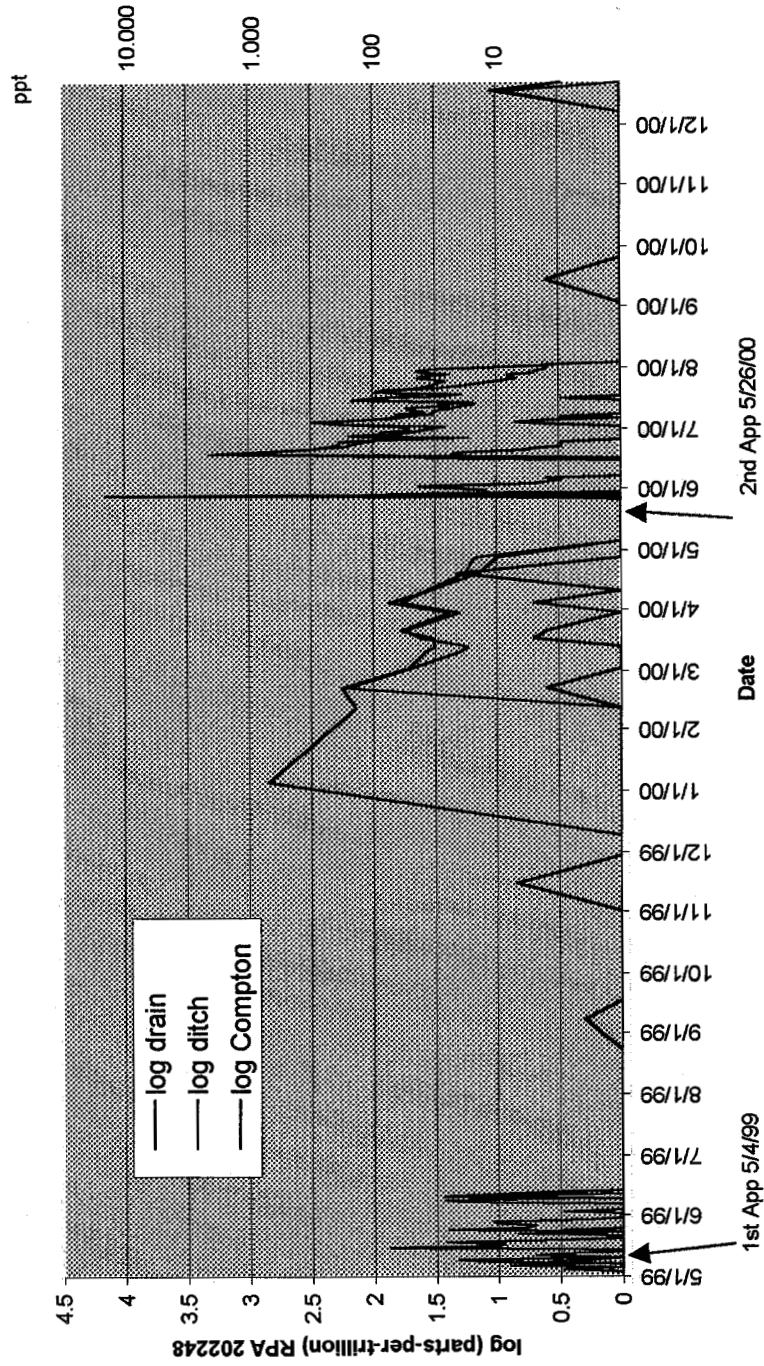
Figure 1: New Holland OH 2-year Tile Drain study

The study results for 2000 are similar to those seen in the other tile drain studies with daily sampling. As shown in figure 1, concentrations of the degradate RPA202248 were highest (peak value over 10 ppb or 10,000 parts-per-trillion) in the drain soon after the second application in 2000. Concentrations declined through June and July to between 10 and 100 parts-per-trillion.

The study results for 1999 differ, however. Because of the drought, little or no tile drainage was produced through the summer and into the fall. When the rains returned in the winter of 2000, tile flow resumed, and RPA202248 exceeded 300 ppt in January. The concentration of RPA202248 declined to about 100 ppt by March and 30 ppt by April.

This behavior suggests that in the absence of adequate rainfall, isoxaflutole persists in soil where it remains to be re-mobilized at a later time. A terrestrial field dissipation (TFD) study in California (MRID 43904838) also suggested that isoxaflutole would persist in soil if rainfall was inadequate. The dissipation half-life of RPA202248 in that study was 133 days, compared to about a month at the three other TFD sites.
