**Coal Combustion Residue Impoundment  
Round 9 - Dam Assessment Report**

***Plant McIntosh***

***Ash Dike***

***Georgia Power Company  
Rincon, Georgia***

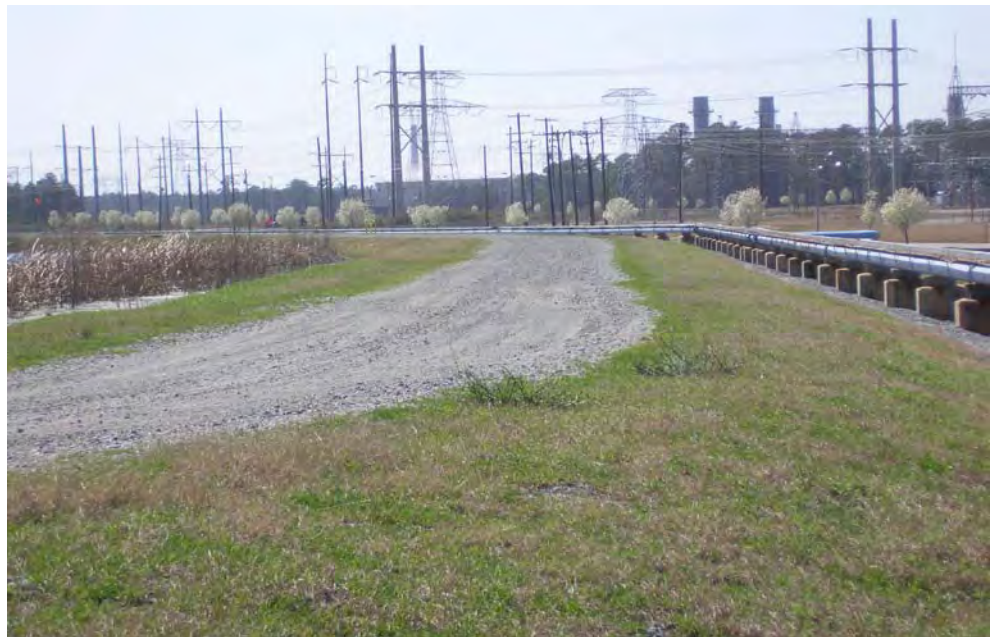
Figure 5.2.1-1 – West Embankment Crest

The crest of the west dike had a crushed stone gravel surface and had no sign of depressions, tension cracks, or other indications of shear failures. Previous inspection reports reviewed by Dewberry did not indicate issues concerning the embankment crest. Figure 5.2.1-1 shows the crest of the dike near the north groin.

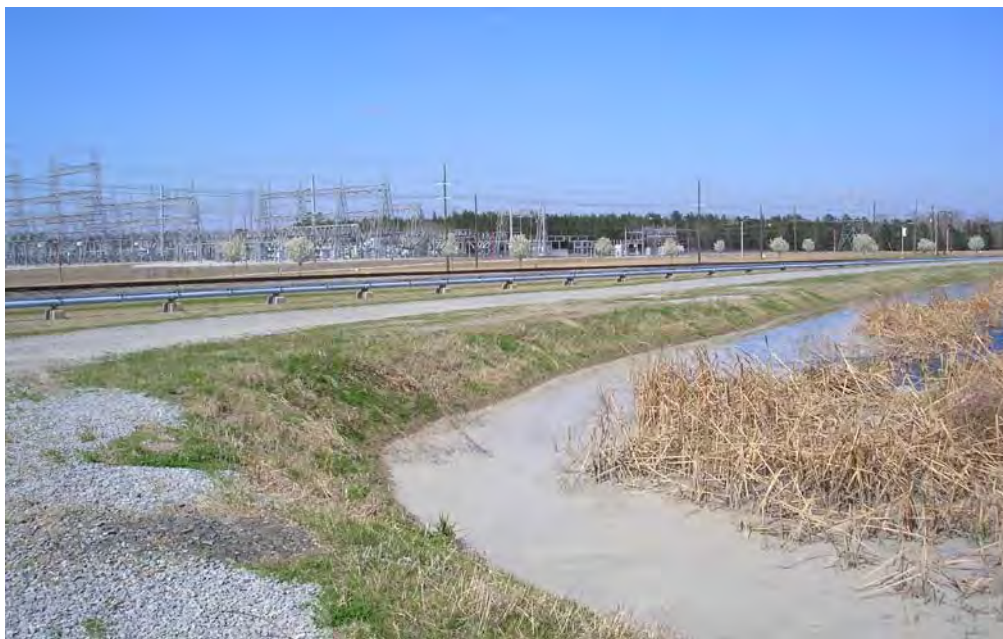
Figure 5.2.2-1 – Inside Slope of West Embankment at South Groin

The upstream/inside slope of the west embankment is grassed. There were no observed scarps, sloughs, bulging, cracks, depressions, or other indications of slope stability or significant erosion. There are a few gravel spots where erosion rills have been repaired. Figure 5.2.2-1 shows the inside slope of the west embankment.

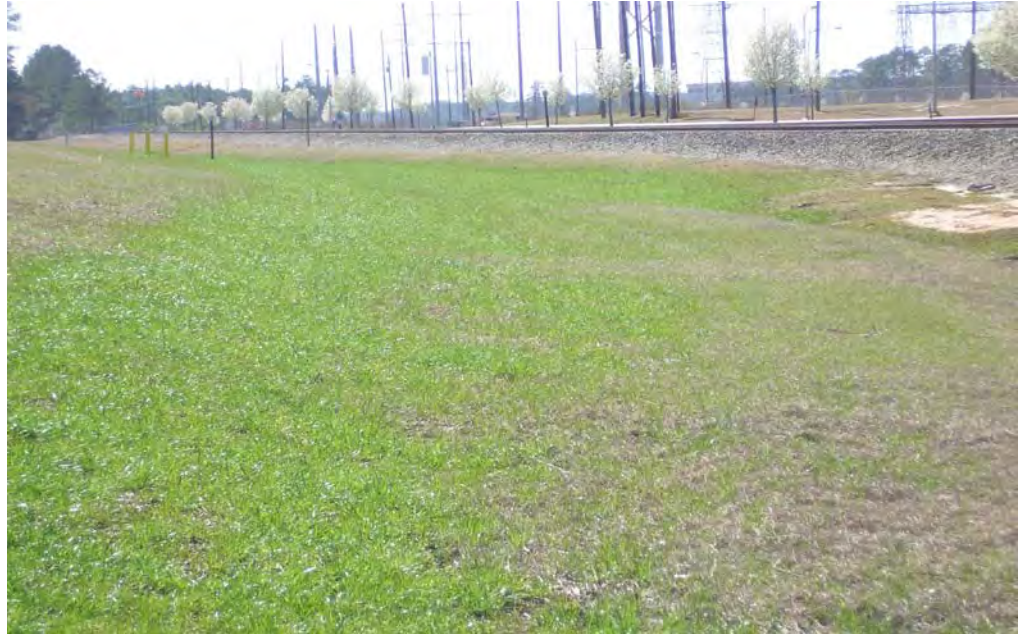
Figure 5.2.3-1 – West Embankment Outside Slope

Observations of potential seepage near the toe of the west embankment in 2004 resulted in recommendations for installation of a new filter drain (See Appendix A Doc 10). The 2010 *Annual Dam Safety Inspection* report (See Appendix A Doc 12) indicated a sump and subsurface drains had been installed along a portion of the toe of the west embankment. The report recommended extending the drain systems southward to the end near the center of the embankment. Newly sowed grass along the toe of the embankment indicated the area of the extended drain system. Figure 5.2.3-1 shows the grassed outside slope of the west embankment.

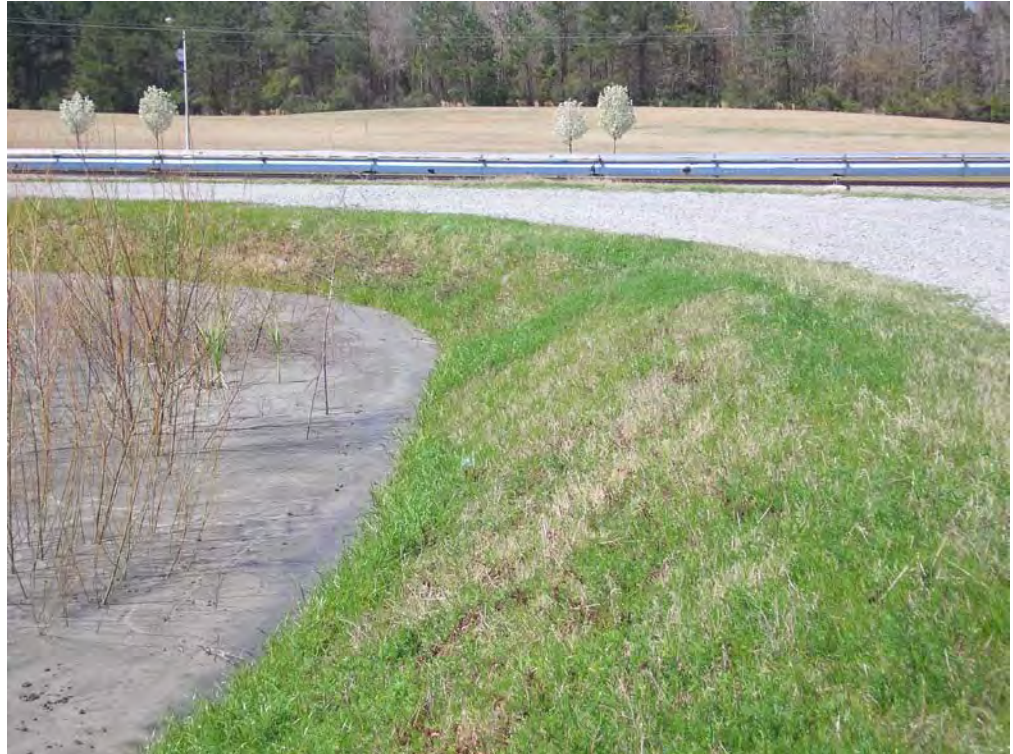
Figure 5.2.4-1 – West Embankment Inside Groin at North End

The west embankment was constructed as part of a continuous perimeter embankment without abutments. West embankment groins are vegetated with grass. No uncontrolled seepage was observed along the west embankment groins. Figure 5.2.4-1 shows the interior groin at the north end of the west embankment.

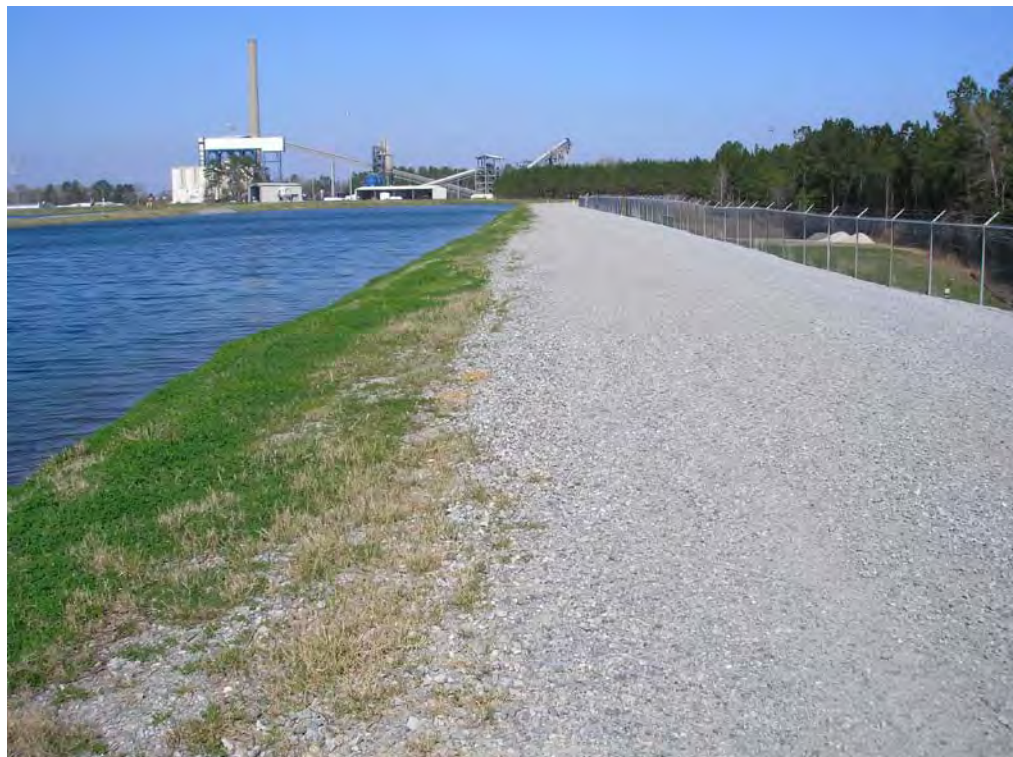
Figure 5.3.1-1 – Crest of East Embankment near South End

The east embankment crest had a crushed stone surface and no sign of depressions, tension cracks, or other indications of shear failures. Previous inspection reports reviewed by Dewberry did not indicate issues concerning the embankment crest. Figure 5.3.1-1 shows the crest of the dike.

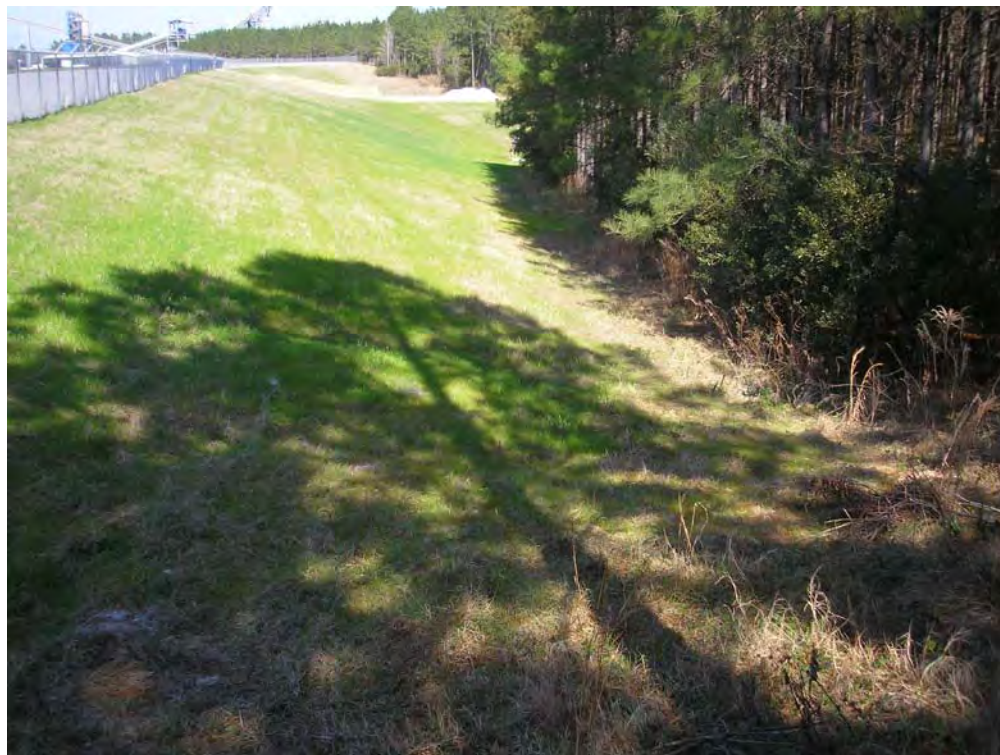
Figure 5.3.3-1 – East Embankment Outside Slope

The outside slope of the west embankment is vegetated with grass. There were no observed scarps, sloughs, bulging, cracks, depressions, or other indications of slope stability or significant erosion. Figure 5.3.3-1 shows the outside slope of the east embankment.

The 2009 *Annual Dam Safety Inspection* report (See Appendix A Doc 10) noted a damp area and hydrophilic vegetation. The report recommended a subsurface drain to control potential localized seepage through the east embankment. The 2010 *Annual Dam Safety Inspection* report (see Appendix A Doc 12) indicated the subsurface drain was installed.

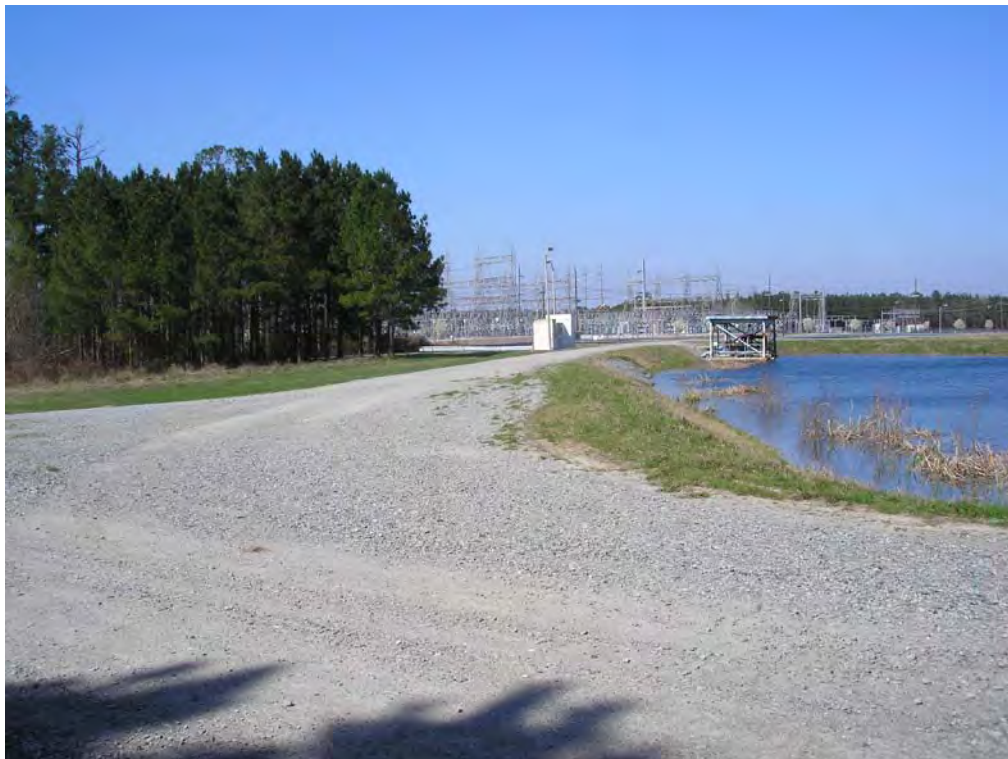
Figure 5.3.4-1 East Embankment Inside Groin at South End (East Embankment on Right Side of Photograph)

The east embankment was constructed as part of a continuous perimeter embankment without abutments. East embankment groins are vegetated with grass. No uncontrolled seepage was observed along the west embankment groins. Figure 5.3.4-1 shows the interior groin at the south end of the east embankment.

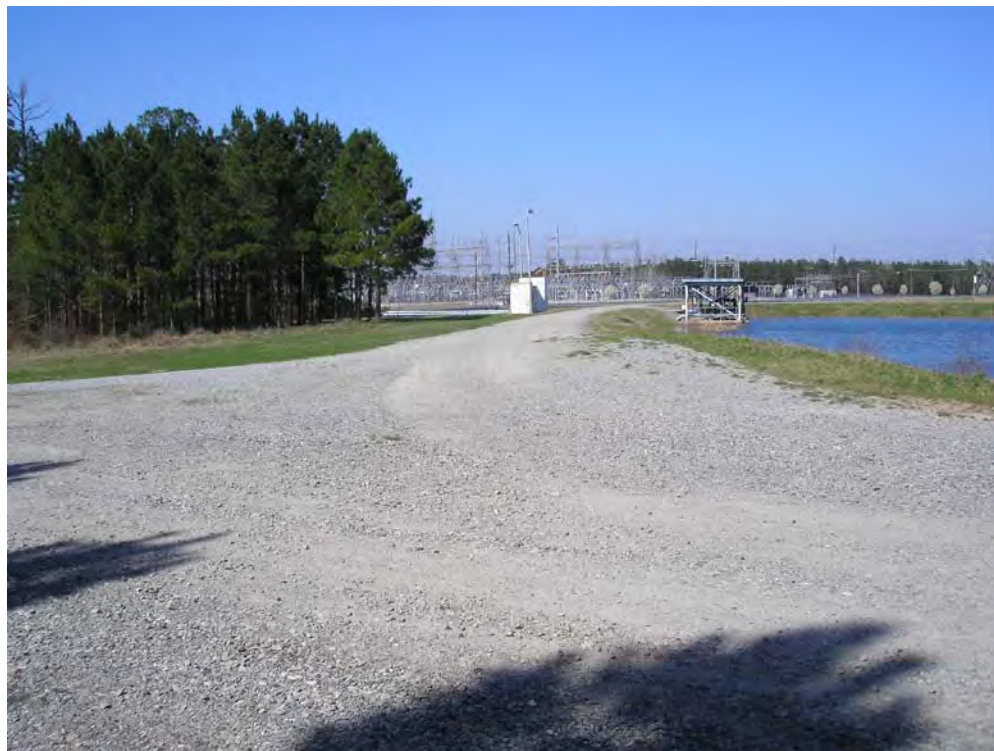
Figure 5.4.1-1 – South Embankment Crest at East End

The south embankment crest had a crushed stone surface and no sign of depressions, tension cracks, or other indications of shear failures. Previous inspection reports reviewed by Dewberry did not indicate issues concerning the embankment crest. Figure 5.4.1-1 shows the crest of the dike.

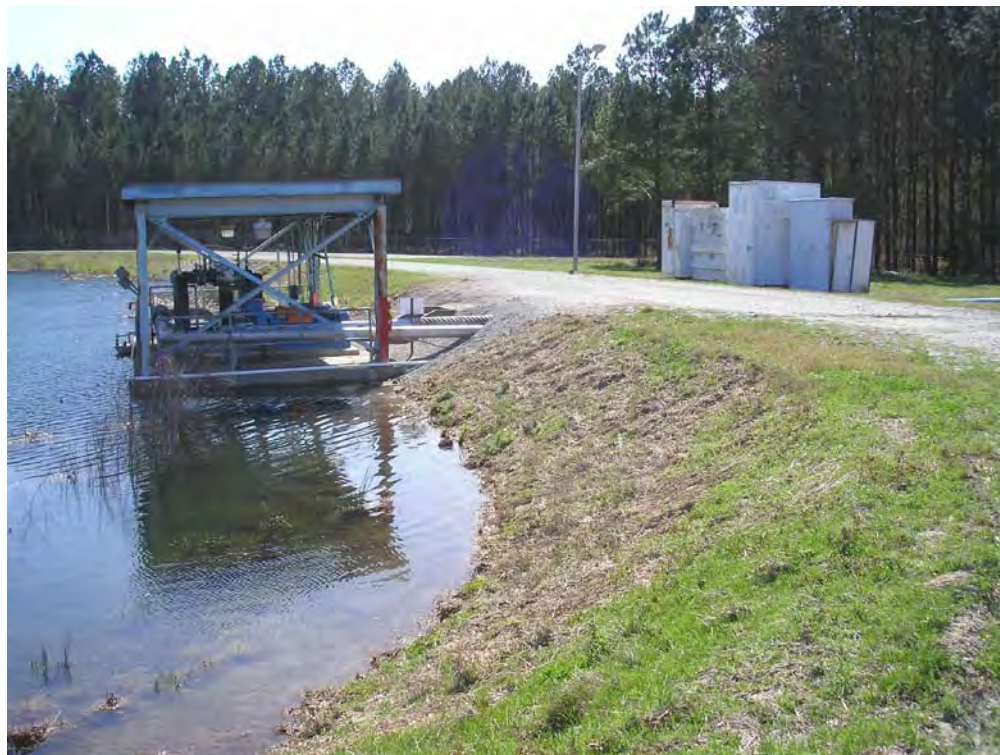
Figure 5.4.2-1: South Embankment Inside Slope

The upstream/inside slope of the south embankment is grassed. There were no observed scarps, sloughs, bulging, cracks, depressions, or other indications of slope stability or significant erosion. There are a few gravel spots where erosion rills have been repaired. Figure 5.4.2-1 shows the inside slope of the south embankment.

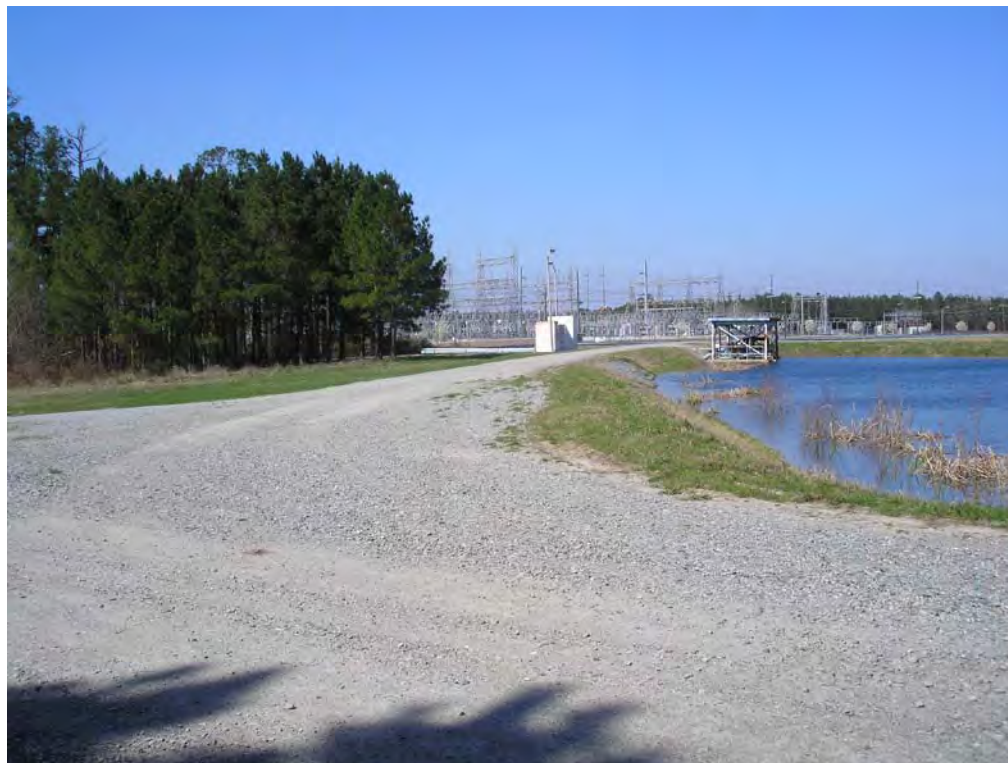
Figure 5.4.3-1 – South Embankment Downstream Slope (Left Side of Gravel Surfaced Crest).

The downstream or outside slope of the south embankment is only a few feet high and very flat to transition to existing grade south of the impoundment. The outside slope of the south embankment is vegetated with grass. There were no observed scarps, sloughs, bulging, cracks, depressions, or other indications of slope stability or significant erosion. Figure 5.4.3-1 shows the outside slope.

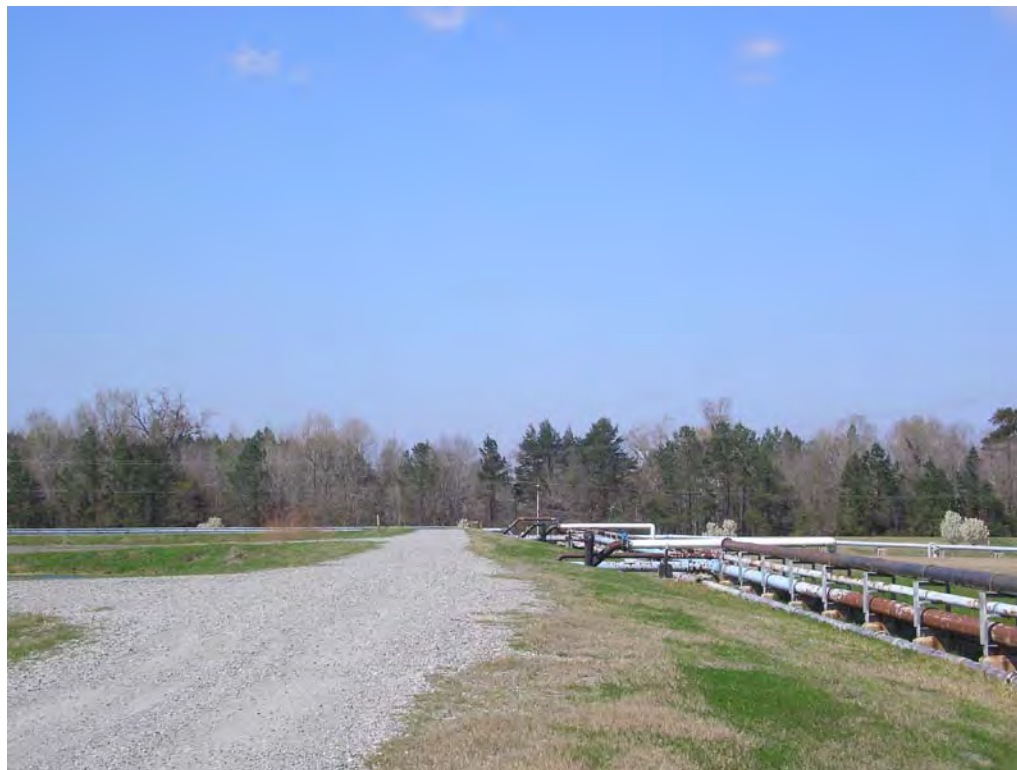
Figure 5.5.1-1 – North Embankment Crest and Outside Slope

The crest of the North Embankment was surfaced with a gravel roadway used for servicing the ponds, embankments, and piping system. No sign of depressions, tension cracks, or other indications of shear failures were observed. Figure 5.5.1-1 shows the crest, the outside slope and the adjacent sluice piping system.

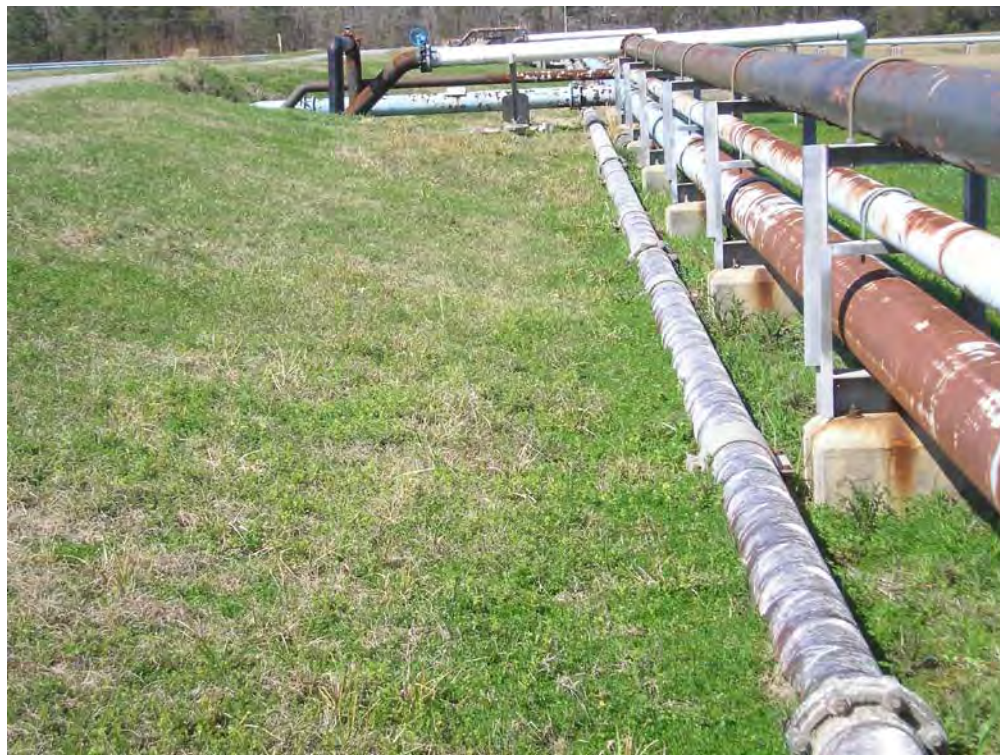
Figure 5.5.3-1 – North Embankment Outside Slope.

The downstream or outside slope of the north embankment is only a few feet high and very flat to transition to existing grade north of the impoundment. The outside slope of the north embankment is vegetated with grass. There were no observed scarps, sloughs, bulging, cracks, depressions, or other indications of slope stability or significant erosion. Figure 5.5.3-1 shows the outside slope of the north embankment.

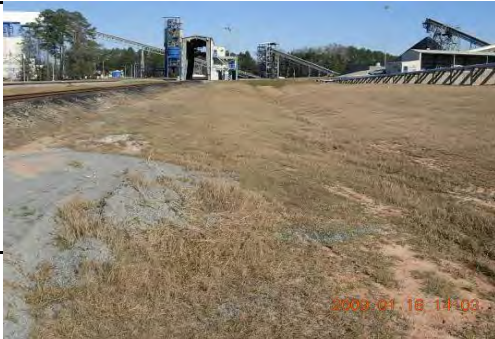
| Location<br>No.<br>Photo No. | Description | |
|---|---|---|
| 308<br>2875 | Ditch between railway and ash cell A, looking northeast. There was no seepage evident at the time of this inspection. Cell A has been low for some time and was at the mark of 11 on the staff gage. <b>When this pond level is raised this area should be monitored.</b> | |

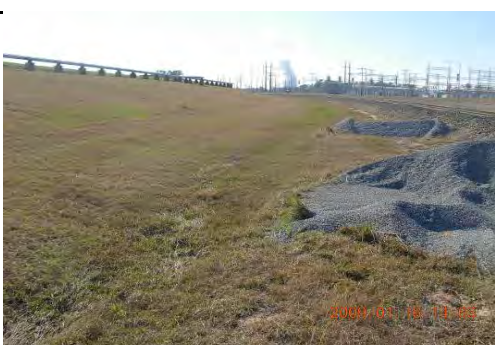
| Location<br>No.<br>Photo No. | Description | |
|---|---|---|
| 308<br>2876 | Ditch between railway and ash cell A, looking southwest. This area was the site of seeps in 2003. pH testing of the seepage water at that time showed a very high reading, indicating that the water was coming from the ash cell. At that time stockpiles of sand, #89 stone, and #57 stone were stockpiled there to be used for an emergency filter in the event of a boil. <b>These stockpiles should be restored.</b> | |

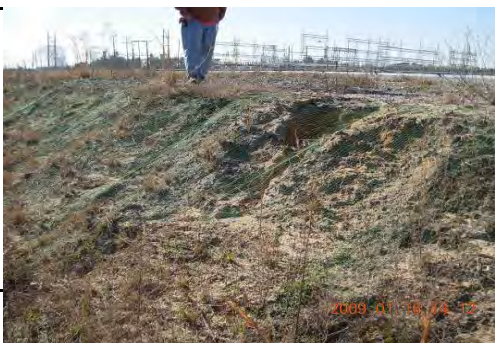
| Location<br>No.<br>Photo No. | Description | |
|---|---|---|
| 309<br>2877 | Erosion gully at crest of ash cell A. The plastic netting indicates that some attempt to repair and regrass this area has been made. It appears that rainwater from the crest concentrates and runs down the slope at this point. Installing a plastic down drain in this location might be the best way to deal with this problem. | |

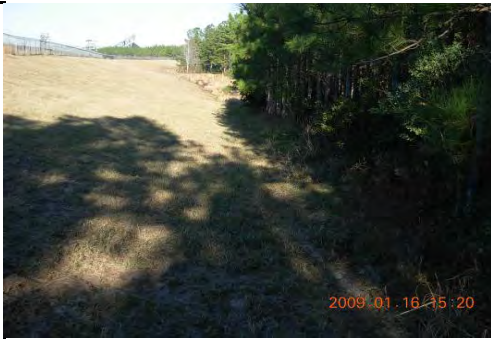
| Location No.<br>Photo No. | Description | |
|---|---|---|
| 316<br>2894 | Toe of cell C east dike. Note trees up to toe of slope. These trees would make it difficult to get emergency equipment in to the toe to work. <b>The trees should be cleared a distance of 20 feet from the toe of the east dike of ash cell C.</b> The east slope had 4" diameter trees on it until two years ago. The trees were cut off flush with the ground and the roots left in place. | |

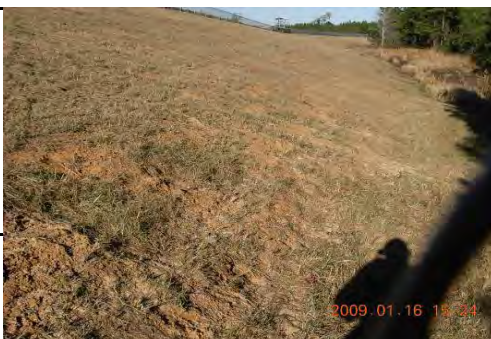
| Location No.<br>Photo No. | Description | |
|---|---|---|
| 317<br>2895 | Toe of cell C east dike. Note damage to the grass due to mower tires. <b>The mowing techniques and equipment should be evaluated to see if a more suitable technique or type of equipment is available.</b> | |

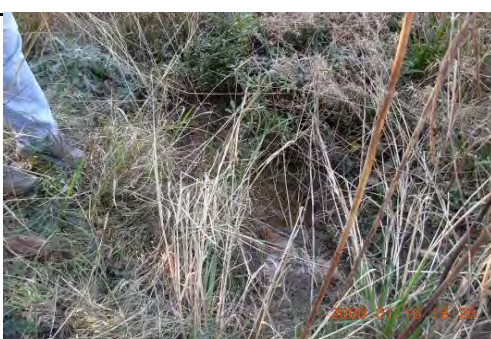
| Location No.<br>Photo No. | Description | |
|---|---|---|
| 318-319<br>2896 | Boggy area at toe of ash cell C east dike with plants typical of a swampy area, except this location is on a slope. This location appears to be lower in elevation than the bottom of ash cell C. Since ash cell C is almost empty and this area is still wet, there is potential for increased seepage when ash cell C is refilled. <b>A subsurface drain should be installed in this area prior to refilling ash cell C.</b> | |

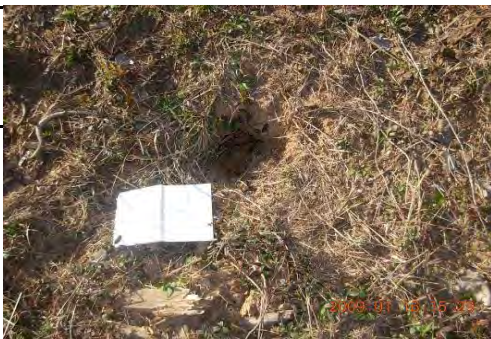
| Location No.<br>Photo No. | Description | |
|---|---|---|
| 320<br>2898 | Ash cell C east dike toe: Armadillo burrow. This burrow should be filled in. | |

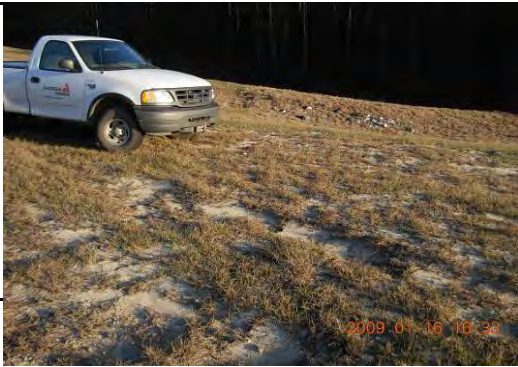
| Location<br>No.<br>Photo No. | Description | |
|---|---|---|
| 324<br>2902 | Closed monofill: 'The surface of the closed landfill has a decent cover of grass for the most part, but <b>there is a need for some gravel on the driving lanes. A general application of seed and fertilizer would be a good investment.</b> | |

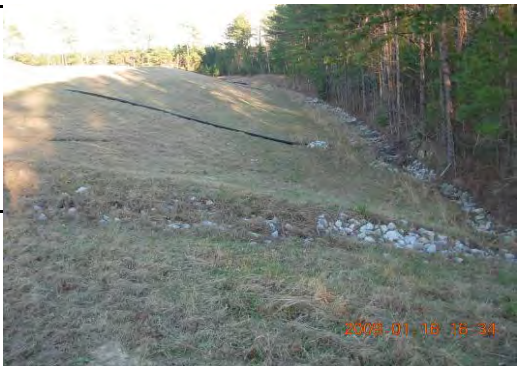
| Location<br>No.<br>Photo No. | Description | |
|---|---|---|
| 324<br>2903 | There was some minor scalping from the mowers noted. <b>It would be worthwhile to caution the mowing crew and to review the suitability of the mowing equipment and techniques to this task.</b> | |

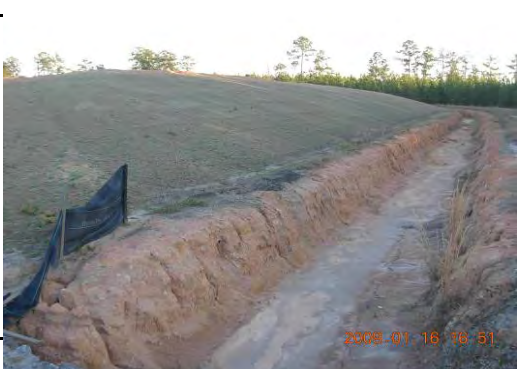
| Location<br>No.<br>Photo No. | Description | |
|---|---|---|
| 326<br>2904 | The drainage ditches around the perimeter of the ash stack have been cut with vertical sides. This has lead to erosion and makes maintaining the ditch impossible. These ditches were designed with 2:1 side slopes. The present configuration could eventually lead to erosion that will expose ash. <b>The ditches need to be regraded to the design configuration and grassed.</b> | |

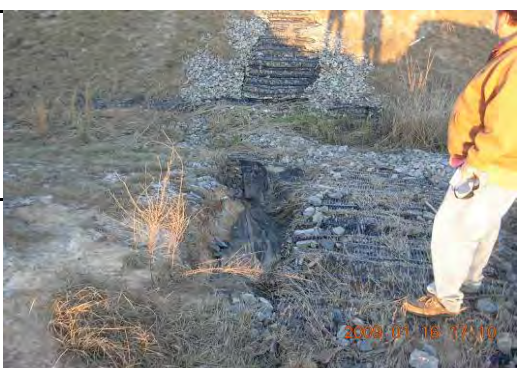
| Location<br>No.<br>Photo No. | Description | |
|---|---|---|
| 327<br>2909 | Runoff has cut gullies on either side of the gravel/geogrid mattress where the perimeter ditches meet. <b>This gully should be built up with Type III riprap bedded on #57 stone and choked with #57 stone.</b> | |

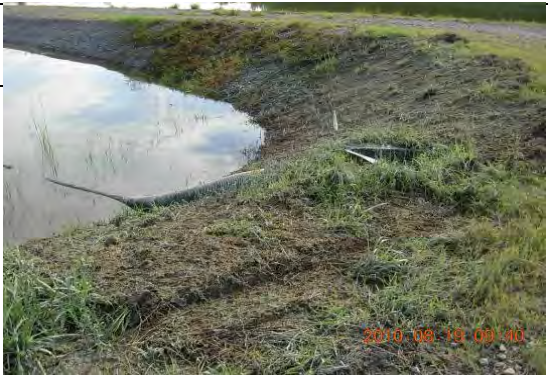
| Photo No. | Description | Photo |
|---|---|---|
| 4097 | Interior slope of south corner of B cell. Note plastic pipe down drain installed to address erosion problems. | A close-up photograph of a grassy and gravelly slope next to a body of water. A black plastic pipe is visible, partially buried in the ground, extending from the slope towards the water. The water reflects the sky. A timestamp "2010-08-19-09-40" is visible in the bottom right corner of the photo. |

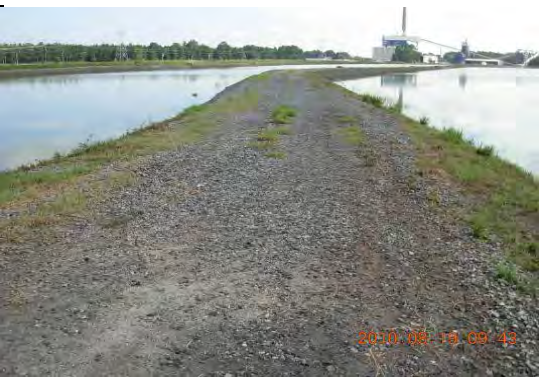
| Photo No. | Description | Photo |
|---|---|---|
| 4098 | BC dike looking from northeast from south end of dike. Gravel has been added to the crest to address past rutting issues. This repair has been successful. | A photograph of a gravel-covered dike or road stretching from the foreground into the distance, separating two bodies of water. The gravel surface appears well-maintained. In the background, industrial structures are visible across the water. A timestamp "2010-08-19-09-42" is visible in the bottom right corner of the photo. |

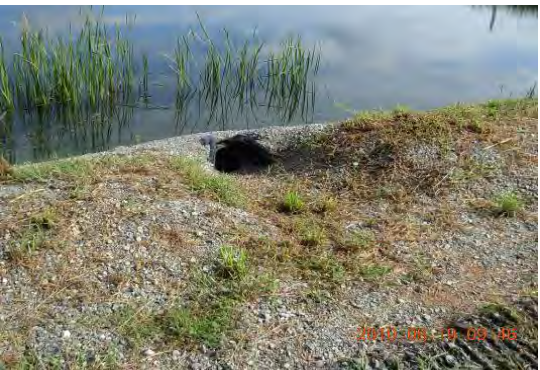
| Photo No. | Description | Photo |
|---|---|---|
| 4099 | Down drain installed to deal with concentrated runoff from crest road gullying slope of BC dike. This repair has been successful. | A close-up photograph of a black down drain pipe installed in a gravelly area on a dike. The pipe is surrounded by gravel and some sparse vegetation. The water is visible in the background. A timestamp "2010-08-19-09-43" is visible in the bottom right corner of the photo. |

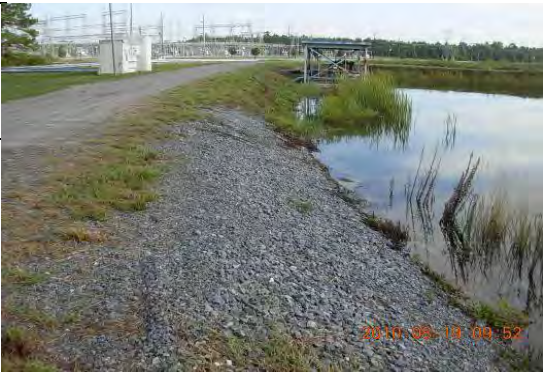
| <div> <div>Plant McIntosh</div> <div>2010 - Ash Cell Dam Safety Inspection Photographs</div> <div>19 &amp; 31, 2010</div> <div>August</div> </div> | | |
|---|---|---|
| 4100 | West interior slope of D cell: gravel bolster installed to address past sluffing of the interior slope. This repair has been successful. | A photograph showing a gravel bolster installed along the west interior slope of the D cell. The gravel is dark and contrasts with the surrounding vegetation. A body of water is visible to the right. A timestamp '2010.08.19.08:52' is visible in the bottom right corner. |

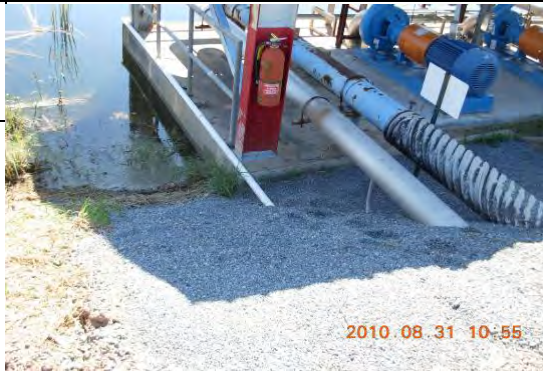
| <div> <div>Plant McIntosh</div> <div>2010 - Ash Cell Dam Safety Inspection Photographs</div> <div>19 &amp; 31, 2010</div> <div>August</div> </div> | | |
|---|---|---|
| 4165 | Follow-up photo on 8/31/2010: Gravel has been added to the oversteepened slope noted above. | A follow-up photograph showing gravel added to the oversteepened slope. The gravel is dark and covers a significant portion of the slope. A body of water is visible to the left. A timestamp '2010.08.31.10:55' is visible in the bottom right corner. |

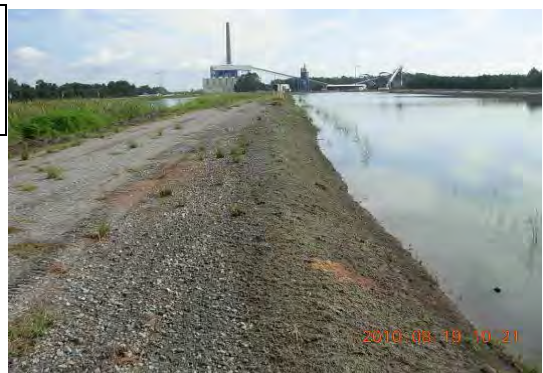
| <div> <div>Plant McIntosh</div> <div>2010 - Ash Cell Dam Safety Inspection Photographs</div> <div>19 &amp; 31, 2010</div> <div>August</div> </div> | | |
|---|---|---|
| 4102 | AB dike looking northeast from south end. Note recently dressed and hydro-seeded slope. | A photograph showing the AB dike looking northeast from the south end. The dike is covered in gravel and has a recently dressed and hydro-seeded slope. A body of water is visible to the right. A timestamp '2010.08.19.10:21' is visible in the bottom right corner. |

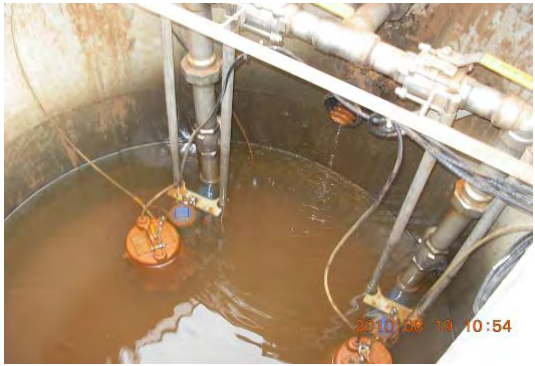
| Photo No. | Description | Photo |
|---|---|---|
| 4112 | Interior of south sump at toe of C dike. Note small stream of water entering sump from drain. Also note iron oxide deposition in drain and in sump. | |

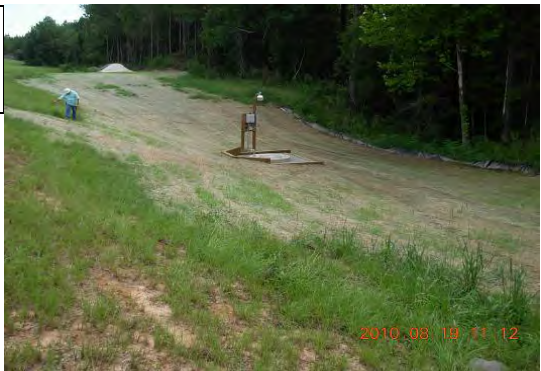
| Photo No. | Description | Photo |
|---|---|---|
| 4113 | Sump at south end of C dike. Some additional work is needed to address poor grass cover on slopes. | |

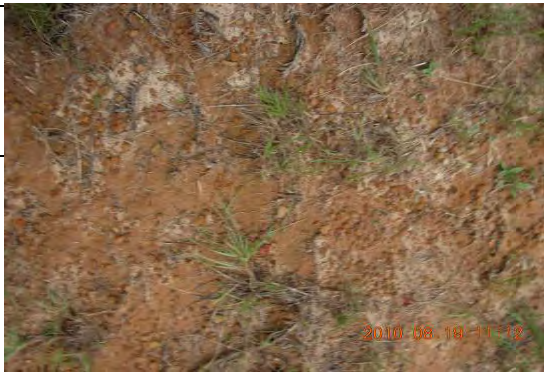
| Photo No. | Description | Photo |
|---|---|---|
| 4114 | There was not sign of the boils previously noted in the area of the new toe drain (which discharges to the sump) along the toe of C dike in its southern section. | |

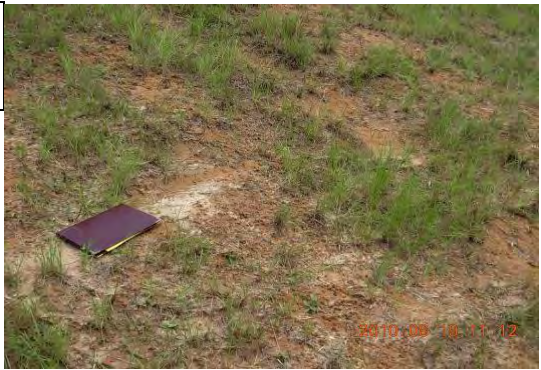
| Photo No. | Description | Photo |
|---|---|---|
| 4115 | Bare spots on slope of C dike. The grass is thin. The area should be tilled, seeded, fertilized and mulched. | |
