FACILITY SITING REPORT

DECEMBER 2004

United States Army
Corps of Engineers

Evaluation of the FCSs

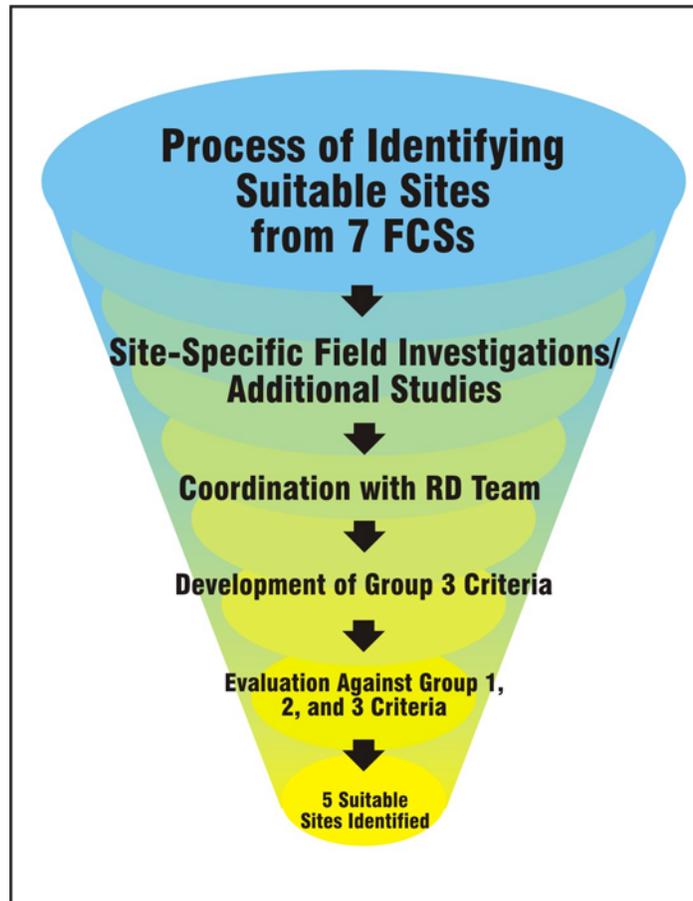
Figure 3-1 Process of Identifying Suitable Sites from 7 FCSs

Screening and evaluating the sites defined in more detail the existing resources, features, and conditions within (and in the near vicinity of) each of the FCSs. The objective of this phase was to determine which sites were suitable for the construction and operation of a sediment processing/transfer facility. Sites considered suitable have been identified as the Suitable Sites (see Figures 3-1 and 3-2).

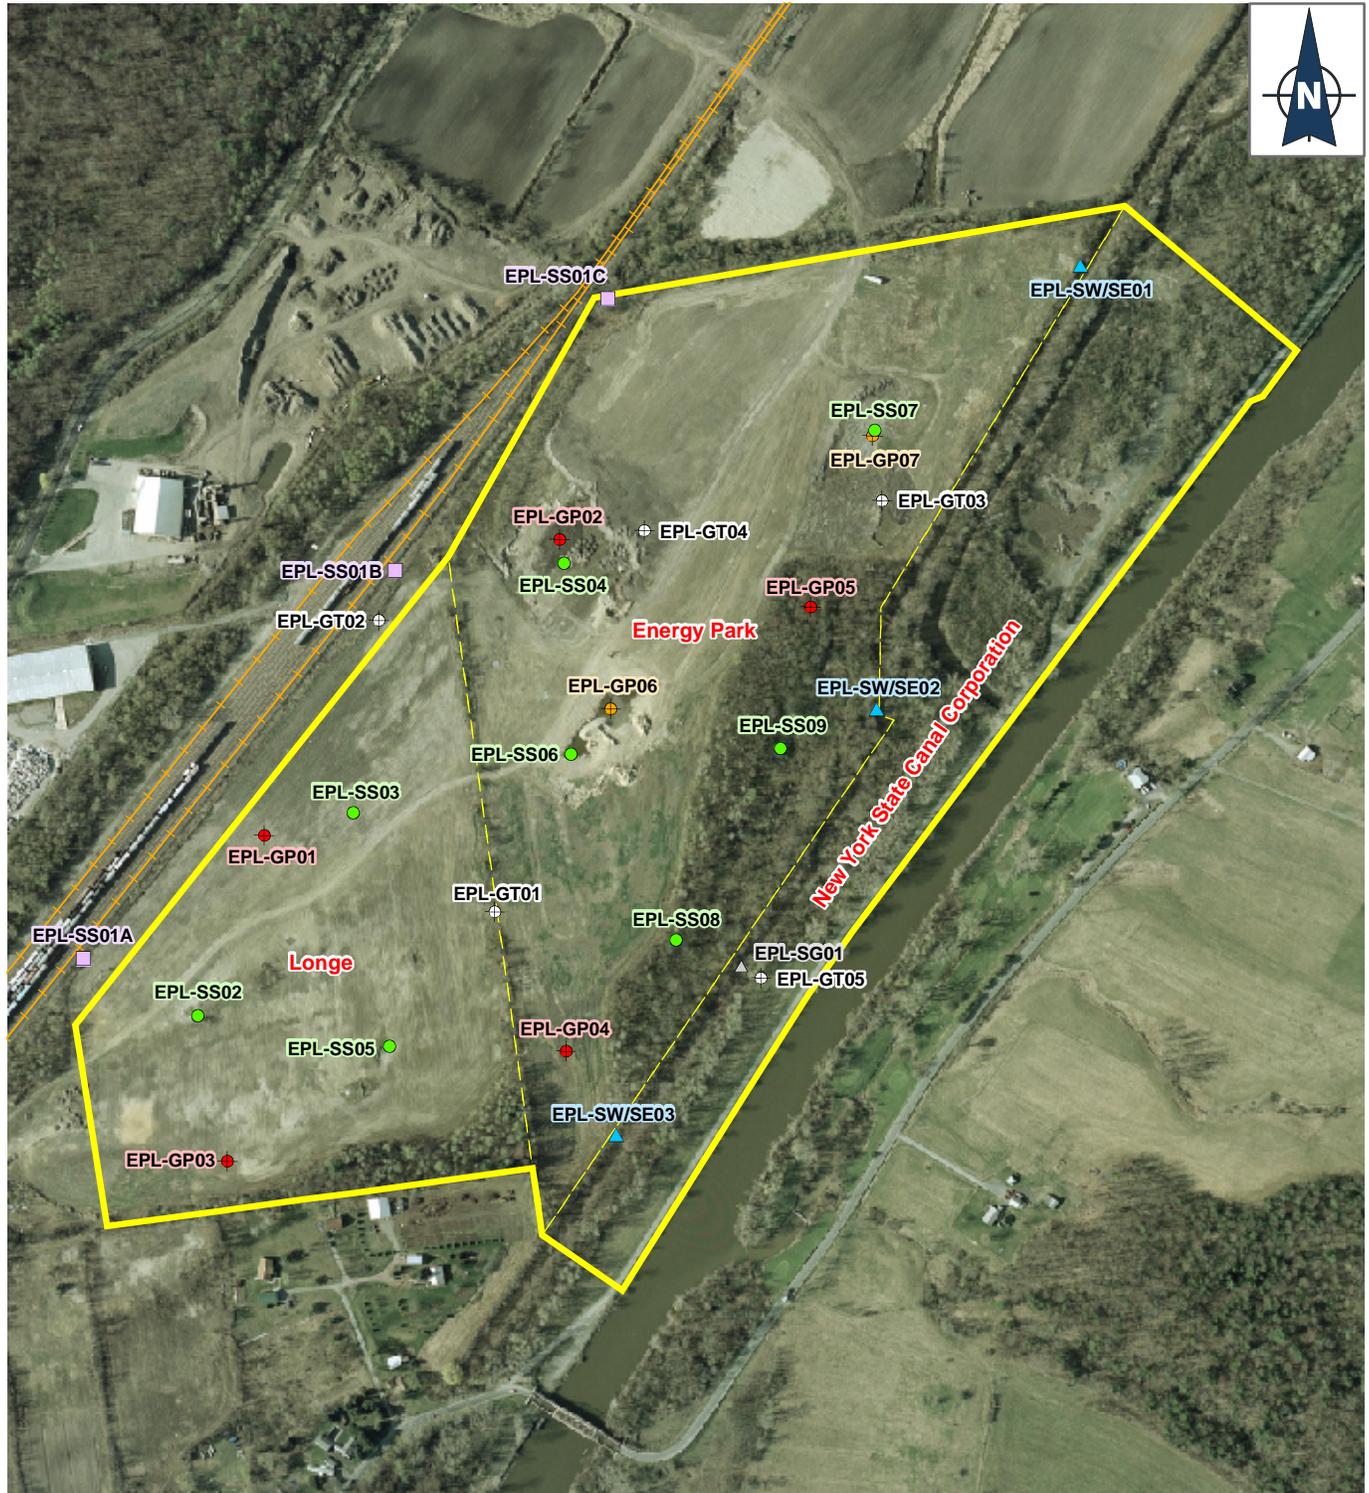
The subsurface data collected during the Phase II ESA indicates that site soils generally consist of silty sands underlain by sand with trace amounts of gravel starting at a depth of 10 feet below ground surface (BGS). Silt content decreased with depth starting at approximately 12 feet BGS, while the coarser fraction of unstratified sands correspondingly increases with depth. Site standard penetration test (SPT) n-values (the sum of the blows recorded over the second and third 6-inch SPT intervals) generally ranged from 4 to 11 in granular soils, indicating a soil density of loose to moderately dense. One exception is the 8.5- to 9.5-foot interval in the northwest area, where moderately dense sands yielded an n-value of 24. Clay was encountered along the west-central portion of the site at depths of approximately 18 and 21 feet BGS. Recorded SPT n-values indicate its consistency was very soft.

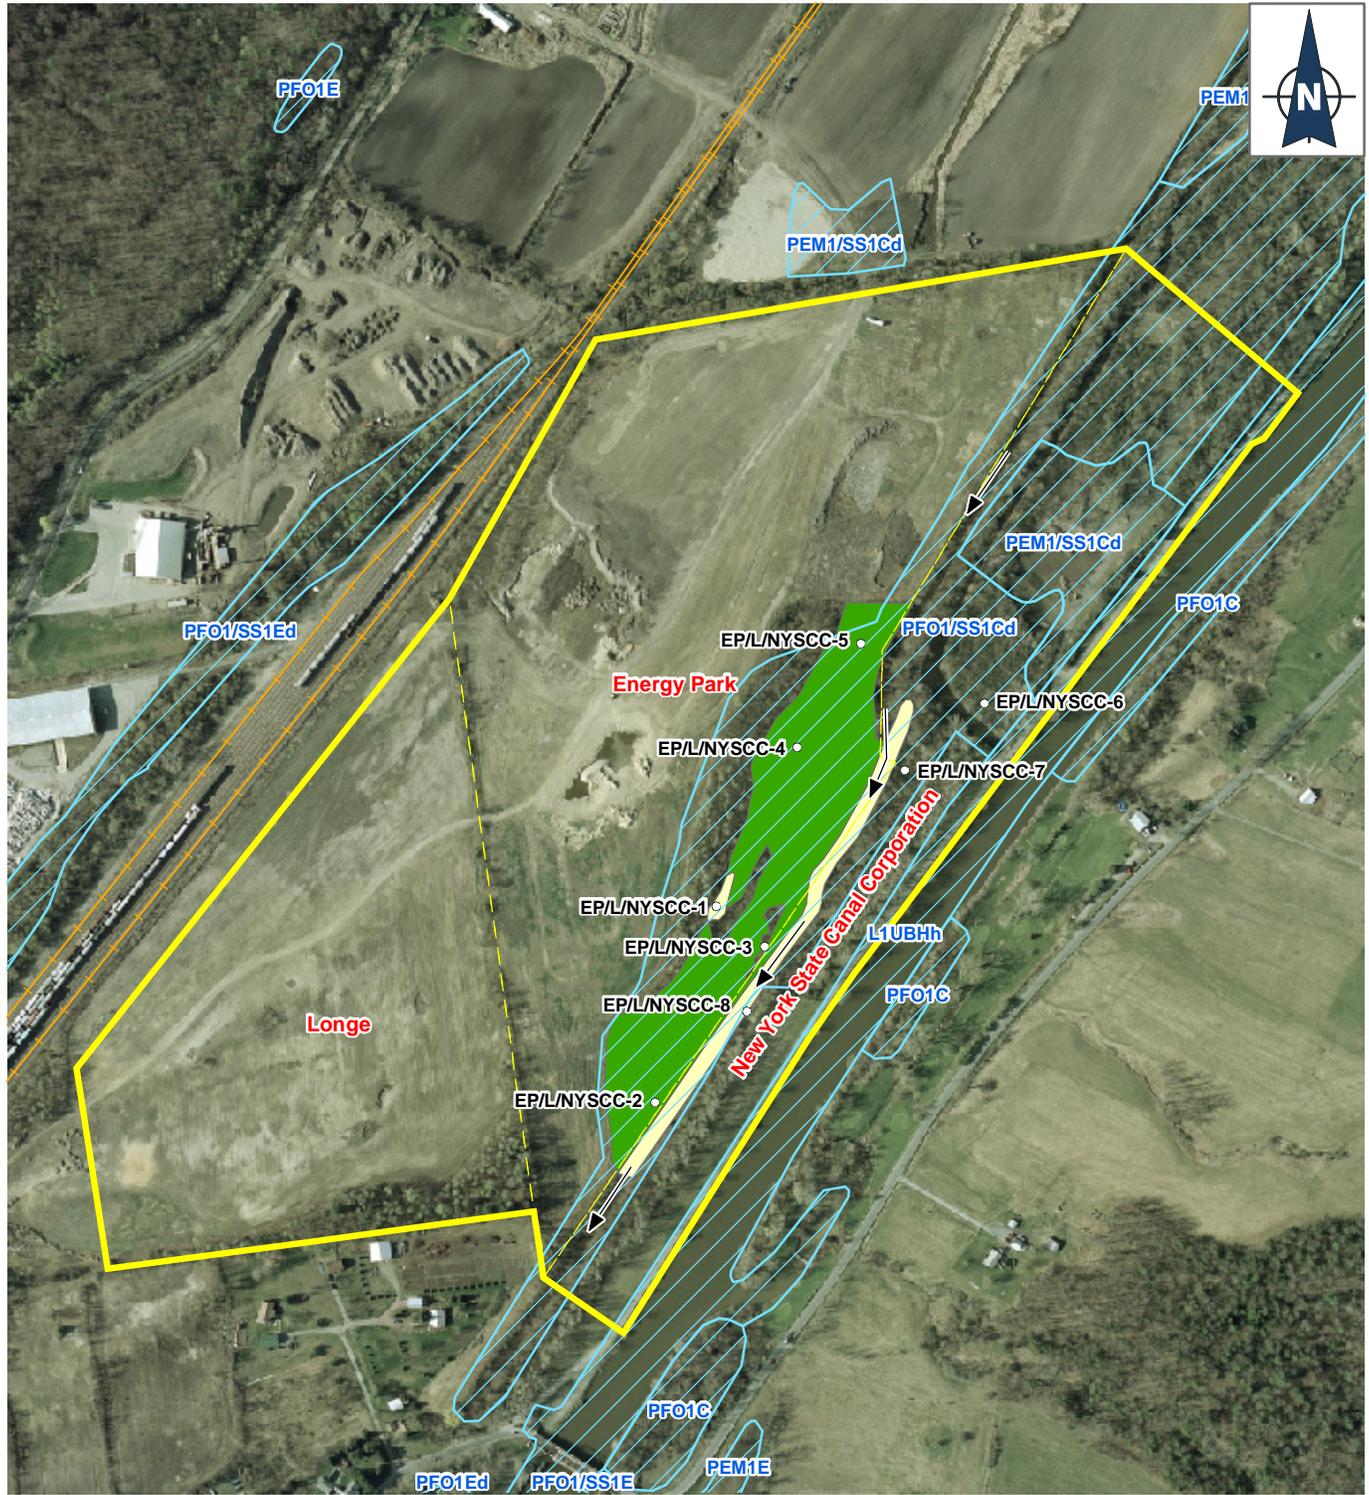
Field determination procedures resulted in the delineation of one wetland area covering approximately 8.42 acres on the Energy Park parcel (see Table 3.2.1-1 and Figure 3.2.1-4). The discrepancy between field-delineated acreage and acreage indicated by NWI mapping may have been caused by alterations to the landscape from logging and filling activities on these parcels. However, NWI mapping primarily uses remote sensing techniques (i.e., photo interpretation) without field confirmation and therefore does not necessarily represent an accurate description of on-site conditions. Rather, the mapping is a basis for further investigation.

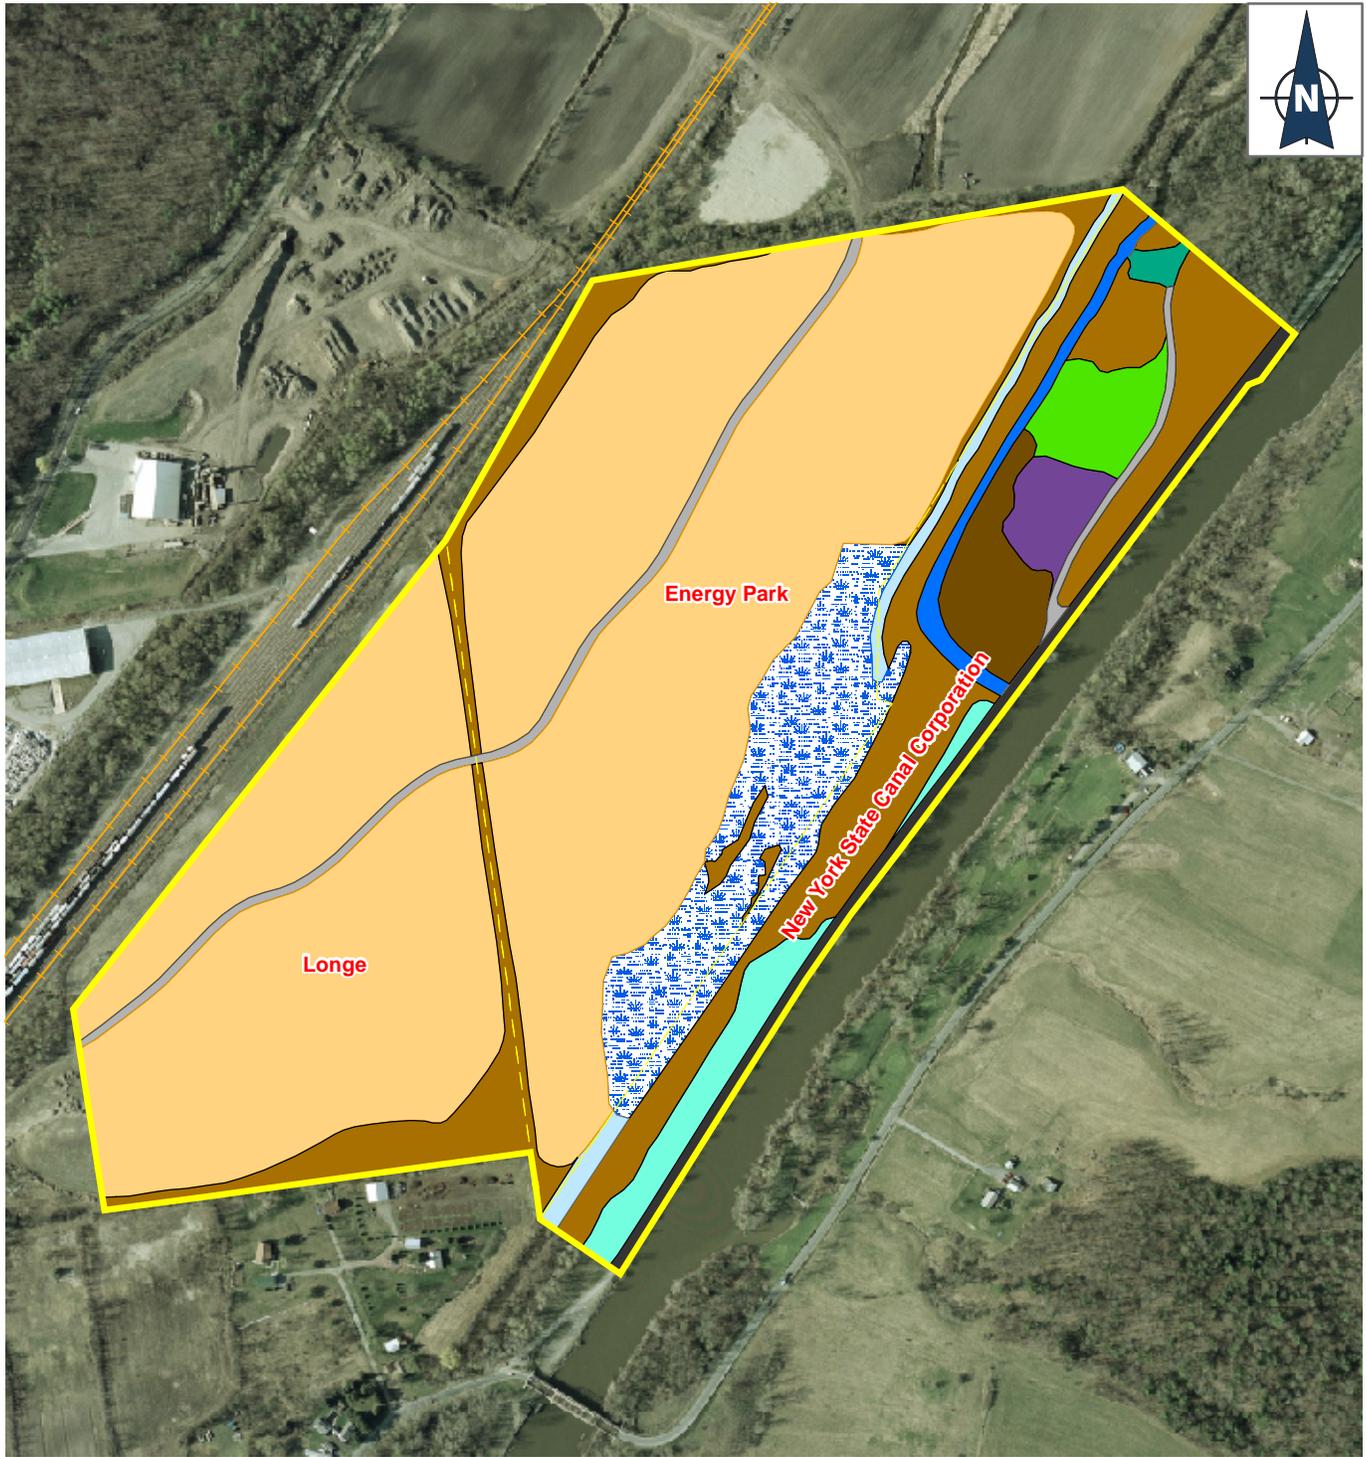
Using *Ecological Communities of New York State* (Edinger et al. 2002) as a framework for habitat identification, twelve community types were found on this 104-acre site (see Figure 3.2.1-6). No sensitive or rare habitats were among them. Cropland temporarily covers approximately 61% of the site. Other communities include successional northern hardwoods, mowed lawn, wetlands, dredge spoils with successional species, and successional shrubland. Some locations contain larger, older trees (diameter at breast height [dbh] of 12 to 27 inches) that are isolated inside early to middle-aged stands.
