EROSION CONTROL

STREAM BANK STABILIZATION UTILIZING COMPOST

An area with heavy pedestrian and pet traffic was restored with a combination of native vegetation, composted biosolids and yard trimmings.

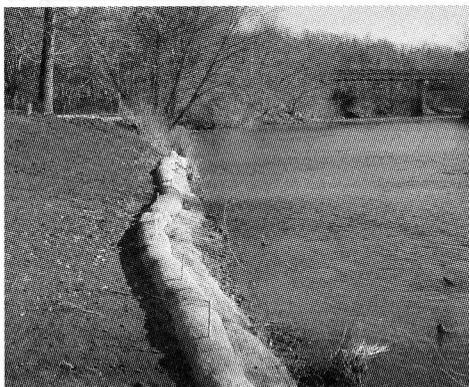
Following use of compost blankets, filter berms and sometimes "sock" containers, the stream bank and buffer have been completely stabilized.

Screened (half-inch minus) compost made from biosolids and yard trimmings was provided by Athens Clarke County Composting. It was blended with some unscreened compost (six-inch minus). A two-inch compost blanket was applied to the slope (by volunteers) and seeded with rye, switchgrass and false sea oat. Geotextile erosion control mats were placed directly on top of the compost blanket and staked in. A compost filter berm — 3-feet wide by 1.5-feet high — made of the unscreened material was placed at the shoulder of the slope. Sediment filters filled with hay were used at the base of the slope next to the river's edge. Steps were built adjacent to the project for public access to the river, diverting pedestrian and pet traffic from the remediated stream bank.

The stream buffer had to be stabilized as well to protect the stream bank. To restore natural woody vegetation to the buffer area, approximately 20 horizontal feet from the top of the bank was disturbed along a 150-foot reach (3,000 sq. ft.). A compost blanket was applied. Willow was planted on the bank slope and the top of the bank was planted with a mix of bottomland hardwood species. About 100 cubic yards of compost were used for the whole project.

Although several flood events completely submerged the compost blankets and much of the staked vegetation, the compost blanket held in place while some of the woody vegetation was destabilized and/or washed down stream. This project was a particular challenge as concentrated storm runoff flowed from a hill above and over the stream bank in addition to rising river conditions that submerged the bank at its lower portions. Some reseeding of grass was done after severe storm events. Today, the stream bank and buffer have been completely vegetated, stabilized and open to the public, due in part to the use of compost blankets and filter berms.
