UNITED STATES ENVIRONMENTAL PROTECTION AGENCY
FINAL DECISION AND RESPONSE TO COMMENTS

TE CONNECTIVITY
LANDISVILLE, PENNSYLVANIA
EPA ID NO. PAD980554778

Attachment B: TE Connectivity Plating Pit Investigation Report, December 14, 2014

Re: Plating Pit Sampling Findings
Kauffman Road Facility
Landisville, Lancaster County
HRG Project No. R004625.0435

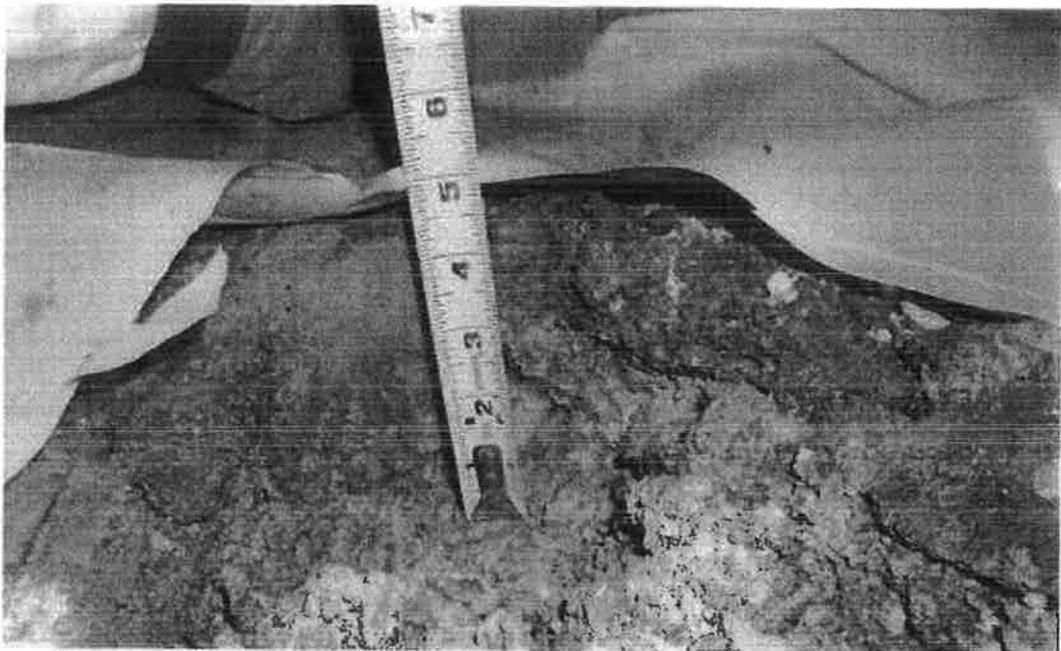
one inch. At S-23, deterioration extended to a depth of four inches. The deteriorated concrete or rotten concrete was characterized as a wet paste. Concrete below the deterioration was dry and intact. Photographs of locations S-21 and S-23 are attached.

The four locations sampled by HRG are representative of worst-case conditions where deterioration extends below the surface. In these locations, rotten concrete was found to a depth of one inch and in one location (S-23) to four inches. However, in all locations, from four to seven inches of dry, competent concrete was present below the deteriorated surface. Even in areas of deteriorated concrete, the analytical data demonstrate that the overall thickness of the concrete floor remains effective in attenuating the vertical migration of plating fluids to the bedrock beneath the floor.

S-23: 4 inches of rotten concrete

Based on these findings, no further assessment is warranted. The deteriorated concrete and epoxy-like coating needs to be repaired and maintained with routine and regular flushing/washing. Removal of the surficial layer of concrete as part of any pit floor repair would require its disposal as a listed hazardous waste for cyanide. Annual inspection, and repairs as necessary, will maintain the effectiveness of the plating pit in preventing subsurface impacts.

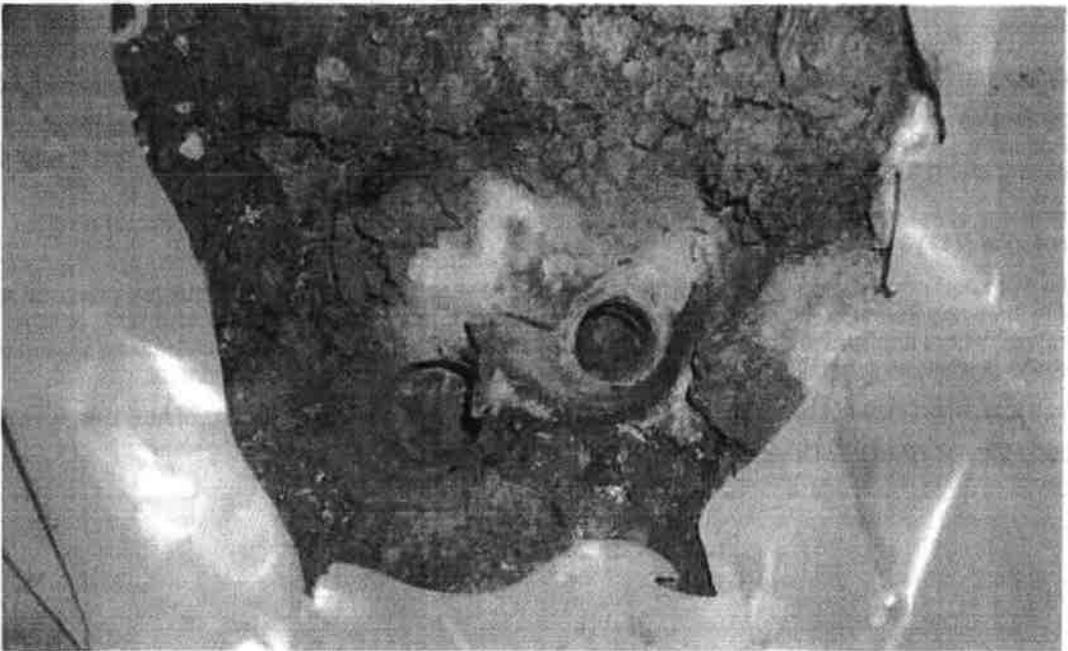
S-23: shallow refusal and offset showing rotten concrete
