Technical Memorandum: Updated Conceptual Site Model

Pompton Lake Acid Brook Delta Area Project
DuPont Pompton Lakes Works
Pompton Lakes, New Jersey
EPA ID #NJD002173946, SRP PI#007411

March 2014

Prepared by:
ARCADIS
Anchor QEA, LLC
O'Brien & Gere

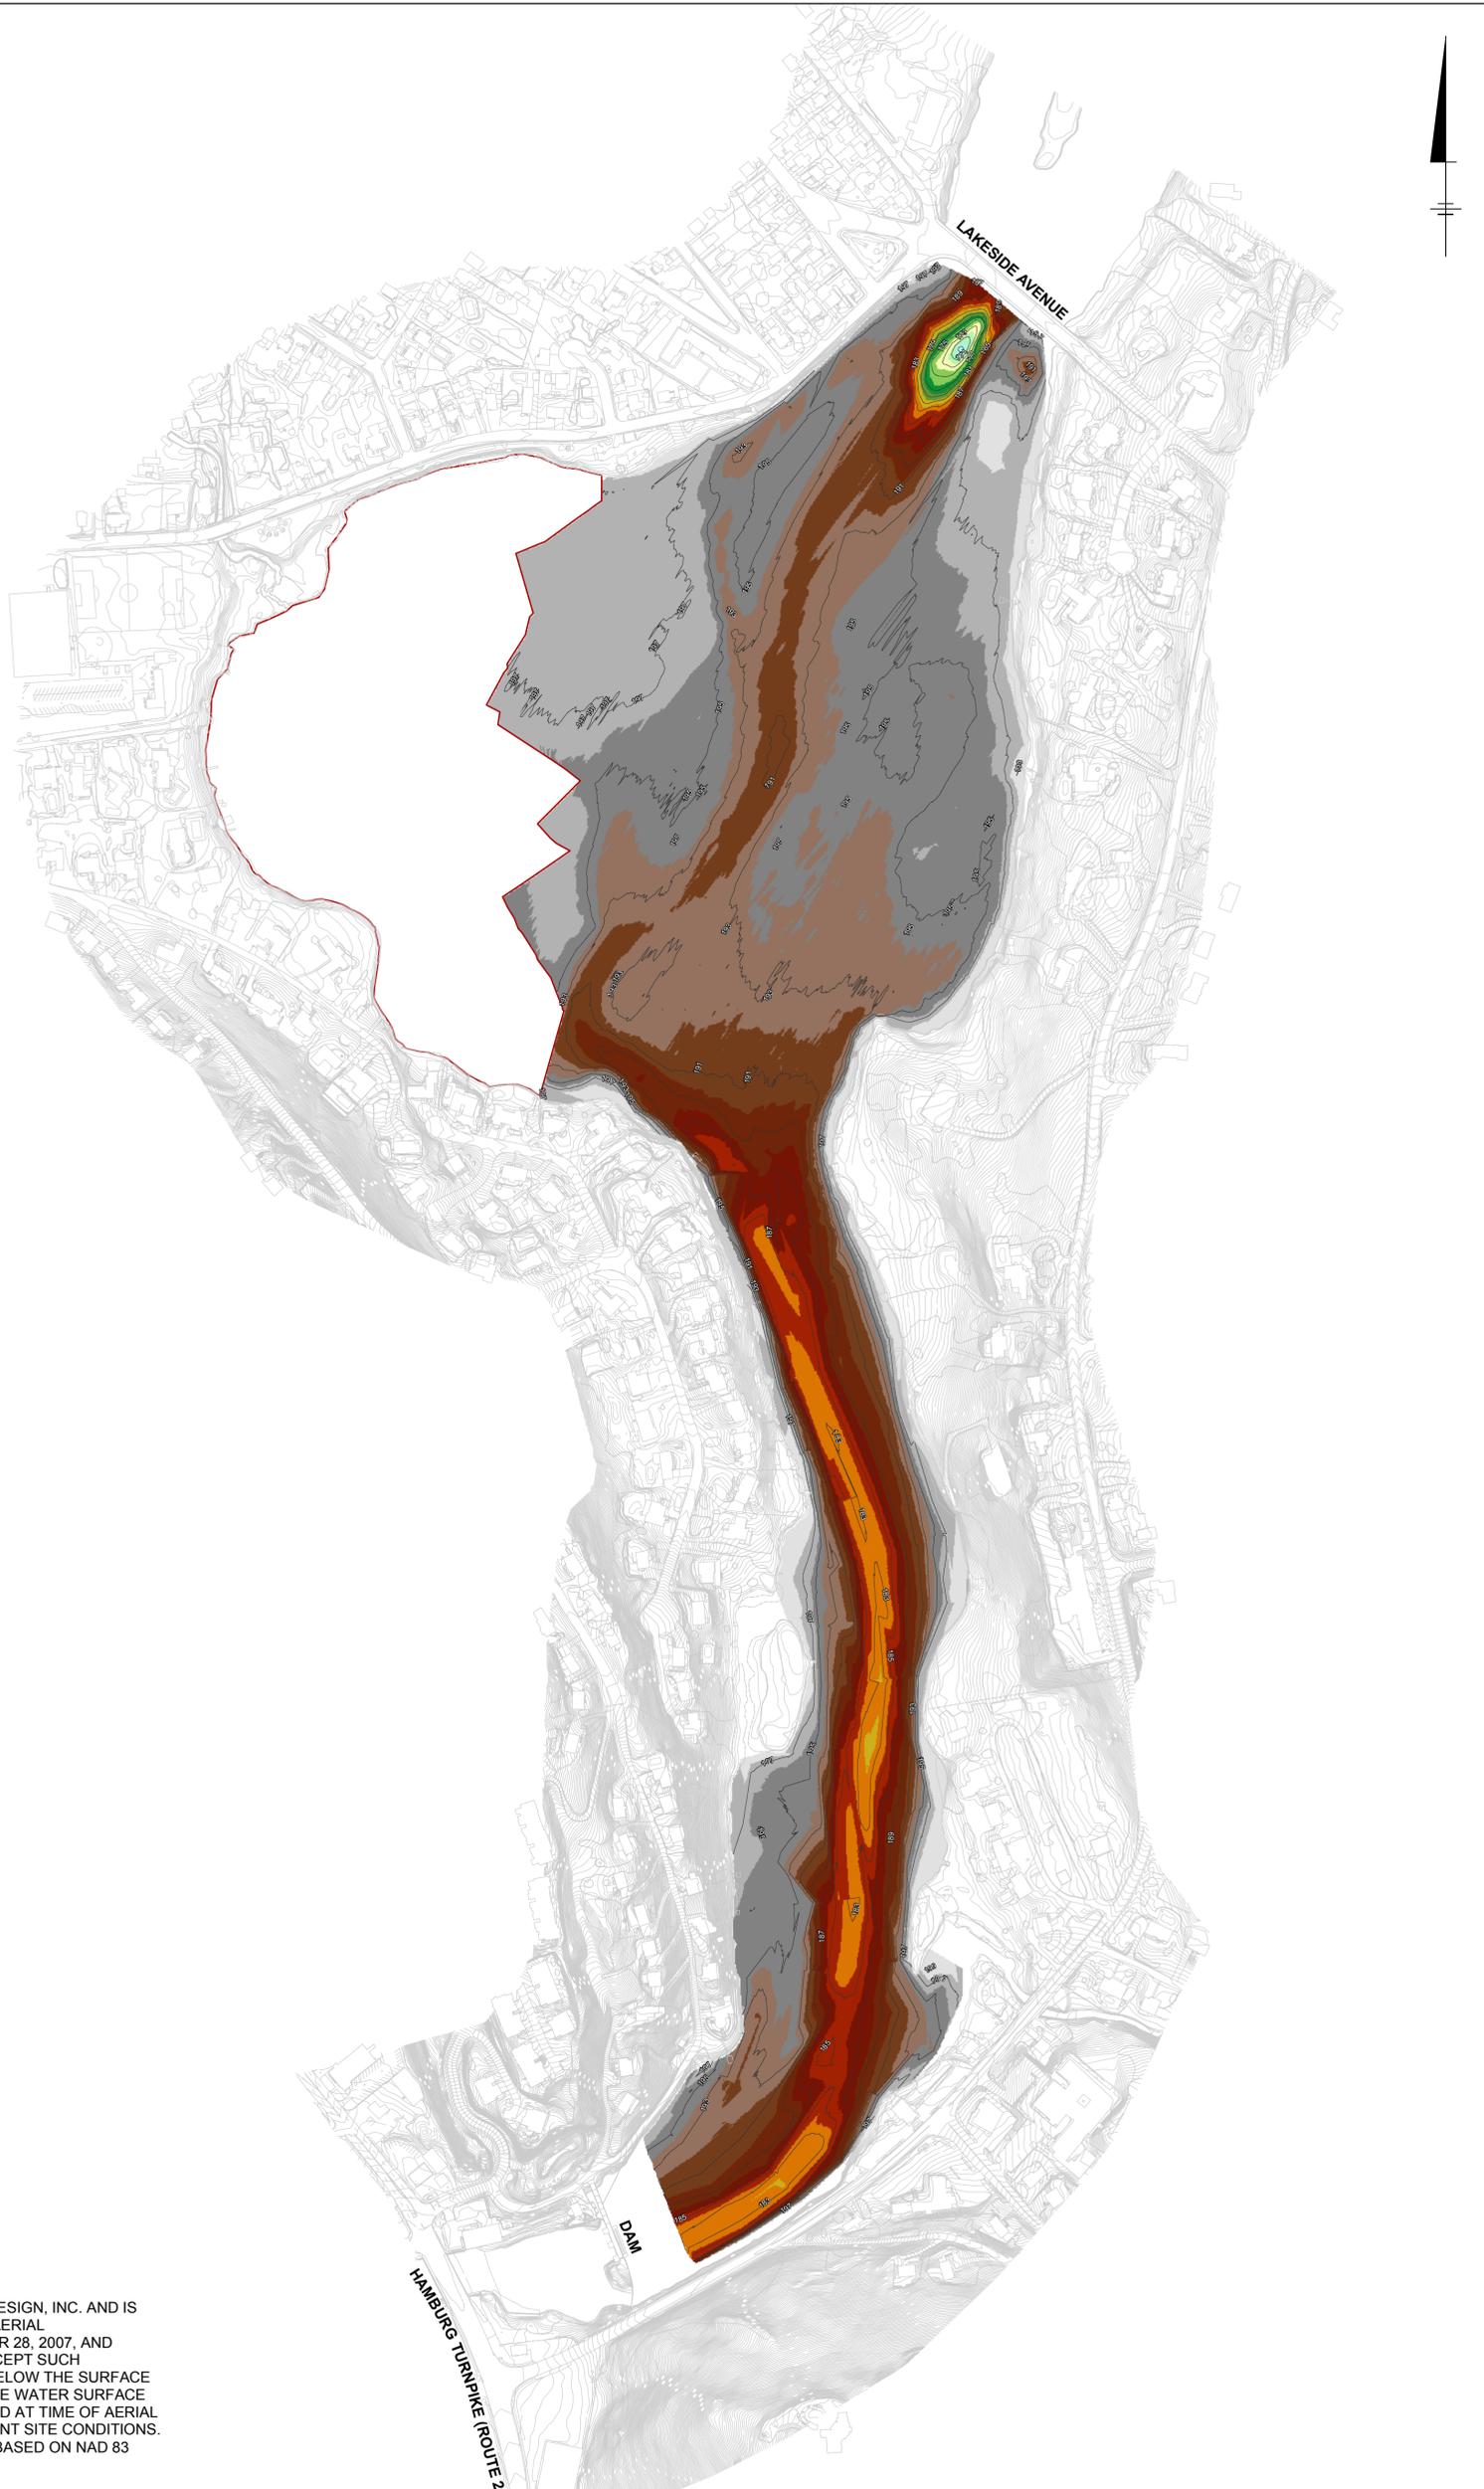
FIGURE
2-1

NOTES:
 1. THE BASE MAP WAS PREPARED BY R.C.C DESIGN, INC. AND IS BASED UPON ACTUAL FIELD SURVEY AND AERIAL PHOTOGRAPHY PERFORMED ON DECEMBER 28, 2007, AND REPRESENTS THE CONDITIONS FOUND EXCEPT SUCH EASEMENTS OF IMPROVEMENTS, IF ANY, BELOW THE SURFACE LANDS AND NOT VISIBLE. THE APPROXIMATE WATER SURFACE ELEVATION SHOWN HEREIN WAS MEASURED AT TIME OF AERIAL SURVEY, AND MAY VARY BASED ON CURRENT SITE CONDITIONS. HORIZONTAL AND VERTICAL DATUMS ARE BASED ON NAD 83 AND NAVD 88, RESPECTIVELY.
 2. THE 2013 BATHYMETRIC SURVEY WAS PERFORMED BY AQUA SURVEY, INC. ON MAY 13, 2013. THE SURVEY IS A SINGLE BEAM AND SINGLE FREQUENCY SURVEY.

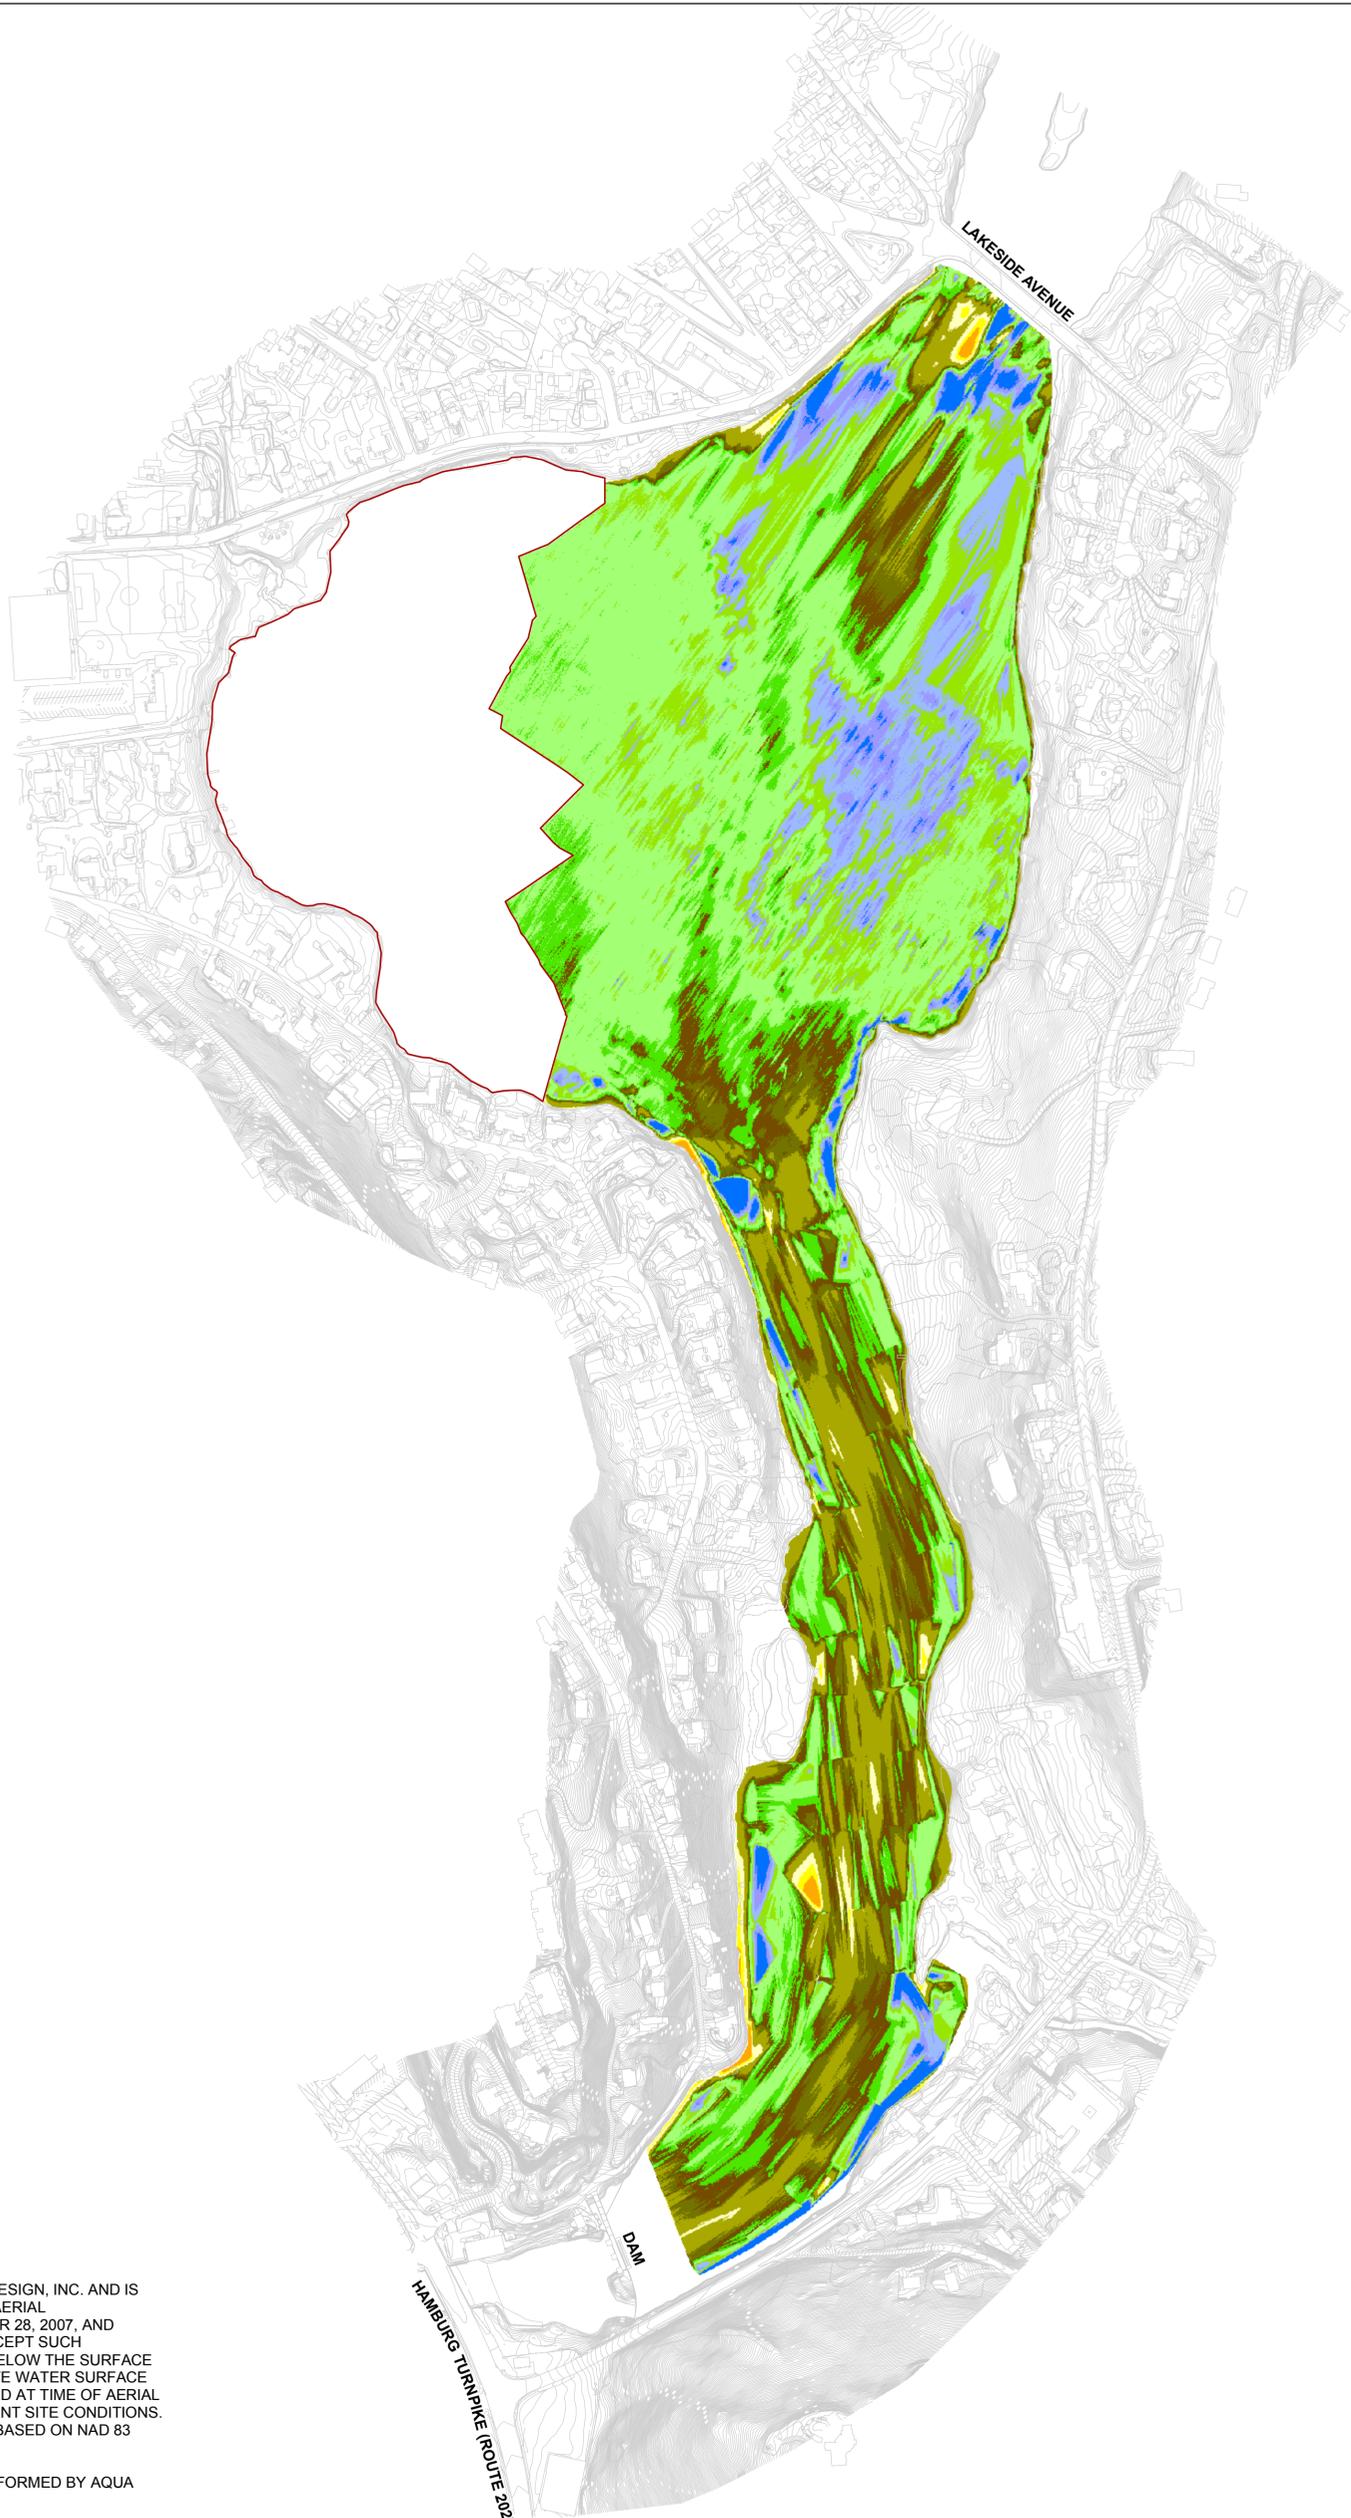
FIGURE
2-3

- NOTES:
1. THE BASE MAP WAS PREPARED BY R.C.C DESIGN, INC. AND IS BASED UPON ACTUAL FIELD SURVEY AND AERIAL PHOTOGRAPHY PERFORMED ON DECEMBER 28, 2007, AND REPRESENTS THE CONDITIONS FOUND EXCEPT SUCH EASEMENTS OF IMPROVEMENTS, IF ANY, BELOW THE SURFACE LANDS AND NOT VISIBLE. THE APPROXIMATE WATER SURFACE ELEVATION SHOWN HEREIN WAS MEASURED AT TIME OF AERIAL SURVEY, AND MAY VARY BASED ON CURRENT SITE CONDITIONS. HORIZONTAL AND VERTICAL DATUMS ARE BASED ON NAD 83 AND NAVD 88, RESPECTIVELY.
 2. THE 2013 BATHYMETRIC SURVEY WAS PERFORMED BY AQUA SURVEY, INC. ON MAY 13, 2013.
 3. THE 2007 BATHYMETRIC SURVEY WAS PERFORMED BY OCEAN SURVEYS, INC. IN APRIL/MAY 2007.

Comparison of the 2011 and 2007 bathymetry indicated apparent sediment surface decreases in elevation in two areas. In addition, a data gap was noted in the lower Ramapo River channel to the Pompton Lake Dam since no data for this stretch were available from 2011. To further evaluate the two areas of decreased sediment elevation and data gap, a single beam bathymetric survey and side scan sonar data collection were performed in May 2013 to obtain current bathymetry and river bed characterization data.

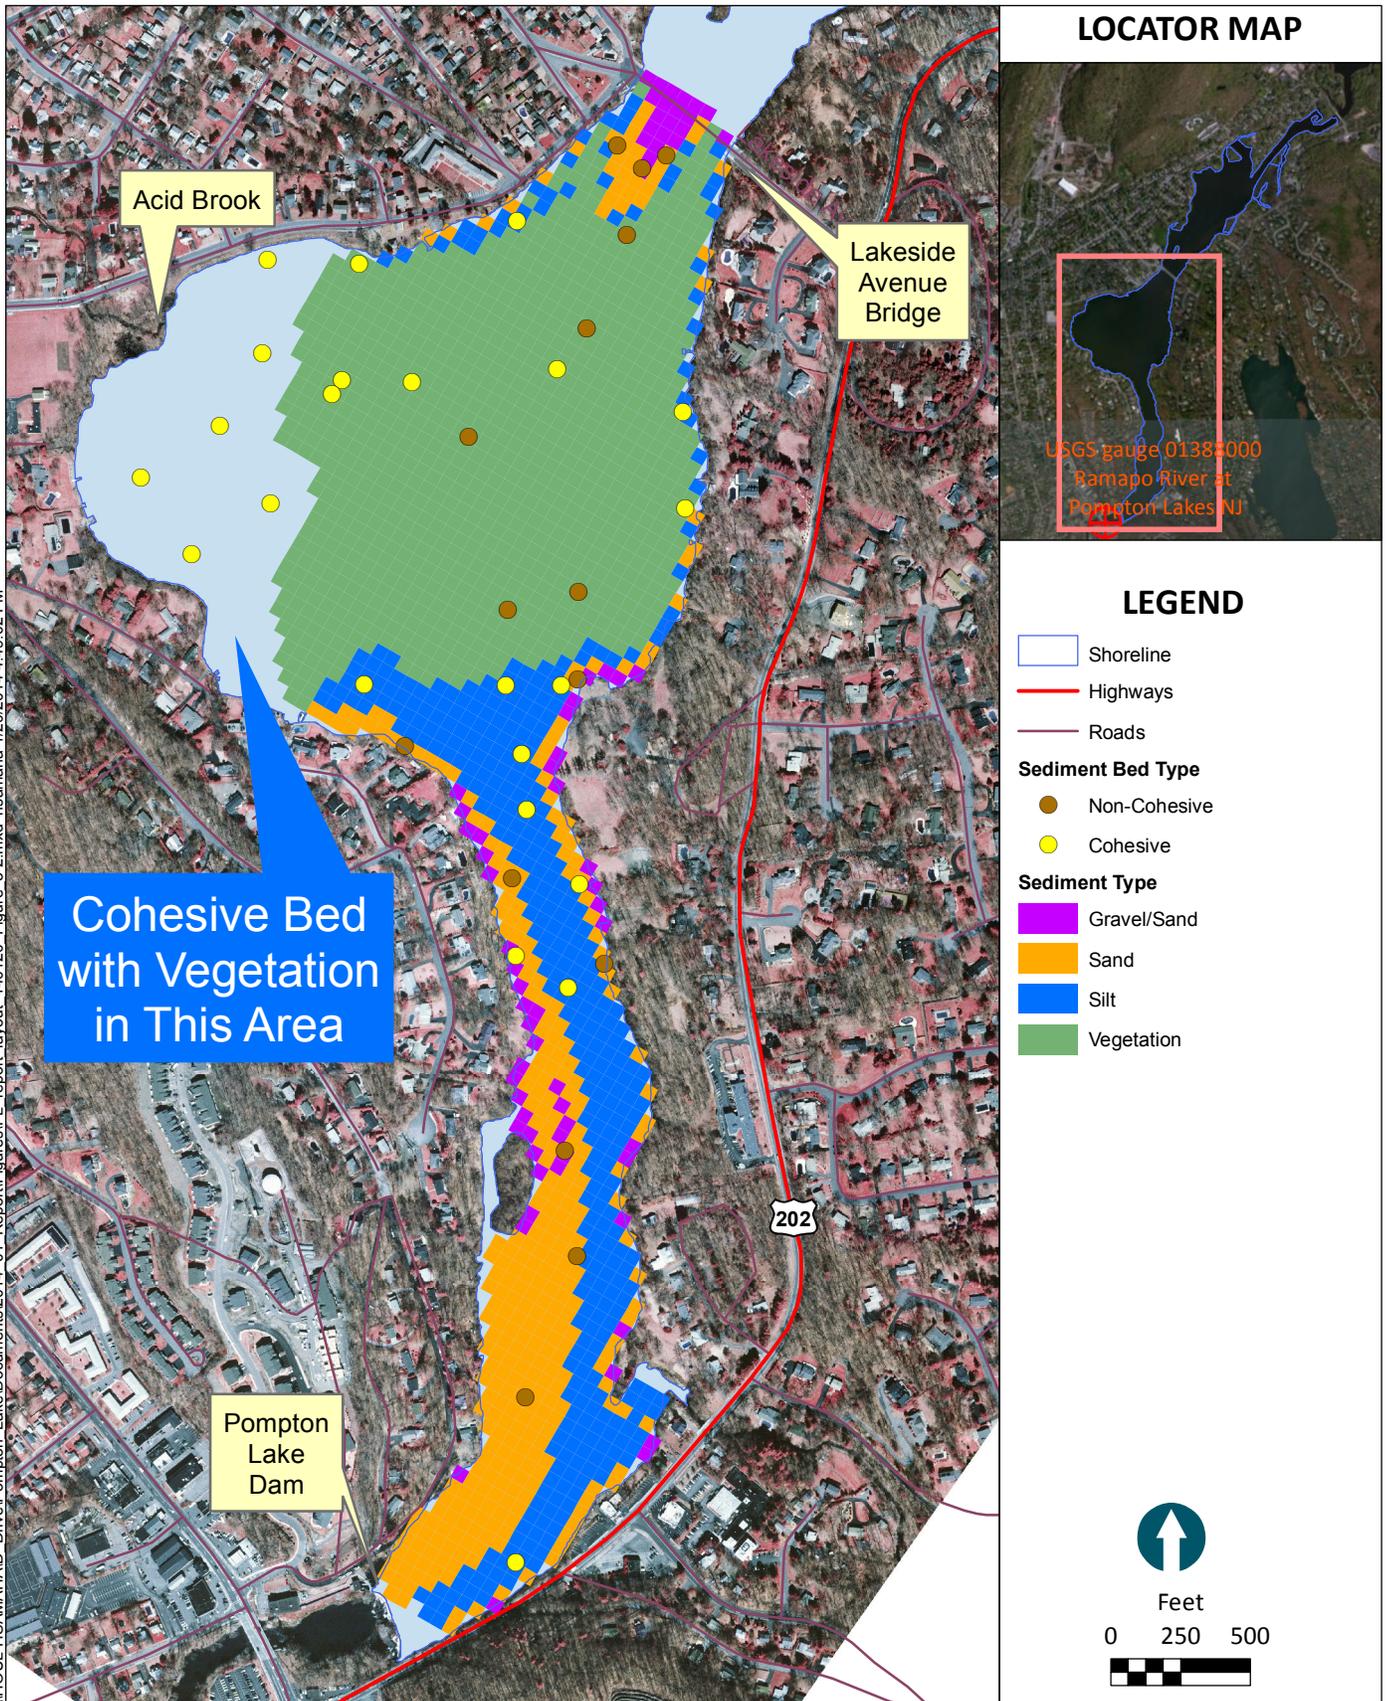
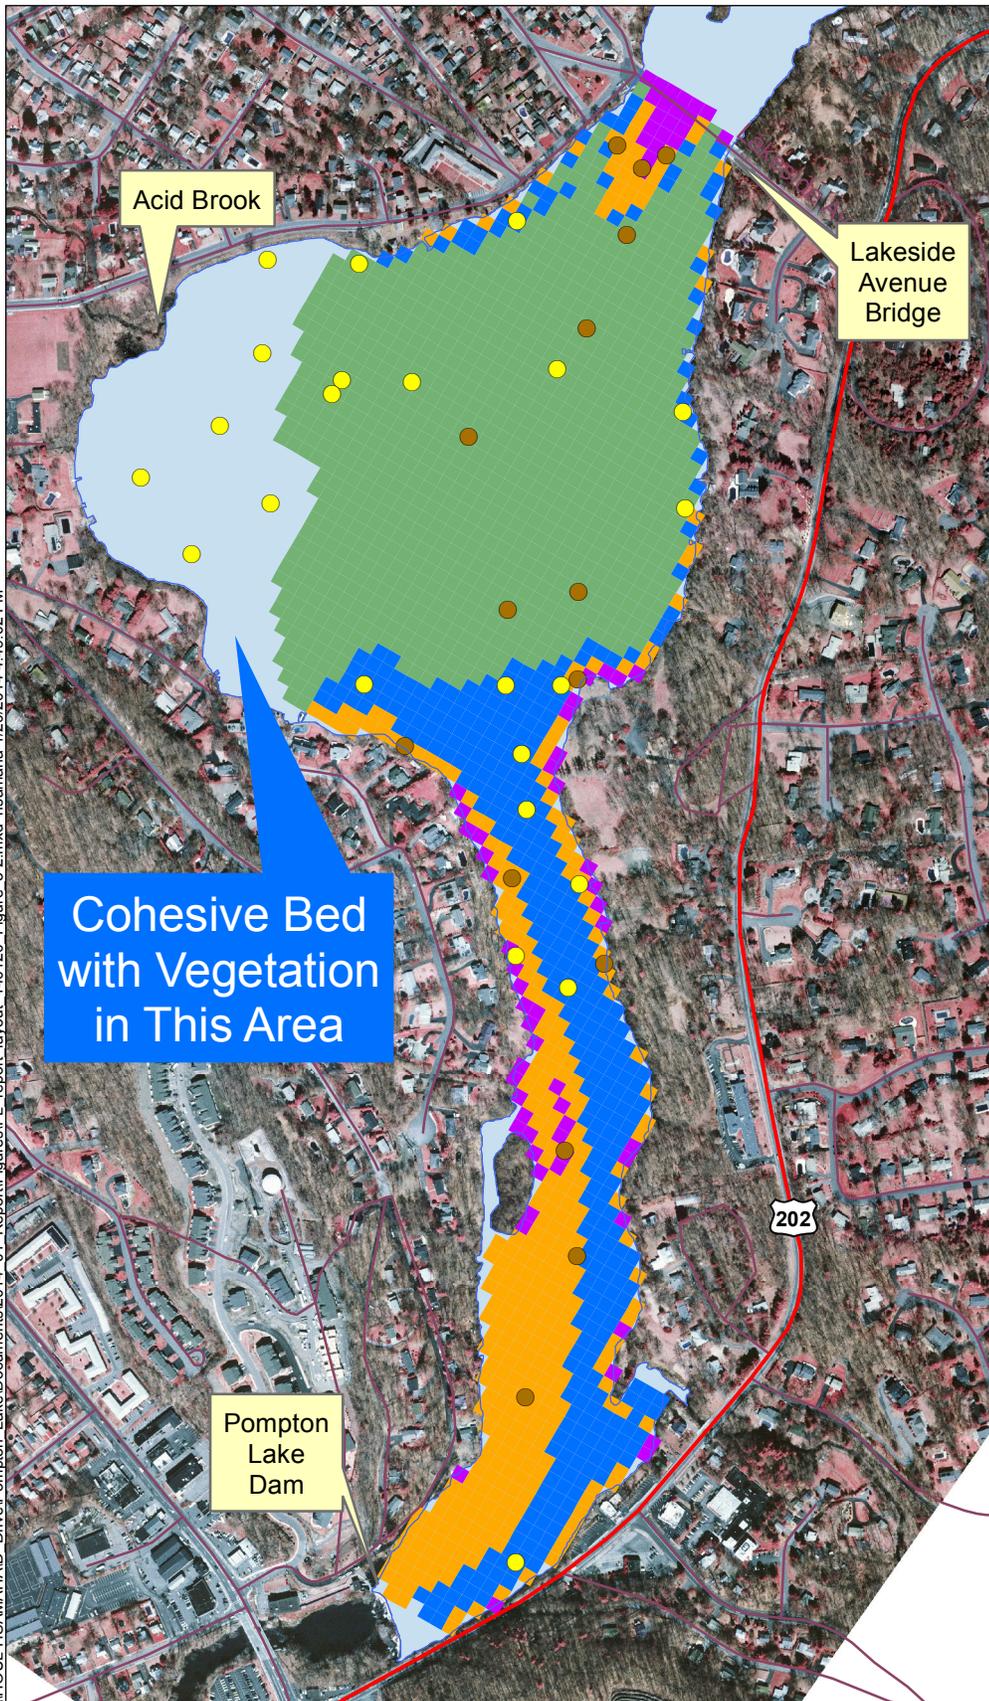
Figure 3-2

Bed Type Based on Grain Size Distribution and Side-Scan Sonar Data Pompton Lake Study Area

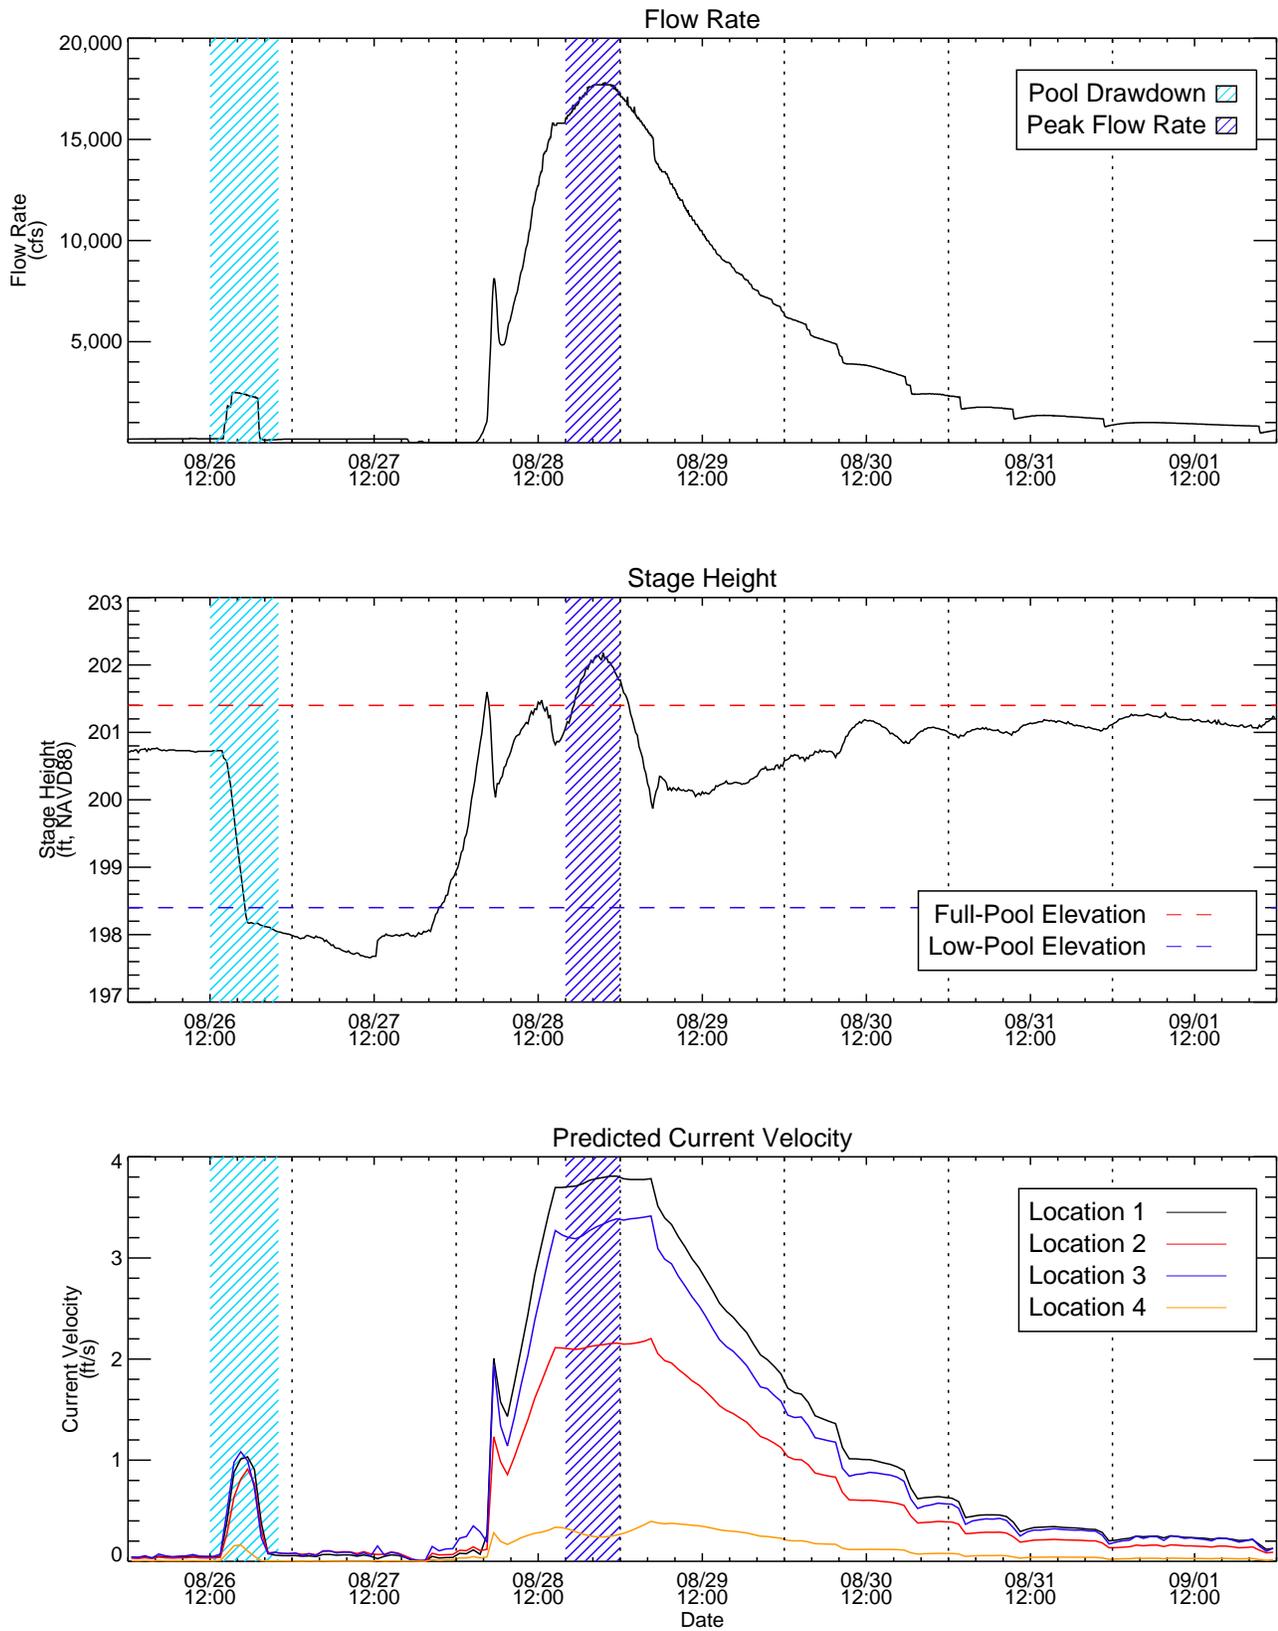
Figure 3-20

Time Series of Predicted Current Velocity at 4 Locations in the Lake During Hurricane Irene Pompton Lake Study Area

The effects of the lake pool drawdown on August 26 were also simulated by the hydrodynamic model. Temporal variations in predicted current velocity at five locations in the lake were evaluated (Figures 3-19 and 3-20). The modeling results show that during the pool drawdown current velocities were relatively low within the Study Area (i.e., less than about 1 foot per second (ft/s)). Bed shear stresses during the drawdown (Figure 3-21) would have caused minimal surficial sediment bed decreases in elevation (i.e., 0.1 to 0.3 centimeters) in a few isolated areas. No changes in sediment bed elevation would have occurred in most of the lake.

The maximum current velocity and bed shear stress occurred during peak flow rate conditions on August 28, when the lake was at or above full pool level (Figure 3-20). The spatial distribution of predicted maximum bed shear stress during Hurricane Irene is shown on Figure 3-22. A comparison of the spatial distributions of maximum bed shear stress (Figure 3-22) to bed elevation changes between 2007 and 2011 (Figures 3-11 and 3-12) indicates that, generally, net sediment bed elevation decreases occurred in areas of higher bed shear stress.

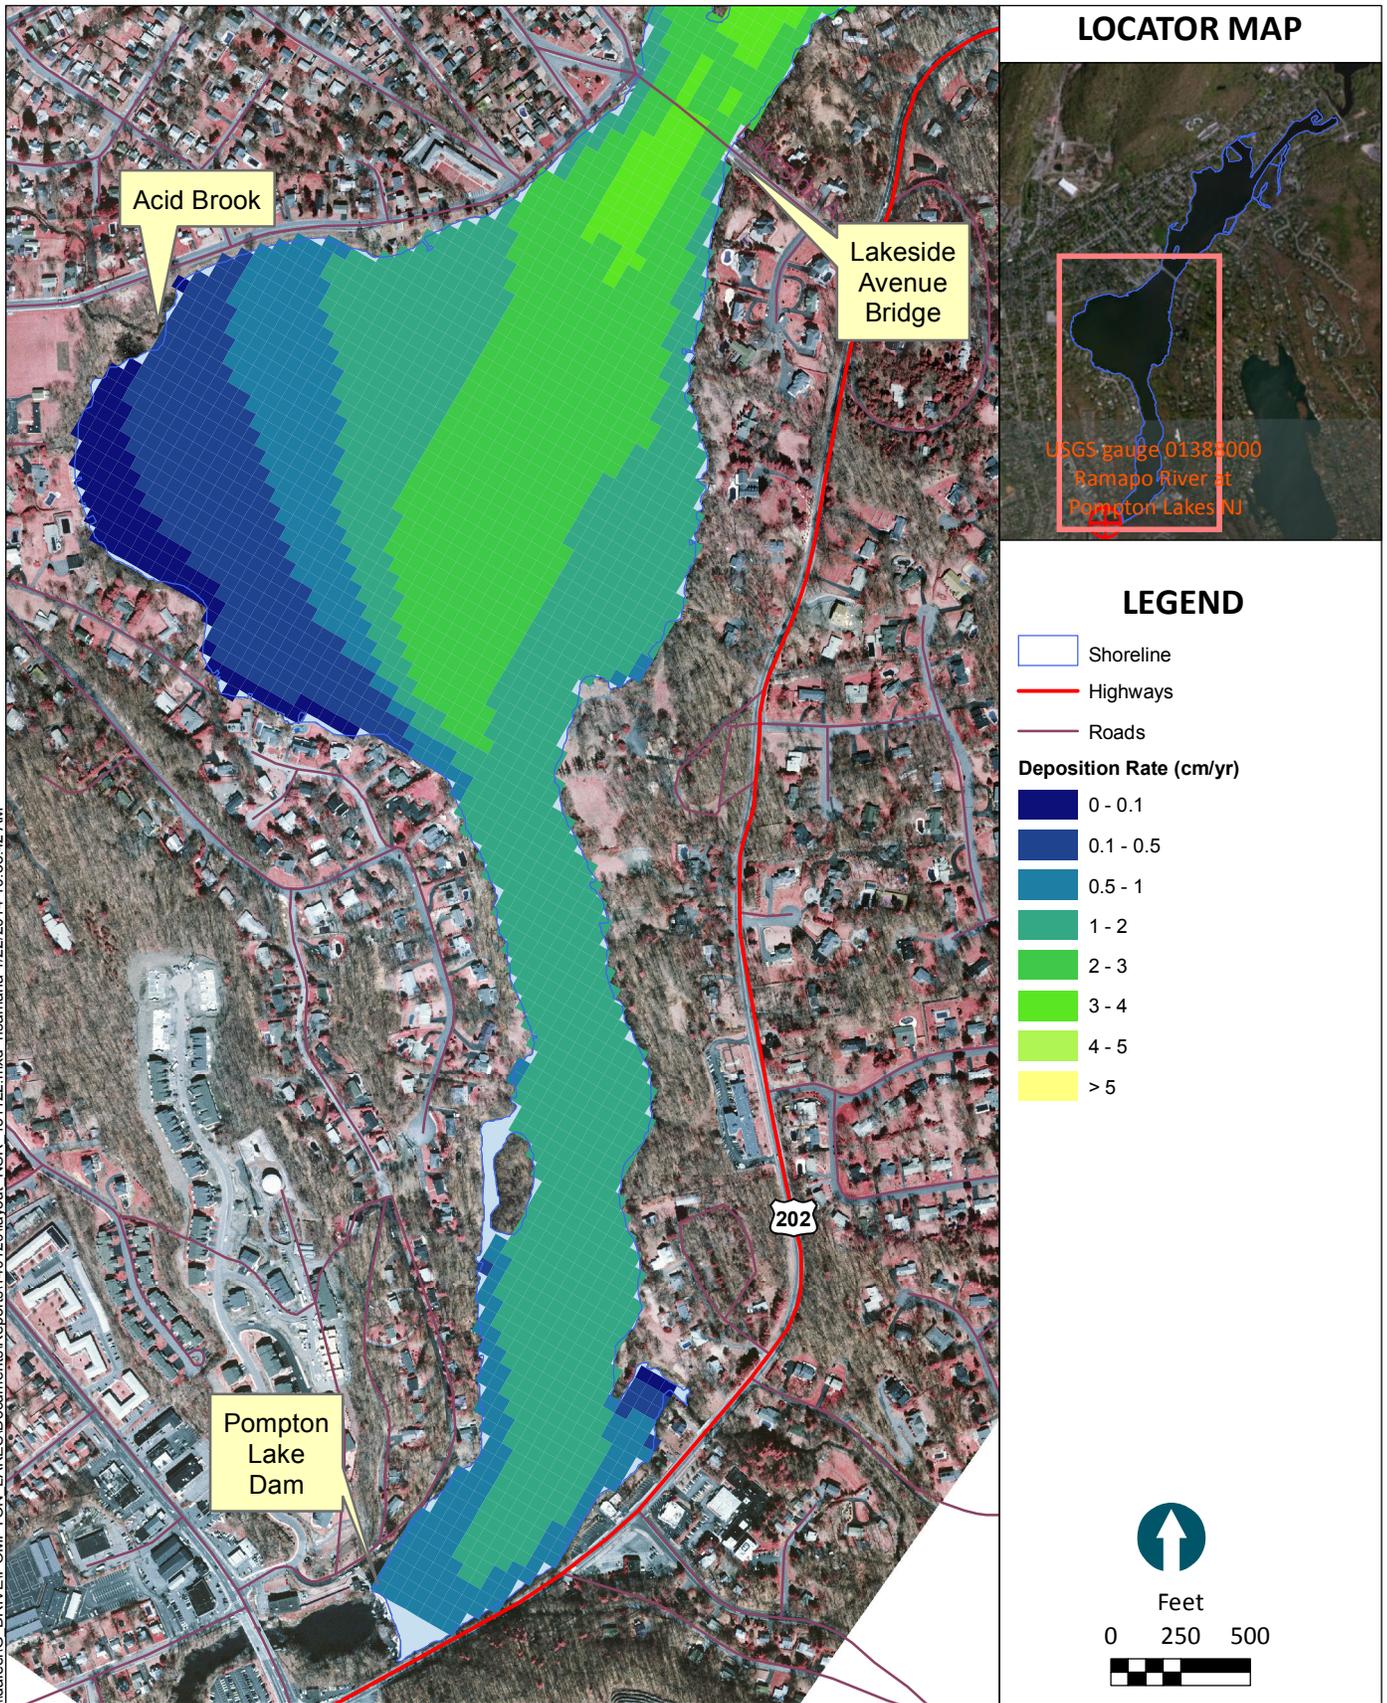
Figure 3-36

Predicted Deposition Pattern in the Lake
During Low-Moderate Flow Conditions: 700 cfs
Pompton Lake Study Area

The hydrodynamic model simulations discussed in Section 3.2.2 were extended to include simulation of sediment transport. The objective of this analysis was to evaluate sediment bed change patterns in the Study Area during low to moderate flow conditions (i.e., 300 to 3,900 cfs), which occur greater than 99% of the time over a multi-year period. The effects of vegetation were included in the hydrodynamic model for these simulations.

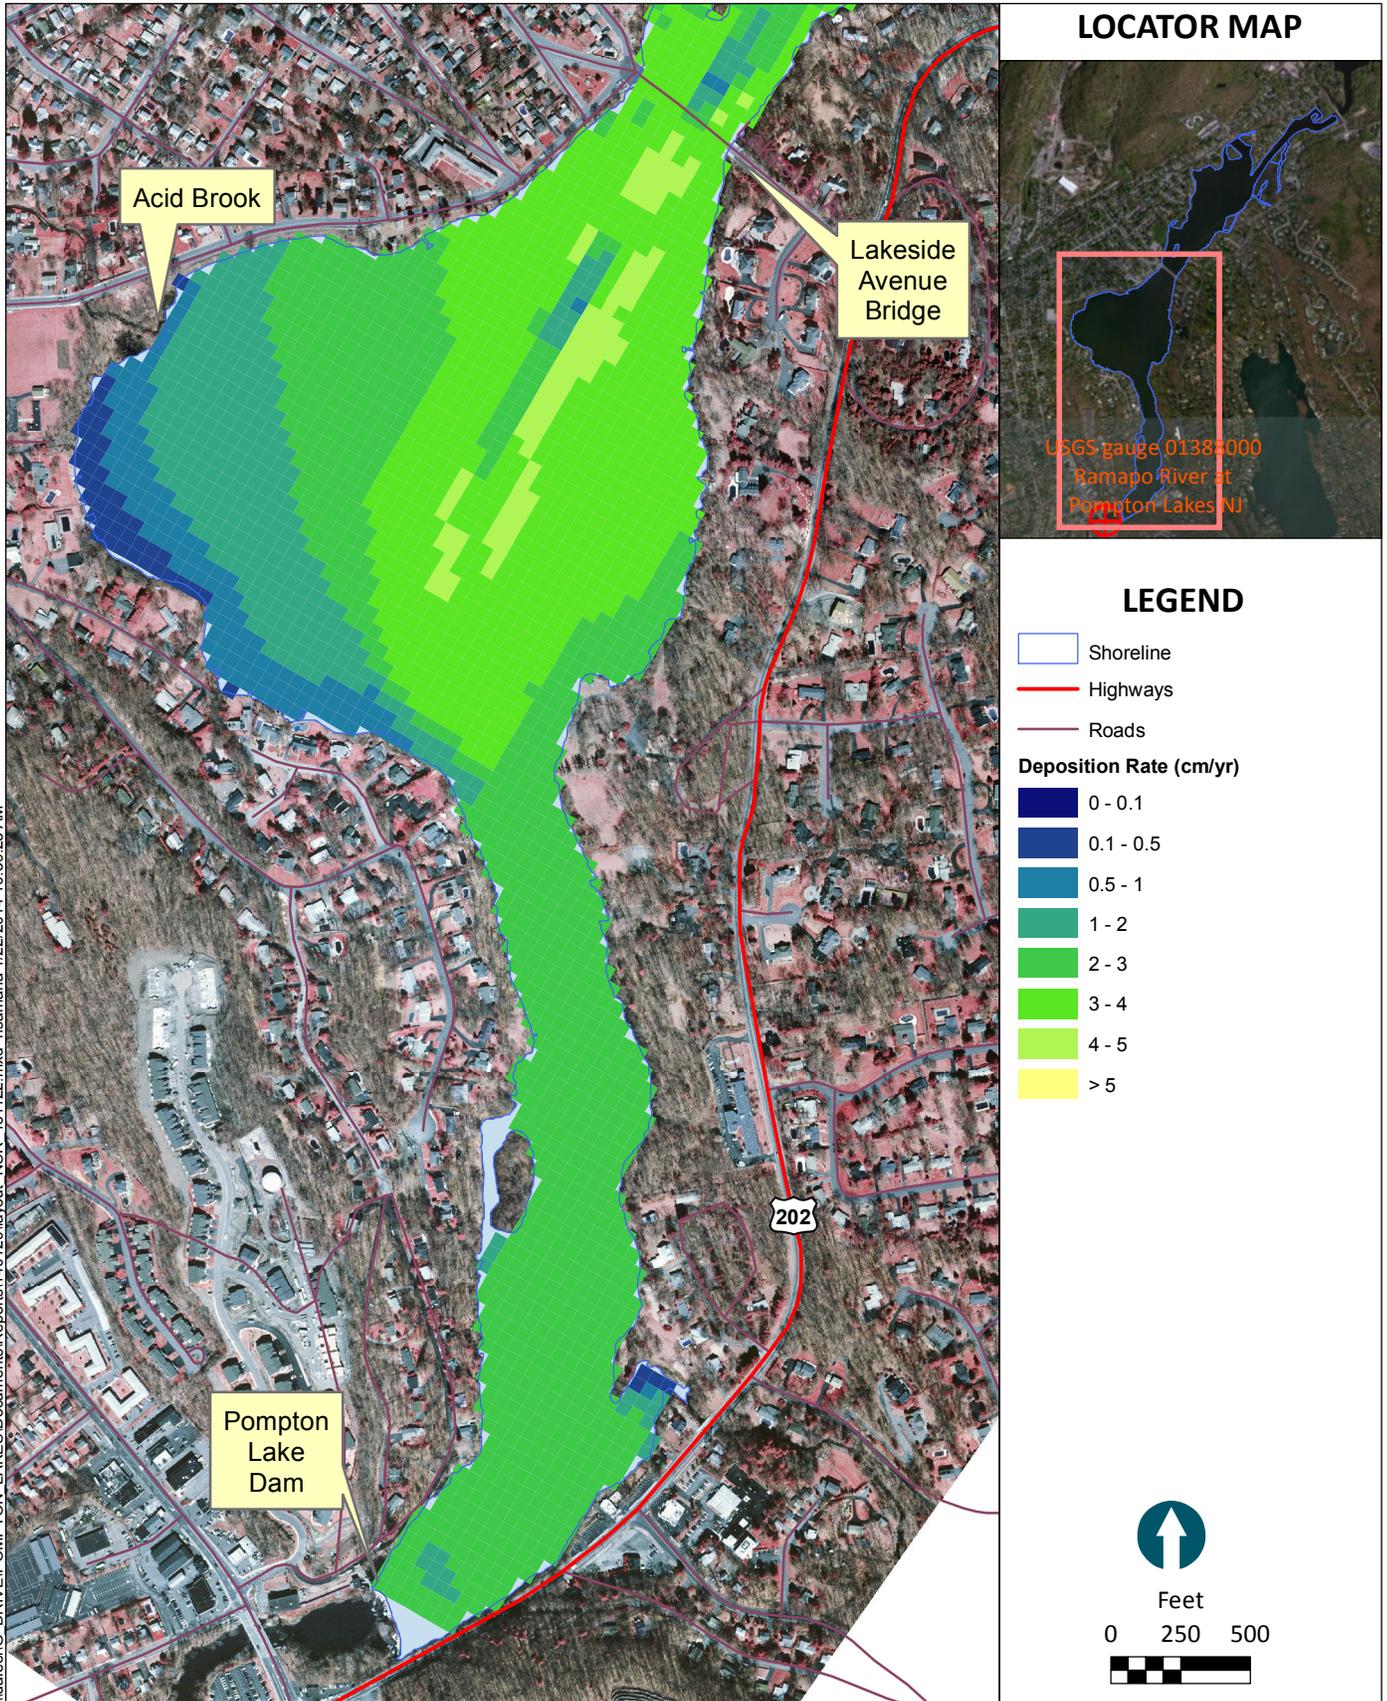
Figure 3-37

Predicted Deposition Pattern in the Lake
During Low-Moderate Flow Conditions: 1,500 cfs
Pompton Lake Study Area

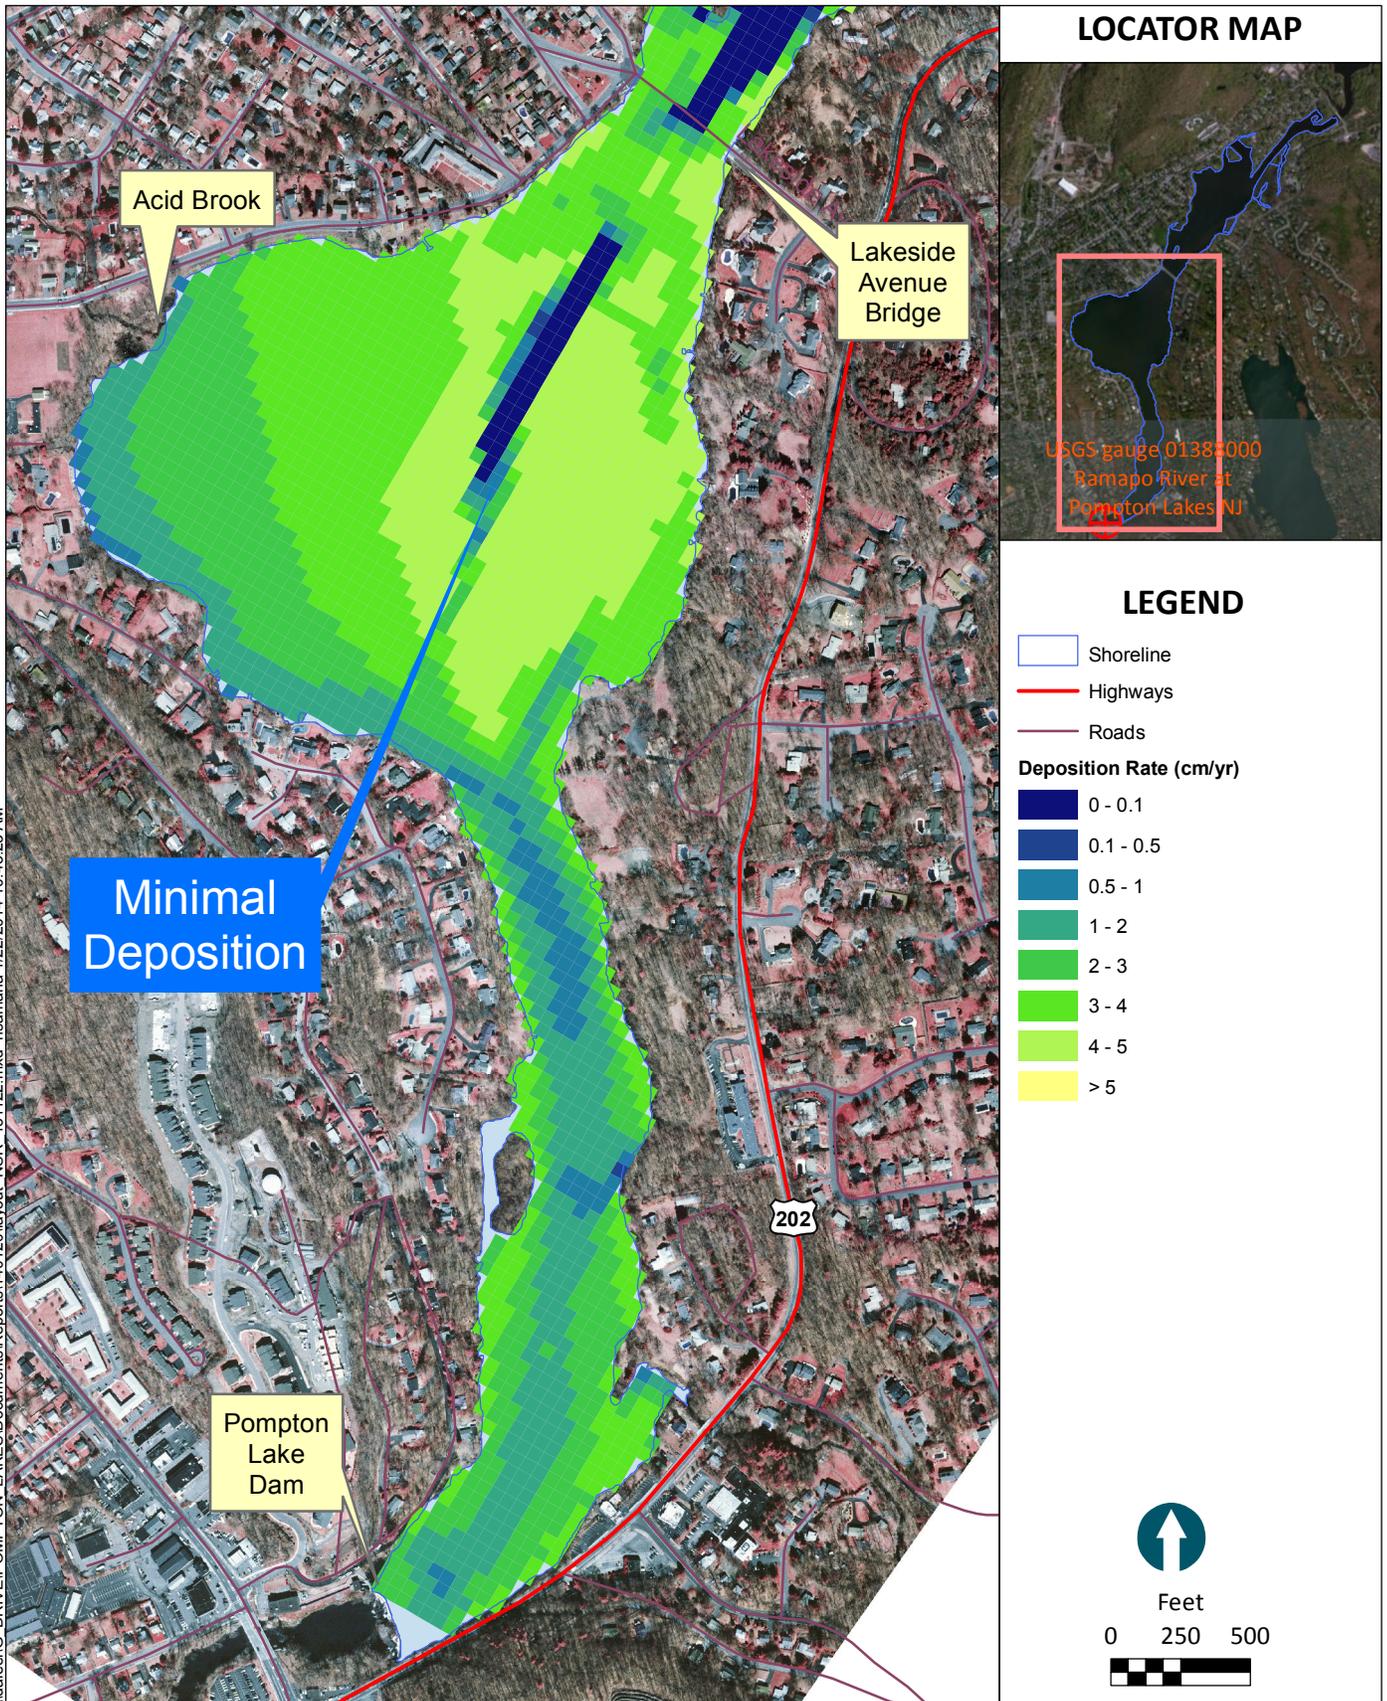
Figure 3-38

Predicted Deposition Pattern in the Lake
During Low-Moderate Flow Conditions: 2,700 cfs
Pompton Lake Study Area
