Technical Memorandum: Updated Conceptual Site Model

Pompton Lake Acid Brook Delta Area Project
DuPont Pompton Lakes Works
Pompton Lakes, New Jersey
EPA ID #NJD002173946, SRP PI#007411

March 2014

Prepared by:
ARCADIS
Anchor QEA, LLC
O'Brien & Gere

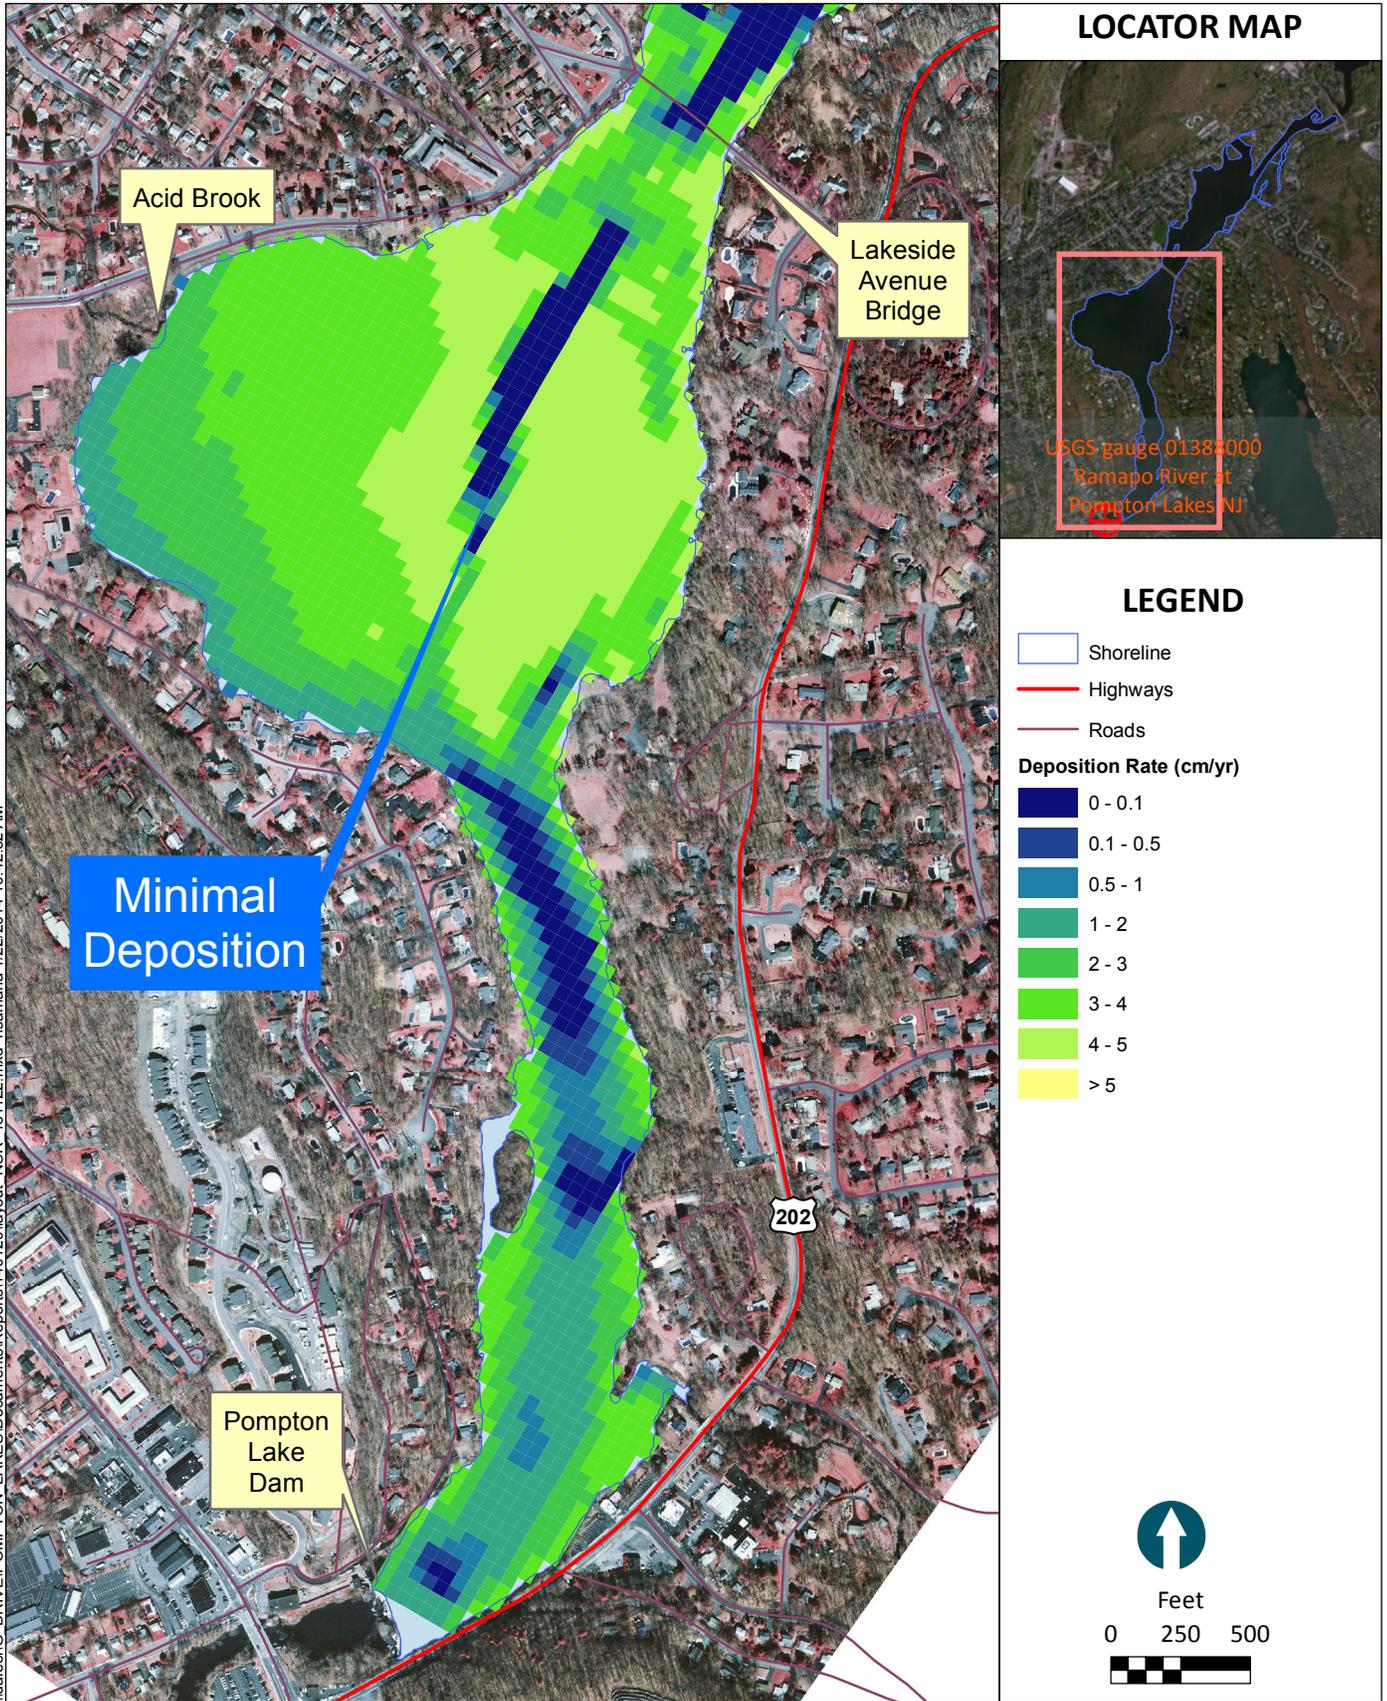
Figure 3-39

Predicted Deposition Pattern in the Lake
During Low-Moderate Flow Conditions: 3,100 cfs
Pompton Lake Study Area

The hydrodynamic model simulations discussed in Section 3.2.2 were extended to include simulation of sediment transport. The objective of this analysis was to evaluate sediment bed change patterns in the Study Area during low to moderate flow conditions (i.e., 300 to 3,900 cfs), which occur greater than 99% of the time over a multi-year period. The effects of vegetation were included in the hydrodynamic model for these simulations.

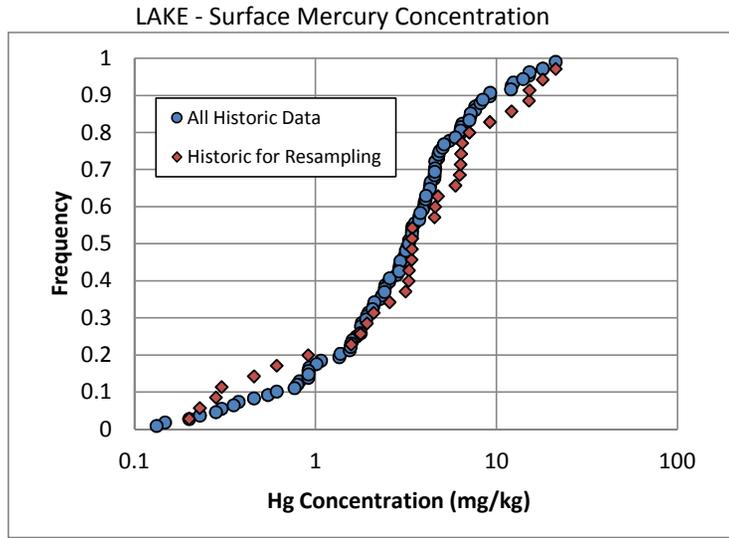
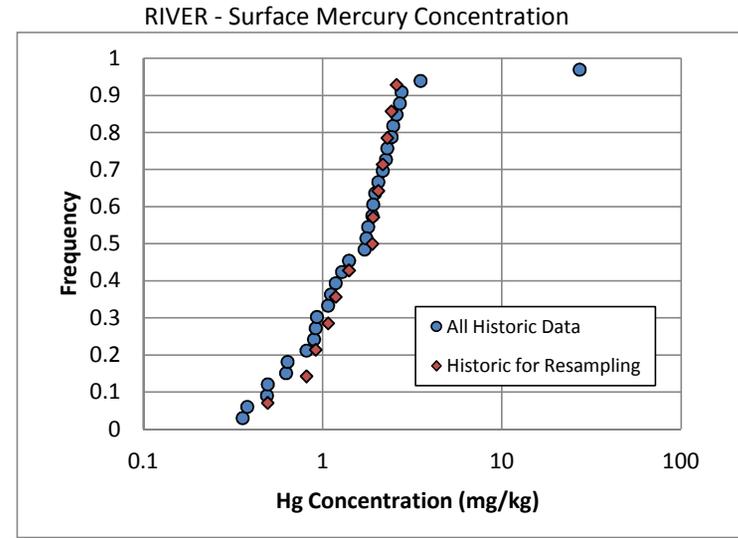
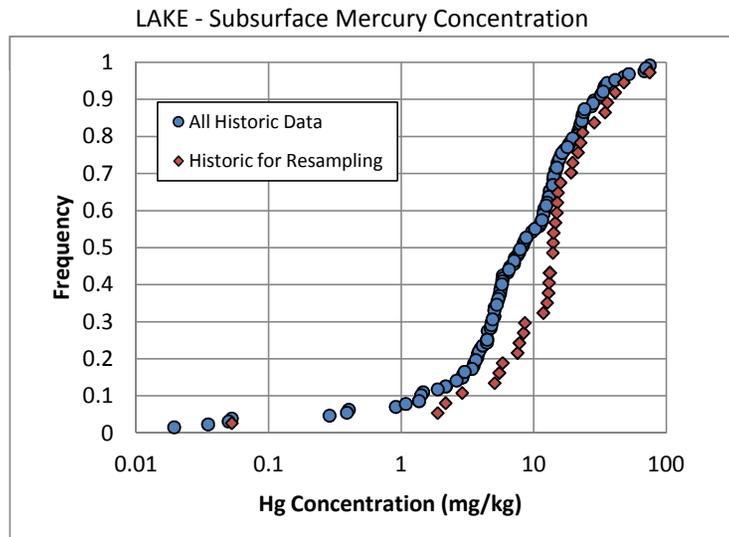
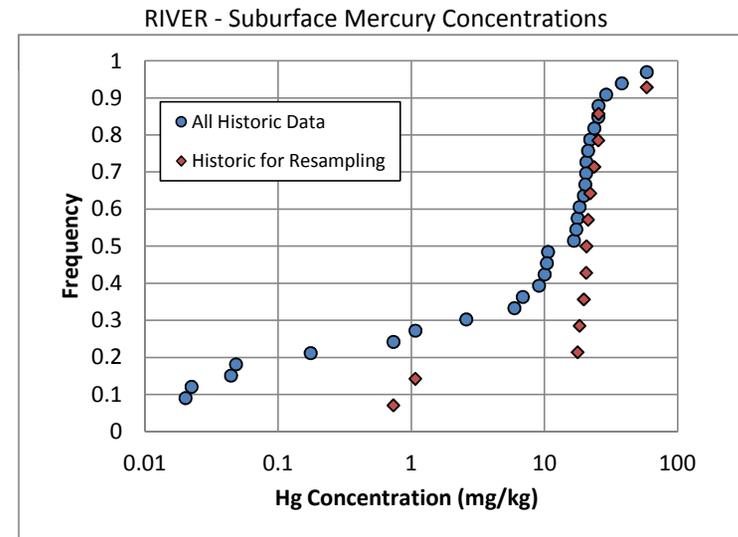
**Figure 4-2: Cumulative Frequency Curves for Mercury Concentration at Resampled Locations
Historical vs. 2013**

Ramapo River Surface Sediment: The unpaired comparison of the historical and 2013 resampled river surface sediment mercury concentrations is provided on Figure 4-2. While there was not a statistically significant difference between the overall populations observed when nonparametric comparison of the medians was tested (historical = 1.9 mg/kg and 2013 = 2.2 mg/kg), there was a statistically significant higher mean mercury concentration in 2013 versus the historical mean (4.3 mg/kg vs. 1.6 mg/kg). A large part of the increased variability at the upper end of the 2013 concentration distribution, and the corresponding increase in mean concentration, is driven by higher mercury concentrations reported at two locations (537-482 and 537-474) as discussed below.

The unpaired cumulative frequency distribution plot and associated statistics are provided in Figure 4-2 and Table 4-2. This figure shows that the overall populations were generally similar and no significant statistical difference was observed between the historical and 2013 data sets at resampled locations when using the maximum subsurface mercury concentration data. The historical lake subsurface mercury mean
