Re: August 19, 2011 Clean Water Act Inspection

**U.S. Environmental Protection Agency
Region 9
Clean Water Act Compliance Office**

Industrial User Inspection Report

Industrial User: Coast Creative Nameplates, a Division of Coast Engraving Companies, Inc.
Industrial User Address: 1097 N. Fifth St., San Jose, CA 95112
Inspection Date: August 19, 2011
EPA Region 9 Inspector: Anna Yen, Environmental Engineer
Water Division, CWA Compliance Office
City of San Jose Inspector: Casey Fitzgerald, Environmental Inspector
Facility Contact During Inspection: Sam Wool, Vice-President
Report Date: October 17, 2011

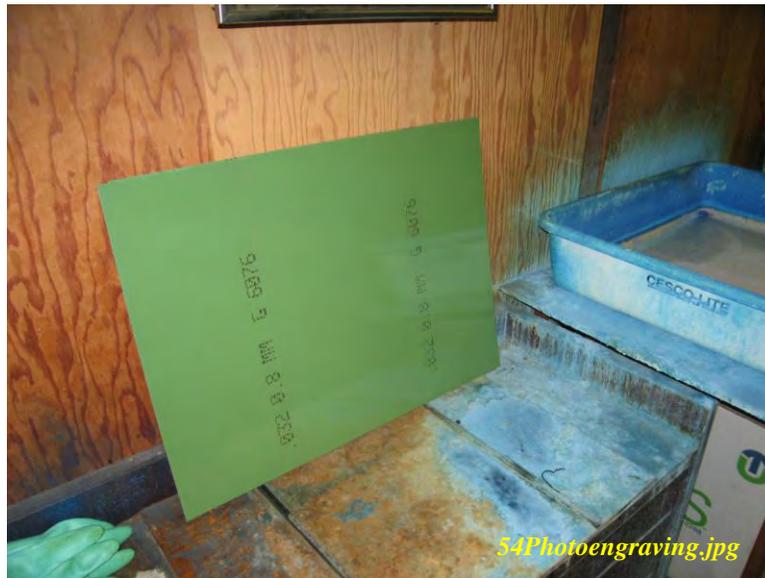
Photo 1

Magnesium photoengraving plate
Taken by Anna Yen on August 19, 2011

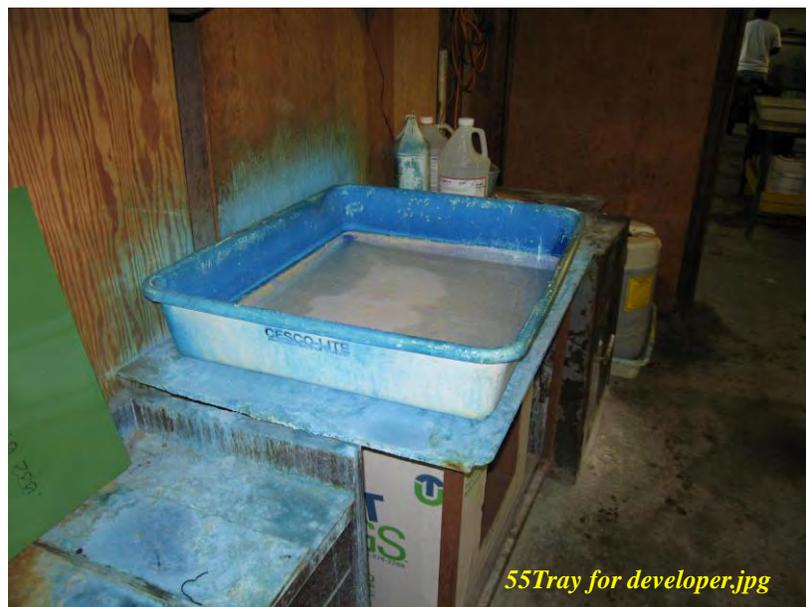
Photo 2

Tray used for developing the magnesium plate
Taken by Anna Yen on August 19, 2011

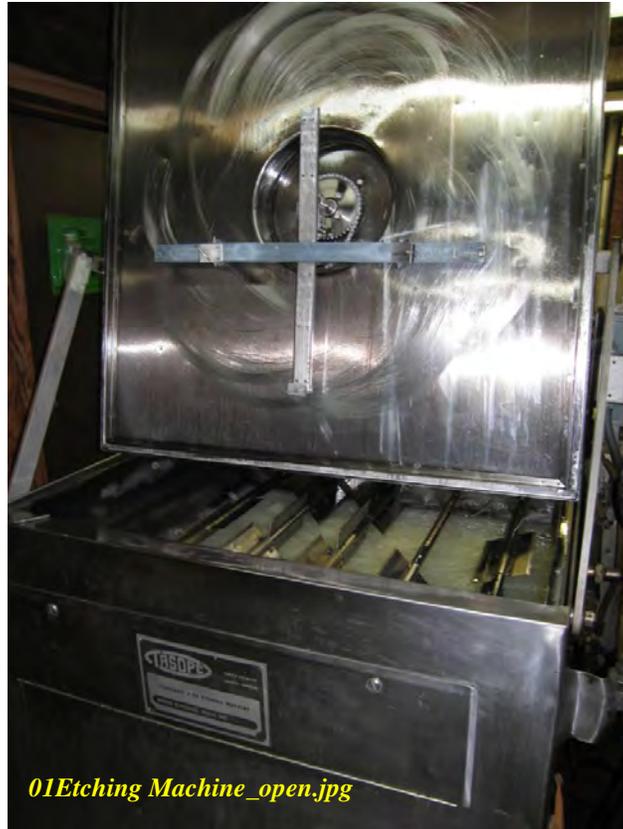
Photo 3

For the magnesium blocks and plates, a film is adhered to one surface with the design or lettering that the customer has requested. A light exposure unit exposes the film. The film is then developed by washing the piece in a plastic tray with a chemical specifically produced for use with magnesium photoengraving (AQ-Blu Developer Concentrate). *See Photos 1 and 2.* The piece is then placed in one of two large etching machines. (At the time of the inspection, Coast stated that one of the large machines was not being used because it was broken.) A smaller etching machine is also used but not as frequently. The etching machine contains a nitric acid and water bath. More specifically, the solution is comprised of approximately 80% water, the remaining 20% is 16 liters of X-flex, which is an etching additive, and 32 liters of nitric acid. The bath is heated to approximately 80 to 85°F. The piece is not actually immersed in the bath; instead, paddles inside the machine agitate the bath so that the liquid splashes onto the piece. *See Photos 3 and 4.* Coast stated that it keeps a log of the pieces processed in the etching machine.

Etching machine

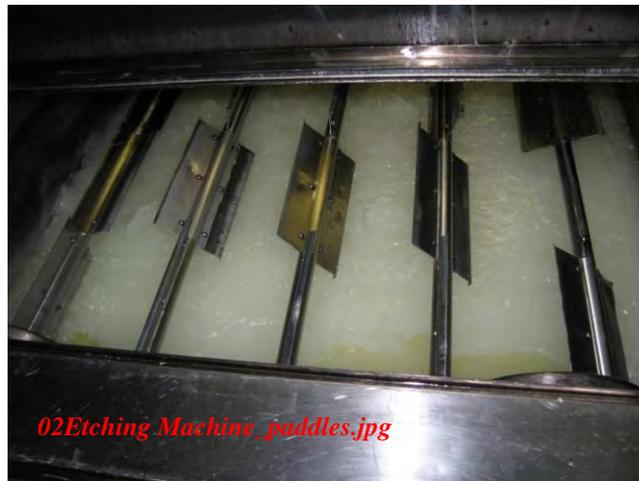
Photo 4

Inside of etching machine

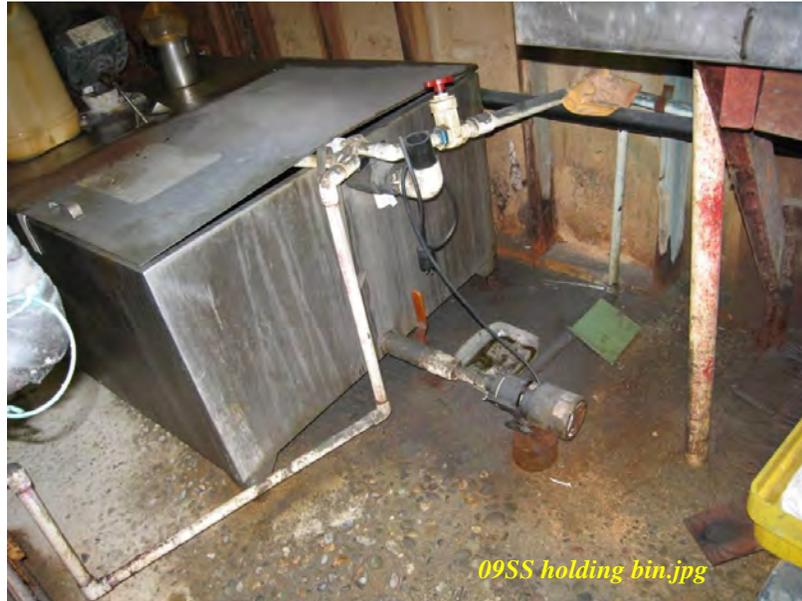
Photo 5

Coast replenishes the bath periodically by adding nitric acid. Once the bath becomes exhausted, the liquid is pumped to a stainless steel holding bin in the same room. *See Photo 5.* This is true for each etching machine. From this holding bin, the liquid is pumped in controlled amounts to a 350-gallon holding tank in the adjacent room. This 350-gallon holding tank is part of the wastewater treatment system. *See Photo 6.*

Stainless steel holding bin for spent etching bath

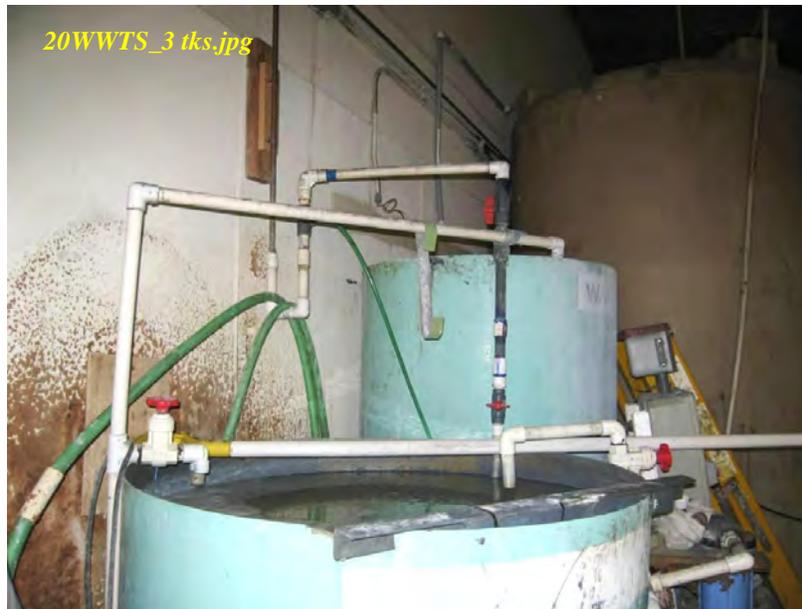
Photo 6

Once the 350-gallon holding tank is almost full, the contents are pumped by submersible pump (which sits inside the holding tank) and hose to an adjacent 250-gallon treatment tank. *See Photo 6.* Mop wash water from mopping the floors of the process areas, approximately once per week, is also sent to the treatment tank. Caustic is mixed with the appropriate amount of water in a bucket and poured manually into the treatment tank. Polymer is also added into the treatment tank. The treatment tank contains an air sparger for mixing. Coast checks the pH with a pH kit, checking for a pH of 9.1. If the pH is satisfactory, Coast turns the air off and allows the contents to sit for 30-40 minutes. Coast then pumps the contents of the tank through a filter press.

Onsite wastewater treatment system
(Blue tank in back is the holding tank. Tank in front is the treatment tank.)

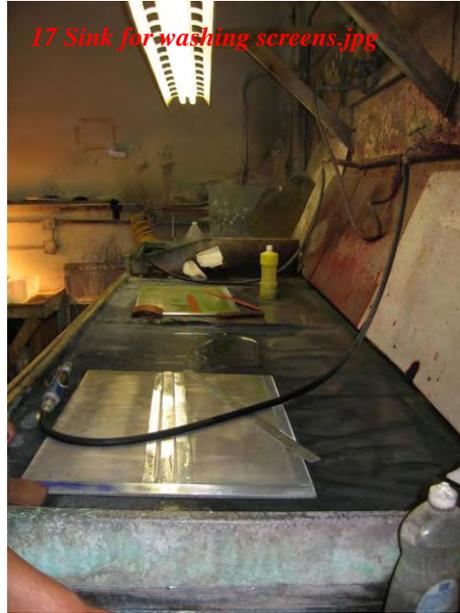
Near the wastewater treatment system is a long, industrial sink for washing screens. *See Photo 7 and 8.* Screens are used for hand imaging a pattern onto film. Screens are washed off with a detergent (Screen Clean) and water. All drainage from this sink flows into a small mesh-covered plastic bin. *See Photo 9.* This liquid is then pumped to the 350-gallon tank. Coast manages the makeup of the wastewater in the 350-gallon tank so that it is approximately 20% sink drainage and 80% etching machine spent solution.

Long sink – for washing screens
Taken by Anna Yen on August 19, 2011

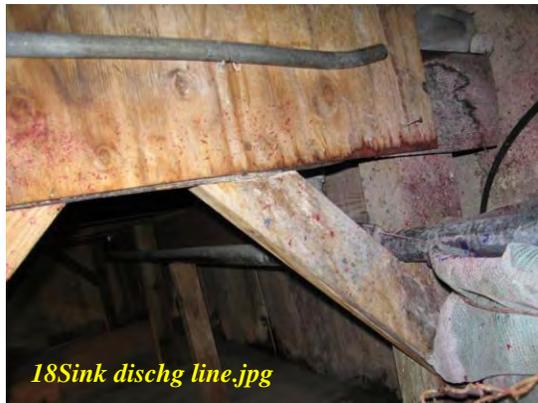
Photo 8

Drain pipe beneath sink –
discharging to collection bin
Taken by Anna Yen on August 19, 2011

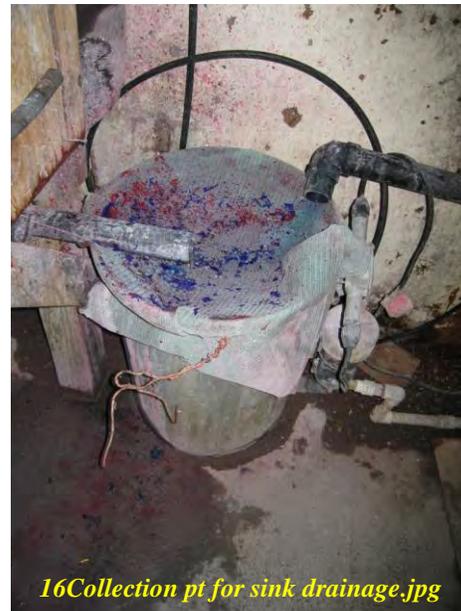
Photo 9

Collection bin for sink drainage –
immediately upstream of wastewater
treatment system
Taken by Anna Yen on August 19, 2011

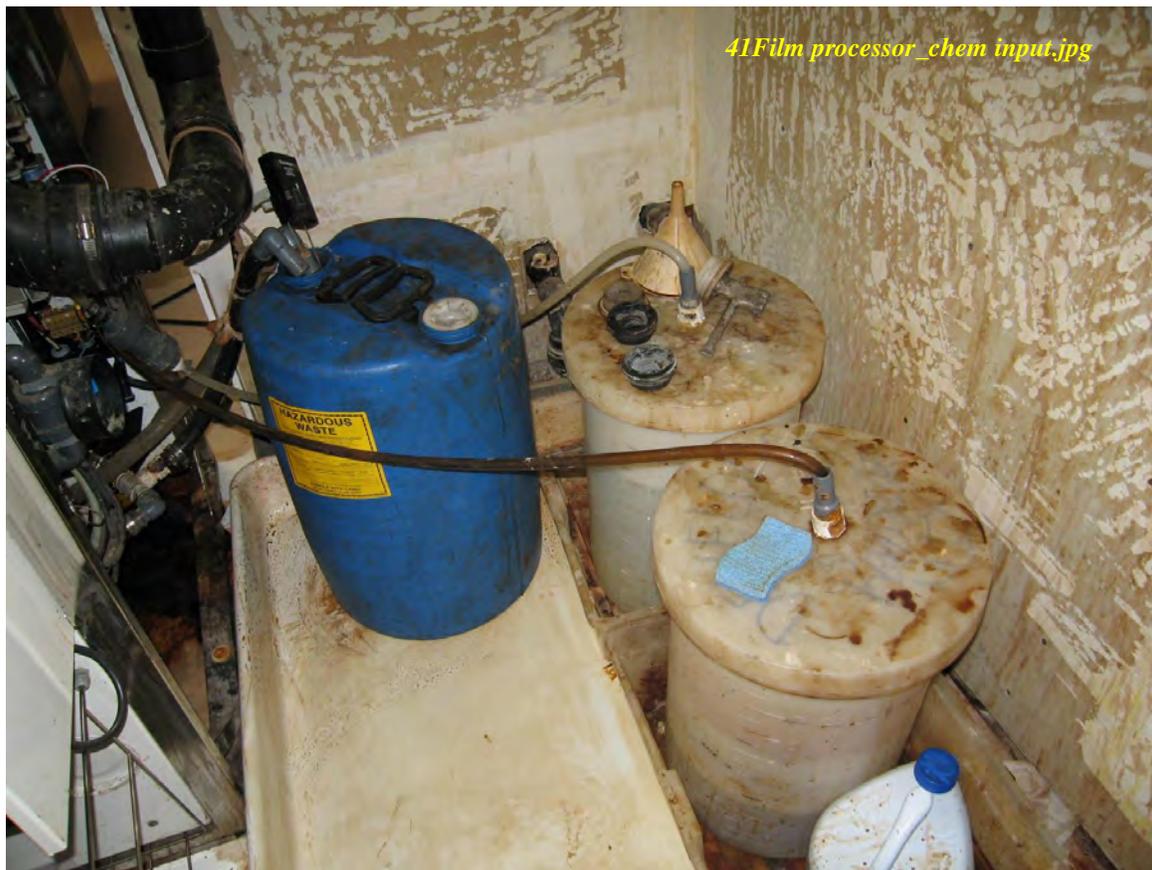
Photo 10

Coast's film processor machine is located in a different room than the main process area. This machine is used only once a day for approximately 10-15 minutes. The customer sends the file, and Coast runs the film through the machine. The developer and fixer solution, once spent, is collected in a hazardous waste plastic drum, to be hauled offsite for hazardous waste disposal. *See Photo 10.* Based on hazardous waste manifest records, Coast generates approximately 90 gallons of silver-based hazardous waste from this machine every few months.

Film processor (on left side) –
chemicals fed into machine and hazardous waste discharge
Taken by Anna Yen on August 19, 2011

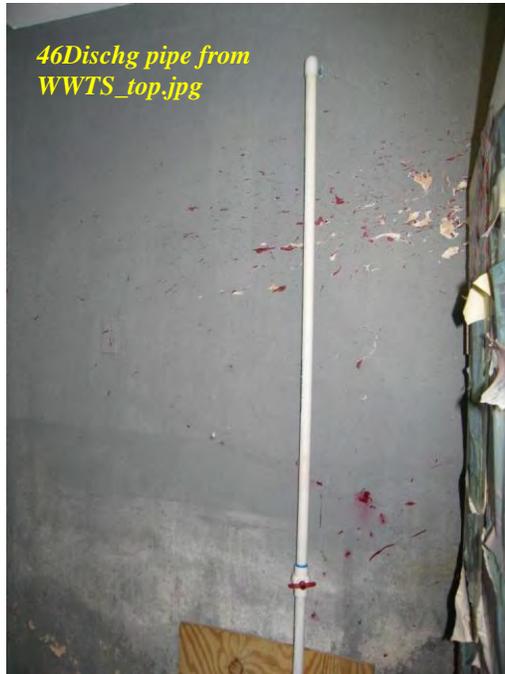
Photo 11

In a room on the other side of the wall from the wastewater treatment system is the sample point. *See Photos 11 and 12.* Nearby is an industrial sink, also used for washing

The treated wastewater in the large holding tank flows to a sample box on the other side of the wall. The discharge pipe from this holding tank to the sample box is controlled by a valve. *See Photos 11 and 12.* The City of San Jose (“the City” or “San Jose”) requires Coast to test its wastewater for pH before batch discharging to the local sewer system. Coast discharges on a weekly basis, approximately 400 gallons per batch.

Discharge pipe from wastewater treatment system to sample box
Taken by Anna Yen on August 19, 2011

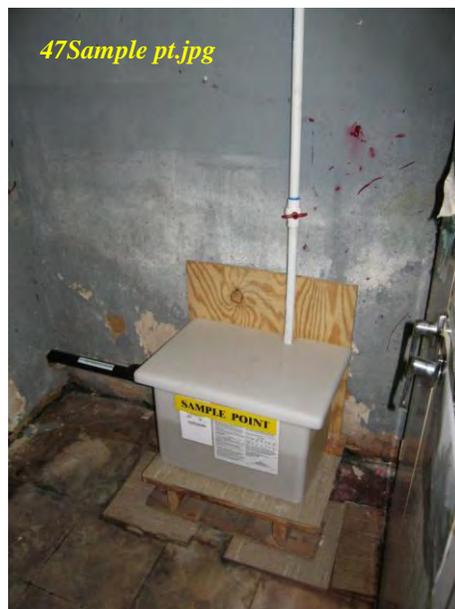
Photo 12

Sample box
Taken by Anna Yen on August 19, 2011

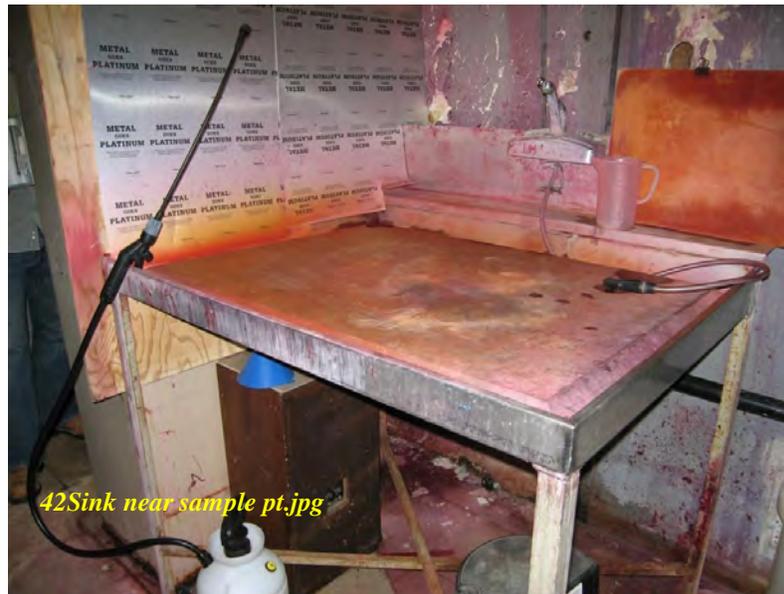
Photo 13

screens, which is plumbed to drain to the treatment tank of the wastewater treatment system. *See Photos 13 and 14.* In the past, Coast had created an illegal discharge point by sending untreated wastewater through a hole in the wall to this sink. This sink, at that time, discharged to the local sewer system. See Section 2.2 for details on the illegal wastewater discharge.

Sink – (sample box is on the other side of the left wall)
Taken by Anna Yen on August 19, 2011

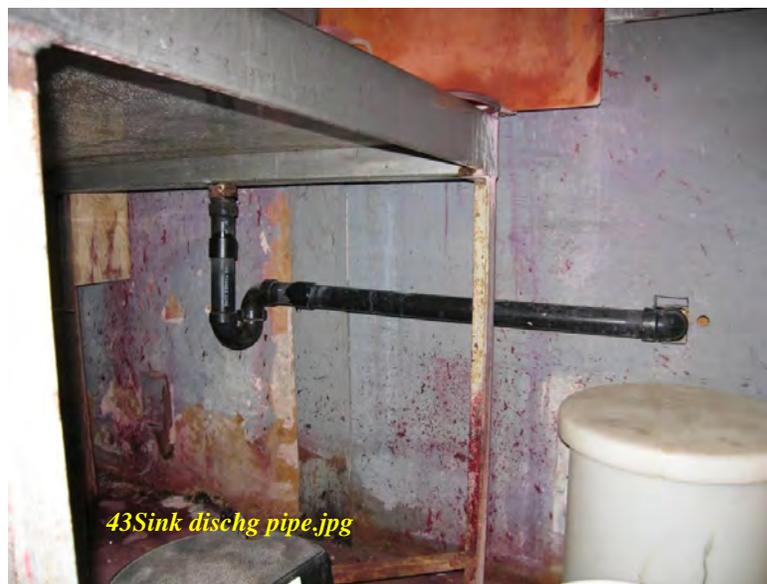
Photo 14

Sink discharge pipe
– leads to wastewater treatment system
Taken by Anna Yen on August 19, 2011

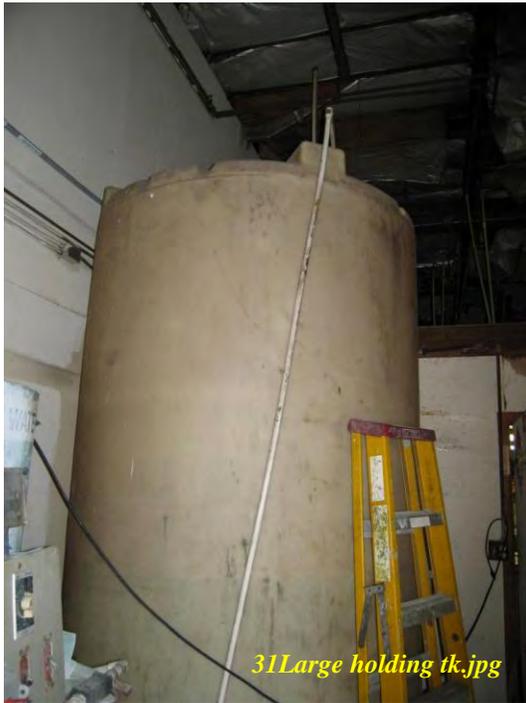
Photo 15

The filtrate is sent to the large holding tank (approximately 1200 to 1400 gallons), which drains to the sample point and ultimately to the local sewer system. *See Photos 15 and 16.* The filter cake is transferred to a nearby holding bin for subsequent transferal to a one-cubic-yard cardboard box designed for such waste and disposed of offsite as hazardous waste.

Large holding tank of wastewater
treatment system

The PVC lines conveying the filtrate from the filter press to the large holding tank were outfitted with two filter housings. Coast stated that these were polishing filters but the housings were presently empty because of operational problems. Coast stated that they plan to install new filters. Coast said that it will also reconfigure the PVC piping as the configuration is not straightforward and unnecessarily complex.

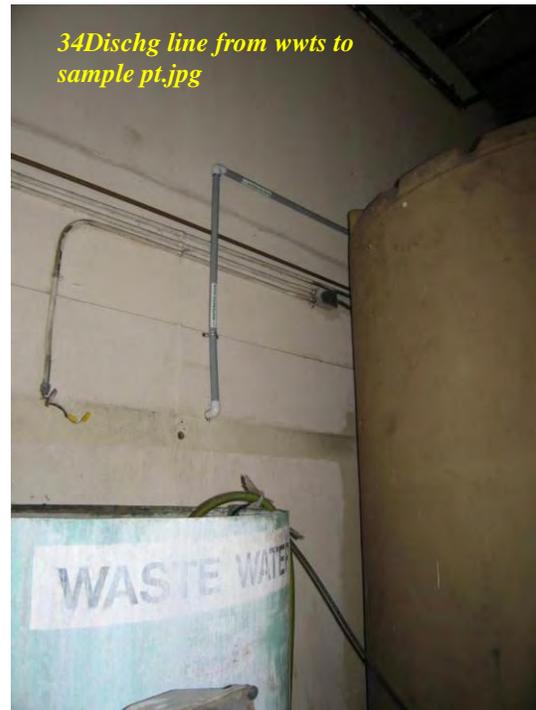
Photo 16

Discharge pipe from large holding tank
– leads to sample box on other side of
wall

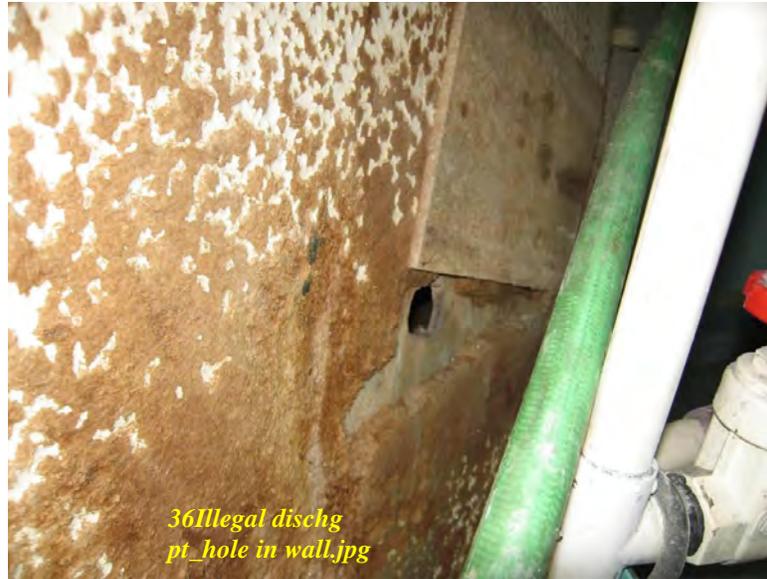
Photo 17

The City has issued numerous enforcement notices and penalties to Coast over the past couple of years. Coast claimed to be a zero discharger prior to the current permit issued May 24, 2010. However, in 2009, the City discovered that Coast was discharging industrial wastewater to the local sewer system through an illegal discharge point. Coast had drilled a hole through the wall separating the wastewater treatment system from the current sample point, allowing its untreated wastewater to flow into a sink which discharged directly to the local sewer system. This hole was covered up by steel and wooden plates attached to the wall. *See Photos 17-19.*

Illegal discharge point discovered in 2009
– (wood plank was moved to reveal the hole for this photo)
Taken by Anna Yen on August 19, 2011

The City referred Coast to the City Attorney's office for further enforcement for falsification of information and discharging without the required permit. Since then, the City has issued a verbal warning, a warning notice, notices of violation, and two \$500 fines ("administrative citations") for late submittal of required reports. The City has also issued notices of violation and administrative citations to Coast for violations of local limits for cyanide and zinc as well as violations of federal limits. In July 2011, the City held a compliance meeting with Coast. Coast is currently under a compliance agreement which specifies that Coast must sample monthly for three months for TTO, cyanide, and metals; submit procedures for treatment system operation and monitoring; submit an updated solvent management plan; submit a slug discharge prevention plan; and attend the San Jose/Santa Clara Water Pollution Control Plant Industrial User Academy. All but the last requirement are due by October 31, 2011.

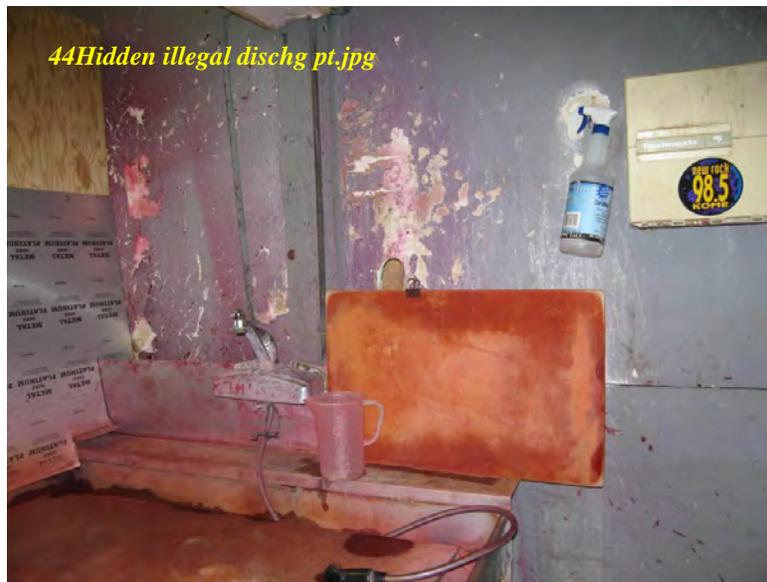
Photo 18

Illegal discharge point discovered in 2009
– hole in wall is hidden by plate leaning against wall
Taken by Anna Yen on August 19, 2011
