Purpose: TSCA Compliance Evaluation Inspection

Facility: Waste Management, Inc.
(Kettleman Hills Facility)

Date of Inspection: November 29, 2012
Time In / Time Out 9:12 am / 4:58 pm

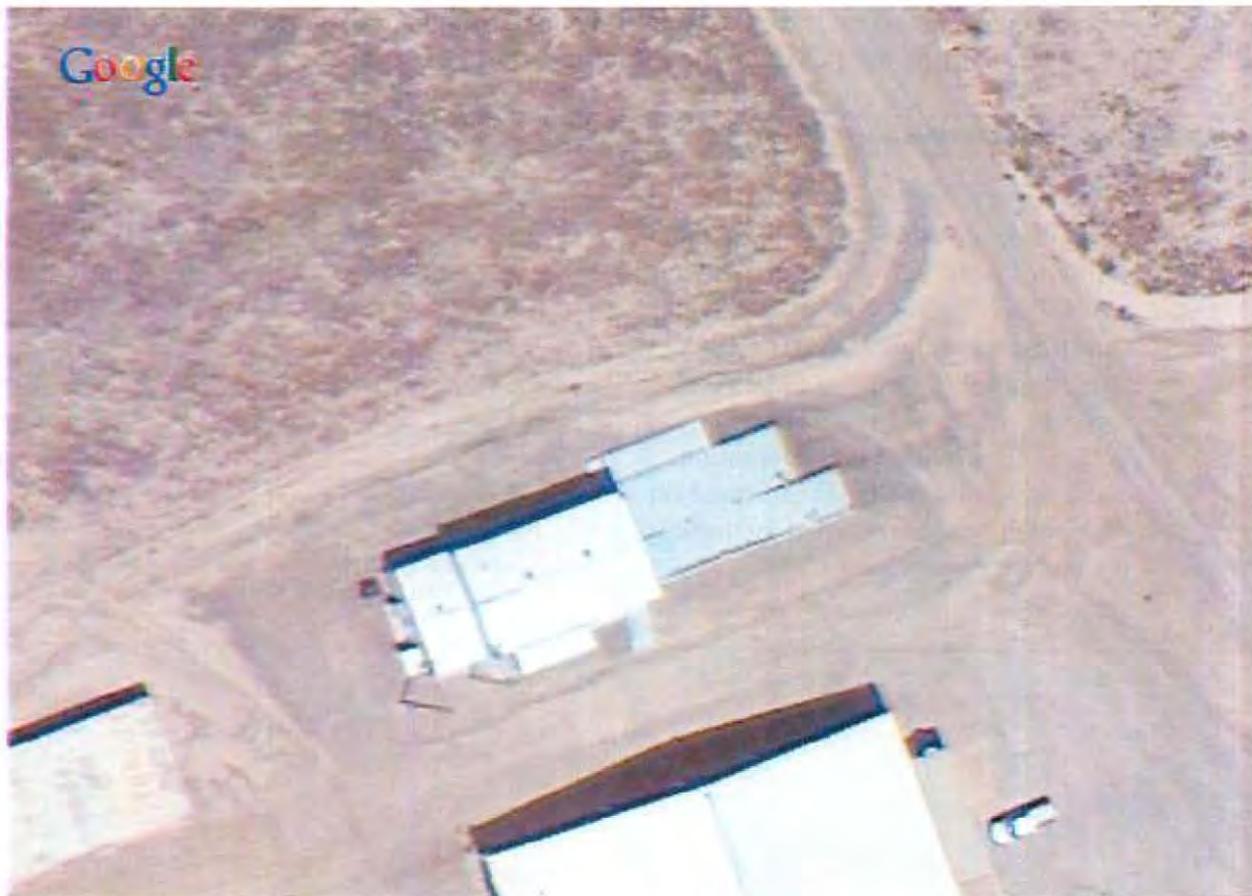
Below is an aerial photograph of the WM-KHF's PCB Storage Building (Middle of Photo), located in Kettleman City, CA. The PCB Storage Building houses a 10,082 gallon PCB oil tank; PCB solid waste collected from the general public is also stored in the building; as well as PCB waste generated by the facility's on-site operations.

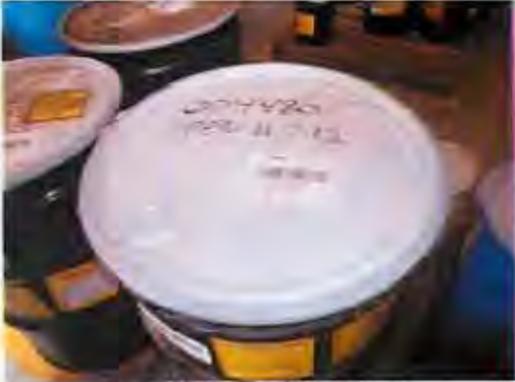
<p data-bbox="987 1373 1284 1409">No. 1 (PB290098.JPG)</p>

Observation	Photograph
<p>1. EPA observed a black 55-gallon metal container with PCB waste generated by WM-KHF. The container had an Out of Service Date (OSD) of 10/9/11, more than one year prior to EPA's inspection. During the inspection, WM-KHF provided documentation confirming that the OSD indicated on the container was recorded incorrectly. It should have read 10/9/12.</p>

EPA observed that OSD's were recorded by the facility in a few different ways and in different locations on containers in the PCB Storage Building. EPA recommends that WM-KHF be more consistent regarding where and how they record the OSDs on PCB containers in-order to decrease the potential for confusion by inspectors or workers.

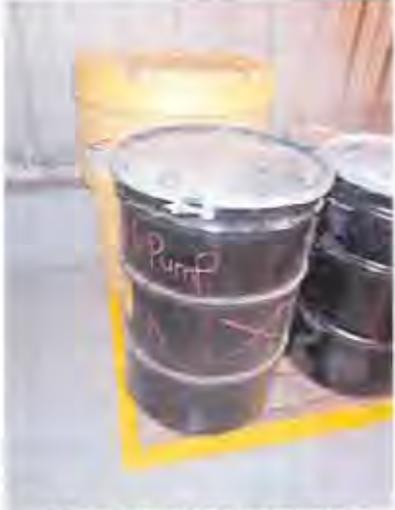
Observation	Photograph
<p>2. EPA observed a black 55-gallon container marked with the words "PCB Pump". The container was properly marked with a PCB M_L label, to indicate that it was contaminated with PCBs, but not a hazardous waste label. The pump was owned by WM-KHF and was a spare used to clean-up liquid PCBs from spills and leaky equipment. The pump was not a waste and therefore not required to be marked with a hazardous waste label in accordance with California's labeling requirements.</p>

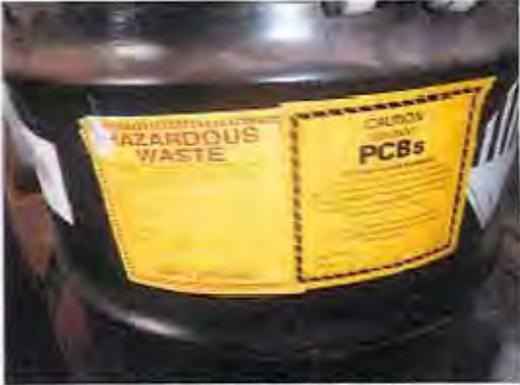
<p>No. 2 (PB290100.JPG)</p>
<p>3. The EPA inspector observed a black 55-gallon container of PCBs generated by a third party, whose hazardous waste label was faded and marked improperly with an accumulation date of 01/00/00. During the inspection, WM-KHF provided documentation confirming that the OSD indicated on the container was recorded incorrectly by the generator. It should have read 9/18/12.</p>

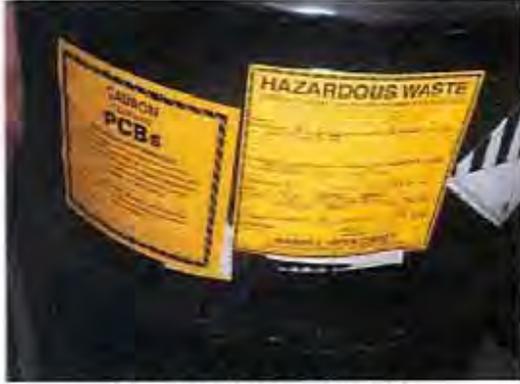
<p>No. 4 (PB290104.JPG)</p>

<p>4. The inspector observed a black 55-gallon container of PCB waste, generated by a third party, without an accumulation start date or OSD on the PCB or hazardous waste labels. During the inspection, WM-KHF demonstrated that they recorded the OSD on the top of the container that read 10/20/12.</p>

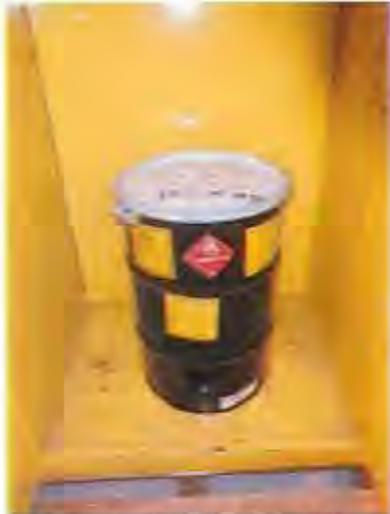
<p data-bbox="974 787 1282 829">No. 5 (PB290108.JPG)</p>

Observation	Photograph
<p>5. EPA observed a black 30-gallon container of hexane contaminated with PCBs and generated by WM-KHF's on-site lab. The container had two separate accumulation start dates on its hazardous waste labels, one of which was incorrectly recorded (6/11/12 and 5/17/22). During the inspection, WM-KHF provided documentation confirming that two separate batches of hexane contaminated with PCBs were placed in the same drum and the earliest accumulation date should have read 5/17/12.</p>
