Observation Report

PROJECT NO. 385687.F1.01

A) Work Activities In Progress: Screening soils for use as utility line backfill material.

B) Issues concerning conformance to specifications and/or design: This visit focused on dust control measures for soil screening.

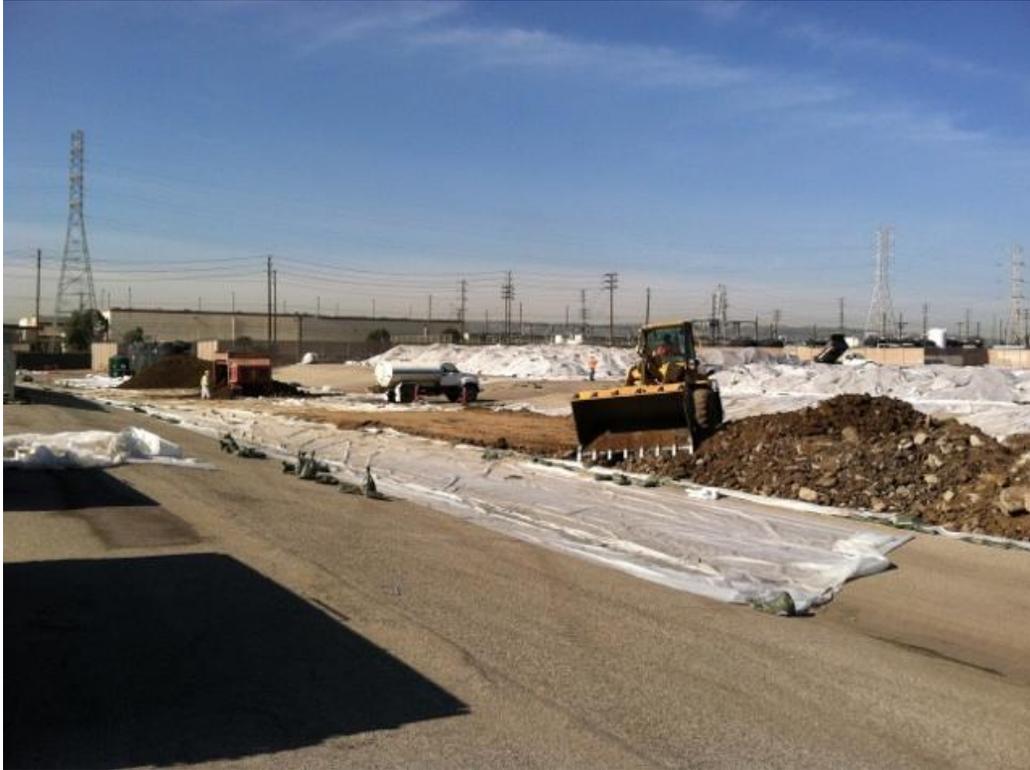
Figure 1: Soil screening - stockpile from excavation north of shaker, shaker (red machine), and stockpile of screened soil south of shaker (distance).

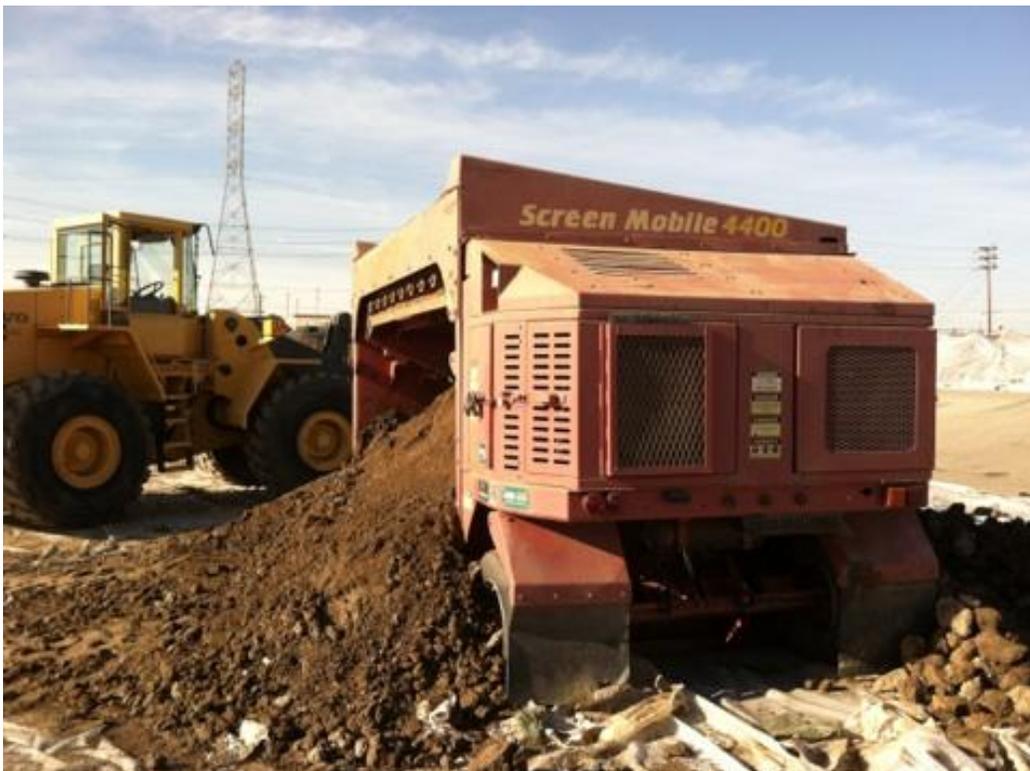
Figure 2: Soil screening machine.

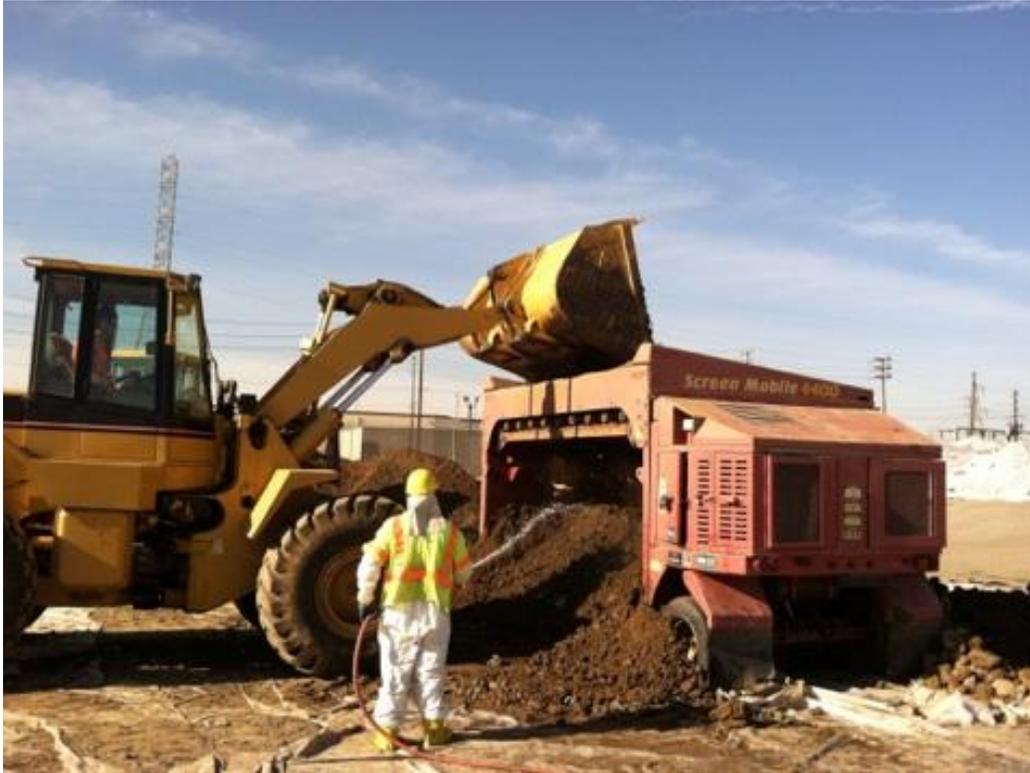
Figure 3: Loading shaker, note worker spraying soils as they fall from screen, note lack of dust.

E) Communications and discussion with PRP site representative: Discussed dust control with Kevin Thomas of AECOM. Care was being taken to minimize dust by spraying water on the soils falling from the soils screen as well as the area around the screen and soils stockpiles. Dust was also being measured by stationary and handheld devices.

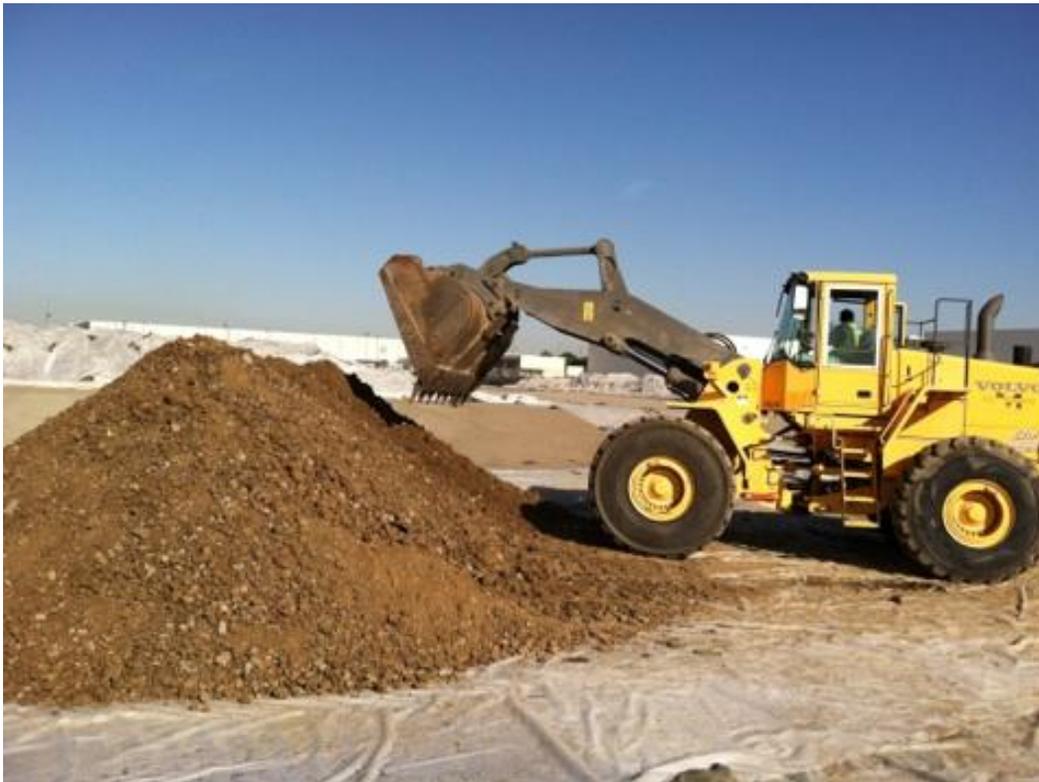
Figure 4: Screened soil being dumped on stockpile, note lack of dust.
