**CORRECTIVE MEASURES STUDY  
 COLUMBIA MANUFACTURING COMPANY  
 RESTORATION PROJECT  
 WESTFIELD, MASSACHUSETTS**

**DISTRIBUTION OF CHROMIUM  
 SOUTH END GROUNDWATER - MAY 2009**

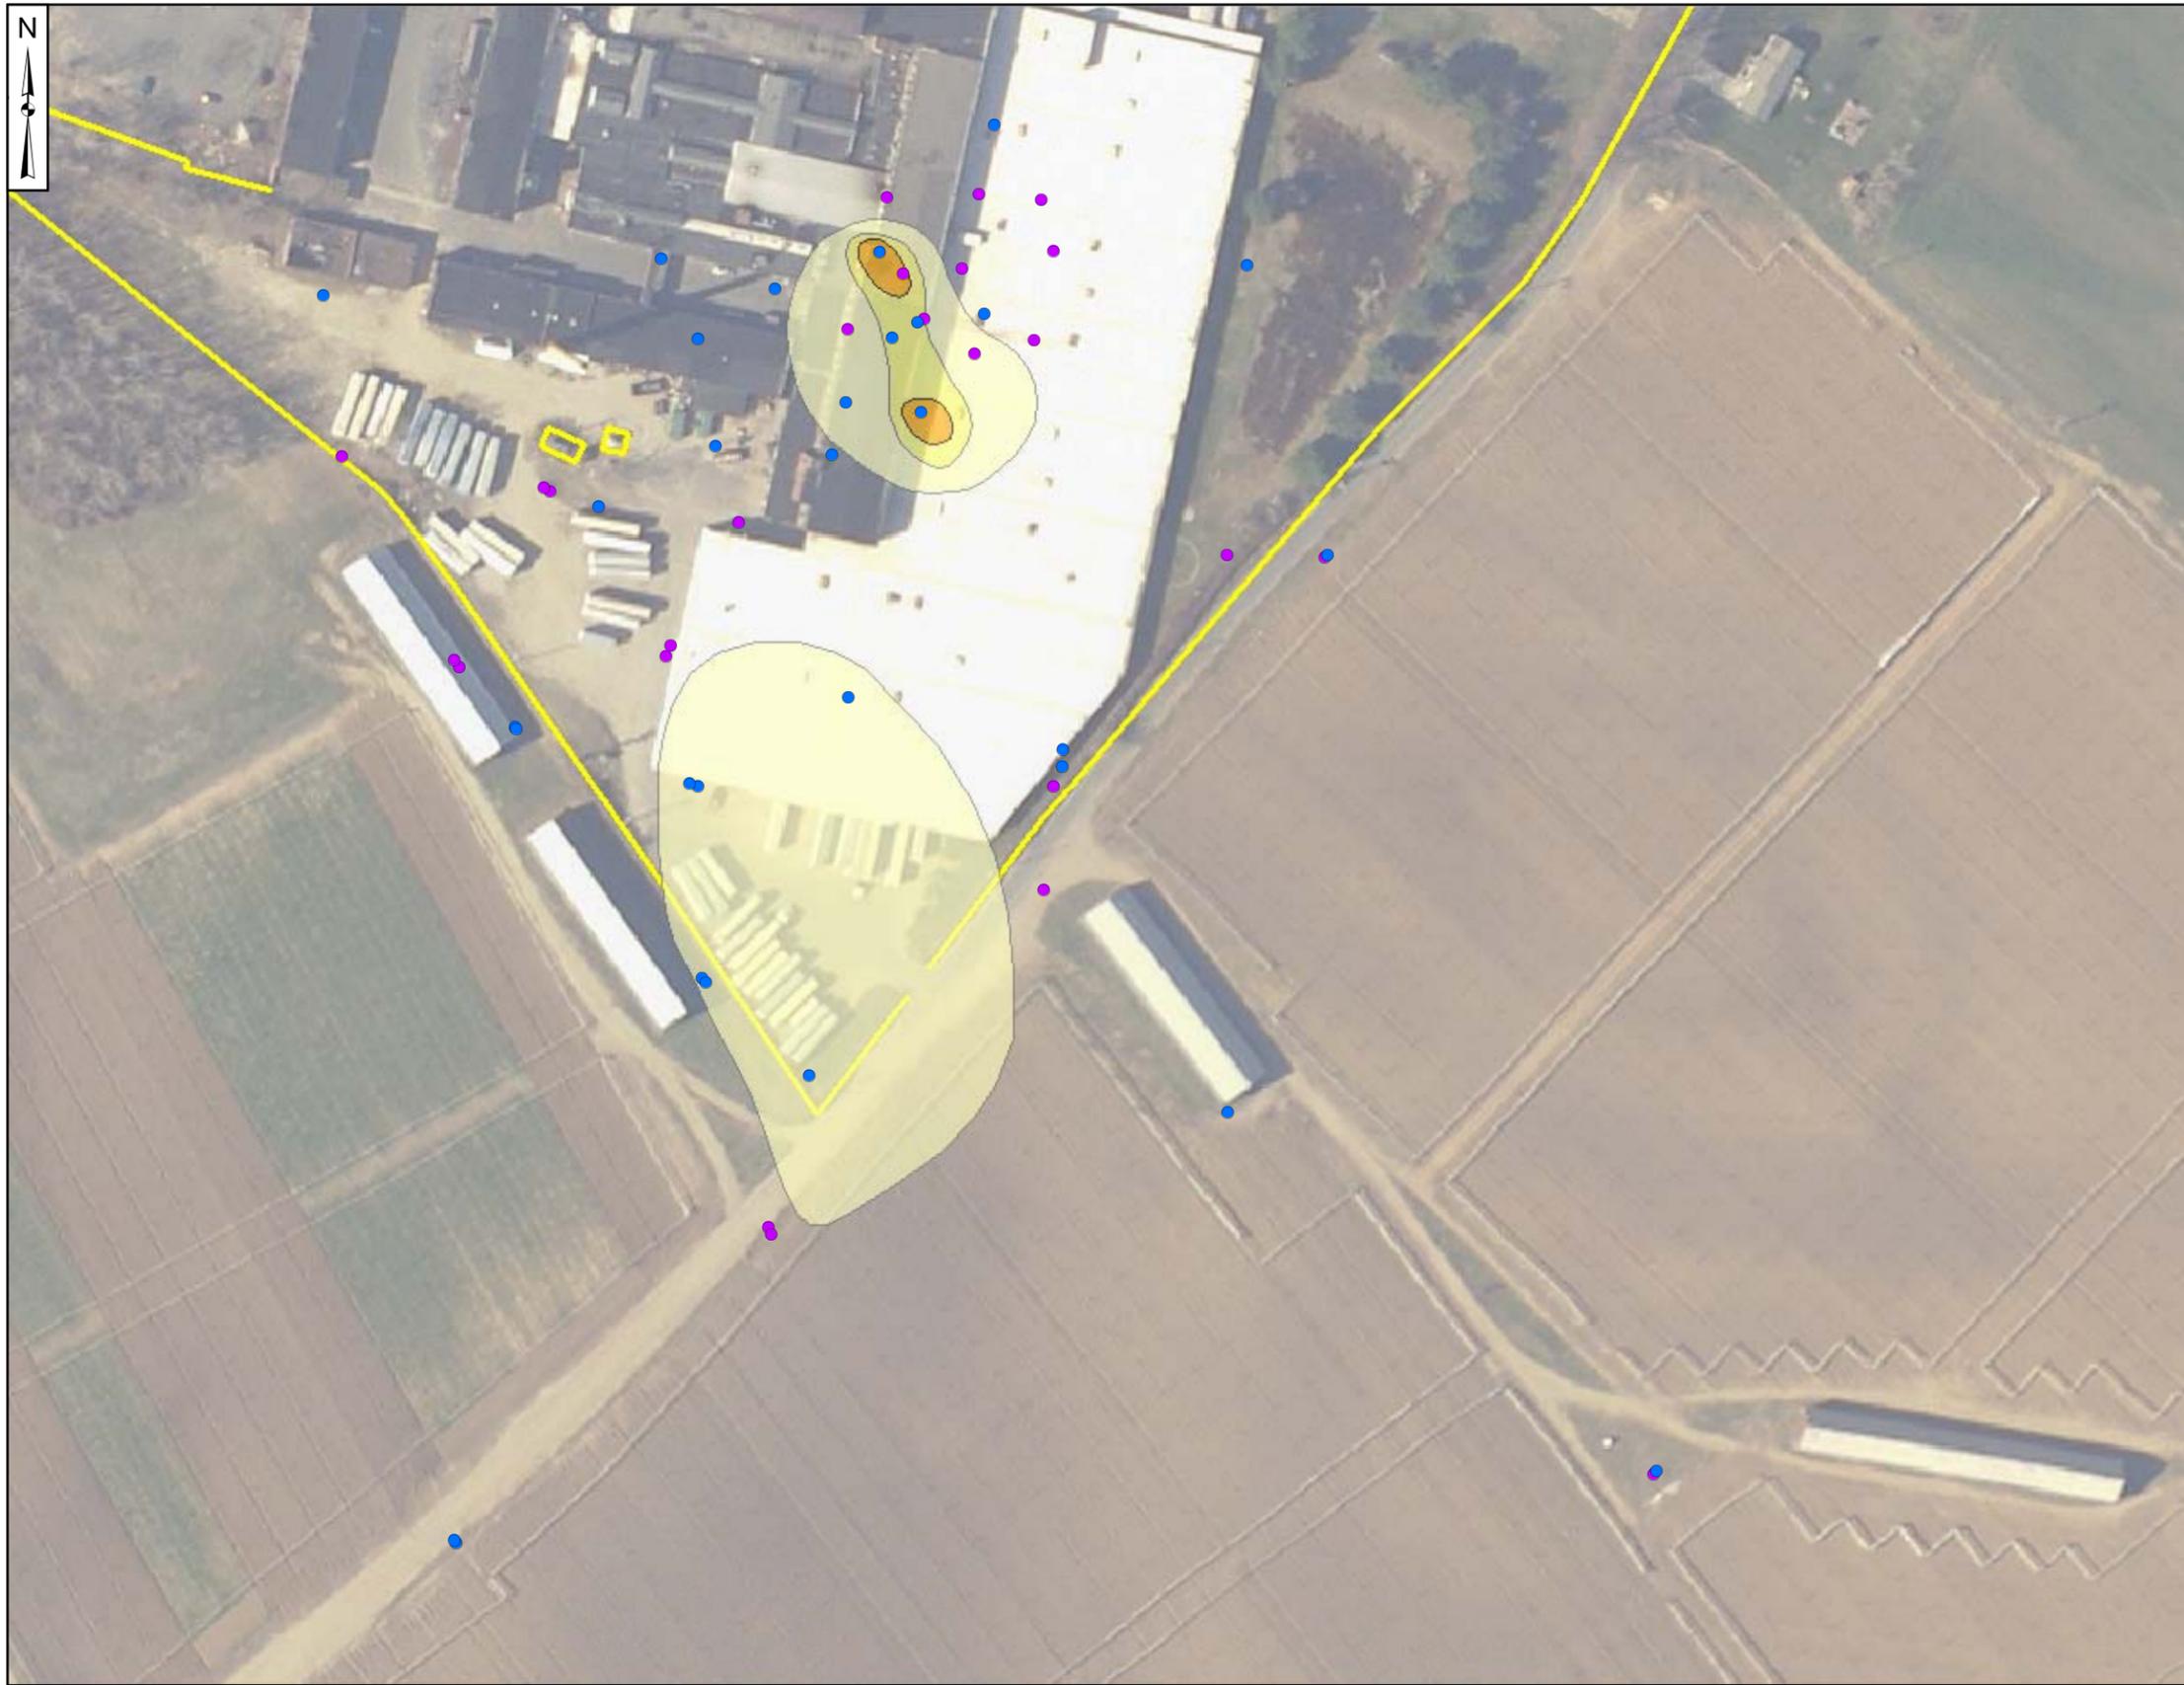
Chromium Concentration (mg/L)

Aerial photograph taken ca. 2004.  
 Multiple structures have been deconstructed since the aerial photograph was taken.
