Subject: Additional request for information for EPA SSA review on proposed MPMGR

USEPA
SOLE SOURCE AQUIFER REVIEW
RESPONSE

Massachusetts National Guard
Camp Edwards, MA 02542

22 March 2022

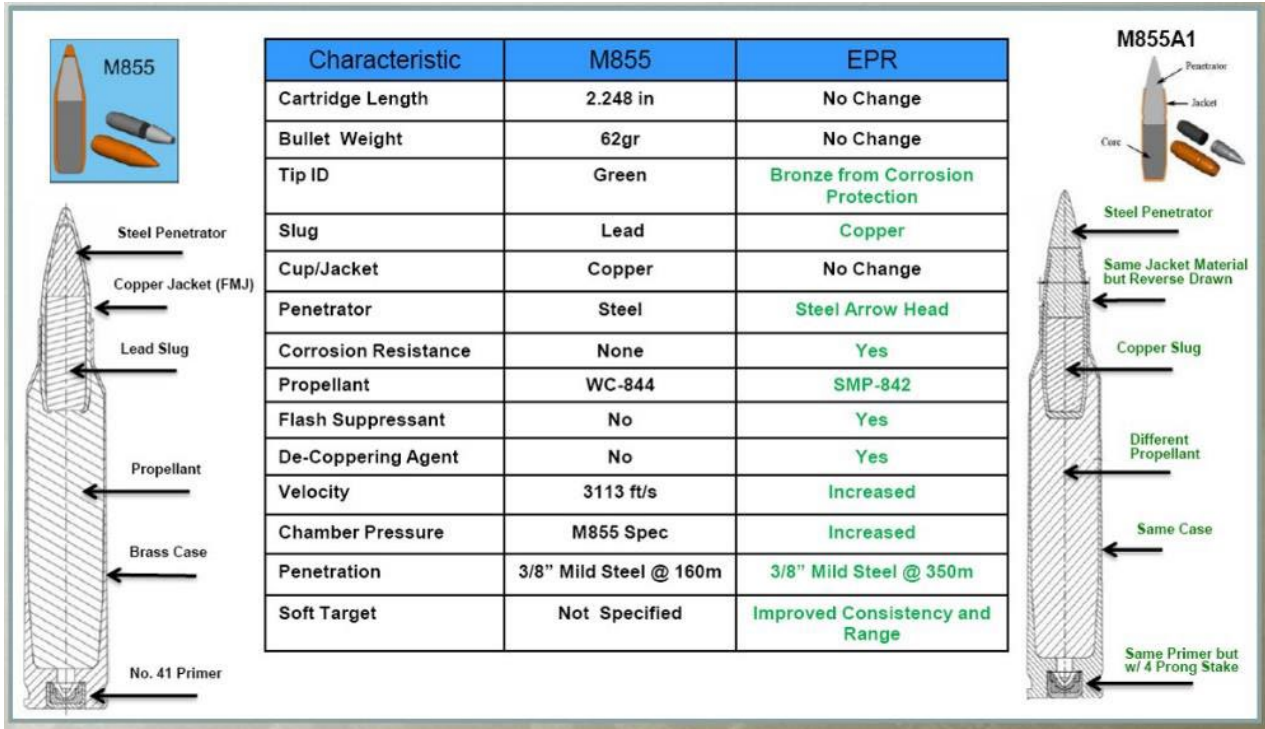
Figure 1. Lead vs Copper Ammunition (5.56 and 7.62 mm ammunition), Camp Edwards, Massachusetts

Projectile Recovery Efficiency is a function of bullet type, containment media, and fragmentation. In the case of Camp Edwards when referring to bullet type we are referencing lead vs copper projectiles. They both have the same basic structure, bullet core, jacket, and penetrator (Figure 1.) For the purpose of projectile recovery, the main difference is the lead core that is rarely found intact, where with the copper core it is primarily found intact even at the closest targets. In other words, the lead core has an extreme tendency to fragment where the copper core does not and remains largely intact. The jackets are the same; but with the copper round the jacket is more tightly bound to the core and are often found bound together. The lead core and its jacket are most often separate and in pieces due to the fragmenting nature of the lead core. The steel penetrator for both rounds readily oxidizes away; therefore they are not recoverable, and this must be taken into account for any recovery operations. Containment media is critical to projectile recovery. Containment material must be able to capture a round in a relatively shallow manner, must be as free as possible of material that can cause ricochets or fragmentation, and must be of a nature to capture and reduce fragmentation. The containment media, i.e. berms, must be constructed to the appropriate height and width such that the containment media functions as intended. Finally, reducing fragmentation is very important to projectile recovery; with lead bullets the fragmentation is generally extreme where the lead core and copper jacket are in pieces versus the copper bullets where the copper core and jacket generally remain intact, and if separated, there is almost no fragmentation of the copper core (Figure 2).

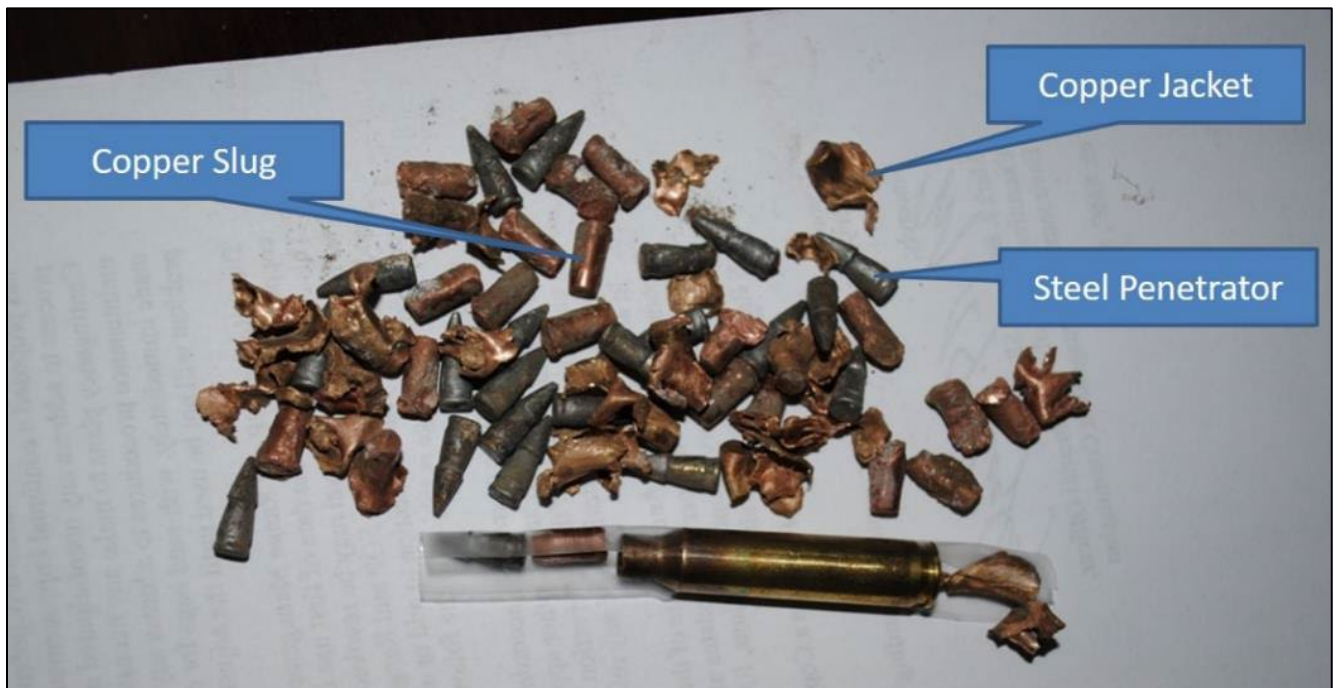
Figure 2. Copper Projectile Fragmentation, Camp Edwards, Massachusetts

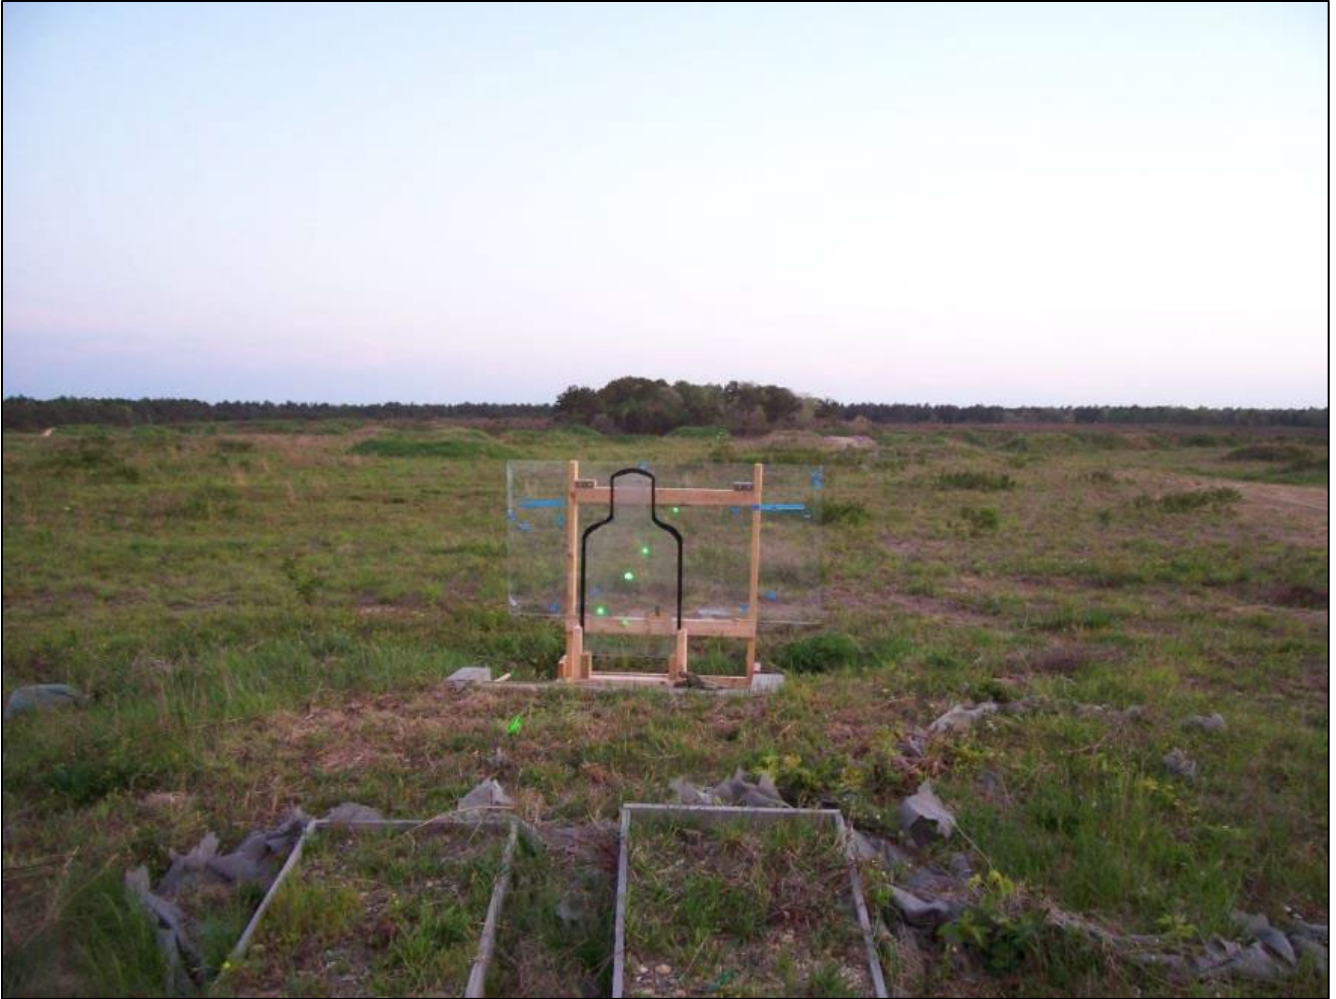
Figure 2. Phase 2 Line of Site Laser Analysis Confirming Phase 1 Virtual Line of Site
Sierra Range, Camp Edwards, Massachusetts

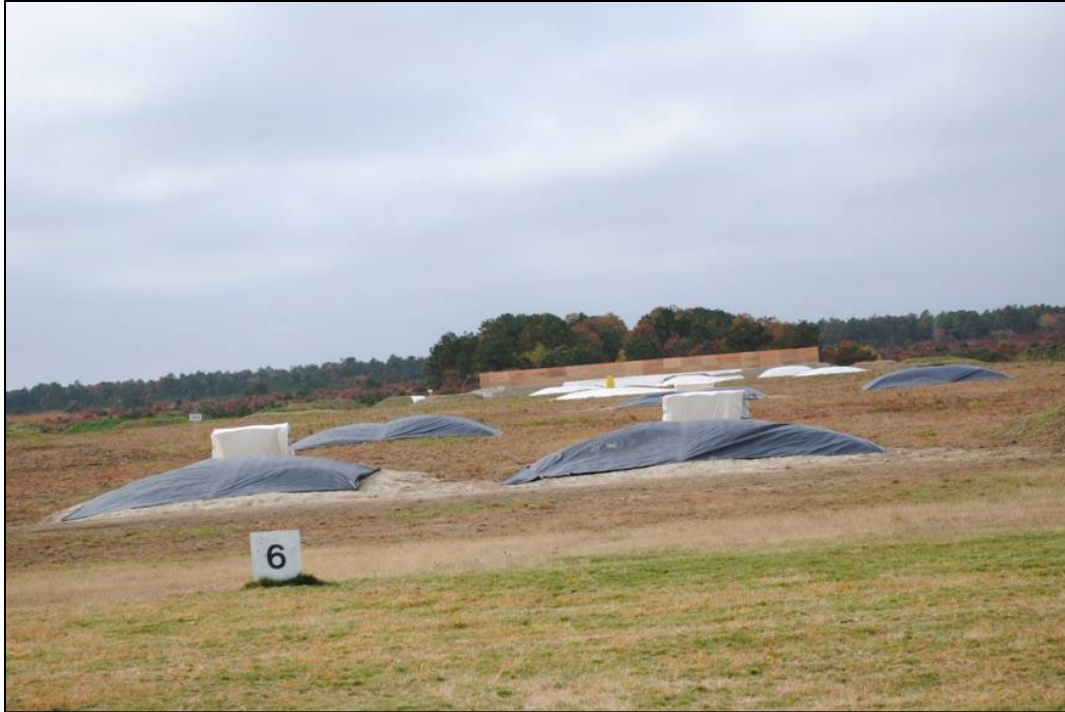
Figure 3. Test Fire Set Up to confirm Phases 1 (Virtual) and 2 (Laser), Sierra Range, Camp Edwards, Massachusetts

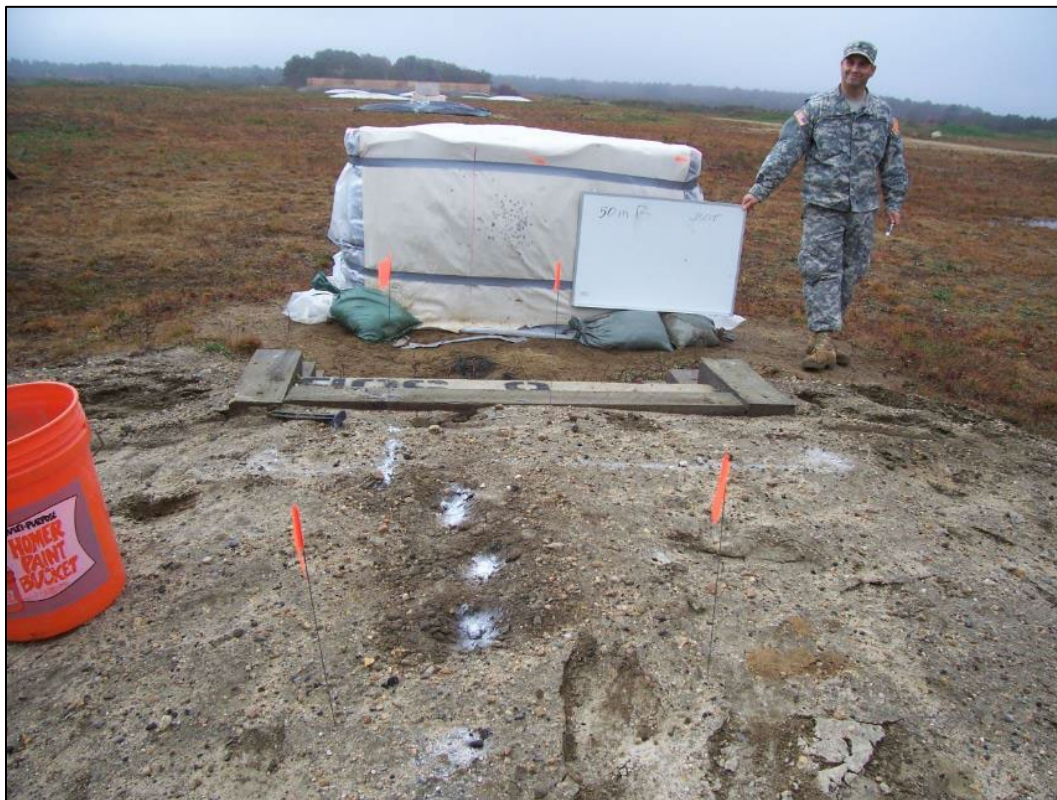
Figure 4. Fifty Meter Target Berm with Backstop after Test Fire, Sierra Range, Camp Edwards, Massachusetts

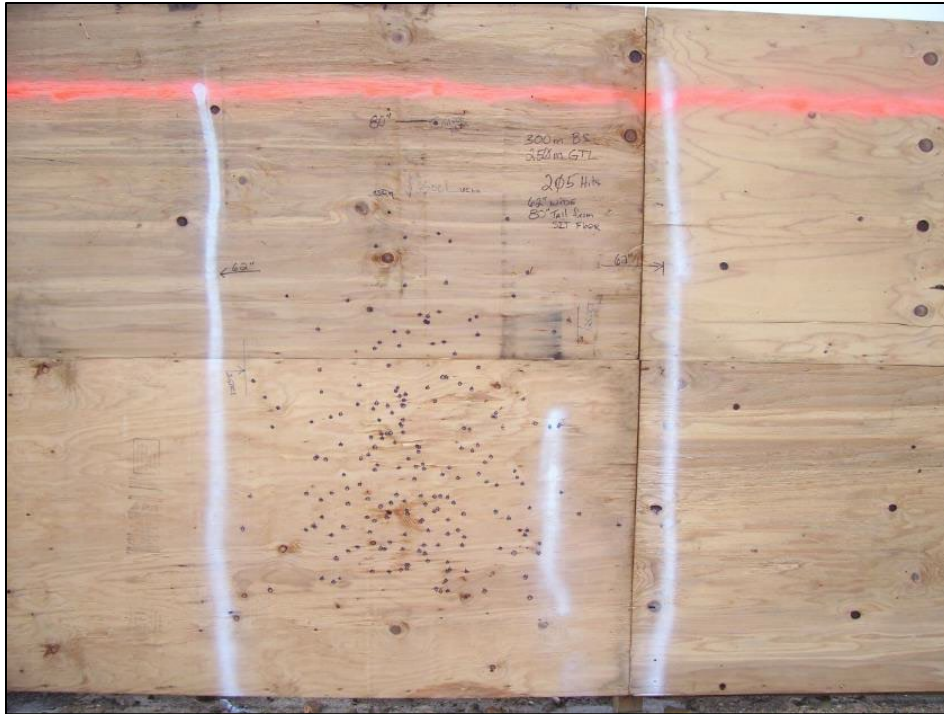
Figure 5. Three Hundred Meter Target Berm Overshot Plywood Telltale after Test Fire
Sierra Range, Camp Edwards, Massachusetts

as constructed, verifiably contained 72.6% of projectiles fired into the DefenCell® auxiliary berms, confirmed via the telltale target covering, but the overall actual material recovery was only 13.2%. Recovery of projectile material within DefenCell® auxiliary berms is difficult due to the nature of the material contained within the DefenCell®. The material caused extensive fragmentation of the lead core rounds which made recovery difficult; also during this test there was overshoot that was not recoverable.

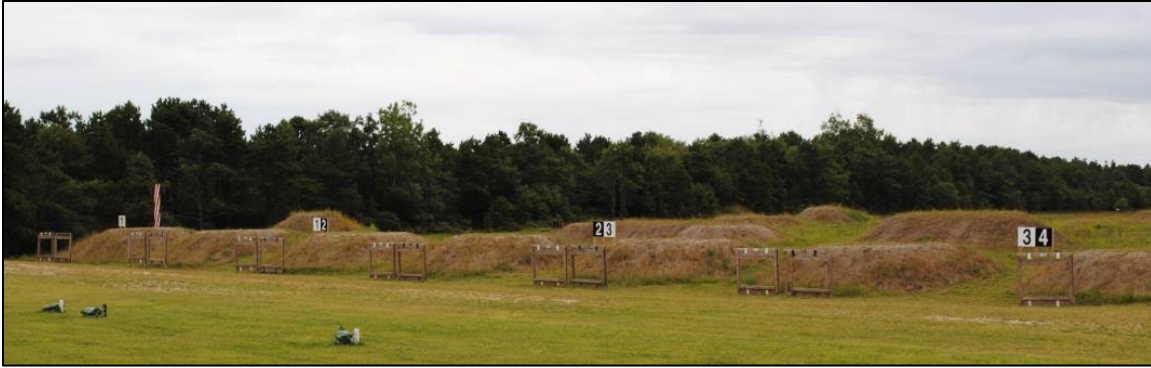
Figure 1. Zeroing Lanes in front of 50 meter Target Frontal Berms
Sierra Range, Camp Edwards, Massachusetts.

At Sierra Range, two lanes will be test harvested. One high use lane (lanes 1-4), generally the center lanes, and one with a zeroing capacity (Figure 1) will be harvested out to 320 meters. As opposed to India Range, where there is one single large berm across the range, the individual Sierra Range berms will have the full front of the berms harvested. Knowns for the range are projectiles by range and lane and that the steel penetrators oxidize away in approximately a year depending on exposure. This known weight can then be compared to the harvested weight.

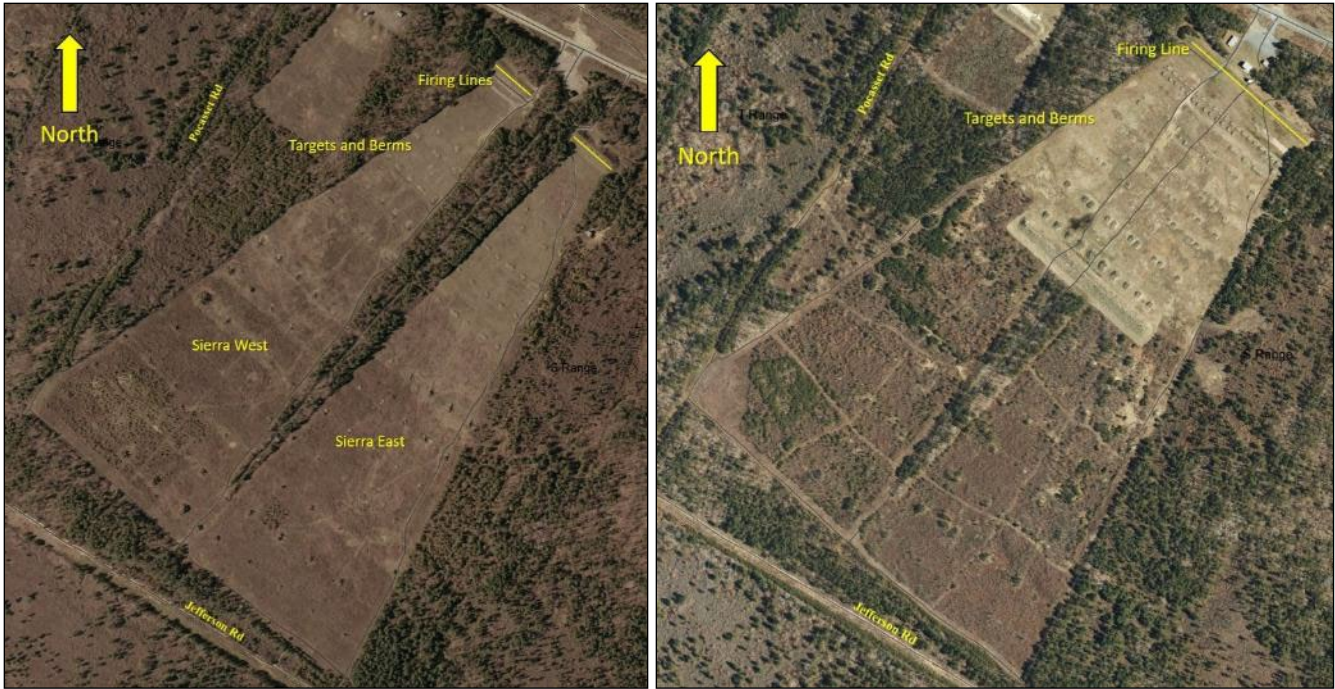
Figure 2. Sierra Range Complex 2002 and 2018, Camp Edwards, Massachusetts

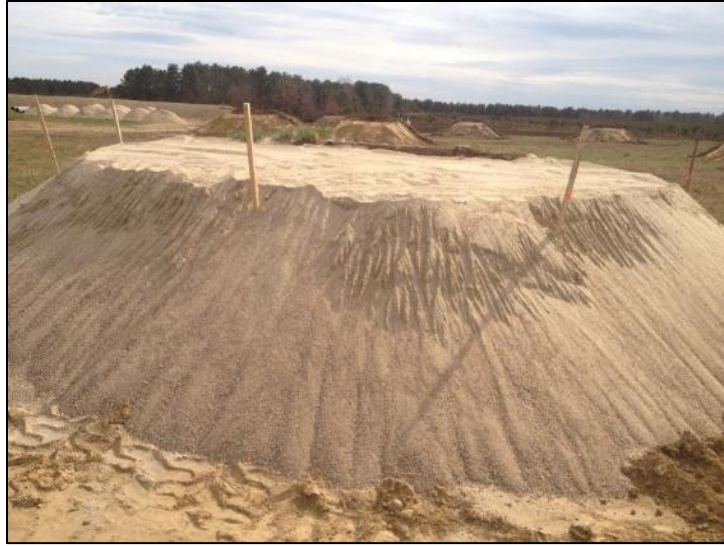
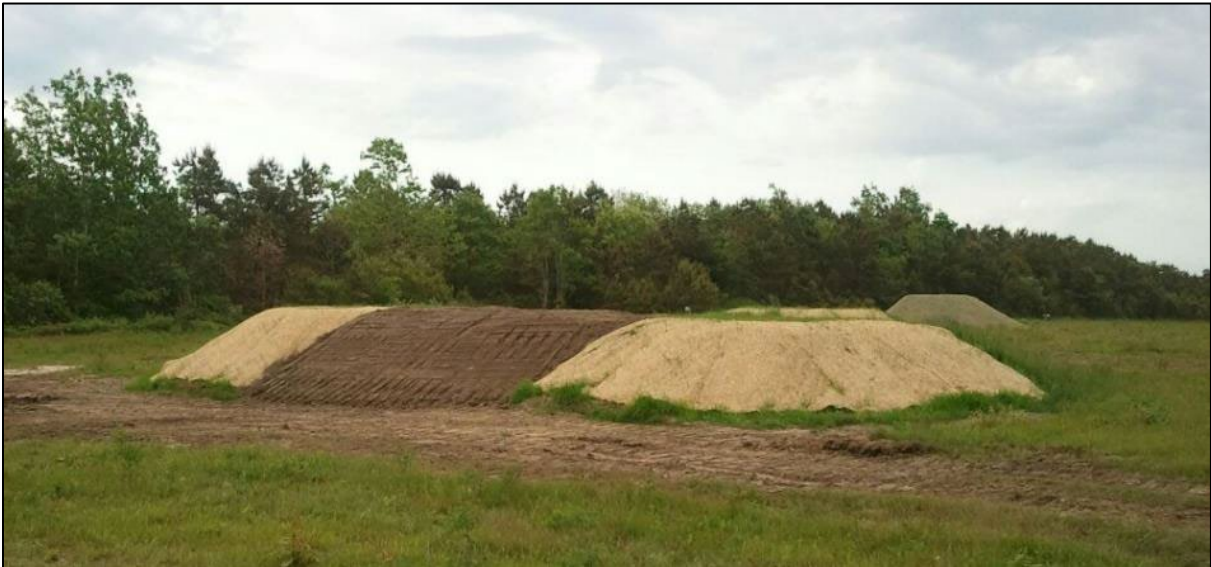
Figure 5. Sierra Range Targets Berms with Core Material (Background), Sand, Top Soil and Erosion Control Matting, Camp Edwards, Massachusetts

At Sierra Range from 2012 to 2021, 908,243 of EPR bullets were fired on the range. This equates to 90,824.3 bullets fired per lane and 10,092 bullets fired per target (2021 State of the Reservation Report). Target and backstop berms are constructed in a fashion that will capture projectiles and reduce fragmentation. In general, target and backstop berms are constructed from a core material, three feet of sand, and from 10 to 18 inches of topsoil (Figure 5). The primary capture and containment medium is the top soil layer (Figure 6).

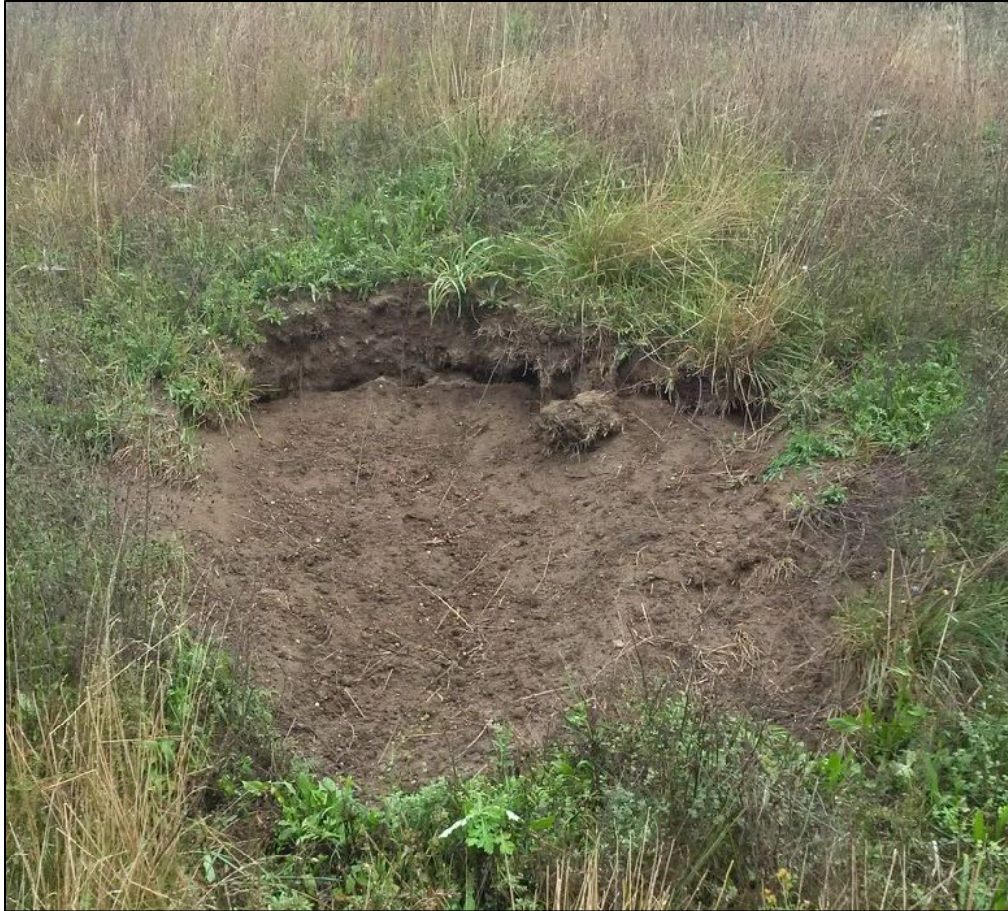
Figure 6. India Range, Top Soil Bullet Pocket, Camp Edwards, Massachusetts
(Note: sand visible, needs maintenance to reduce erosion for berm integrity)

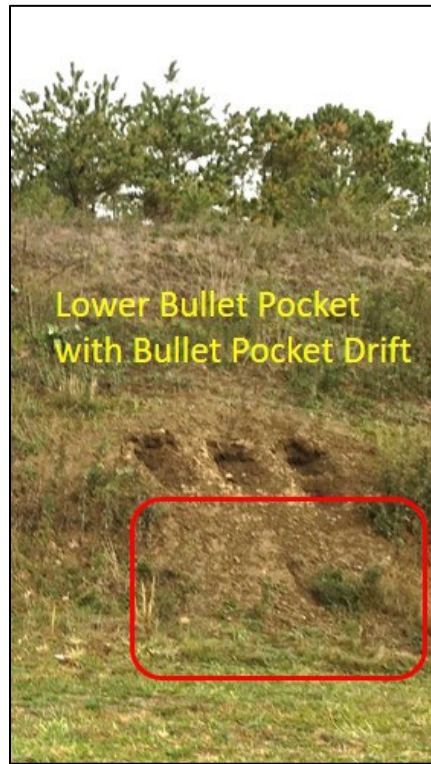
Figure 8. Lower Bullet Pocket with Drift (India Range), Camp Edwards, Massachusetts.

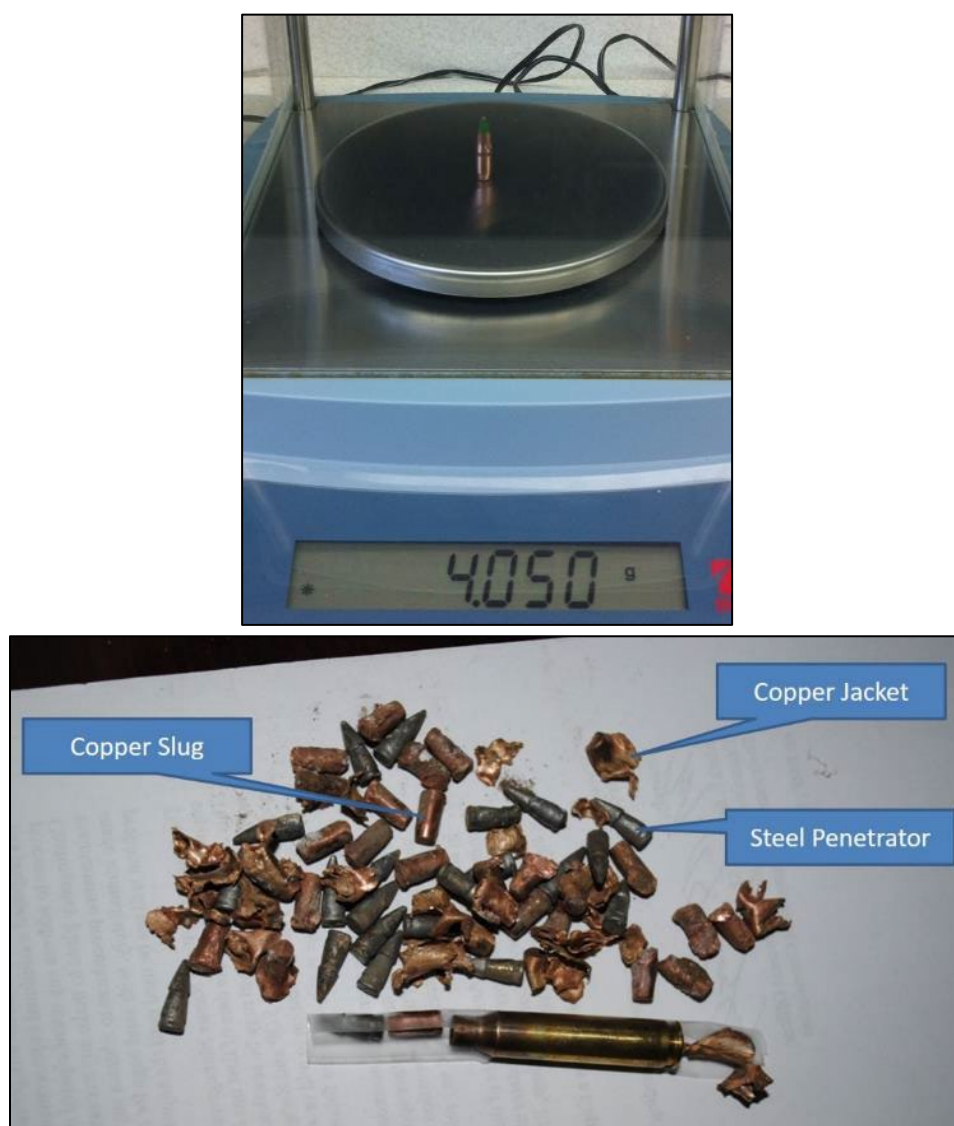
In the context of range management fragmentation refers to the condition of the projectile after being fired into the bullet pocket and thereafter. Each target level has differing ‘fragmentation levels’ (Figure 9). Targets closest to the firing line receive bullets with the greatest energy and penetration and the projectiles are more likely to fragment. As we progress down range there is obviously less energy when a bullet strikes a target. For example, most bullets within the fifty meter target berm have come apart, i.e. steel penetrator, copper jacket, and copper slug are usually separate (Figure 9). However, the further down range the less fragmentation to the point where when looking at the 320 meter berm we find intact bullets (Figure 9). The secondary but no less important cause of further fragmentation is bullet on bullet impact, which can further fragment projectiles.

Figure 9. Intact Copper Bullet and Projectile Fragmentation, Camp Edwards, Massachusetts.

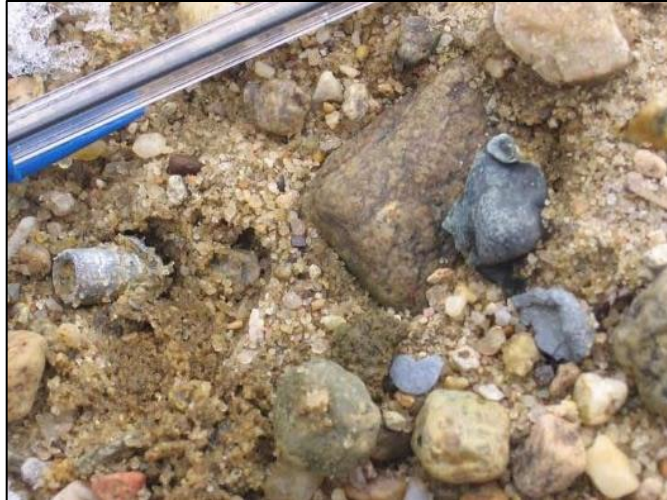
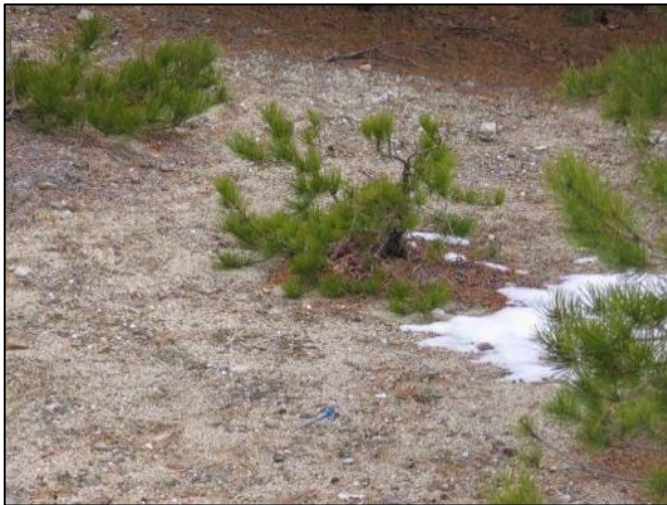
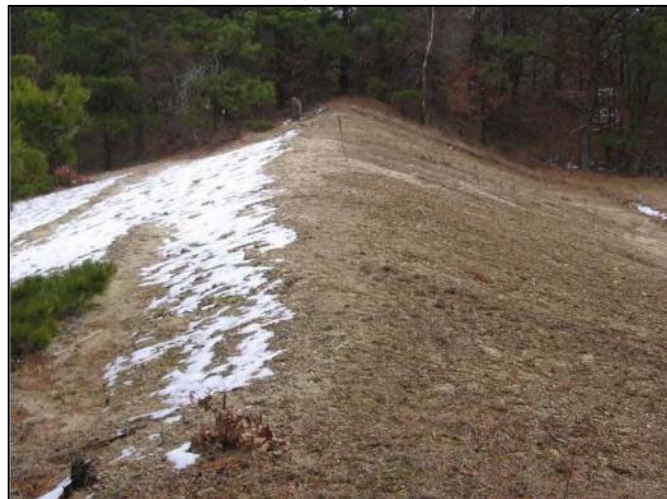
Figure 10. Projectile Debris, Bullet Pocket Ricochets (Tidily-Wink), Juliet Range behind Backstop Berm 2008, Picture 1 lead pieces with ball point pen, Picture 2 back side of berm with pen inset, Picture 3 clean berm face with snow cover and the location of lead pieces, Camp Edwards, Massachusetts.

The word “ricochet” invokes a picture of a bullet hitting a point and wildly taking off in another direction. Classic ricochets do happen on Sierra Range, but this is not the norm or what is referenced when discussing bullet pocket maintenance and harvest. On any small arms range with earthen target and backstop berms there is a projectile volume limit where “bullet pocket ricochets” will occur. At most public and private shooting ranges this type of ricochet is very common. As bullet pockets at target and backstop berms receive bullets, projectile debris can build to the point where fired bullets hit projectile debris ejecting this debris from the primary bullet pocket. This projectile debris does not fly off wildly but actually “tidily-winks” to the sides and over the top of the target and backstop berms (Figure 10). This affect can cause debris to be far enough away from the berm that projectile debris management will have to harvest from a greater area. This is not an acceptable condition for berm or projectile management at any small arms range.

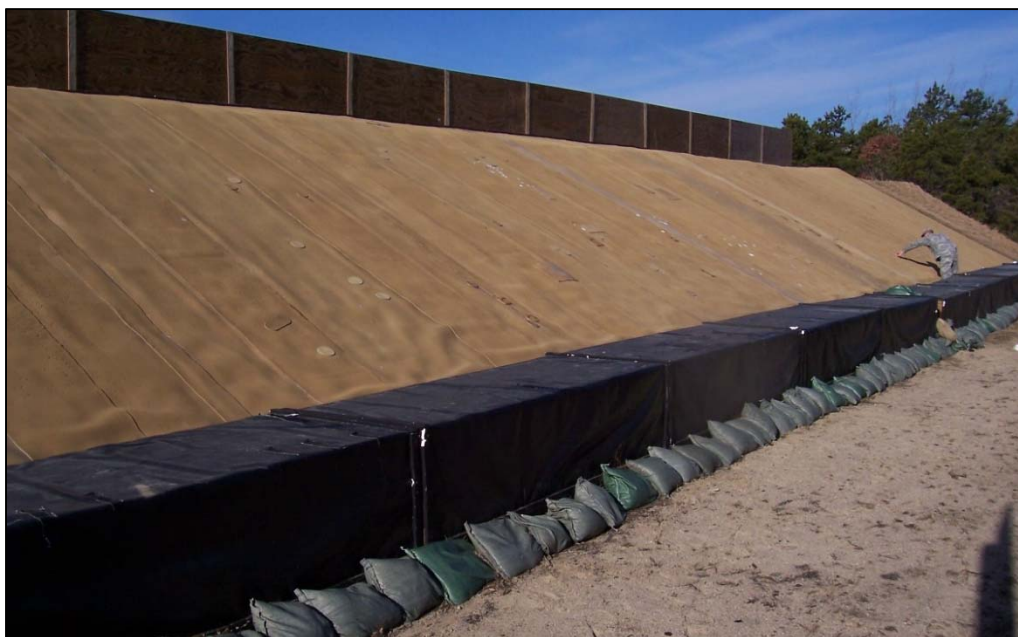
Figure 3. Toe-Berm Boxes, Tango Range, Protecting STAPP™ system Base and Internal Reservoir, Camp Edwards, Massachusetts.

The STAPP™ system on Tango Range consists of a composite lumber frame approximately 100-feet long by 23-feet wide with 15 firing lanes. On Juliet Range the system is 120-feet long by 25 feet wide with 17 lanes. Kilo Range is 200-feet long by 25-feet wide with 29 lanes. Granular rubber was placed on top of the bottom-liner inside the composite frame to a depth of 18 inches. The granular rubber was then capped with a patented “self-closing” top cover. The bullets pass through the top cover and are captured in the granulated rubber layer. This system is designed to capture and contain fired bullets. The system also minimizes potential airborne lead and runoff. The system includes an internal water collection reservoir to capture any water that infiltrates the STAPP™ system. The MANG built and placed toe berm boxes at the base and in front of the systems to protect the framing and water reservoir of the STAPP™ systems from projectiles (Figure 3).

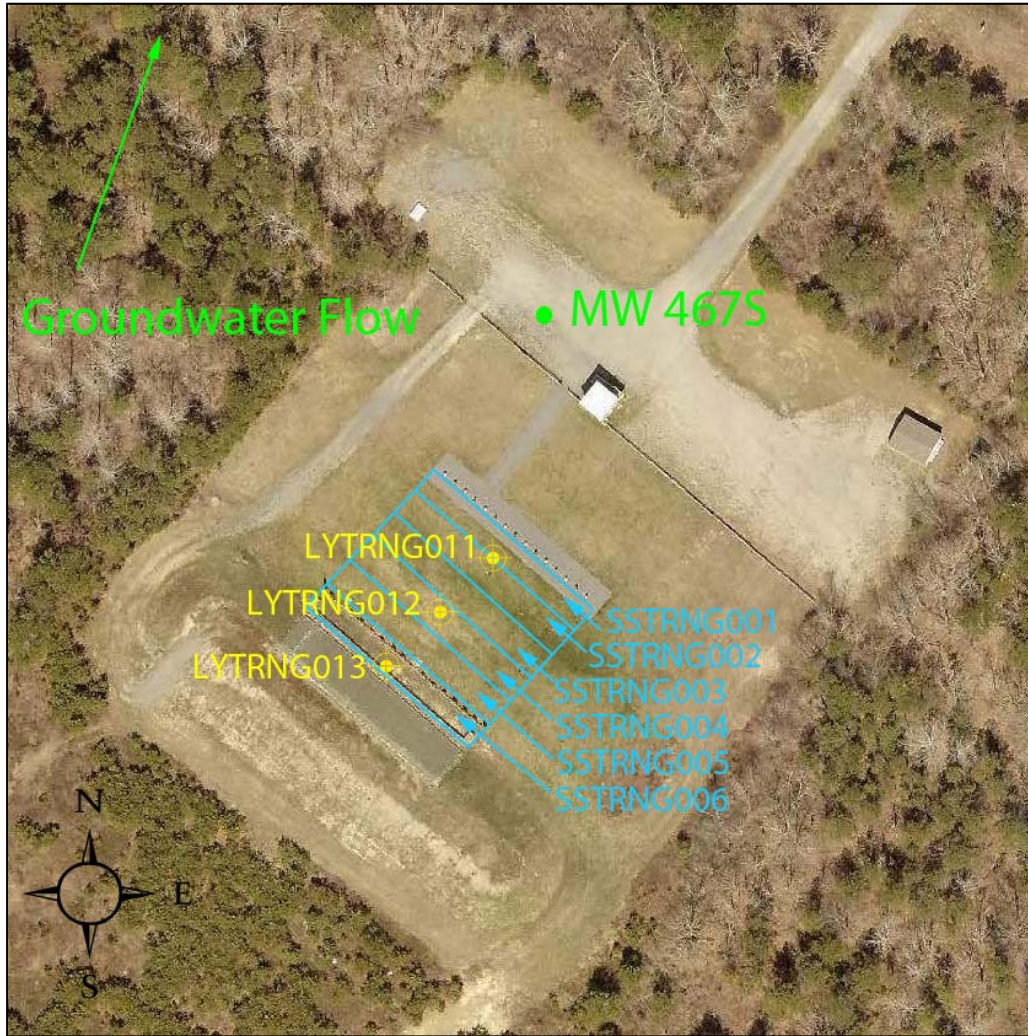
Figure 4. Lysimeters, Soil Grids, and Monitoring Well on Tango Range Camp Edwards, Massachusetts.

On Tango Range tension lysimeters designed to sample soil pore water for potential contaminants were installed in front of the firing line and between the target line and STAPP™ system. Three lysimeters were installed at a depth of five feet below the ground surface near the target line and three were located at the firing line. In 2008 it was determined that tension lysimeters can provide false sampling results because the materials that they are composed of may bind or release other contaminants. All tension lysimeters were replaced with pan lysimeters that are not known to have the same issue with contaminants seen in tension lysimeters. Three pan lysimeters were installed on Tango Range in 2010 (Figure 4). Each of these is essentially a plastic bucket with a screened lid to allow percolating water into the bucket. Tubes provide access to the collected water which is pumped to the ground surface for sampling. The screens are all placed approximately 2 feet below the ground surface. There is one pan lysimeter in front of the firing line, one in the center of the range floor and one between the target frames and the STAPP™ system.

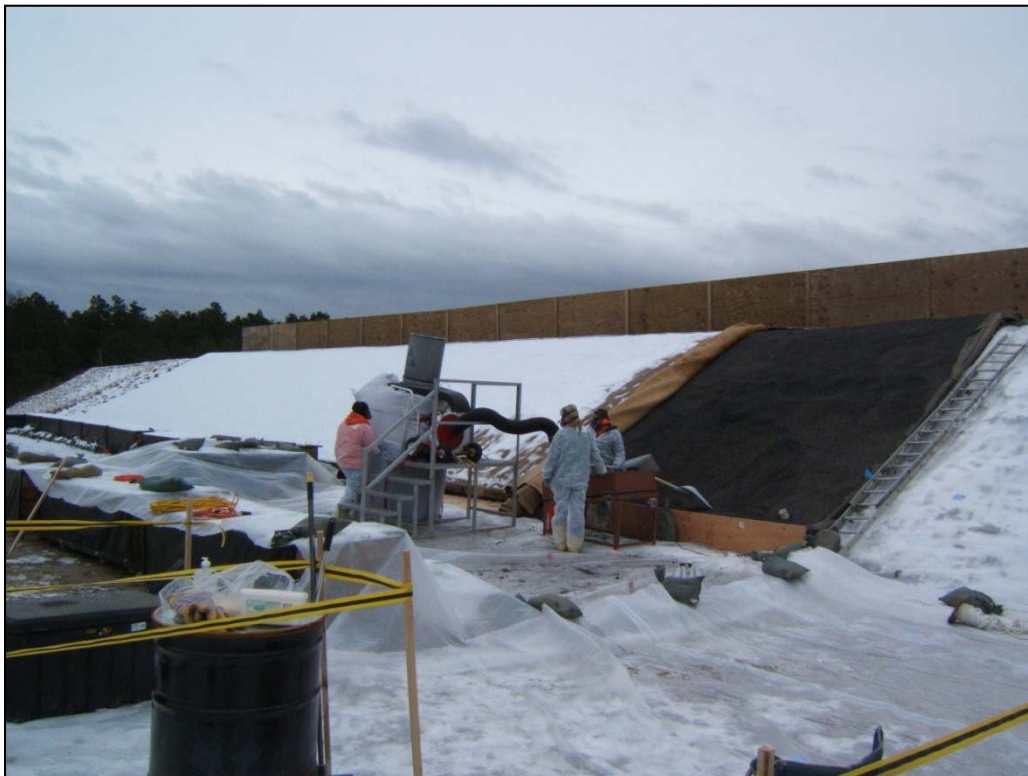
Figure 8. Tango Range Lanes 14 and 15, Sorting and Sifting Operation during Mass Balance Work, Camp Edwards, Massachusetts

Additionally, two lanes (Lanes 14 and 15) were selected for complete removal of all rubber granules that would be sifted and sorted to obtain projectiles to be weighed (Figure 8). This weight allowed for the extrapolation across the range of the rate of capture of projectiles fired into the STAPP™ system.

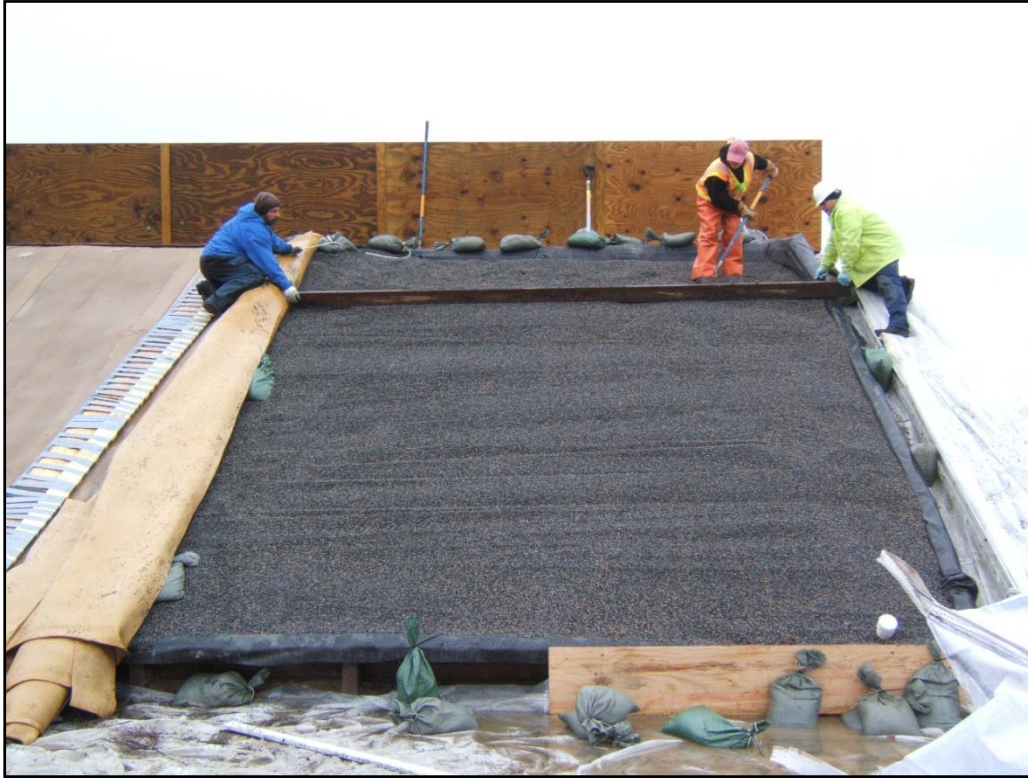
Figure 9. Tango Range Lanes 14 and 15, Re-Installing Rubber Granules after Mass Balance Work, Camp Edwards, Massachusetts

To determine the total lbs. of weight recovered from Lanes 14 and 15 during the bullet pocket cleanup, complete lane sift and resift of the 2,000 lbs sample, the following equation was used:

Bullet Pocket weight lane 14 and likely lane 15	Weight of spent bullets from lane 14 and 15 not including bullet pocket weight	Extrapolated weight from above from resifting lane 14 and 15	Total spent bullets recovered from Lanes 14 and 15
32.00 lbs.	+ 68.50 lbs.	+ 1.99 lbs.	= 102.49 Lbs.

Compared to data on weight of total rounds fired per the Range Control log (102.29 lbs./108.45 lbs.) = 94.3%.

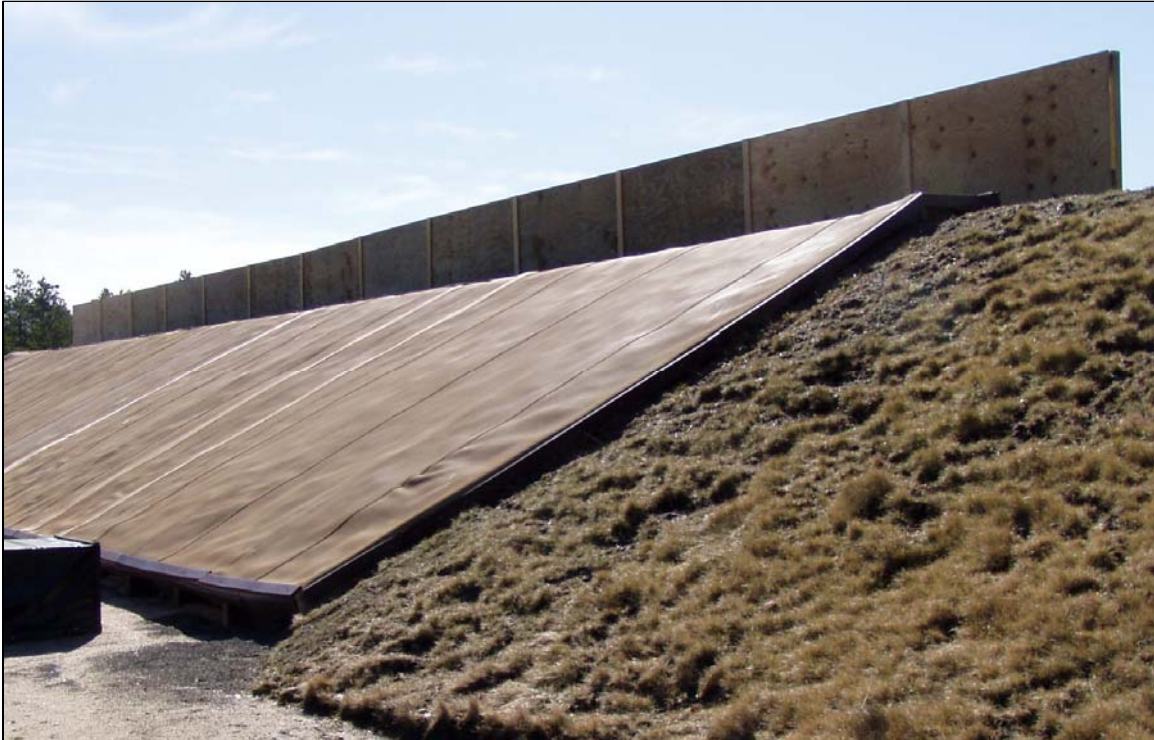
Figure 10. Plywood Overshot Telltale Wall, Tango Range, Camp Edwards, Massachusetts.

A red stripe was painted on the upper portion of the top cover on all STAPP™ ranges to limit overshoot (Figure 11). The red line provides for an upper limit of aiming for all range users. This has greatly reduced impacts to the STAPP™ system above the red upper limit line.

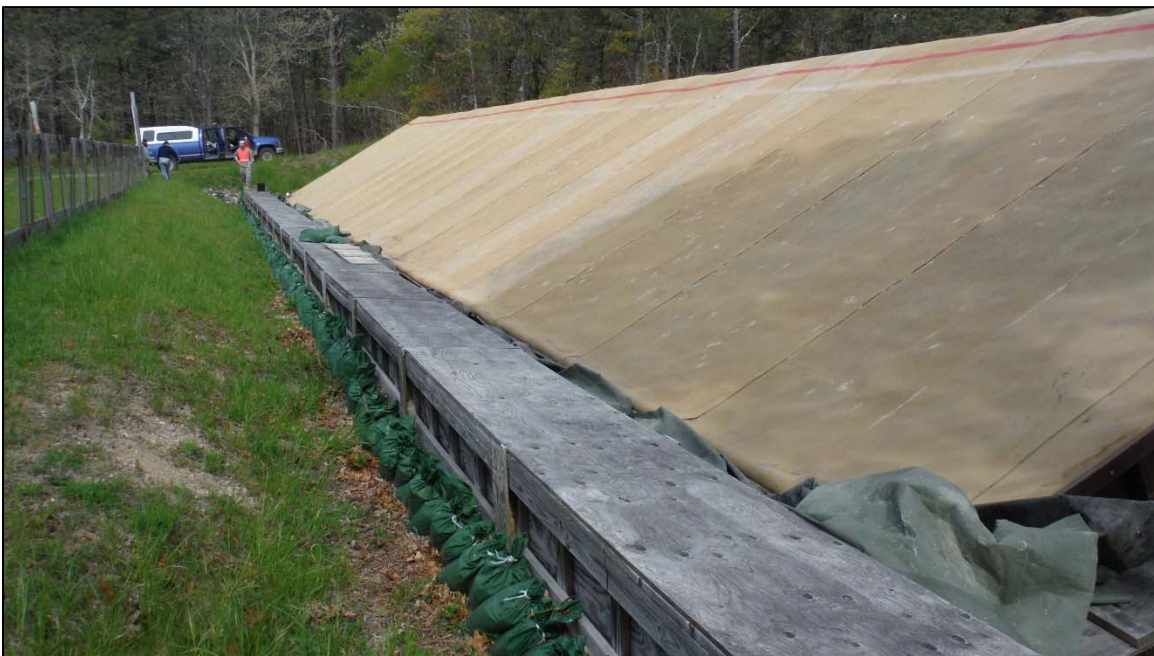
Figure 11. Red Line, Upper Limit of Aiming to Decrease Overshot, Juliet Range Camp Edwards, Massachusetts.

The OMMP now references a red stripe that was painted on the upper portion of the top cover on all STAPP™ ranges to limit overshoot (Figure 11). The red line provides for an upper limit of aiming for all range users. This has reduced overshoot and impacts to the STAPP™ system above the red upper limit line.

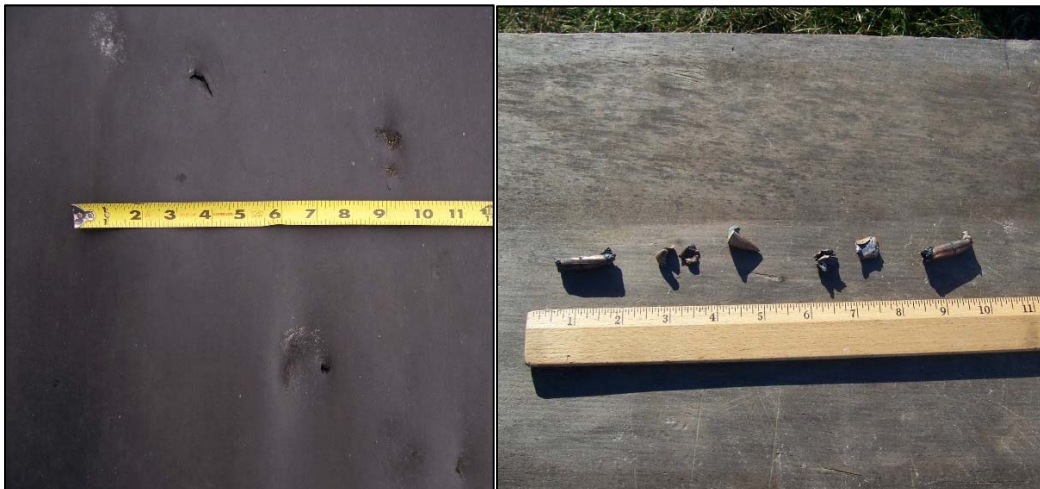
rounds captured within the system. During the mass balance and inspection activities, it was noted that the bottom-liner between Lanes 6 and 7 was perforated by several 7.62mm rounds. The penetrations were investigated by recovering the bullets (Figure 12). The bottom-liner was repaired by STAPP™ and Range Control personnel. The exact cause of the 7.62mm bullet penetrations in these two lanes is not known. It can be speculated that the depth of rubber granules was not sufficient at the location of the penetrations and could be caused by repeated use of the lane by machine gun fire (M240B, 7.62mm). The bottom-liner under the “bullet pocket” of all 15 lanes was inspected during the mass balance work and no penetrations were found other than Lanes 6 and 7. The original OMMP accounted for the potential of penetrations in the bottom-liner and the MANG followed the appropriate procedures: they notified regulators, recovered the rounds, repaired the bottom-liner, and returned to training. To further lower the probability of penetrations, approximately two tons of additional granular rubber material was added during the top cover replacement performed in July 2009.

Figure 12. Bottom Liner Penetrations and Recovered Rounds, Tango Range Camp Edwards, Massachusetts.

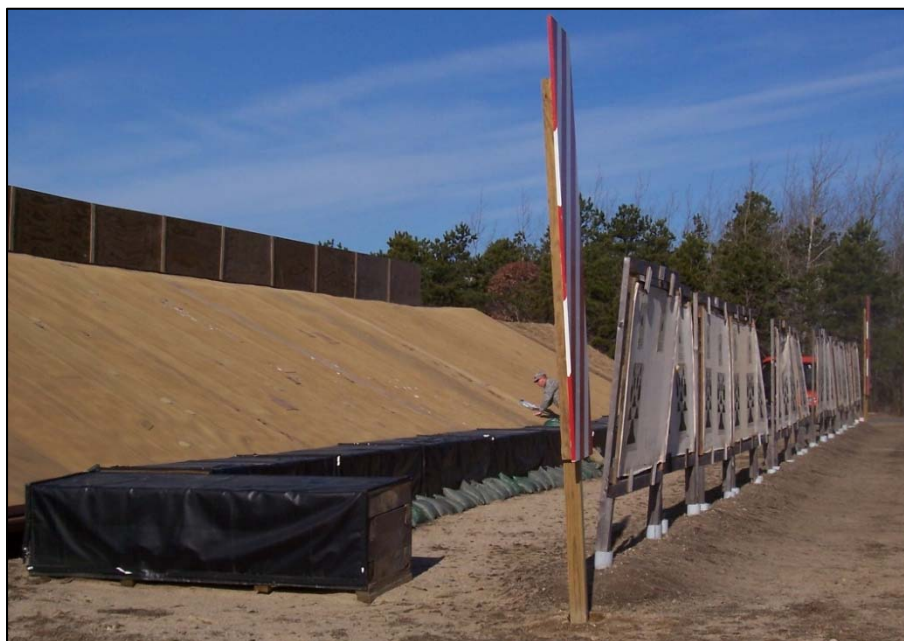
Figure 13. Tango Range Top Cover Inspection, Range Control Camp Edwards, Massachusetts.

The ranges are inspected again after range use is complete to document the post-firing conditions (Figure 13). The form provided in the OMMP (Appendix A) is used to document the pre- and post-range firing inspections and to note any changes or discrepancies.

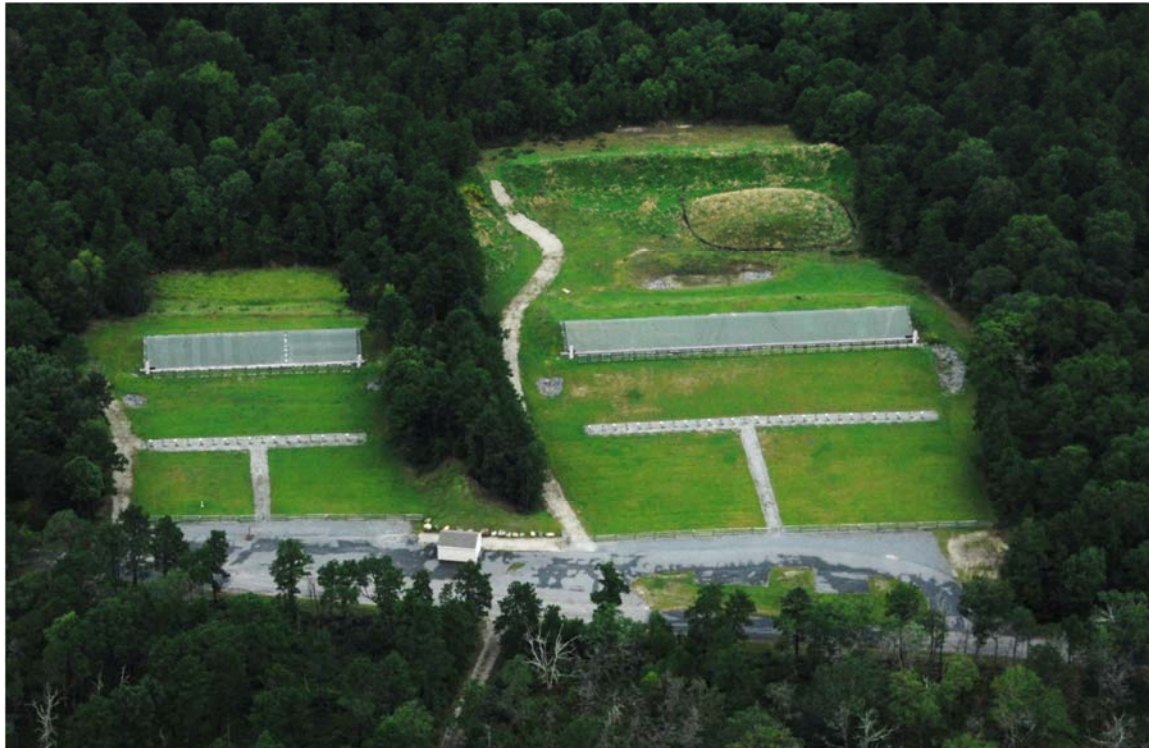
**Figure 14. Tarp Covered STAPP™ Systems at Juliet and Kilo Ranges
Camp Edwards, Massachusetts.**

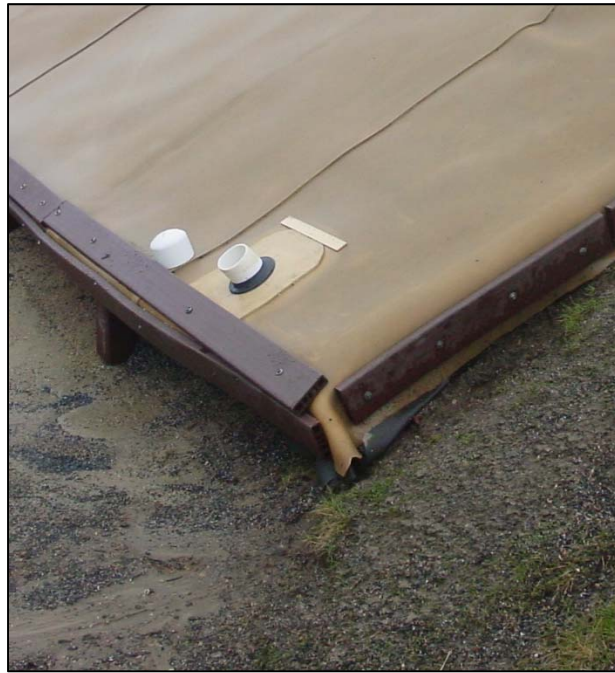
**Figure 15. STAPP™ System internal Reservoir Access Port
Tango Range, Camp Edwards, Massachusetts.**

Another modification to the STAPP™ systems was the incorporation of a view/extraction port for the internal water collection reservoir (Figure 15). Initially, the internal reservoir was only accessible by unbolting and peeling back the top cover. Range Control installed an external port to allow for the

viewing and removal of collected water. The riser pipe was extended and a round hole was cut into the top cover, a sealed rubber boot was applied and top cap was installed. This modification saves time and effort in evaluating the internal water collection reservoir. This modification was implemented at Tango, Juliet, and Kilo Ranges. The port on Tango Range is located in the lower right hand corner facing the system, on Juliet Range it is in the lower left hand corner, and on Kilo Range there is a port at both the lower right and left hand sides of the system.
