Subject: Additional request for information for EPA SSA review on proposed MPMGR

USEPA
SOLE SOURCE AQUIFER REVIEW
RESPONSE

Massachusetts National Guard
Camp Edwards, MA 02542

22 March 2022

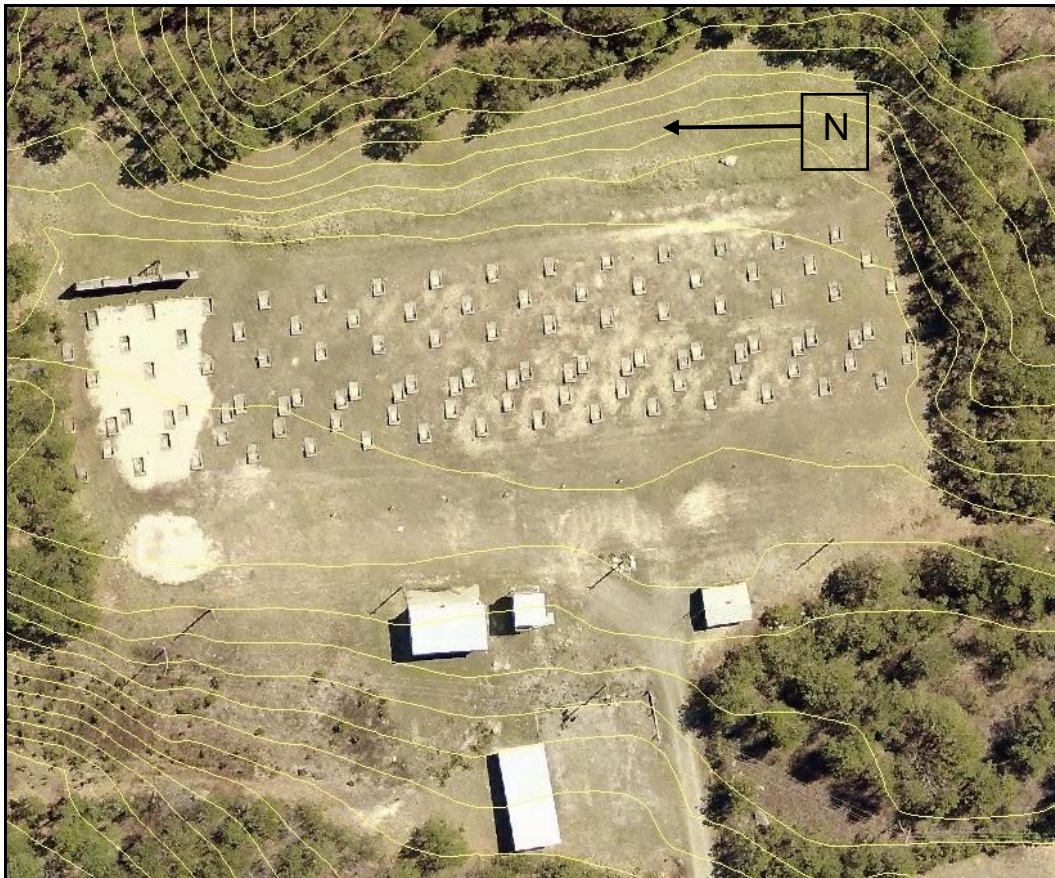
Figure1. Echo Range, Camp Edwards, Massachusetts

A test fire was conducted on Lane 4 at Echo Range (Figures 1 and 2) on 19 June 2015 to determine if the Line of Sight Analysis was valid and if the information gathered could be used to determine the initial design of Echo Range, which can be protective of the environment while meeting regulatory requirements and training standards. The test fire was conducted to determine if an angle of fire can be established such that most projectiles will be captured in a band across the back berm thereby eliminating the range floor as the main capture medium for fired projectiles. It is assumed that due to the varying skills of shooters using the range, there will be low shots that will be captured by the SIT frontal materials such as sand and Dura-Block.

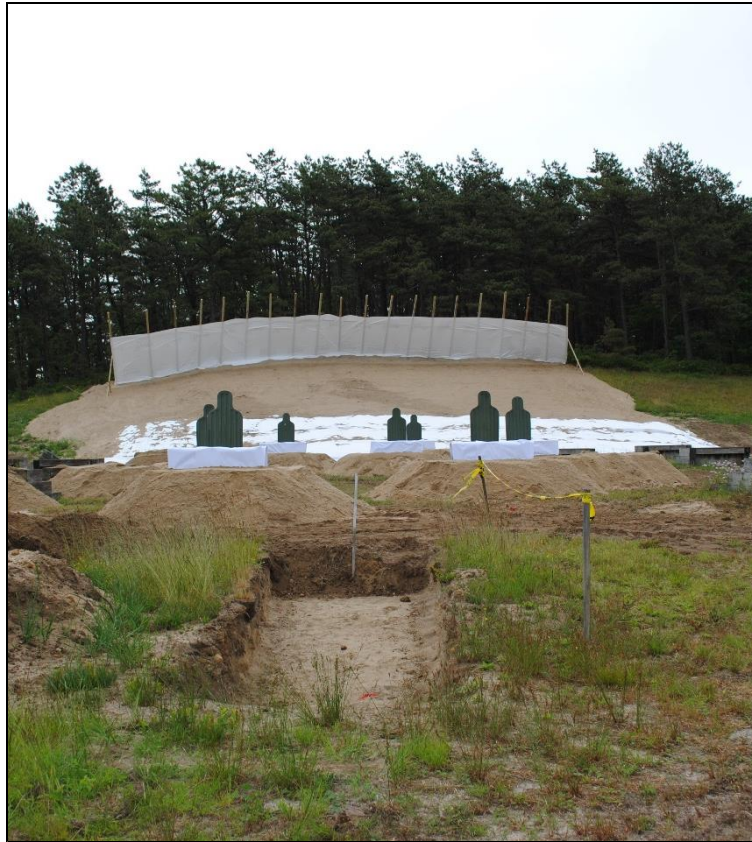
Figure 2. Echo Range, Lane 4, Camp Edwards, Massachusetts

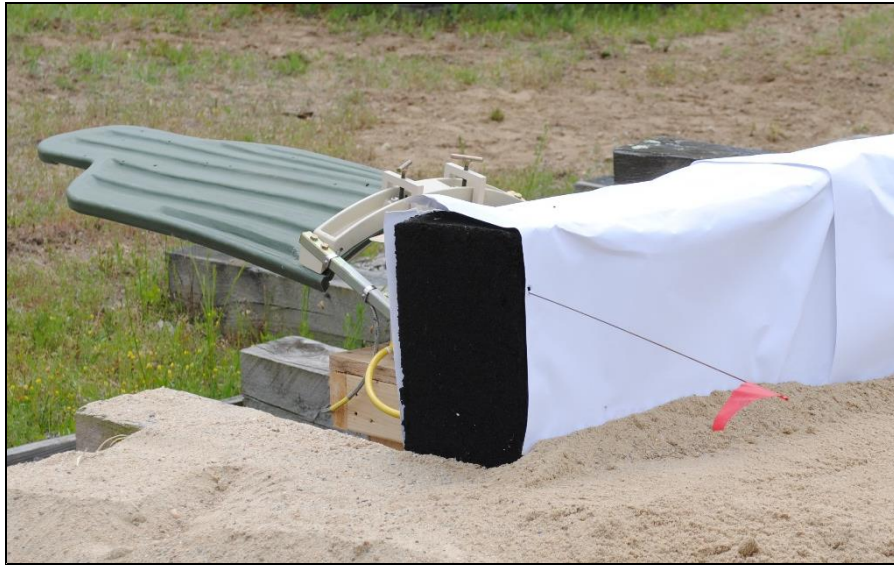
Figure 3. Dura-Bloc on end with flagged projectile pass through, Camp Edwards, Massachusetts

would penetrate this material. This firing was conducted based on the observation that there was a Dura-Bloc pass through during one of the courses of fire. It was determined that the Dura-Bloc was arranged incorrectly, placed on end versus on its side (Figure 3). When placed correctly, the Dura-Bloc was effective at stopping all 10 projectiles fired into the block (Figure 4).

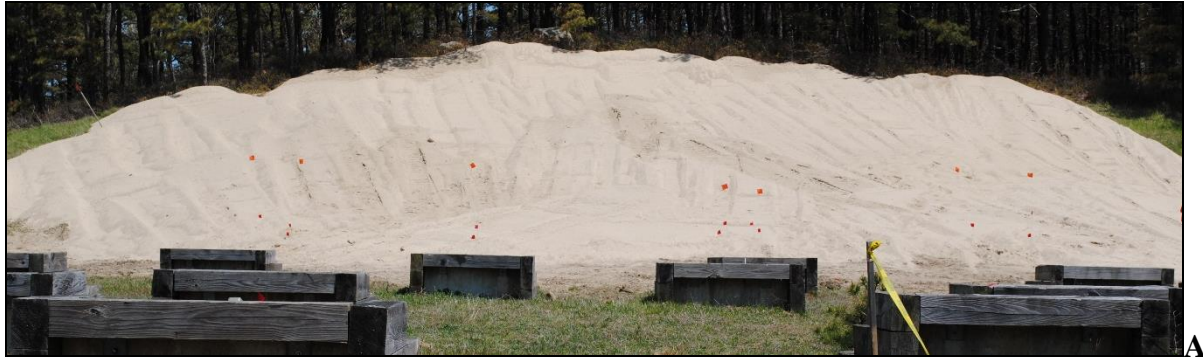
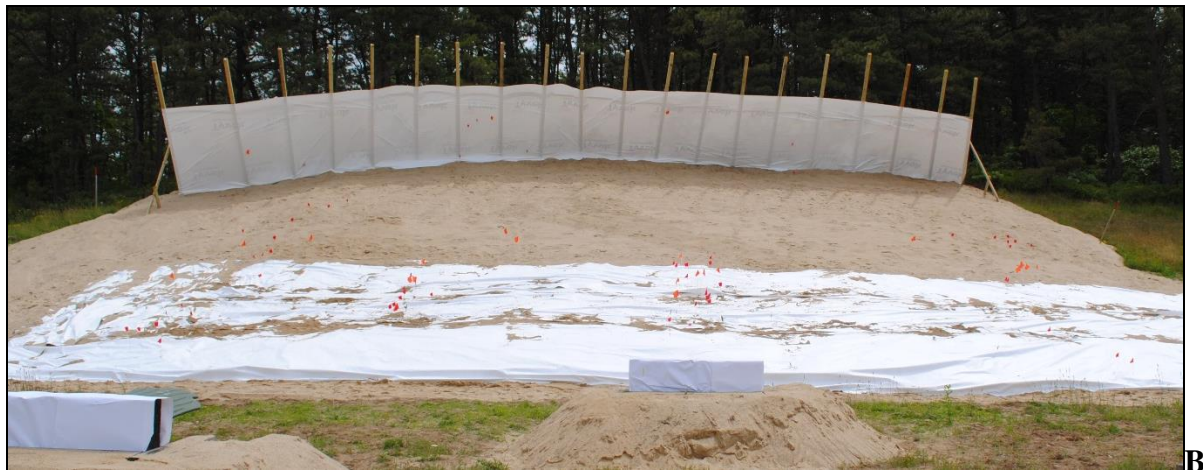
Figure 5. A) Line of Site Analysis theoretical projectile locations, B) Actual Test Fire Projectile Locations, Echo Range, Camp Edwards, Massachusetts

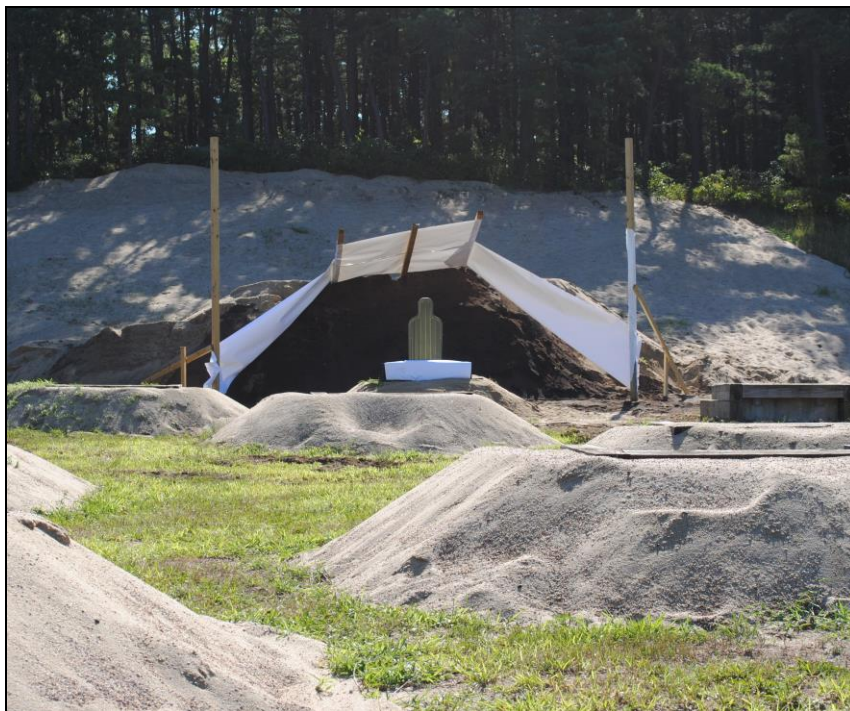
Figure 6. Last target in Lane 4, Echo Range Camp Edwards, Massachusetts

The test fire was conducted at Lane 4 with rounds fired at the last target within the lane (Figure 6). The eastern back berm was prepared by placing sand from the toe of the existing berm to a height of approximately 7 feet (Figure 7). This created the desired slope of approximately 2:1. The slope was then covered with approximately 4 inches of loam. A telltale overhang along with side wall was placed on the back berm. The overhang was constructed using 4x4 timbers covered with paper. Dura-Bloc was again placed in front of the target mechanism for low shot protection.

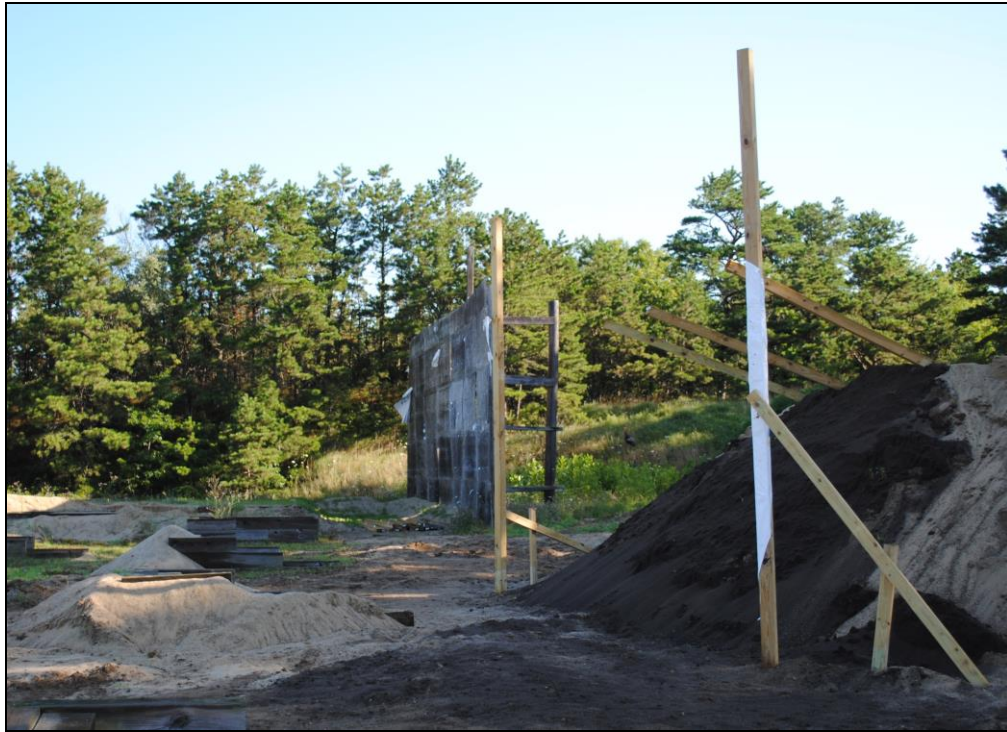
Figure 7. Eastern Backstop Berm Supplemental Test Fire 2:1 Slope Echo Range Camp Edwards, Massachusetts

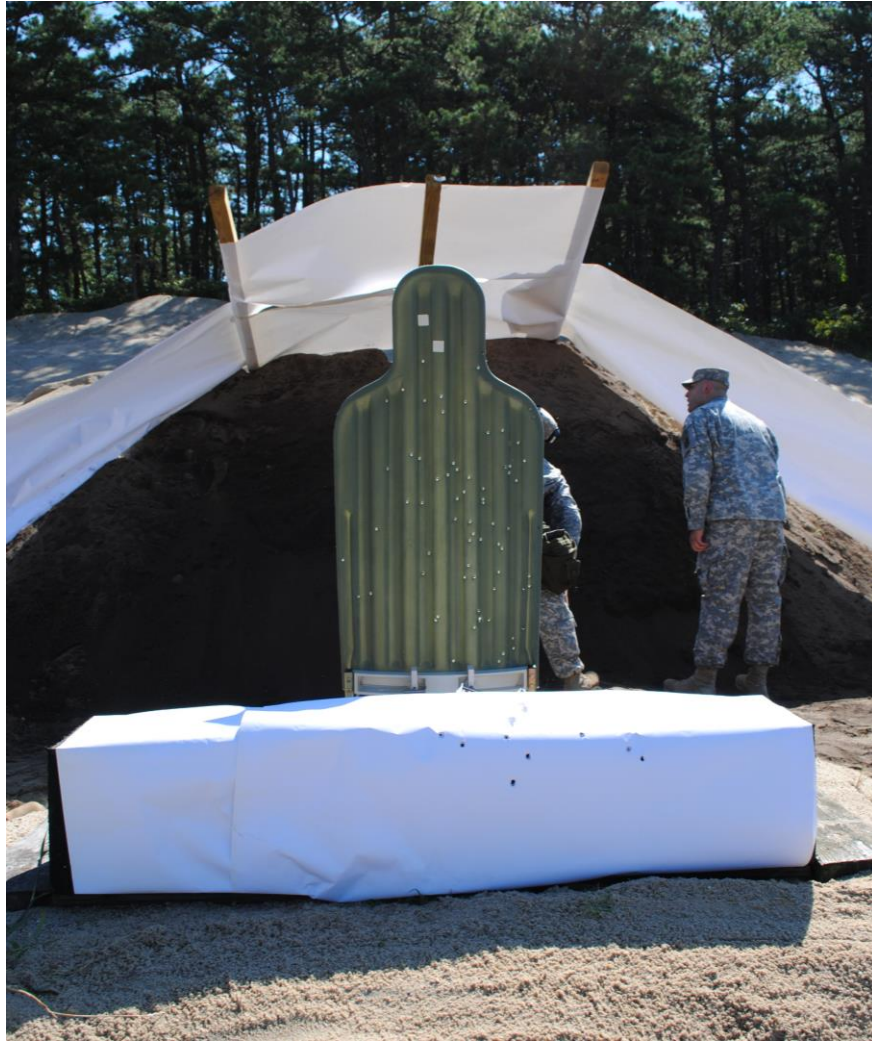
Figure 7. Dura-Bloc, Target, and Overhang Telltale, Echo Range, Camp Edwards, Massachusetts

A total of 100 projectiles were fired through four courses of fire. Two courses of thirty and twenty shots were fired respectively. The last twenty were fired with purposeful “bad,” or off target shots, to determine if high and side shots would react to striking the berm differently. All shots reacted similarly and were contained by the back berm with no ricochets or “skip-ups” (Figure 7). The Dura-Bloc did again protect the target mechanism. It is thought that five low shots entered the Dura-Bloc with three others grazing the top of the block during the test fire. The telltale paper covering the Dura-Bloc showed the projectile strikes (Figure 7).

The results of the test fire confirmed the objective that the back berm with a slope as close to 2:1 as possible would be sufficient to capture projectiles and avoid ricochets through the overhang telltale at the top of the back berm. The results also confirmed that projectile recovery rates could be improved as a result of the increased back berm slope. The back berm was effective at capturing the projectiles and did increase recovery rates. Of 100 rounds fired, 95 projectiles were recovered with five rounds believed to be contained within the Dura-Bloc that was protecting the target mechanism (Figures 7 and 8). This is a 95% projectile recovery rate.

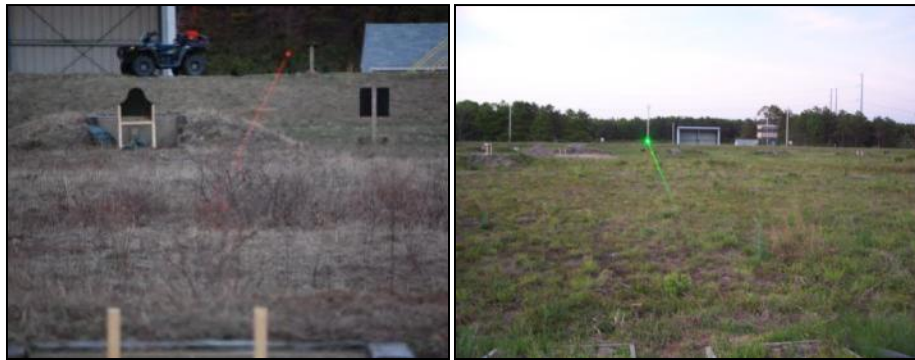
Figure 2. Temporary Plexiglas Targets and Backstops erected at each SIT location to provide a surface to mark laser “impacts” according to a hypothesized target distribution and dispersion patterns.

During the LOS Analysis Phase 2; the MAARNG mounted a GB II on a tripod located at the firing point on each lane and systematically “engaged” each target at the various distances (50-300m) for each lane in accordance with the modified record fire qualification table. Temporary targets simulating the actual size of targets and the height of exposure were placed at each SIT position and a temporary 4’ x 8’ clear Plexiglas “backstop” was erected at each SIT location to provide a surface to mark laser “impacts” according to a hypothesized target distribution and dispersion patterns (Figure 2.). The laser was additionally used to indicate potential projectile impact locations on the range floor or other SIT positions down range. This information produced the predicted projectile distribution and initial dispersion for each GTL. Projectile impact locations identified to potentially strike the range floor were mitigated by strategically placing backstops (n=17) to capture the projectile prior to impacting in an unrecoverable location.

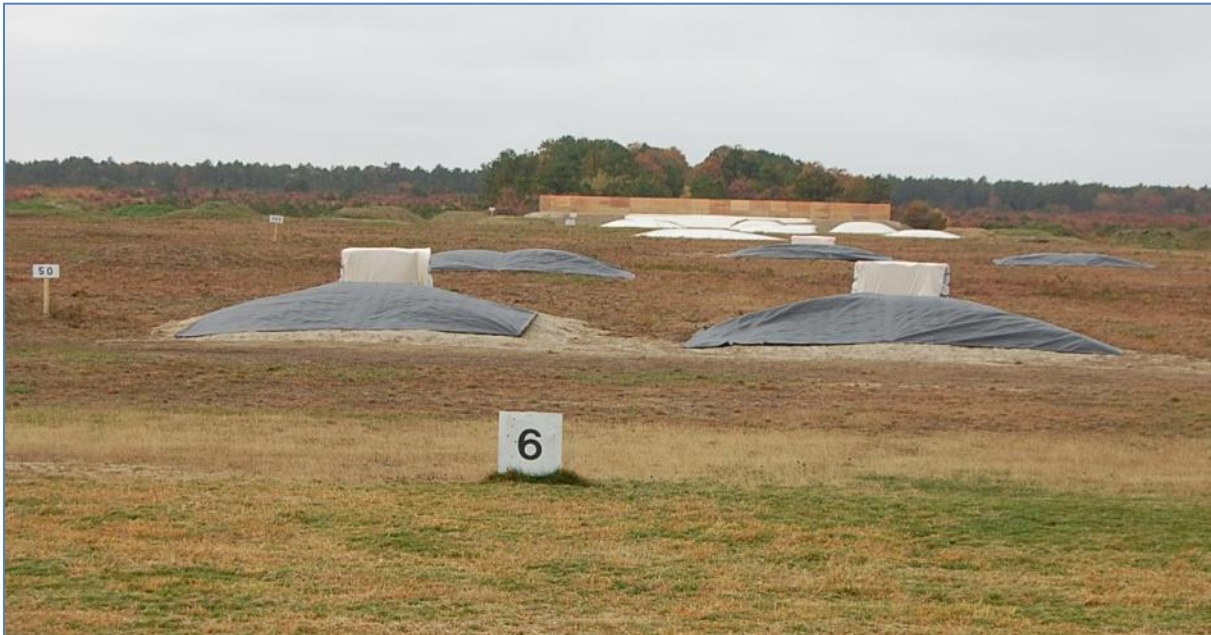
Figure 3. Lane 6 Prepared for Live Fire Demonstration for Phase III of the Line of Sight Analysis.

Prior to the execution of the live fire exercise; Lane 6 was prepared in accordance with the Range Adaptive Management Plan core elements (Figure 3.). Refer to Appendix B for the construction specifications associated with the design Sierra Range modifications. Site preparation was conducted as follows:

1. At the 300 meter berm; the area between the SIT positions of lanes five and six and six and seven was in-filled with clean fill to provide a base for a secondary berm structure and to capture projectiles which travel lower and between the existing SIT berms.
2. A tell tale plywood backstop was constructed on top of the end 300 meter berm, approximately 302 meters from the firing point, which was approximately 7 feet in height starting from the base of the SIT and approximately 130 feet long.
3. The exposed face of the 300 meter earthen berm was covered with soil screened 1/2 inch minus and to a minimum of 6" deep with clean fill.
4. Three backstop berms were constructed offset behind the 50 meter alpha, 50 meter bravo and the 100 meter targets positions. These backstop berms were constructed of a screened earth/sand fill contained

within a geo-textile revetment type material (i.e. DefenCell®) to eliminate projectile impacts down range on the range floor.

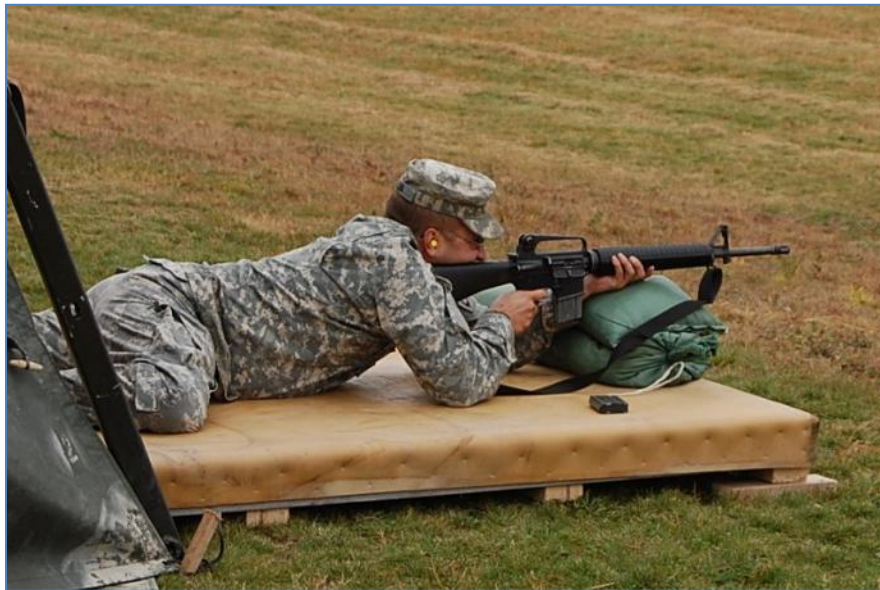
Figure 4. Firing platform, Constructed of Plywood and 2"x4" Frame

7. A firing platform, constructed of plywood and 2"x4" frame, was placed at the firing point of lane 6 where the Beamshot laser "engaged" the targets to maintain continuity of the line of sight and allow Soldiers to qualify on a level surface (Figure 4).

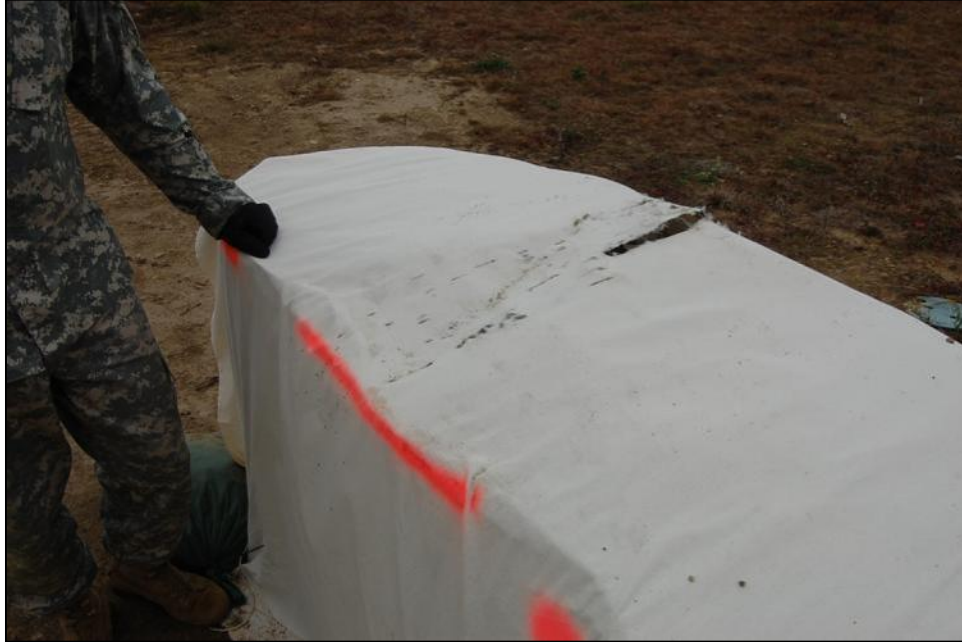
Figure 6. Projectile “Grazing” Across Backstop Berm 100 meter GTL.

One area of concern that developed was the distribution of projectiles to the 100 meter GTL. The DefenCell® back stop was specifically designed to contain projectiles that would potentially impact the range floor but allow the rest of the projectiles to travel to the 300 meter berm. Projectile “grazing” across the top of the berm observed during the live fire event raised doubts to the terminal ballistics of that particular GTL (Figure 6.).

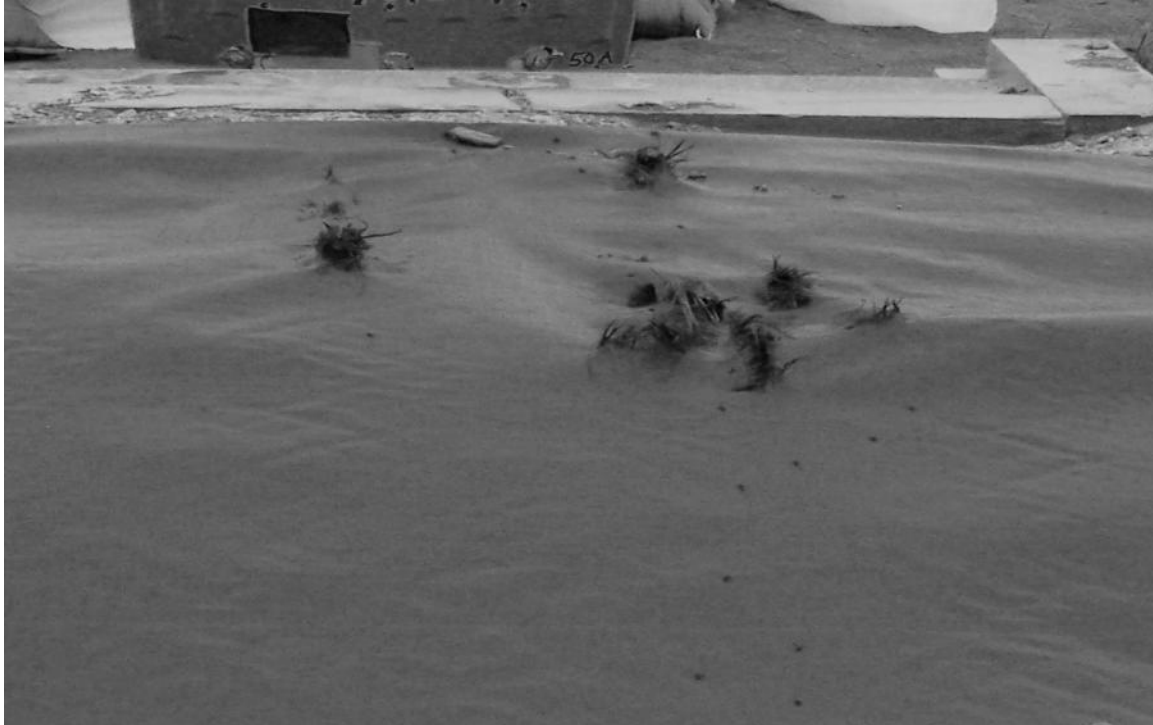
Figure 7. 50 Meter Alpha Frontal Berm and Cover.

During the analysis of the frontal berm plastic cover; multiple penetrations were observed. The exact count of these penetrations is masked because of the tearing in the fabric and what seem to be projectiles weaving in and out of the fabric toward the back stop. The visual indications in the fabric support the real time observations where 13 projectiles struck the frontal cover. Refer to Figure 7. for projectile impact indications to the 50m Alpha frontal berm.

Note: Colors were adjusted to increase the visualization of the image.

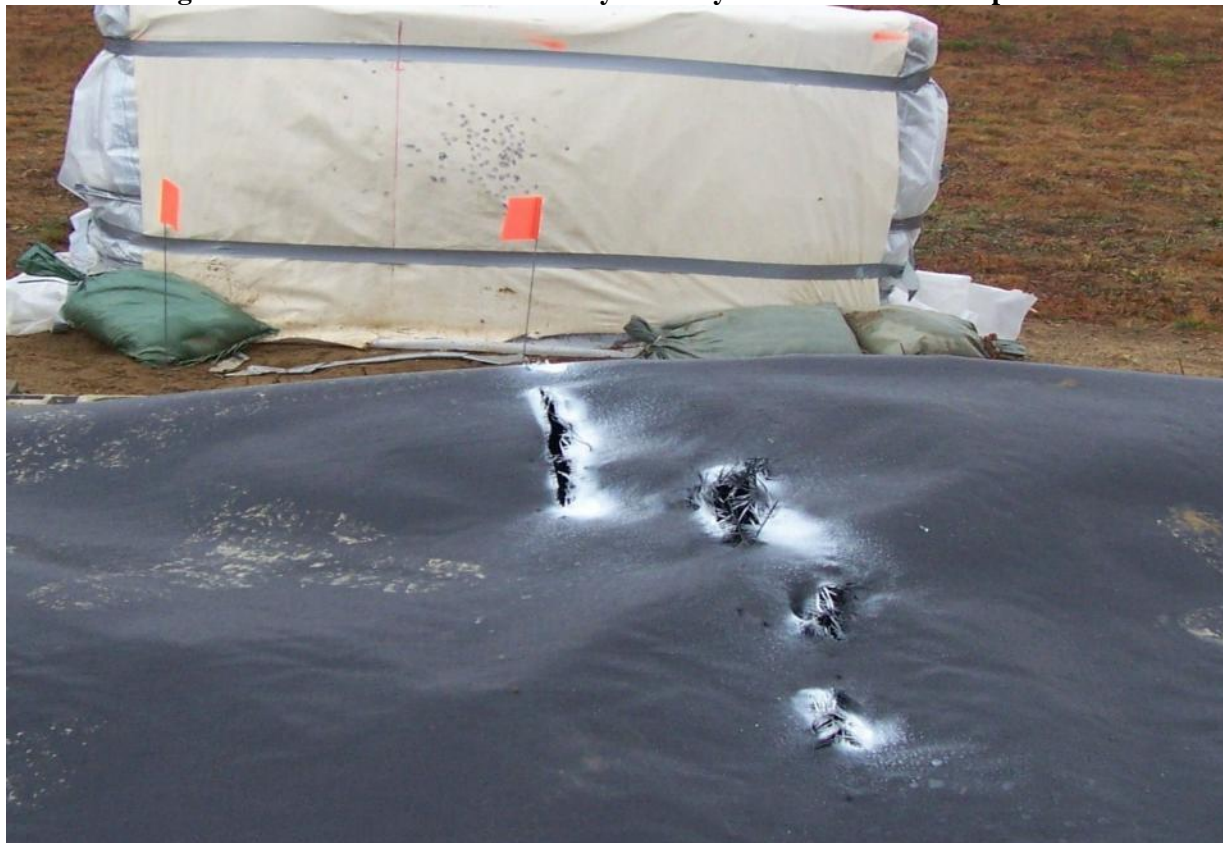
Figure 9. 50 Meter Bravo Stationary Infantry Frontal and Backstop Berm

During the analysis of the frontal berm plastic cover; multiple penetrations were observed. The exact count of these penetrations is masked because of the tearing in the fabric and what seem to be projectiles weaving in and out of the fabric toward the back stop. The visual indications in the fabric support the real time observations where 6 projectiles struck the frontal cover. Refer to Figure 9. for the observations of the 50m Bravo frontal berm.

Note: Red survey flags indicate the board of projectile impact locations to the frontal berm.

Observations of the DefenCell® back stop indicate approximately 119 penetrations in the plastic cover. These penetrations were manually counted and the plastic covers were retained as visual aids. The back stop appeared to function as designed to contain projectiles as there were penetrating holes and no exit hole.

The frontal berm, however, did not function to contain all the projectiles. Projectiles hitting closer to the top of the frontal berm seemed to continue to the back stop while projectiles hitting closer to the bottom seemed to penetrate into the frontal berm. This is most likely due to the slope of the frontal berm. An exact number of frontal berm hits cannot be definitively determined due to the condition of the plastic cover but the indications illustrate a combination of projectiles skimming the top of the frontal berm and penetrating into the frontal berm. The intent of the frontal berm's functionality should be evaluated as part of future best management practices.

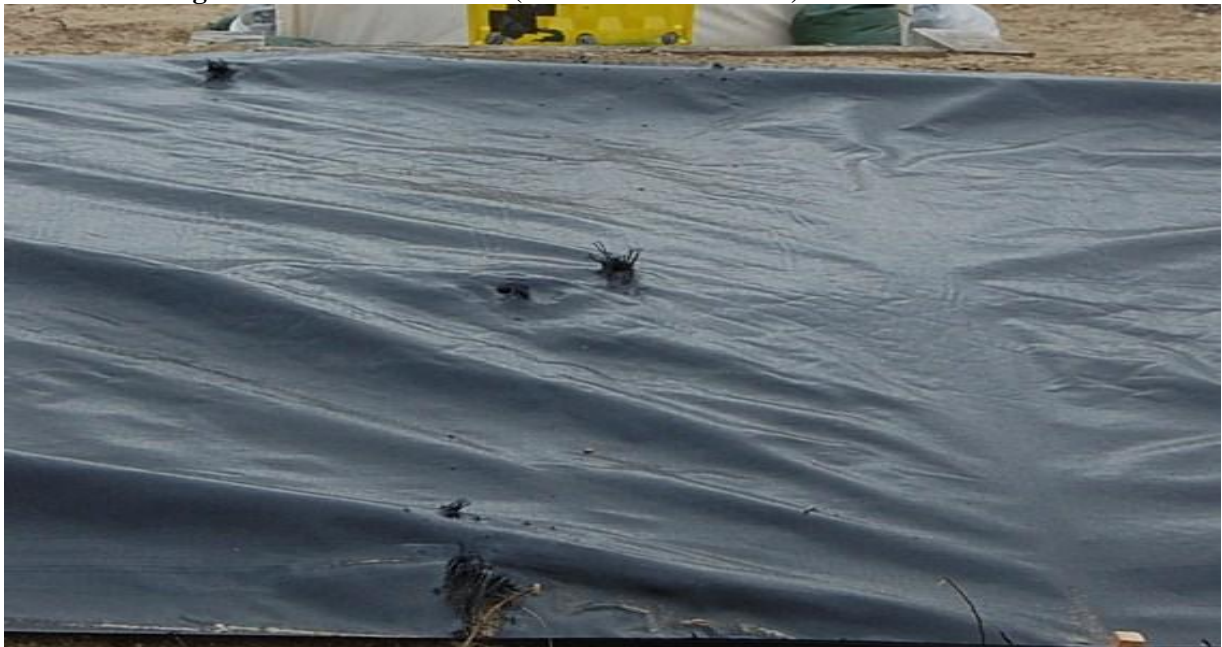
Observations of the DefenCell® back stop indicate at least 225 penetrations in the plastic cover. These penetrations were manually counted and the plastic covers were retained as visual aids. Aside from the original DefenCell® design methodology; the back stop appeared to function to contain projectiles as there were penetrating holes and no exit hole. Additionally, a manual count cannot determine the number of projectiles which struck the top of the DefenCell® berm.

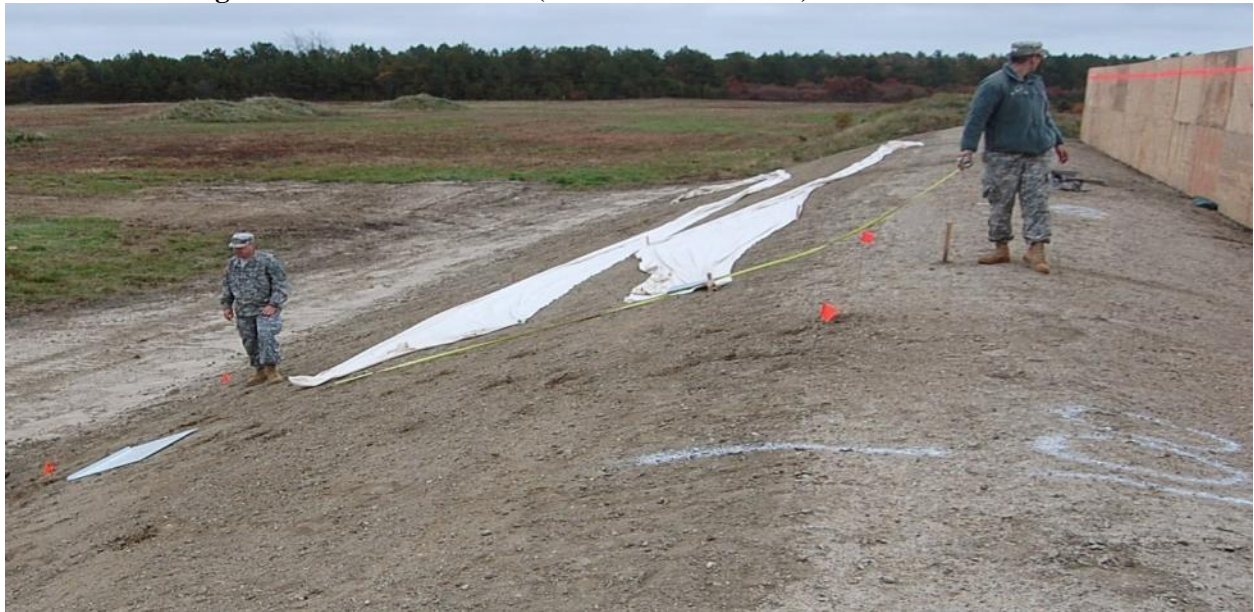
Figure 13. 100 Meter GTL (300m Earthen Berm) on 25 October 2010

The 300m earthen berm, also, did not function to contain all the projectiles. In the same conditions as the SIT frontal berms; projectiles hitting closer to the top of the frontal berm, where the slope is closer to zero, seemed to continue to the plywood back stop while projectiles hitting closer to the bottom seemed to penetrate into the berm. Additionally, copper fragmentation was observed hitting but not penetrating in the plywood overshoot barrier. This is most likely due to the slope of the frontal berm and the level of compaction of the soil material. An exact number of earthen berm hits cannot be definitively determined because the geo-textile cover was removed due to high wind conditions; however, the boarder was marked with red survey flags to delineate the magnitude of the projectile impact location. The intent of the 300m berm's functionality should be evaluated as part of future best management practices. Refer to the figure 13. for 300m earthen berm observations.

Note: The red survey flags indicate the boarder of the projectile impact location. Additionally, due to high wind conditions; the earthen berm covers blew out of place during the live fire event.

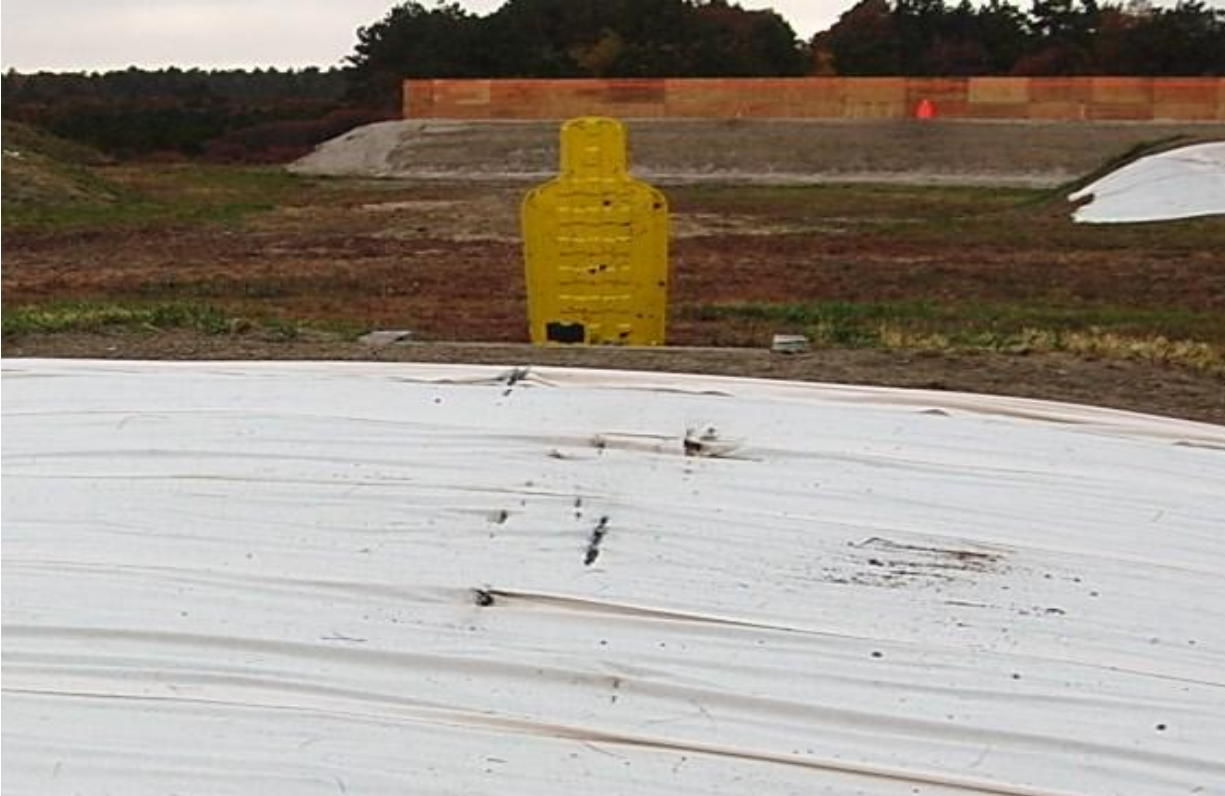
During the analysis of the 300m earthen berm; multiple penetrations were observed. The exact count of these penetrations cannot be determined because during the event the tell tale fabric was removed due to high wind conditions and any analytical value the fabric presented when the fabric blew out of place. However, the borders of the projectile impact location on the 300m earthen berm was marked with red survey flags to delineate the magnitude of that particular impact location. Refer to Figure 16.

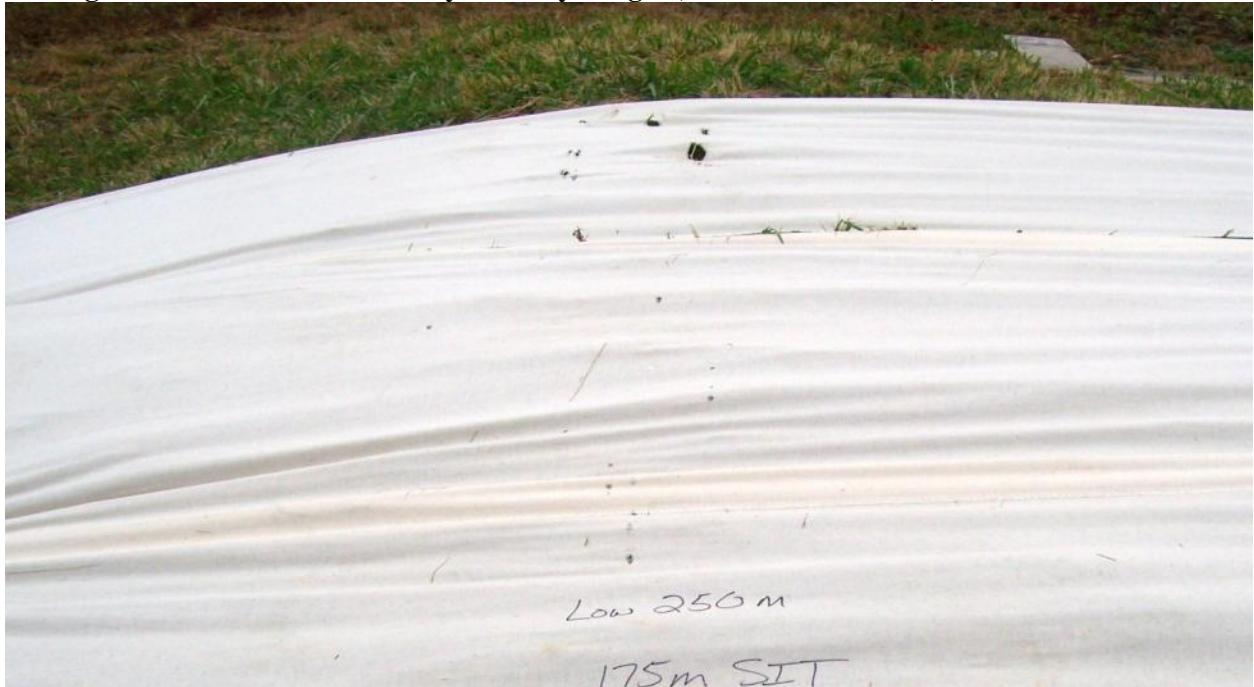
During the analysis of the 250m frontal berm geo-textile cover; multiple penetrations were observed. The exact count of these penetrations is not definitive because high winds blew part of the tell-tale fabric out of place during the live fire event. The visual indications in the fabric support the real time observations where at least 20 projectiles struck the frontal berm. Refer to the Figure 19 for 250m frontal berm impacts.

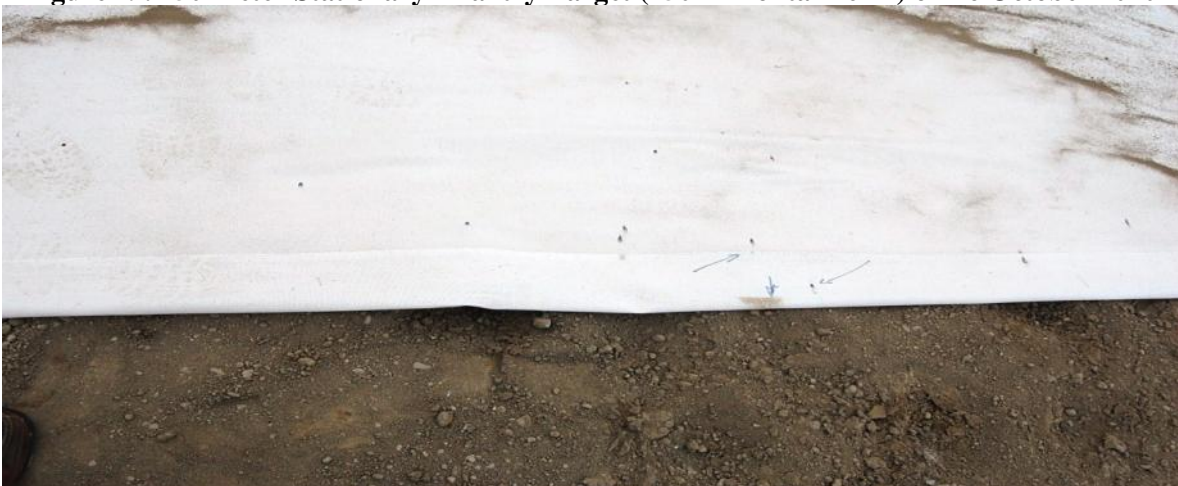
Out of the 265 projectiles fired; 205 have been definitively contained at the plywood overshoot barrier. The remaining 60 projectiles which are not contained in the plywood overshoot barrier are assumed to be in the 175m, 250m or 300m frontal berms because they are the only other locations projectile impact indications exist for this gun target line which is not outside the projectile impact locations identified during Phase I and II of the LOS analysis. This cannot be definitively answered because the recovery process could not validate this assumption and the 250m and 300m earthen berm covers were removed due to high winds conditions. Refer to Figure 20.

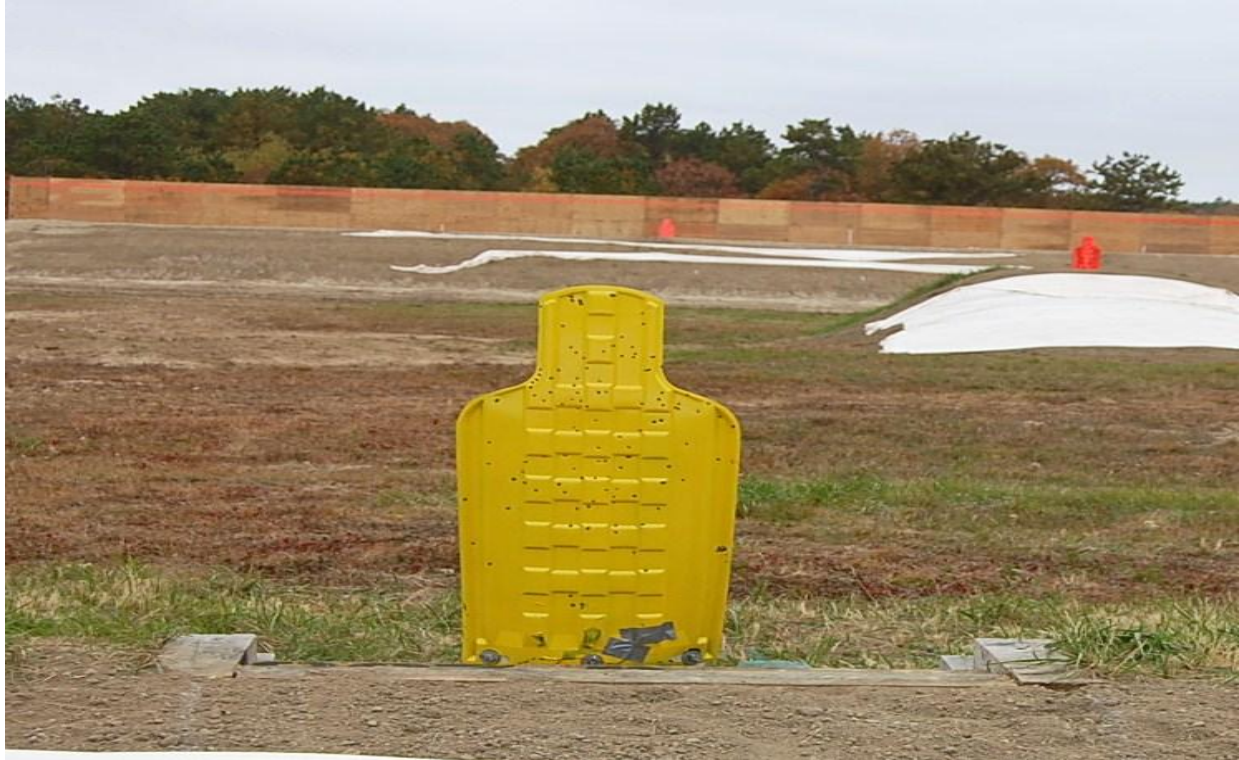
Figure 21. 150/ 300 Target Gun Target Line with Overshoot Barrier

The 150 and 300 meter gun target lines overlap each other making it impossible to distinguish between the dispersion areas at the 300 meter earthen berm and plywood telltale overshoot barrier (Figure 26). The 150/ 300 meter Gun Target Line, on Lane Six, was determined to not need an auxiliary berm to contain projectiles. This gun target line methodology, after the Phase I and II analysis, was to attempt to contain projectiles at its anticipated projectile impact locations; 150m frontal berm, the 300m frontal berm, the 300m earthen berm and the plywood overshoot barrier. Refer to figure 21.

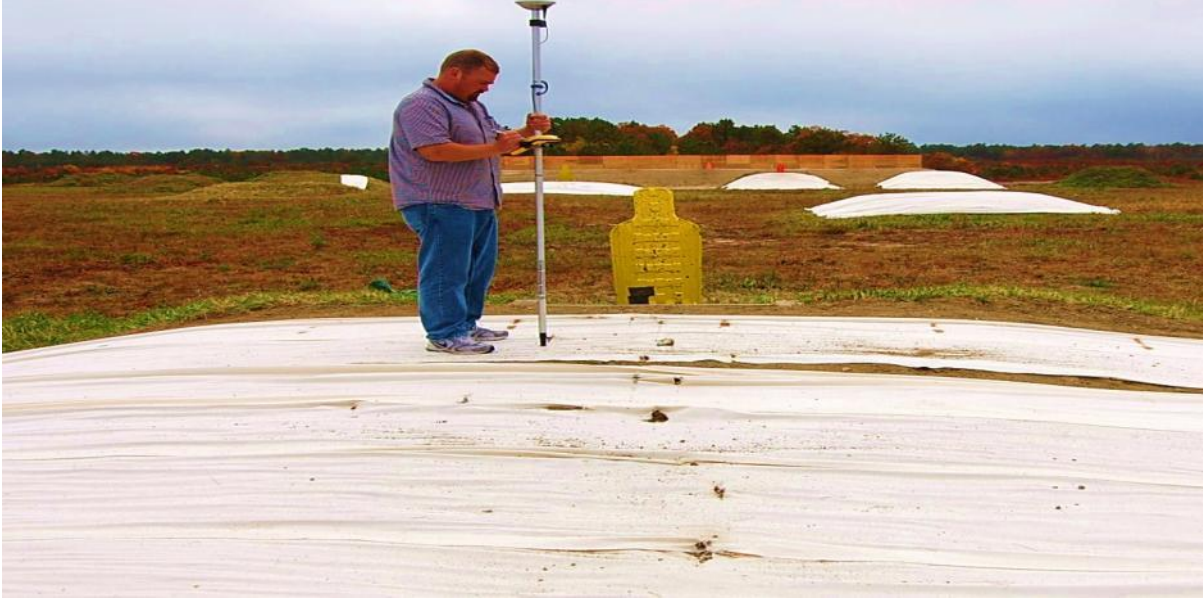
Figure 22. 150 Meter Stationary Infantry Target Gun Target Line

During the analysis of the 150m frontal berm geo-textile cover; multiple penetrations were observed. The exact count of these penetrations is masked because of the tearing in the fabric and what seem to be projectiles weaving in and out of the fabric toward the back stop. The visual indications in the fabric support the real time observations where 22 projectiles struck the frontal cover. Refer to Figure 22 for 150m frontal berm impact observations.

Observations of the 300m overshoot barrier indicated 375 definitive penetrations in the plywood. These penetrations were manually counted and highlights with black permanent marker to aid in visualization of projectile dispersion patterns. There are more than double the penetrations in the plywood then which were fired at the 300 meter target alone, indicating that the dispersion area of the 150 meter target is the largest of all gun target lines. Refer to Figure 22, 25 and 26 for the distribution of projectiles to the 150/300m Gun Target Line.

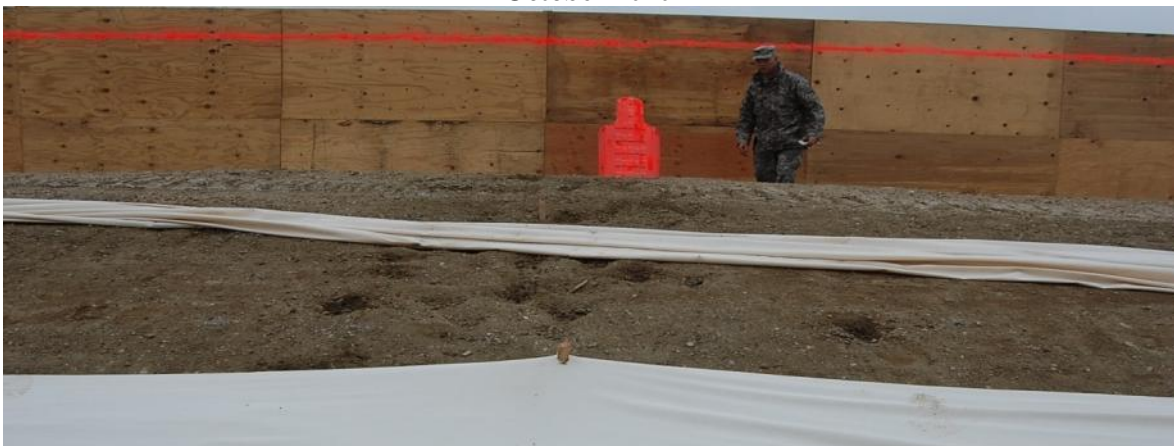
Figure 23. 300 Meter Stationary Infantry Target Gun Target Line with Overshot Barrier on 25 October 2010

Observations of the 300m frontal berm earthen berm indicated numerous projectile impacts. The exact count of these penetrations is masked because of the tearing in the fabric and what seem to be projectiles weaving in and out of the fabric toward the back stop. The visual indications in the fabric support the real time observations where approximately 400 projectiles struck the 300m earthen berm. Refer to Figures 23, 24 and 25.

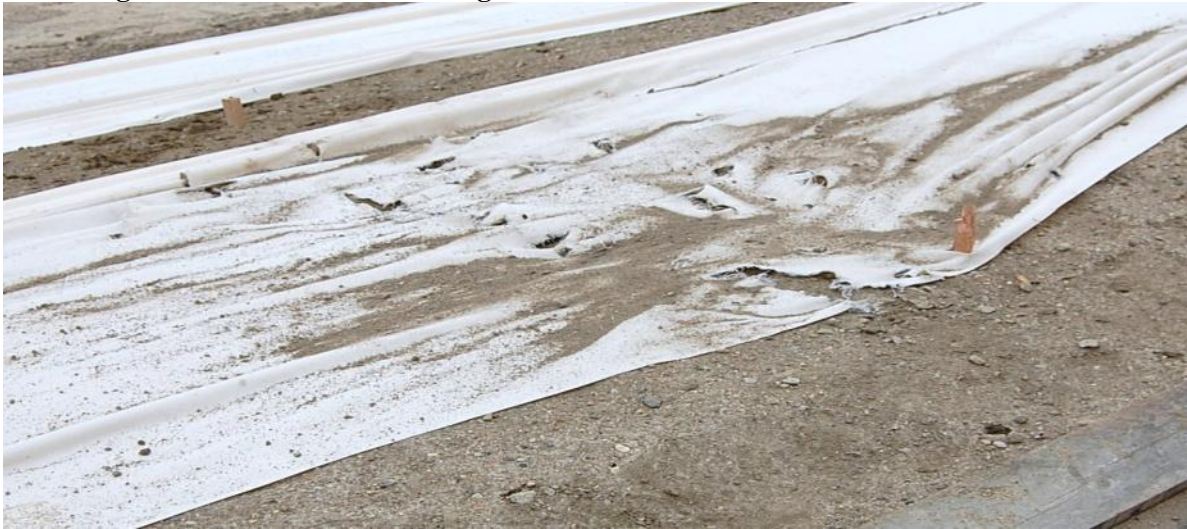
Figure 24. 300 Meter Gun Target Line Earthen Berm and Cover on 25 October 2010

Note: fabric condition provided inconclusive count of projectile impacts.

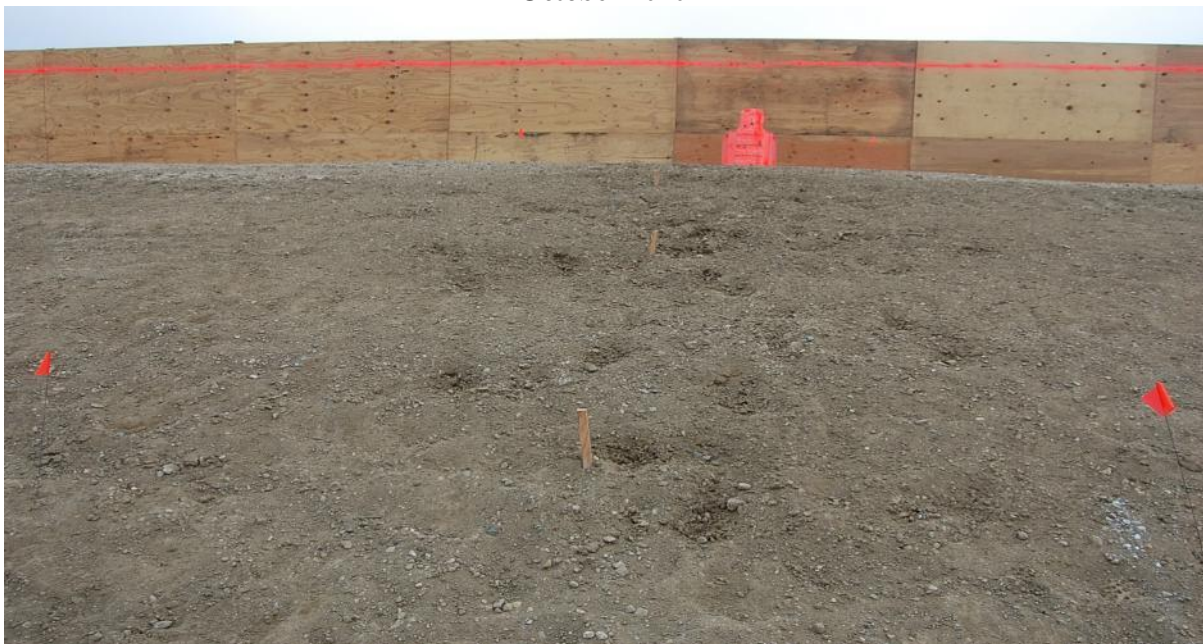
Figure 25. 300 Meter Stationary Infantry Target Gun Target Line with Overshot Barrier on 26 October 2010

Note: Red Survey Flag indicate the projectile impact dispersion area.

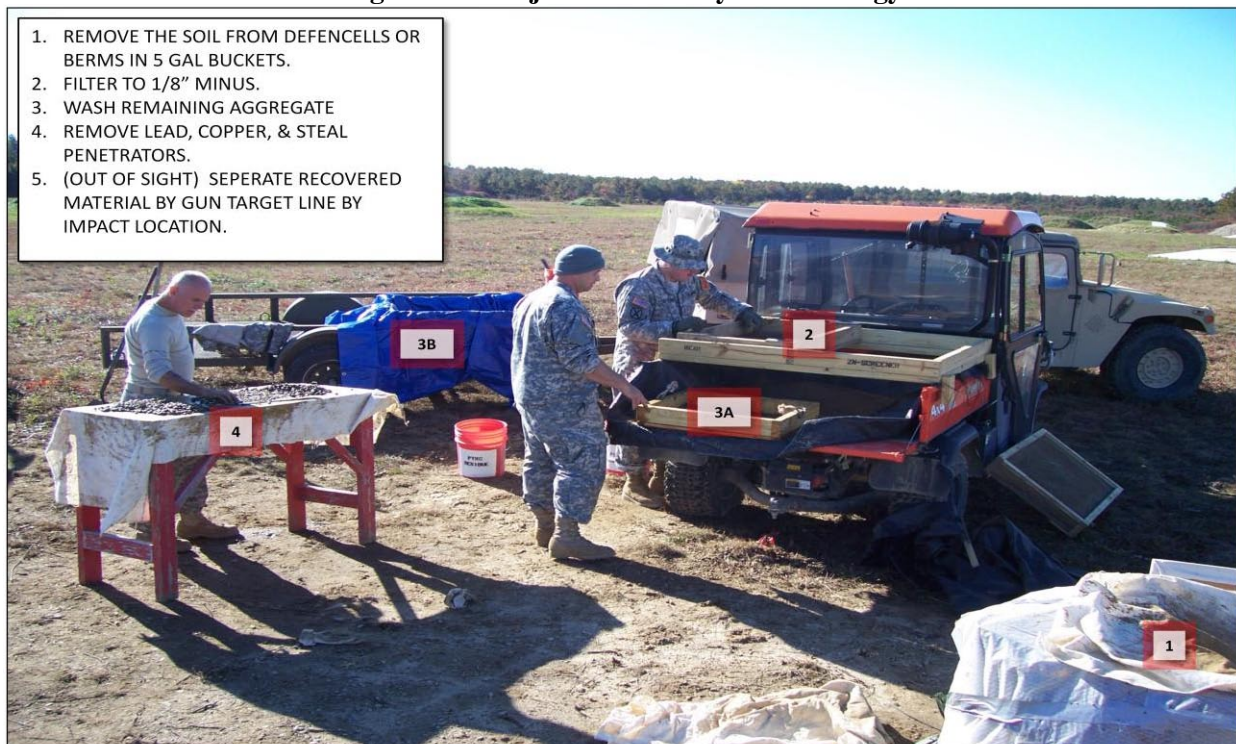
Figure 27. Projectile Recovery Methodology

During the execution of the post-phase III analysis, inclement weather created less than ideal conditions to visually identify and extract projectile fragments. In reaction to the poor ability to identify projectile residue; an additional step was integrated to aid in the identification process. Soil was collected in a secondary sieve constructed with lumber and a 1/8" diameter galvanized mesh where it was submerged in a bath which was constructed of plywood with a tarp liner and filled with 5 gallons of water. Refer to Figure 27 to view the recovery methodology.
