Subject: Additional request for information for EPA SSA review on proposed MPMGR

USEPA
SOLE SOURCE AQUIFER REVIEW
RESPONSE

Massachusetts National Guard
Camp Edwards, MA 02542

22 March 2022

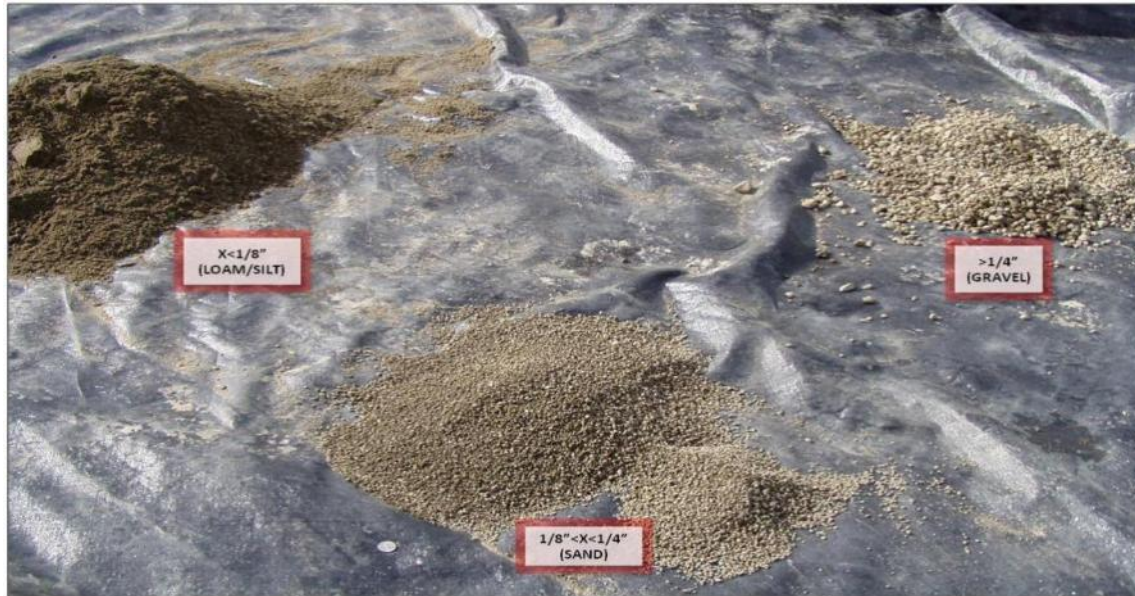
Figure 28. Screened soils from Sierra Range.

The surface soil on the frontal berm locations and the fill in the DefenCell® back stop were obtained from the Unit Training Equipment Site which was top soil that was removed and stockpiled after the installation of the tactical training base at the 3600 Area on the Massachusetts Military Reservation. The soil characteristics on Sierra Range were determined during a sieve analysis conducted by Barbato Construction as Gravelly Sand. Refer to Appendix B for sieve results and refer to Figure 28.

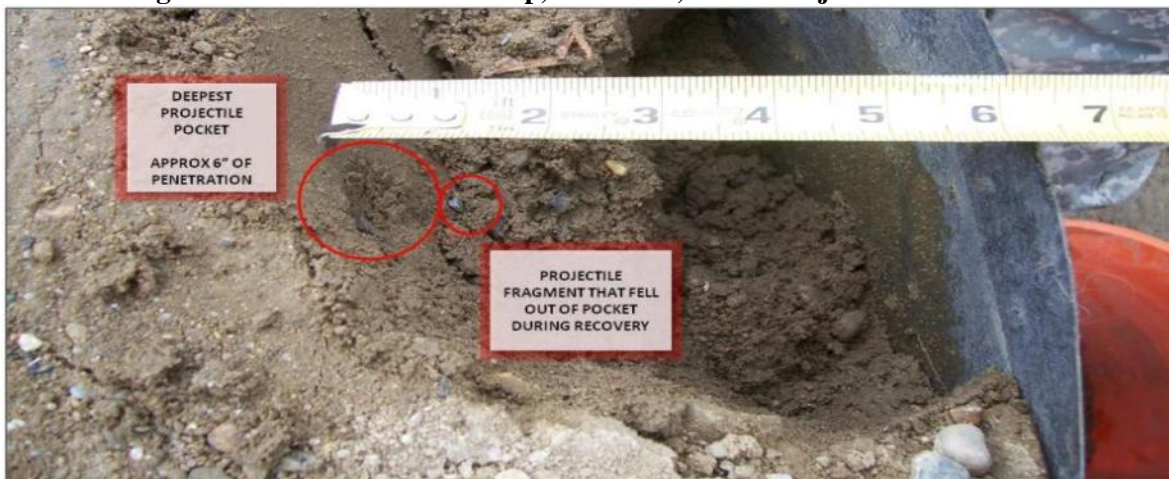
Figure 29. DefenCell® Backstop, 25 meters, 6 inch Projectile Penetration.

During the recovery; it was observation was that the M855 projectile penetrated approximately 6 inches into the DefenCell® backstop at 50m (Figure 15.). This penetration corresponds approximately to a projectile velocity of 2,930 feet per second at 50m. Projectiles recovered from between 50-150 meters were highly fragmented making it difficult to distinguish from the soil media. Refer to figure ## and 29.

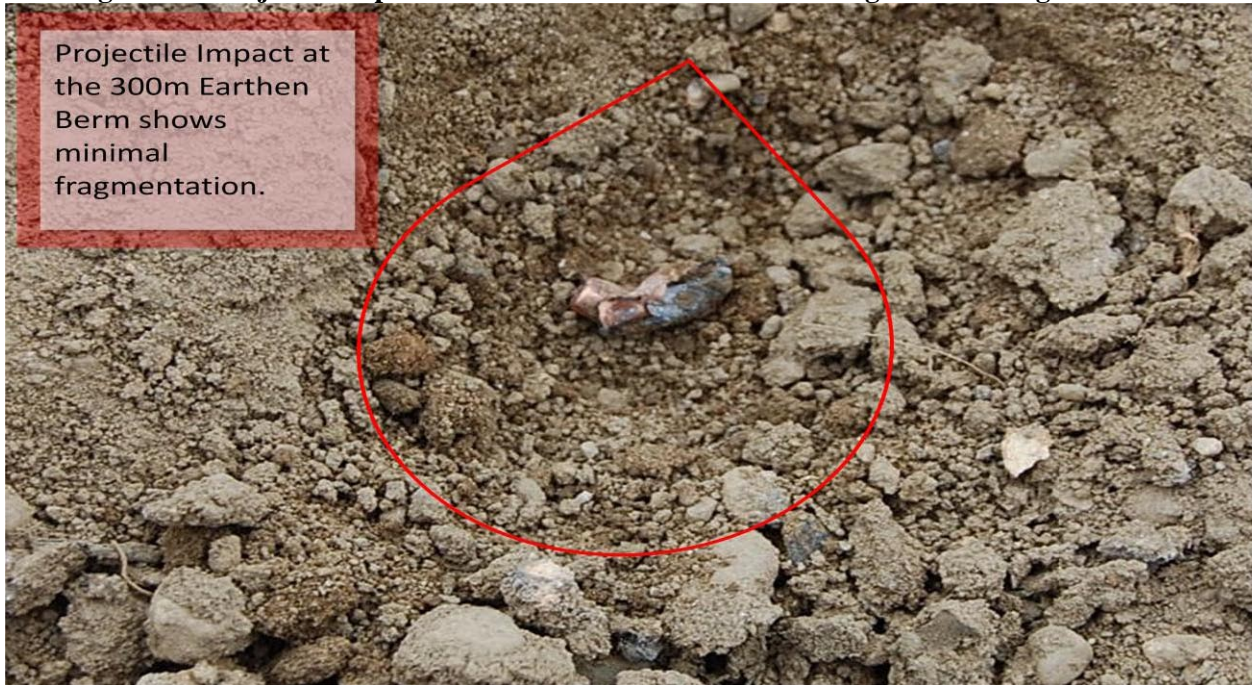
Figure 30. Projectile impact at 300 meter earthen berm showing minimal fragmentation

Projectile fragmentation at the 300m earthen berm was more easily identified. The projectiles, much of the time, had minimal fragmentation. Penetration depths were generally observed to be between 1-3 inches. This penetration depth corresponds to a projectile velocity of approximately 2,115 feet per second. Refer to Chart 8. The transfer of kinetic energy from the projectile to the surface soil seemed too dissipate across a wider surface area than in the DefenCell® backstop locations. The repose of the 300m earthen

berm, compaction of the surface soil and projectile velocity are key factors directly influencing the amount of fragmentation and penetration. Refer to figures 30 and 31 for fragmentation observations.

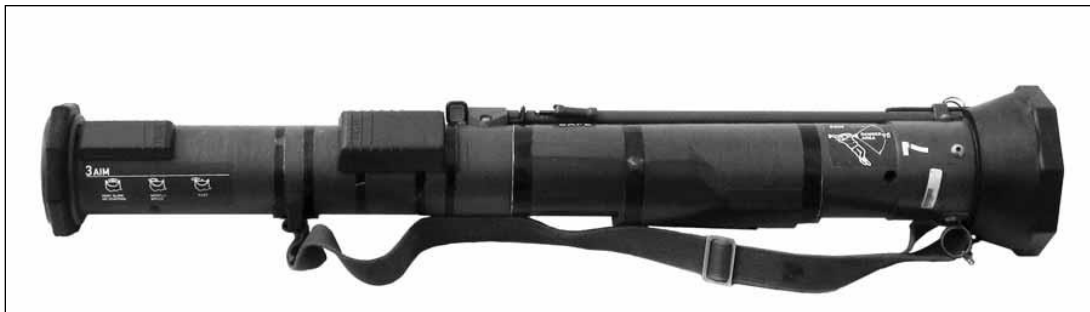
Figure 2, AT4, M287 Subcaliber Tracer Trainer

The M136 AT4 uses the M287 sub caliber training launcher. This AT4 trainer uses the 9-mm M939 training practice-tracer (TP-T) cartridge (Figure 2 and 3). This trainer simulates the M136 AT4 in weight, balance, and operation. The velocity and trajectory of its ammunition match that of the M136 AT4's HEAT cartridge, but the M287 produces less noise and overpressure. The M287 tracer trainer is a specially constructed M136 AT4. It is designed to accept a special rifle barrel that fires a reduced-load 9-mm cartridge. The trainer has a 9-mm submachine gun barrel, a breech assembly, and a bolt. The M939 9-mm tracer cartridge has a lighter powder charge than a standard 9-mm bullet. The lighter charge enables the cartridge to closely duplicate the trajectory of the M136 AT4 tactical round at ranges out to 700 meters. The M939 cartridge also has a tracer element to enable the firer to compare the impact of the cartridge with the sight picture. The firer can see the tracer out to 550 meters. The cartridge's red tip and half-black base distinguishes it from standard 9-mm ammunition, which should never be fired from the M287 tracer trainer.

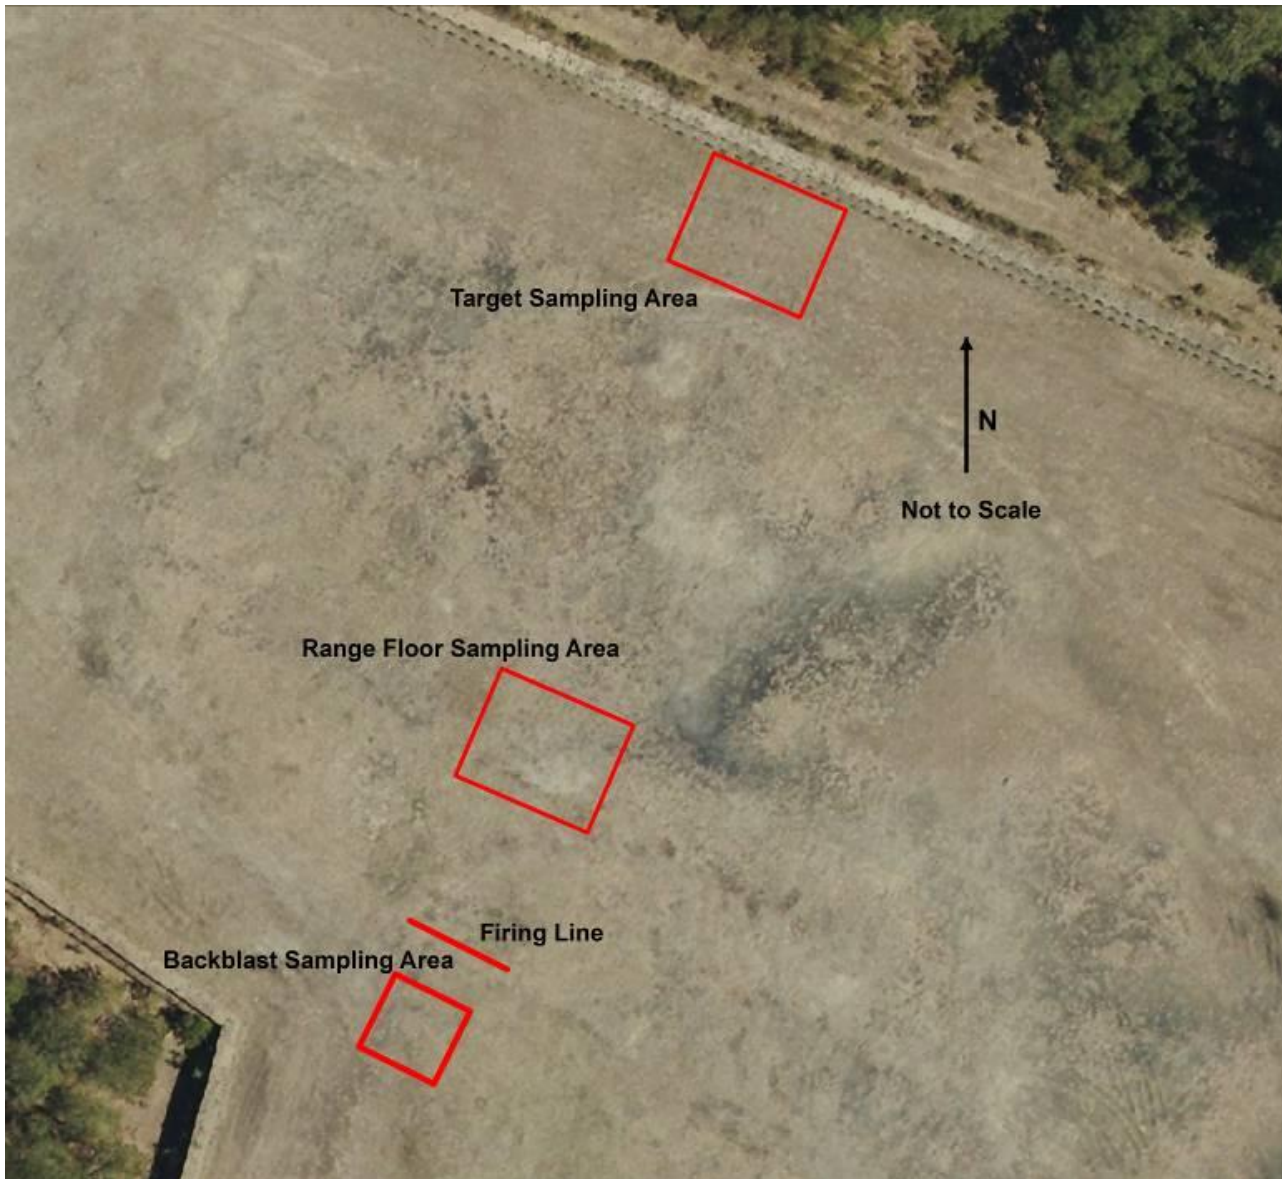
Figure 7. AT4 Trainer Firing Lane and Sampling Areas, Tactical Training Base Kelly
Camp Edwards, Massachusetts
