**QUANTIFICATION OF THE PHYSICAL HABITAT WITHIN  
GARVINS, HOOKSETT, AND AMOSKEAG POOLS OF THE  
MERRIMACK RIVER**

*Prepared for*  
**PUBLIC SERVICE COMPANY OF NEW HAMPSHIRE**  
780 North Commercial Street  
Manchester, NH 03105

*Prepared by*  
**NORMANDEAU ASSOCIATES, INC.**  
25 Nashua Road  
Bedford, NH 03110

**R-22240.002**

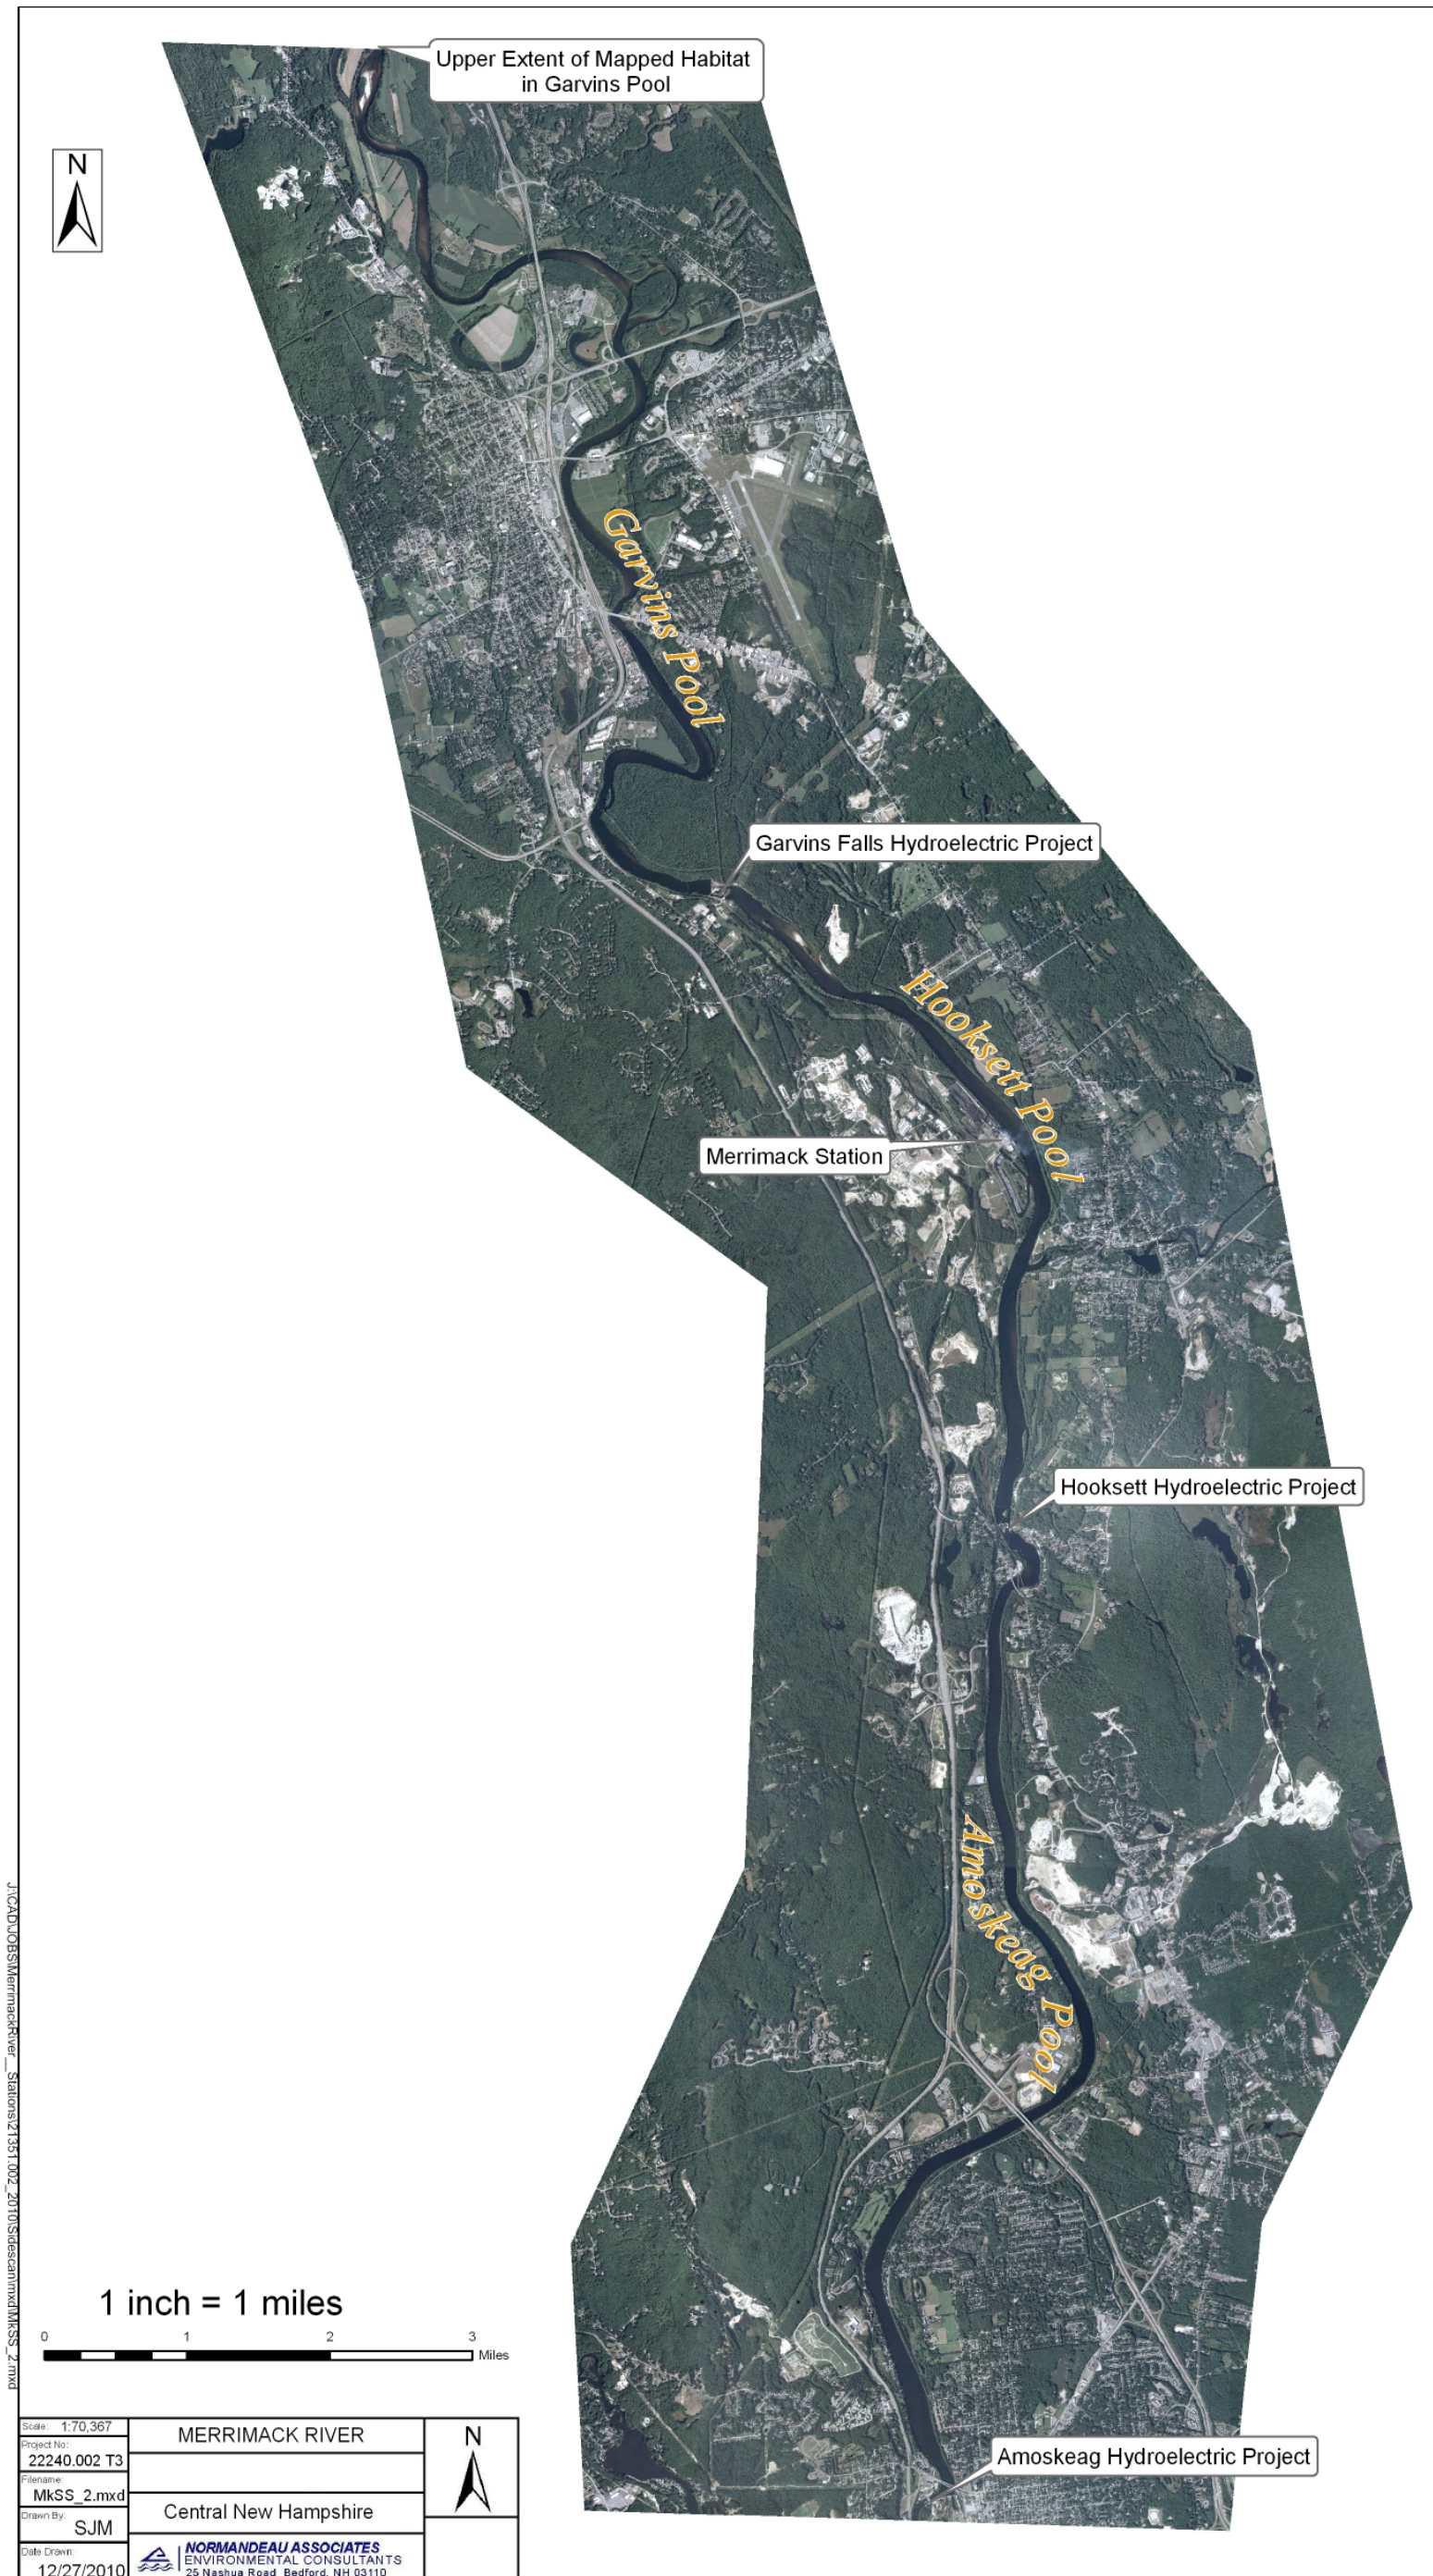
Figure 2-1. Garvins, Hooksett, and Amoskeag Pools of the Merrimack River surveyed during 16 September through 2 November 2010.

Merrimack Station withdraws non-contact cooling water from, and discharges it back into, a reach of the Merrimack River called Hooksett Pool (Figure 2-1). Garvins Falls Dam forms the upstream boundary of Hooksett Pool while Hooksett Dam forms the lower boundary. Hooksett Pool averages between 6 and 10 feet deep under most flow conditions, and has a surface area of 350 acres and a storage volume of 130 million cubic feet at full pond elevation. Hooksett Dam has two spillway sections; both sections have a crest at elevation 187 feet (USGS Datum), and both are topped with 2-foot flashboards, making the full pool elevation 189 feet (USGS Datum). Headpond elevation in Hooksett Pool is maintained within one foot of the full pond elevation as specified in the FERC operating license for the relevant hydroelectric facility.

Aquatic habitat cover types were mapped within Garvins, Hooksett, and Amoskeag Pools of the Merrimack River (Figure 2-1). The mapped portion of Garvins Pool extended from Garvins Falls Hydroelectric Project on the downstream end to the vicinity of Sewell’s Falls on the upstream end, a run-of-river distance of approximately 9.8 miles. Habitat cover types were mapped for the full reach

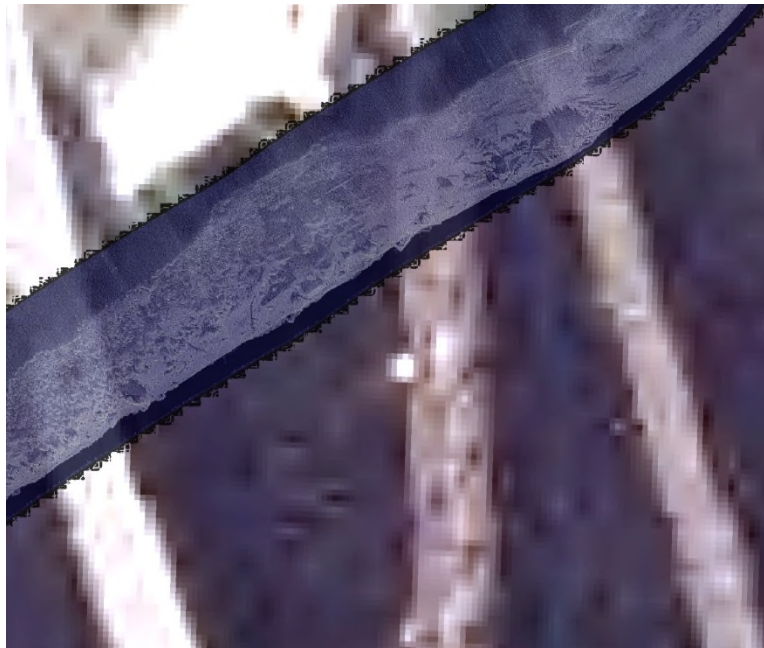
Figure 3-2. Example of sonar imagery acquired along shoreline habitat using a single side beam for the habitat survey of the Merrimack River, 16 September through 2 November 2010. This technique resulted in imagery with 2 inches of accuracy.

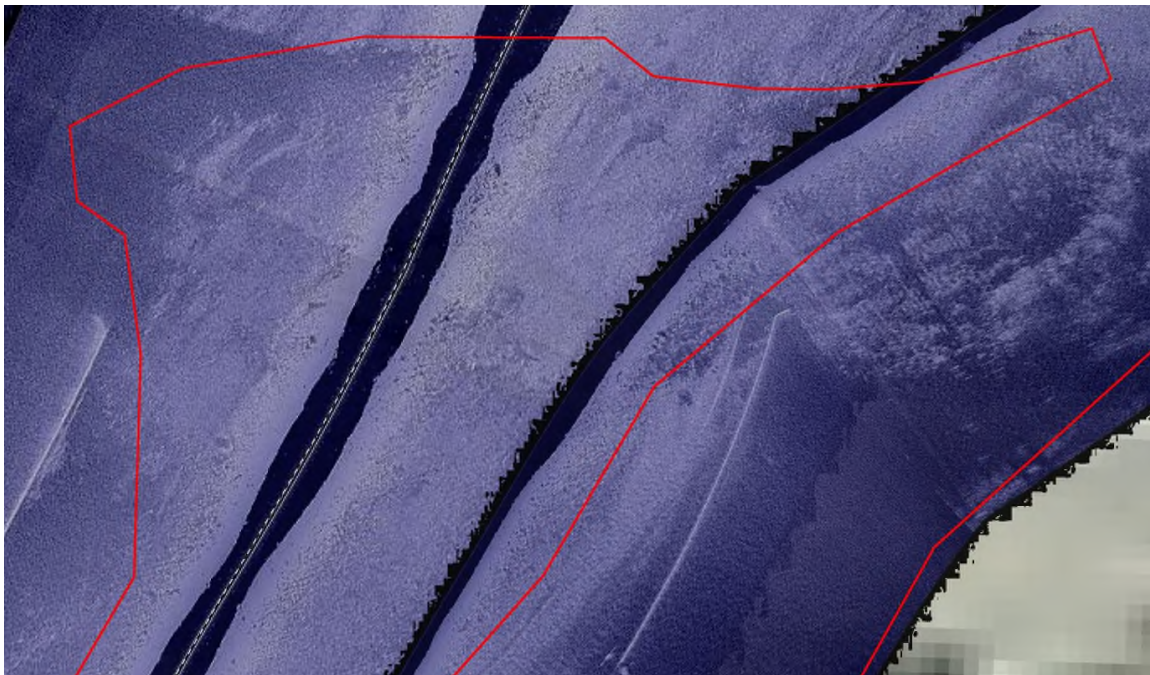
Figure 3-7. Example of gravel/cobble habitat type as classified from sonar imagery for the habitat survey of the Merrimack River, 16 September through 2 November 2010. (Note: gravel/cobble habitat is located within the bounds of the red polygon in the center of the figure).

A total of six substrate types were identified at the resolution of 2-4 inches in imagery from the Humminbird unit; sand/silt/clay, gravel/cobble, boulder, rip-rap, ledge, and woody debris. Figures 3-6 through 3-11 provide examples for the six habitat types classified from the sonar imagery. The habitat types were delimited with a predetermined precision of  $\pm 100$  sq ft (0.0023 acres). However, in most cases habitats smaller than this area or habitat borders were discernable at a greater resolution and were mapped at a higher precision. The total area (acres) for the six habitat types found in each of the three surveyed pools was quantified. Areas of aquatic vegetation were identified separately as an individual vegetation bed can occur over more than one substrate type. An example of submerged aquatic vegetation as identified by sonar imagery can be found in Figure 3-12.

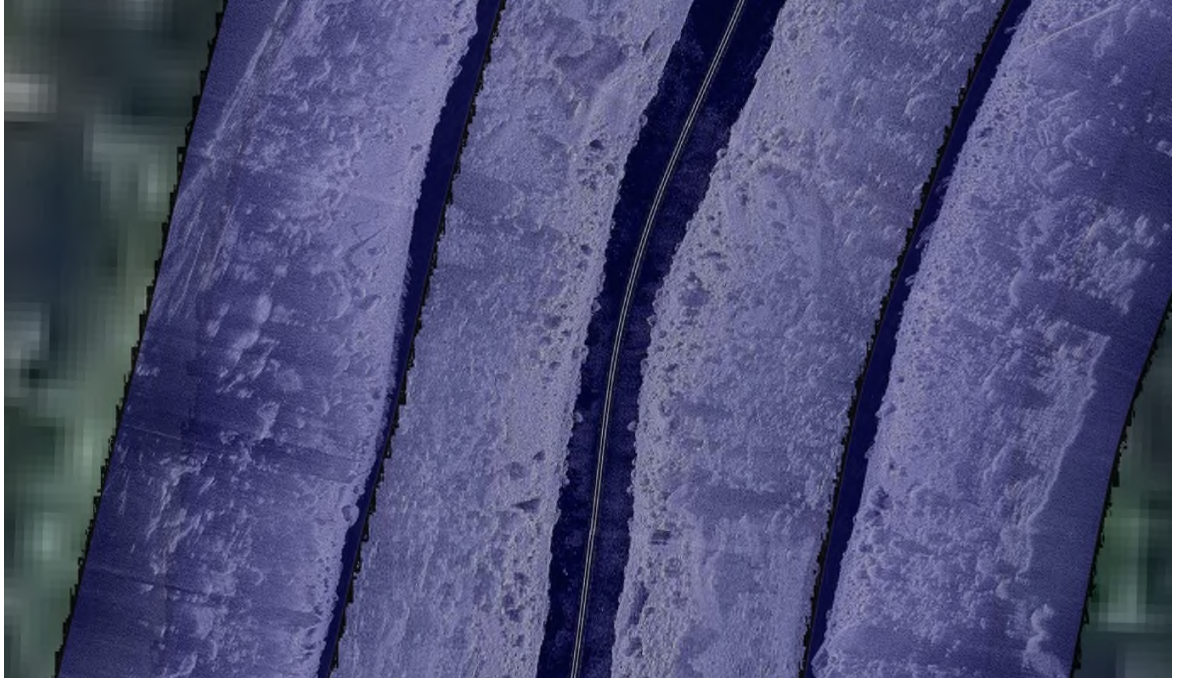
Figure 3-8. Example of boulder habitat type as classified from sonar imagery for the habitat survey of the Merrimack River, 16 September through 2 November 2010.
