# Troubleshooting and Antifoam Application Minimizes ZLDS Plant Operating Costs and Downtime

Kevin Boudreaux  
Power Industry Technical Consultant  
Nalco Company  
Naperville, Illinois

Steve Biggar  
Operations Manager  
Quantum Auburndale Power, LP  
Auburndale, Florida

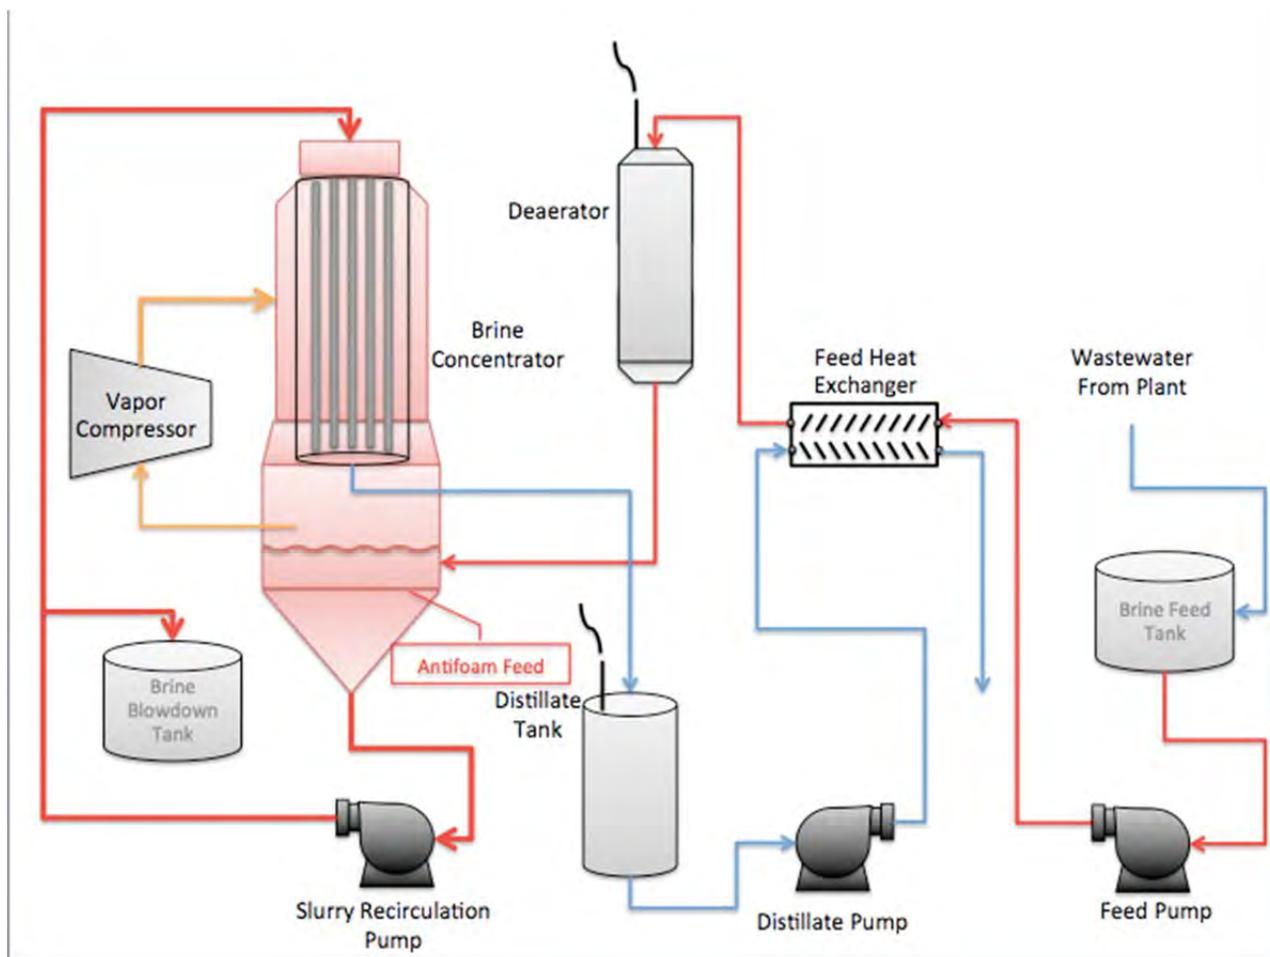
Figure 4: BC Details

the brine feed heat exchanger, where it gives up heat to the incoming wastewater. Depending on the water chemistry, the evaporator recovers 95-99% of the original wastewater as high purity distilled water (<10ppm total dissolved solids) (Bostjanic & Ludlum, 1995). A small amount of concentrated brine is continuously drawn from the evaporator to control the percent solids of the recirculating slurry. A typical concentration increase in a BC is from a 0.5% total dissolved solids (TDS) influent solution to a 10-14% TDS effluent solution, with total solids (TS) reaching 25%.

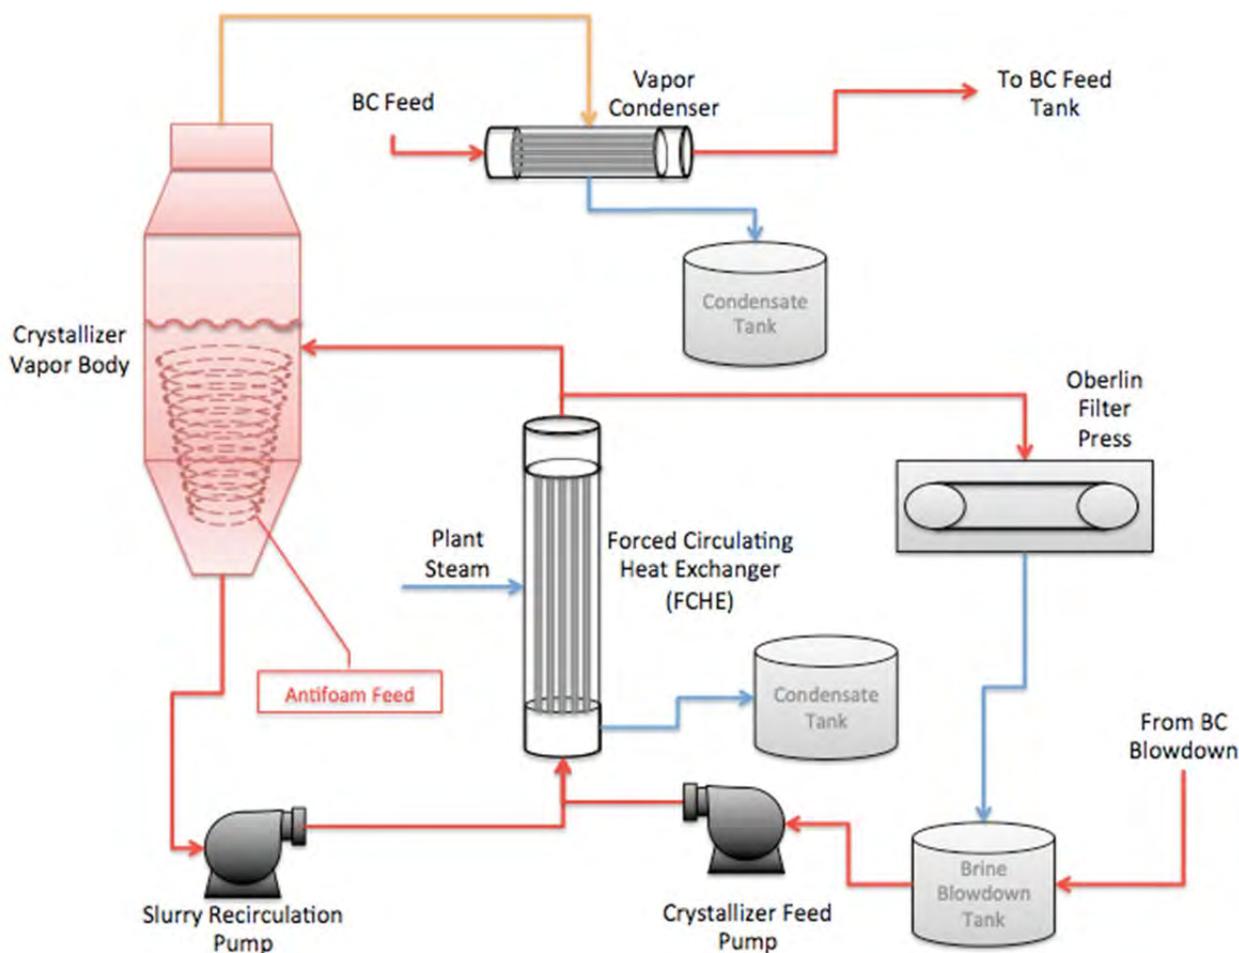
Figure 5: Crystallizer Details

Waste slurry from the BC is pumped to the Brine Blowdown (BD) tank, which then feeds the crystallizer's forced circulating heat exchanger (FCHE) (Figure 5). Typically, the FCHE is positioned below the water line of the crystallizer vapor body so that the FCHE tubes remain flooded. Flooding the tubes keeps the slurry under a slight head pressure, which inhibits boiling within the tubes, and thus minimizes the scaling potential. The recirculating brine inside the tubes is heated

with steam sent to the outside of the heat transfer tubes. The steam condenses on the outside of the tubes, giving up its heat to the brine slurry inside. Condensate is collected and may be recycled in the plant. This water is also quite pure, typically <50ppm total dissolved solids. From the FCHE, the slurry enters the crystallizer vapor body where small amount of the brine evaporates. The vapor passes through a mist eliminator and then to a condenser. Depending on the configuration, the vapor can be sent either directly to a condenser, or to a thermocompressor to recompress a portion of the vapor and then send it back to the crystallizer FCHE. In Auburndale's case, the vapor is pulled to a vapor condenser where once condensed, it is collected in the condensate tank (Figure 5). As water is evaporated from the brine, crystallization occurs. While most of the brine is recirculated back to the FCHE, a small amount is sent to a centrifuge or filter, Auburndale uses an Oberlin filter press, to separate the remaining water from the crystals. The filtrate from the centrifuge or filter is

pumped back to the crystallizer's recirculating stream. The crystallized slats are landfilled off site (Bostjanic & Ludlum, 1995). A typical concentration increase in a crystallizer is from 25% influent TS to 40-50% TS in the waste stream, with approximately 30-35% being TDS.

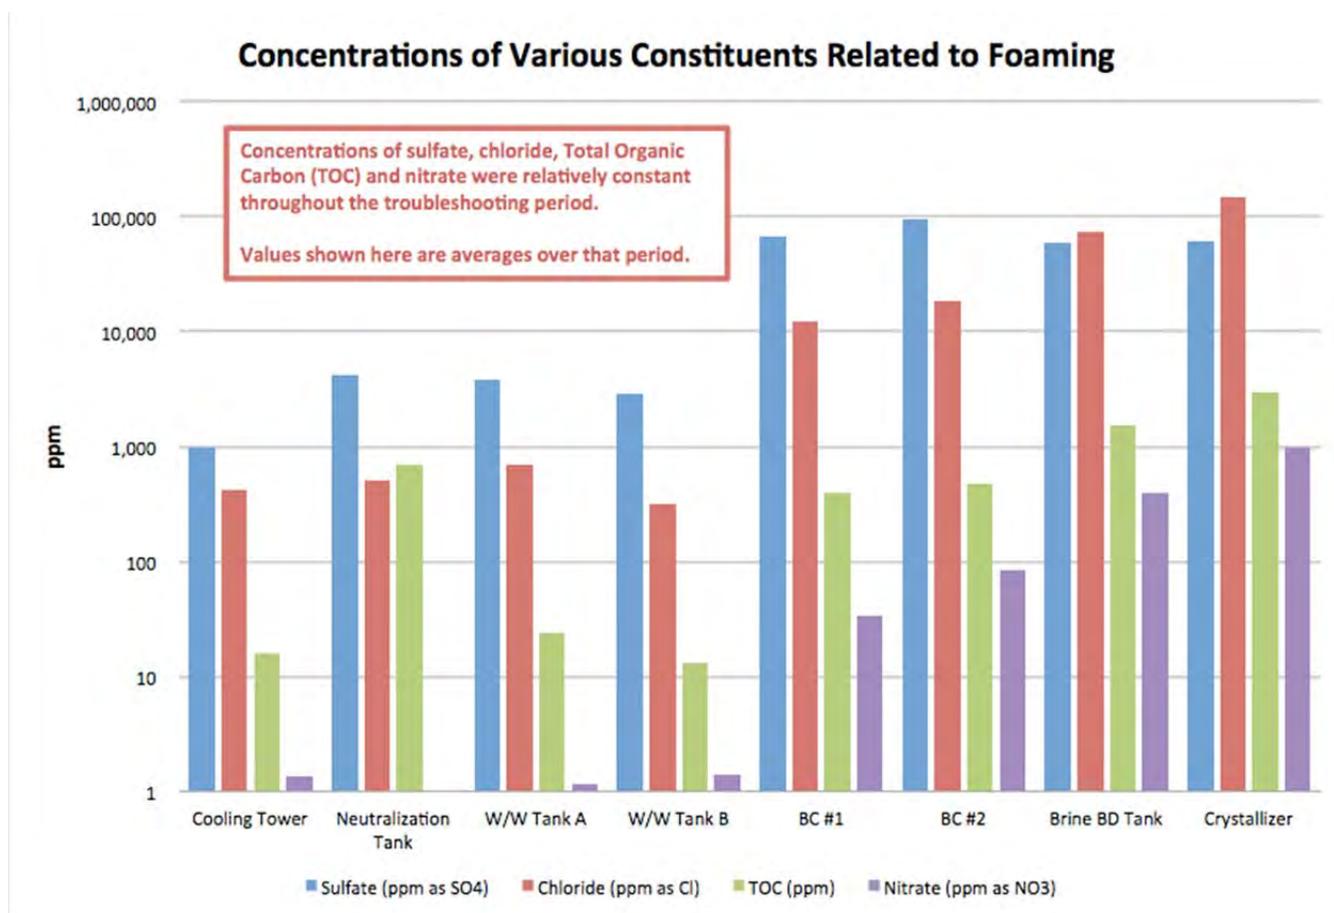
Figure 6: Ionic and Total Organic Carbon Results

Ionic – Ionic in this particular discussion refers to chloride, sulfate, and nitrate concentrations, as these are key species pertaining to this operation (Figure 6). As expected, the chloride and sulfate levels were well within the manufacturer's guidelines, and there were no results of concern in regards to over-cycling of TDS. Nitrate levels were slightly elevated in the crystallizer, but when compared to other ZLDS's around the country that have known nitrate concerns, they are low. Therefore, it was not believed that the nitrate levels were contributing to the foaming issue. Notice that the Brine BD tank ionic concentrations are higher than the two BC's from which it is fed. This is because the filtrate from the Oberlin filter press also feeds this tank. This is an important fact since any soluble constituents, such as soluble salts and organics that are not removed by the press recycle back to the Brine BD tank, which then feeds the crystallizer.

**Total Organic Carbon** – Prior to its cleaning, the TOC levels in W/W Tank A were high at 69ppm. While this may not seem significant, one must consider that the cycles of concentration from the W/W Tanks to the crystallizer, recycle of filter press filtrate back to the Brine BD tank is considered in this calculation (Figure 6), is in excess of 240 based on the provided TOC analyses. Therefore, that 69ppm becomes greater than 16,000ppm in the crystallizer. Obviously, this is an enormous amount of organic loading on the crystallizer. Once cleaned, W/W Tank A TOC levels appear to drop to within what would be considered *normal* by plant standards.

However, even with the lower TOC levels in the W/W tanks, cooling tower, and neutralization tank, the TOC levels in the BC's, Brine BD tank, and crystallizer remained high (Figure 7). Recall in the DMA discussion, the May 18<sup>th</sup> analyses

have contributed to the elevated TOC levels. However, based on the lab results, there was never any appreciable TOC found, all <1.0ppm, in any of the condensate return samples. Furthermore, the TOC levels in the cooling tower have remained fairly steady at an average of 15ppm (Figure 6), which is not uncommon and not alarming.

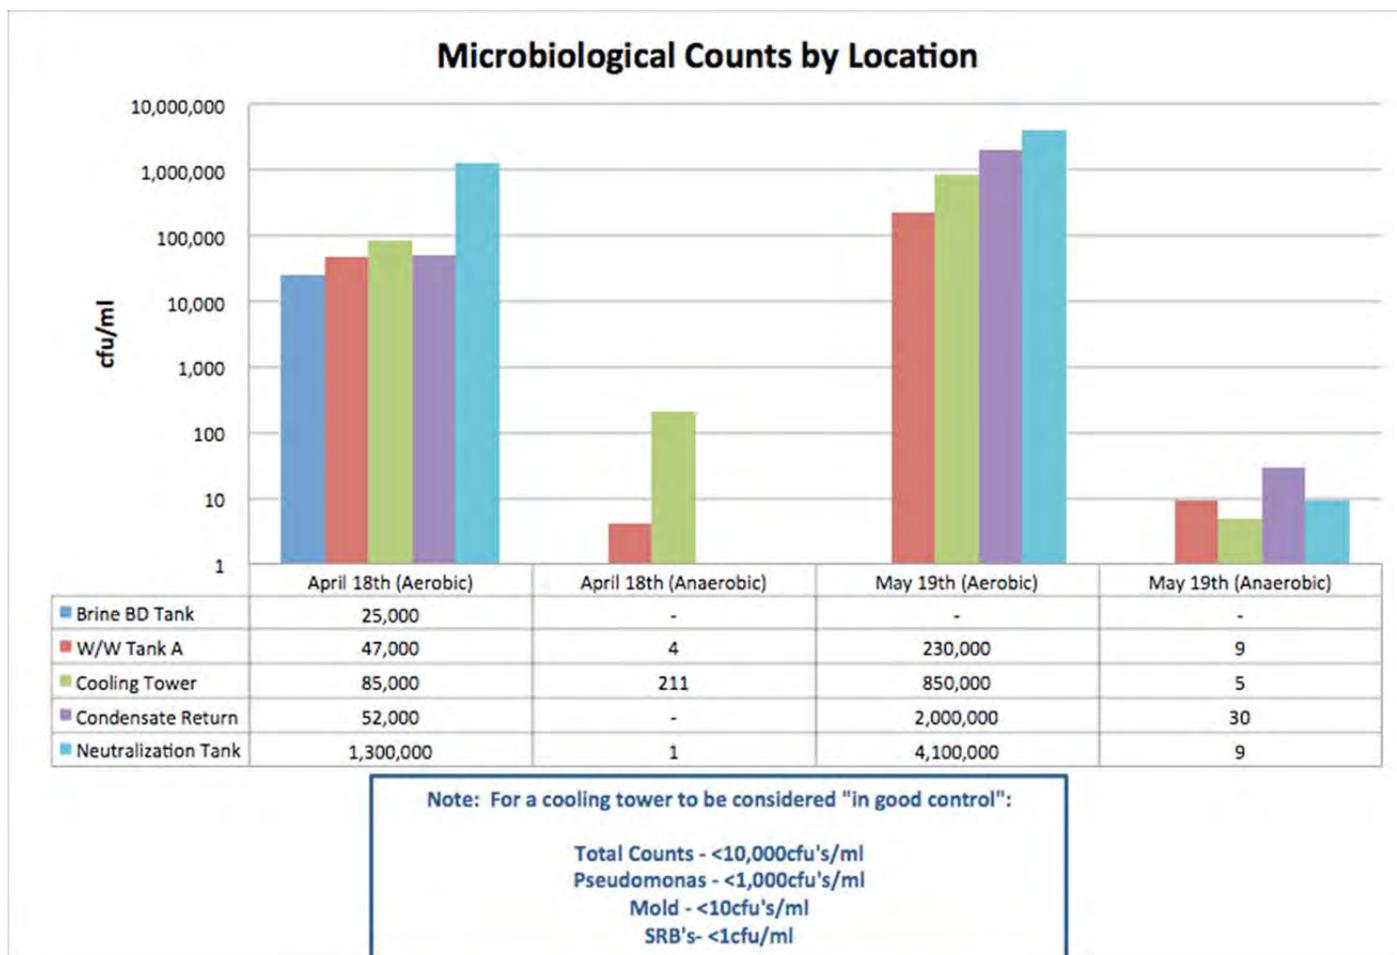
Figure 7: Microbial Counts (DMA)

Differential Microbial Analysis (DMA) – The DMA is a widely used set of laboratory tests that provides important information about the microbiology of the system in question. It can differentiate many of the bacteria into principle classes, and other organisms, like algae, protozoa, and fungi, can be determined by microscopic observation. The results for the samples to be reviewed can be found in Figure 7. The samples were taken on April 18<sup>th</sup> and May 19<sup>th</sup>, which is pertinent since the biocide addition to W/W Tanks A and B was performed in late March, just prior to when the first DMA was performed.

The results show the plant was struggling with microbial control. What's more, while there are no results prior to the March biocide addition to the W/W tanks, it is clear that the bioactivity was considerably less on April 18<sup>th</sup> than on May 19<sup>th</sup>. It is suspected that the biocide addition did clean the W/W tanks, and thus subsequently the Brine Feed tank, but that the W/W tanks were contaminated shortly after the cleaning. Recall that the cooling tower blowdown, Area Drain Sumps, and Neutralization tank supply the W/W tanks. Figure 7 shows that the cooling tower biological activity is beyond what would be considered *good control*, and while there are no true guidelines for microbial activity in the W/W and neutralization tanks, it would appear from the May 18<sup>th</sup> results that they were also heavily contaminated.

ruled out as a possible root cause. However, an important fact is that the Brine BD tank, which is a direct feed to the crystallizer, was free of any biological activity based on the May 19<sup>th</sup> results (Figure 7). With this information in mind, the thought was that the microbes were being destroyed in the BC's, and the TOC from that breakdown was being transferred to the crystallizer as a dissolved organic. As previously discussed, organics can lead to foaming, and depending on the type, can do so at very low concentrations.

showed that the Brine BD tank was free from microbial contamination (Figure 7), yet at the same time was very high in TOC. It seemed that theory of elevated TOC levels being the root cause of the foaming issue could be viable. It also appeared the TOC was trapped in the ZLDS cycle due to the fact that the filter press is not removing soluble organics with the solid waste produced. However, the team was not completely convinced the bio growth was the only culprit in the TOC contribution; and therefore the troubleshooting continued.

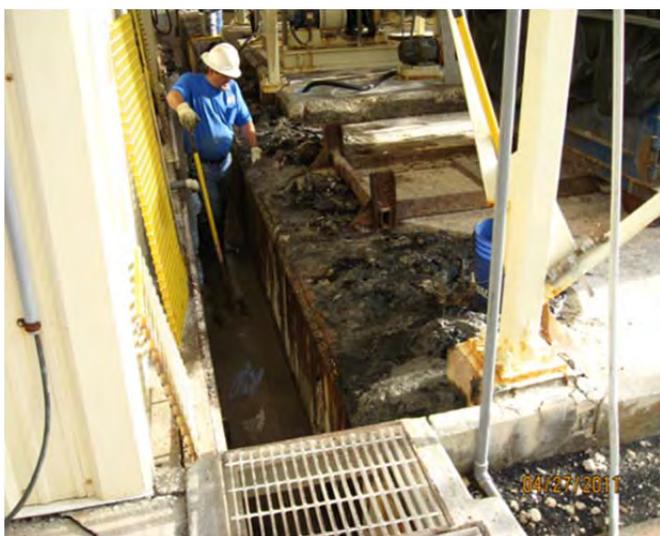
Photo 1: Ditch Clean Out

Most ZLD plants have a myriad of trenches and ditches throughout the plant to capture water sources, such as water wash-downs and rainwater, which are then processed using the concentrator and crystallizer systems. Auburndale has such a ditch physically located just under the BC's and crystallizers, which drains into the Area Drain Sump. The Area Drain Sump then feeds the W/W tanks (Figure 3). Perhaps the turning point in the troubleshooting process occurred when it was noticed that the ditch was full of a significant amount of organic matter and debris. It is not unusual for ditches to accumulate debris, but as seen in Photo #1, this was an exorbitant amount. Further examination revealed that the ditch contained a large amount of bead-blasting material, commonly referred to as "Black Beauty", used during a bead-blasting operation that took place during the outage. During the cleaning of the ditch, it was noted that there was a very foul rotten egg smell, which is typically an indication of the presence of anaerobic bacteria. Future analyses would further confirm the presence

of organic material showing that TOC levels were very high at 700ppm. While the ditch had never been sampled for TOC in the past, it was obvious to the team that this would be a significant source of TOC to the ZLDS process.

Understanding the ditch contamination was a significant source of the TOC problem, as well as *the change* the team had been looking for, it was promptly cleaned of all debris. Furthermore, because the W/W tanks, cooling tower and neutralization tank were all showing high levels of biological contamination, they were treated with a biocide in an effort to reduce the microbial counts to acceptable levels. Also, between April 25<sup>th</sup> and May 4<sup>th</sup>, both BC's were drained, hydro-blasted, and reseeded in an effort to remove any TOC present. However, the Brine BD tank was not cleaned during this time, which would prove to be substantial.

Given that the root cause of the foaming issues was related to accumulation of organics, bio, and debris in the ditch, Mr. Biggar initiated a preventative maintenance (PM) program to clean the ditch once a week. The PM includes shoveling all waste from the ditch, which is then disposed of with the solids produced by the Oberlin filter press.

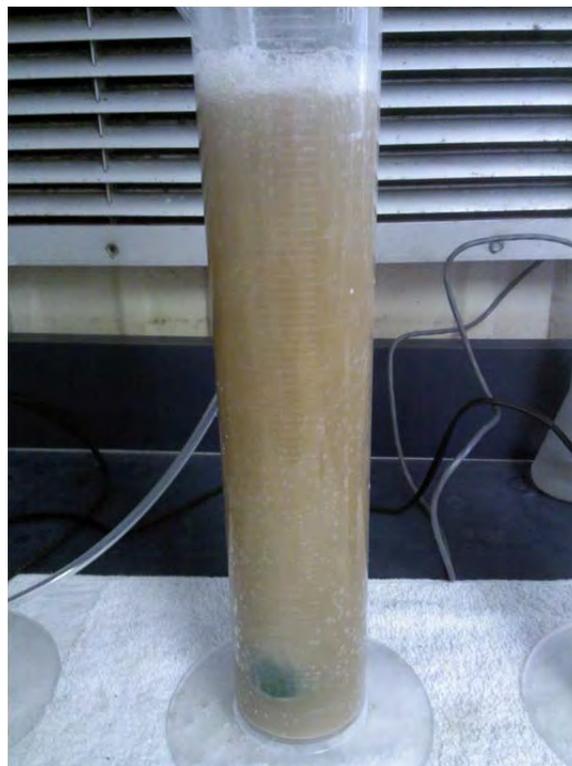
Photo 2: Air Stone and Graduated Cylinder

Procedures for testing antifoams range from simple shake test to using antifoam recirculating test kits. For this particular bench testing, Mrs. Palomo used the Air-Stone Aeration Method, which is an excellent method for evaluating antifoam knockdown and persistence. Knockdown is the amount of foam height reduction after the addition of the antifoam, while persistence is how well the antifoam keeps the foam from reoccurring after antifoam addition. This method uses an air stone placed into a graduated cylinder filled with sample (Photo #2). As the air is supplied to the air stone, it entrains air into the solution, thus initiating foaming. Prior to adding the antifoam, readings are taken to record the maximum foam height. After antifoam addition, multiple recordings are taken to judge the knockdown and persistence of the antifoam. From this, one can start to determine the best antifoam for the application. Obviously, the determined antifoam feed rates are estimates, and a full-scale trial needs to be performed to determine injection location and feed rates.

With the samples collected and the antifoams prepared, Mrs. Palomo began bench testing using the Air-Stone Aeration method previously described. The bench testing process was quick, and more importantly, proved to be exact in selecting the proper antifoam for the application. As Figure 8 shows, Nalco 7569 was found to act very quickly, and more importantly, was the most persistent in maintaining foam control. Furthermore, the dose rate was the lowest of all the antifoams trialed, which is a key fact when considering antifoam applications. Because antifoams are usually hydrophobic, finely
