**QUANTIFICATION OF THE PHYSICAL HABITAT WITHIN  
GARVINS, HOOKSETT, AND AMOSKEAG POOLS OF THE  
MERRIMACK RIVER**

*Prepared for*  
**PUBLIC SERVICE COMPANY OF NEW HAMPSHIRE**  
**780 North Commercial Street**  
**Manchester, NH 03105**

*Prepared by*  
**NORMANDEAU ASSOCIATES, INC.**  
**25 Nashua Road**  
**Bedford, NH 03110**

**March 2011**

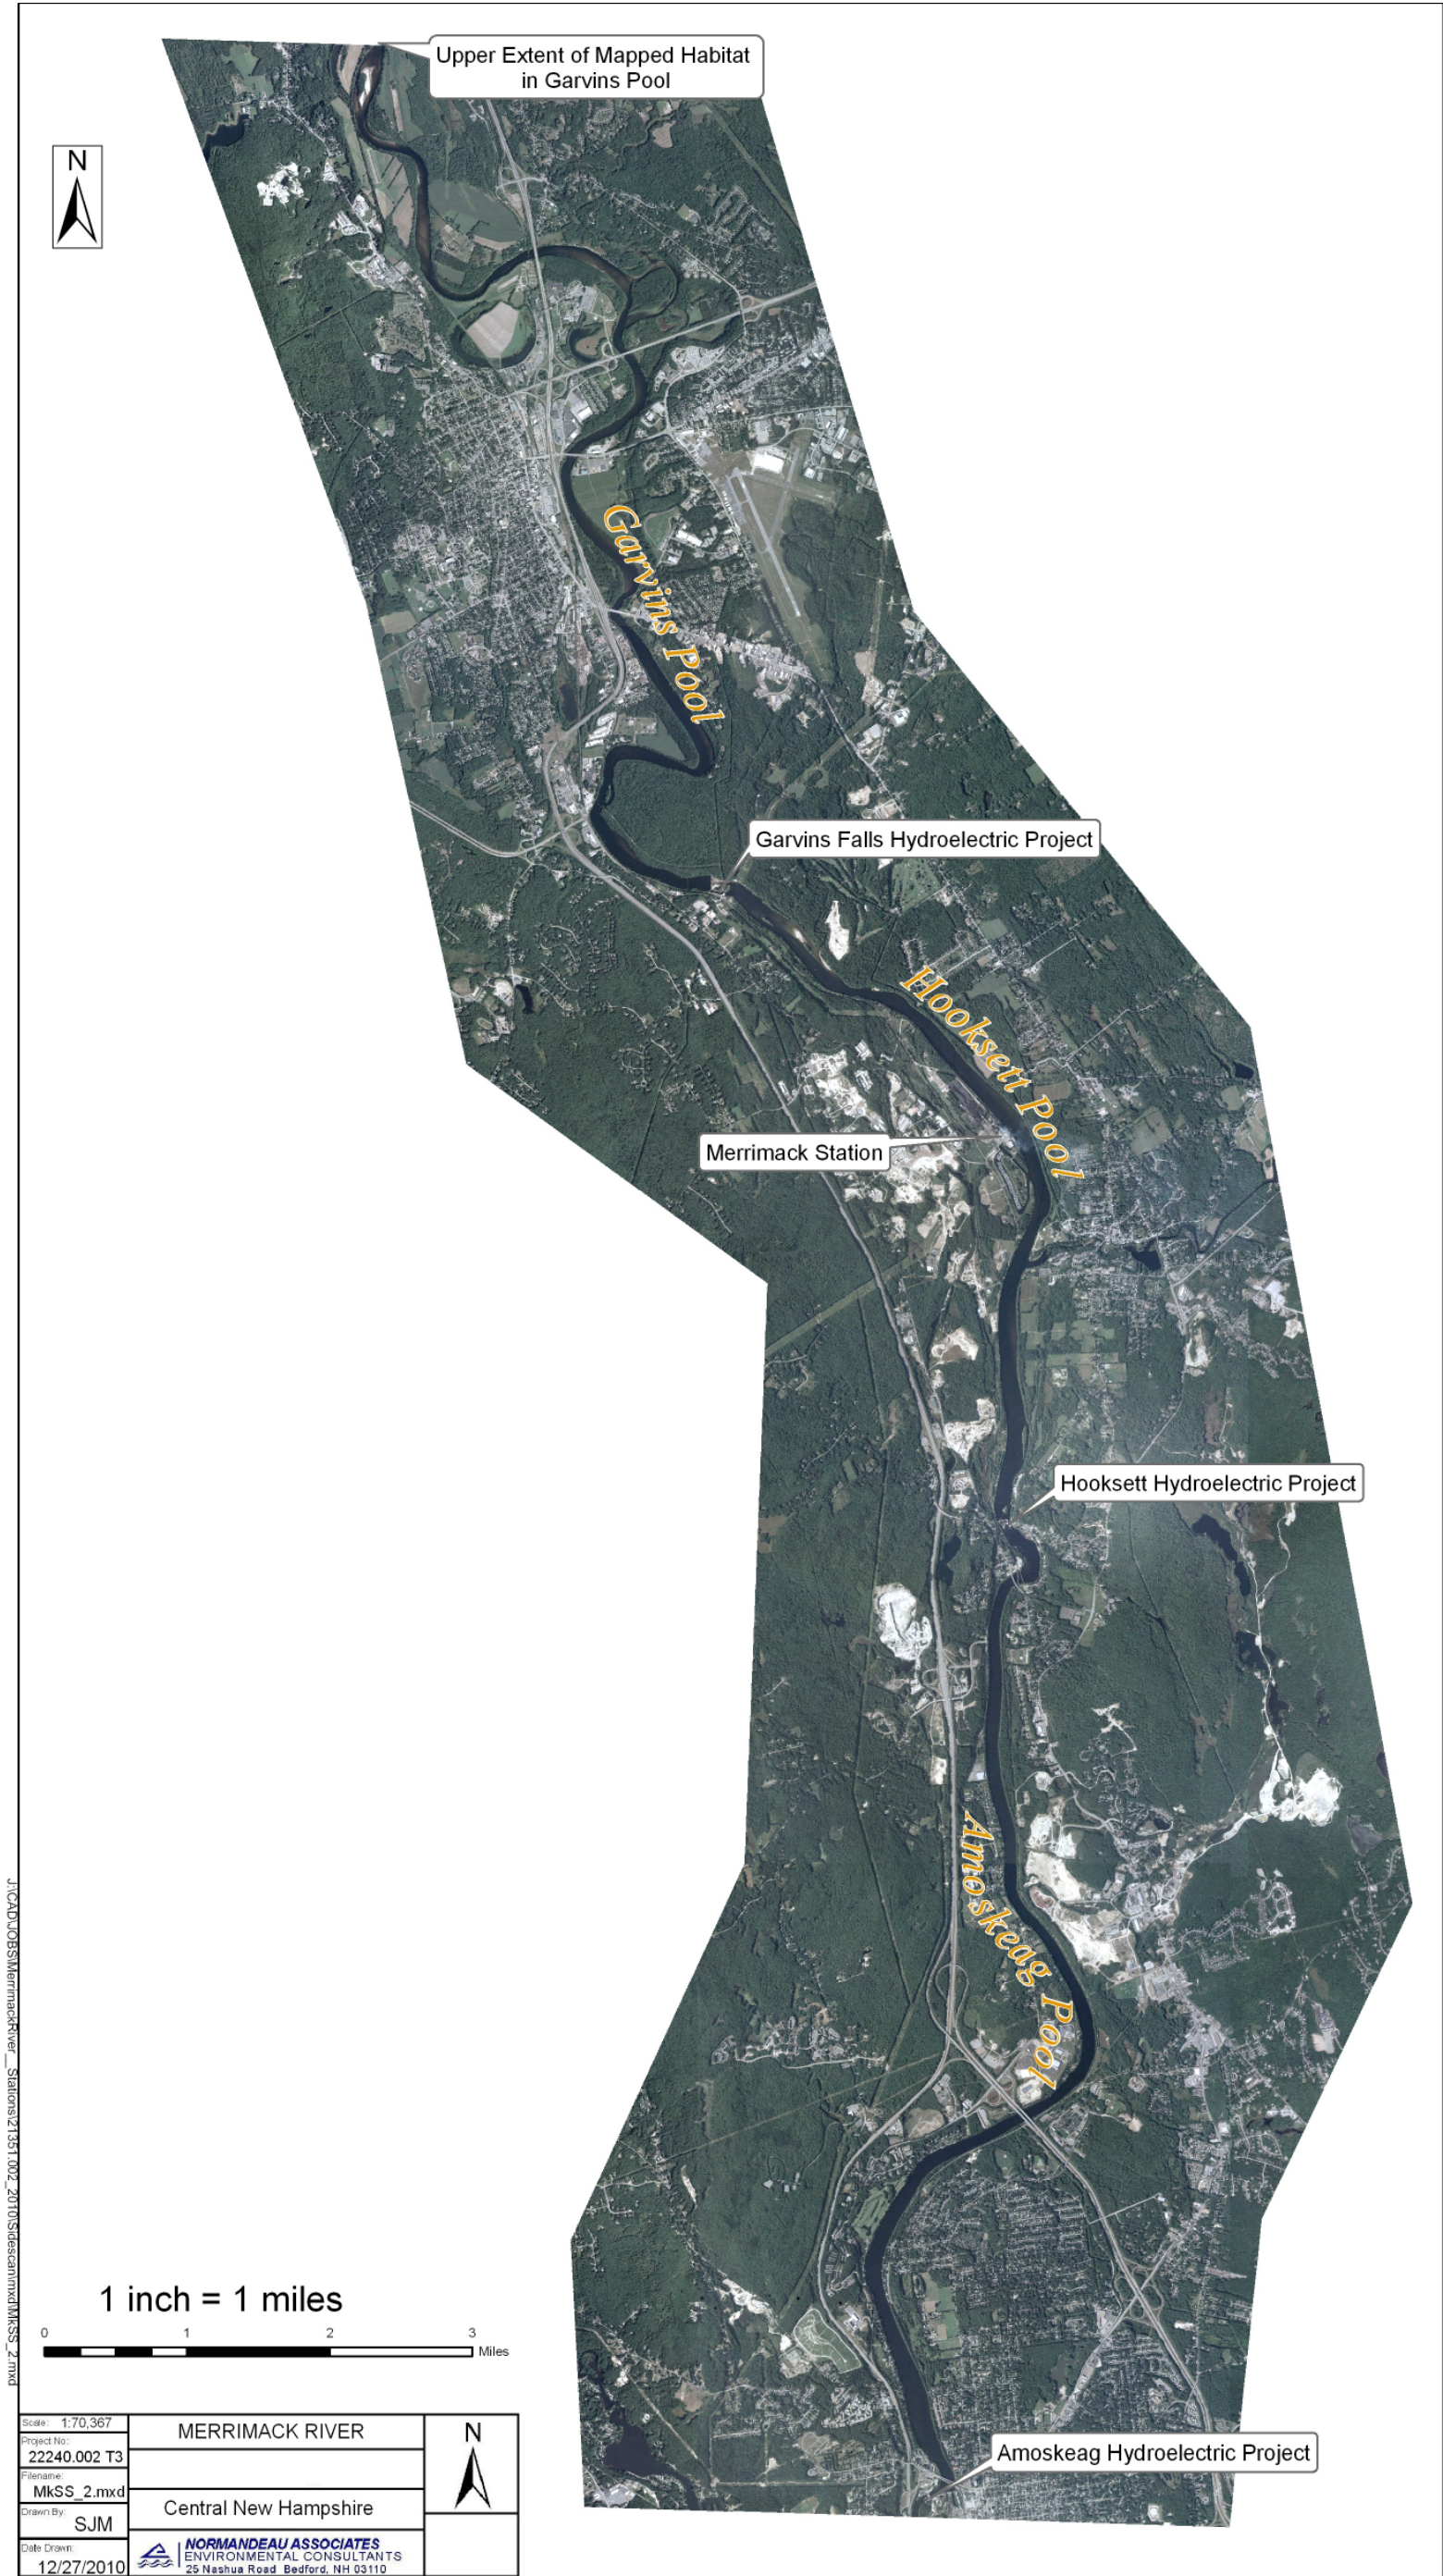
Figure 2-1. Garvins, Hooksett, and Amoskeag Pools of the Merrimack River surveyed during 16 September through 2 November 2010.

Merrimack Station withdraws non-contact cooling water from, and discharges it back into, a reach of the Merrimack River called Hooksett Pool (Figure 2-1). Garvins Falls Dam forms the upstream boundary of Hooksett Pool while Hooksett Dam forms the lower boundary. Hooksett Pool averages between 6 and 10 feet deep under most flow conditions, and has a surface area of 350 acres and a storage volume of 130 million cubic feet at full pond elevation. Hooksett Dam has two spillway sections; both sections have a crest at elevation 187 feet (USGS Datum), and both are topped with 2-foot flashboards, making the full pool elevation 189 feet (USGS Datum). Headpond elevation in Hooksett Pool is maintained within one foot of the full pond elevation as specified in the FERC operating license for the relevant hydroelectric facility.

Aquatic habitat cover types were mapped within Garvins, Hooksett, and Amoskeag Pools of the Merrimack River (Figure 2-1). The mapped portion of Garvins Pool extended from Garvins Falls Hydroelectric Project on the downstream end to the vicinity of Sewell’s Falls on the upstream end, a run-of-river distance of approximately 9.8 miles. Habitat cover types were mapped for the full reach

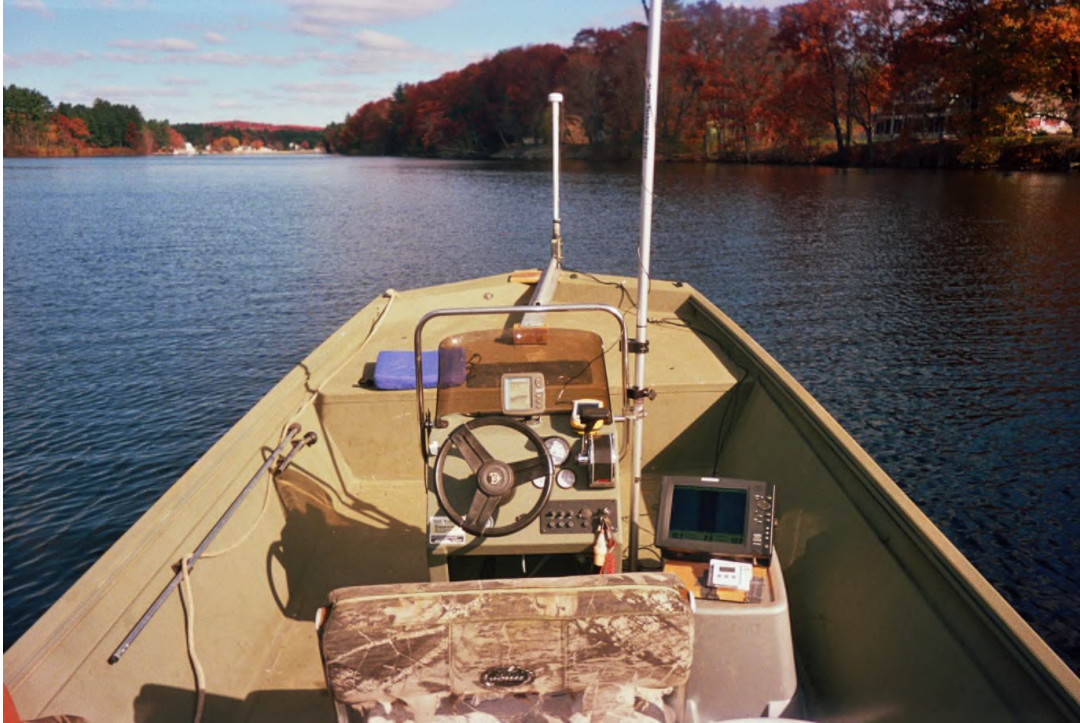
Figure 3-1. Side scan sonar configuration used for Merrimack River surveys during 16 September through 2 November 2010.

Sonar data was collected from Garvins, Hooksett, and Amoskeag Pools using a Humminbird™ 1197c, side imaging unit. The Humminbird unit was used in conjunction with a Trimble GeoXT™ dGPS to provide the precise coordinate information necessary for geo-referencing captured images with 12-24 inches of accuracy in the horizontal plane. The Humminbird transducer was positioned at the bow of 20-ft flat-bottom work-boat and was attached using a custom mount (Figure 3-1). The operating frequency for the unit was set at 455 kHz for all surveys. Prior to data collection, survey lines within each pool were established in ArcGIS and were laid out in a manner which would provide full coverage of the bottom substrate within each pool during data collection. The number of survey lines needed for a particular reach of river was based on a combination of river width and the transducer's effective range. Data collection along shoreline areas for each pool was conducted by recording using a single side beam set at a range of 90 to 100 ft (Figure 3-2). Data collection along survey lines within the central portions of the three pools were conducted with the side beam range set at 100 to 140 ft per side (Figure 3-3). Collected data images were allowed to overlap to ensure full coverage of the bottom habitat. Boat speed was maintained at 3-5 mph during all data collection.

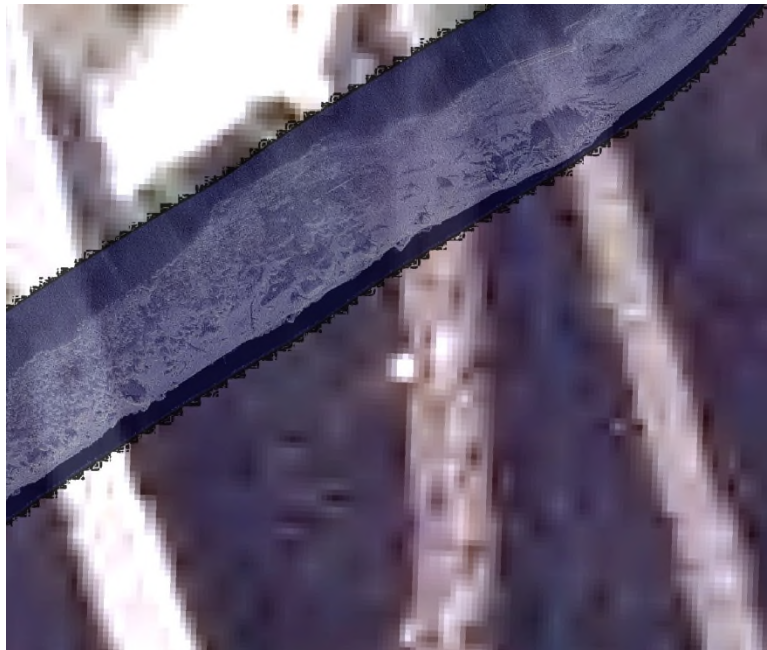
Figure 3-2. Example of sonar imagery acquired along shoreline habitat using a single side beam for the habitat survey of the Merrimack River, 16 September through 2 November 2010. This technique resulted in imagery with 2 inches of accuracy.

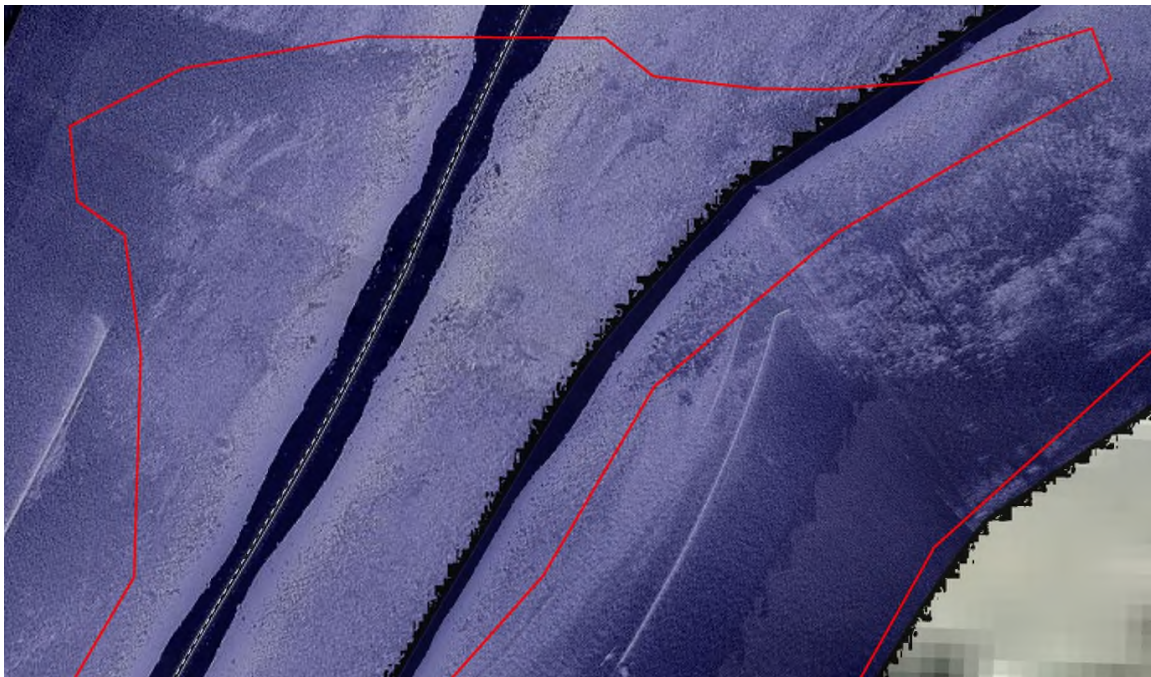
Figure 3-7. Example of gravel/cobble habitat type as classified from sonar imagery for the habitat survey of the Merrimack River, 16 September through 2 November 2010. (Note: gravel/cobble habitat is located within the bounds of the red polygon in the center of the figure).

A total of six substrate types were identified at the resolution of 2-4 inches in imagery from the Humminbird unit; sand/silt/clay, gravel/cobble, boulder, rip-rap, ledge, and woody debris. Figures 3-6 through 3-11 provide examples for the six habitat types classified from the sonar imagery. The habitat types were delimited with a predetermined precision of  $\pm 100$  sq ft (0.0023 acres). However, in most cases habitats smaller than this area or habitat borders were discernable at a greater resolution and were mapped at a higher precision. The total area (acres) for the six habitat types found in each of the three surveyed pools was quantified. Areas of aquatic vegetation were identified separately as an individual vegetation bed can occur over more than one substrate type. An example of submerged aquatic vegetation as identified by sonar imagery can be found in Figure 3-12.

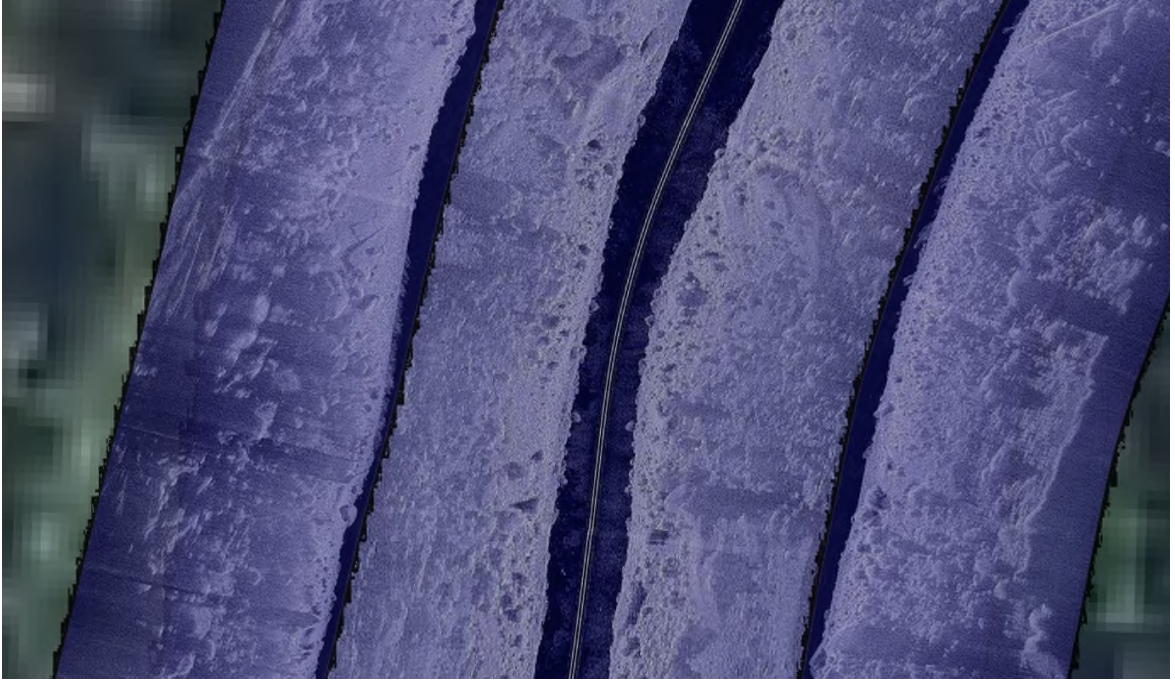
Figure 3-8. Example of boulder habitat type as classified from sonar imagery for the habitat survey of the Merrimack River, 16 September through 2 November 2010.

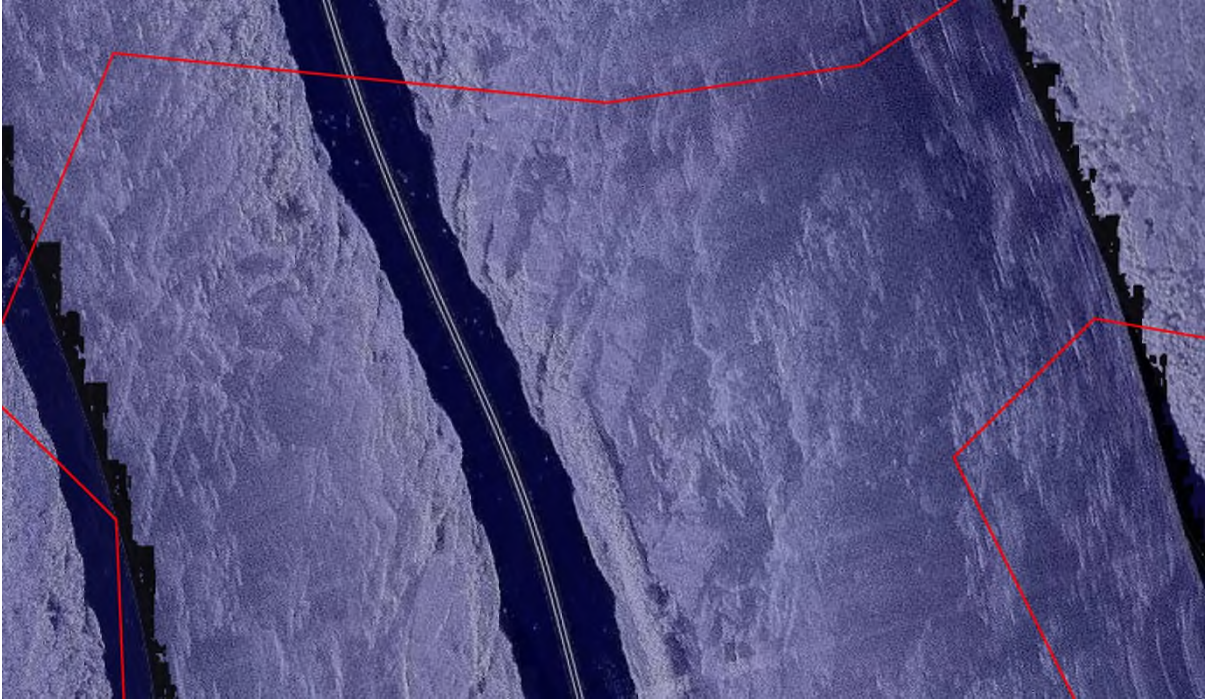
Figure 3-10. Example of ledge habitat type as classified from sonar imagery for the habitat survey of the Merrimack River, 16 September through 2 November 2010. (note: ledge habitat is located within the bounds of the polygon in the center).
