RE: Request for Permit Coverage: July 2003  
National Pollutant Elimination Discharge System (NPDES) General Permit for Storm Water  
Discharges from a Small Municipal Separate Storm Sewer System (MS4)  
Division of Capital Asset Management (DCAM) Surplus Properties  
Medfield State Hospital NOI Letter

RE: Division of Capital Asset Management (DCAM) Surplus Properties  
Medfield State Hospital Assessment Letter Report

**Figure 1**  
**DCAM Surplus Properties - Medfield State Hospital**  
**NPDES Phase II Assessment Report**

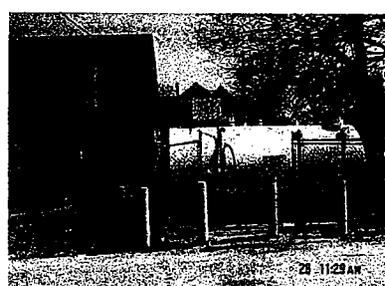
**Figure 1-24**  
1,000-gallon gasoline AST  
between shop building and  
garage.

- 1,000-gallon Gasoline Tank (Attachment C, Figure 1-24)
- Propane Tank (Attachment C, Figure 1-41)

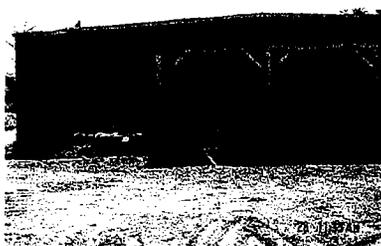
**Figure 1-26**  
Metal equipment and salt  
storage behind Garage.

Although no significant pollution issues were observed, there are potential storm water issues. Asphalt and brick debris (Attachment C, Figures 1-37 and 1-38) located on the north side of the Property have the potential to enter the Charles River. The Salvage Yard area contains a significant amount of debris including construction material, metal equipment, and used plastic containers (Attachment C, Figures 1-21, 1-22, and 1-23). In addition, the Garage, salt storage area (north side of the Garage), and debris (north of the Garage) all have the potential to cause storm water pollution (Attachment C, Figures 1-26 and 1-27).
