**Municipality/Organization:** Shrewsbury, Massachusetts

**EPA NPDES Permit Number:** MAR041158

**Annual Report Number  
& Reporting Period:** No. 2: March 04-Mar 05

## NPDES PII Small MS4 General Permit Annual Report

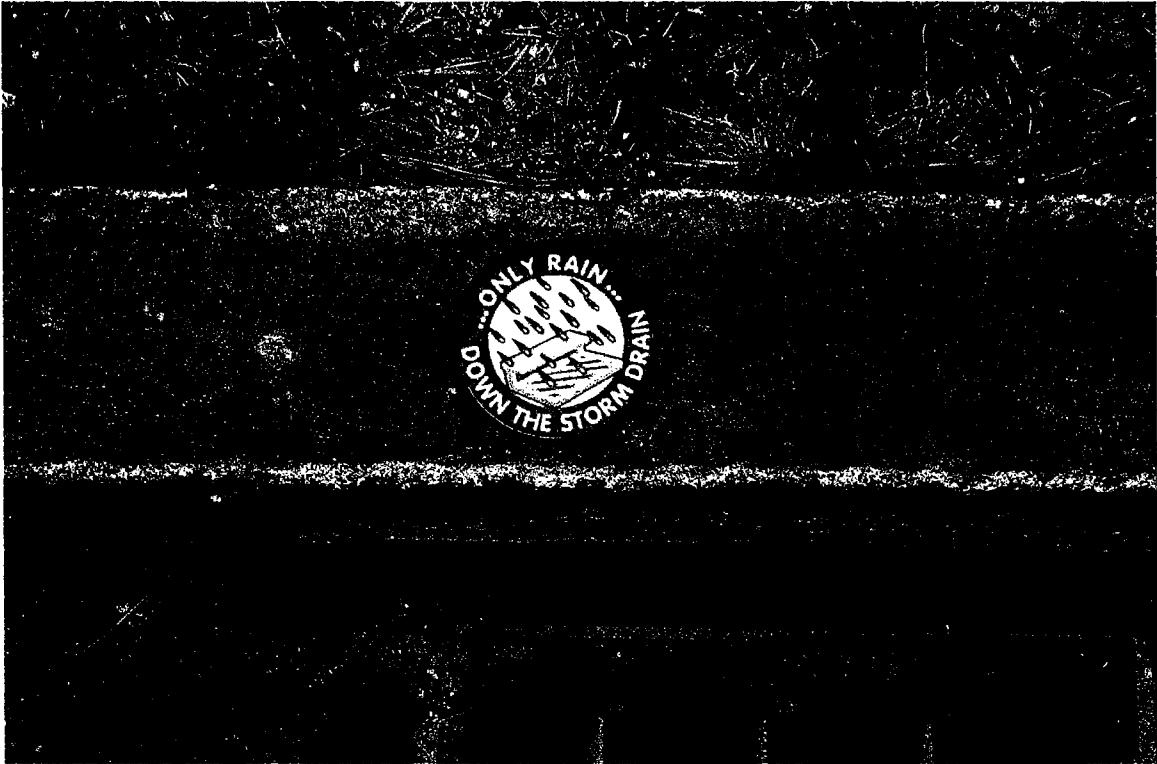
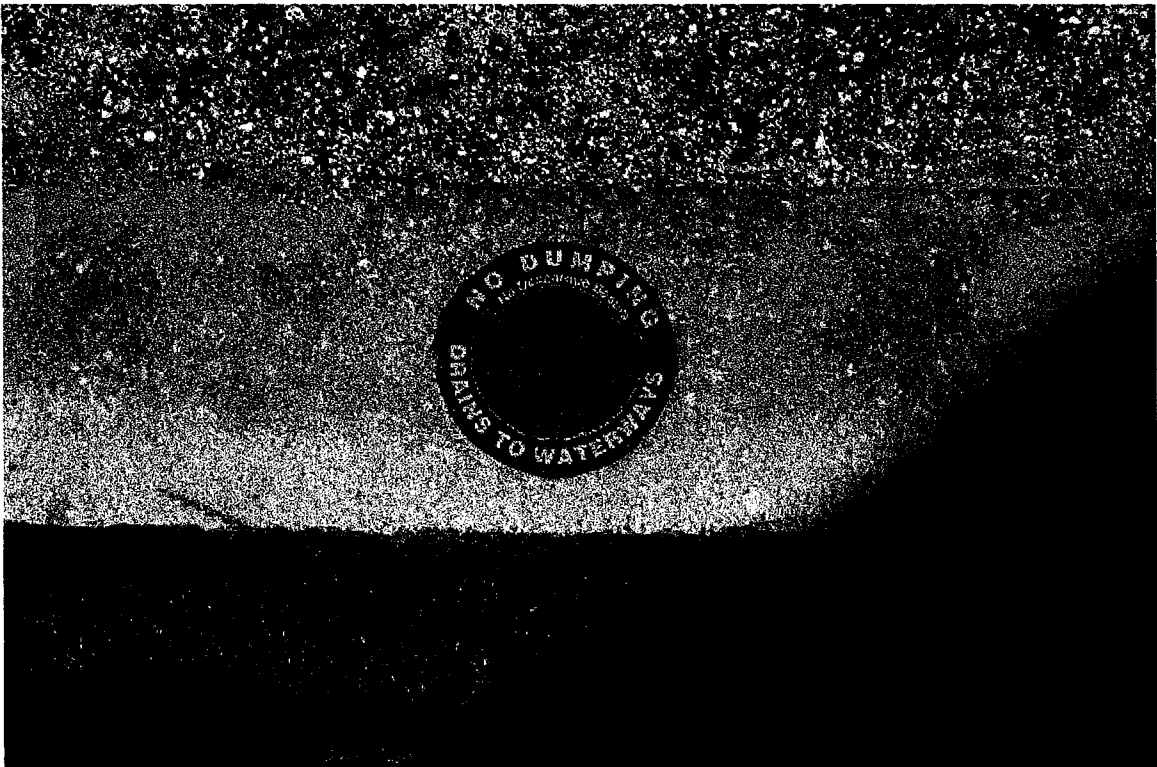
Installed Catch Basin Markers

BMP ID #	BMP Description	Responsible Dept./Person Name	Measurable Goal(s)	Progress on Goal(s) – Permit Year 2 (Reliance on non-municipal partners indicated, if any)	Planned Activities – Permit Year 3
03 Revised	Catch Basin Stenciling	Engineering Dept.	# Catch Basins Stenciled	25 Crystal Cap markers were installed at catch basin inlets and will be evaluated for durability.	Volunteers to install markers at catch basins near Lake Quinsigamond, Flint Pond, and Jordan Pond.
04 Revised	Water Monitoring & Sampling	Health Dept.	Sample Data	Samples for E Coli and Total Coliform bacteria were taken on a weekly basis during the bathing season in Lake Quinsigamond.	Same as Permit Year 2.
Revised					
Revised					
Revised					
Revised					
Revised

*During Year 3 the Town and public participants will install catch basin markers near Flint Pond, Lake Quinsigamond, and Jordan Pond.*

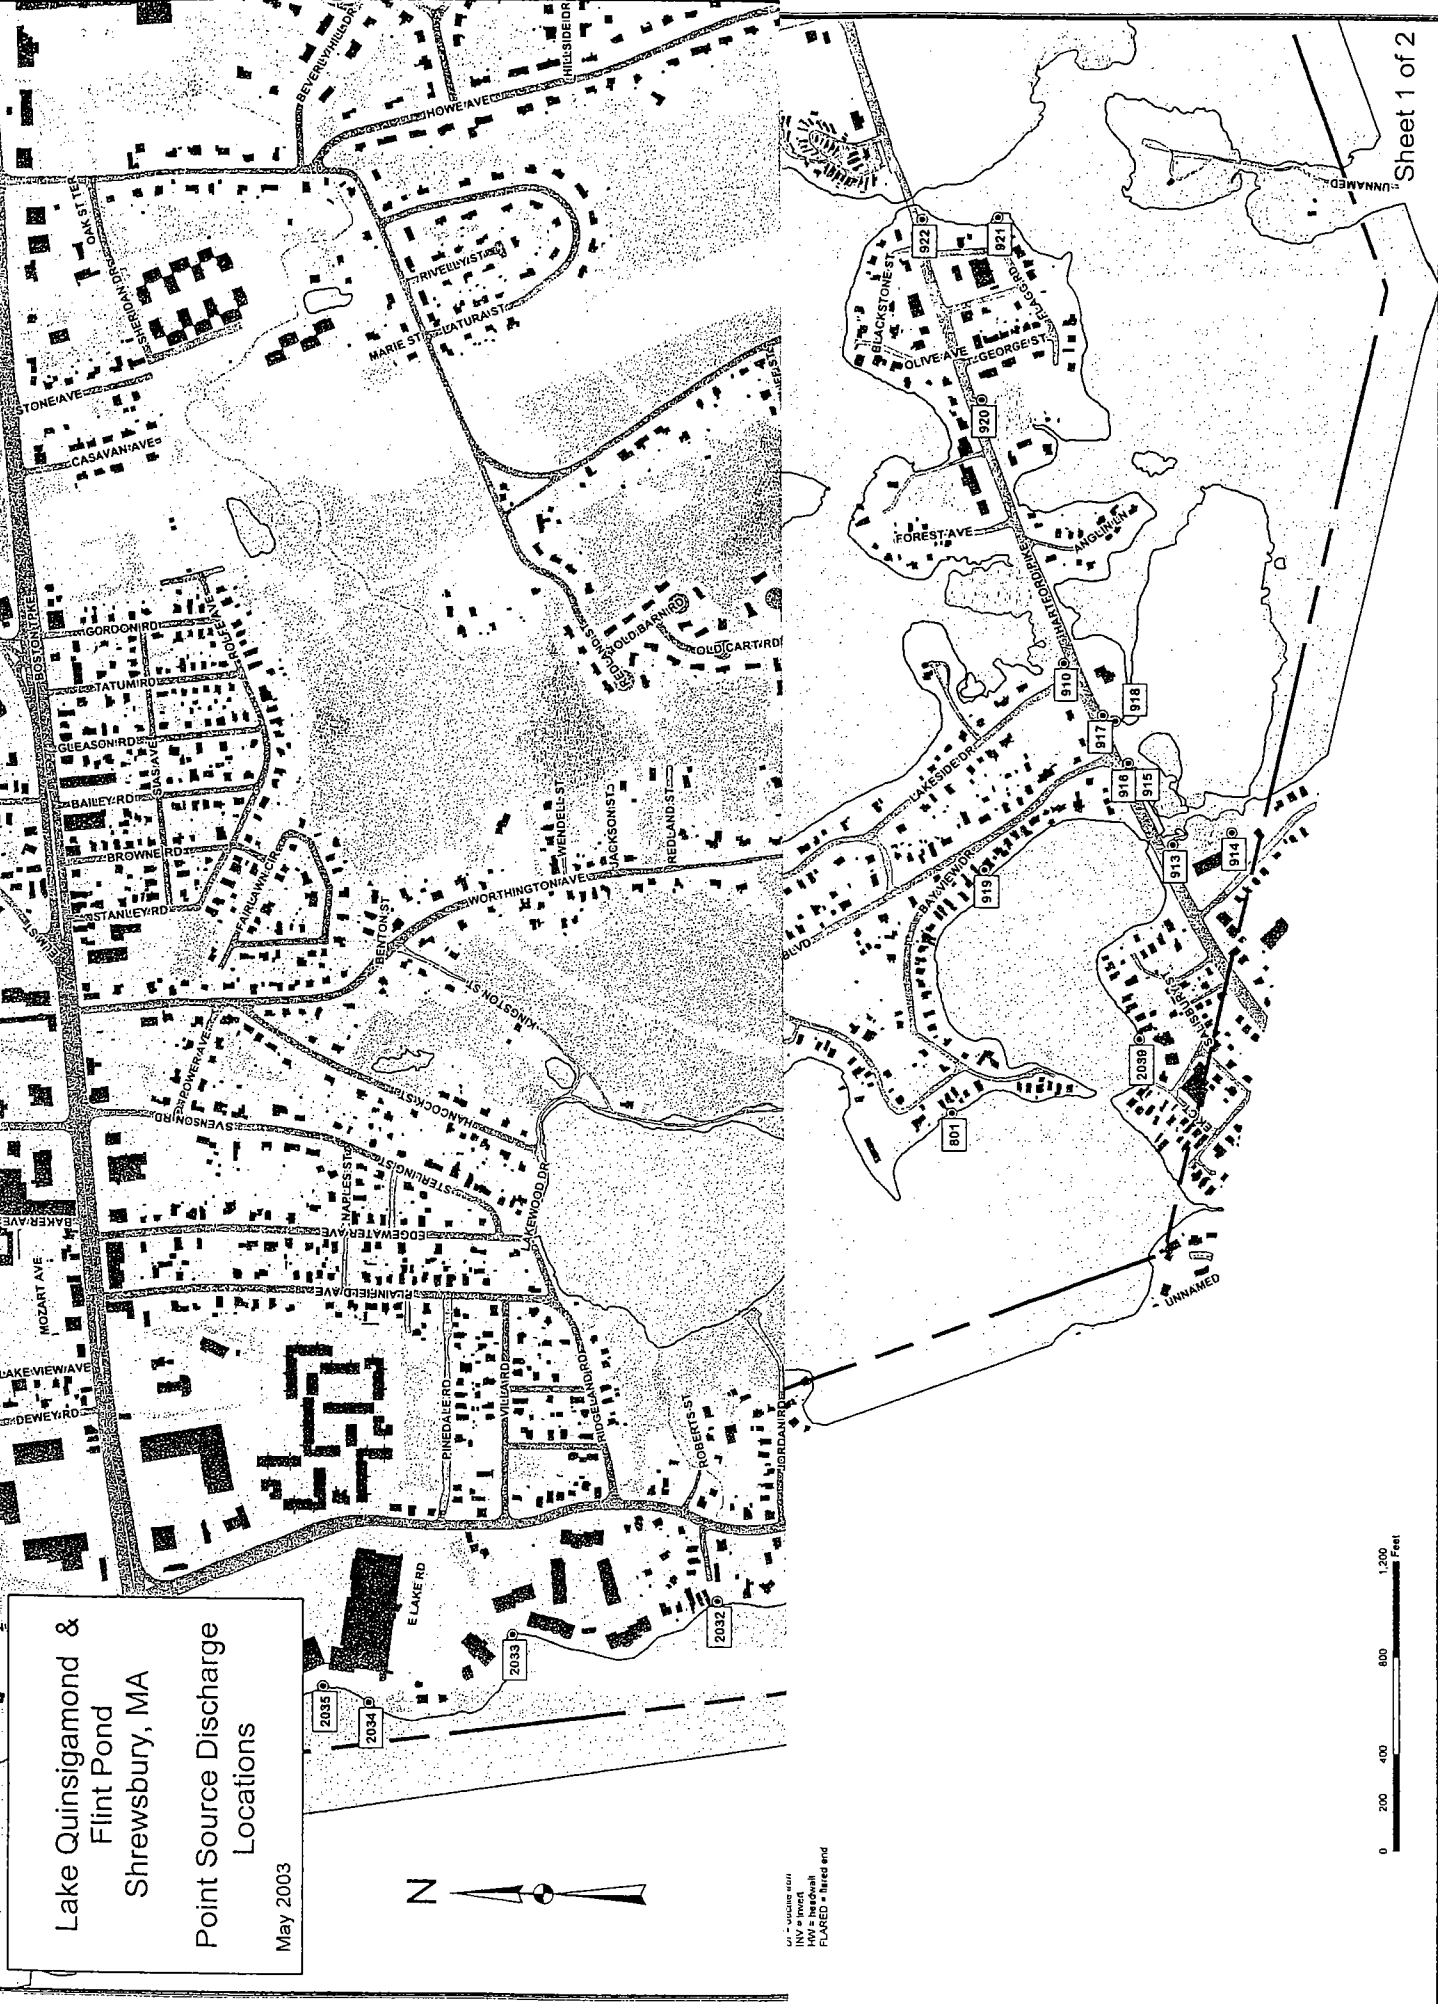
*The budget constraints are expected to have an impact on the Town's ability to complete the required GIS Storm Water Outfall Map. In the past the Town has rented GPS equipment for outfall mapping, and we have located approximately 57 outfalls at Lake Quinsigamond and Flint Pond. Not all of these outfalls may be part of Shrewsbury's MS4 but were located anyway, as they discharge into TMDL designated water bodies. As GPS equipment improves it is also becoming less expensive to own and operate. The Town hopes to purchase a GPS unit as soon as funding is available to assist in completing the required outfall map.*

Lake Quinsigamond & Flint Pond  
 Shrewsbury, MA  
 Point Source Discharge Locations  
 May 2003
