Municipality/Organization: Department of Conservation and Recreation

**Annual Report Number
& Reporting Period:** No. 6: May 08-April 09

Department of Conservation and Recreation NPDES PII Small MS4 General Permit Annual Report

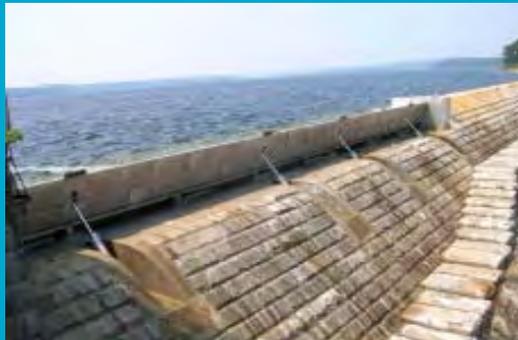
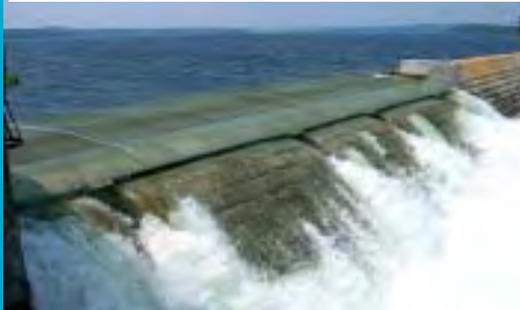
New hydraulically operated crest gates at the Wachusett Dam are shown above in the "up" position. Shown below in the "down" position the new crest gates can allow spillway flows of up to 600 million gallons of water per day.

The peak inflow of water to the reservoir from this storm is calculated at about 82,000 cubic feet per second (cfs). After routing through the reservoir, the peak outflow of water through the new spillway improvements is 62,000 cfs.

Combined, these improvements satisfy current state of design requirements for passing a Probable Maximum Flood (PMF) while protecting the main Wachusett Dam. The PMF is a theoretical situation resulting from a Probable Maximum Precipitation (or PMP) event of 28 inches of rainfall on the reservoir watershed over a 72 hour storm period. This is not a likely occurrence, but current regulations for dam and downstream safety require a design to this standard.

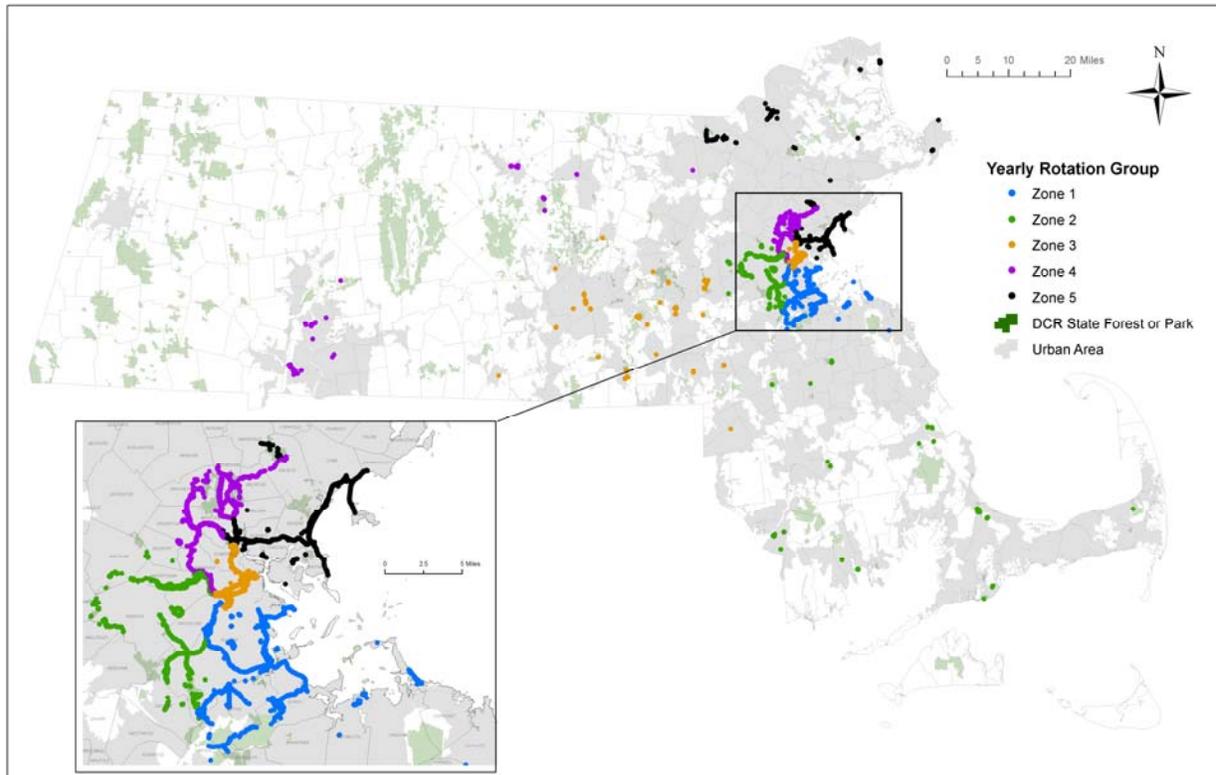
Figure 2-1 IDD Five-Year Inspection Rotation

Prior to developing an inspection rotation, AECOM examined priority areas listed in the Stormwater Management Plan including suspected illicit connections based on previous site visits and direct discharges to impaired waterbodies. With DCR, AECOM determined that these priority areas have a state-wide spatial distribution that would hinder IDD program implementation. Therefore, each rotation zone contains approximately 4,000 stormwater features and 55 road miles of DCR property (Figure 2-1) grouped by spatial location. Approximately 50 percent of the map data for features in each zone came from scanned plan data and therefore have not been field verified.

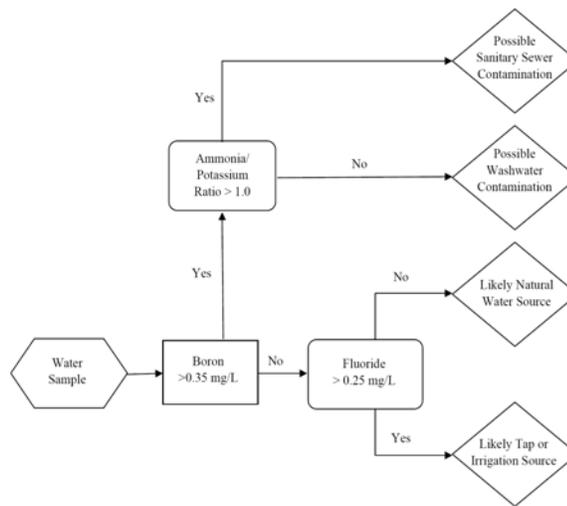
Figure 2-2 IDD Flow Diagram

Technicians then tested the collected sample for a series of analytes in a specific order. Figure 2-2 demonstrates the order of analyte testing and the process used to determine the likely origin of the sampled discharge. Although the IDD procedure precludes certain tests based on the presence of boron; technicians performed the entire suite of tests on each sample and recorded the values in a table related to the spatial location of the stormwater feature on the GPS unit and in the field book. If site conditions or further stormwater investigations delayed analysis of the samples the field crew repeated temperature and pH measurements prior to performing the subsequent tests.

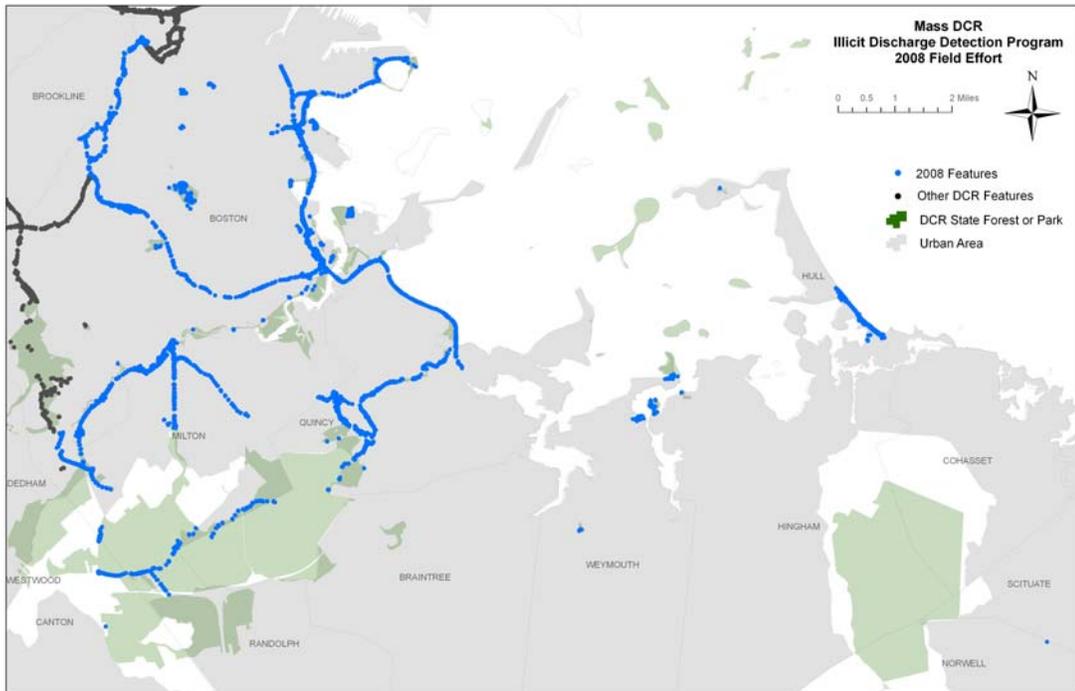
Figure 3-1 2008 IDD Inspection Area

AECOM implemented the IDD protocol outlined in Section 2.2 and began field investigations of DCR's drainage systems on July 29th 2008. The effort focused on the DCR parks and parkways of IDD Zone 1 located in the southern Boston metro area (Figure 3-1). This zone encompasses several large parks including the Blue Hills Reservation and Old Harbor Reservation along with major roads like the Furnace Brook Parkway, Morrissey Boulevard and the JamaicaWay. This section presents AECOM's inspection activities and results.

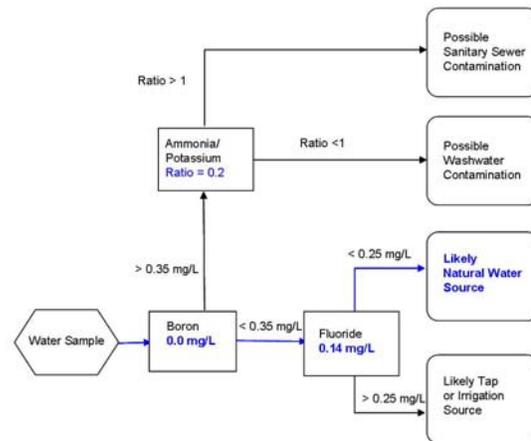
Figure 3-2 Results for Features 21786/21790

The results from the analyte tests suggest the source of this flow is natural water (Figure 3-2). Field observations support this conclusion as the field crew determined that the manhole contained a stream running through culverts under the road.

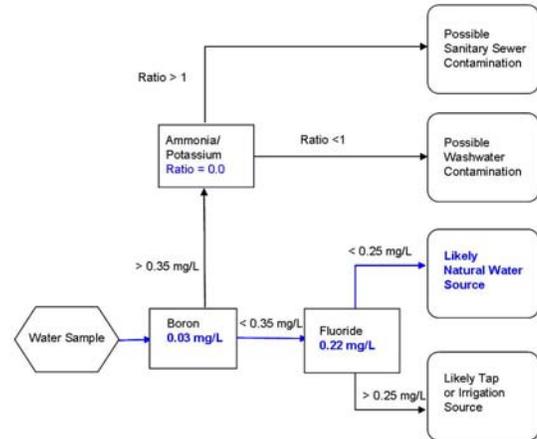
Figure 3-3 Results for Feature 2921

The results from the analyte tests suggest the source of this flow is natural water (Figure 3-3). Field observations support this conclusion as the field crew determined that the manhole contained a stream running through culverts under the road.

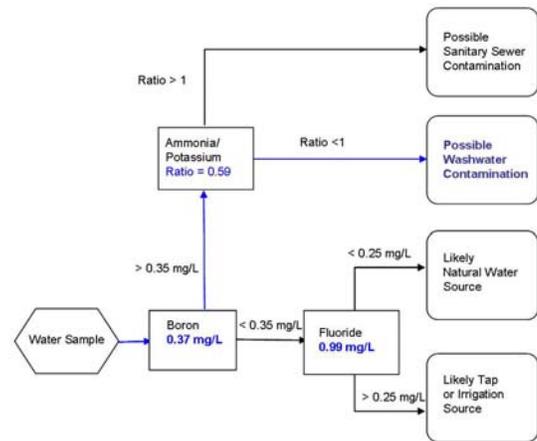
Figure 3-4 Results for Feature 18703

The results from the field analyte tests suggest the source of this flow is washwater (Figure 3-4). However, observations made after testing lead the field crew to determine that drainage plans of the area were inaccurate and that the feature was actually a sewer manhole and not part of the stormwater system.

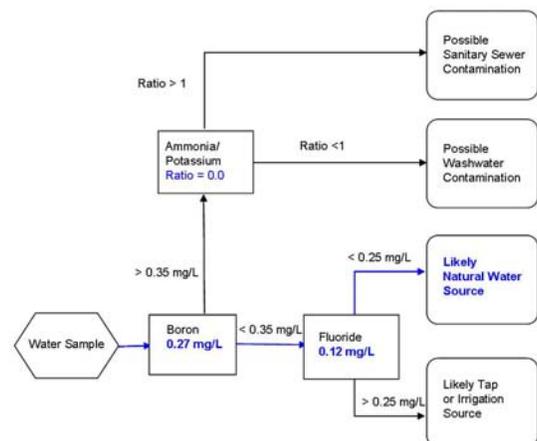
Figure 3-5 Results for Feature 27772

The results from the analyte tests suggest the source of this flow is natural water (Figure 3-5). Field observations support this conclusion as the field crew determined that the manhole contained a stream running through culverts under the road.

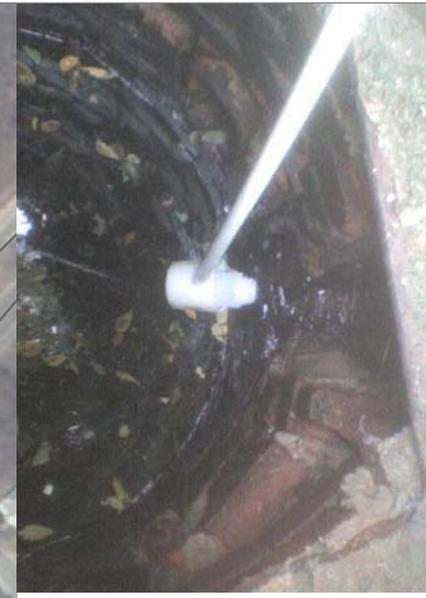
**Figure 3-7 Summary for Features 13218/18571
JamaicaWay, Boston
Inspection Date: 9/18/08**

Catchbasin #1848

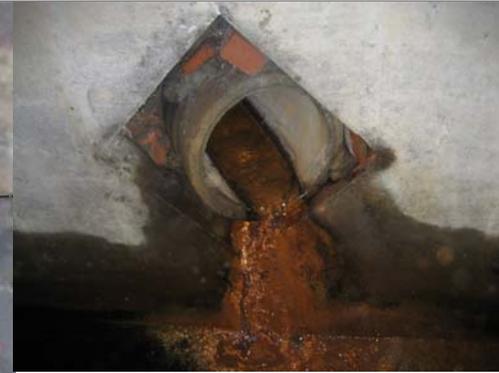
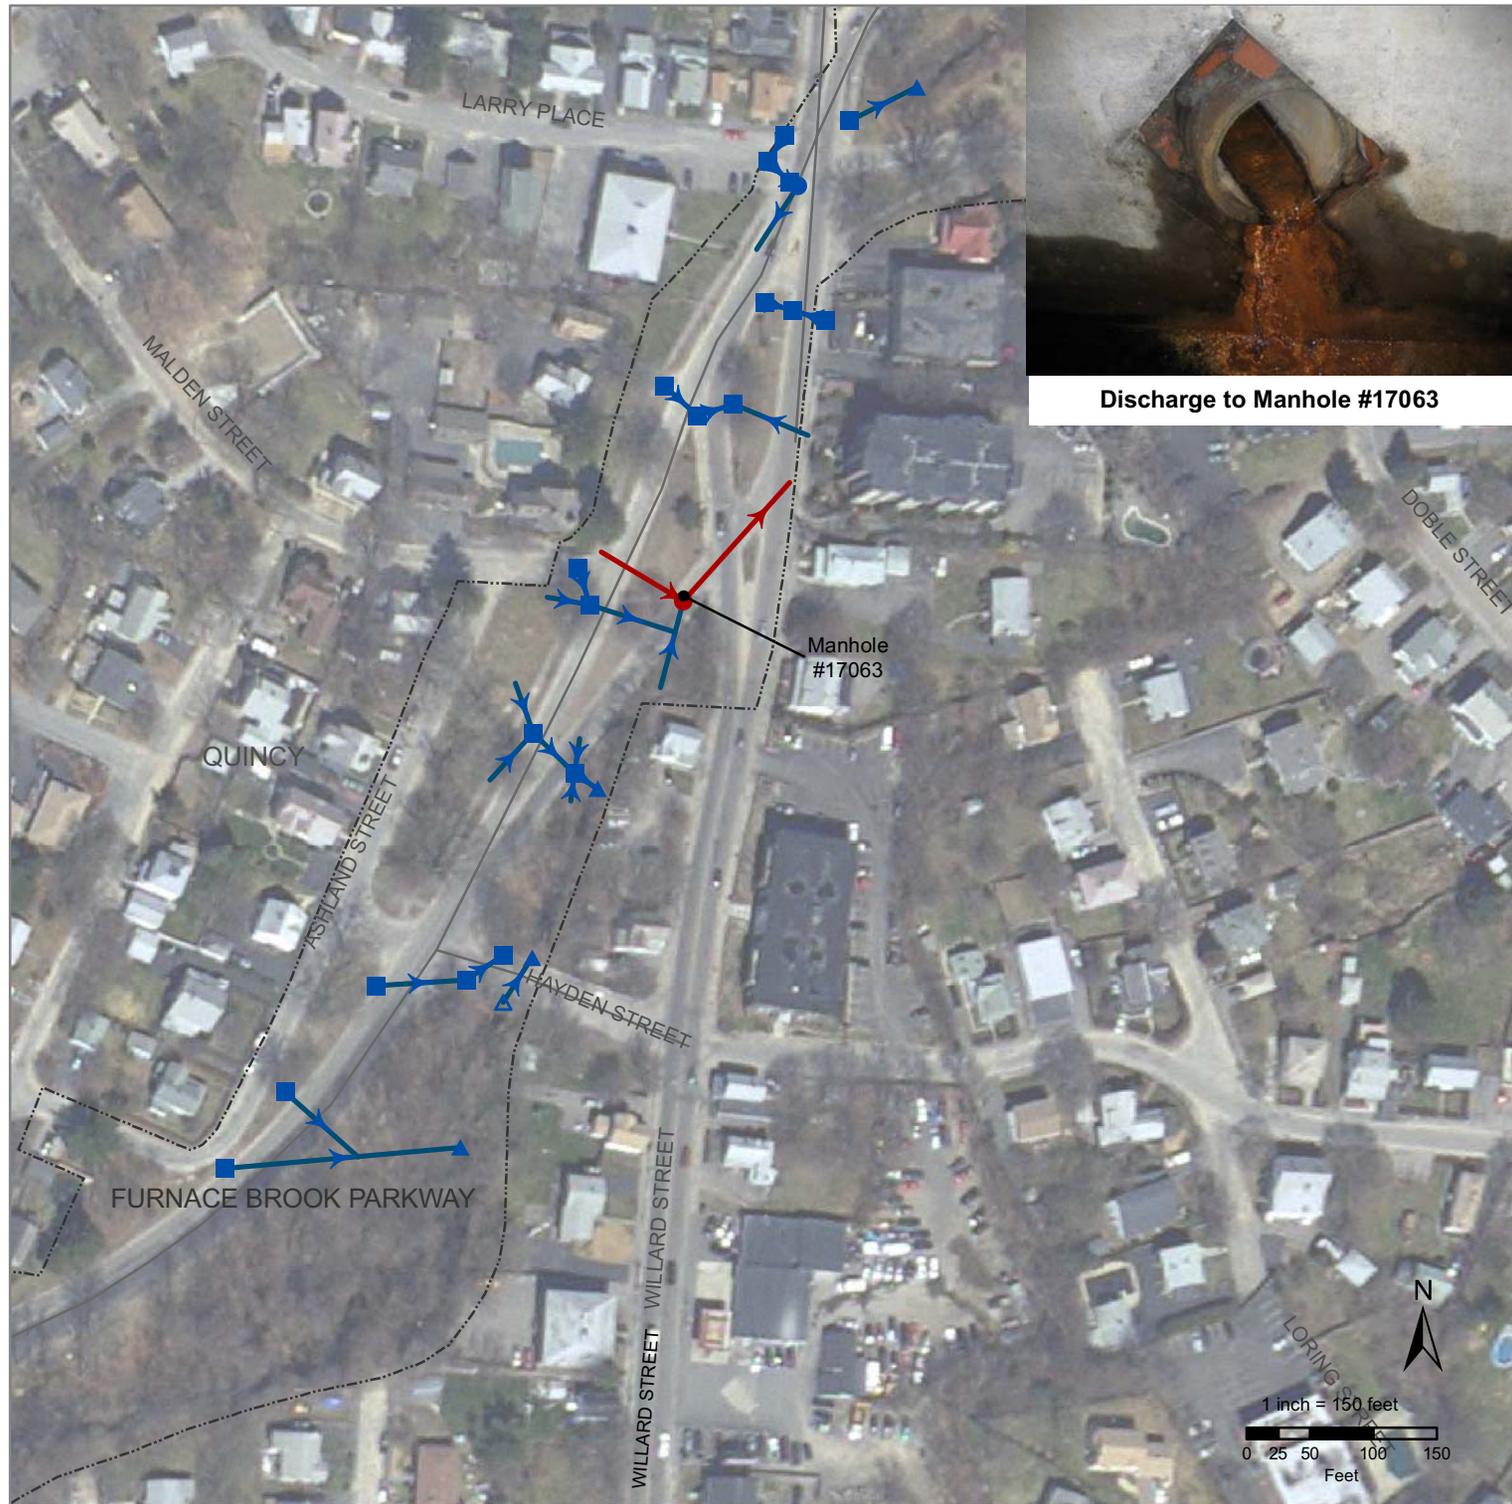
Figure 3-8 Summary for Feature 17063
Furnace Brook Parkway, Quincy
Inspection Date: 9/4/08

Days since last rain event: 16, (0.10")
 Temperature: 71 F
 pH: 7.13

Potential Source:

Discharge to Manhole #17063

Note: Red features represent observed dry weather flow path

-Source determination with City of Quincy

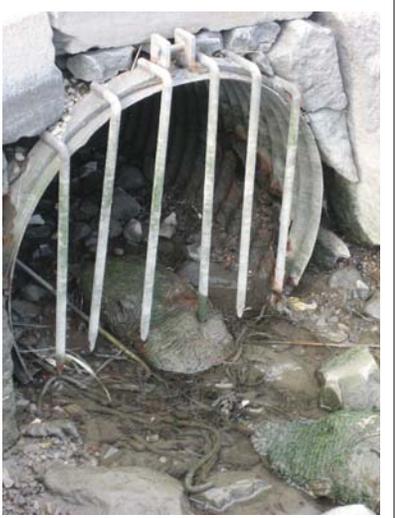
Outfall #18300

Part of the Dorchester Shores Reservation, Malibu Beach is a popular swimming and boating area for local residents. Point #18300 is an outfall at the edge of the parking lot that is subject to tidal exchange with Boston Harbor. The 36 inch corrugated metal pipe that discharges at the outfall originates at an unknown source beyond the DCR property. The flow observed on 10/14/08 was a clear trickle with no odor or floatables. The sample results most likely represent saltwater mixing with the discharge and do not indicate a possible source. This site may require further investigation including bacterial testing due to primary contact recreation activities in the receiving water.

Recommended Actions:
