Municipality/Organization: City of Malden

EPA NPDES Permit Number: MA041046

Annual Report Number & Reporting Period: No. 14: April 1, 2016-March 31, 2017

NPDES PII Small MS4 General Permit Annual Report

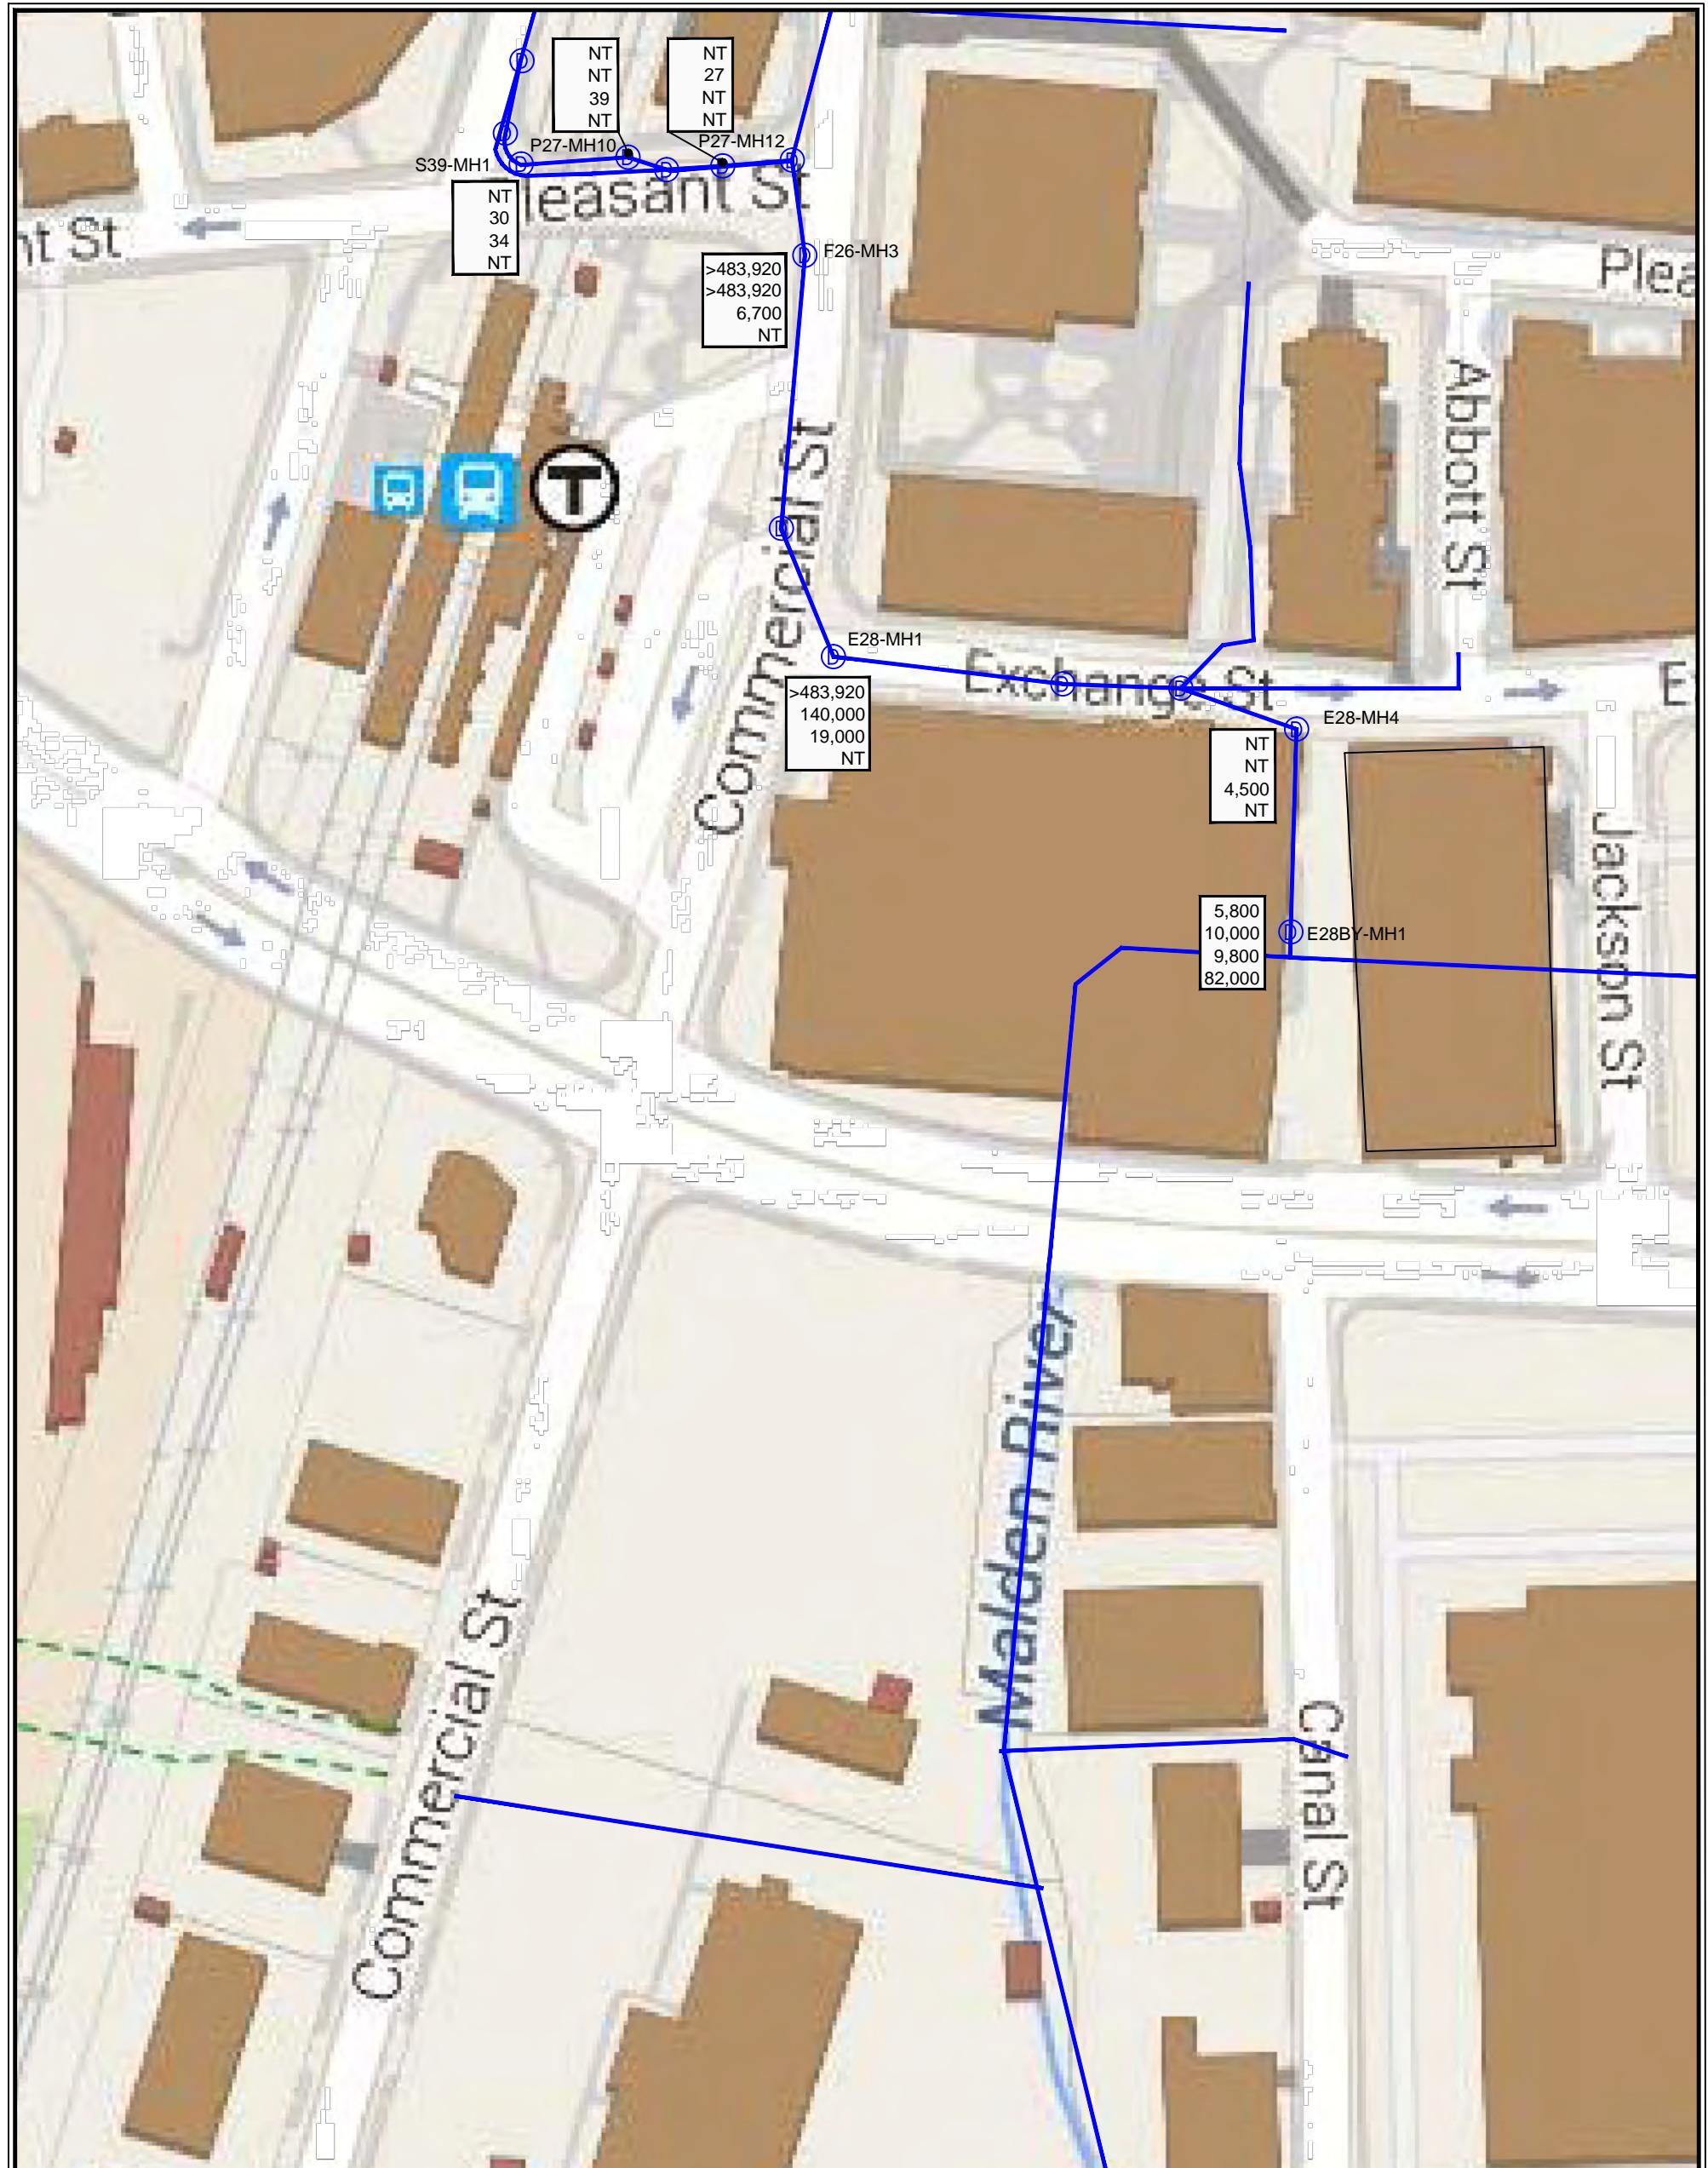
DETAIL PLAN
COMMERCIAL & EXCHANGE STREET AREA
MALDEN, MASSACHUSETTS

As a part of this inspection program, an evaluation of the drainage system in Pleasant/Commercial/Exchange Street portion of the Malden River watershed was conducted in response to the detection of high E. coli levels during a dry weather sampling event at manhole E28BY-MH1, which is located between Route 60 and Exchange Street. An inspection of the drainage manhole revealed an approximate 48-inch RCP line with flow containing a strong sewage odor that was observed to be approximately 10 – 12 gallons per minute. Based upon a review of historic plan information, as well as field observations, this flow moves in a southerly direction into the Spot Pond Brook culvert, which ultimately discharges into the Malden River. Due to the high levels of E. coli encountered, a mass balance flow isolation of the drainage network within to the Exchange and Commercial Street area was conducted.

During the inspection of Exchange Street drainage manhole E28BY-MH1, a strong sewage odor was identified and the evaluation of both the sewage and drainage infrastructure indicated that the invert elevations for the piping systems were very close, suggesting that possible exfiltration from the municipal sewage system was impacting the nearby drainage network. In response to the observations recorded within the Exchange Street area, representatives of CDM Smith Inc. (CDM) were requested to review the results of their inflow/ infiltration investigation in the area and according to CDM, no significant or obvious signs of infiltration or exfiltration were noted. To further investigate the drainage system in the area, the City contracted National Water Main Cleaning Company (National) to camera the area of concern. On 2 June 2016, National, under the direction of the City, CDM and NCA initiated the CCTV inspection.

An evaluation of the drainage system in Pleasant/Commercial/Exchange Street portion of the Malden River watershed was conducted in response to the detection of high E. coli levels during a dry weather sampling event at manhole E28BY-MH1, which is located between Route 60 and Exchange Street, as shown on Figure 5. An inspection of the drainage manhole revealed an approximate 48-inch RCP line with flow containing a strong sewage odor that was observed to be approximately 10 – 12 gallons per minute. Based upon a review of historic plan information, as well as field observations, this flow moves in a southerly direction into the Spot Pond Brook culvert, which ultimately discharges into the Malden River. Due to the high levels of E. coli encountered, a mass balance flow isolation of the drainage network within to the Exchange and Commercial Street area was conducted.

As summarized previously, during the inspection of Exchange Street drainage manhole E28BY-MH1, a strong sewage odor was identified and the evaluation of both the sewage and drainage infrastructure indicated that the invert elevations for the piping systems were very close, suggesting that possible exfiltration from the municipal sewage system was impacting the nearby drainage network. In response to the observations recorded within the Exchange Street area, representatives of CDM Smith Inc. (CDM) were requested to review the results of their inflow/infiltration investigation in the area and according to CDM, no significant or obvious signs of infiltration or exfiltration were noted. To further investigate the drainage system in the area, the City contracted National Water Main Cleaning Company (National) to camera the area of concern. On 2 June 2016, National, under the direction of the City, CDM and NCA initiated the CCTV inspection. To assist in the review of the following information, (referenced as Figure 6), which depicts the approximate location of drain manhole locations associated within this scope of work.

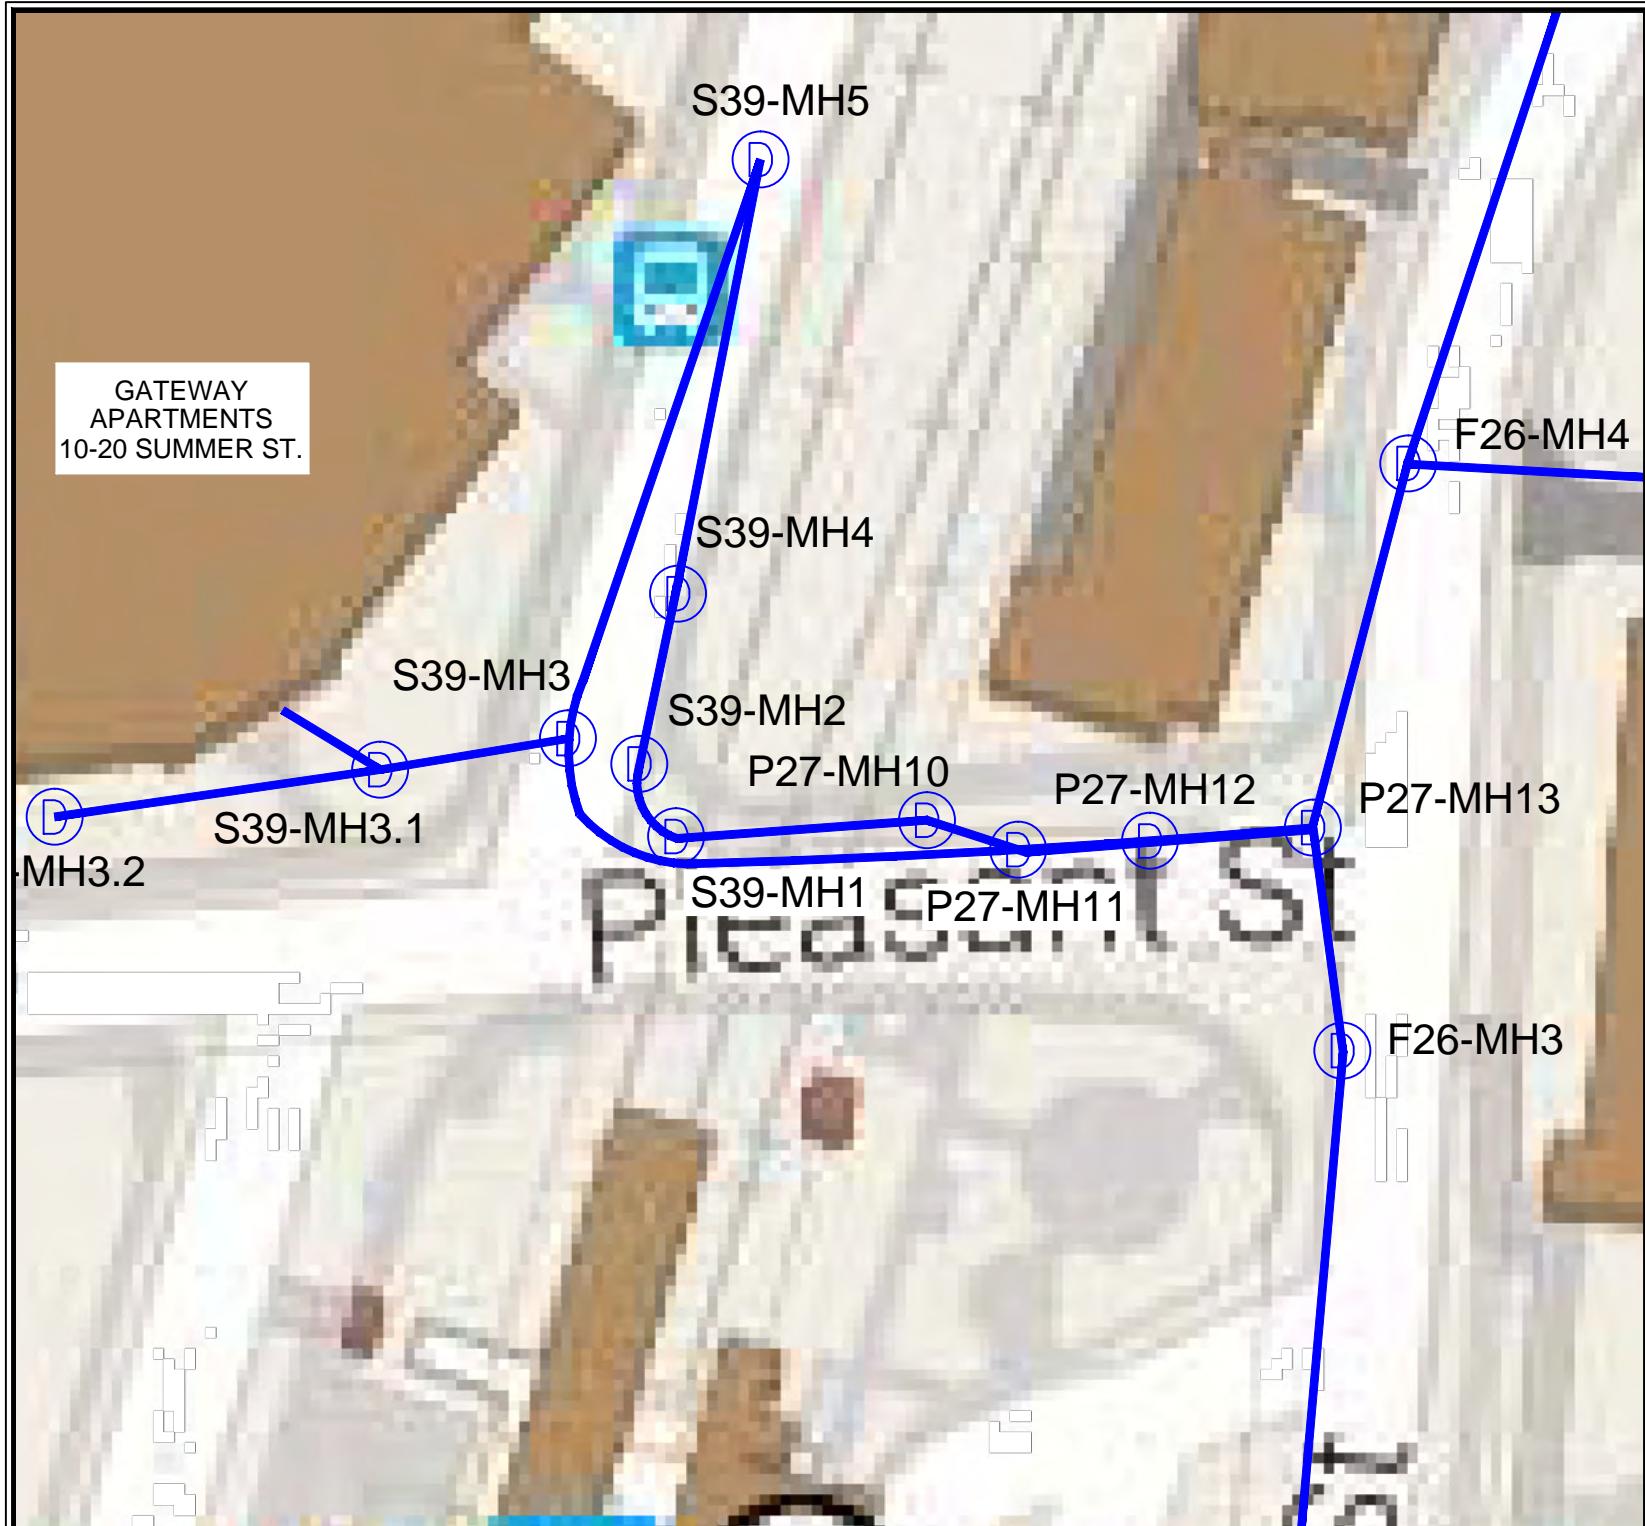
Figure
2

Video inspection of the infrastructure was initiated at the intersection of Pleasant and Florence Streets, at drain manhole P27-MH13. A detail sketch plan of the area may be referenced from Figure 2. A visual inspection of this manhole revealed flow from the west (Pleasant Street) which then flowed in a southern direction down Commercial Street. While placing the video inspection equipment into the manhole, an intermittent flow was observed emanating from an 18-inch reinforced concrete pipe (RCP) drain line located in Florence Street (north). The video inspection of the drain line in Florence Street revealed no illicit connections, or indications of compromise to the pipe, which terminated approximately 115 feet to the north, at manhole F26-MH4. In addition, a colorimetric field test for ammonia was performed by CDM, with only low levels encountered, indicating this flow was most likely not the source of the elevated E. coli levels in the area. The camera was then sent approximately 100 feet west, along a 36-inch RCP to manhole P27-MH10, with no illicit connections or indications of compromise to the pipe noted.

A visual inspection of manhole P27-MH11 revealed that in addition to the 36-inch RCP line that flows from P27-MH10 there was a second 36-inch RCP line that was not identified on plans reviewed during this study. Field observations noted at manhole P27-MH11 included a strong sewage odor and visual indications of sewage contributions from the second 36-inch RCP line. A video inspection of this line revealed that it runs west along the center of Pleasant Street and then turns north to Summer Street, to manhole S39-MH3. It is to be noted that indications of sewage were observed along the entire length of pipe. The video inspection equipment was then moved to manhole S39-MH3 and visual observations of the manhole showed water entering the structure from a 12-inch RCP located of the western side of the manhole. Of particular importance to this mass balance flow isolation program was the absence of flow within the pipe from Summer Street (north). Video inspection of the 12-inch RCP revealed addition indications of sewage discharge and that the drainage line connected to manhole S39-MH3.1, approximately 50 feet to the west. A visual inspection of manhole S39-MH3.1 revealed two (2) 8-inch ductile iron pipe inverts within the structure. The video inspection of the ductile iron pipe that connects to manhole S39-MH3.2, located approximately 100 feet south-southwest of manhole S39-MH3.1, revealed no illicit connections or indications of compromise. However, indications of sewage discharge were identified during the video inspection of the 8-inch ductile iron pipe that connects to the Gateway at Malden Center Apartments (10 – 20 Summer Street), approximately 35 feet to the northwest of manhole S39-MH3.1. Video observations noted included the presence of a stub and two (2) 8-inch ductile iron pipes which connect to 10 – 20 Summer Street building. Indications of sewage were noted within each of the pipes and flow from building was emanating from the northern pipe, which appears to run parallel with Summer Street.

SKETCH PLAN OF SITE
DETAIL PLAN
SUMMER &
PLEASANT STREET AREA
MALDEN
MASSACHUSETTS

The video inspection was initiated at the intersection of Pleasant and Florence Streets, at drain manhole P27-MH13. A visual inspection of this manhole revealed flow from the west (Pleasant Street) which then flowed in a southern direction down Commercial Street. While placing the video inspection equipment into the manhole, an intermittent flow was observed emanating from an 18-inch reinforced concrete pipe (RCP) drain line located in Florence Street (north). The video inspection of the drain line in Florence Street revealed no illicit connections, or indications of compromise to the pipe, which terminated approximately 115 feet to the north, at manhole F26-MH4. In addition, a colorimetric field test for ammonia was performed by CDM Smith, with only low levels encountered, indicating this flow was most likely not the source of the elevated E. coli levels in the area. The camera was then sent approximately 100 feet west, along a 36-inch RCP to manhole P27-MH10, with no illicit connections or indications of compromise to the pipe noted.

A visual inspection of manhole P27-MH11 revealed that in addition to the 36-inch RCP line that flows from P27-MH10 there was a second 36-inch RCP line that was not identified on plans reviewed during this study. Field observations noted at manhole P27-MH11 included a strong sewage odor and visual indications of sewage contributions from the second 36-inch RCP line. A video inspection of this line revealed that it runs west along the center of Pleasant Street and then turns north to Summer Street (Figure 6), to manhole S39-MH3. It is to be noted that indications of sewage were observed along the entire length of pipe. The video inspection equipment was then moved to manhole S39-MH3 and visual observations of the manhole showed water entering the structure from a 12-inch RCP located of the western side of the manhole. Of particular importance to this mass balance flow isolation program was the absence of flow within the pipe from Summer Street (north). Video inspection of the 12-inch RCP revealed addition indications of sewage discharge and that the drainage line connected to manhole S39-MH3.1, approximately 50 feet to the west (Figure 6). A visual inspection of manhole S39-MH3.1 revealed two (2) 8-inch ductile iron pipe inverts within the structure. The video inspection of the ductile iron pipe that connects to manhole S39-MH3.2, located approximately 100 feet south-southwest of manhole S39-MH3.1, revealed no illicit connections or indications of compromise. However, indications of sewage discharge were identified during the video inspection of the 8-inch ductile iron pipe that connects to the Gateway at Malden Center Apartments

(10 – 20 Summer Street), approximately 35 feet to the northwest of manhole S39-MH3.1. Video observations noted included the presence of a stub and two (2) 8-inch ductile iron pipes which connect to 10 – 20 Summer Street building. Indications of sewage were noted within each of the pipes and flow from building was emanating from the northern pipe, which appears to run parallel with Summer Street.

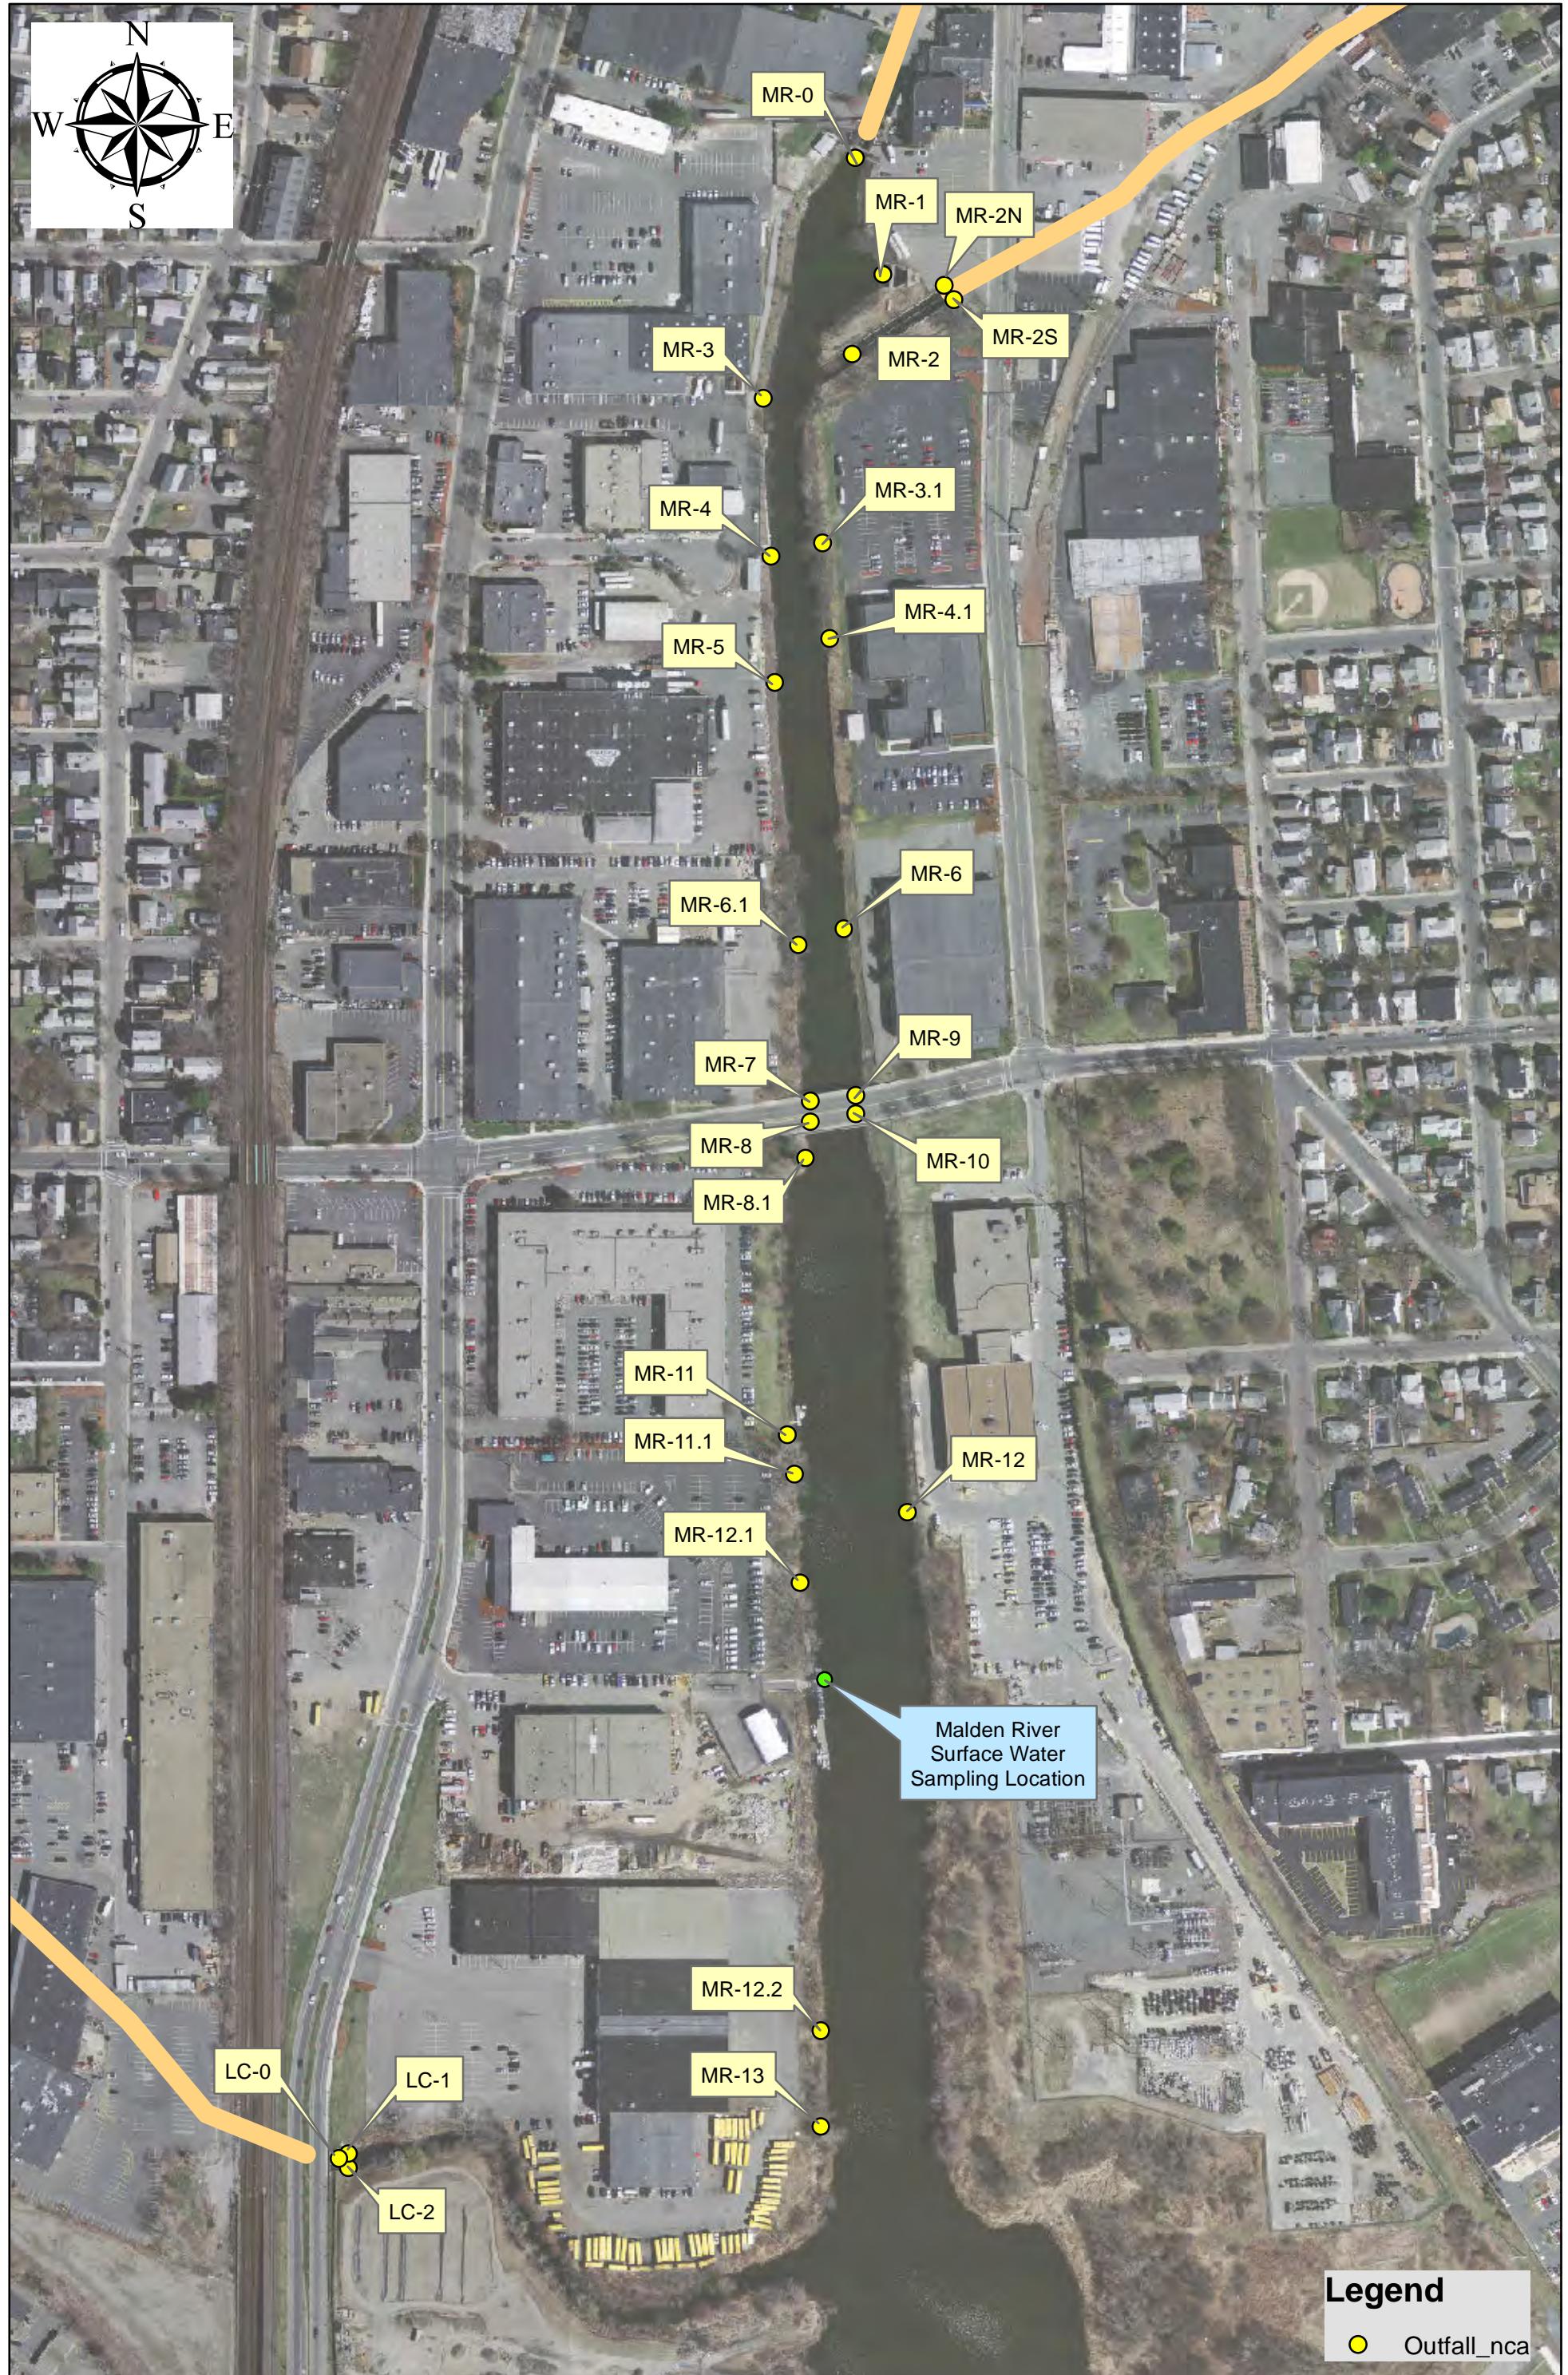
Figure 3 - Malden River Outfalls

As shown in Table 2.0, six (6) Malden River outfalls were found to be flowing, with high E. coli concentrations encountered at MR-4.1 (870 MPN/100ml) and MR-8 (7,000 MPN/100ml). A comparison of the wet weather concentrations with dry weather levels (Appendix B) at these two locations reveals that no flow has been observed at MR-4.1 during dry weather conditions, while flow was observed at MR-8 during the latest dry weather event, the bacteria level was only 5.2 MPN/100ml. In addition to the outfalls, base flow wet weather samples were collected from Little Creek and the Saugus Branch Culvert headwall. Elevated E. coli levels were detected at all three (3) locations, with the highest concentration (4,900 MPN/100ml) detected at the southern Saugus Branch Culvert headwall (MR-2S). It should be noted that little to no flow was observed at these locations during the sampling event.

As shown on Table 4.0, six (6) Malden River outfalls were found to be flowing, with high E. coli concentrations encountered at MR-4.1 (870 MPN/100ml) and MR-8 (7,000 MPN/100ml). A comparison of the wet weather concentrations with dry weather levels (Table 3.0) at these two locations reveals that no flow has been observed at MR-4.1 during dry weather conditions, while flow was observed at MR-8 during the latest dry weather event, the bacteria level was only 5.2 MPN/100ml. In addition to the outfalls, base flow wet weather samples were collected from Little Creek and the Saugus Branch Culvert headwall. Elevated E. coli levels were detected at all three (3) locations, with the highest concentration (4,900 MPN/100ml) detected at the southern Saugus Branch Culvert headwall (MR-2S). It should be noted that little to no flow was observed at these locations during the sampling event.
