**Figure 3.1-3: Photo of Site and
Stink Cove
Callahan Mining Superfund Site,
Brooksville, Maine**

**Figure 3.1-4: Photo of Waste
Rock Pile 2 showing Acid Rock
Drainage Seeps
Callahan Mining Superfund Site,
Brooksville, Maine**

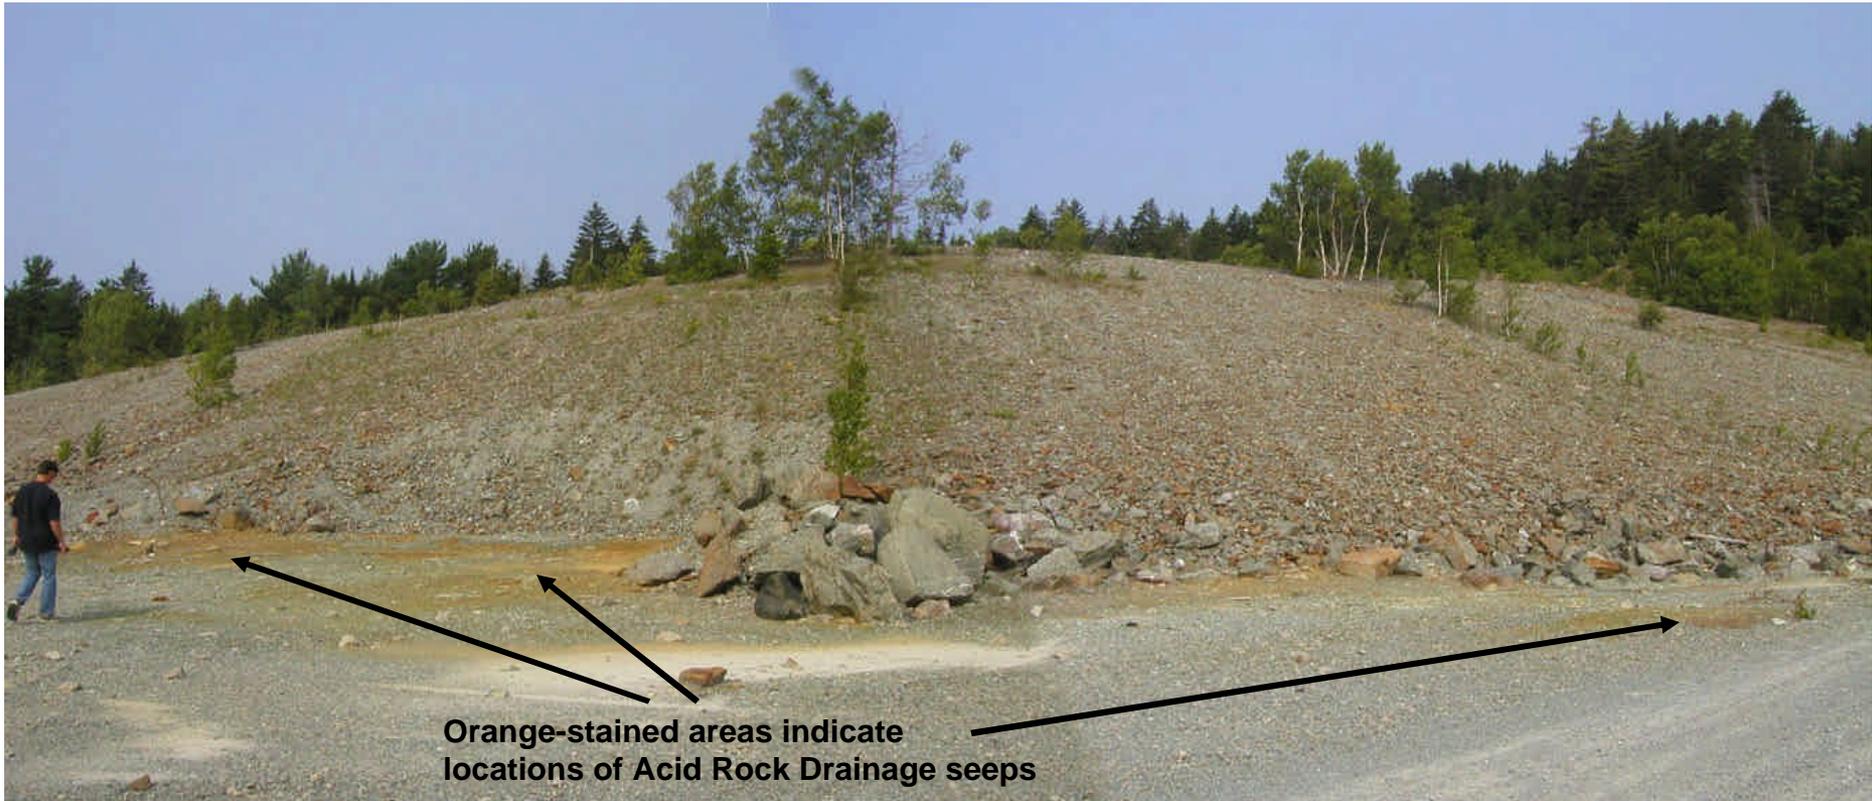
Orange-stained areas indicate
locations of Acid Rock Drainage seeps

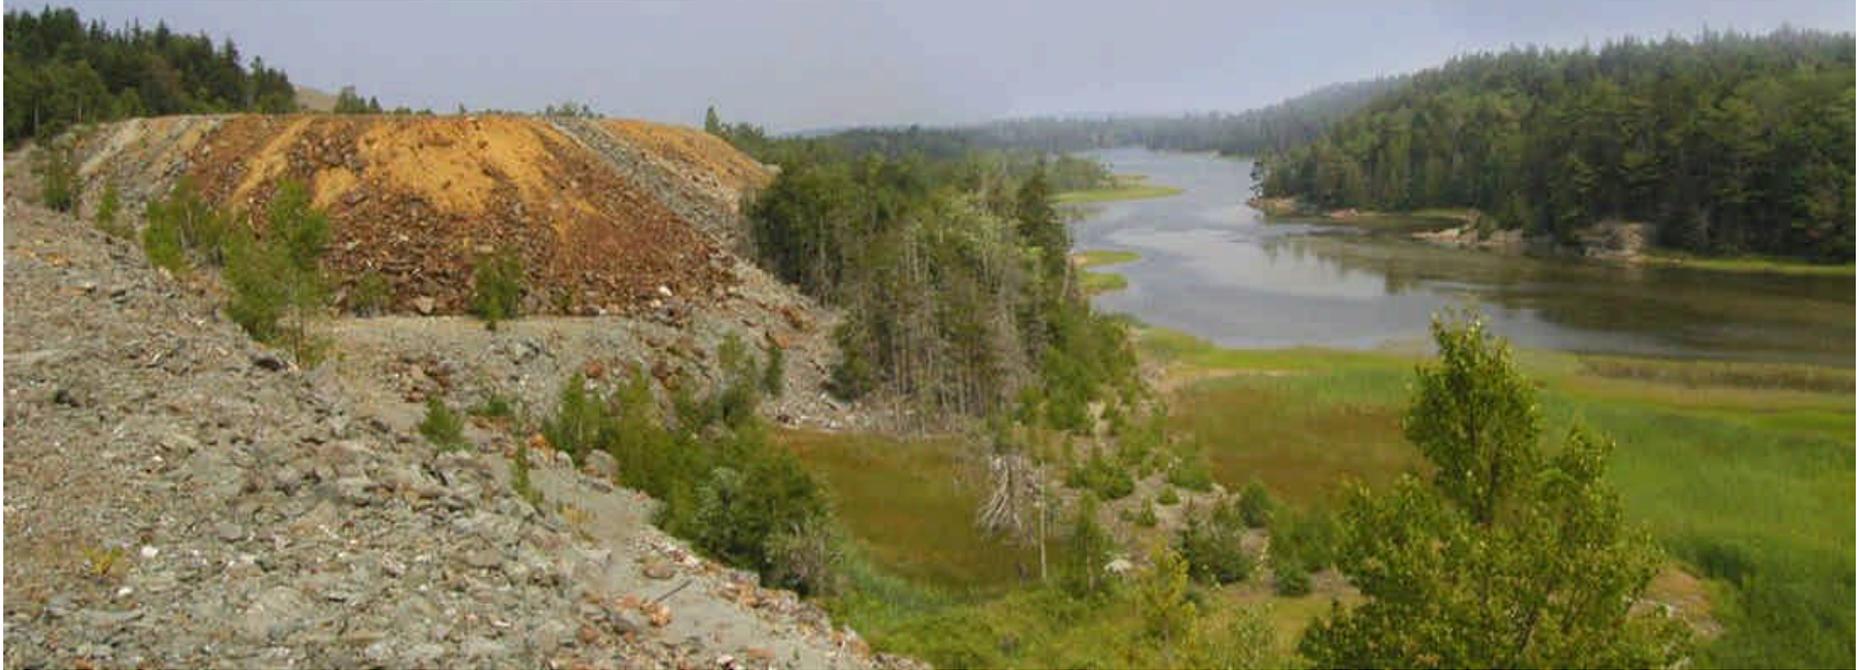
**Figure 3.1-5: Photo of Waste Rock Pile 3 and Goose Pond
Callahan Mining Superfund Site,
Brooksville, Maine**
