REMEDIAL ACTION COMPLETION REPORT

**OPERABLE UNIT 1
CALLAHAN MINE
SUPERFUND SITE
BROOKSVILLE, MAINE**

SEPTEMBER 2013

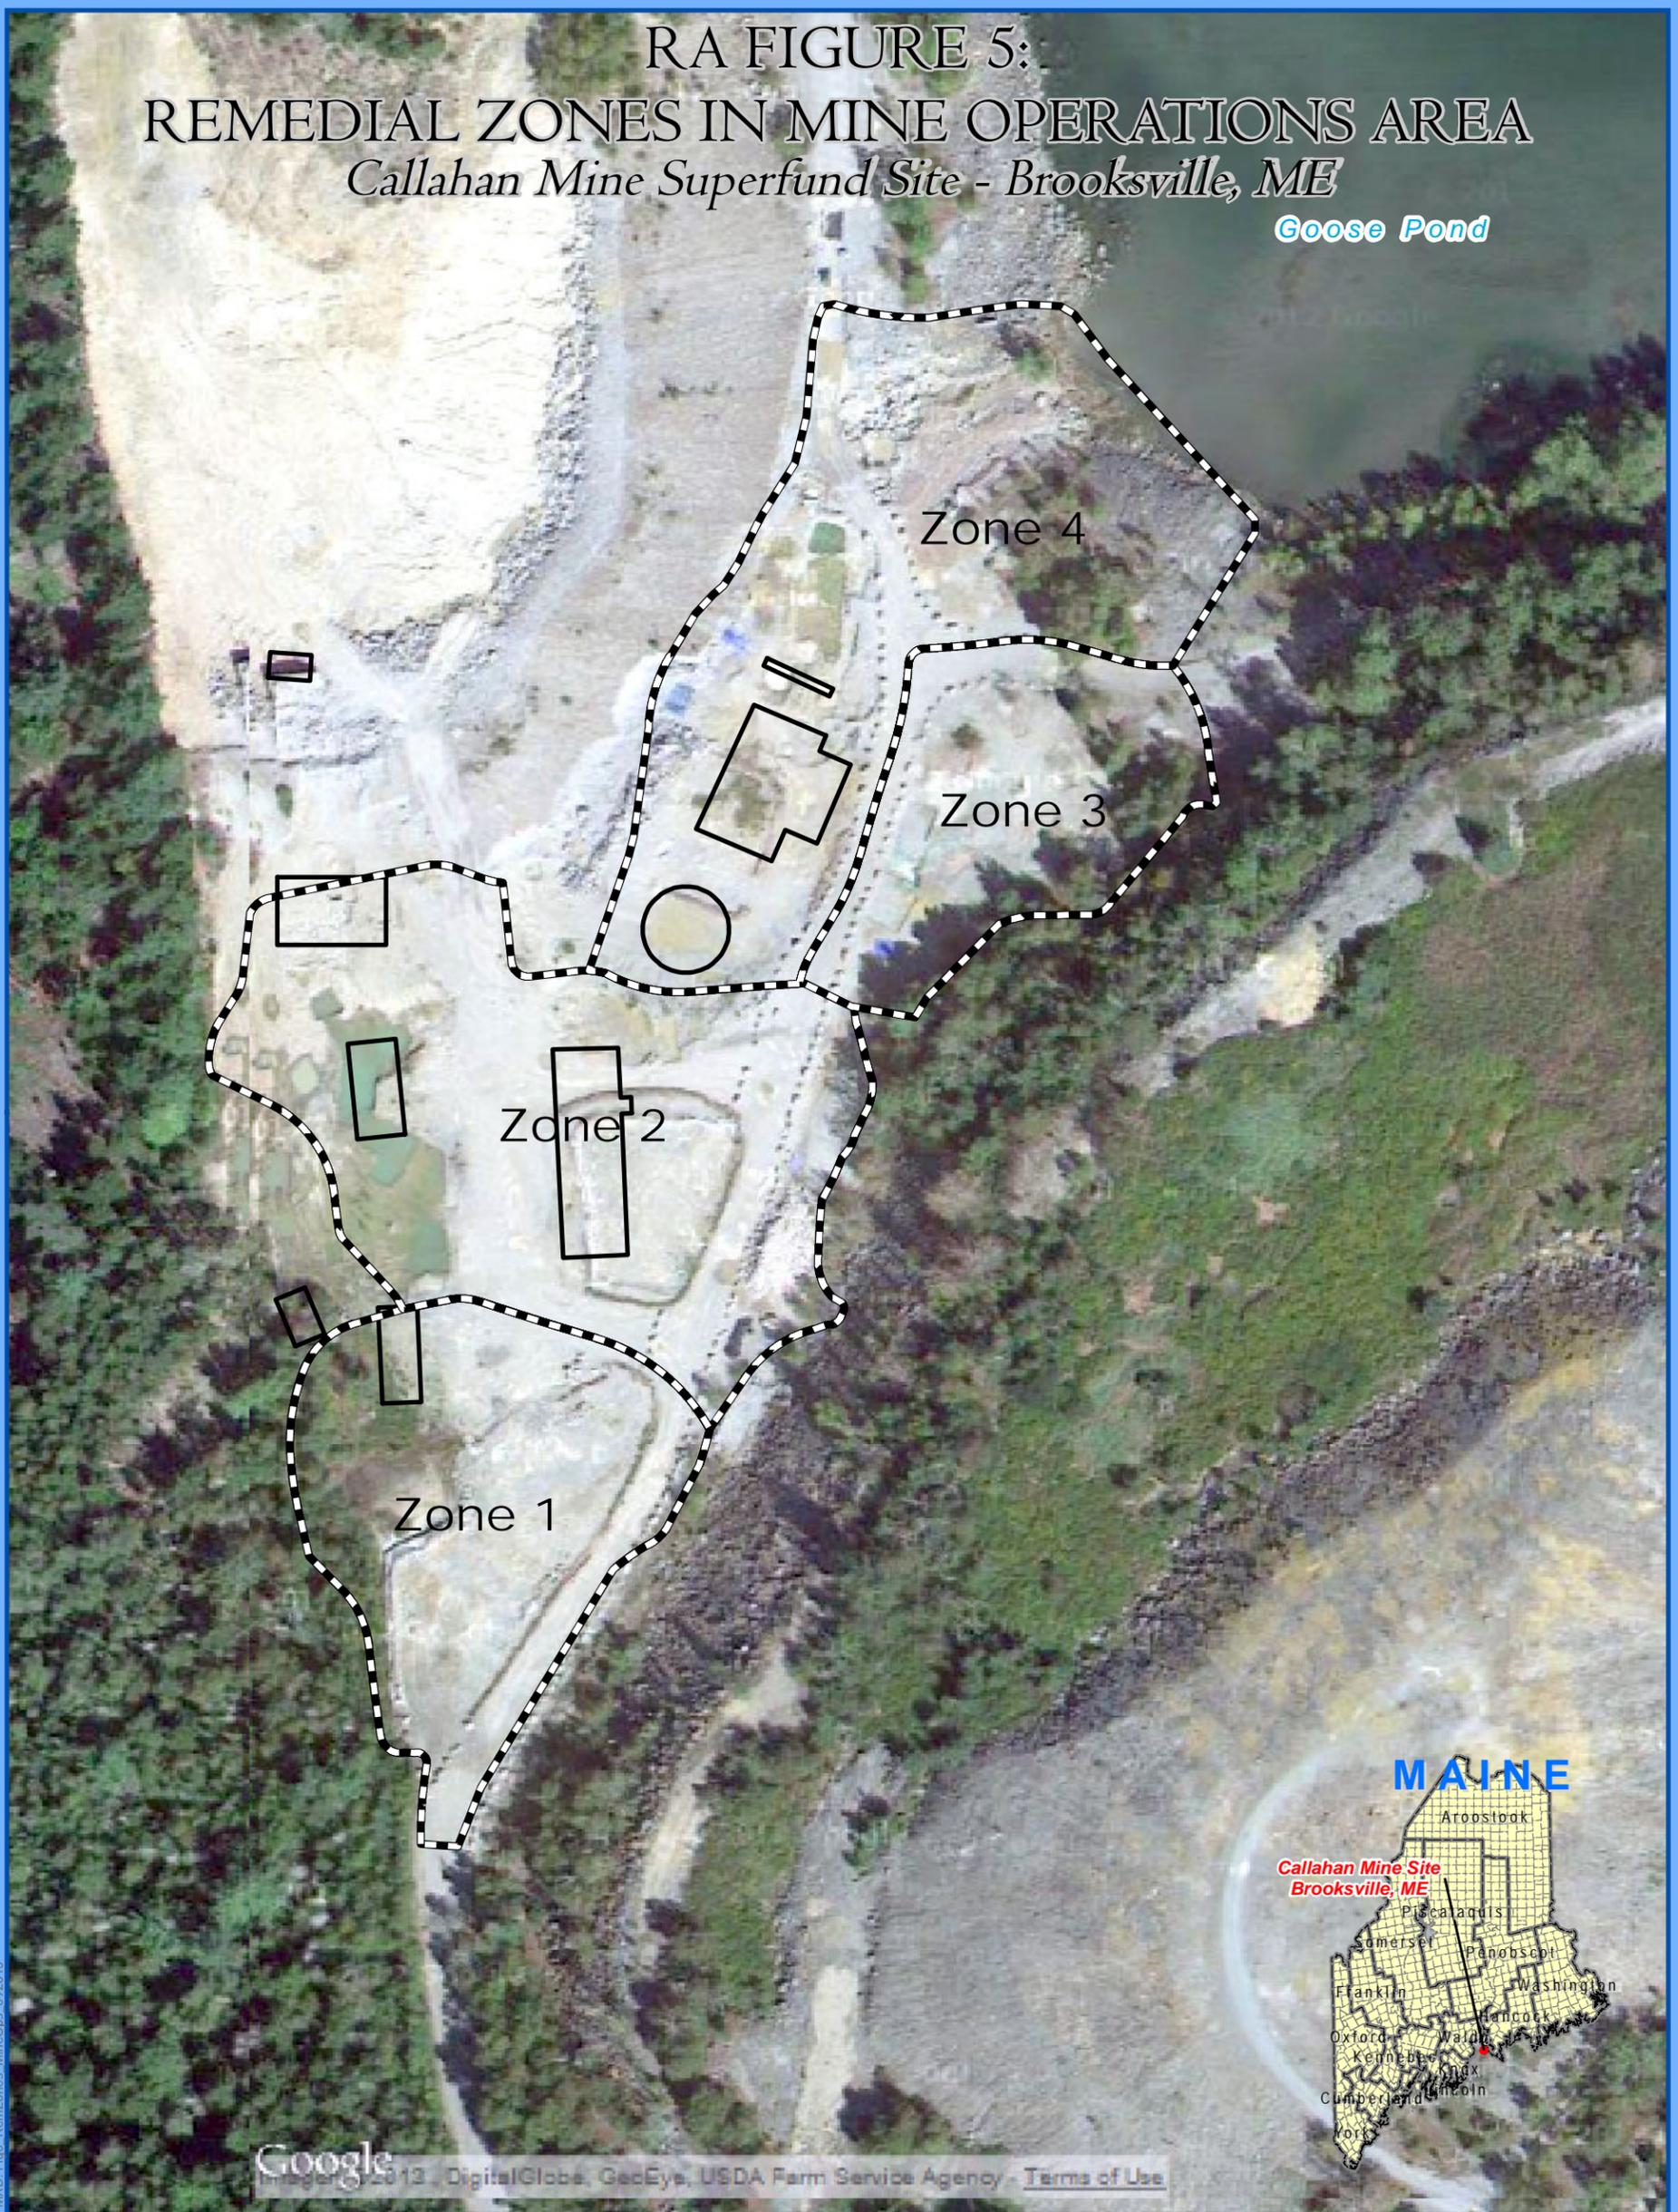
RA FIGURE 5: REMEDIAL ZONES IN MINE OPERATIONS AREA *Callahan Mine Superfund Site - Brooksville, ME*

In April 2012, additional in-situ delineation sampling was completed by MDEP and CES to fully characterize the extent of the PCB contaminated soils along the eastern edge of the former Mine Operations Area and in other areas of the former Mine Operations Area not fully sampled during previous sampling programs. The sampling program included the sampling of surface and subsurface soils and the on-site analysis of these samples for PCBs by the USEPA Mobile Laboratory. Based on the results of this sampling program, PCB contaminated soils were found throughout the former Mine Operations Area. New delineation figures were created and a new approach to excavation and off-site disposal was created prior to the 2012 remedial work. The new approach divided the former Mine Operations Area up into four zones based on topography and stormwater flow. Zone 1 was located in the southern most portion of the former Mine Operations Area proceeding north to Zone 4 which was located in the northern end of the former Mine Operations Area. A new work approach was implemented that required the PCB contaminated soils from Zone 1 to be removed prior to completing work down gradient in Zone 2. Refer to **Appendix E**, Figure 5 for a figure of Zones 1-4 in the Mine Operations Area.
