**PHASE I ENVIRONMENTAL SITE ASSESSMENT**

**LIBUTTI SITE**

Plat 36, Lot 38  
Johnston, Rhode Island

January 2004

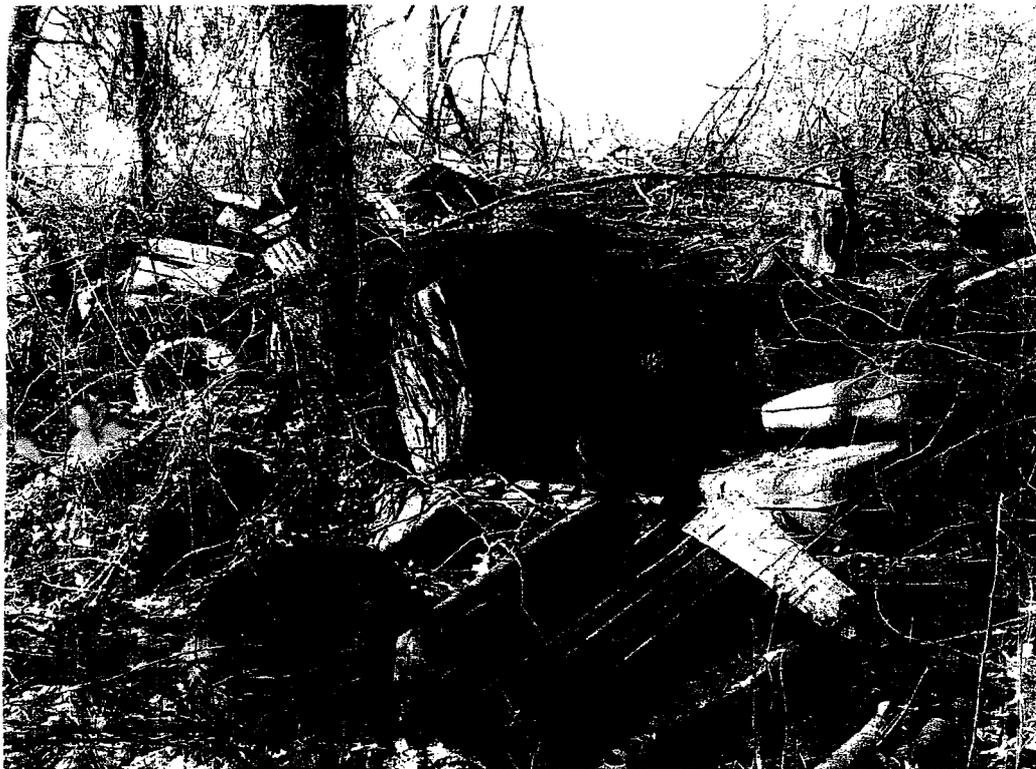
View of dumping east of railroad right-of-way

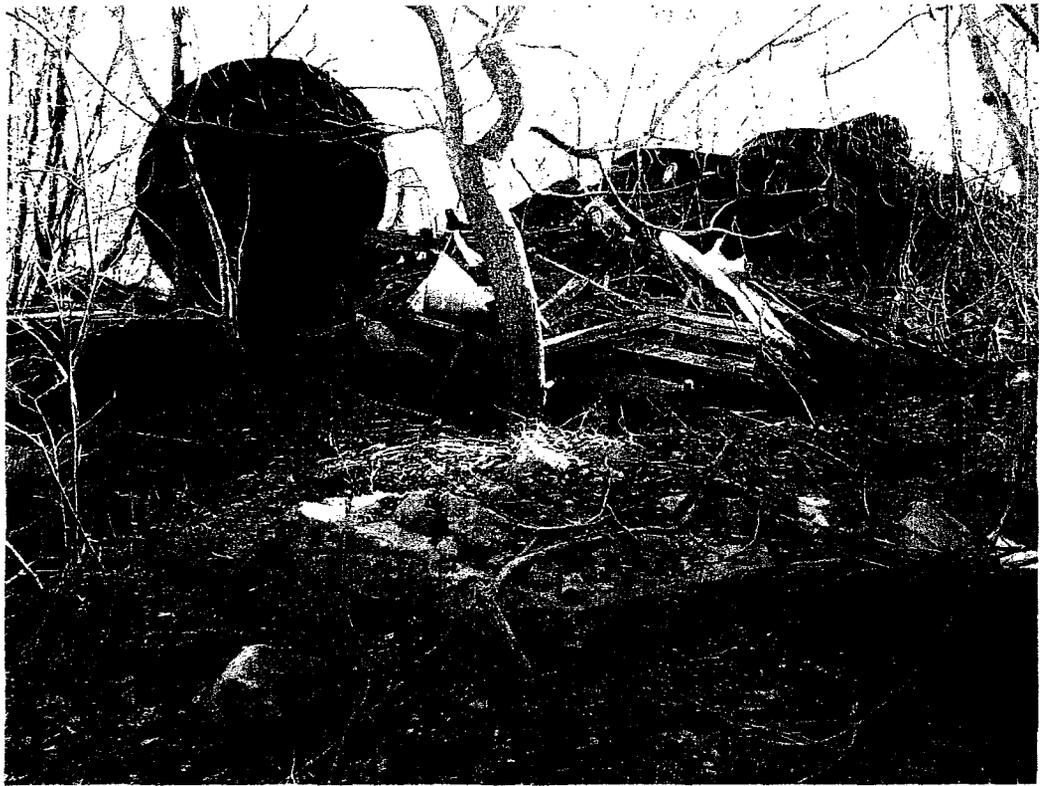
In the southwest corner of the parcel, a large area of former wetlands has been filled in with what appears to be rubble, solid waste and refuse. Access to this area is currently gained through a gate/fence located behind a landscaping business situated on Railroad Avenue. Heavy brush obscures much of the ground surface in this area but where visible, solid waste including discarded tires, tubes and other debris can be observed. Along the banks of this filled area bordering the wetland, a wide assortment of discarded debris was observed including metal drums, scrap metal, containers of various size and materials, a large metal storage tank, an abandoned dump truck, tires, compressed gas cylinders, and demolition debris.

View of abandoned storage tank in southwest corner of parcel

In order to assess the potential liabilities and cleanup costs associated with the various RECs identified above, a comprehensive Phase II environmental assessment would need to be conducted at the subject site. Subsurface investigations should include collection and laboratory analysis of groundwater quality samples from along the upgradient property boundary and from several areas on-site where potentially hazardous fill materials were dumped. Additionally, an extensive investigation using test pit excavations would be required throughout the numerous on-site filled areas and solid waste disposal areas to determine the nature of the fill and whether containers of hazardous material were buried. Since the source of the various fill materials is unknown, analytical testing would need to include laboratory analysis of metals, volatile organic compounds, semi-volatile organic compounds, PCBs, and total petroleum hydrocarbons. A representative sediment sampling program within the parcel's River channel and wetland areas with laboratory analysis for dioxins would also be required to assess potential liability related to the presence of dioxins.

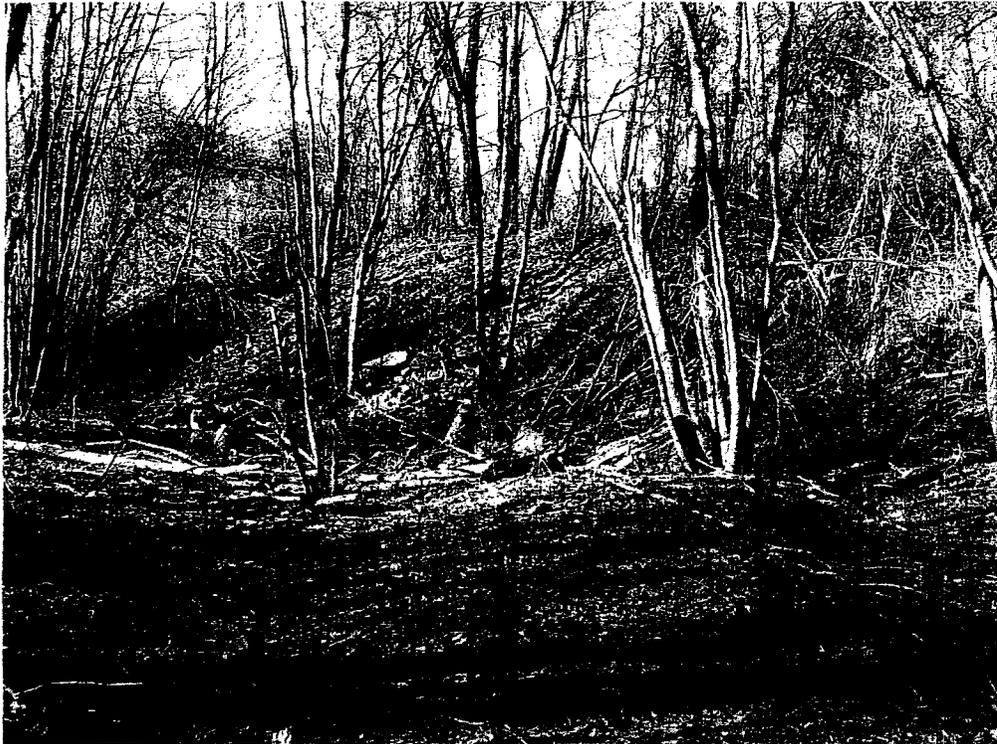
- Johnston Asphalt a.k.a. Town Asphalt - This business is located on the north side of Allendale Avenue although the site referenced in RIDEM's files is an area containing fill in the northeast corner of the subject site which was reported to be owned by Town Asphalt. A review of RIDEM files indicates that a RIDEM inspector visited the site on May 2, 1998. In an interview with RIDEM, Mr. Ray Libutti (Town Asphalt Manager) claimed that no auto fluff was present in the area in question. The RIDEM inspector, however, observed auto fluff within several areas of fill in this portion of the subject site. A sample of the auto fluff collected from this area by RIDEM indicates it contained 8 parts per million of polychlorinated biphenyls (PCBs).

View of fill piles containing asphalt in northeast corner of parcel

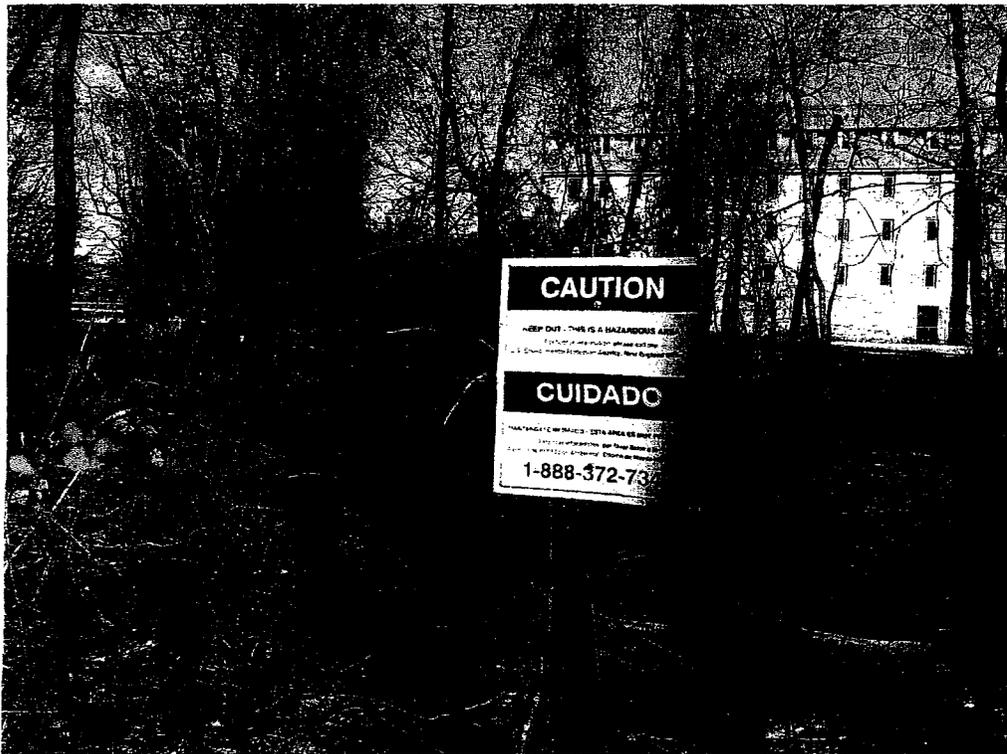
Finally, the subject site is situated immediately downstream of the Centredale Manor federal NPL Site. Sediments along this reach of the Woonasquatucket River have been found to contain elevated levels of dioxin. Owners of properties bordering the River which are found to contain levels of dioxin in excess of the 1 part per billion action level will likely be named as potentially responsible parties and may be required to conduct additional testing and remediation of impacted sediments. Considering that an abandoned segment of the River bisects the subject parcel and 85 percent of the parcel is a wetland area subject to back flow/flooding from the River during storm events, there is a strong potential for dioxins to be present on the subject property. Current and future owners of this parcel may be subject to federal liability for cleanup costs under Superfund laws.

View of EPA warning sign with Woonasquatucket River beyond
