Lincoln has performed a Phase I Environmental Site Assessment in conformance with the scope and limitations of ASTM Practice E-1527 of the property identified as Plat 14, Lot 516 in North Providence, Rhode Island. Any Exceptions to, or deletions from, this practice are described in this report. This assessment has revealed evidence of recognized environmental conditions in connection with the site. Lincoln recommends that a Limited Subsurface Investigation be conducted at the site property to determine if off-site sources have impacted the site.

Plat 14, Lot 516
North Providence, Rhode Island
Photographs Taken: April 4, 2002

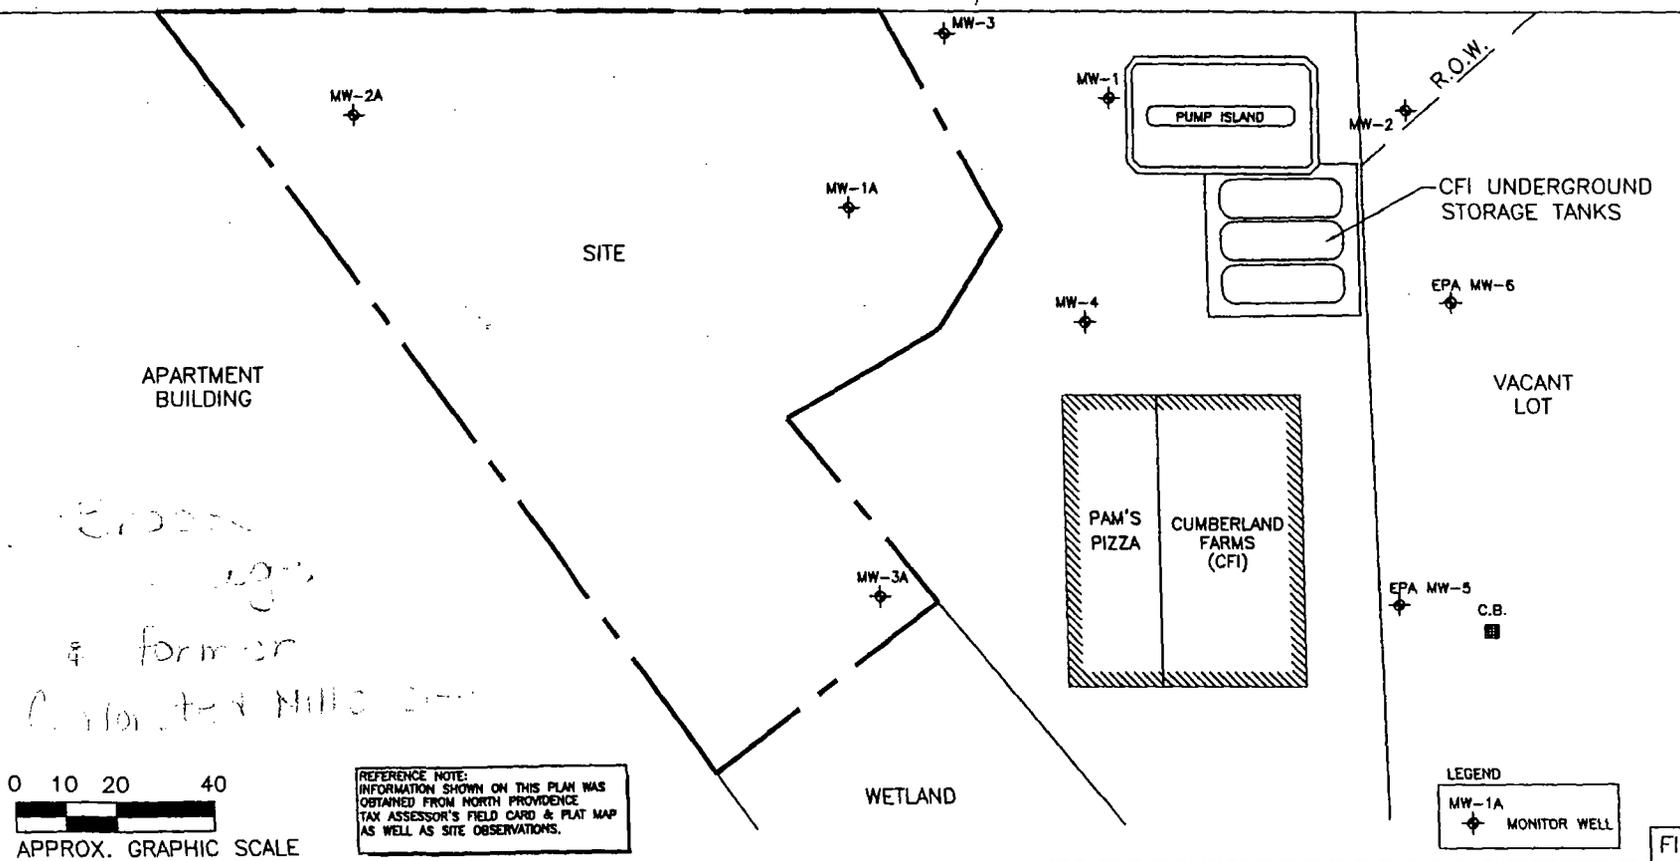
REFERENCE NOTE:
INFORMATION SHOWN ON THIS PLAN WAS
OBTAINED FROM NORTH PROVIDENCE
TAX ASSESSOR'S FIELD CARD & PLAT MAP
AS WELL AS SITE OBSERVATIONS.

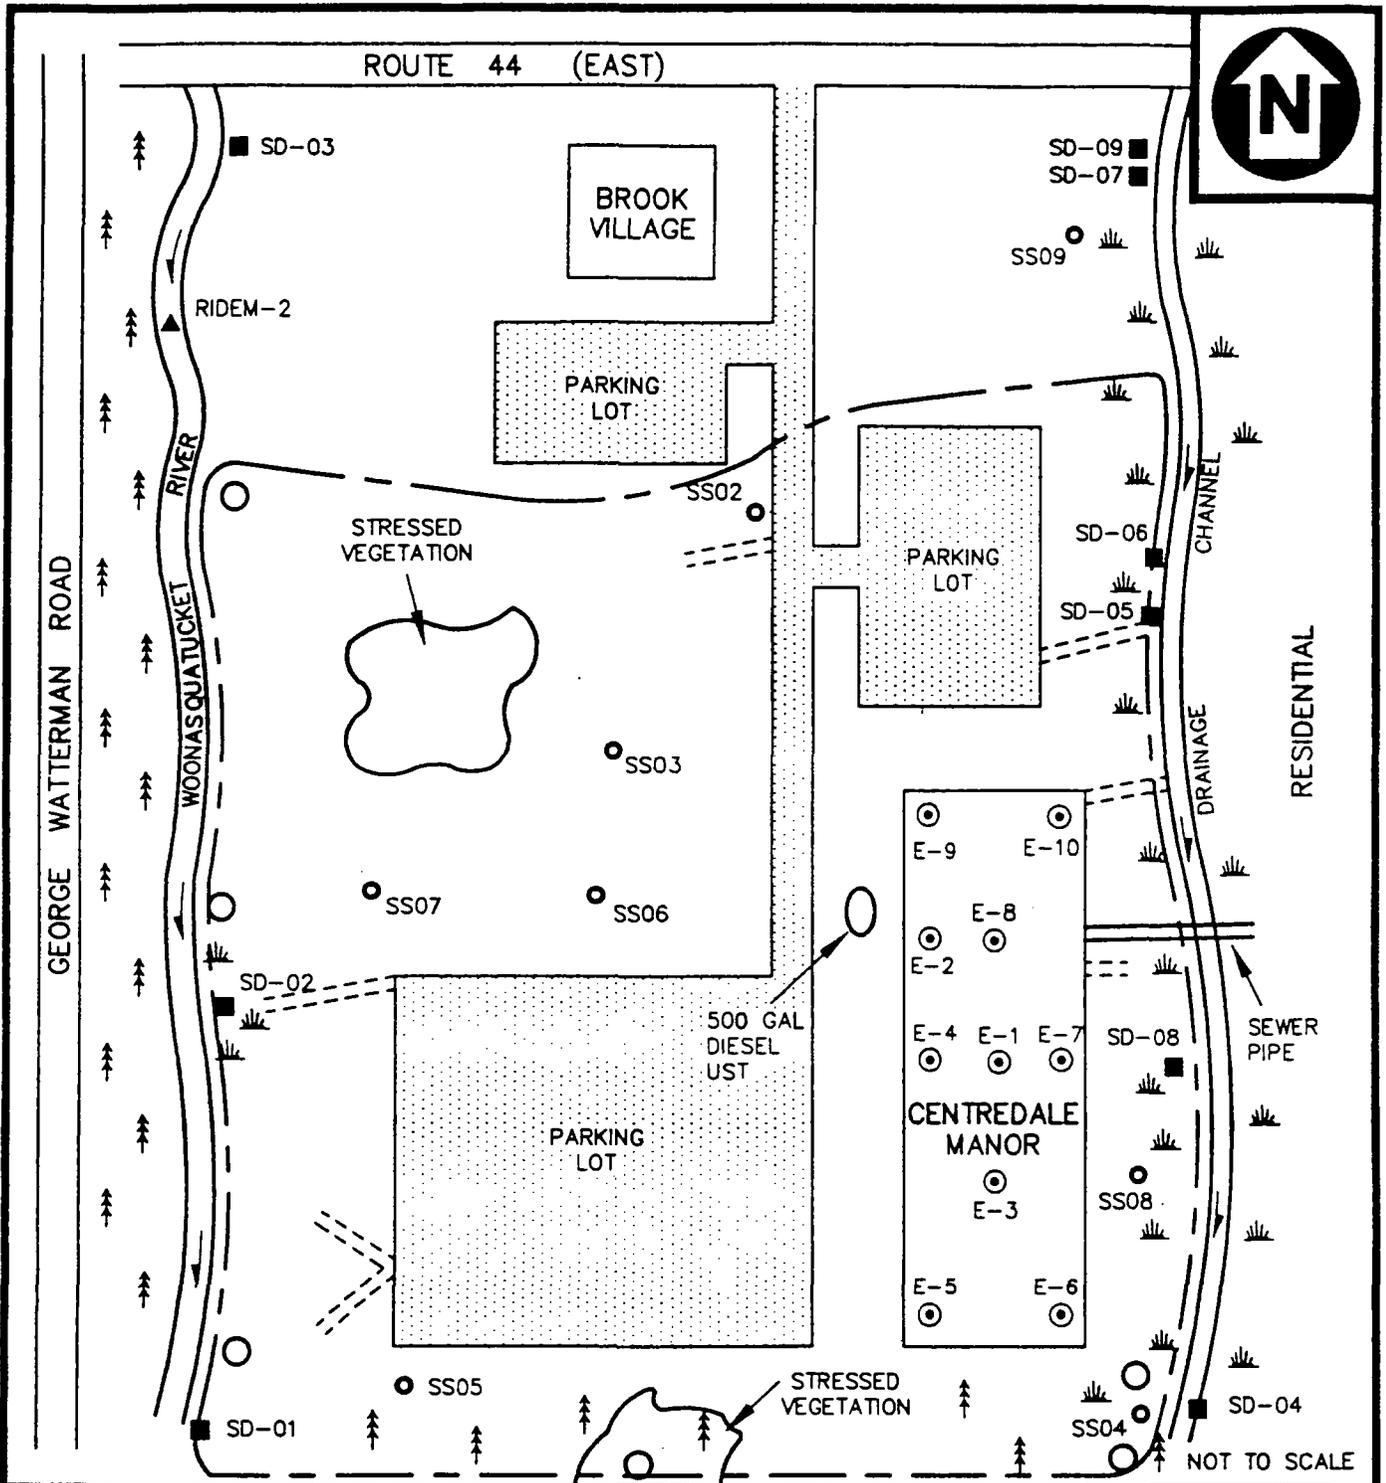
P:\DWG\RHC\ACOE\CENTRE\FIG-2.DWG (PLOT 1=1)

During the WESTON on-site reconnaissance, an area of stressed vegetation measuring 15 feet by 30 feet was observed in the southern portion of the property in a low-lying drainage area along the overland flow route between on-site paved areas and the Woonasquatucket River (Figure 2). A sheen and discolored sediment were observed along a section of the Woonasquatucket River located south of the property boundary [1]. An area of stressed vegetation measuring approximately 450 square feet was also observed on the northwest side of the property between on-site parking areas and a Brook Village Apartment parking lot (Figure 2).

Approximately ten deteriorated 55-gallon drums were observed along the western property boundary along the Woonasquatucket River and in the wooded area located along the southern perimeter of the property (Figure 2). The observed drums were heavily rusted and empty [1].

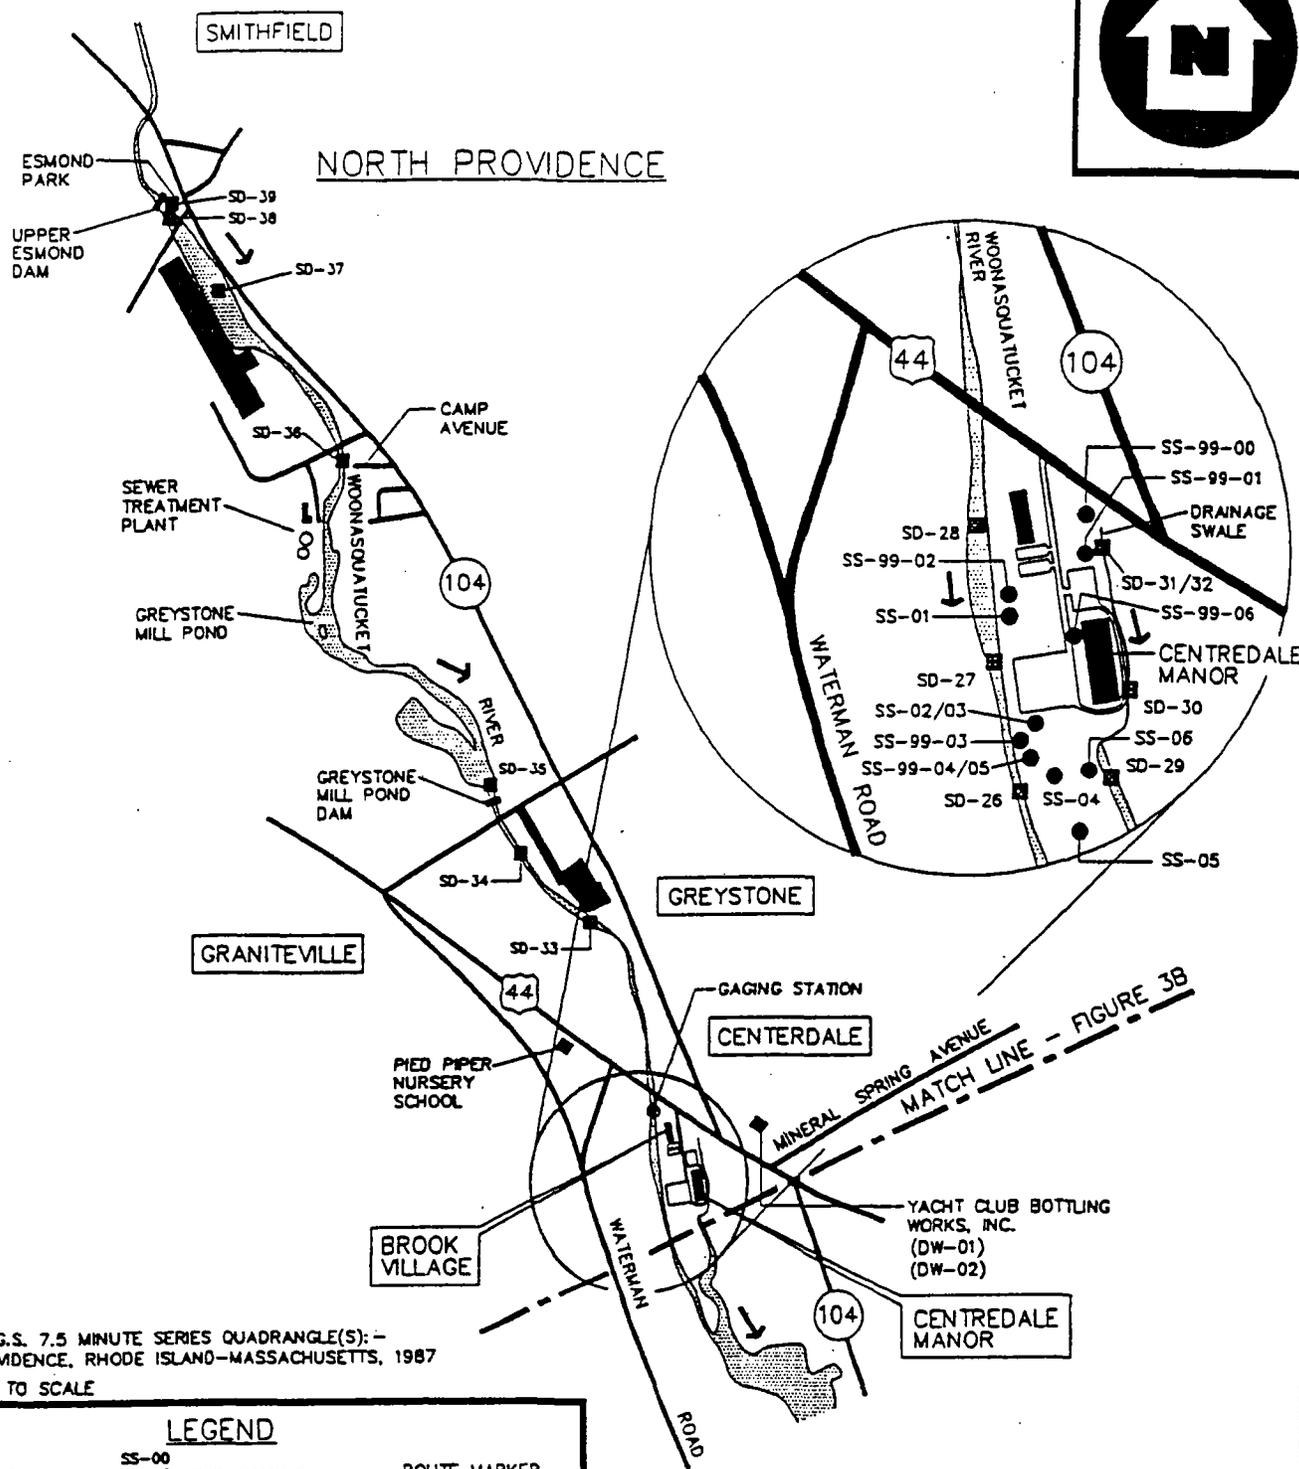
FILE NAME: S:\98060017\FIG1CX	FIGURE 3A
----------------------------------	-----------

LEGEND		
SD-00	■ SEDIMENT SAMPLE LOCATION (9/9/98)	● SOIL SAMPLE LOCATION (9/9/98)
→	FLOW DIRECTION	● SOIL SAMPLE LOCATION (1/15/99)
■	BUILDING	ROUTE MARKER
		□ U.S. ROUTE
		○ STATE ROUTE

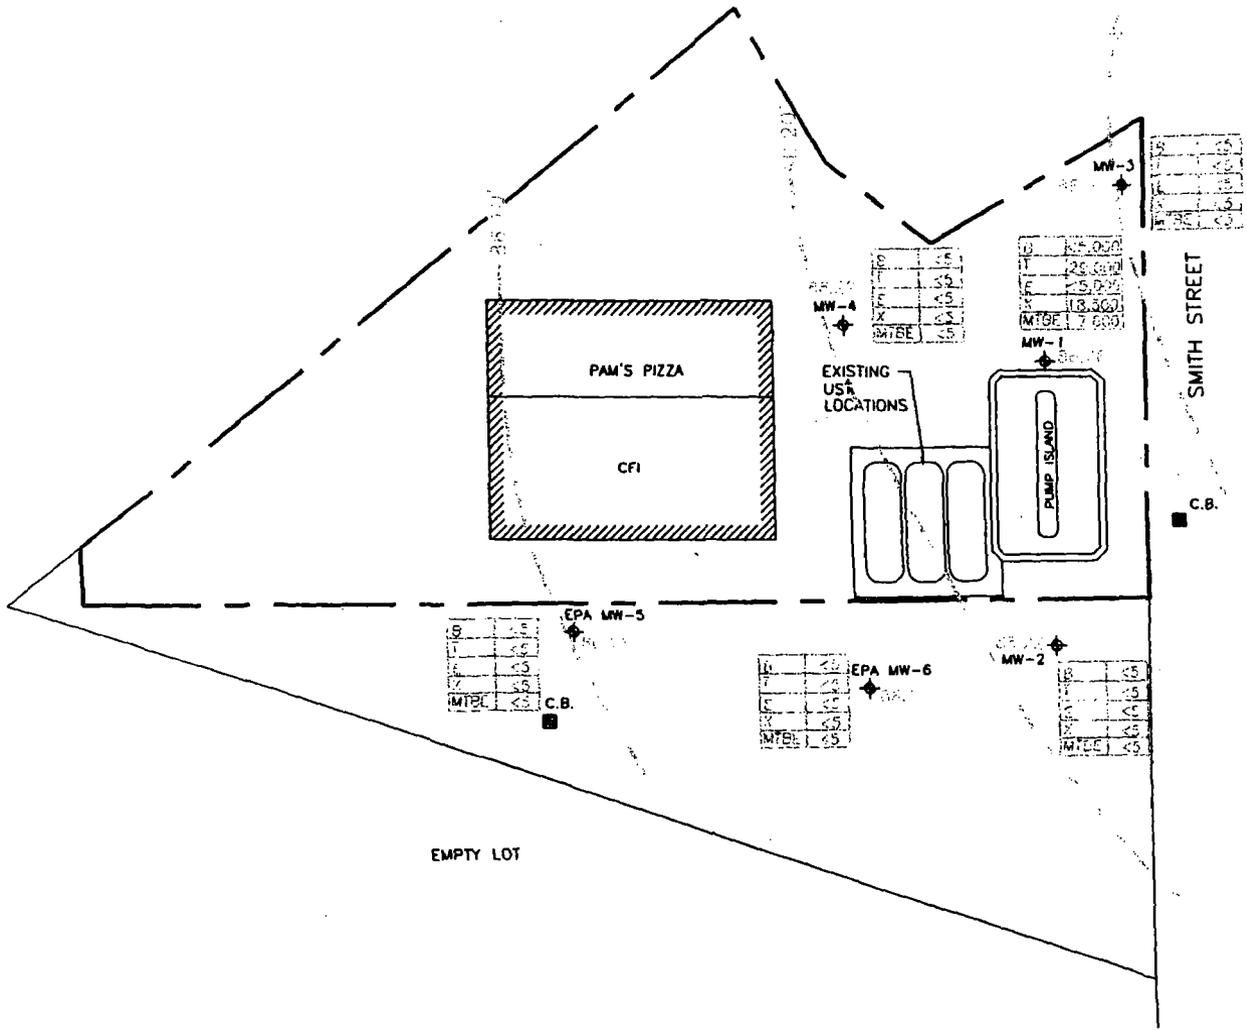
FIGURE 4

GROUNDWATER ANALYTICAL RESULTS AND
 WATER TABLE ELEVATION CONTOUR MAP
 FOR DATE: 1/25/2001

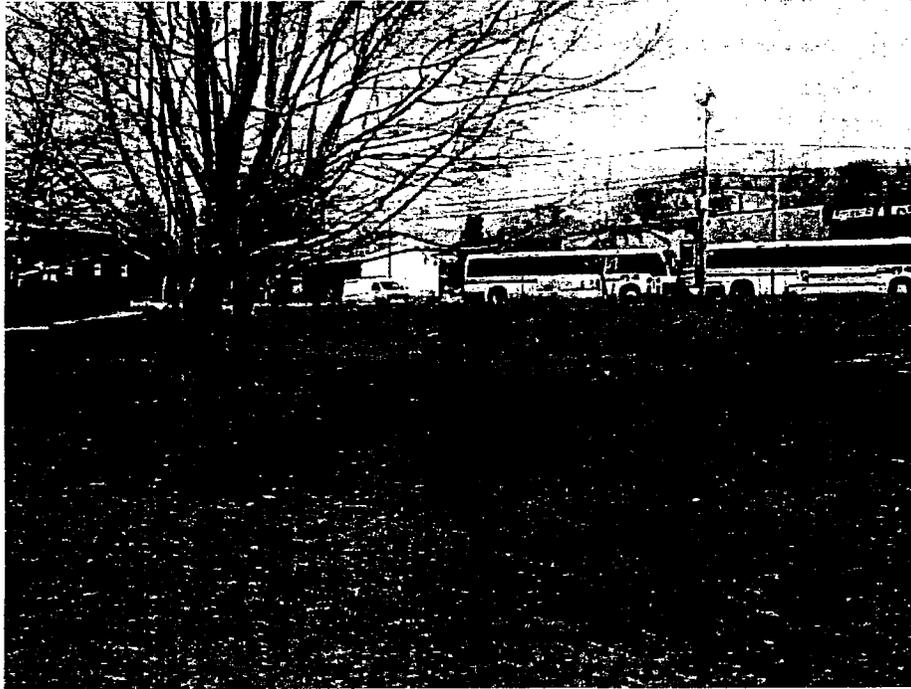
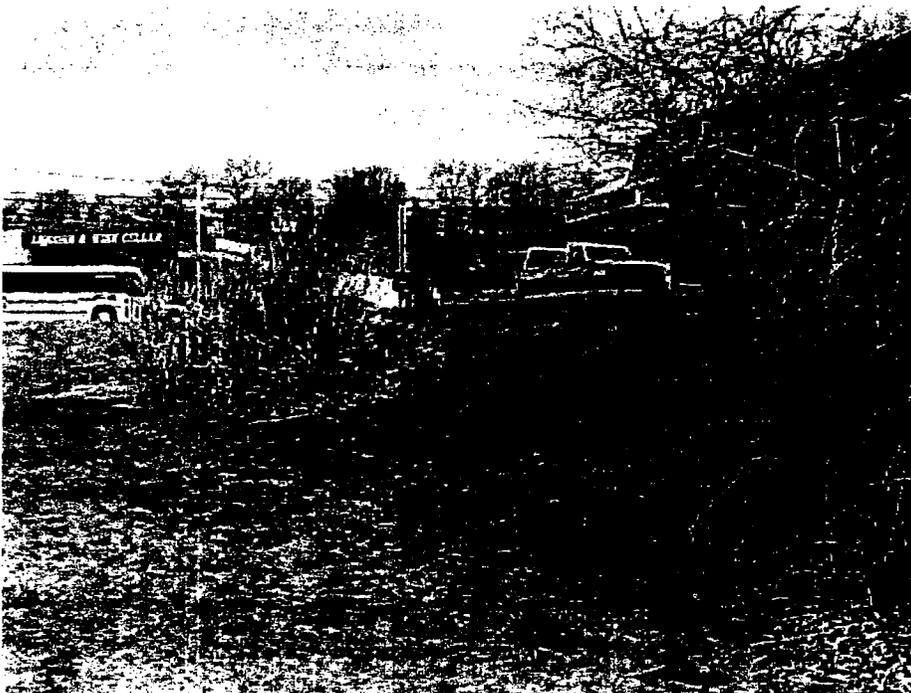
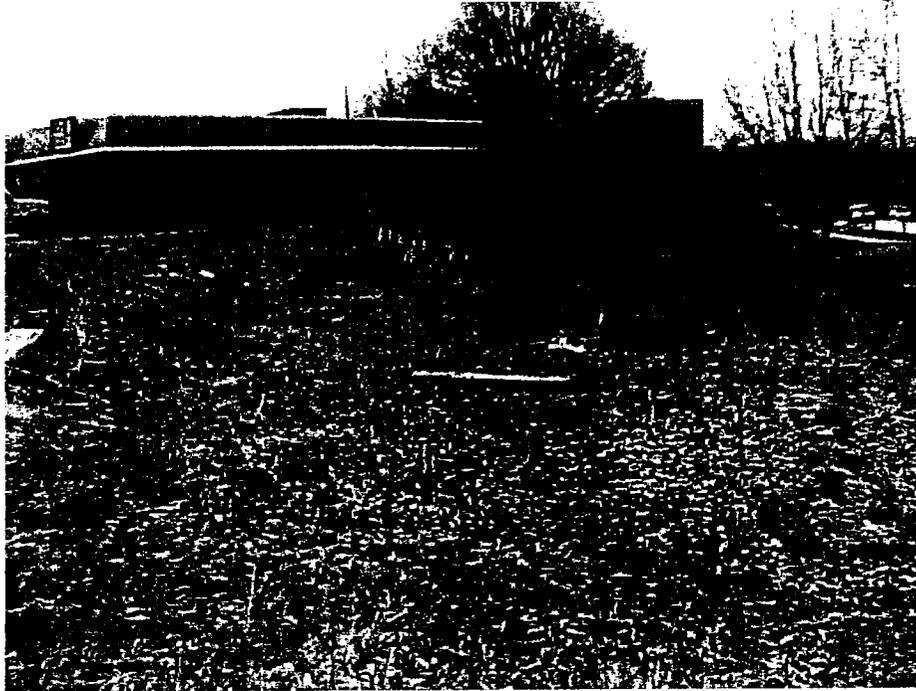
The site property currently consists of 16,500 square feet of undeveloped land. Lincoln observed a few small trees and low lying vegetation. Wetland type vegetation was also observed at the southern portion of the site in what appeared to be a small brook during times of high water. However, this area did not contain running water at the time of Lincoln's site visit. What appeared to be a small concrete foundation was observed on the surface of a grass area located at the center of the site property. The Cumberland Farms filling station was observed to abut the site property to the east, with three underground storage tanks containing gasoline located approximately fifty feet from the site property.

No pits, ponds, or lagoons were observed at the time of Lincoln's site visit. Wetland type vegetation was observed at the rear (south) side of the property on what appeared to be a small brook during times of high water.
