**COMPLETION OF WORK REPORT
ENERGY REPLACEMENT OF WATERLINE
CENTREDALE MANOR
NORTH PROVIDENCE, RHODE ISLAND**

March 2011
File No. 33688

Re: Completion of Work Report – Emergency Water Line Repairs
Centerdale Manor
2074 Smith Street
North Providence, Rhode Island

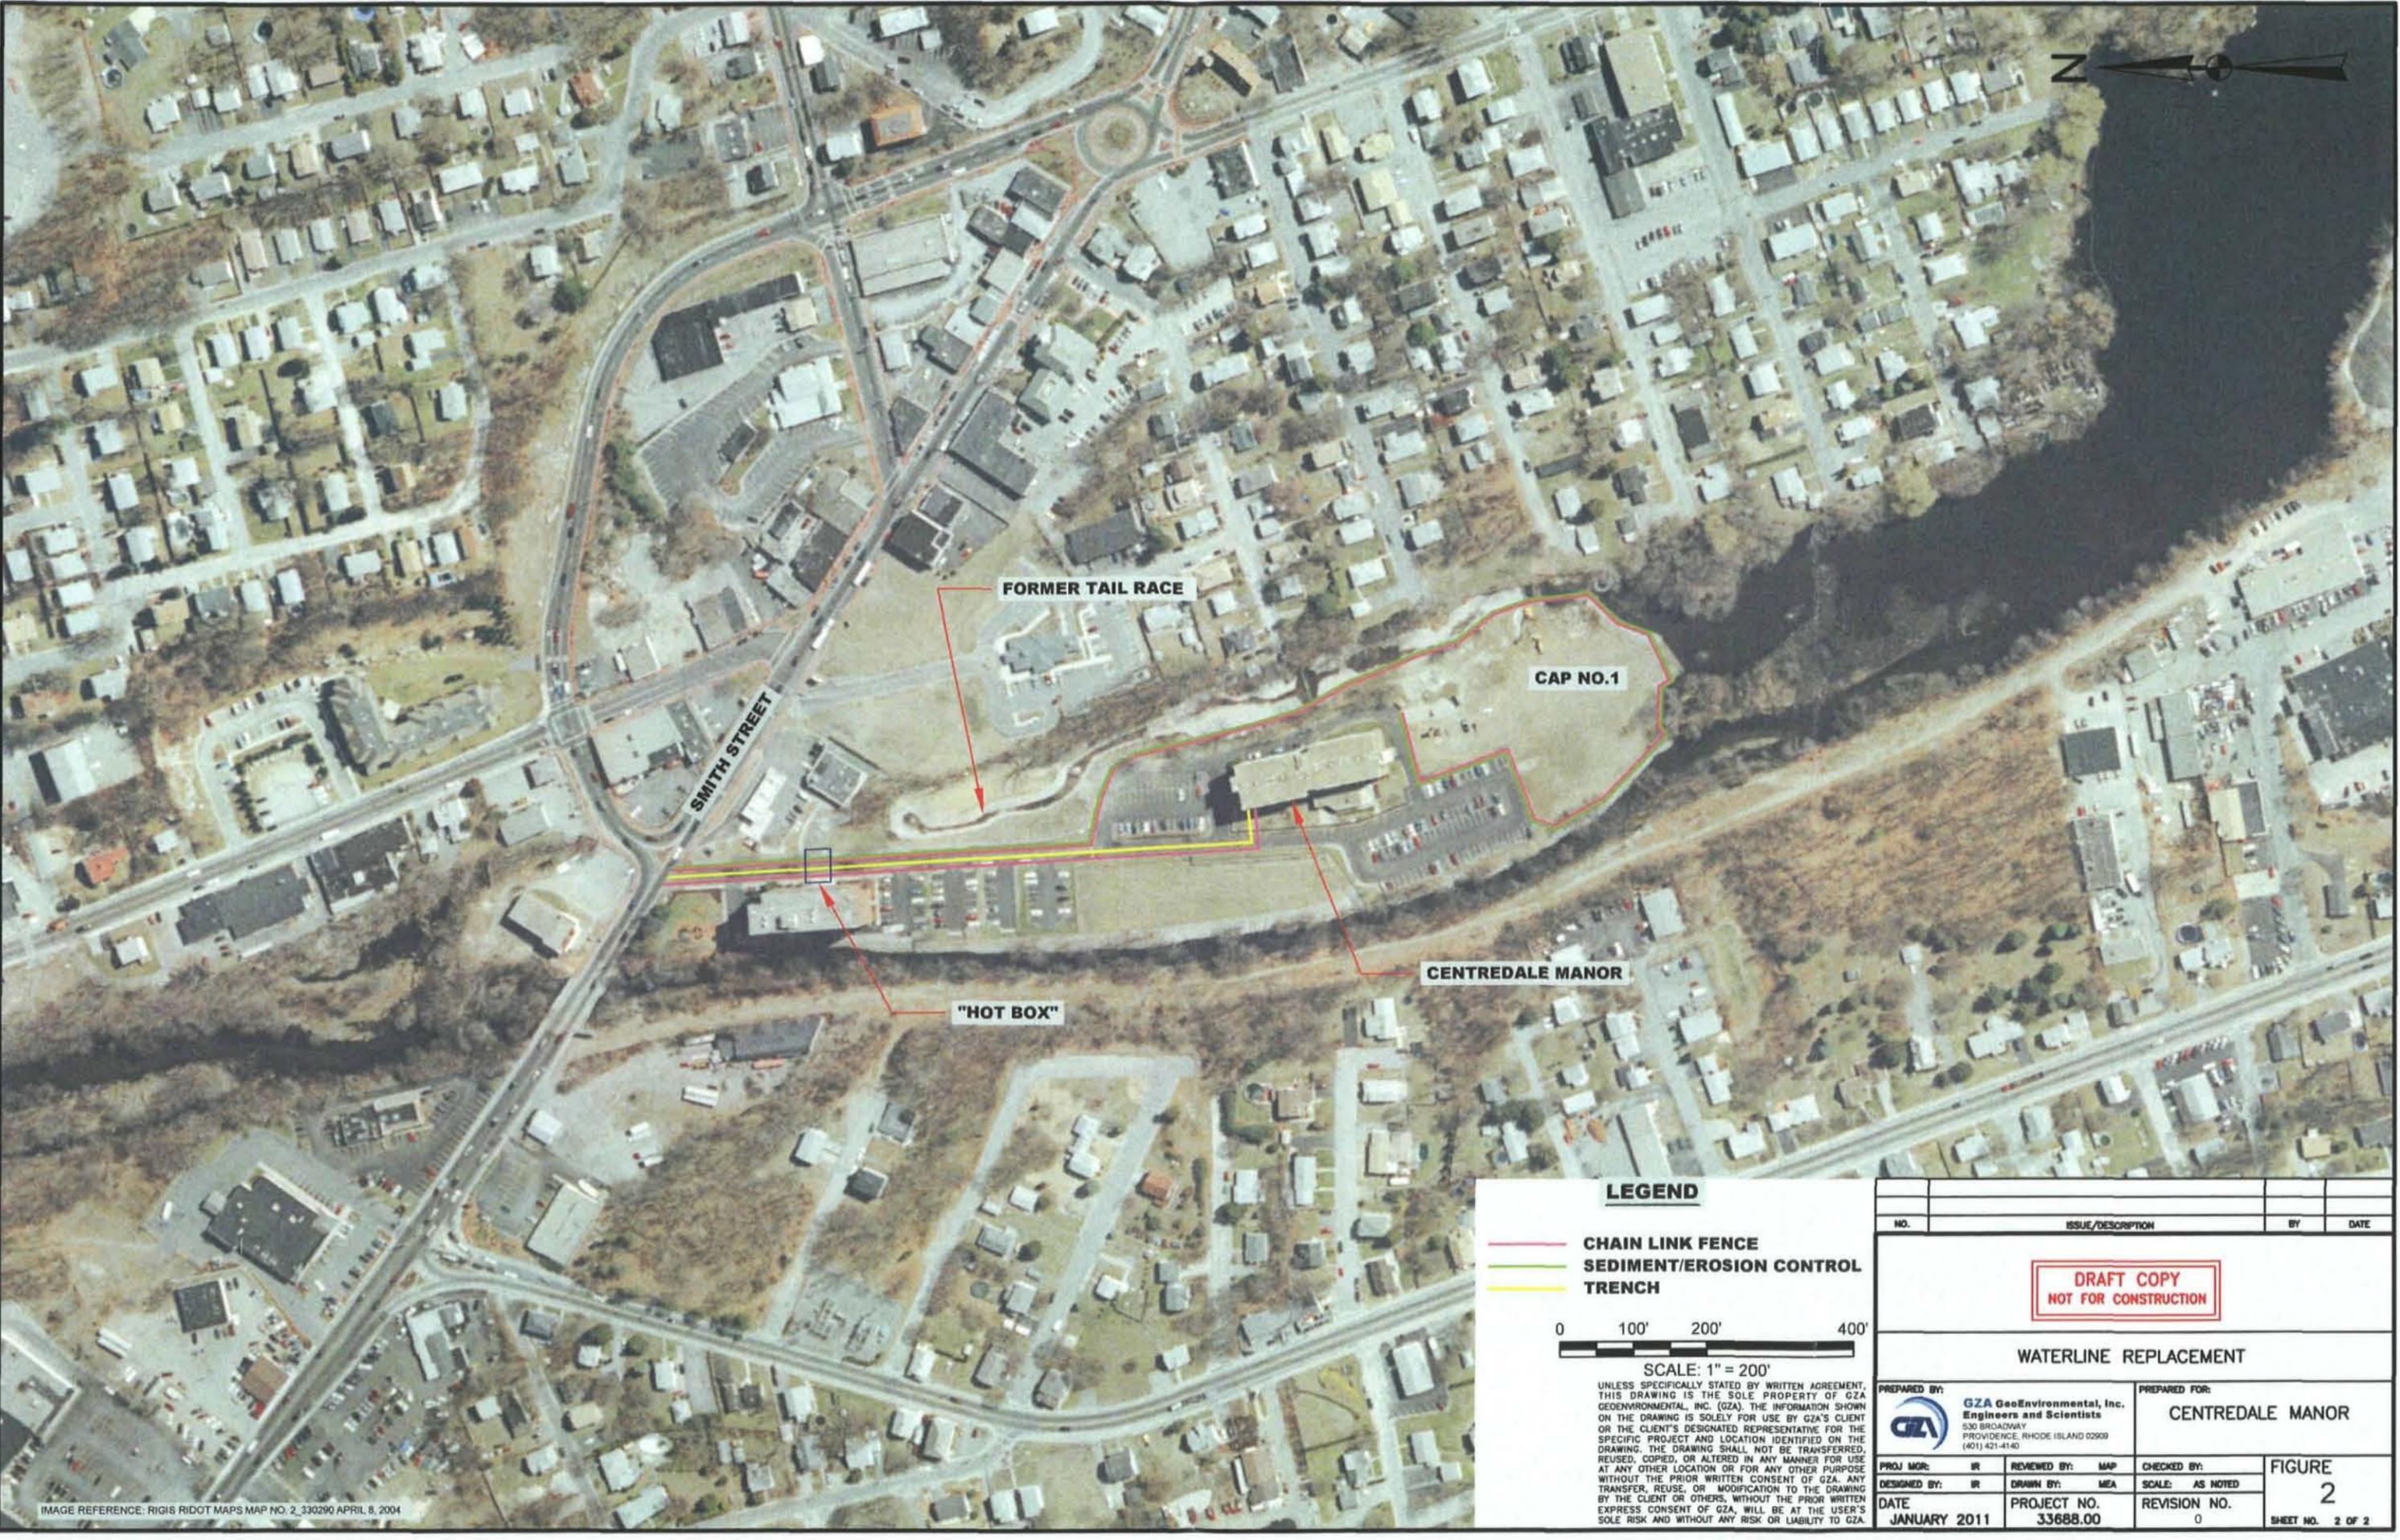
- CHAIN LINK FENCE
- SEDIMENT/EROSION CONTROL
- TRENCH

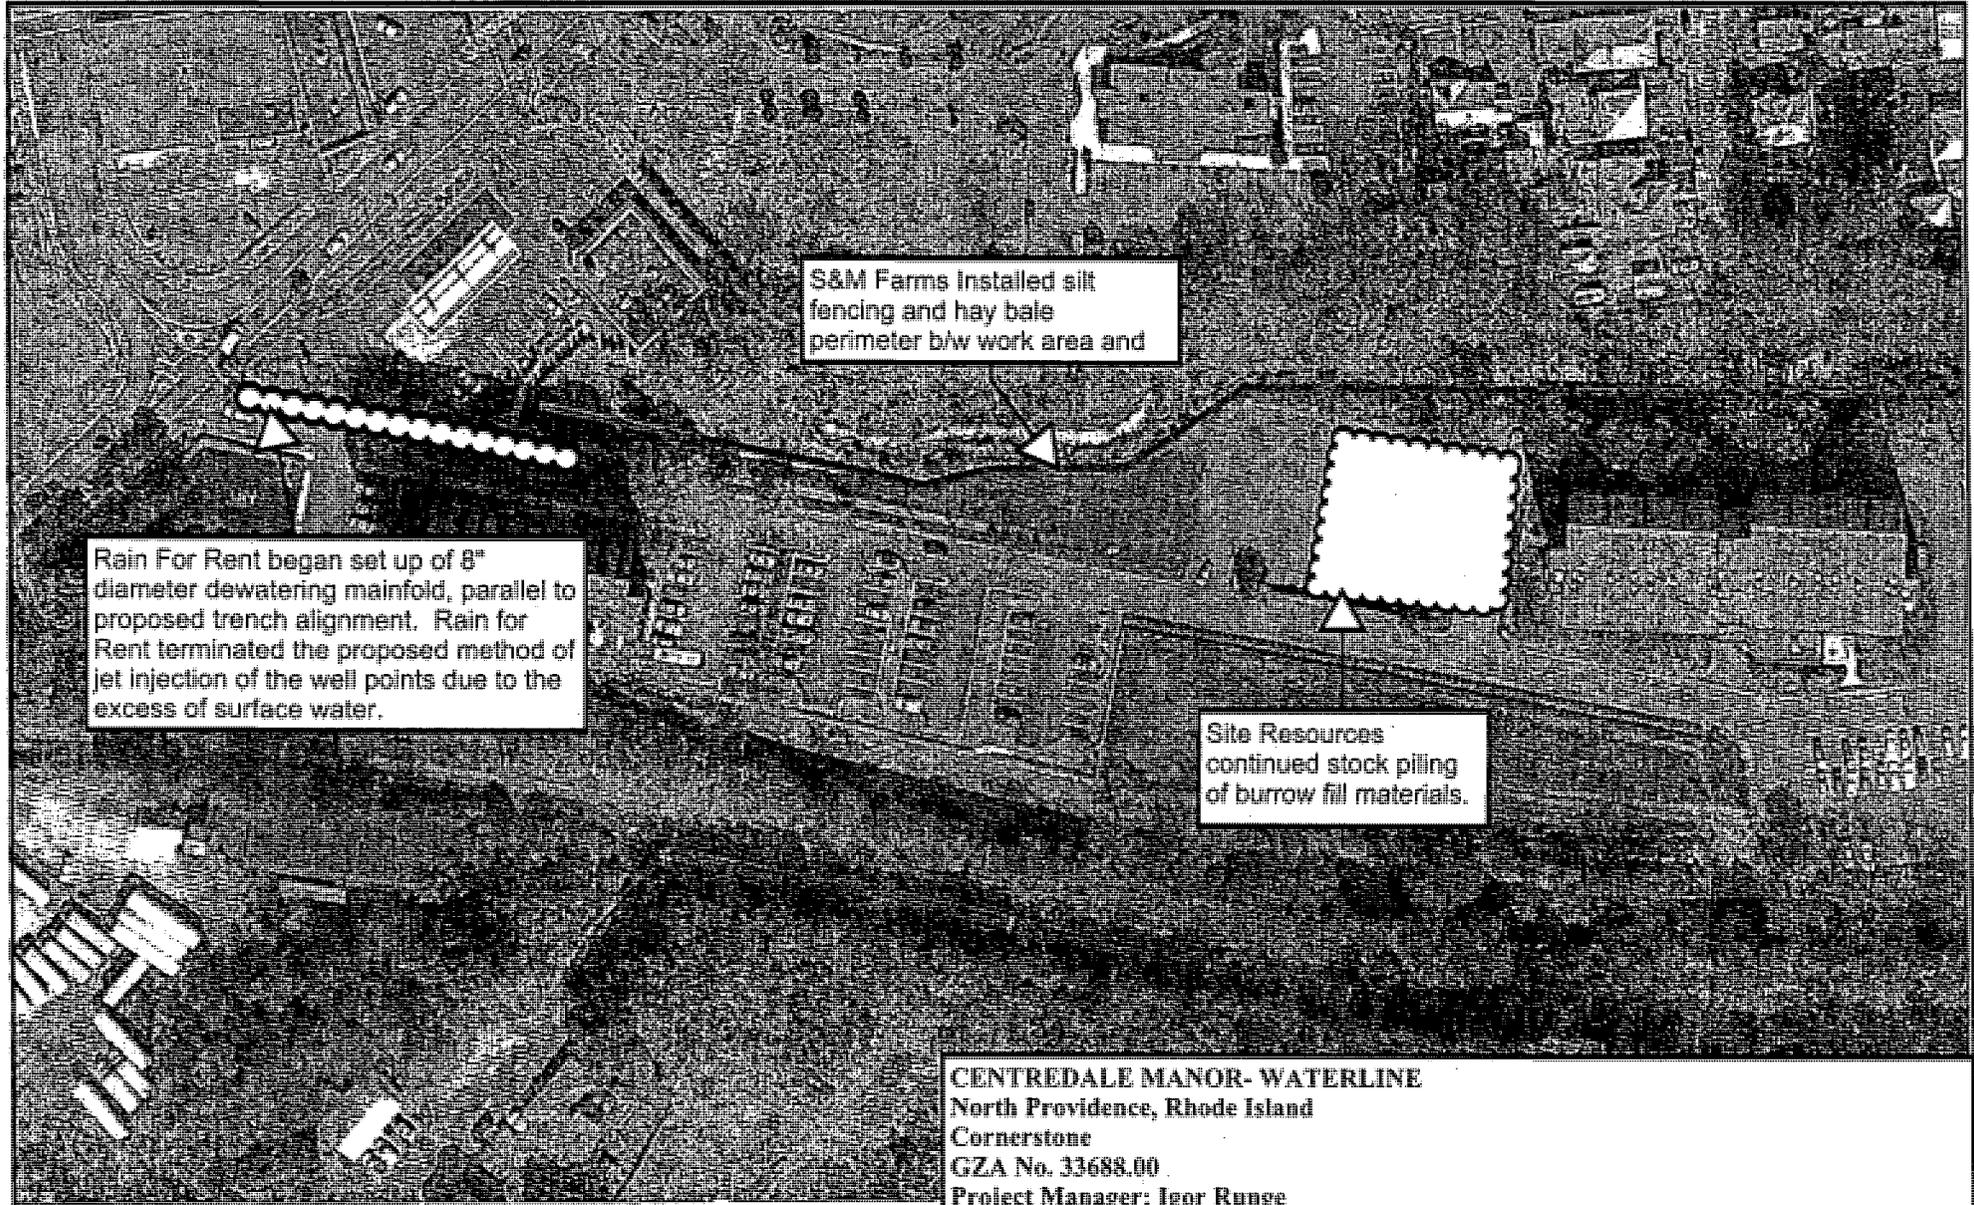
S&M Farms installed silt fencing and hay bale perimeter b/w work area and

Rain For Rent began set up of 8" diameter dewatering manifold, parallel to proposed trench alignment. Rain for Rent terminated the proposed method of jet injection of the well points due to the excess of surface water.

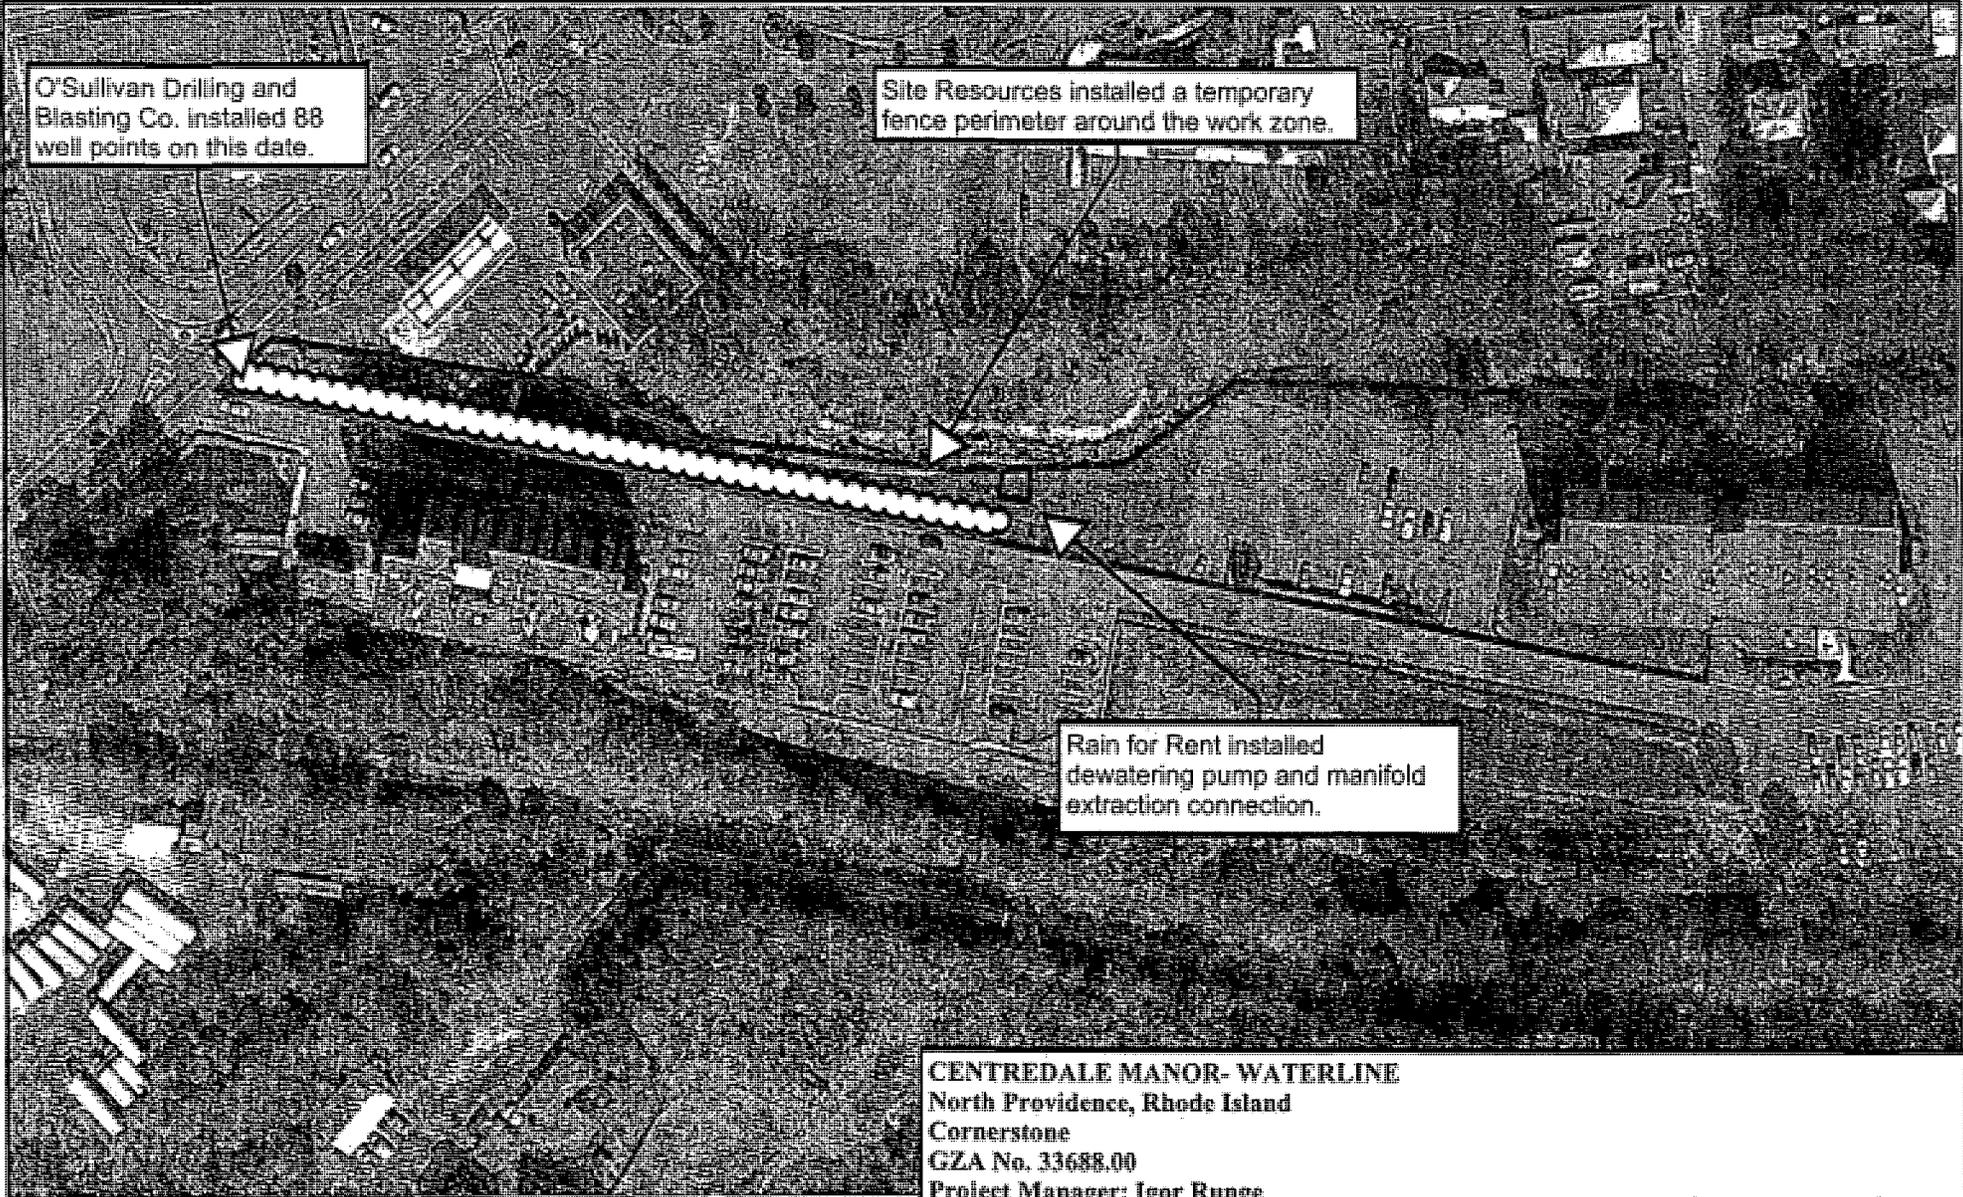
O'Sullivan Drilling and Blasting Co. installed 88 well points on this date.

Site Resources installed a temporary fence perimeter around the work zone.

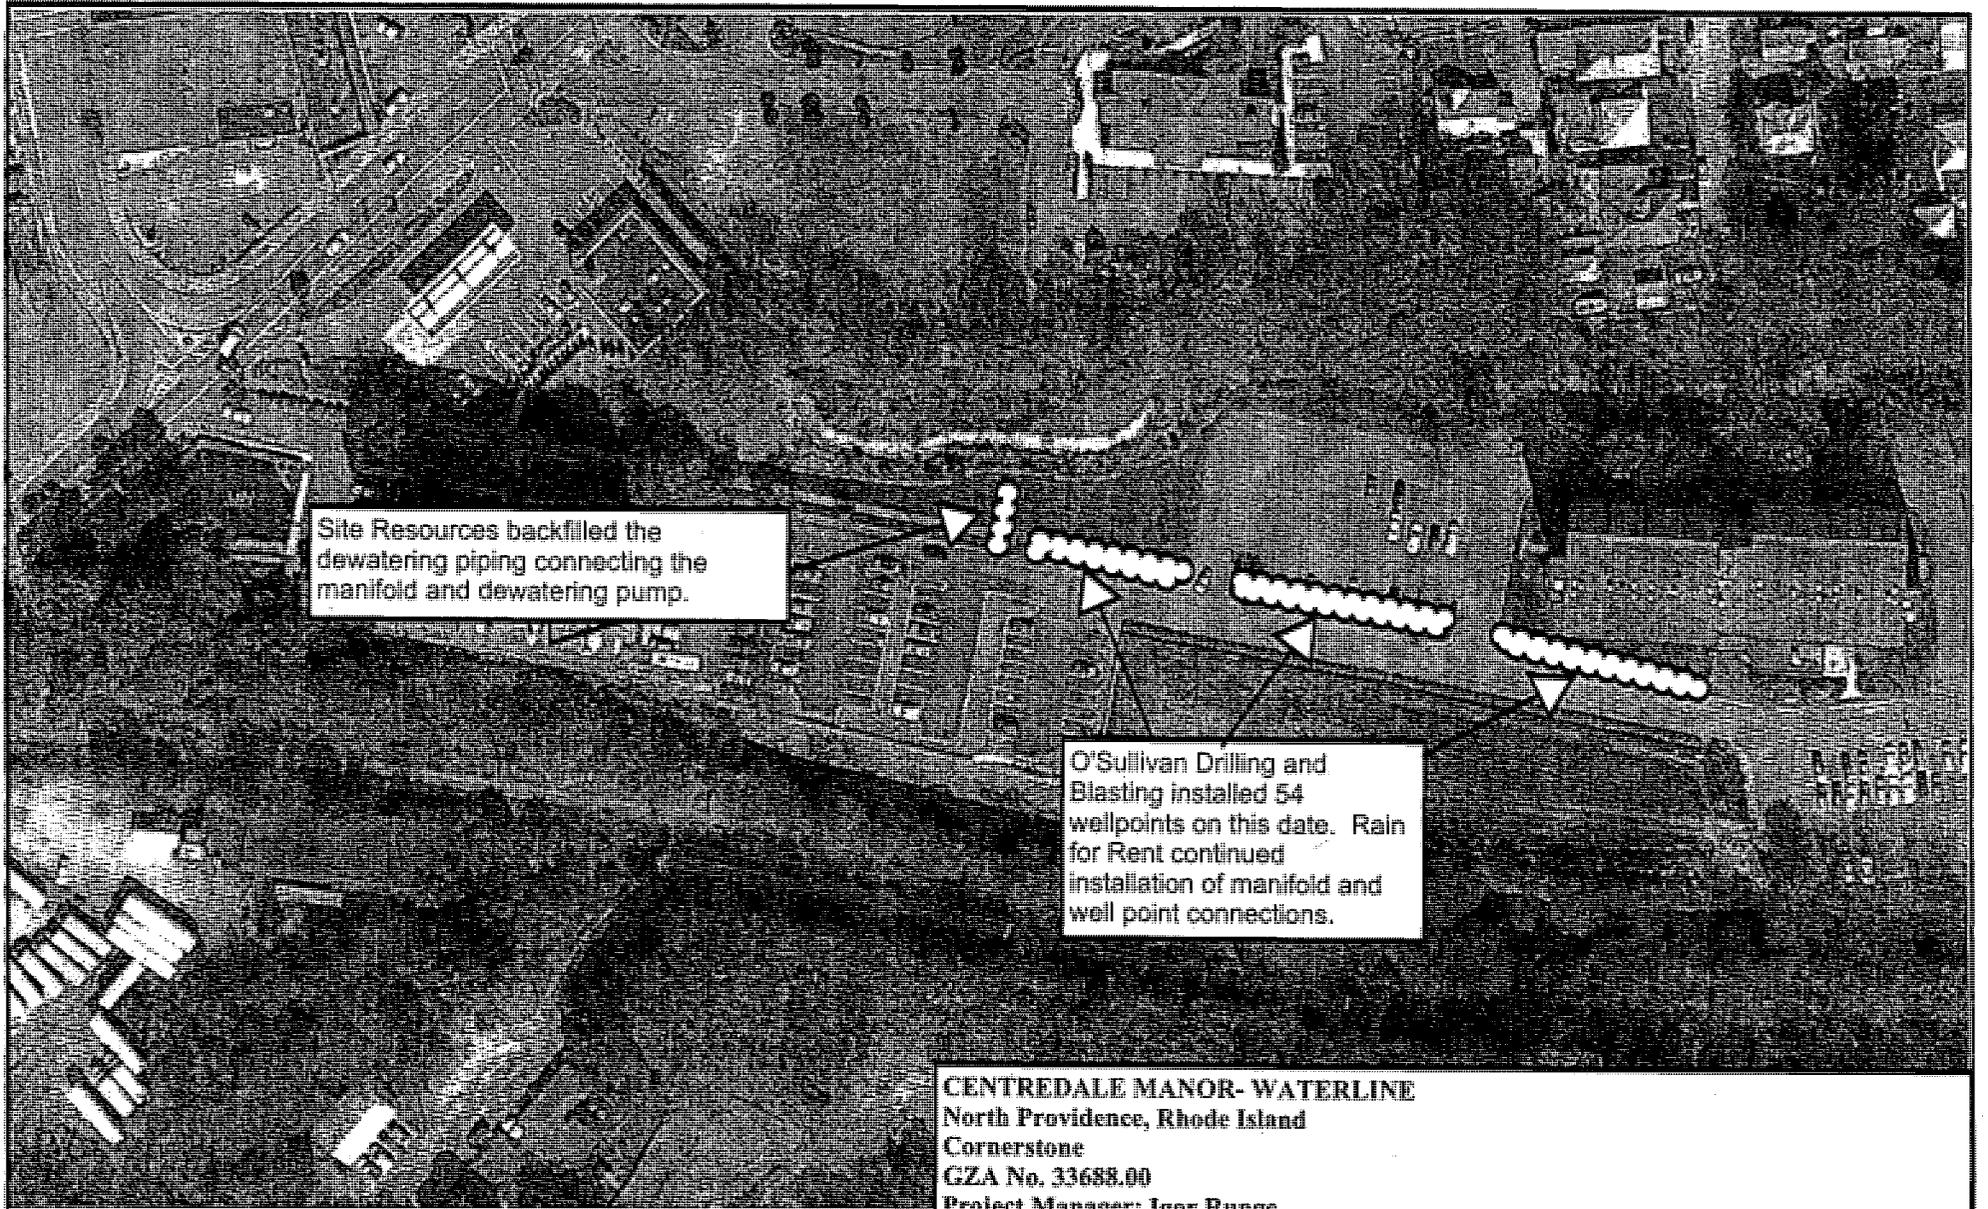
Site Resources backfilled the dewatering piping connecting the manifold and dewatering pump.

O'Sullivan Drilling and Blasting installed 54 wellpoints on this date. Rain for Rent continued installation of manifold and well point connections.

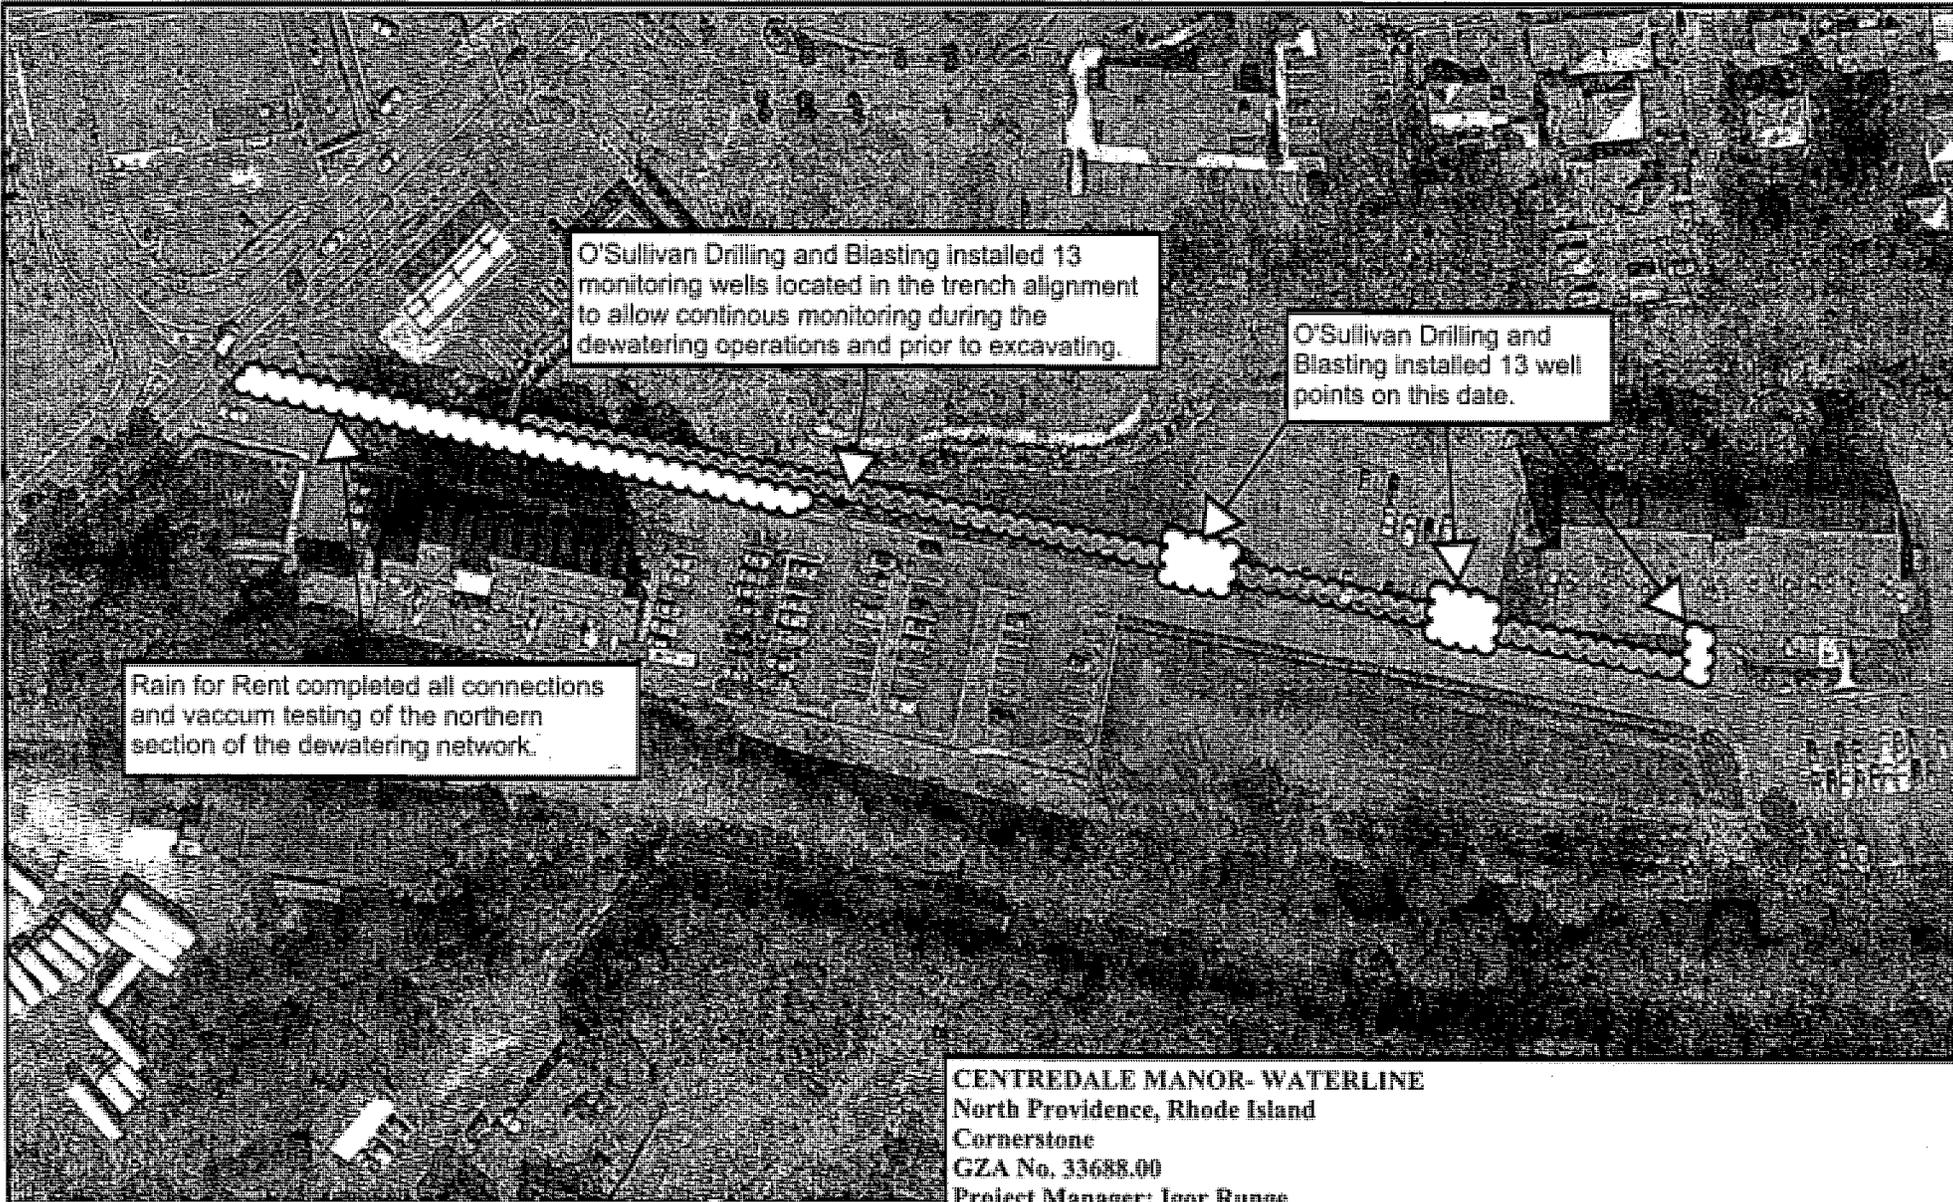
O'Sullivan Drilling and Blasting installed 13 monitoring wells located in the trench alignment to allow continuous monitoring during the dewatering operations and prior to excavating.

O'Sullivan Drilling and Blasting installed 13 well points on this date.

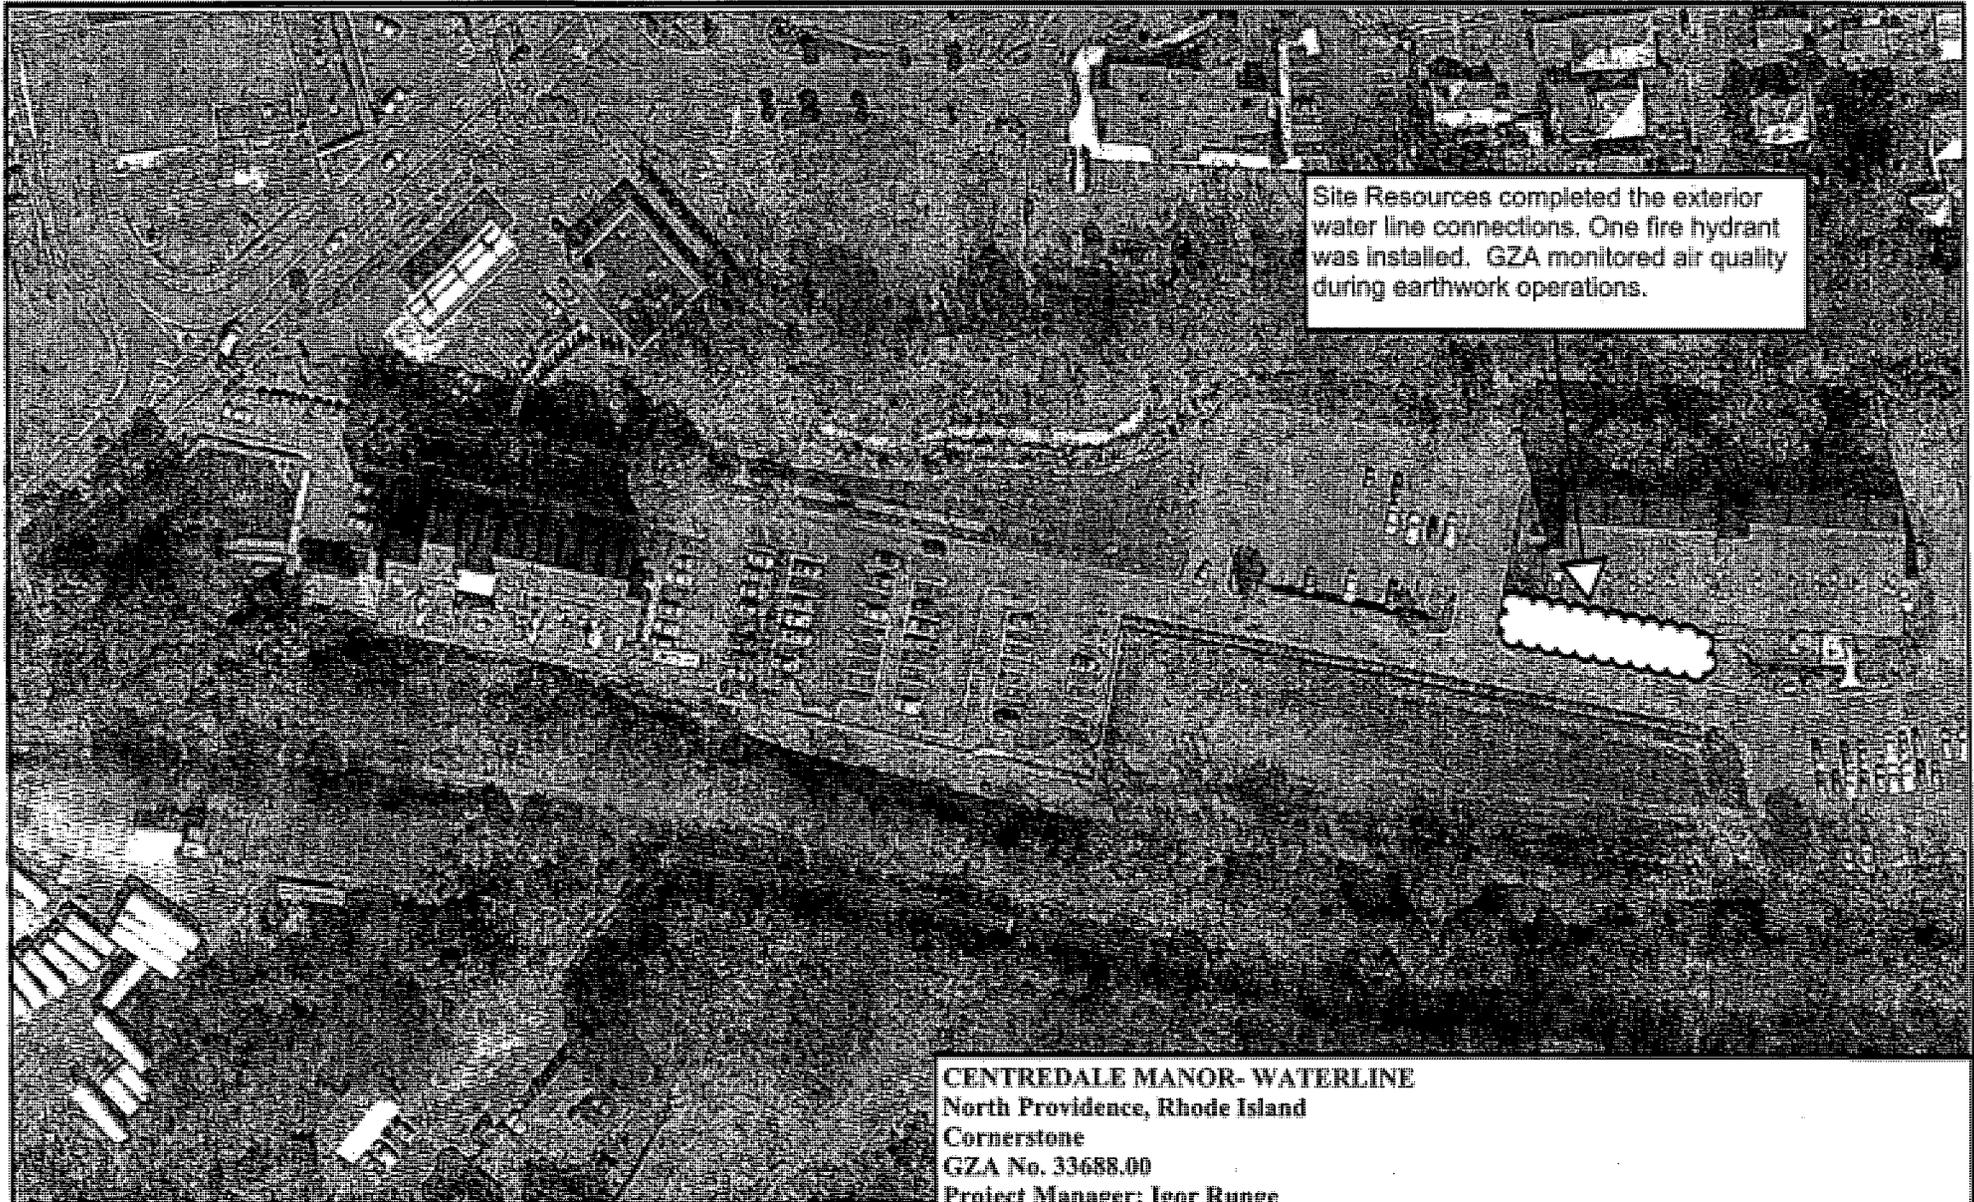
CENTREDALE MANOR- WATERLINE
North Providence, Rhode Island
Cornerstone
GZA No. 33688.00
Project Manager: Igor Runge
Field Sketch -13 Date: 12-14-10
Drawn by: SJR

Site Resources completed the exterior water line connections. One fire hydrant was installed. GZA monitored air quality during earthwork operations.

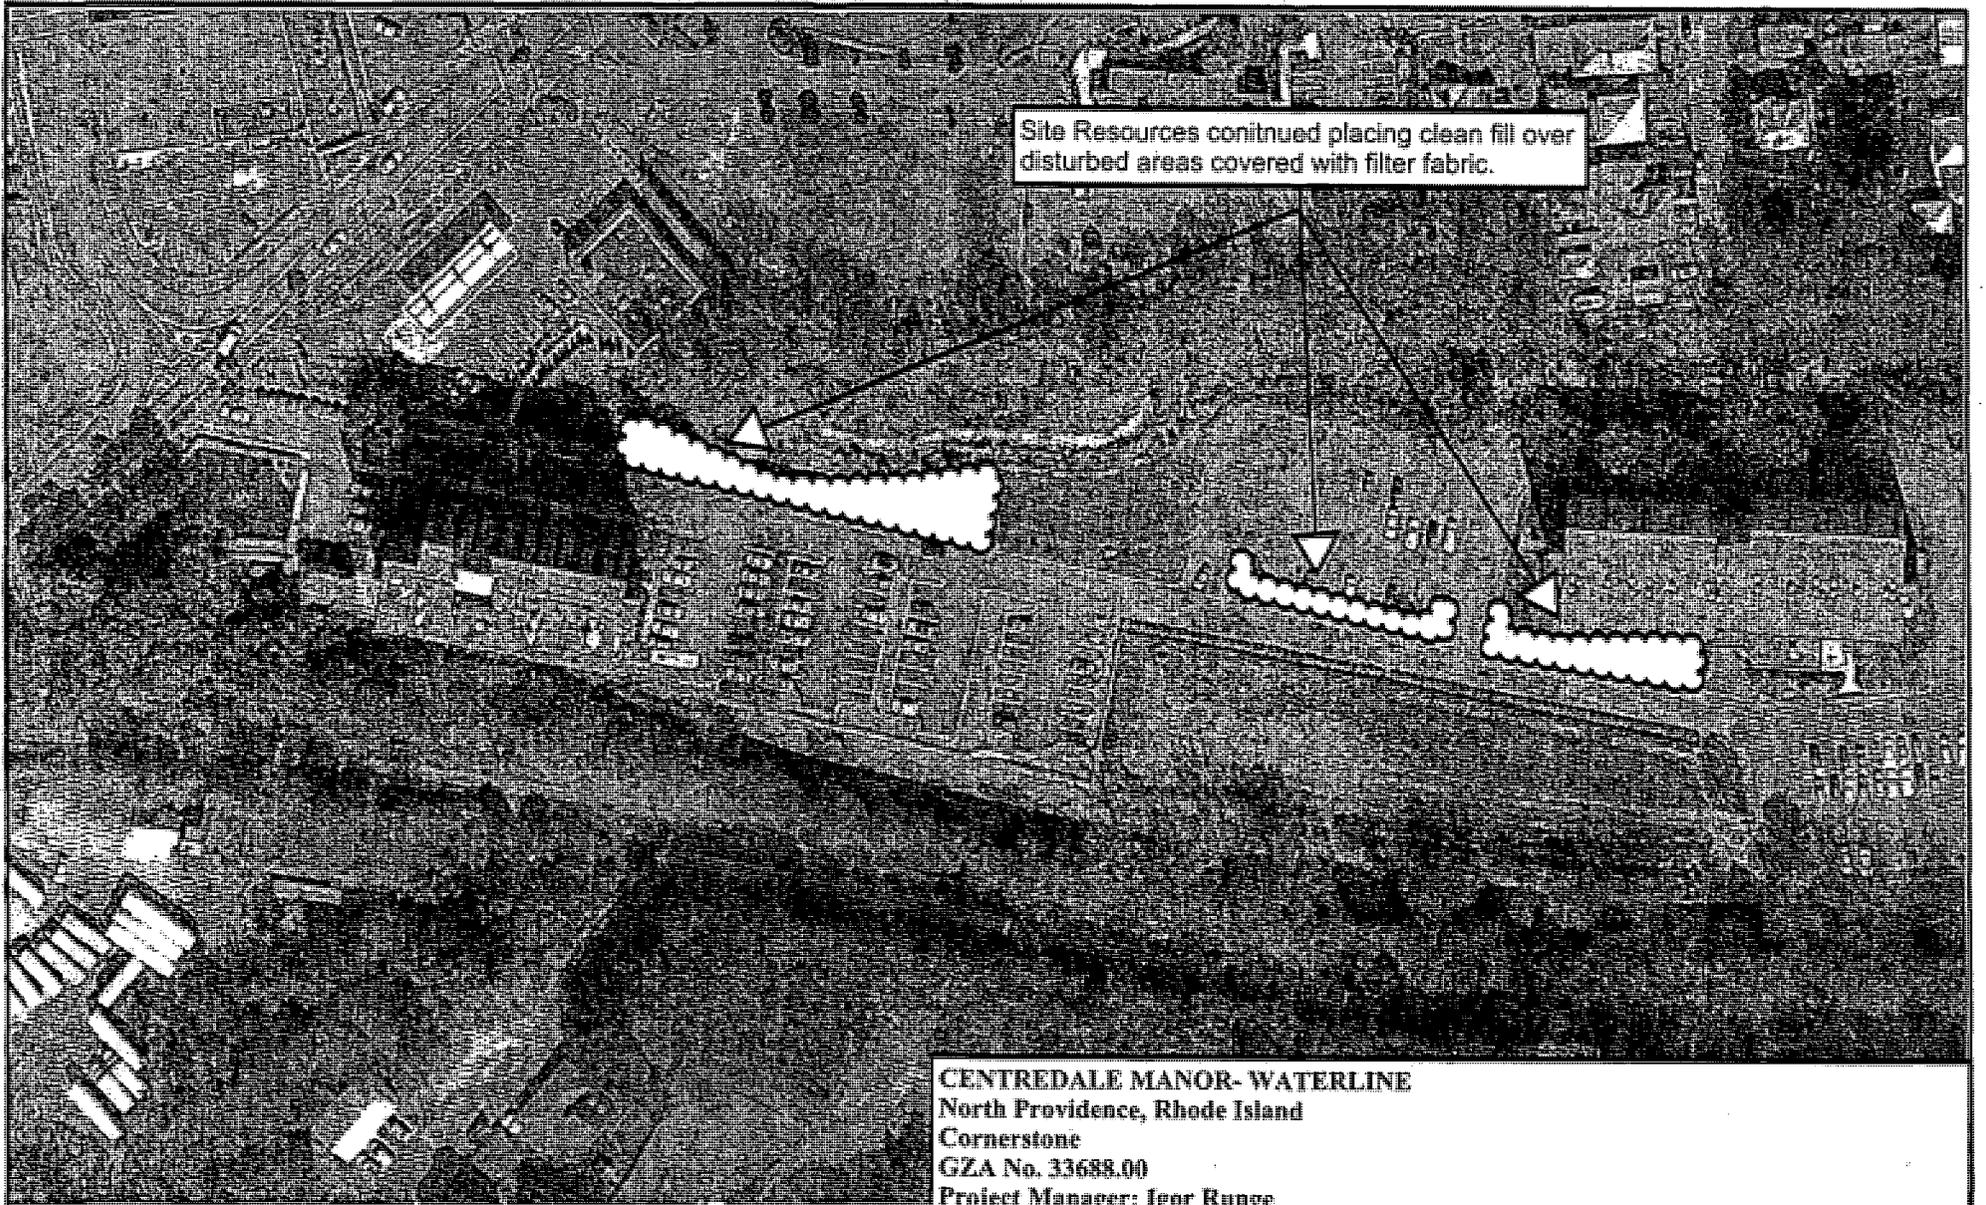
CENTREDALE MANOR- WATERLINE
North Providence, Rhode Island
Cornerstone
GZA No. 33688.00
Project Manager: Igor Runge
Field Sketch -17 Date: 12-20-10
Drawn by: NDW

Site Resources continued placing clean fill over disturbed areas covered with filter fabric.

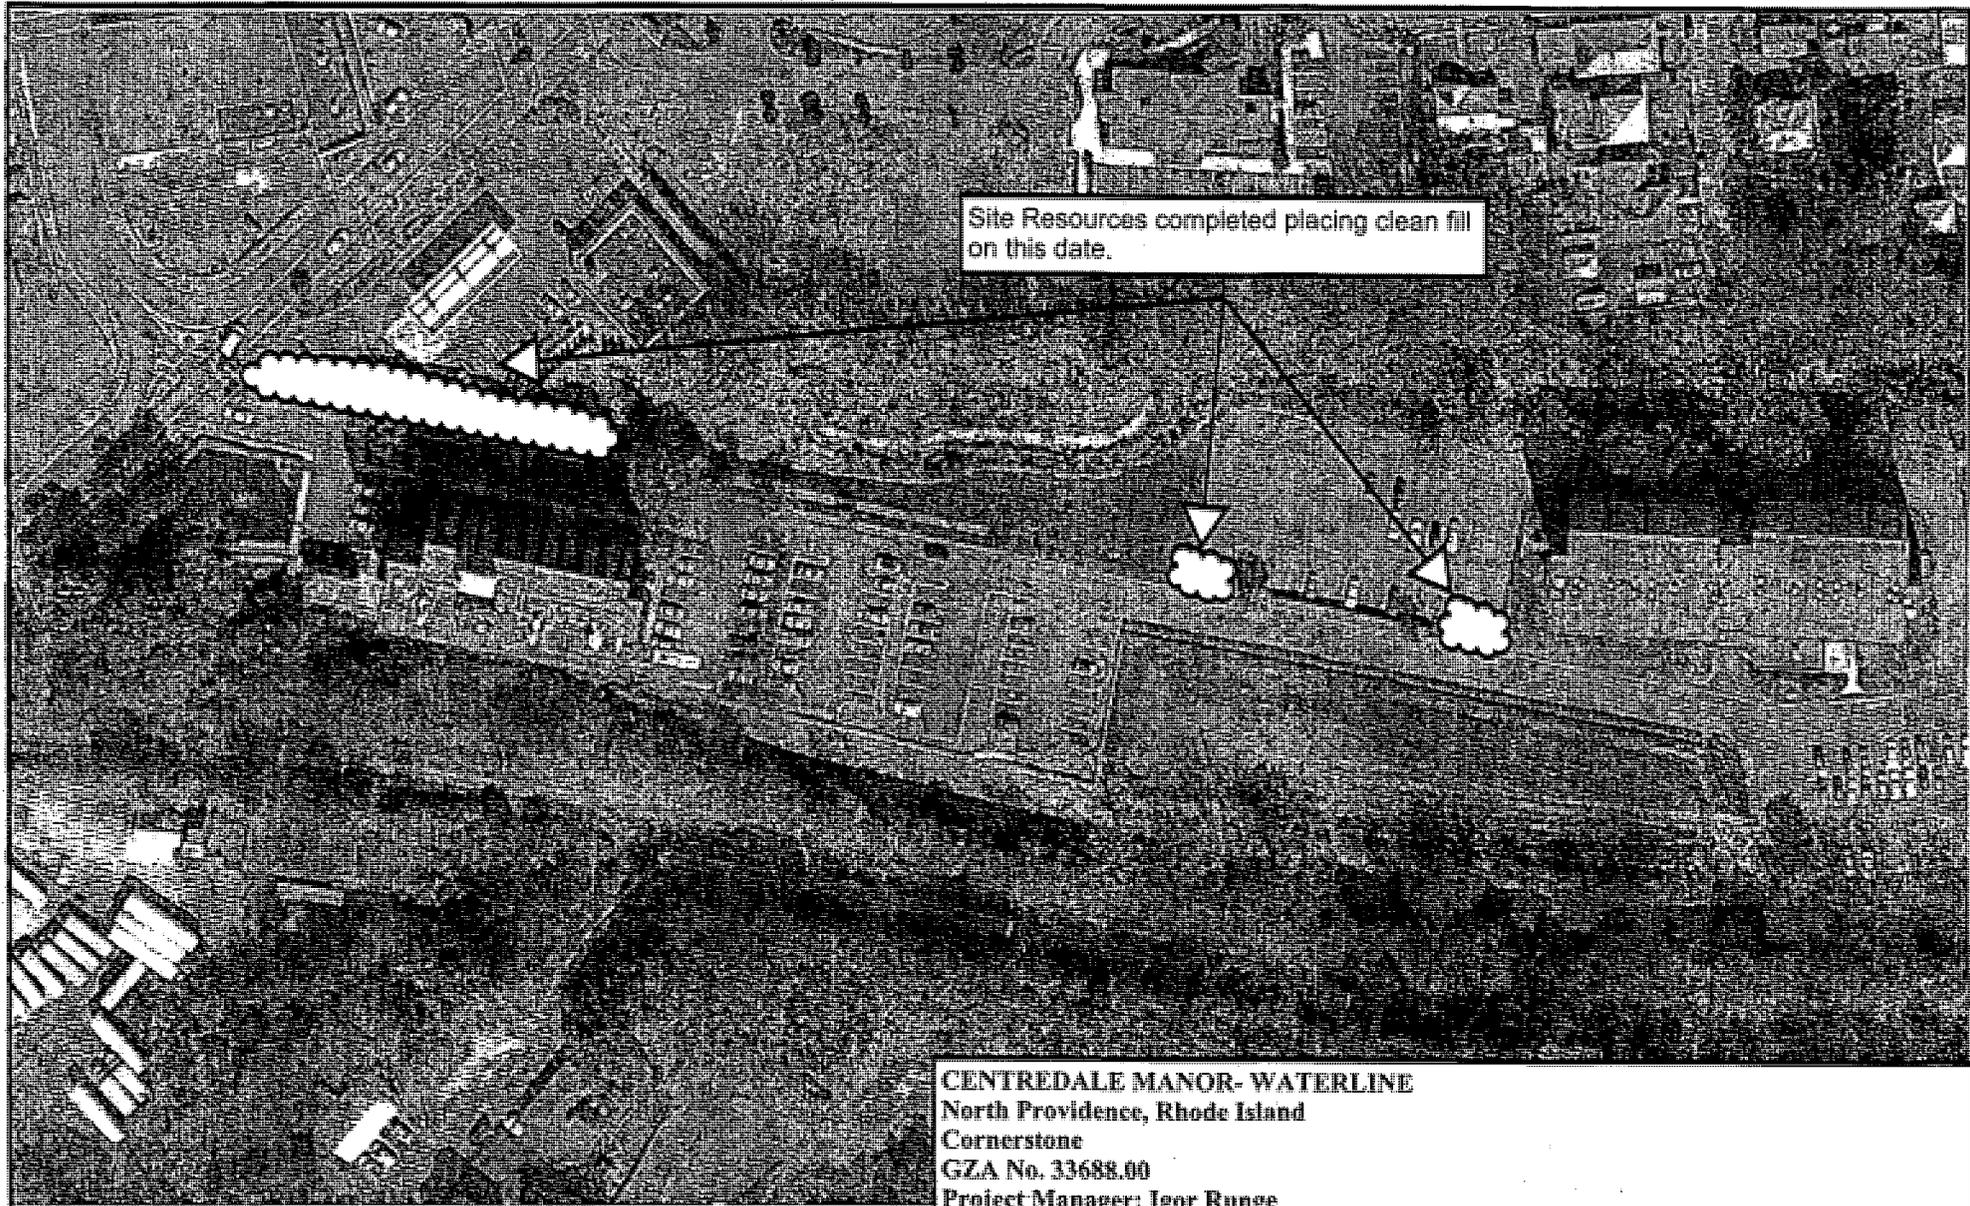
CENTREDALE MANOR- WATERLINE
North Providence, Rhode Island
Cornerstone
GZA No. 33688.00
Project Manager: Igor Runge
Field Sketch -18 Date: 12-21-10
Drawn by: NDW

Site Resources completed placing clean fill on this date.

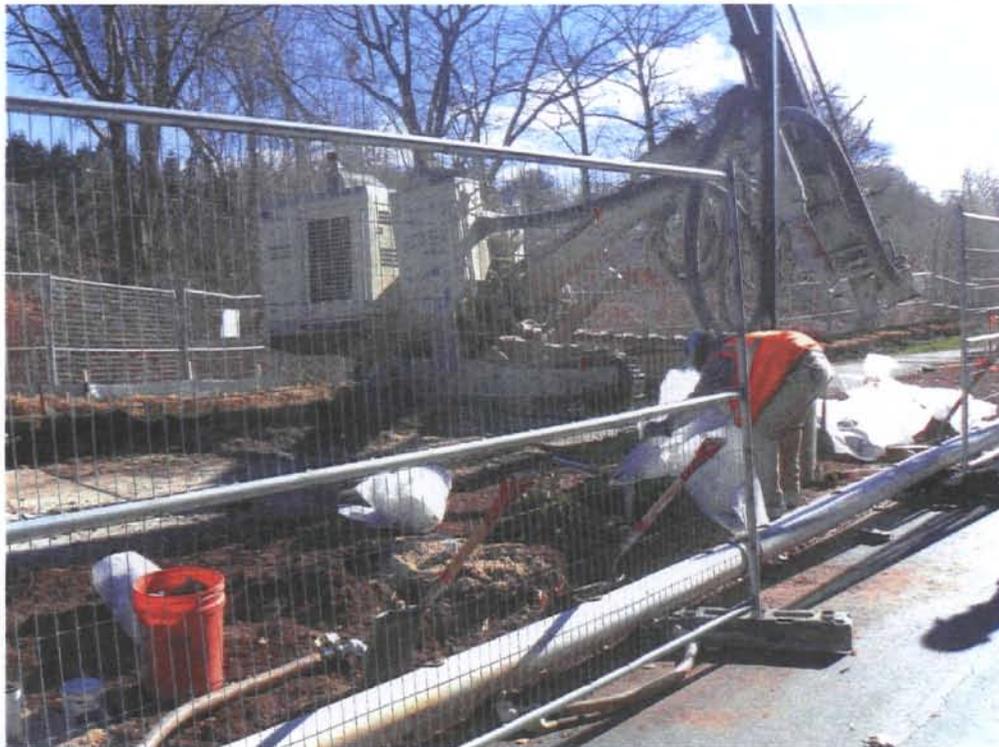
Description: Installation of dewatering components
Name: 6Dec2010 019

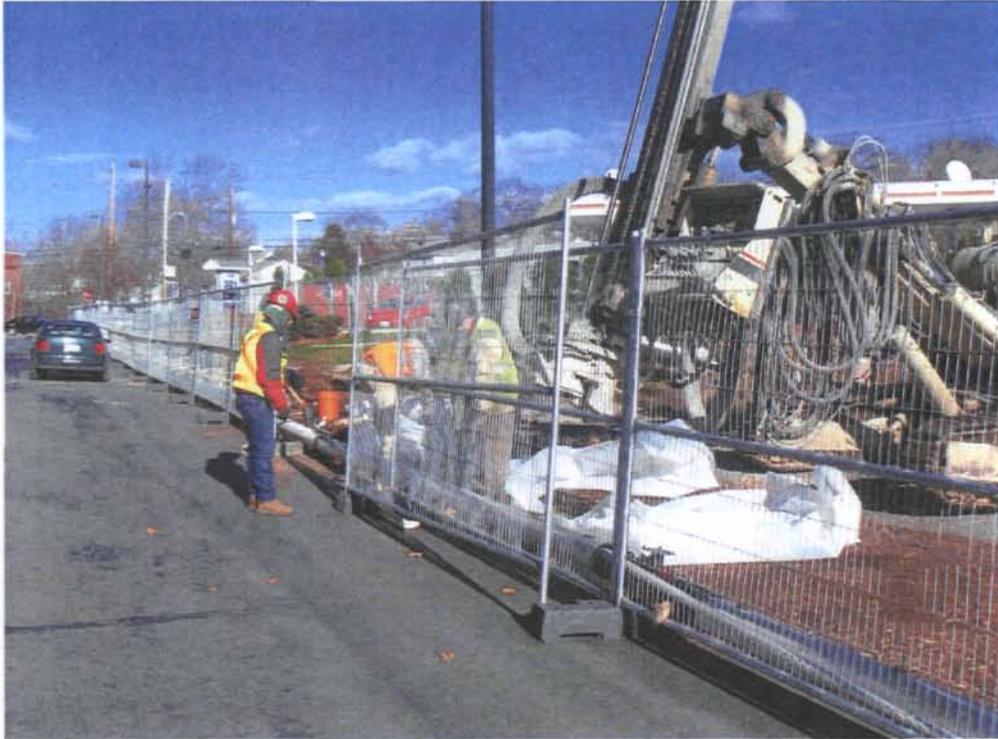
Description: Installation of dewatering components
Name: 6Dec2010 021

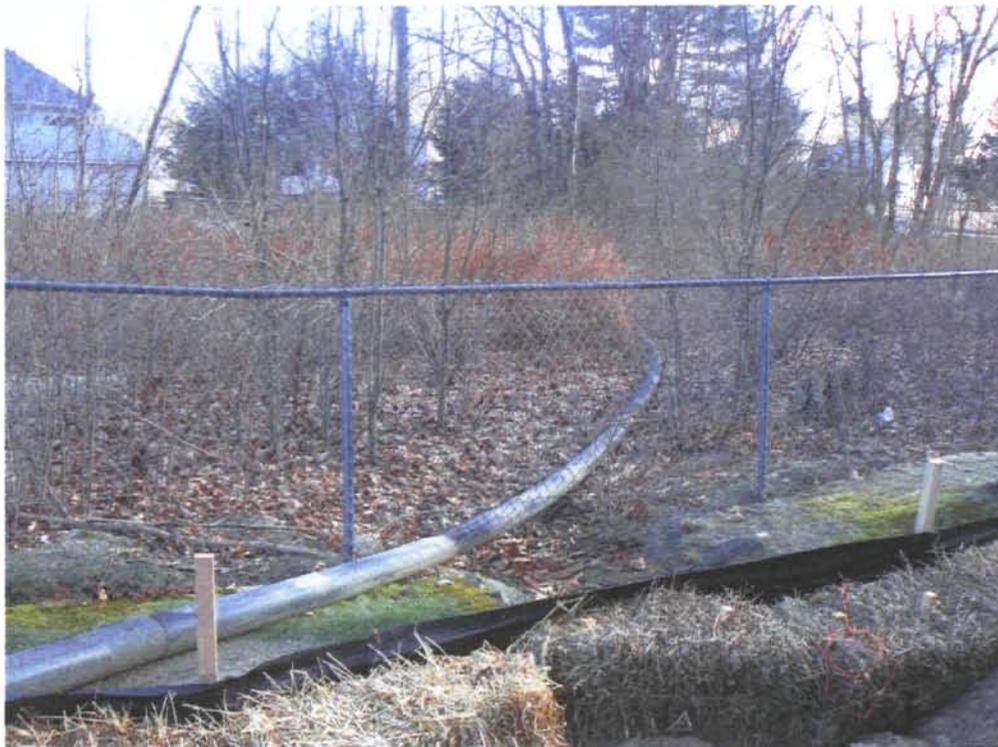
Description: Temporary waterline
Name: 6Dec2010 013
