**COMPLETION OF WORK REPORT
ENERGY REPLACEMENT OF WATERLINE
CENTREDALE MANOR
NORTH PROVIDENCE, RHODE ISLAND**

March 2011
File No. 33688

Re: Completion of Work Report – Emergency Water Line Repairs
Centerdale Manor
2074 Smith Street
North Providence, Rhode Island

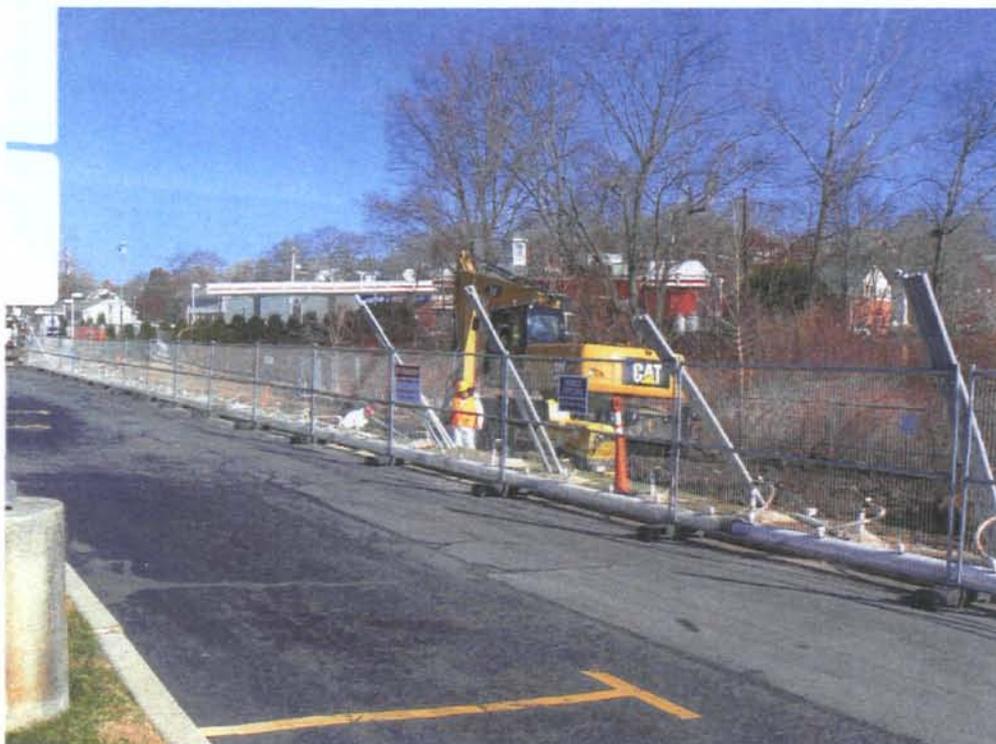
Description: Trench excavation
Name: 11Dec2010 001

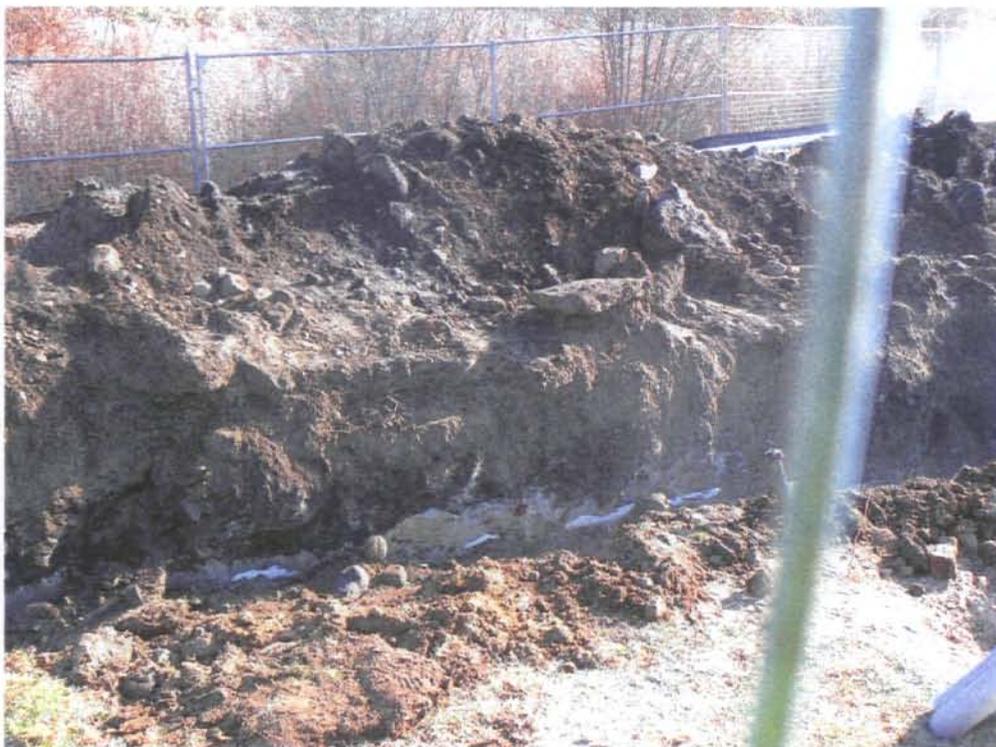
Description: Trench excavation
Name: 11Dec2010 002

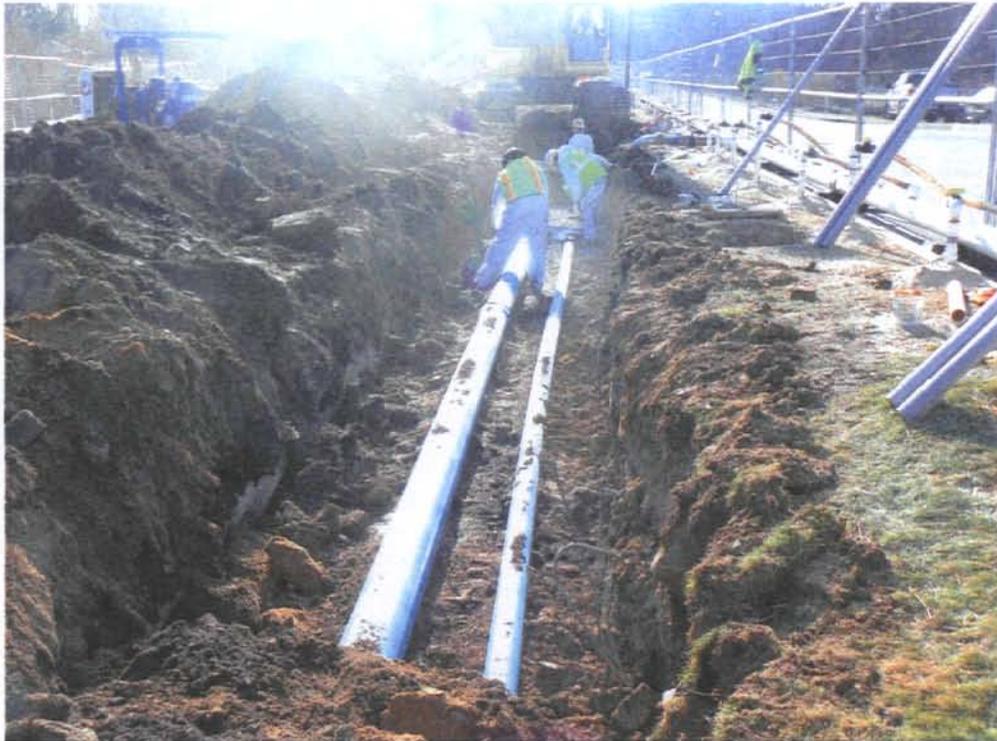
Description: Trench excavation
Name: 11Dec2010 004

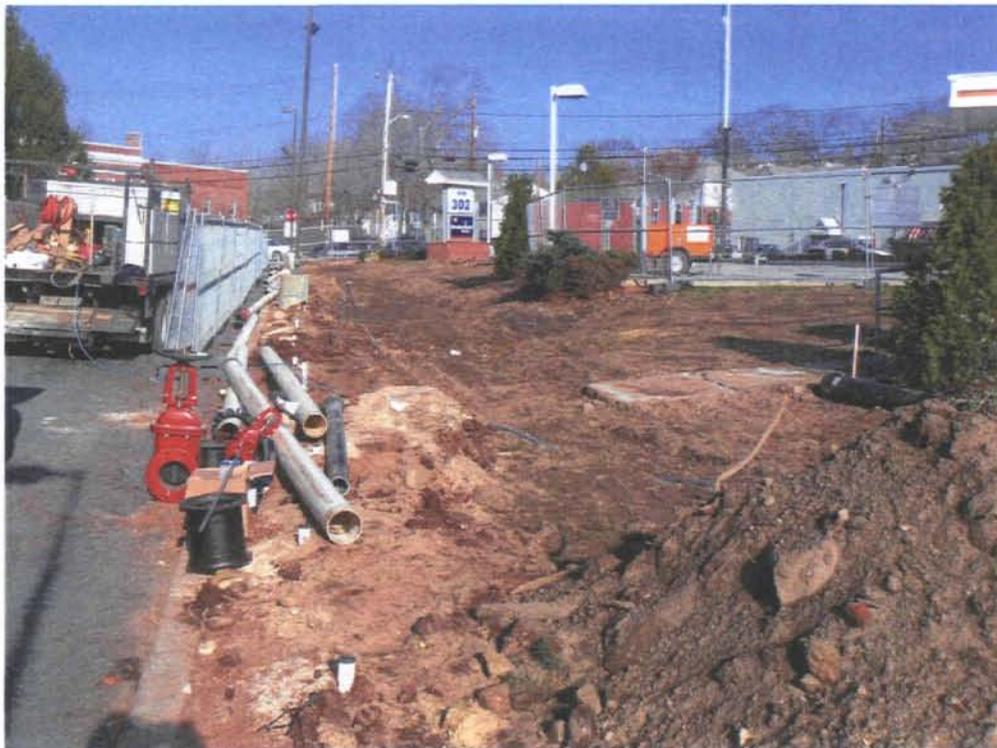
Description: "Hot Box" components
Name: 11Dec2010 008

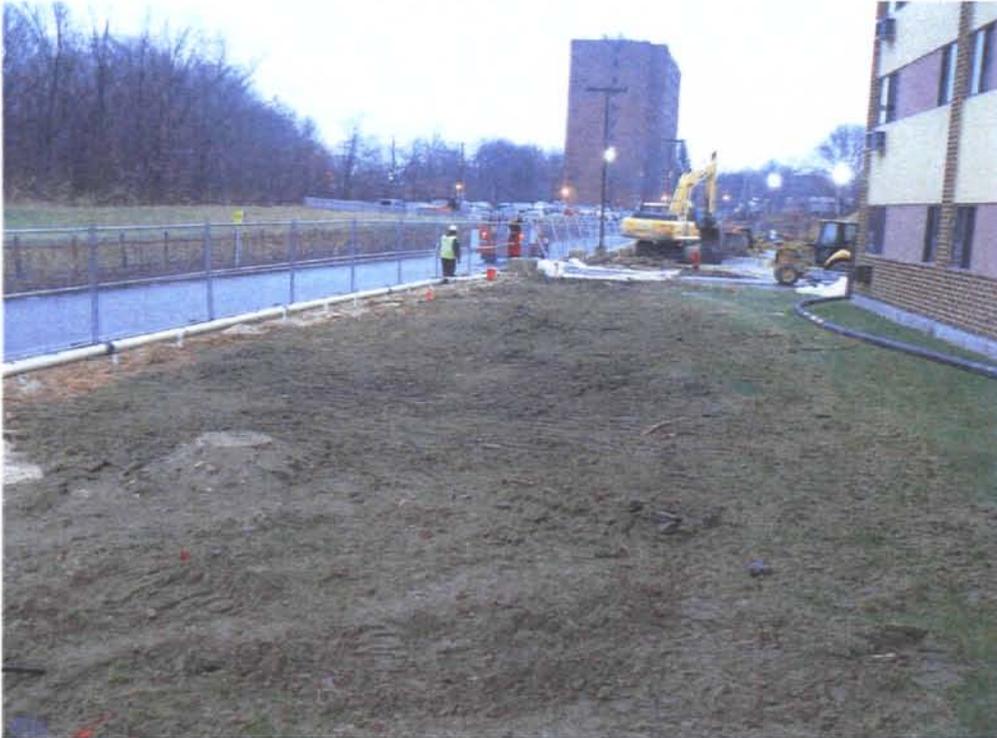
Description: Dewatering components near Centredale Manor buiding
Name: 12Dec2010 001

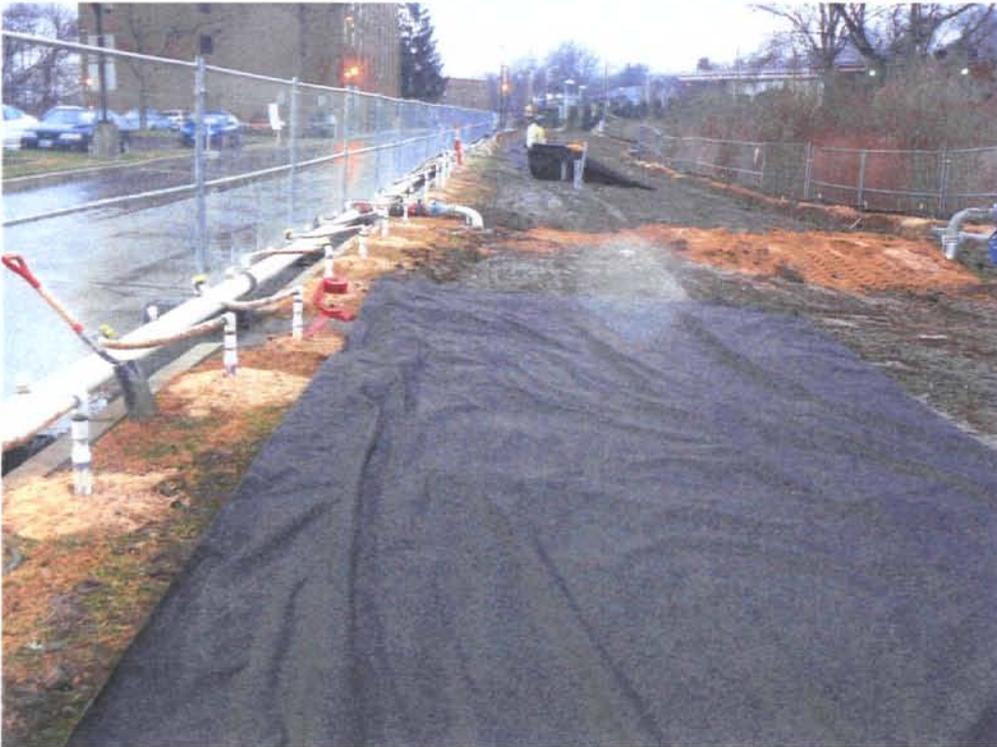
Description: Laying of fabric in preparation for rain
Name: 12Dec2010 005

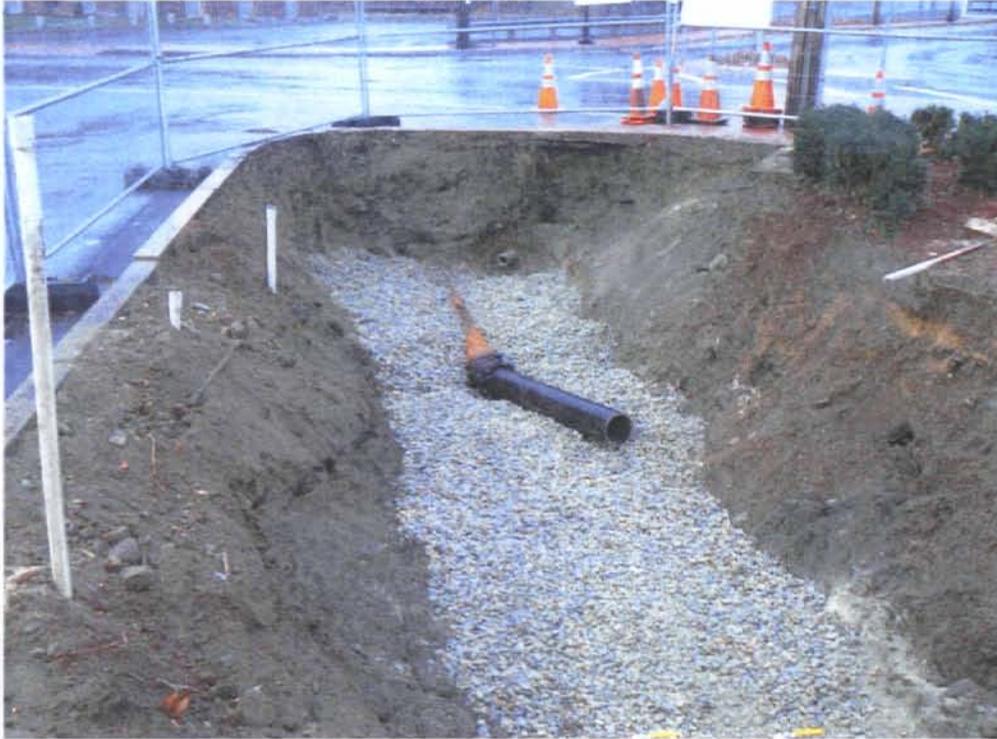
Description: Waterline near Smith Street
Name: 12Dec2010 011

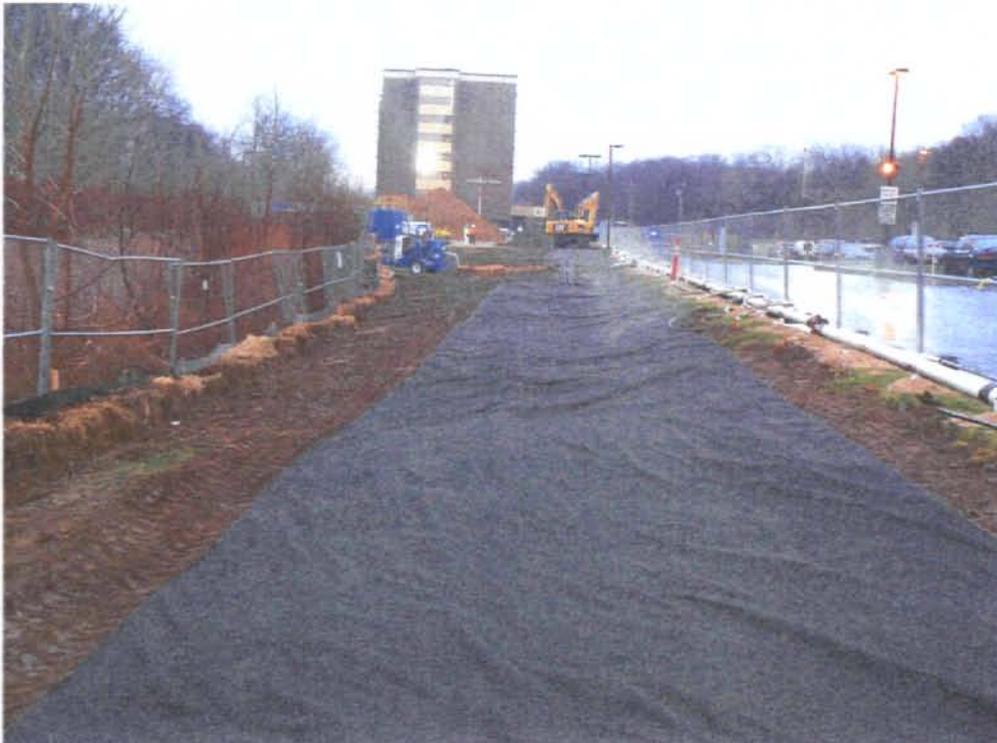
Description: Fabric over completed trench
Name: 12Dec2010 019

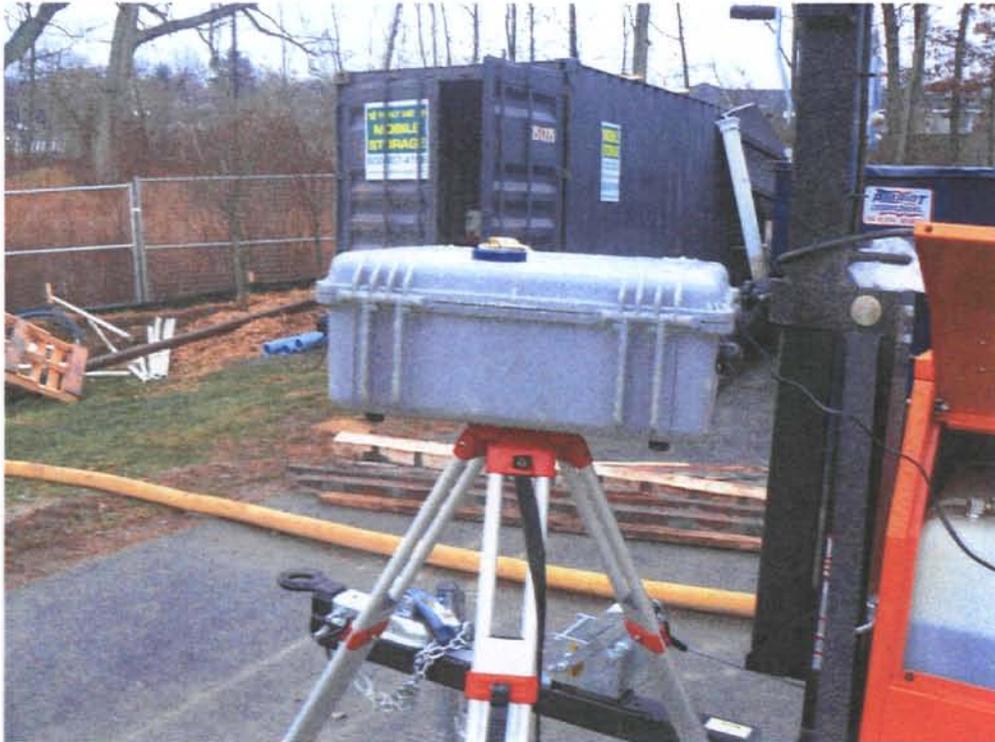
Description: Dust monitoring meter
Name: 12Dec2010 022

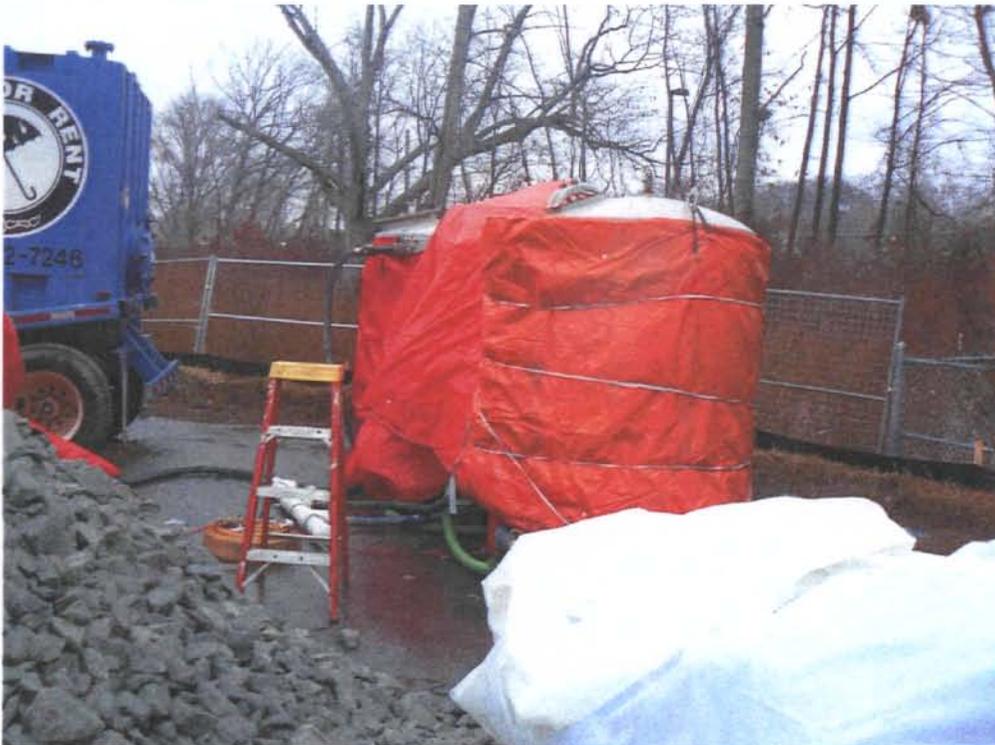
Description: Granular activated carbon vessels
Name: 12Dec2010 026

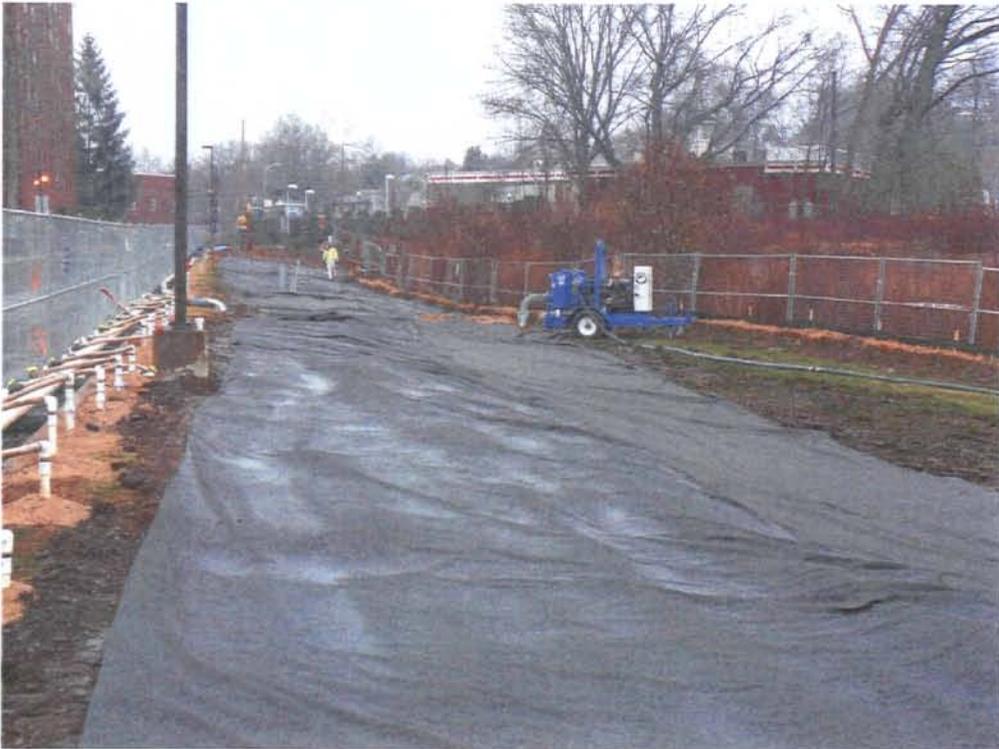
Description: Fabric over completed trench before rain
Name: 12Dec2010 033

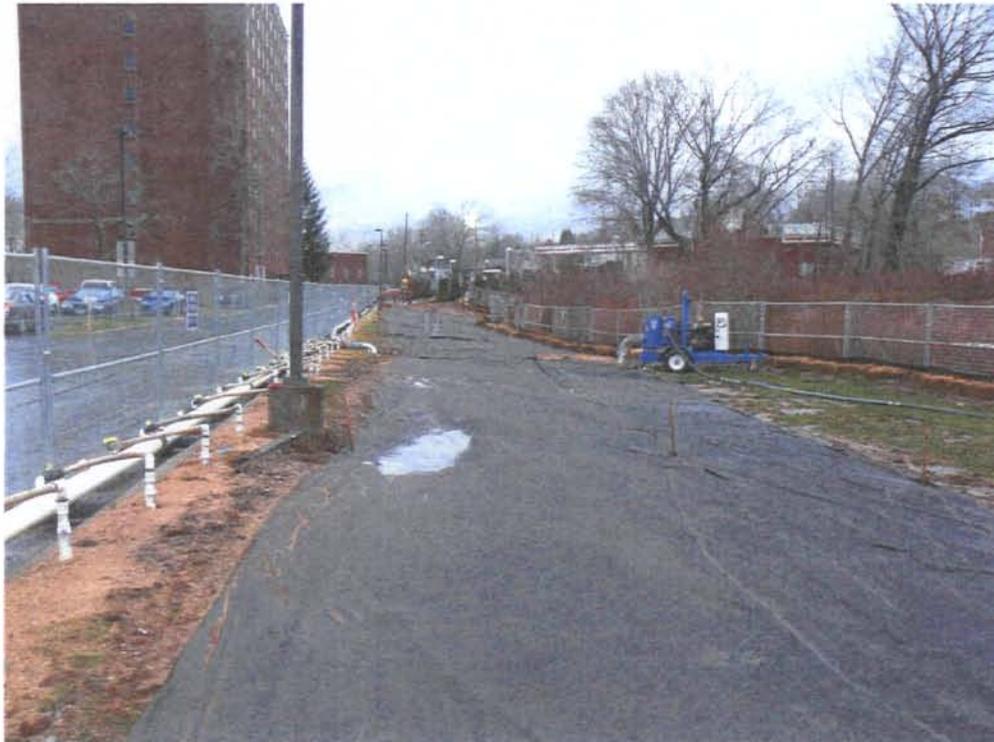
Description: Fabric over completed trench after rain
Name: 13Dec2010 003

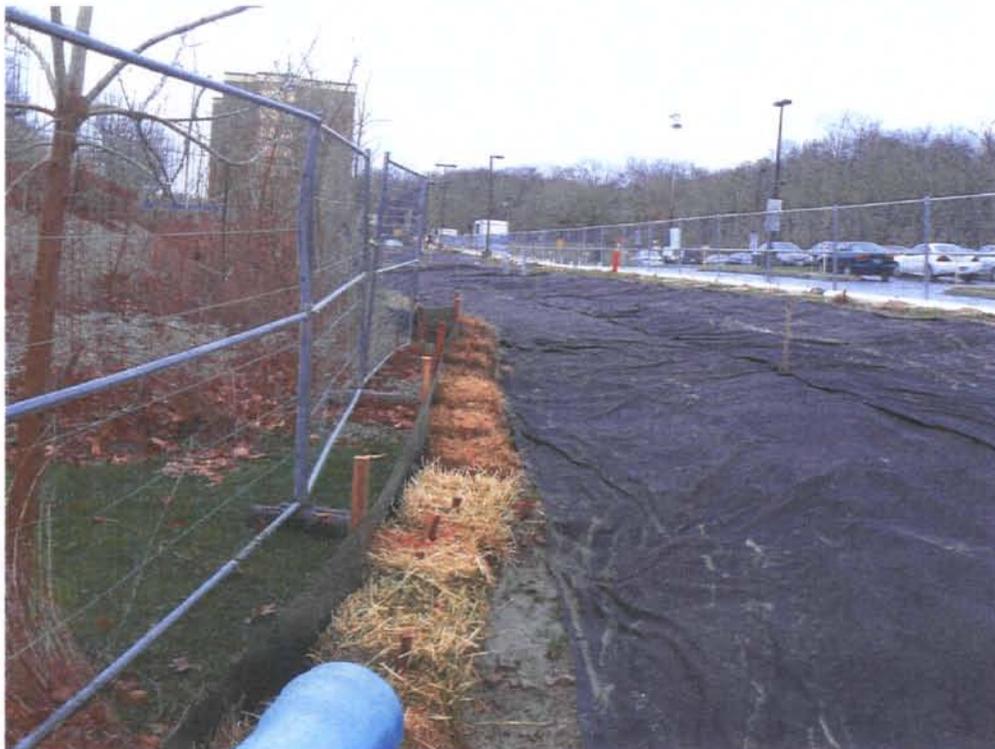
Description: Erosion control haybales
Name: 13Dec2010 008

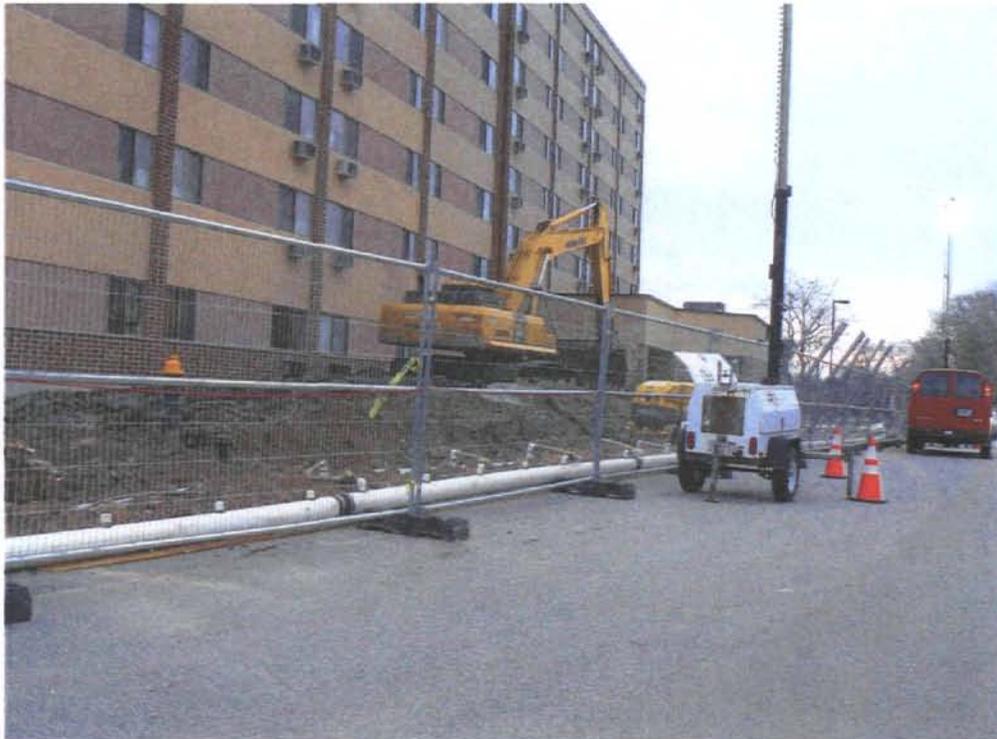
Description: Trenching near Manor building
Name: 14Dec2010 001

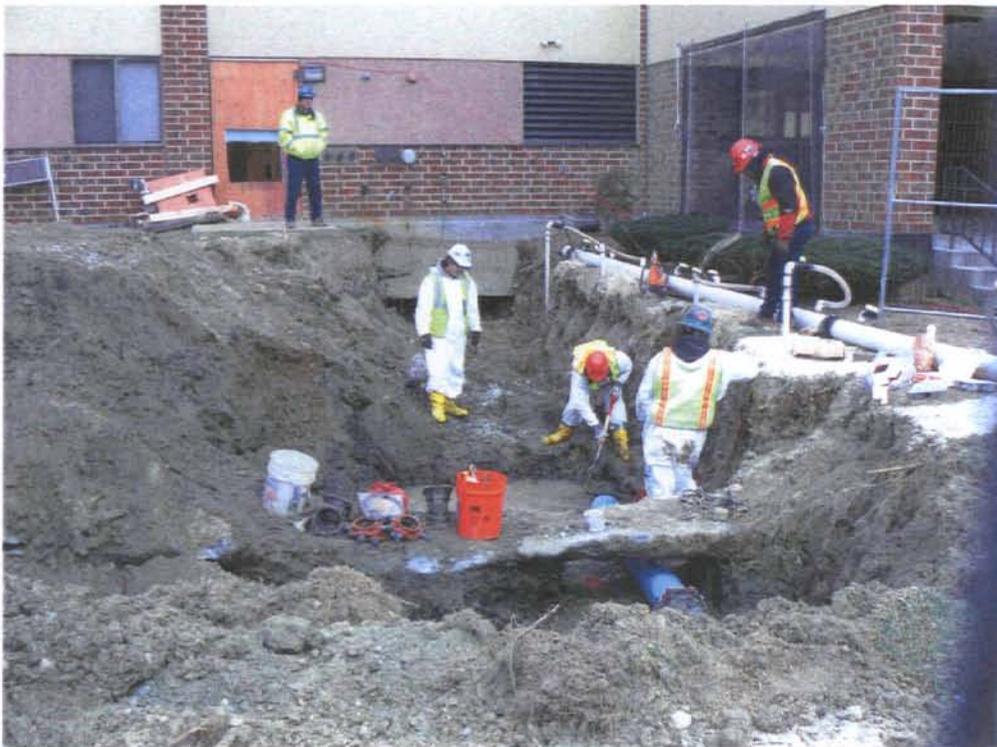
Description: Trenching near Manor building
Name: 14Dec2010 002

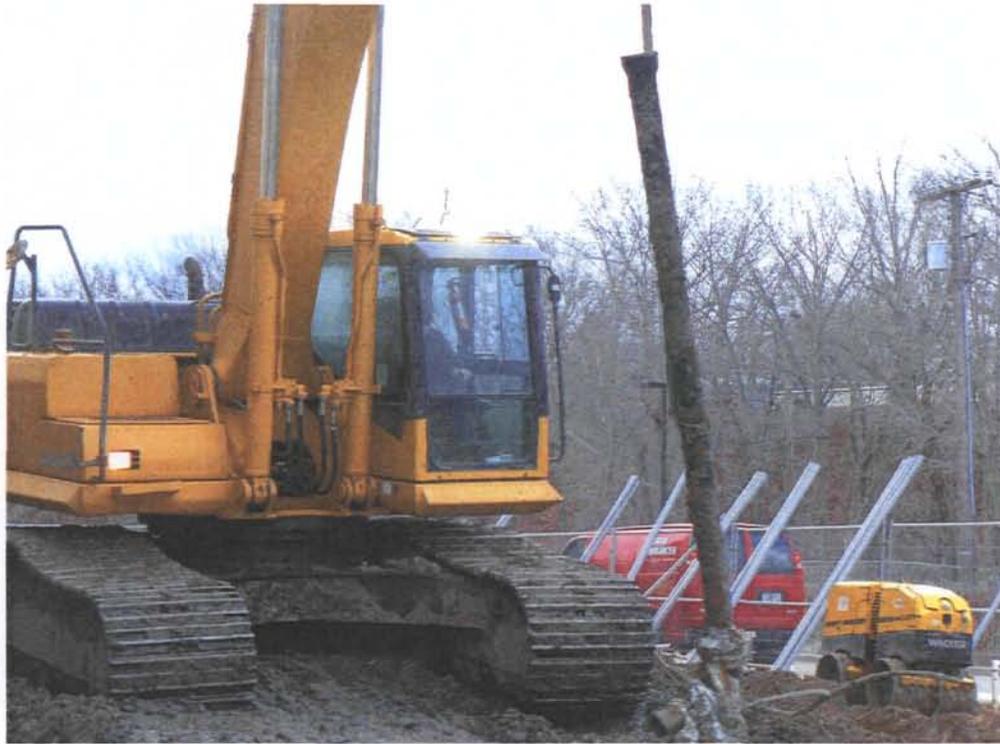
Description: Removal of damaged waterline
Name: 14Dec2010 013

On or about 1 November 2010, the property owner, with the assistance of personnel from GEM Plumbing and Heating Services, Inc. (GEM), identified that the subsurface water line to the subject building was leaking. As a precaution, the residents were provided with bottled water. A subsequent test pit exploration, conducted by GEM on 15 November 2010 established that at least portions of the 8-inch cast iron pipe had been corroded. Visual observations indicated that the bottom of the pipe (at the test pit location, near the North end of the building) was severely corroded with a hole on the order of ½ inch in diameter being noted at one location, while the top and interior of the pipe were in good condition.

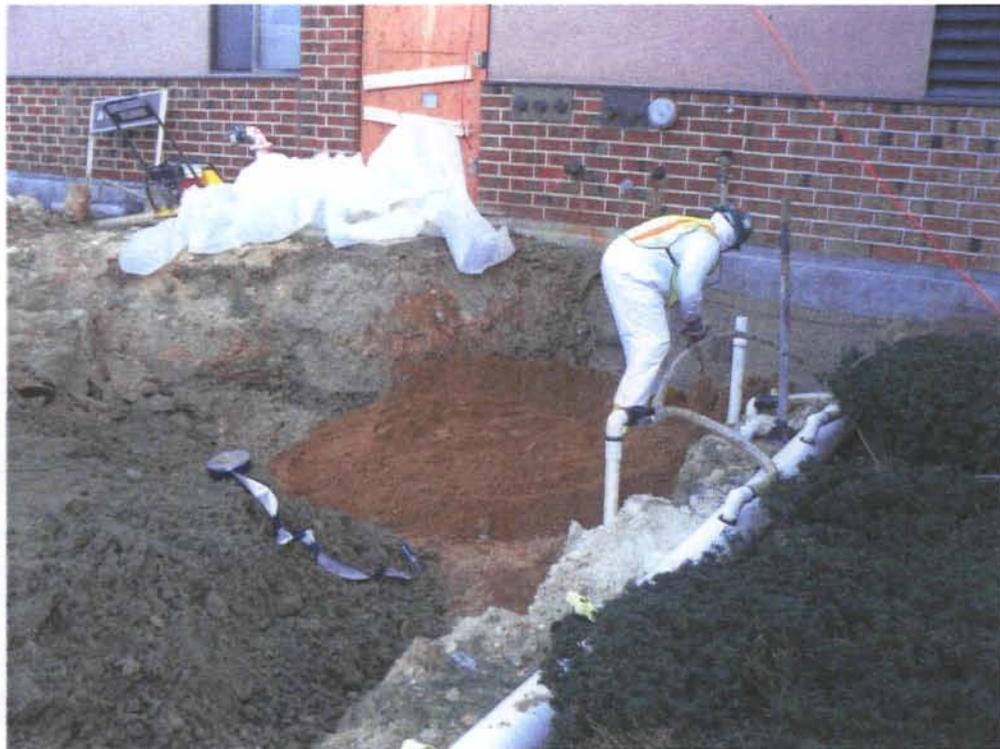
Description: Building connection
Name: 15Dec2010 004

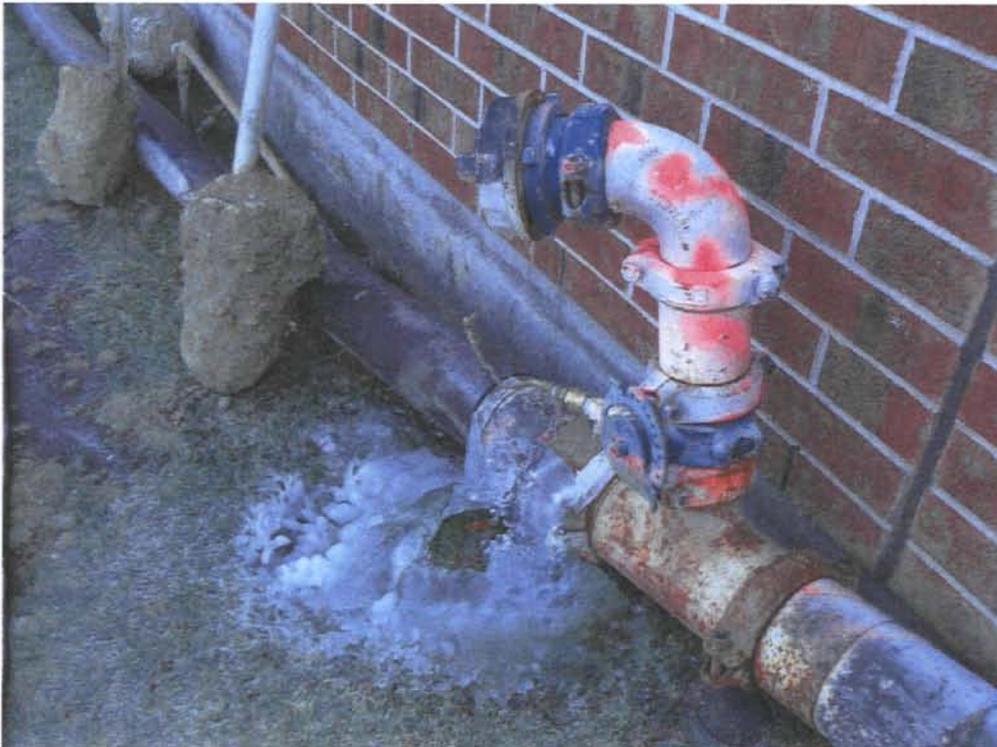
Description: Temporary waterline icing
Name: 17Dec2010 004

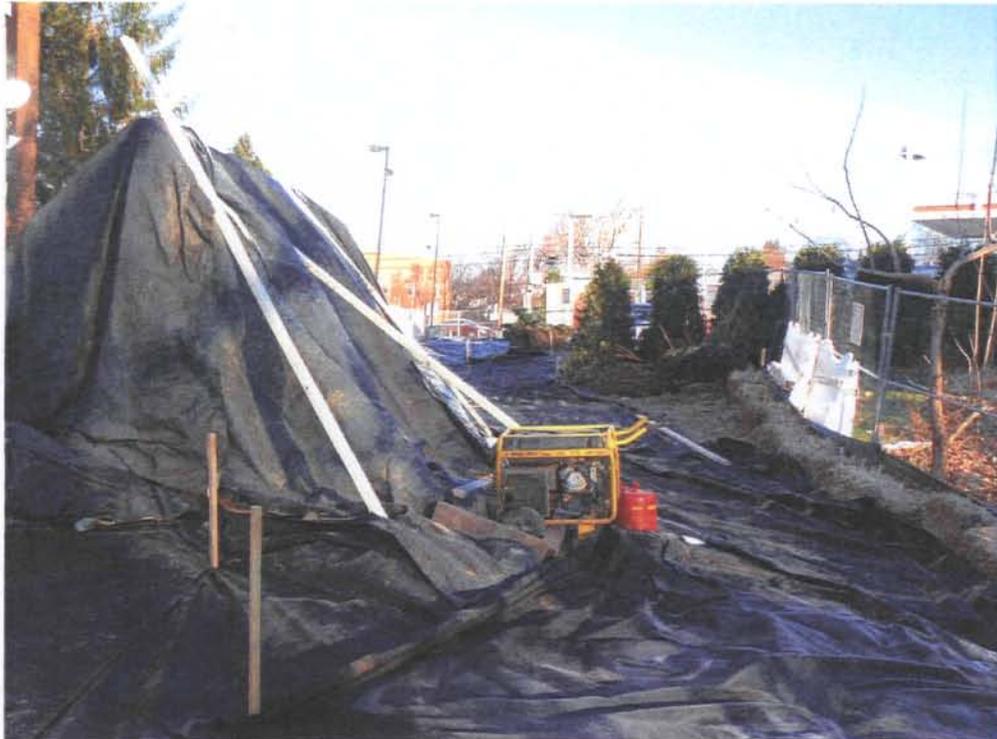
Description: "Hot Box" construction
Name: 17Dec2010 017

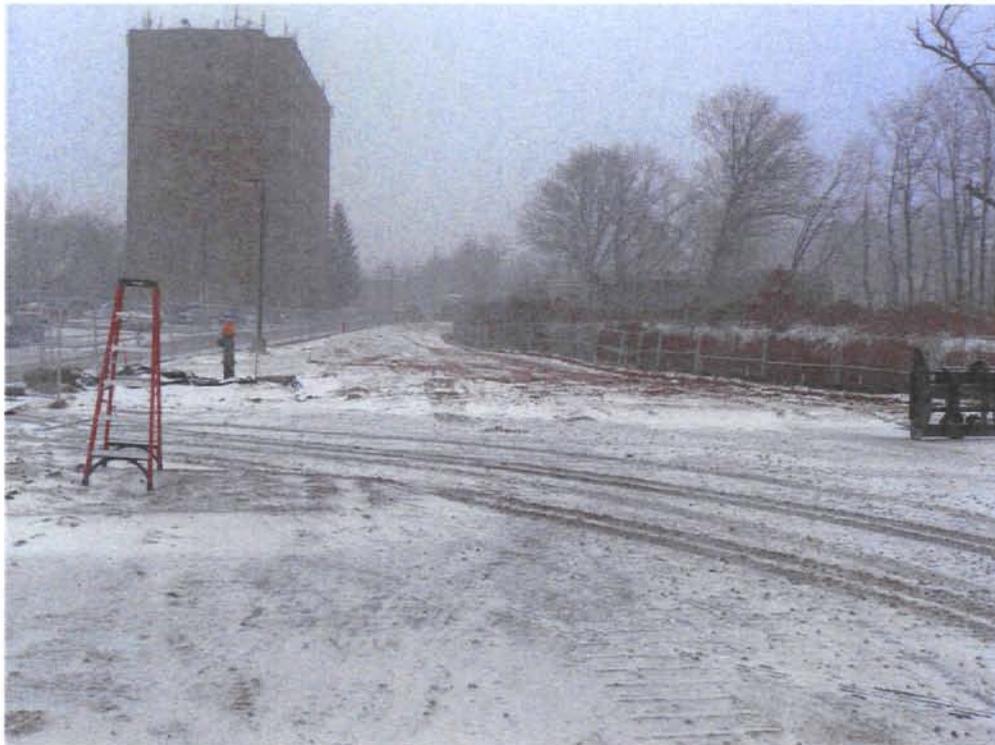
Description: Application of clean fill over trench
Name: 21Dec2010 005

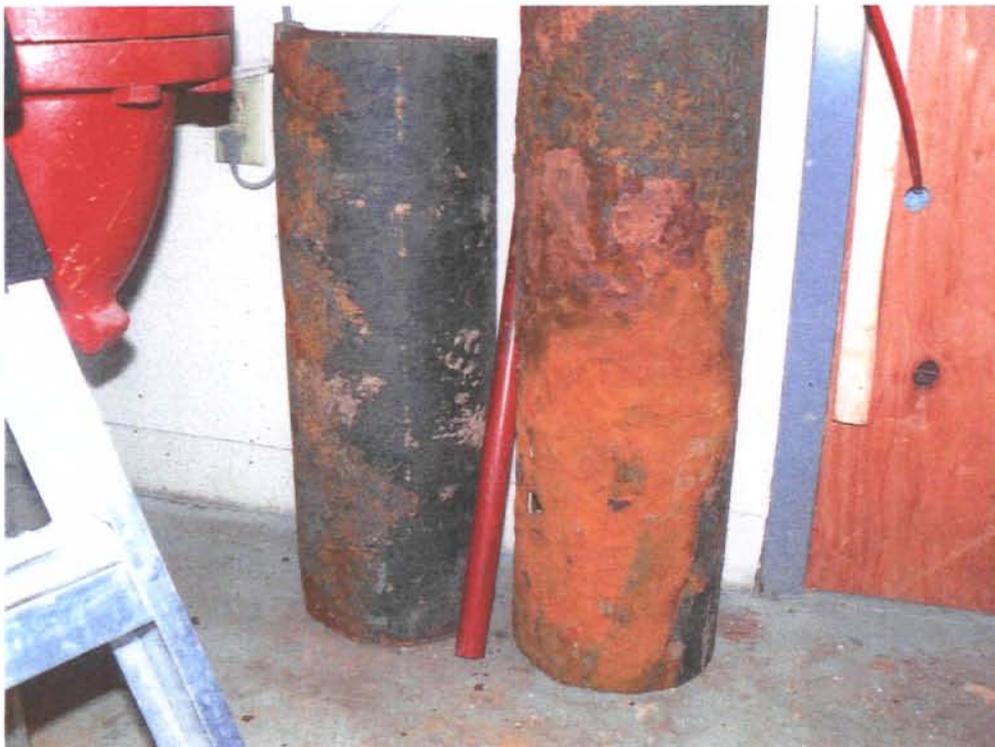
Description: Section of corroded waterline
Name:
