HRS DOCUMENTATION RECORD COVER SHEET

Name of Site: Creese & Cook Tannery (Former)

HRS DOCUMENTATION RECORD

Date Prepared: September 2012

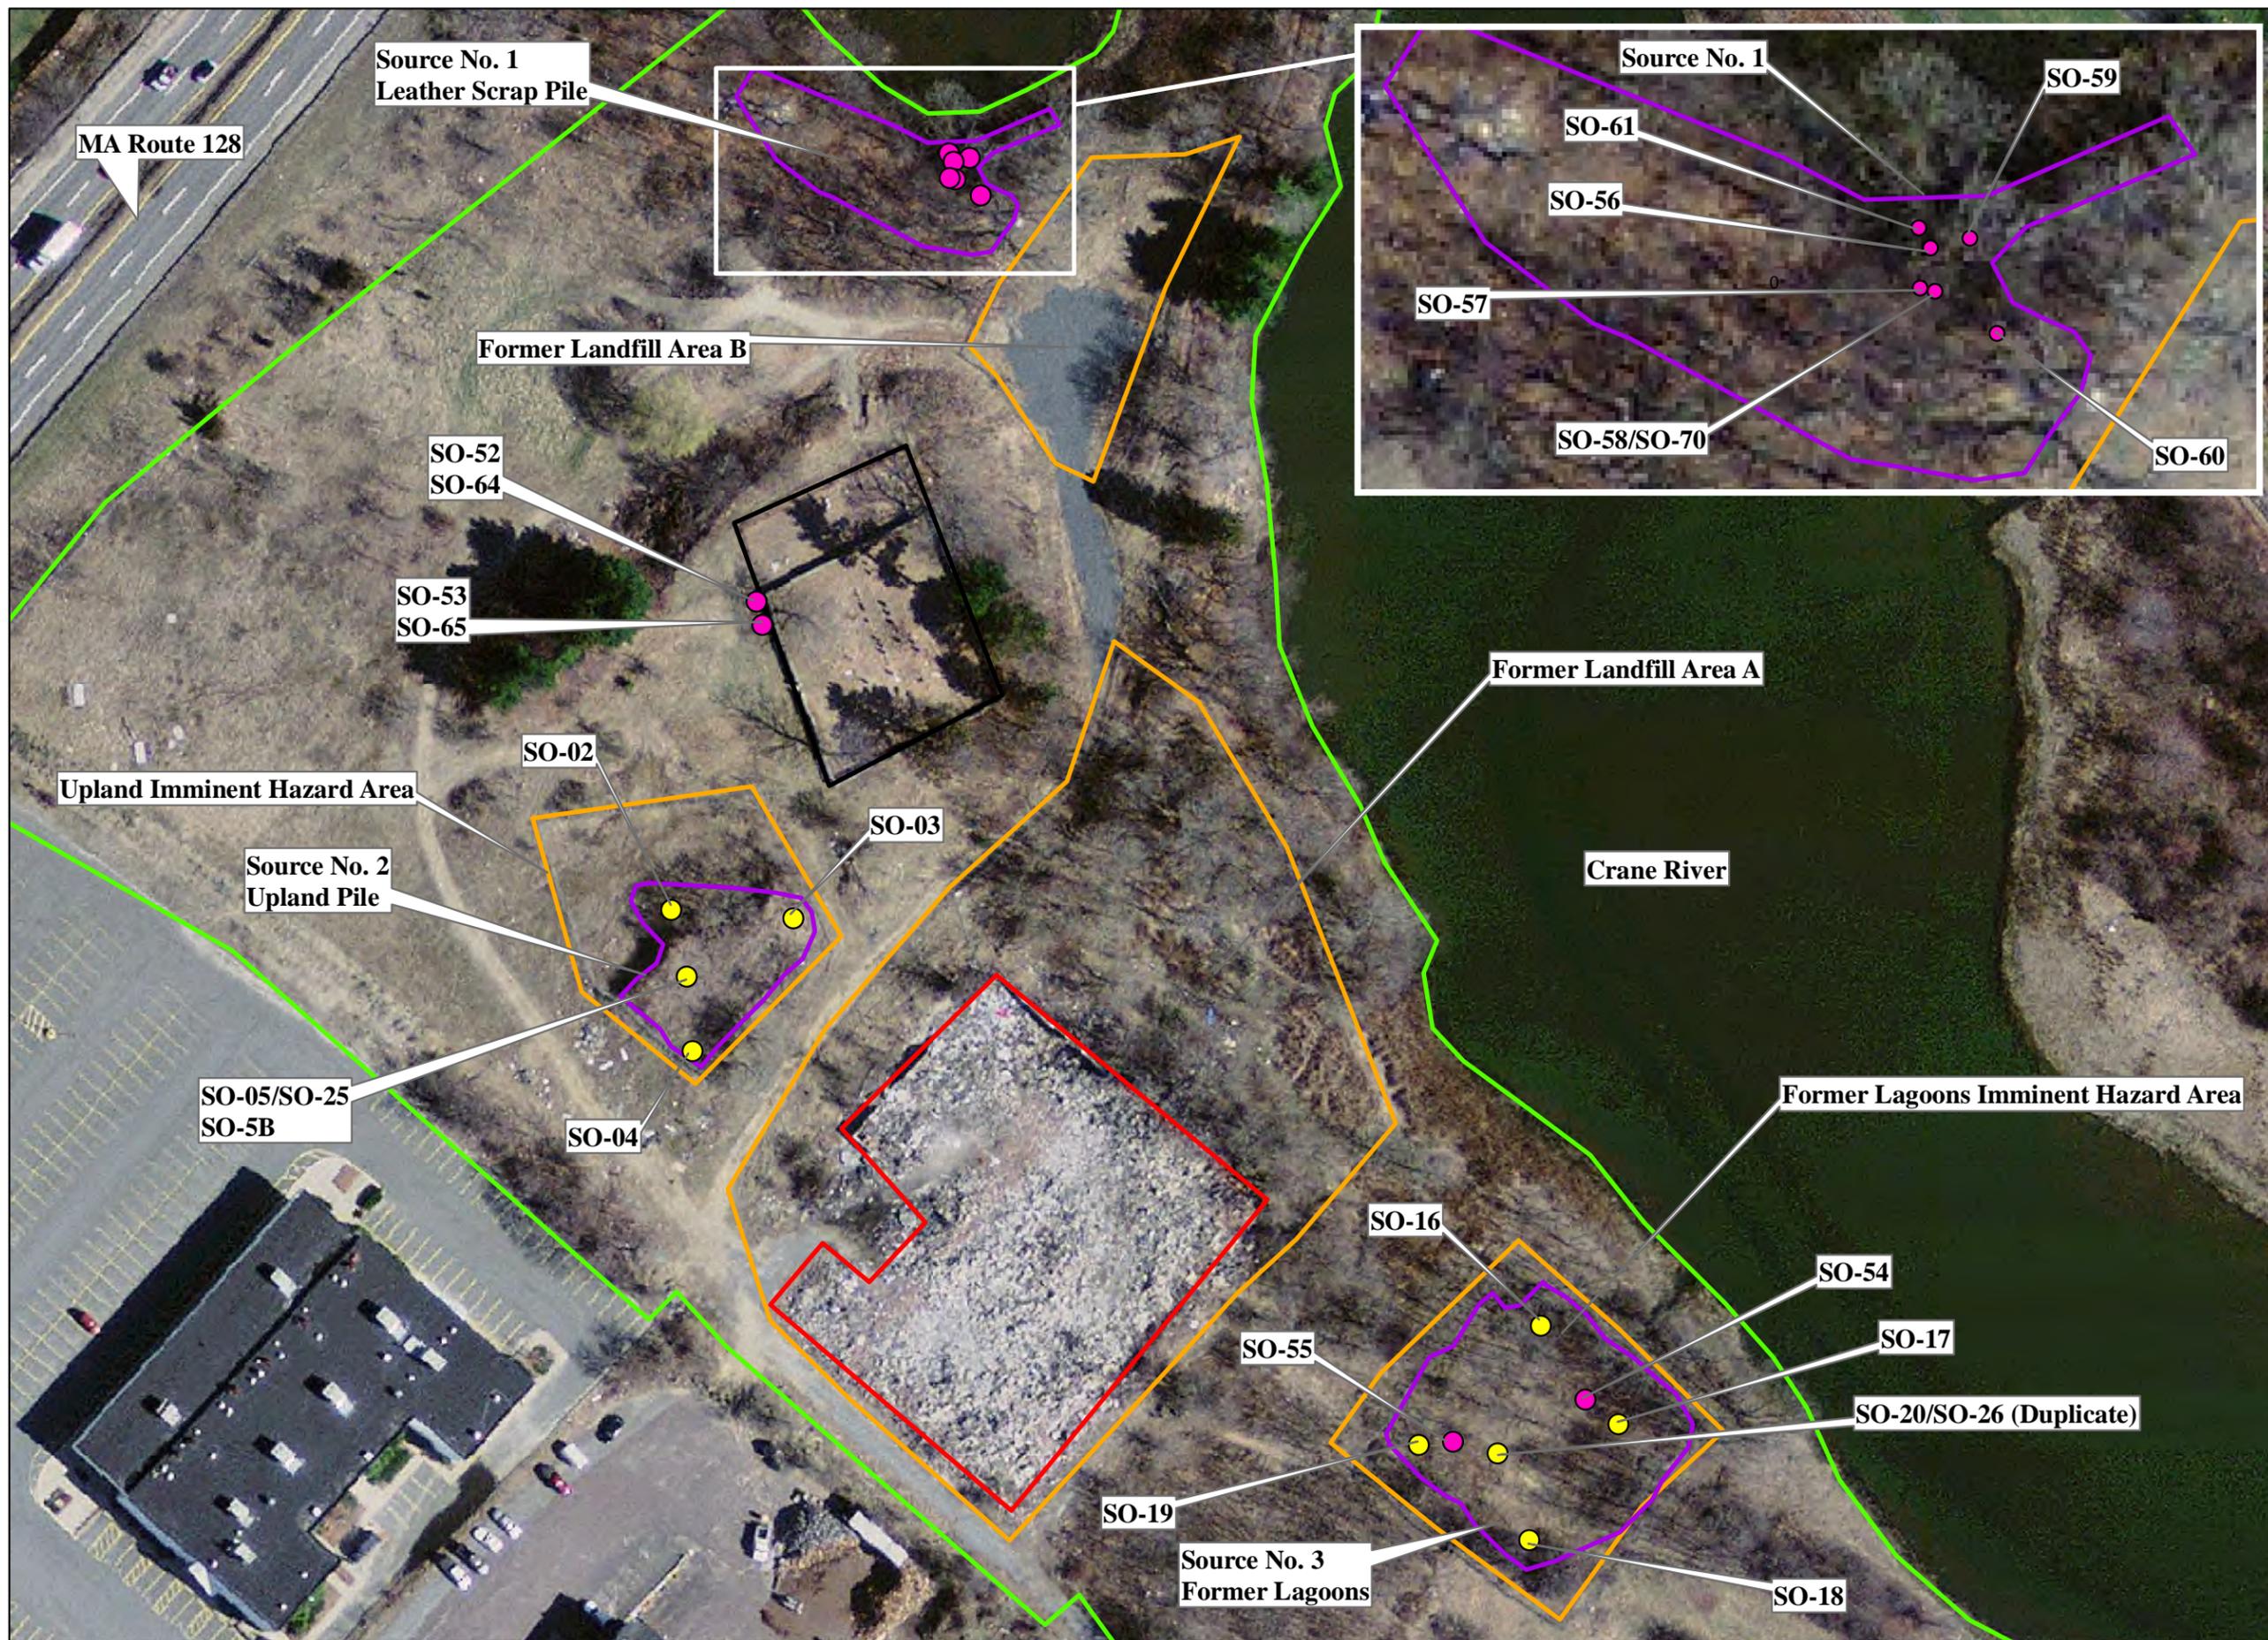
Figure 3a
Soil/Source Sample
Location Map A
 Creese & Cook Tannery (Former)
 Danvers, Massachusetts

- Dec. 2011 Soil/Source Sample
- May 2011 Soil/Source Sample
- 55 Clinton Ave Parcel
- Source Areas
- Fenced Imminent Hazard Areas
- Beamhouse Footprint
- Cemetery

The estimated area and volume of the Upland Pile was not found in available documentation. Based on sampling results and observations of the piled material that constitutes Source No. 2 (Upland Pile), the areal extent of the base of the source pile defined as part of this source characterization was documented using GPS (see Figure 2) [11, p. 13; 21]. Based on the information recorded as part of the EPA SR, the area contained by the Upland Pile (Source No. 2) was determined to be approximately 6,009 ft² (see Figures 2 and 3a) [11, p. 13; 21].

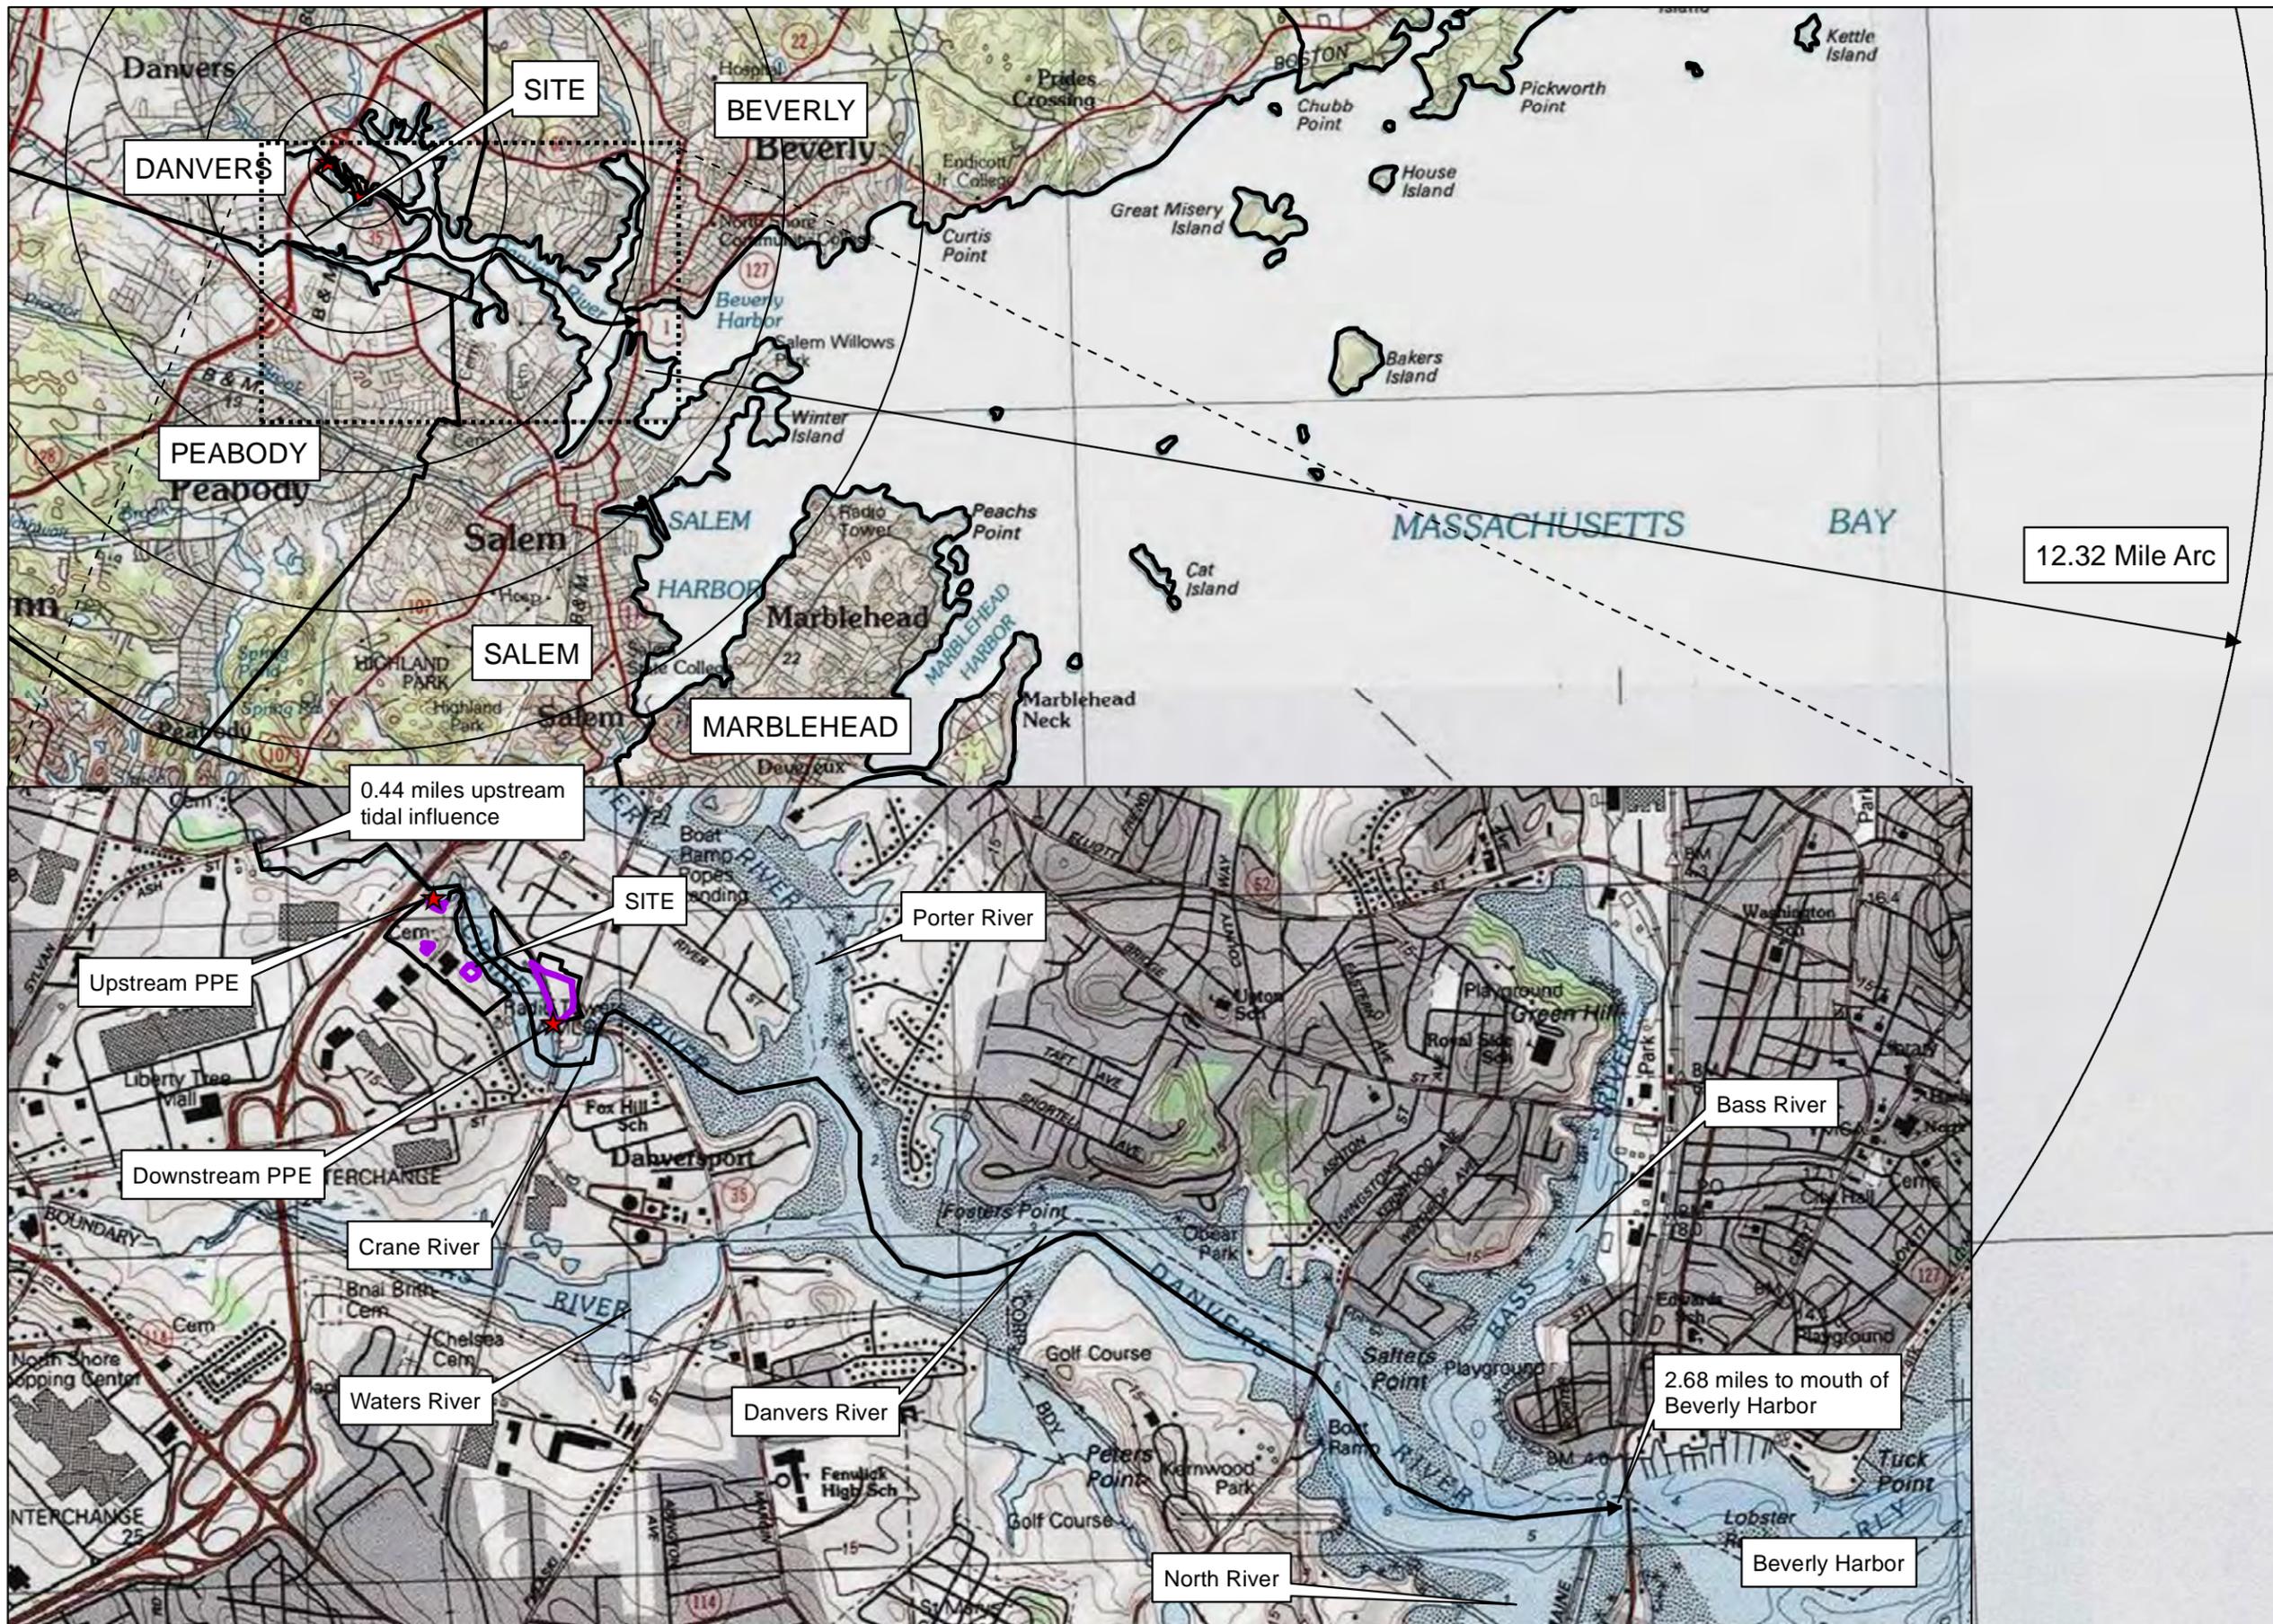
Figure 4a

Target Distance Limit

- Site Boundary
- Source Areas
- SWP
- ★ Probable Point of Entry (PPE)
