FINAL REPORT

**ARCHEOLOGICAL DATA RECOVERY
UPPER AND LOWER COPPERAS FACTORIES AND
INTERCOPPERAS AREAS
AND MONITORING MITIGATION FOR A NON-TIME-CRITICAL
REMOVAL ACTION (NTCRA)
ELIZABETH MINE SITE (VT-OR-28)
South Strafford and Thetford, Vermont**

**Contract #W912WJ-09-D-0001
WHG #PAL0004**

The Public Archaeology Laboratory, Inc.
210 Lonsdale Avenue
Pawtucket, Rhode Island 02860

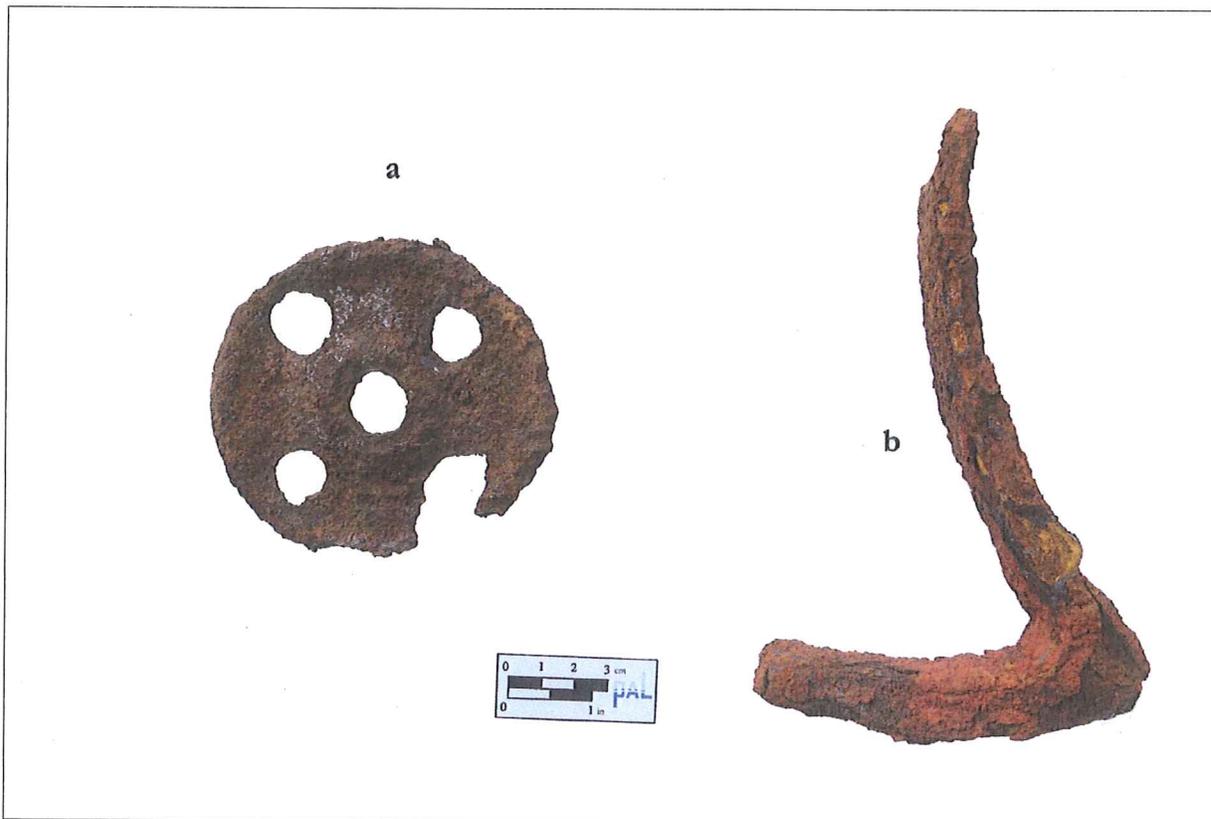
B.1-1. Iron objects recovered from the North Berm at Upper : (a) iron damper wheel, FEA-1-UC in ST-1-UC; (b) iron drive wheel shaft fragment, TR-5-UC.

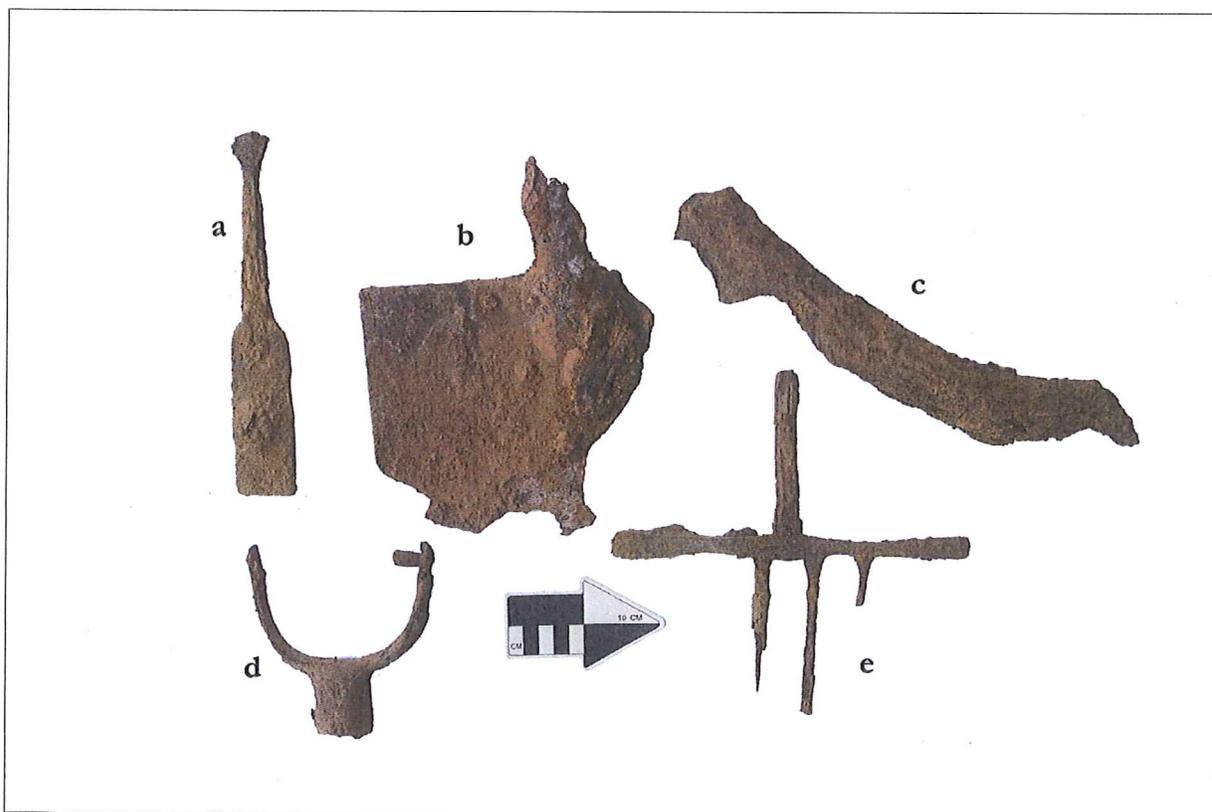
B.1-2. Examples of metal tools recovered at the Lower and Upper Factories: (a) chisel, FEA-4-LC in ST-3-LC; (b) shovel, FEA-1-LC in ST-1-LC; (c) curved wrench, FEA-5-UC in ST-2-UC; (d) tool handle, FEA-2-LC in ST-2-LC; (e) rake, FEA-4-LC in ST-3-LC.

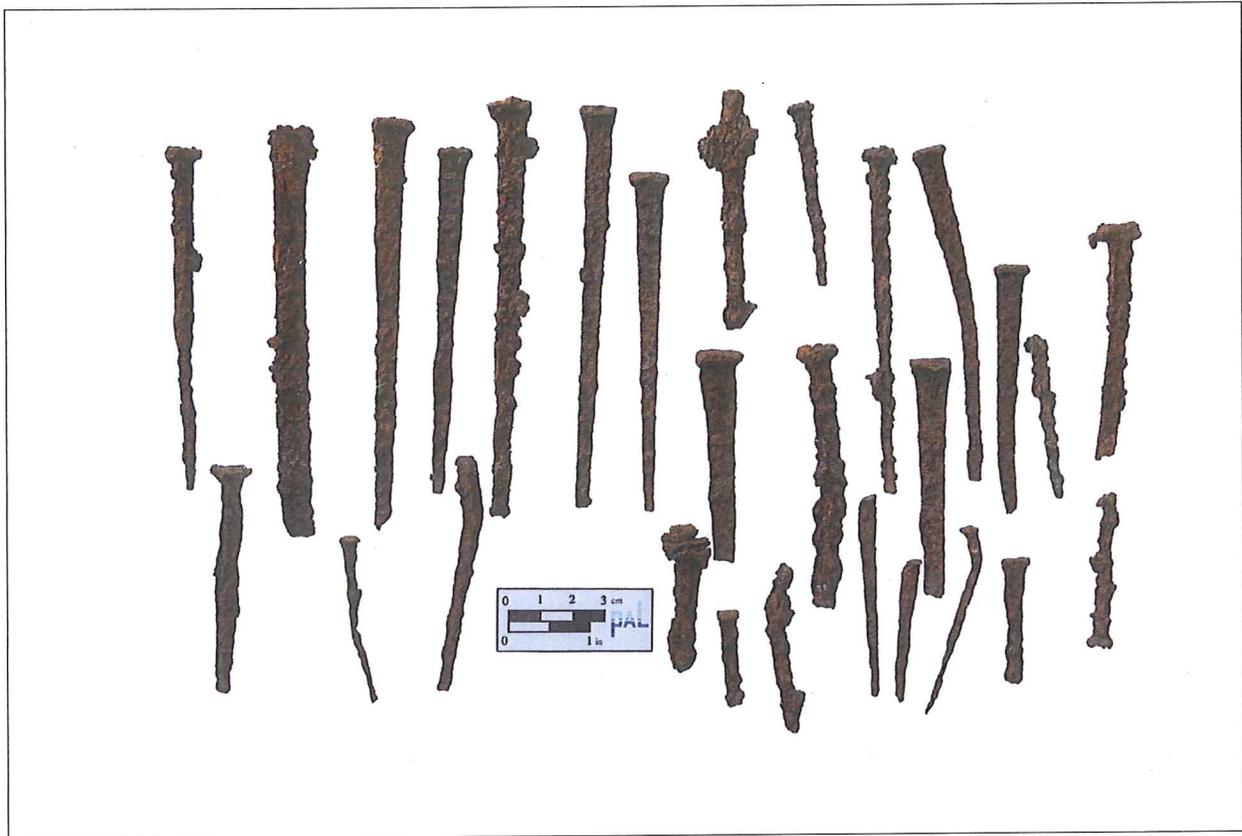
B.1-3. Iron nails recovered from FEA-3-UC in TR-3-UC, before exposure to copperas liquor.

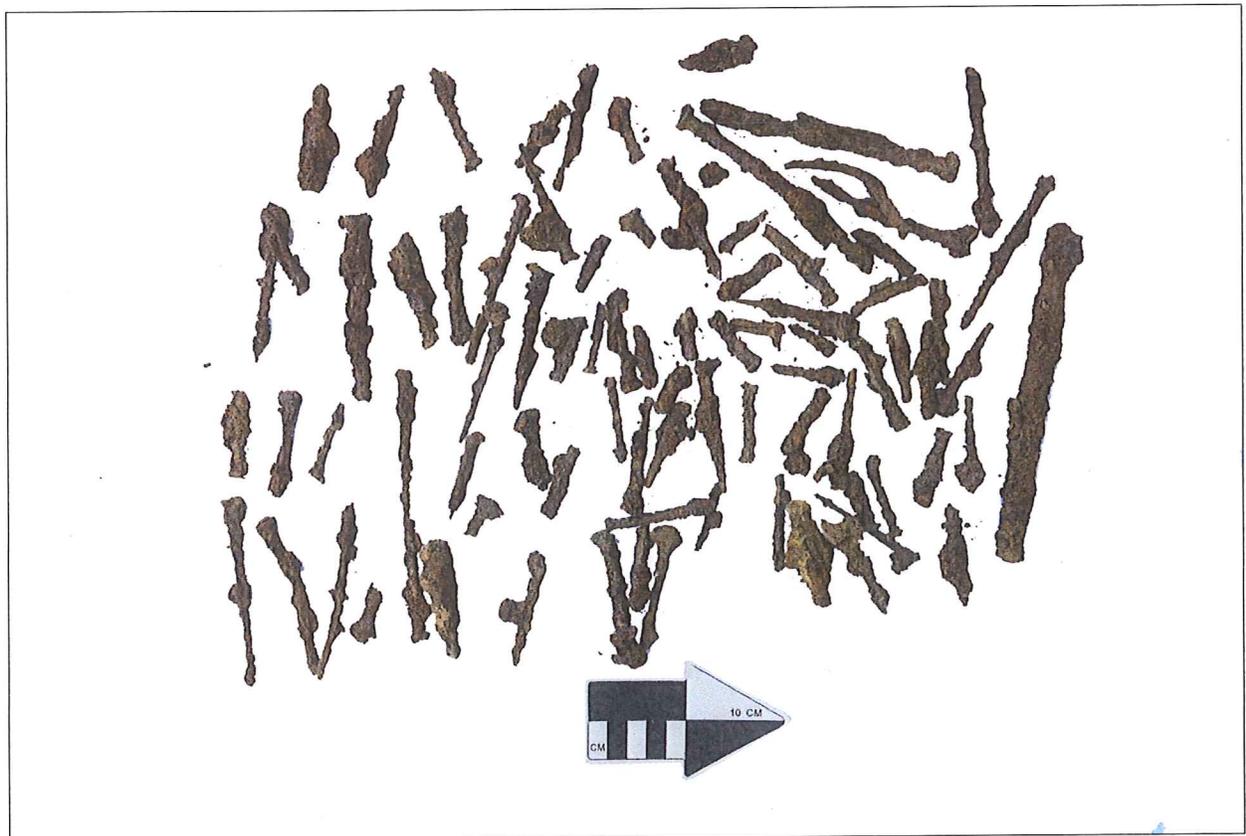
B.1-4. Iron nails recovered from FEA-3-UC in TR-3-UC, after exposure to copperas liquor.

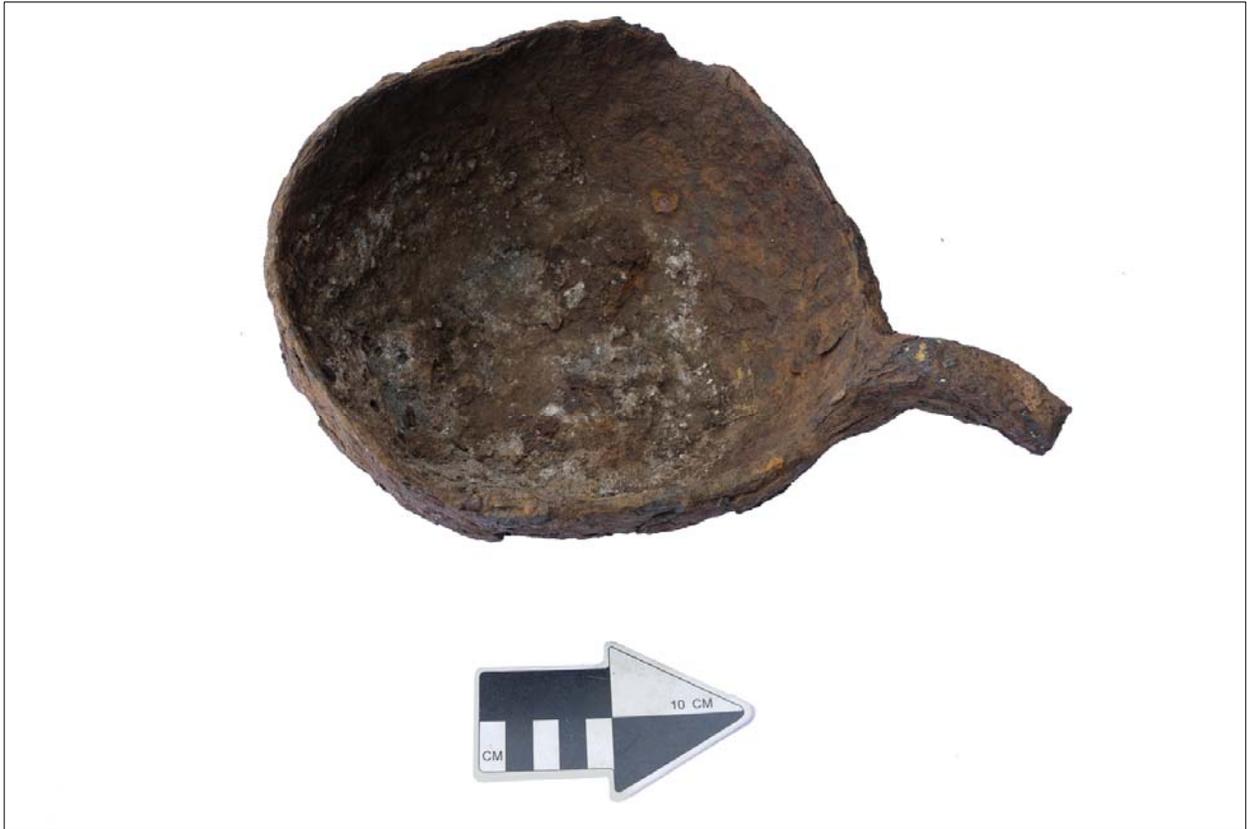
B.1-7. Iron ladle bowl, FEA-2-LC in ST-2-LC. Note: white lead spatter in the bottom of the bowl.

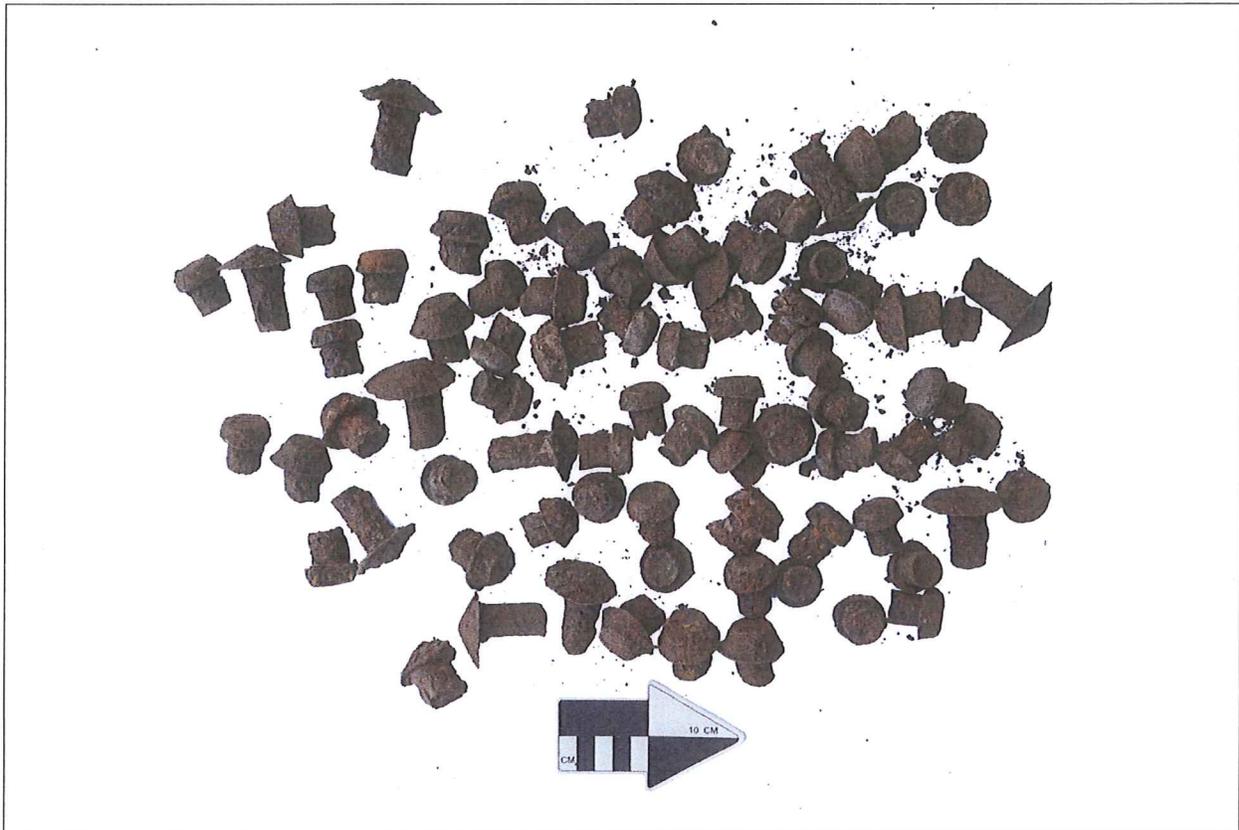
B.1-9. Rivets collected from Context II in ST-2-LC used for recharging the copperas liquor.

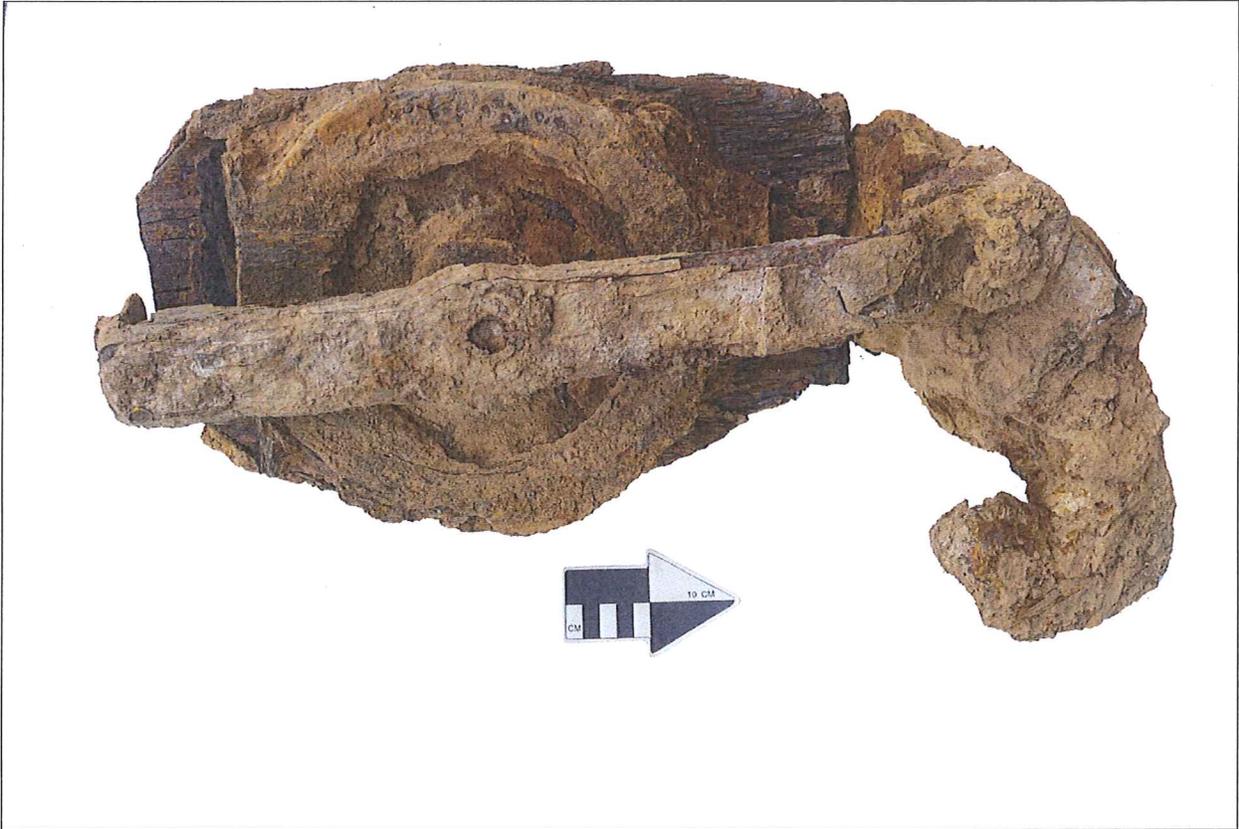
B.1-10. Iron and wood double-pulley hoist block, with plate on, recovered in the Copperas Brook Corridor, FEA-7-BC in TR-5-BC.

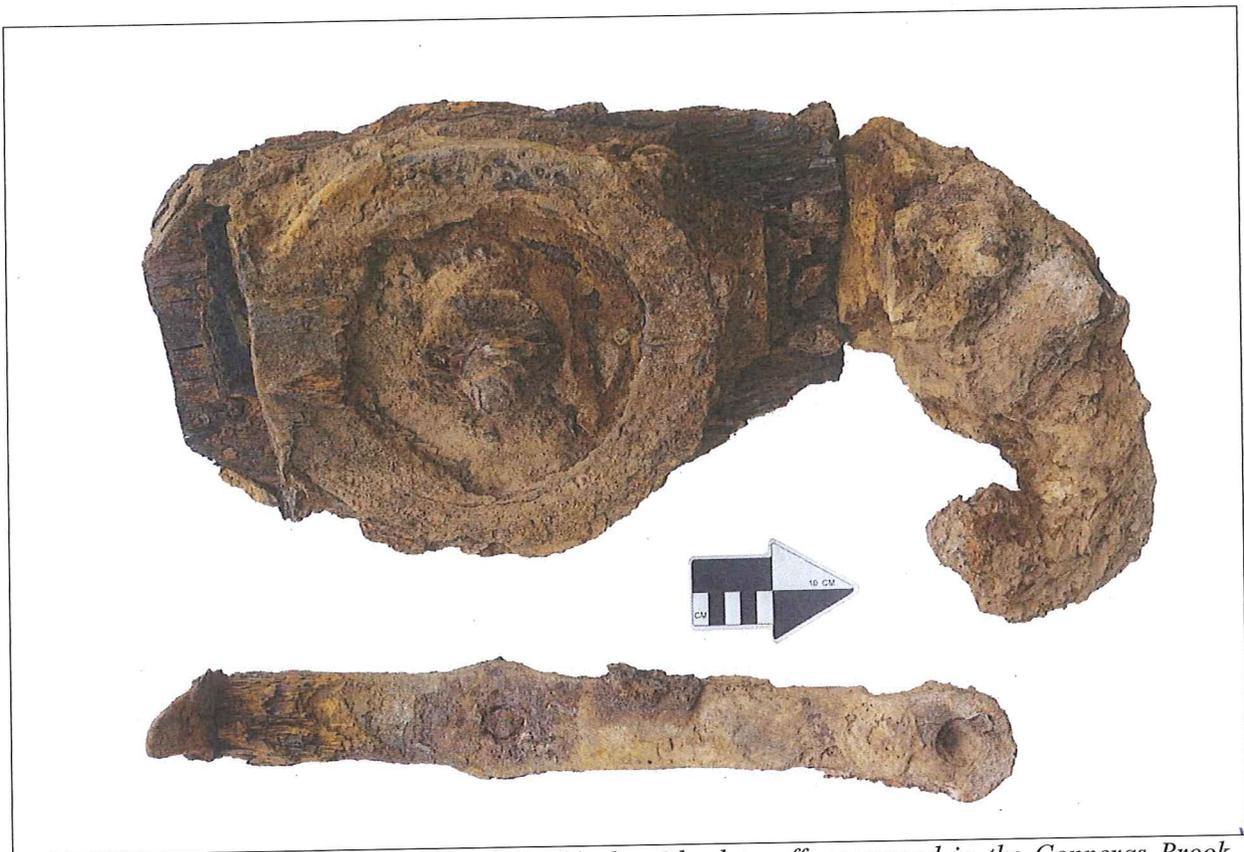
B.1-11. Iron and wood double-pulley hoist block, with plate off, recovered in the Copperas Brook Corridor, FEA-7-BC in TR-5-BC.

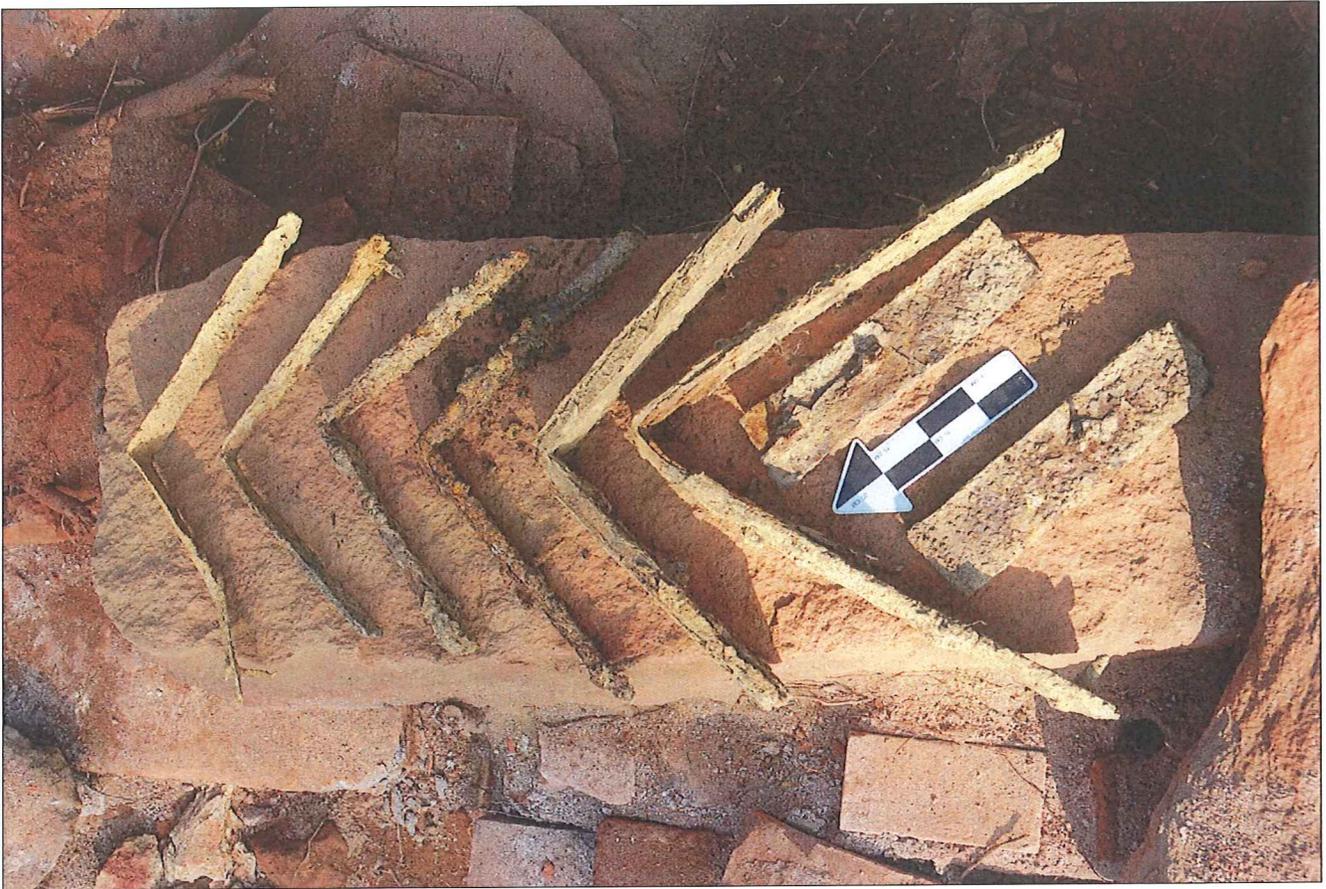
B.2-1. L Brackets from FEA-3-UC in TR-3-UC.

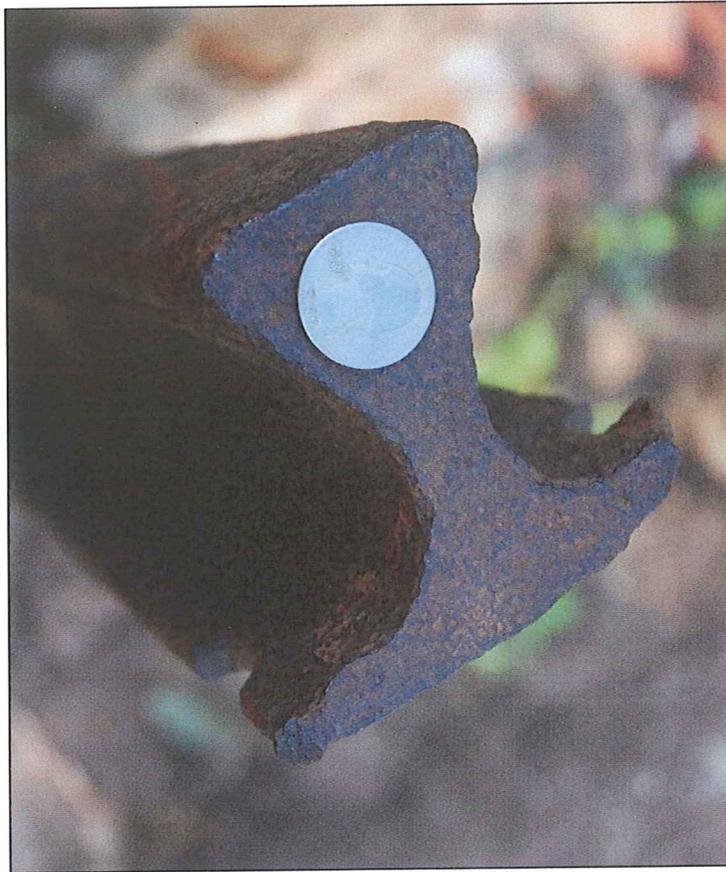
Iron Stanchion

B.2-2. Cross-section of stanchion/upright rail from FEA- 6-UC in ST-1-UC

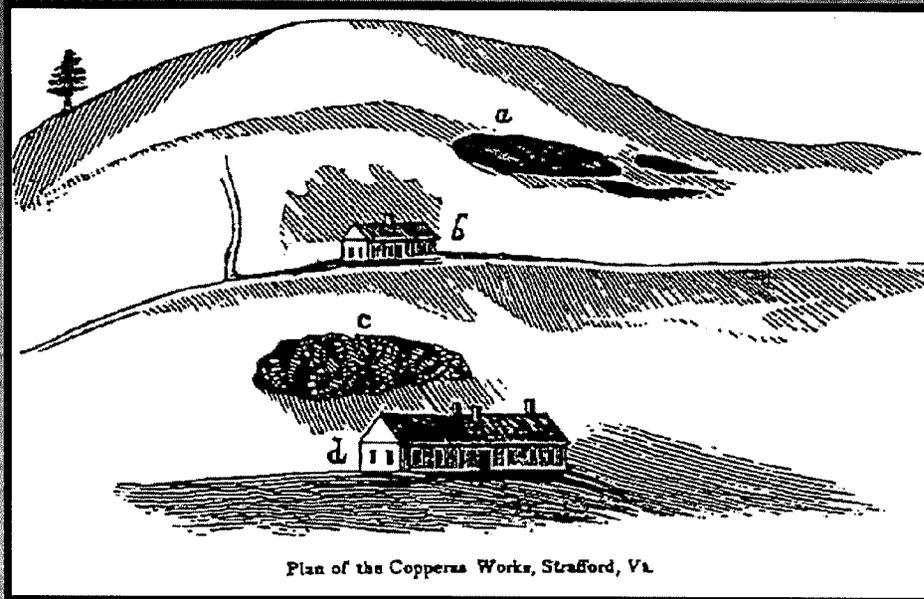
Above: Sketch of Copperas Works, Final Report on Geology and mineralogy of the State of New Hampshire, 1844.

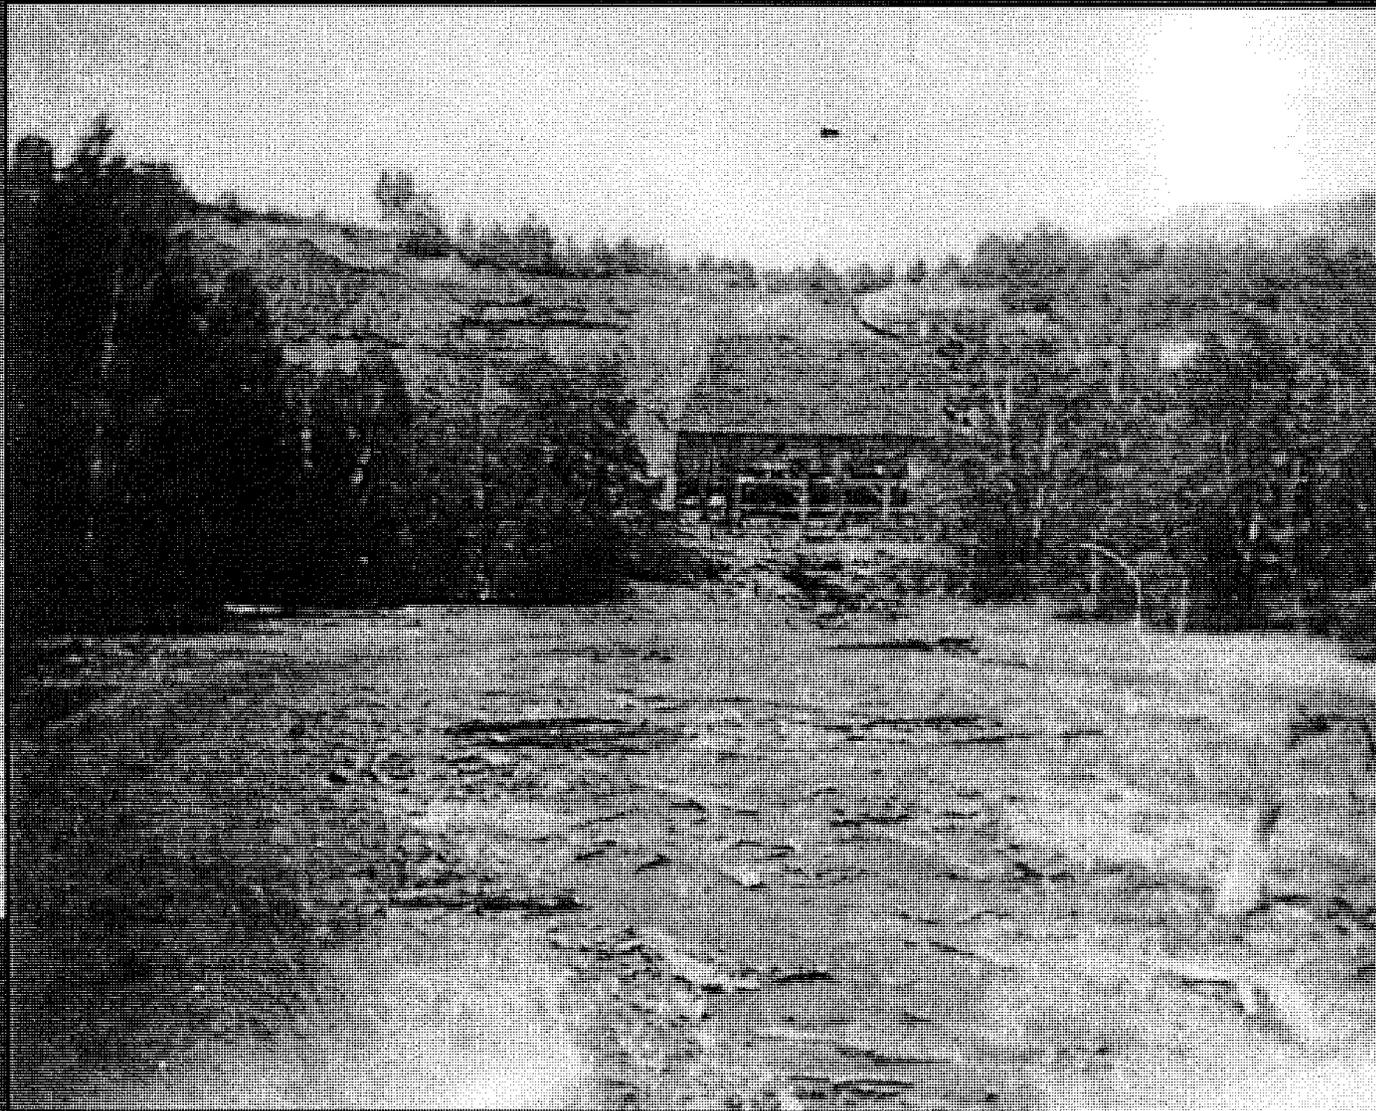
Photograph of Upper Copperas Factory looking west. Gate unknown.
Courtesy: Stafford Historical Society - Stafford, Vermont.

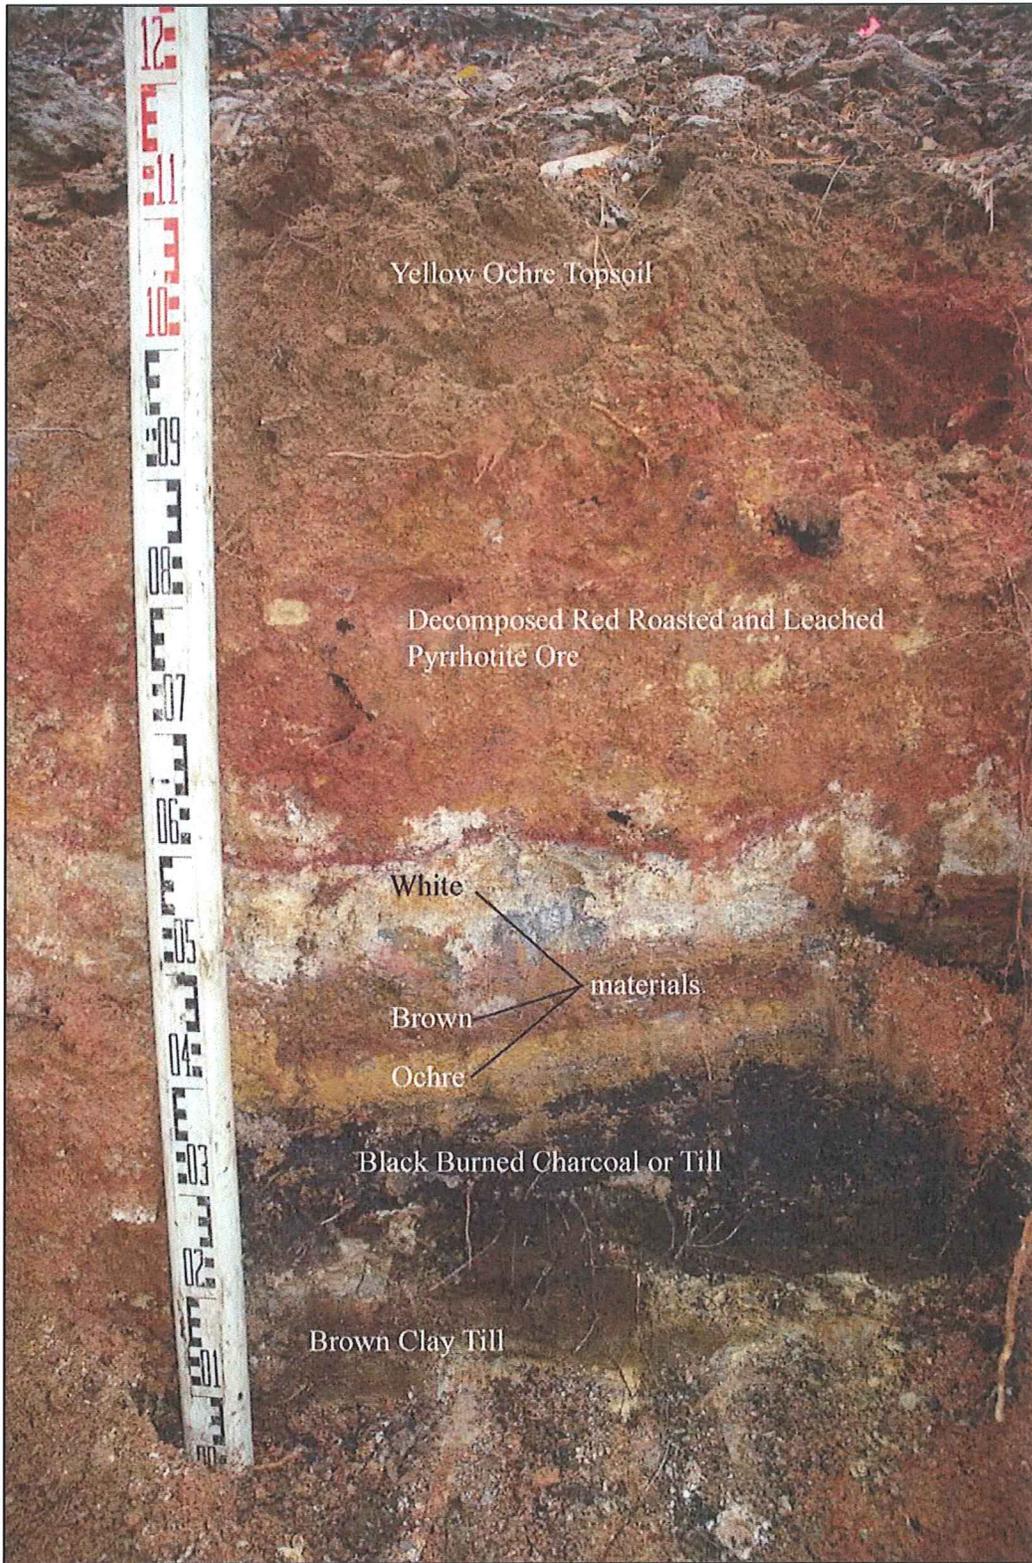
Appendix A-2. West wall profile of test pit WS-105.

The only test pits that contained the diagnostic red roast bed soils and structural materials were WS-105, WS-107, and WS-109, all located due east of the North Open Cut, which was the historic source of the pyrrhotite. This soil was not visible at the surface at these locations, although it does crop out in the vicinity. All three of these pits exhibited colorful roast bed stratigraphy (see Appendix A) including, from top to bottom, layers of yellow ocher topsoil, decomposed red roasted and leached pyrrhotite, thin layers of whitish, brown, and ocher soil (unknown materials), a black burned charcoal or till layer, and brown clay till above the bedrock. WS-107 had unstable walls and was too deep to photograph, but contained a layer of wood plank. WS-109 contained a round horizontal wood timber at approximately the level where the till began (see Appendix A-2 and A-3), consistent with other round timbers exposed in known roast bed material elsewhere on the hillside.

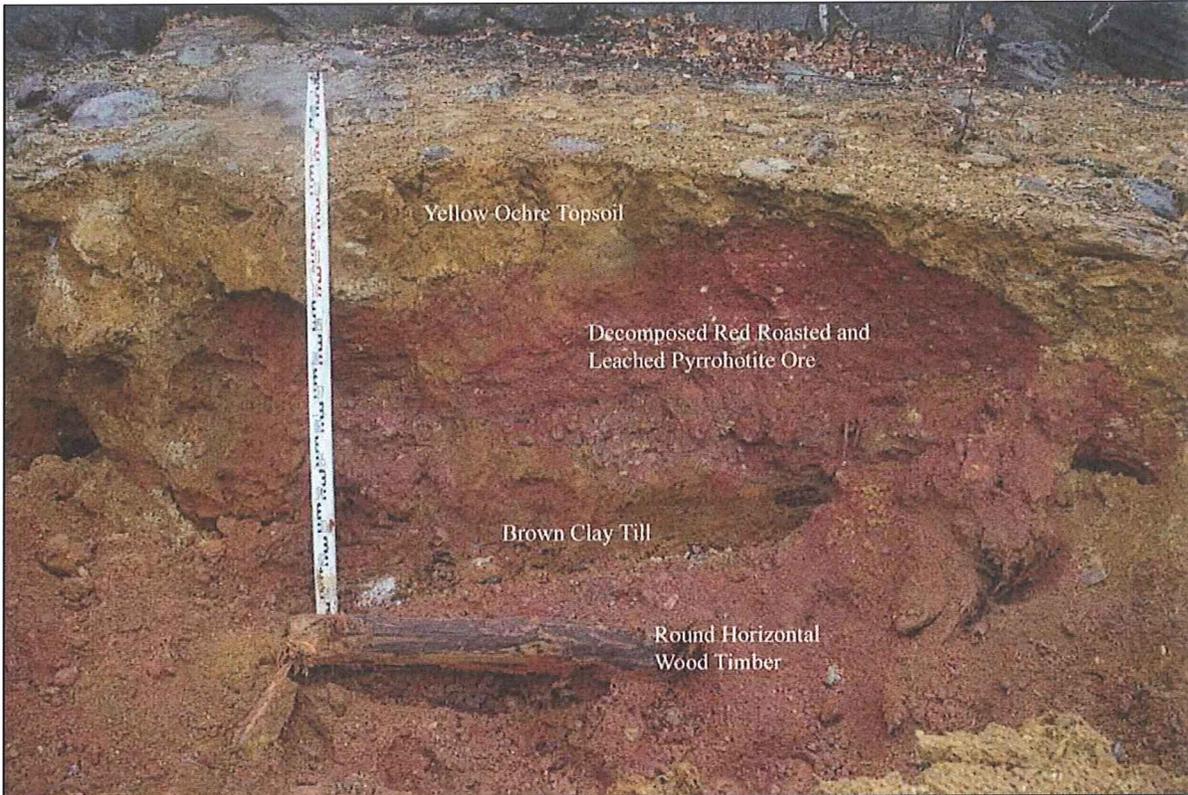
Appendix A-3. West wall profile of test pit WS-109.

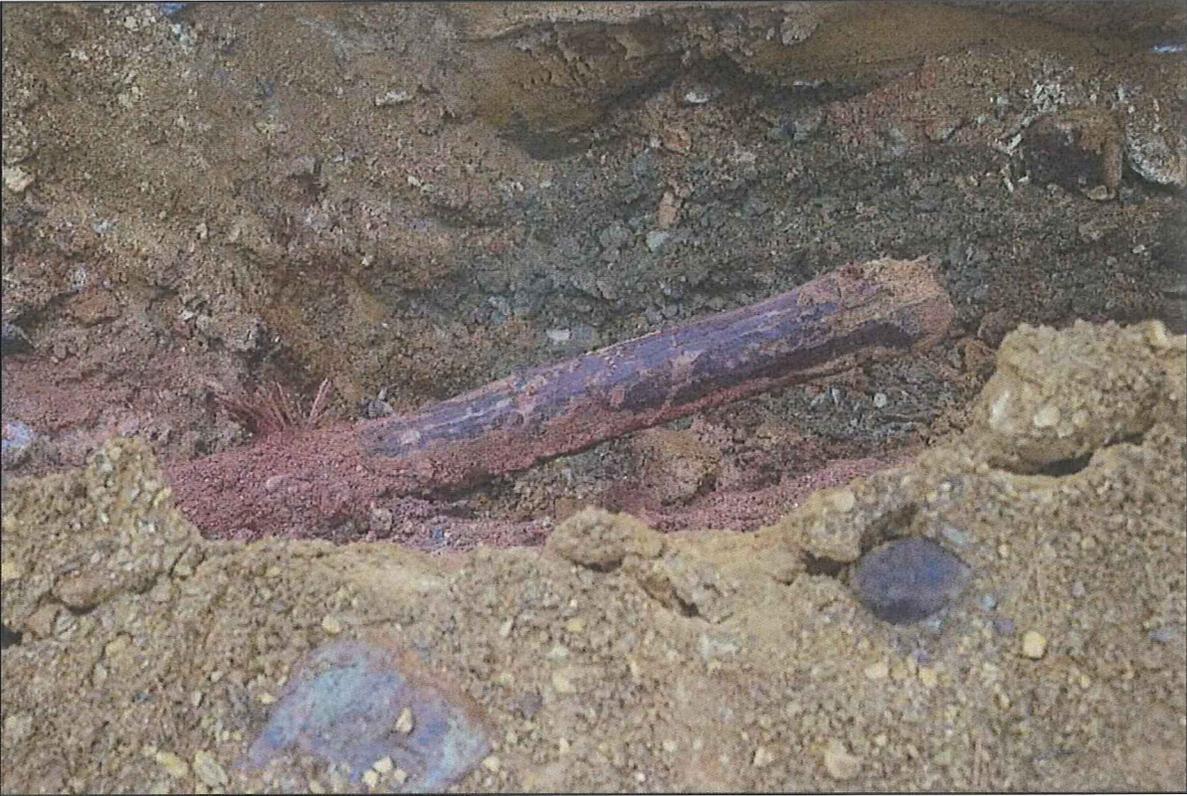
Appendix A-4. Detail of round leach pad deck support timber view facing east of test pit WS-109.
