**TECHNICAL REPORT ADDENDUM
ELIZABETH MINE SITE (VT-OR-28)
South Strafford and Thetford, Vermont**

**U.S. Army Corps of Engineers Contract #W912WJ-11-D-0006
Nobis Contract #12-NH-83602-001**

August 2014

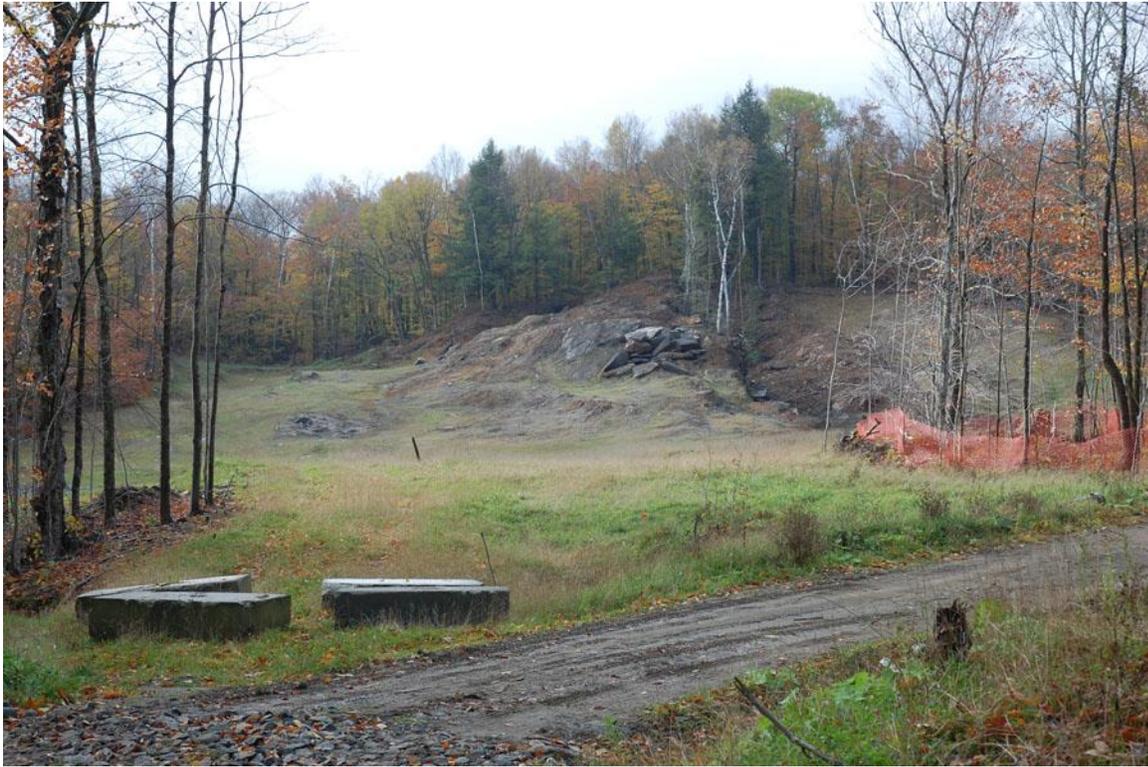
Figure 1. South Mine, overview looking south across Copperas Road.

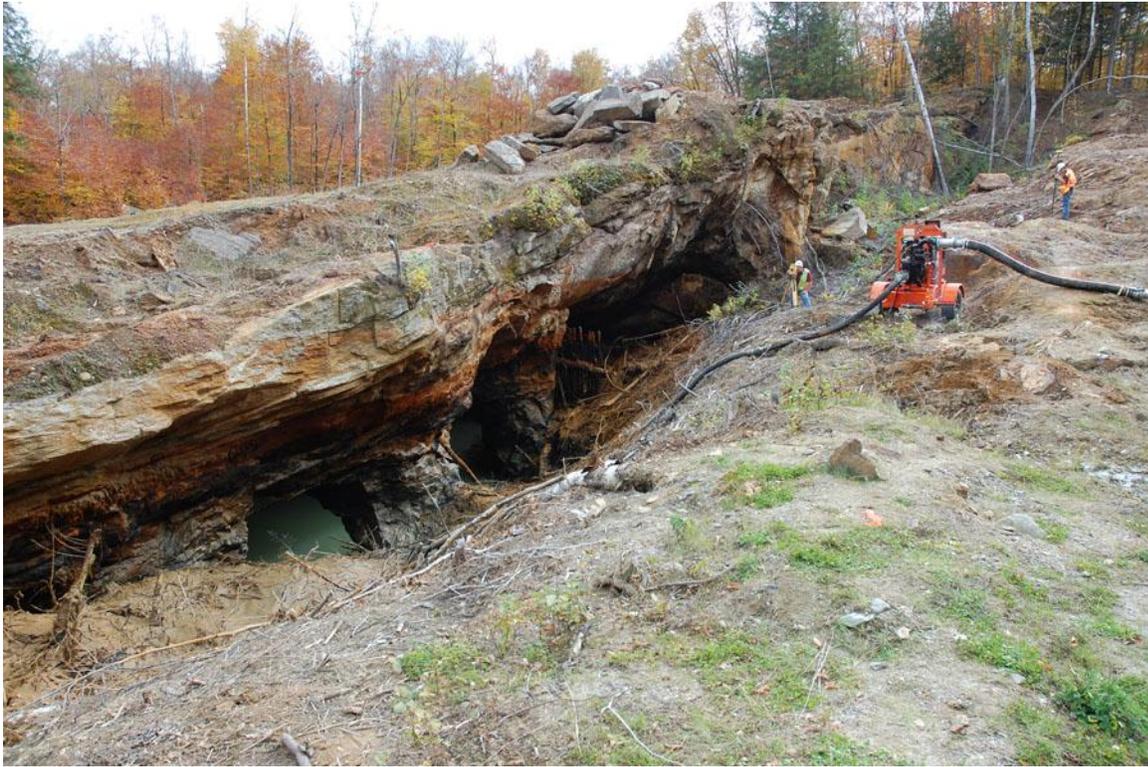
Figure 3. South Mine open cut dewatering, showing roof support pillars, looking southeast.

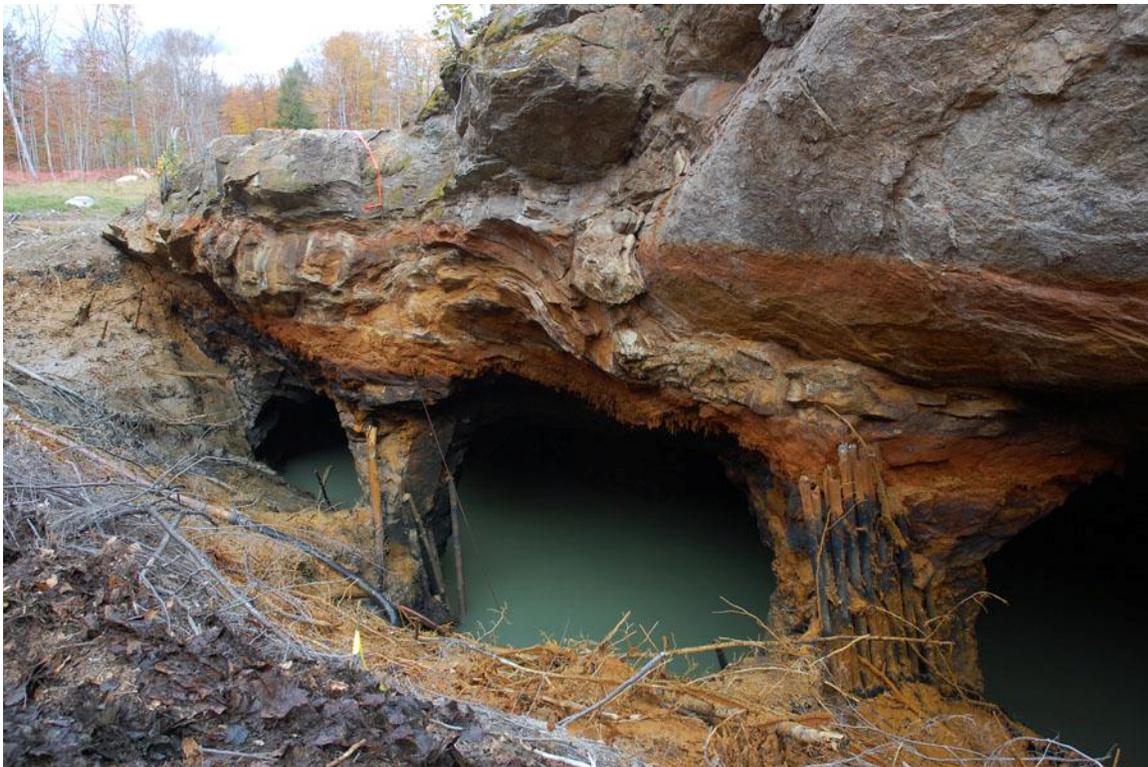
Figure 4. South Mine open cut, detail of pillars, looking northeast.

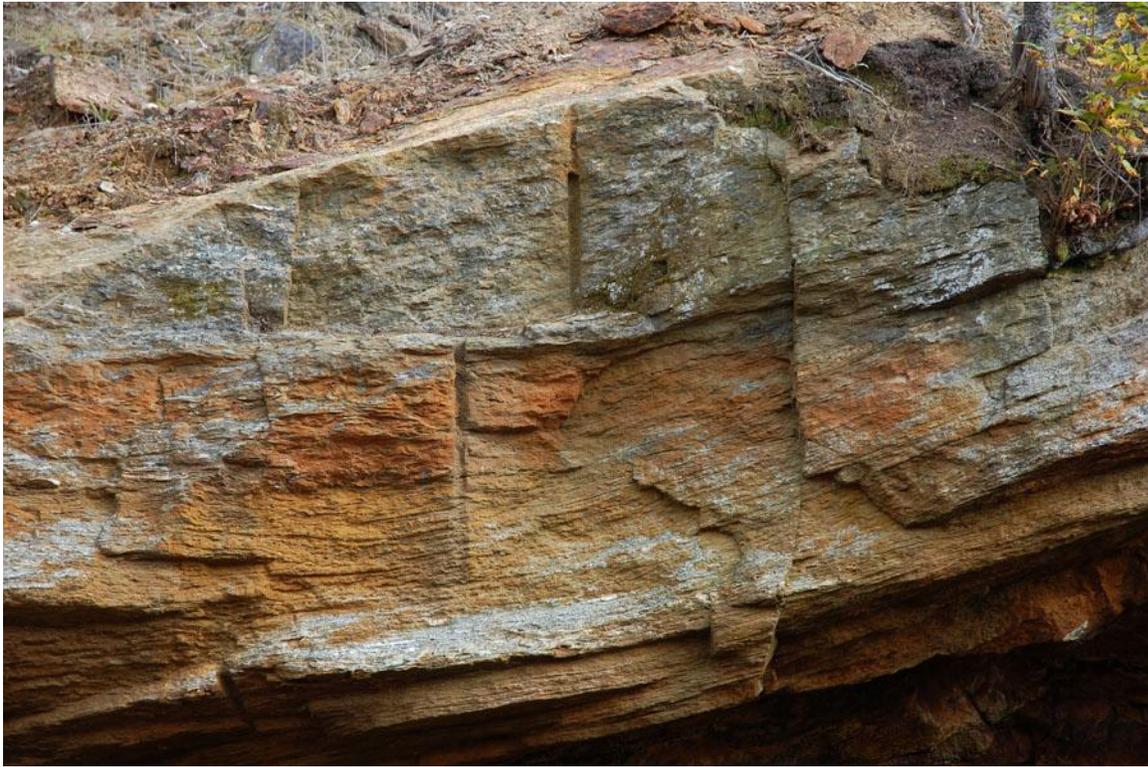
Figure 5. South Mine open cut, detail of hand drill holes in hanging wall, looking east.

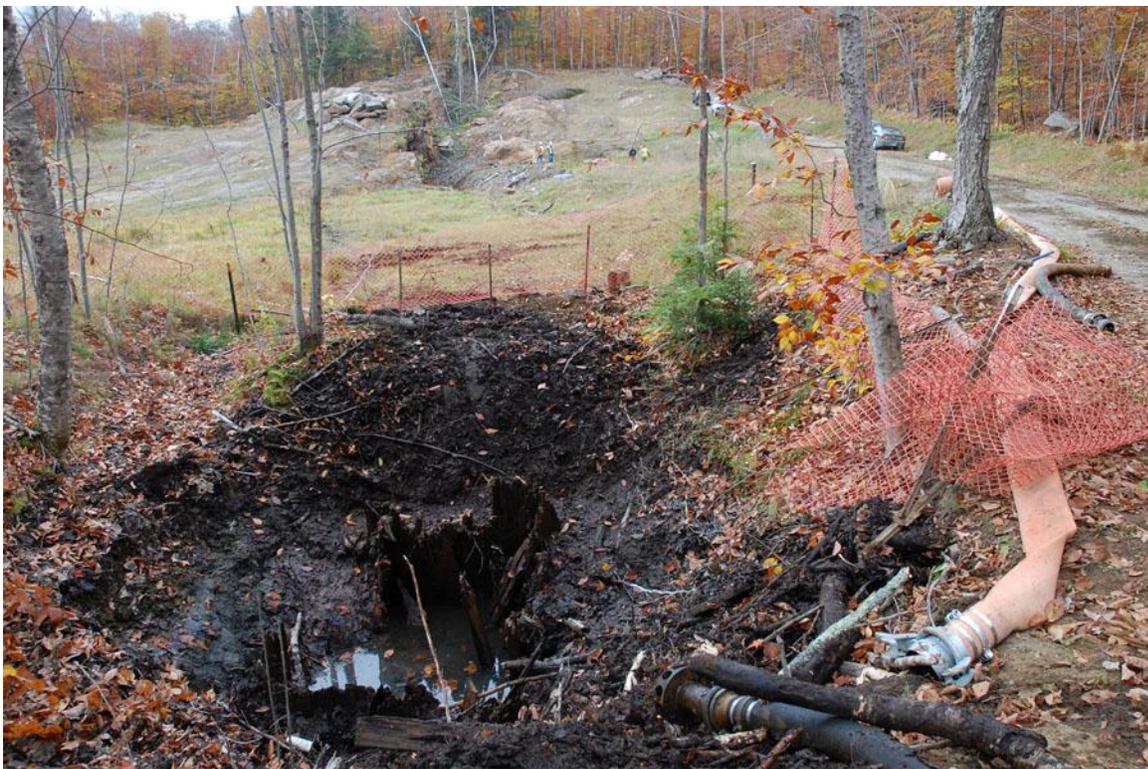
Figure 8. South Mine shaft collar after excavation, looking south to South Mine open cut.

refusal depth strongly suggest this shaft is the uncompleted one noted in the Nash Papers. The shaft opening is currently capped with a temporary timber cover; final capping design is forthcoming.

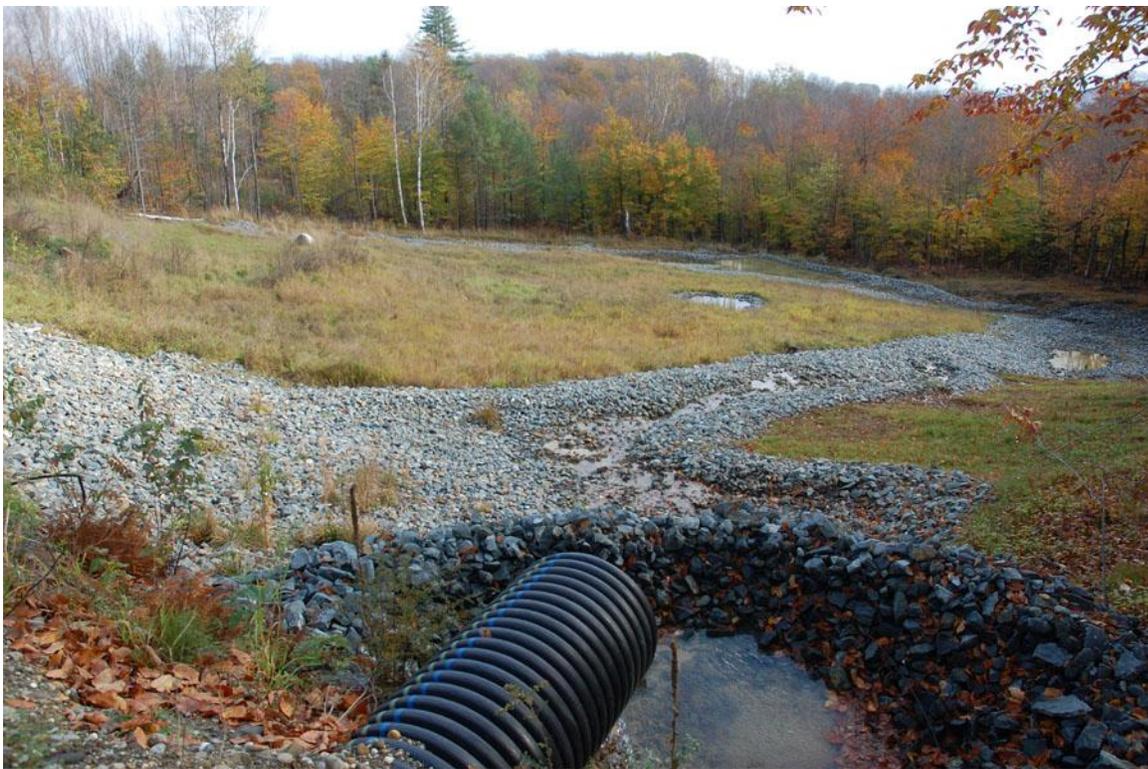
Figure 14. Tailings Pile 4 area after cleanup, looking northeast.

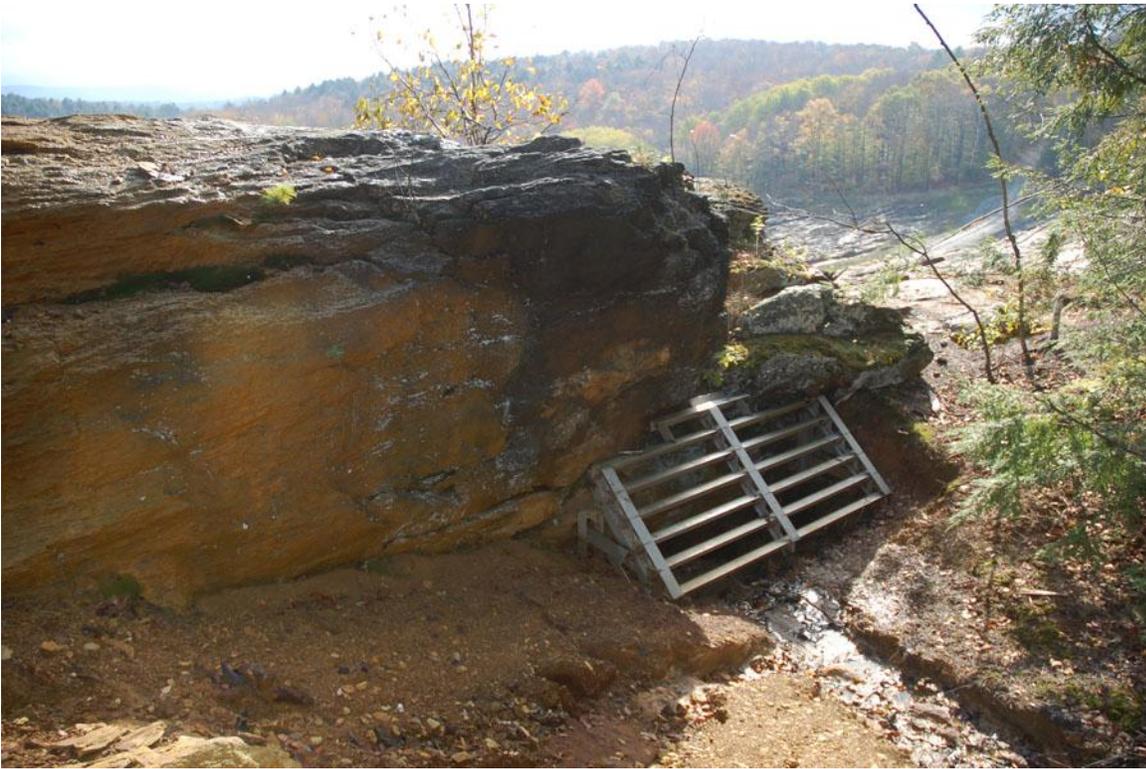
Figure 25. TP-3, Security/bat grate over manway shaft north of North Open Cut, looking southeast.

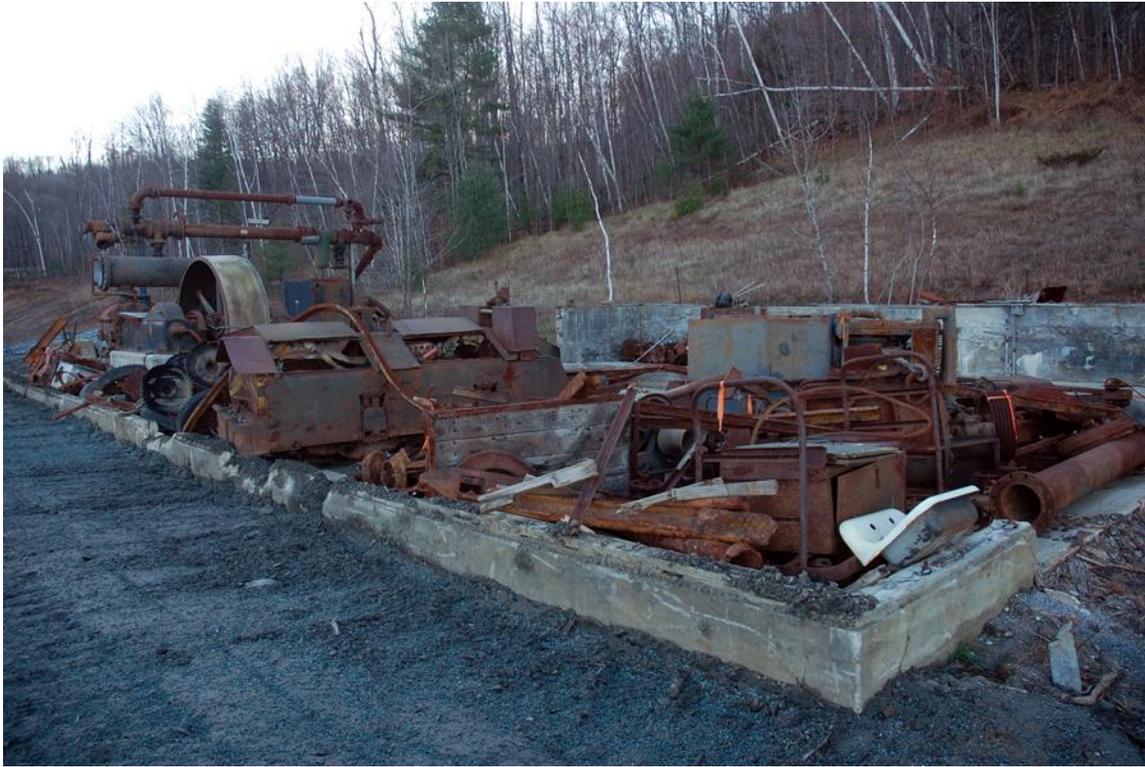
Figure 45. World War II buildings area, Air Compressor Building foundation with salvaged machinery, looking southwest.

The concrete slab foundation is used for open-air artifact storage (Figure 45). The large Ingersoll-Rand air compressor was left in place (Figure 46). The air intake tower pits at the south end of the building were filled for safety.

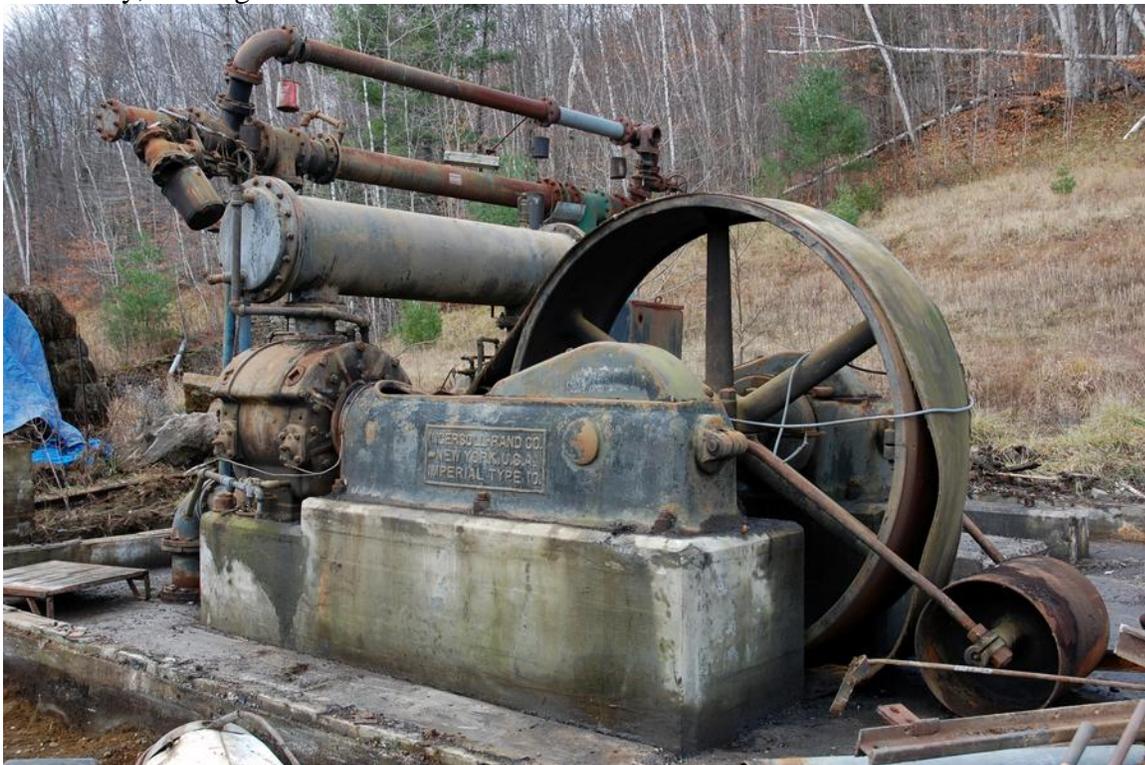
Figure 46. World War II buildings area, Air Compressor Building, detail of Ingersoll-Rand Imperial Type 10" air compressor for underground mine drills, looking southwest.

This building contained an air compressor, tanks, pipes and electrical equipment clustered at its south end. The electrical equipment was removed and disposed of on site. The large Ingersoll-Rand Imperial Type 10 compressor with an approximately 10 ft diameter flywheel and associated plumbing, and including its large drive belt, was left in place. Additional artifacts found in the building and left on the concrete foundation slab include two, four-wheeled shop carts, large pulleys, a hanging beam scale, and a large dial indicator for a mine hoist or truck scale, a 4,000 cfm Roots-type air pump (apparently used to provide fresh air underground), a safe, and an 1890s patented Mead-Morrison compressed air hoist.

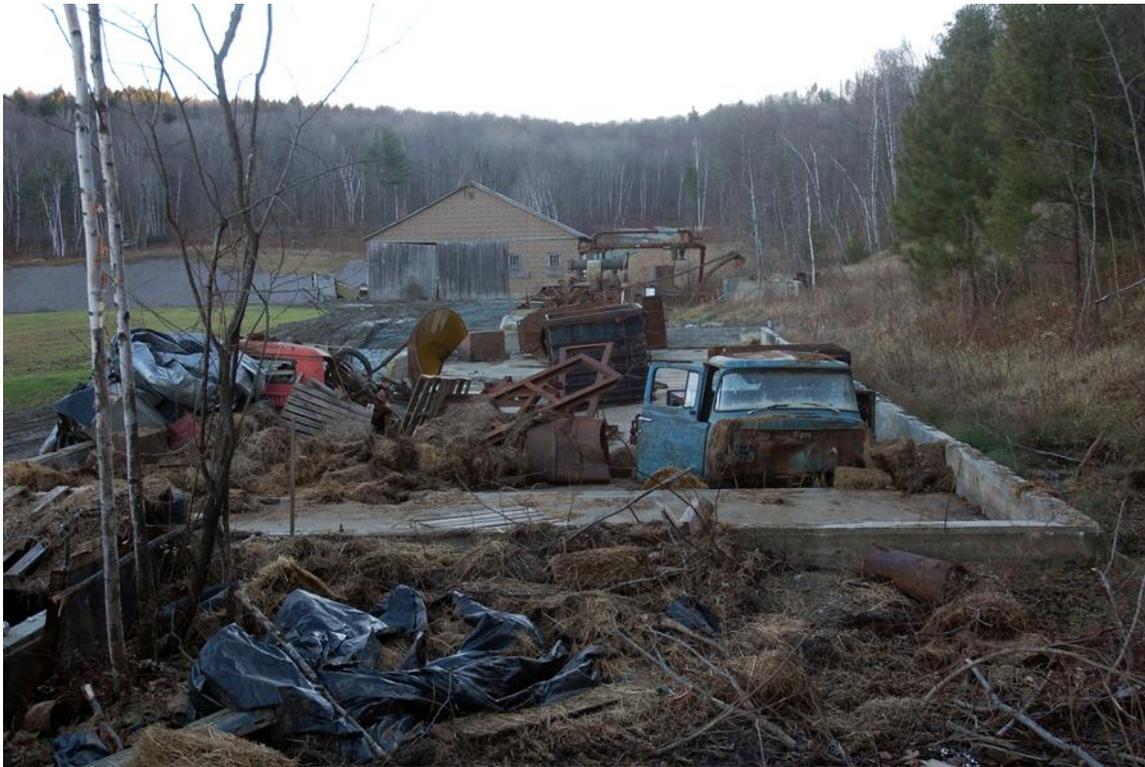
Figure 47. World War II buildings area, Machine Shop/Workshop foundation and stockpiled salvaged artifacts, looking south.

The concrete slab foundation is used for open-air artifact storage. The blacksmith forge and anvil base were left in place. The steps to the partial basement at the north end of the building were filled for safety (Figure 47).

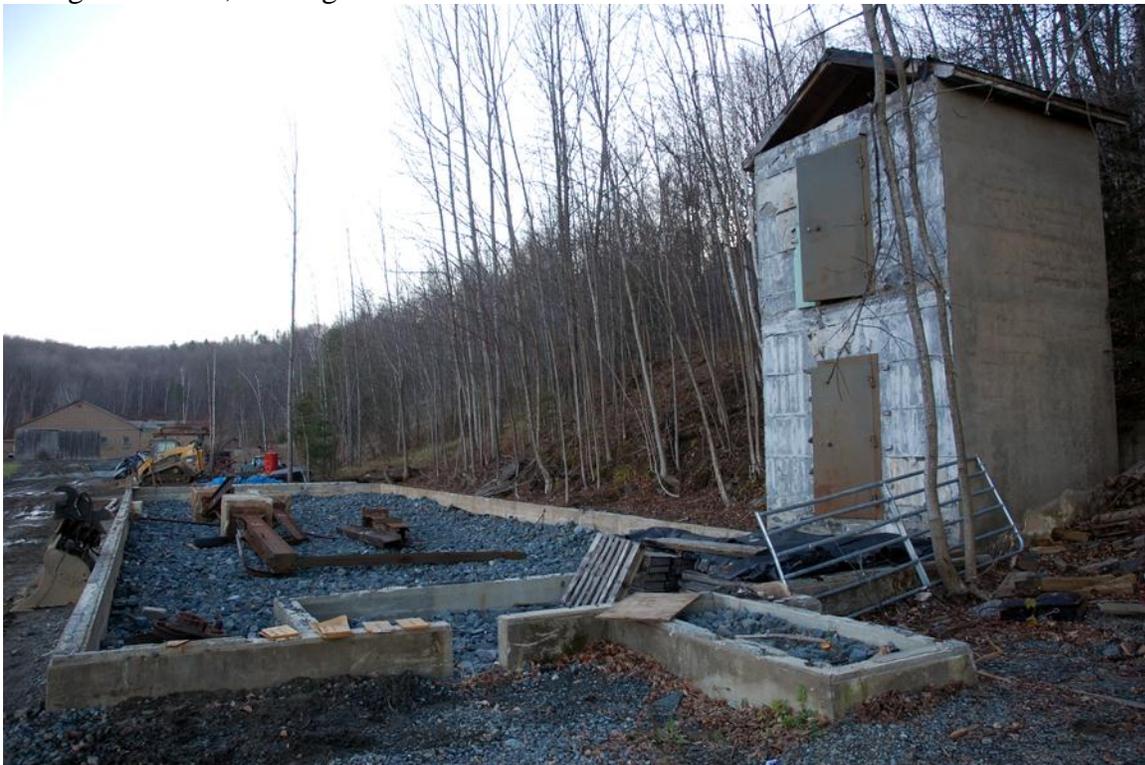
Figure 48. World War II buildings area, Office/Warehouse foundation, with two-story safe tower at right, looking south.

The concrete slab foundation is used for open-air artifact storage. The two-story concrete walk-in safe tower with wood frame gable roof was left standing in the northwest corner of the foundation (Figure 48).

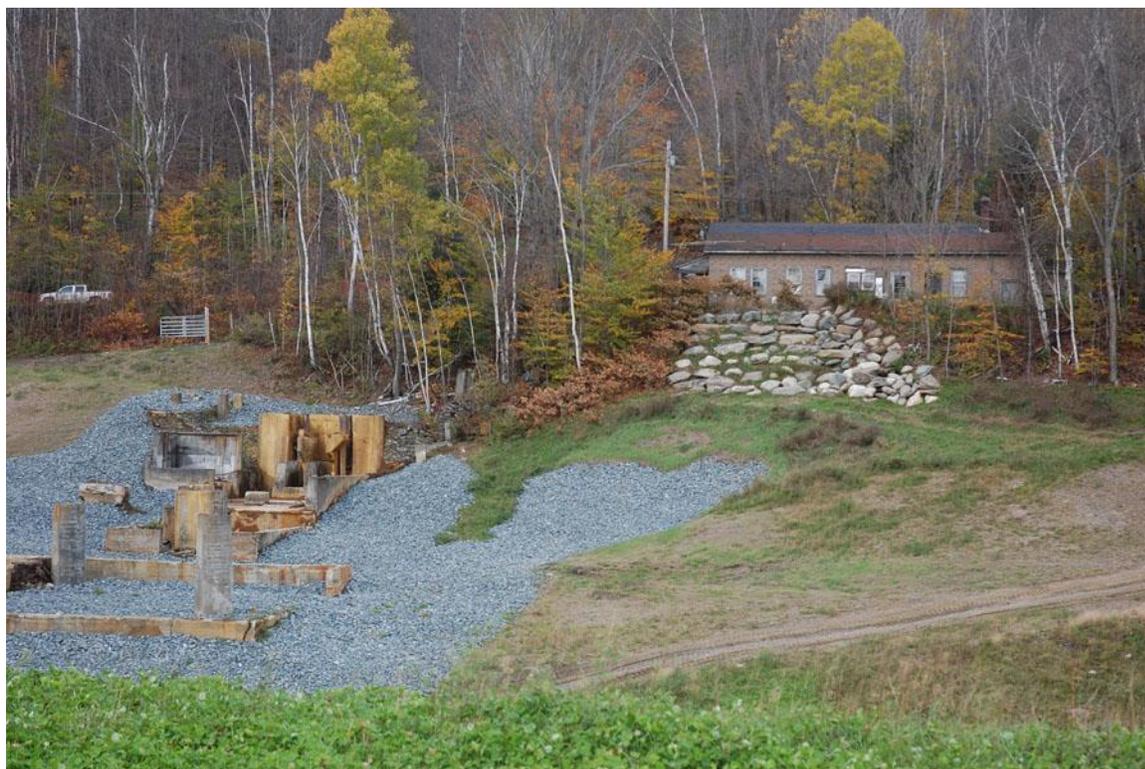
Figure 49. World War II ore crusher foundation (L) and Assay Laboratory (R), looking west from TP-1.

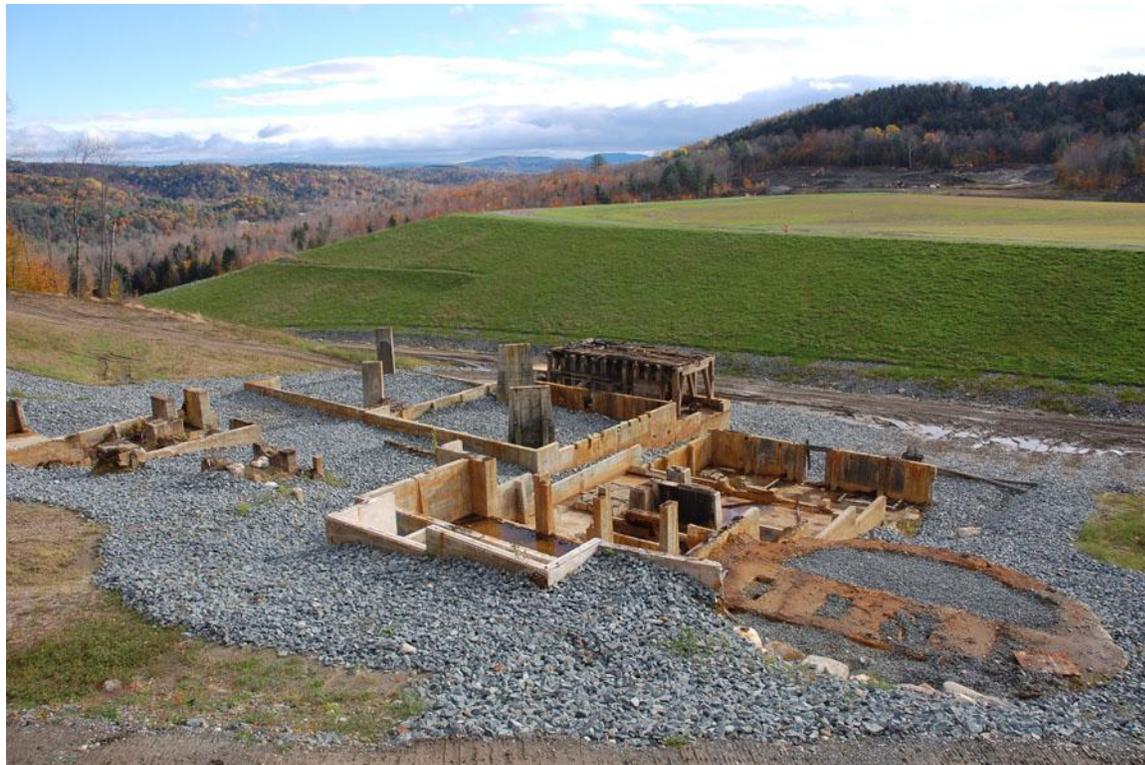
Figure 50. World War II ore plant foundations, L to R: ore crusher, Thickener/Dryer, Flotation Mill and Ore Silo, looking northeast to TP-1/TP-2 waste repository.

Demolition of the lower tier of ore processing buildings exposed massive concrete foundation walls, stepped levels of concrete slab floors, concrete machinery mounting piers and pads, and a timber ore storage bin support structure, all previously hidden by the buildings and their collapsed debris. The PAL cultural resources monitor determined that long-term visibility of this landscape was of potential interpretive value, as the forms and relationships of these structural features clearly express the relative locations of the ore storage, transportation and processing machinery between and within the buildings. The foundations were left in place and the surrounding ground graded, and covered with stone riprap to provide an enhanced view of the foundations to interpret the gravity-fed ore milling process, and inhibit growth of vegetation, especially trees that could damage the foundations and obscure them from view in future (Figure 50).

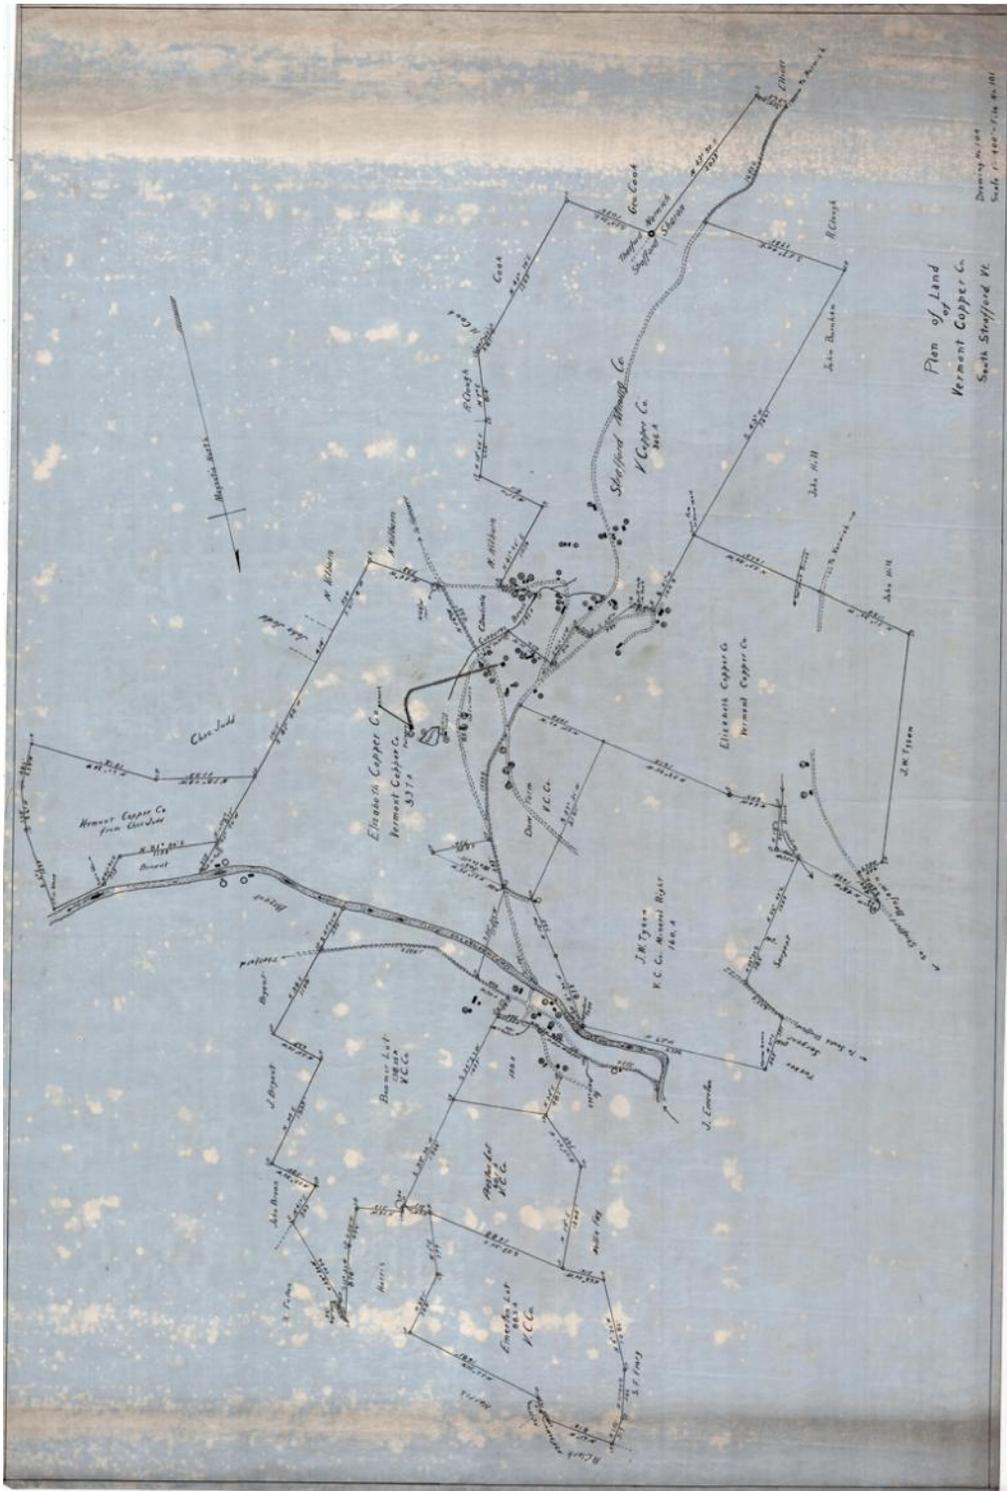
Plan of Land of Vermont Copper Co., South Strafford, VT. Drawing No. 104. Scale 1"=400', File No. 101.

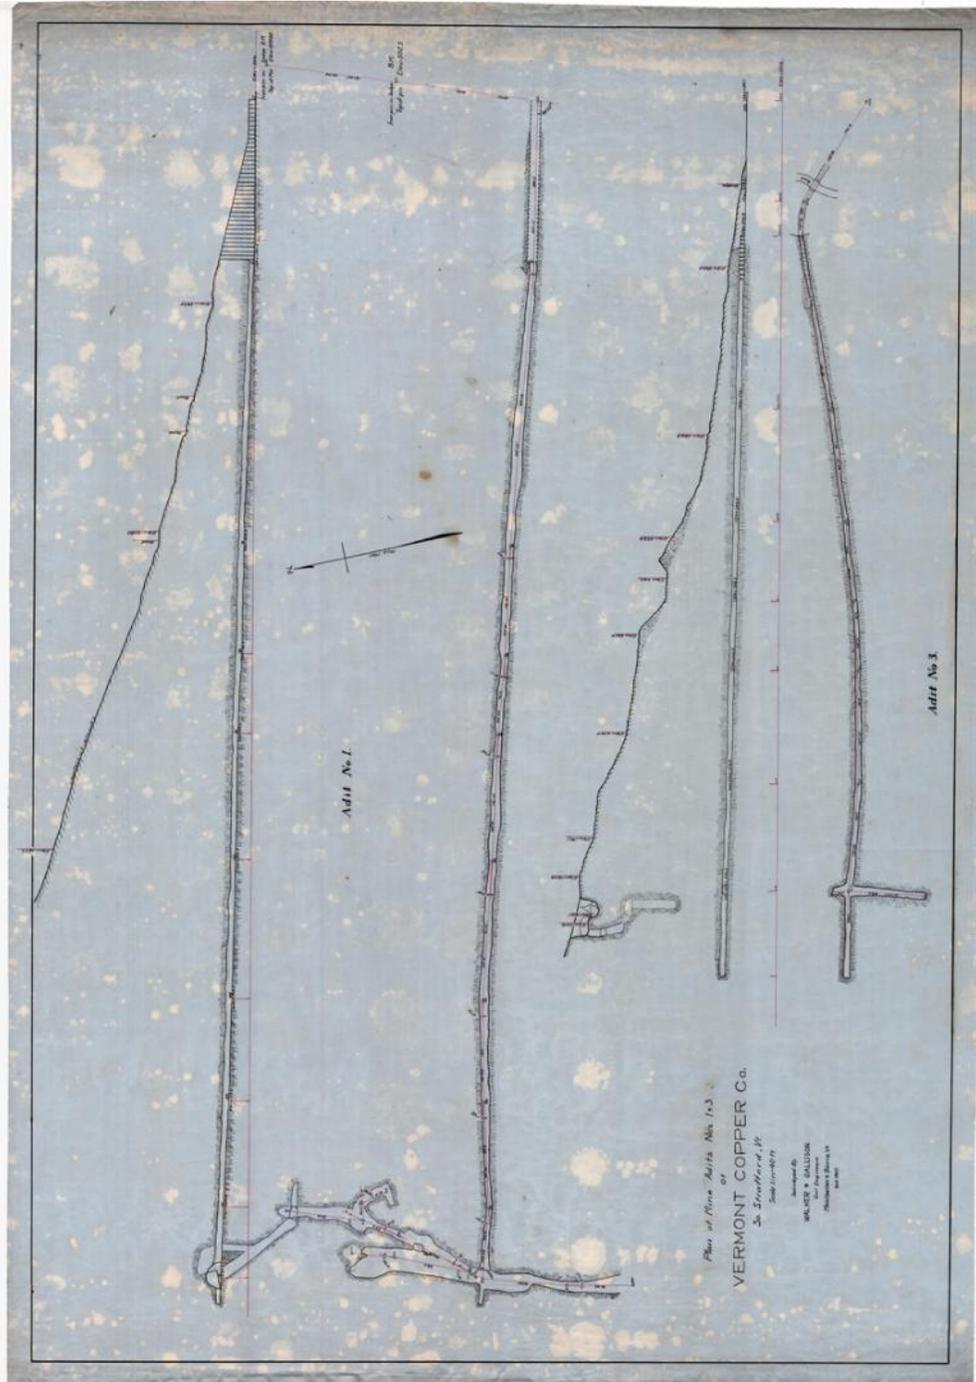
Plan of Mine Adits Nos. 1 & 3 of Vermont Copper Co., So. Strafford, VT. Scale 1 in=40 ft.
Surveyed by Walker & Gallison, Civil Engineers, Montpelier & Barre, VT, Oct. 1907.

This drawing shows reflected plan and profile underground sections through the "Deep Adit" (No. 1) and 1898 Tyson Adit (No. 3). Both adits incline gently to the east to facilitate drainage. The drawings show that the outer approaches to the adits were in timbered trenches in soil and loose rock. The Deep Adit did not connect to upper workings at that time, but ended in short north-south drifts, presumably in, or to locate, the orebody. The map shows the original alignment of Mine Road, crossing the over the Deep Adit approach trench on a short bridge.

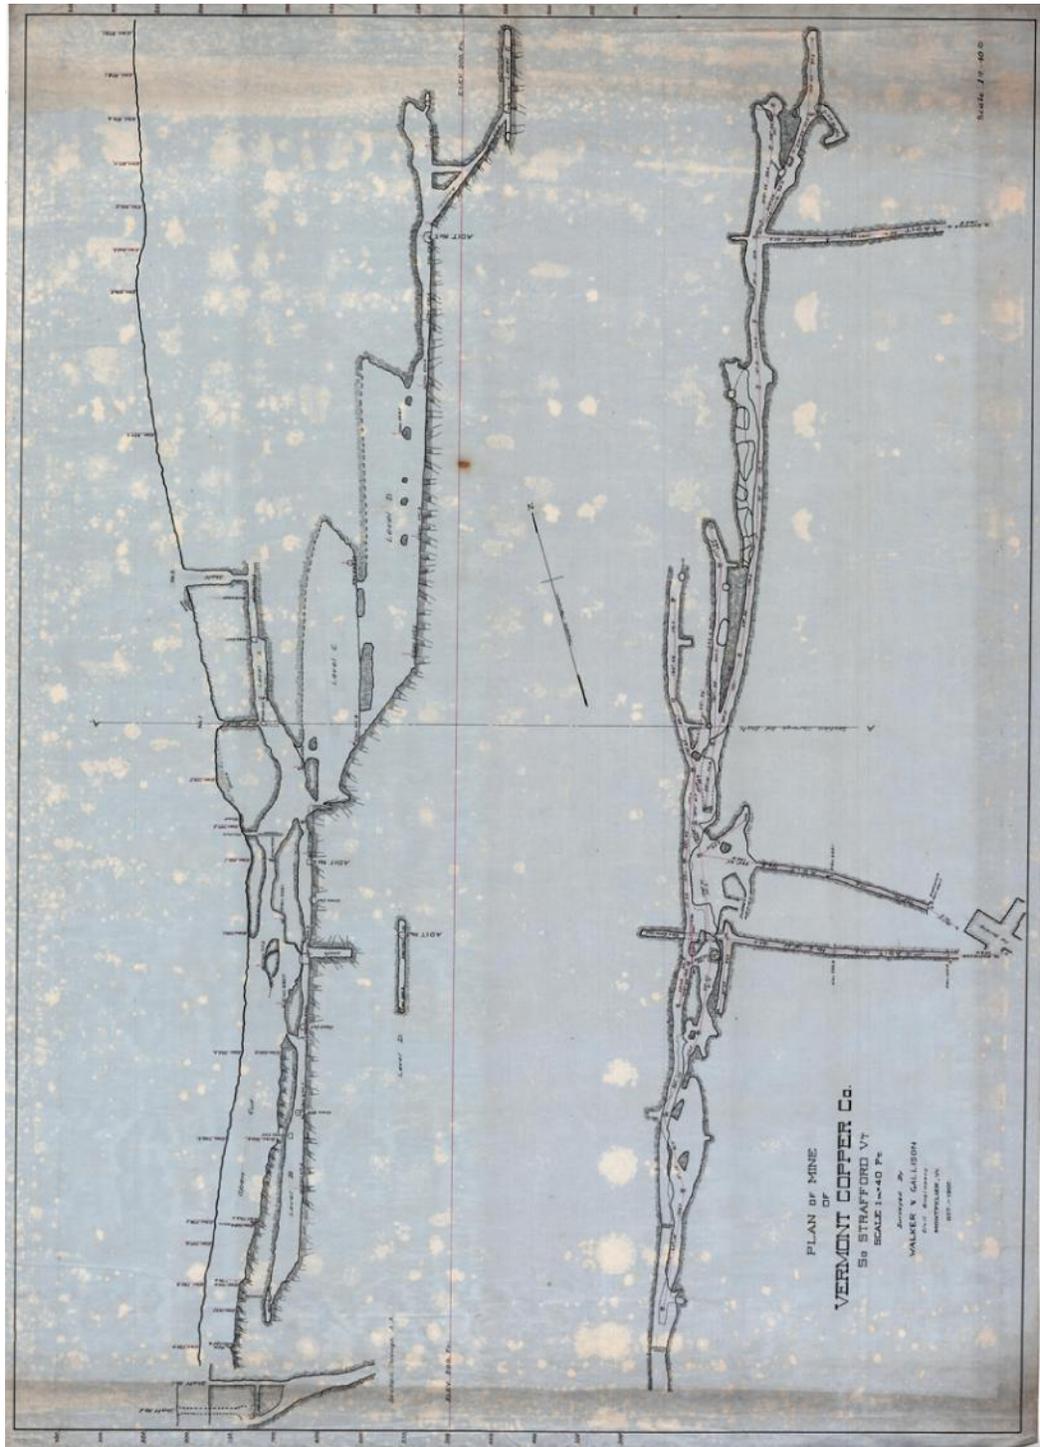
Plan of Mine of Vermont Copper Co., So. Strafford, VT. Scale 1 in.=40 ft. Surveyed by Walker & Gallison, Civil Engineers, Montpelier, VT, Oct. 1907.

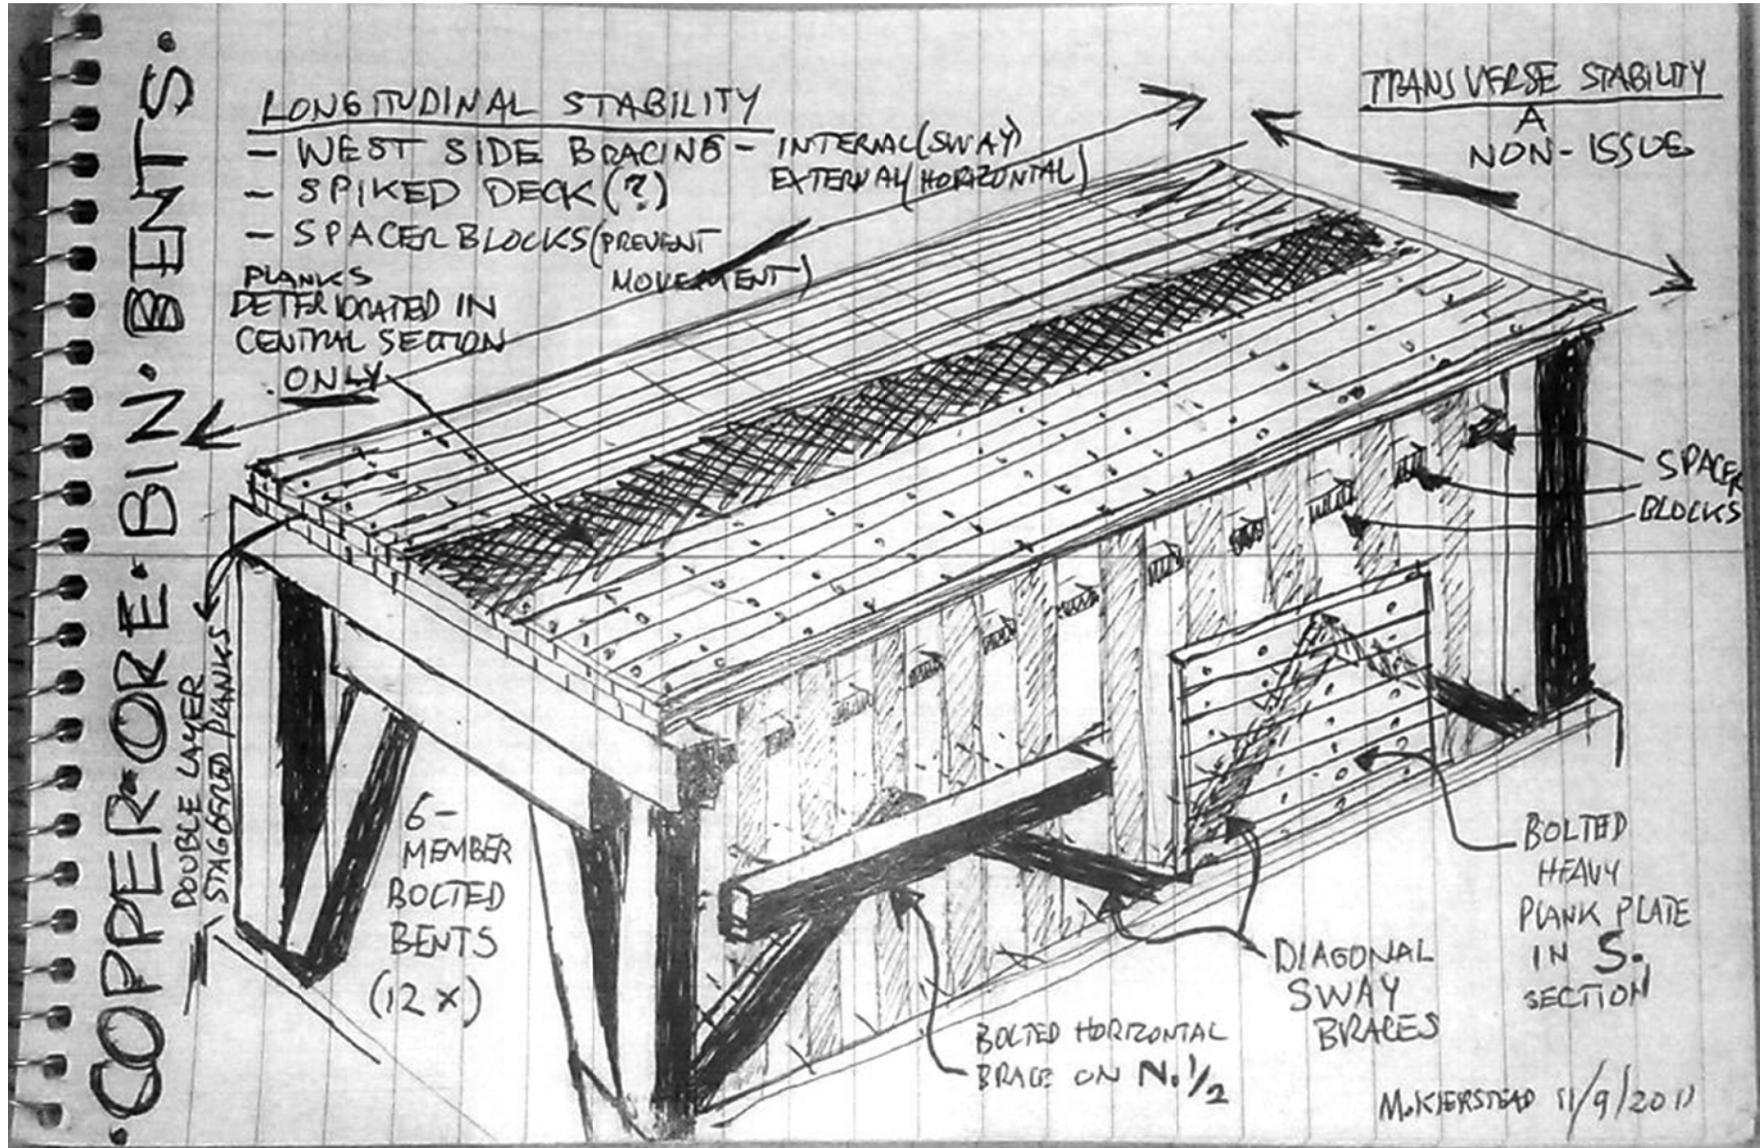
Figure 2. Elizabeth Mine: WW II Ore Concentration Mill, 2011 field sketch of copper ore concentrate bin timber support structure.
