An Assessment of the Biological Integrity of the Aquatic Macroinvertebrate Communities from Intermittent Small Tributaries to Lords Brook Originating from the South Cut and South Mine of the Elizabeth Copper Mine Superfund Site.

**Vermont Department of Environmental Conservation
Watershed Management Division
Biomonitoring and Aquatic Studies Section**

January 18, 2014

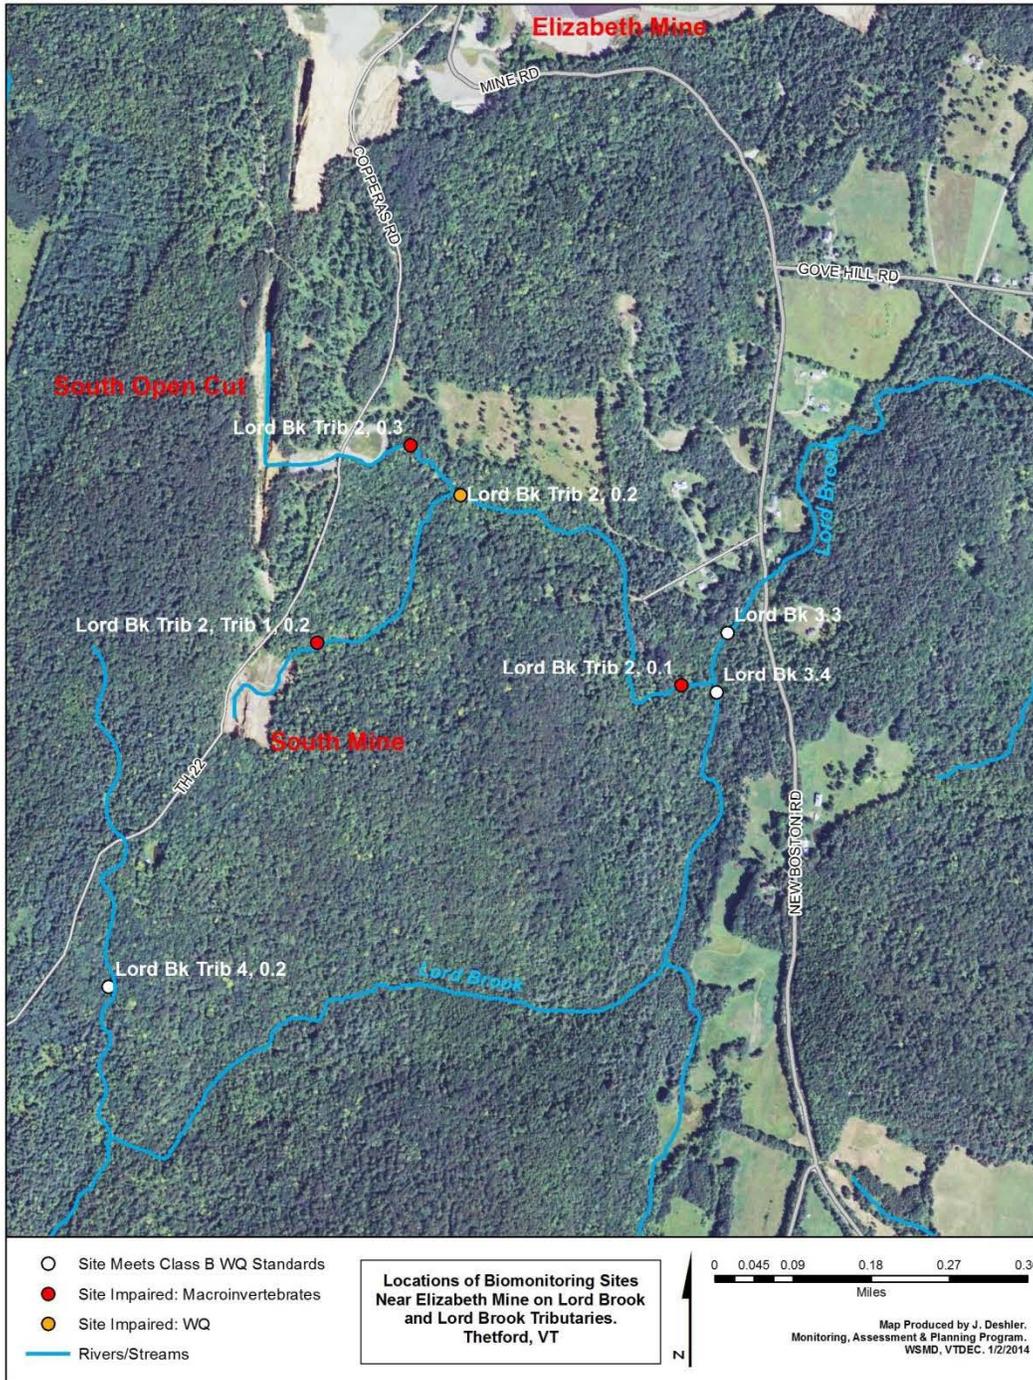
Figure 1: Map showing locations of small intermittent tribs to Lords Brook and the biomonitoring sites.

Table 1, and Figure 1 describe and show the locations of the biological assessments of the small intermittent streams influenced by the south cut and south mine areas, and the “reference” stream location just south of these mine areas.

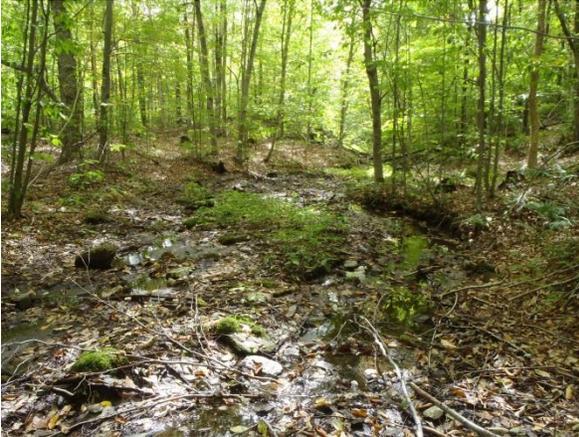
1-Trib 4 0.2 reference stream

Table 5 and Figure 2 below show a very similar size and habitat, between the “reference” control and mine drainage tributary stream reaches. All stream reaches directly below the mine sites were only about a ½ meter wide within channel and all had a lot of organic leaf litter and woody debris. All sites were located within fully forested areas, had complete canopies dominated by hardwoods, and immediate riparian forest well over 25m wide. The photos also show that the flow level reflects a moderate base flow for the streams. The presence of the *Trichoptera Homoplectra sp* within the two upper Trib 2 streams that drain the mine is a strong indicator that the streams are likely intermittent. Other taxa that indicate small cold spring feed systems are the *Trichoptera Parapsyche sp* and *Diplectrona sp* and the, *Diptera Pedicia sp* and *Stilocladius sp*. Also of note was that the salamander *Eurycea bislineata* was common in Trib 4 the local reference control, and not observed at any of the mine drainage tributary reaches. A list of all taxa, their abundance and percent composition from the streams is presented in Table 6.

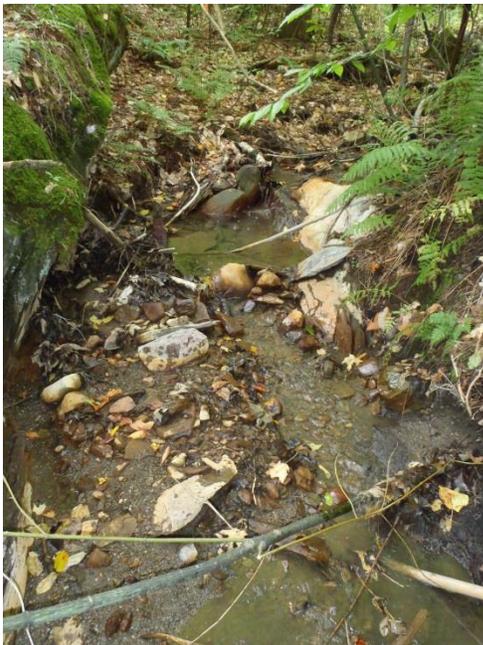
3-Trib 2 0.3 below s.cut

These locations are very small in drainage area, and are likely intermittent during low flow years, but since 2013 was a wet year they may not have gone intermittent. These streams should only be compared to the local intermittent reference stream Lords Trib 4, in determining their biological potential. As anticipated, both of these small intermittent tributaries were found to be in very poor biological condition, exhibiting an extreme departure in community metric values from Lords Trib 4. Almost no macroinvertebrates were present (<20/KN), representing very few taxa. The species richness was <10, and the EPT species was ≤5 at both sites. With less than 20 animals collected the rest of the community metrics have very little relevance in terms of an assessment. The very low density and richness is a strong indication of a toxic impact on the macroinvertebrate community at all the Lords Brook Trib 2 watershed sites.
