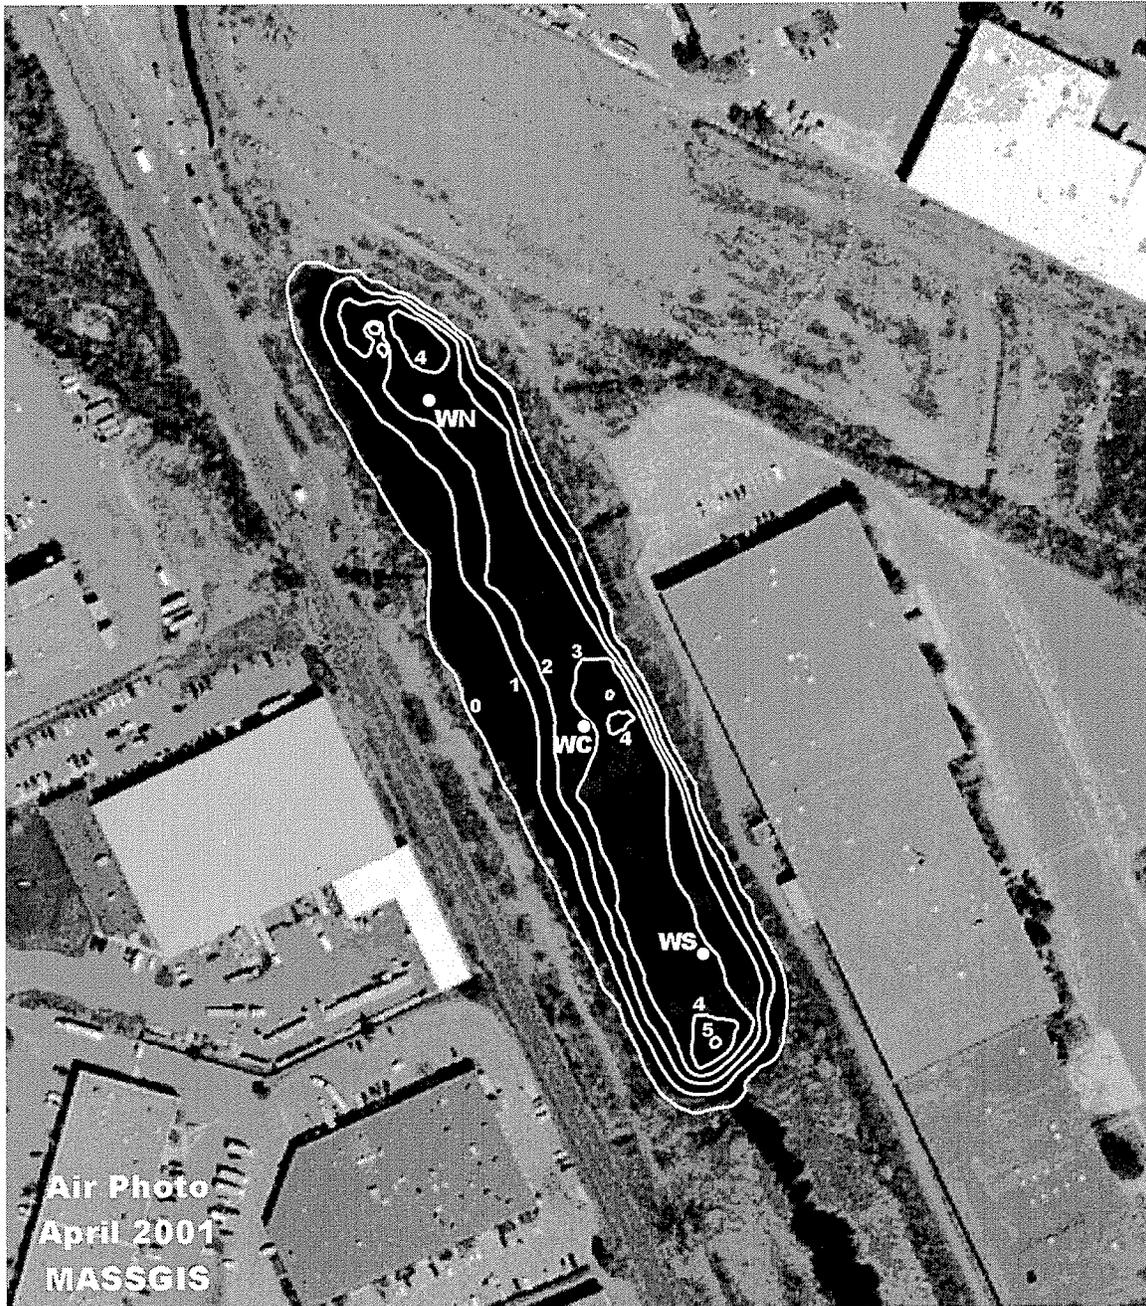
Figure A.7. Results of bathymetric survey for depth to sediment within the HBHA Pond. Contours are shown at one meter intervals. The north (WN), central (WC), and south (WS) surface water sampling locations are also shown. Image was derived from April 2001 aerial photograph obtained from MassGIS.

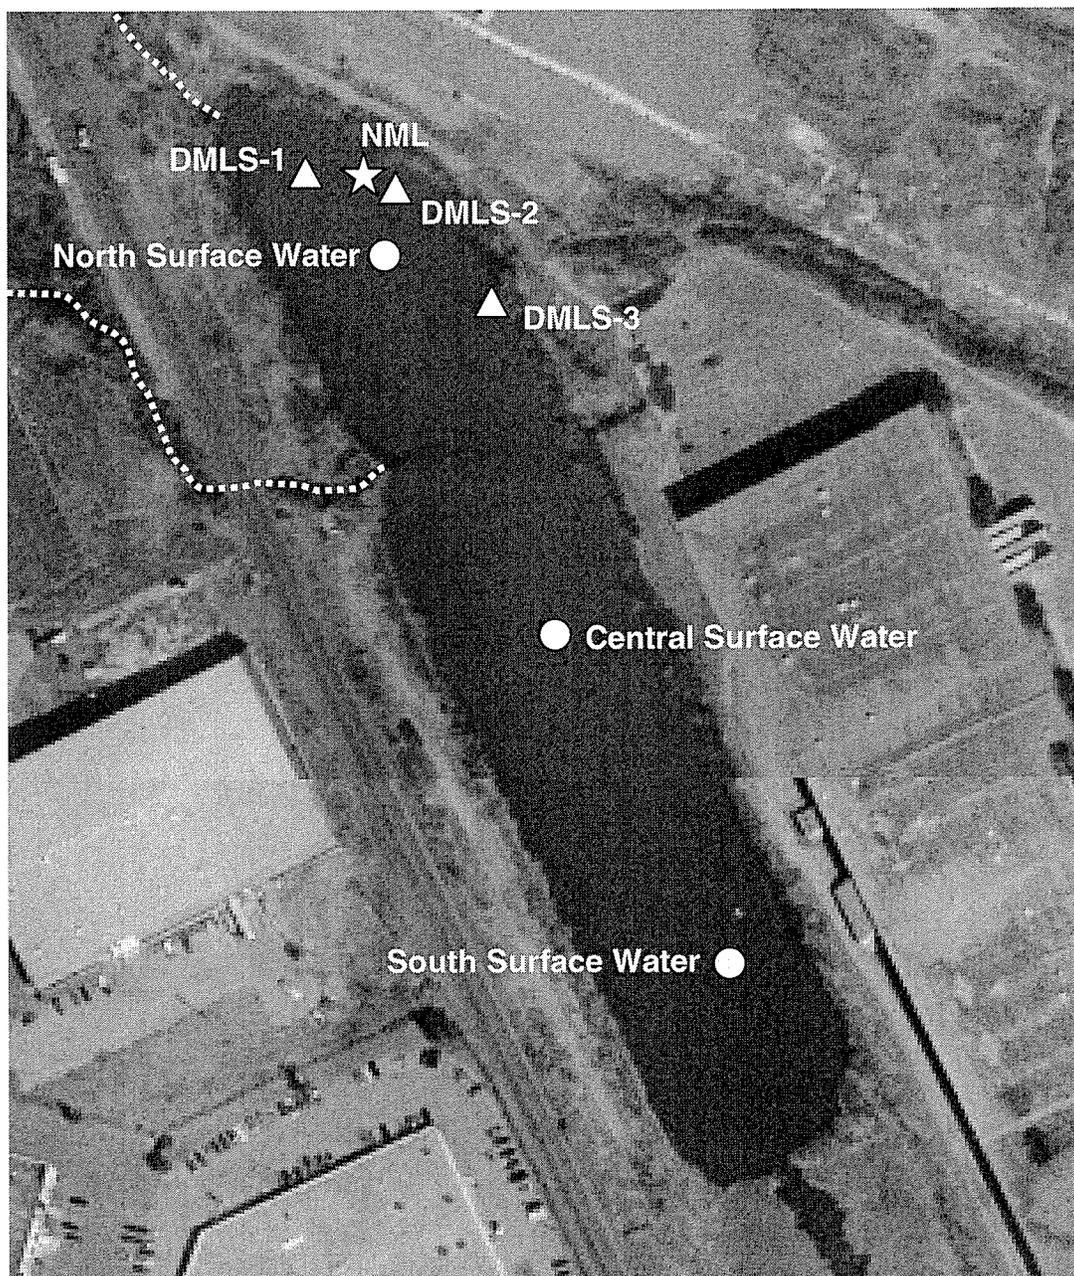
Figure A.8. Surface water and sediment porewater monitoring locations within the Hall's Brook Holding Area Pond. Image was derived from November 1995 aerial photograph obtained from MassGIS.

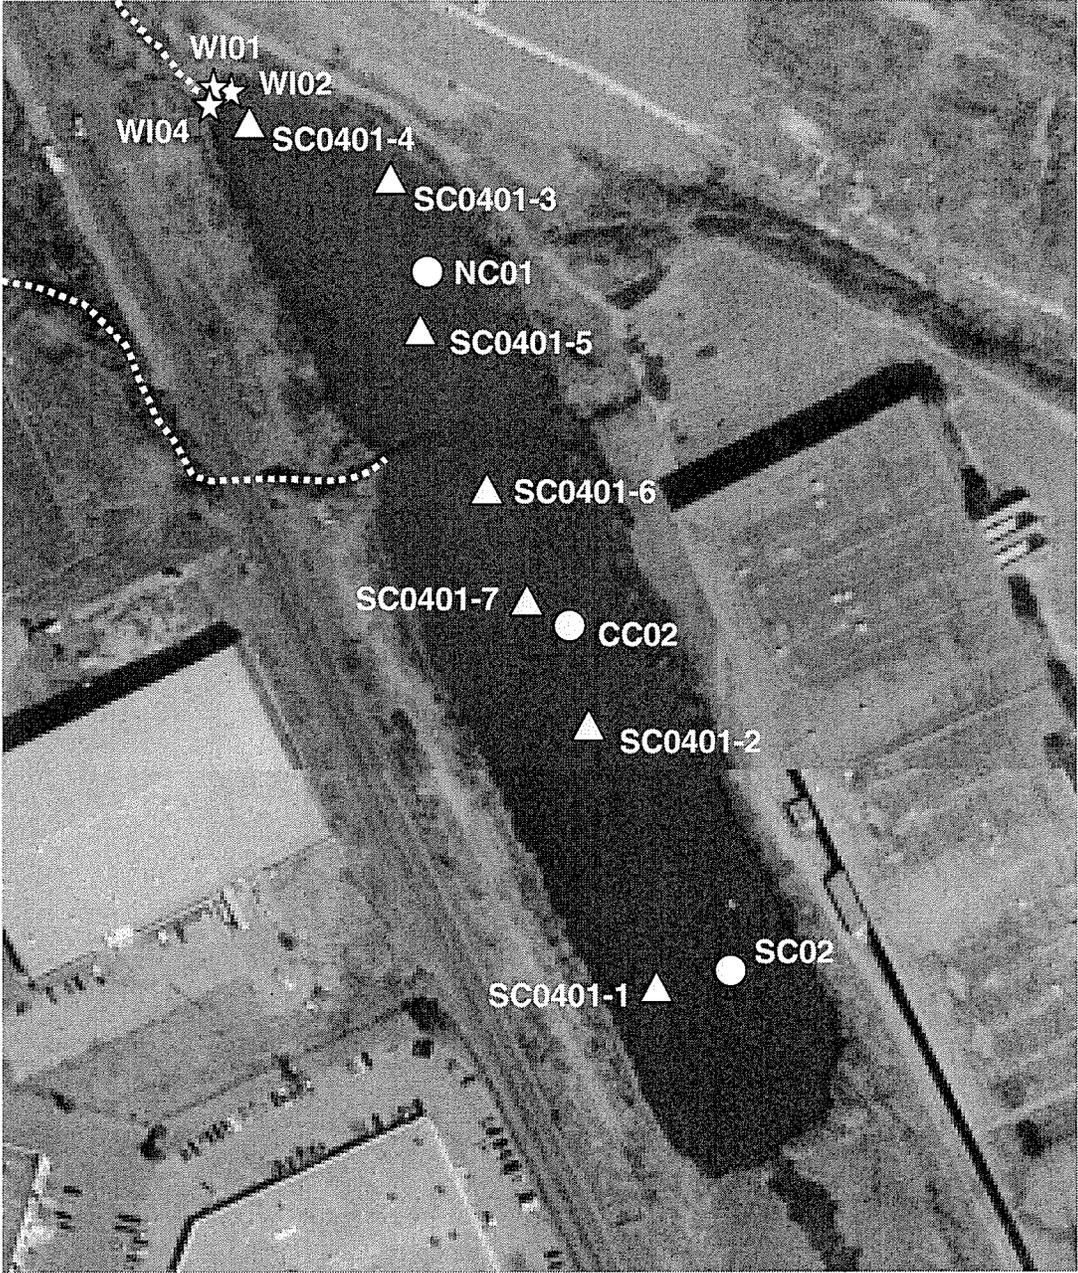
Figure A.9. Location of sediment samples collected from Hall's Brook Holding Area Pond. Symbol notations: ▲ solids pumped from sediment-water interface, ● sediment cores collected using Geoprobe® coring device with 2" sleeves, ★ shallow grab samples. Image was derived from November 1995 aerial photograph obtained from MassGIS.
