Cover Certification Report

**Massachusetts Bay Transportation Authority
New Boston Street, Rear
Woburn, Massachusetts 01801
Tax Map 31-2-2**

September 30, 2008

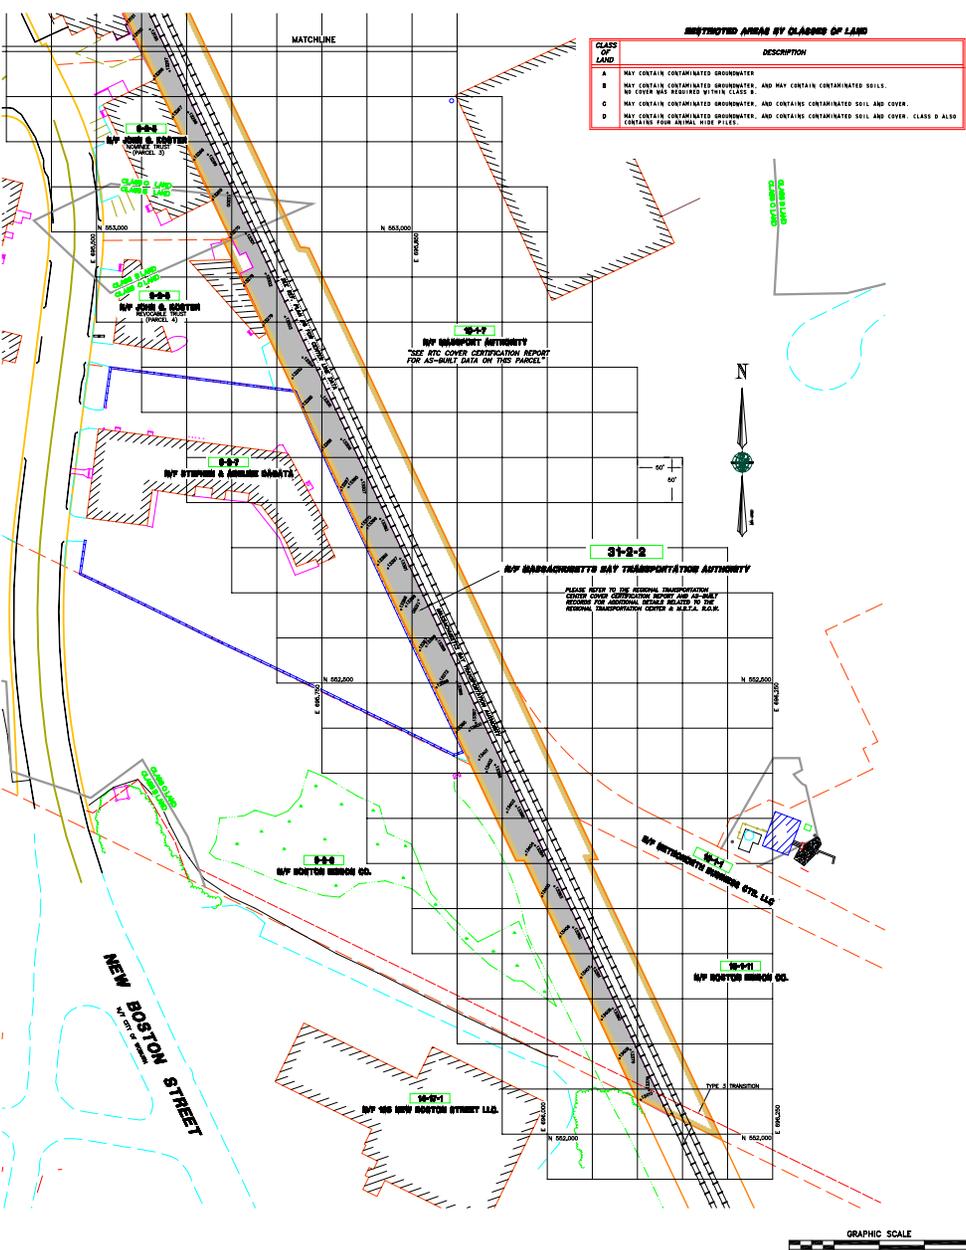
PROJECT RECORD TAX MAP LOT 31-2-2 (WEST ROW)

CLASS OF LAND	DESCRIPTION
A	MAY CONTAIN CONTAMINATED UNDERGROUND
B	MAY CONTAIN CONTAMINATED UNDERGROUND, AND MAY CONTAIN CONTAMINATED SOILS.
C	NO COVER HAS BEEN REQUIRED WITHIN CLASS B.
D	MAY CONTAIN CONTAMINATED UNDERGROUND, AND CONTAINS CONTAMINATED SOIL AND COVER. CLASS D ALSO CONTAINS FOUR ANIMAL WASTE PILES.
