MEMORANDUM

RE: Emergency Response Activities at the Mohawk Tannery site.
TDD No. 01-07-10-0002; Task No. 0350; Document Control No. R-4983.

**Mohawk Tannery ER
Fairmount Street
Nashua, New Hampshire**

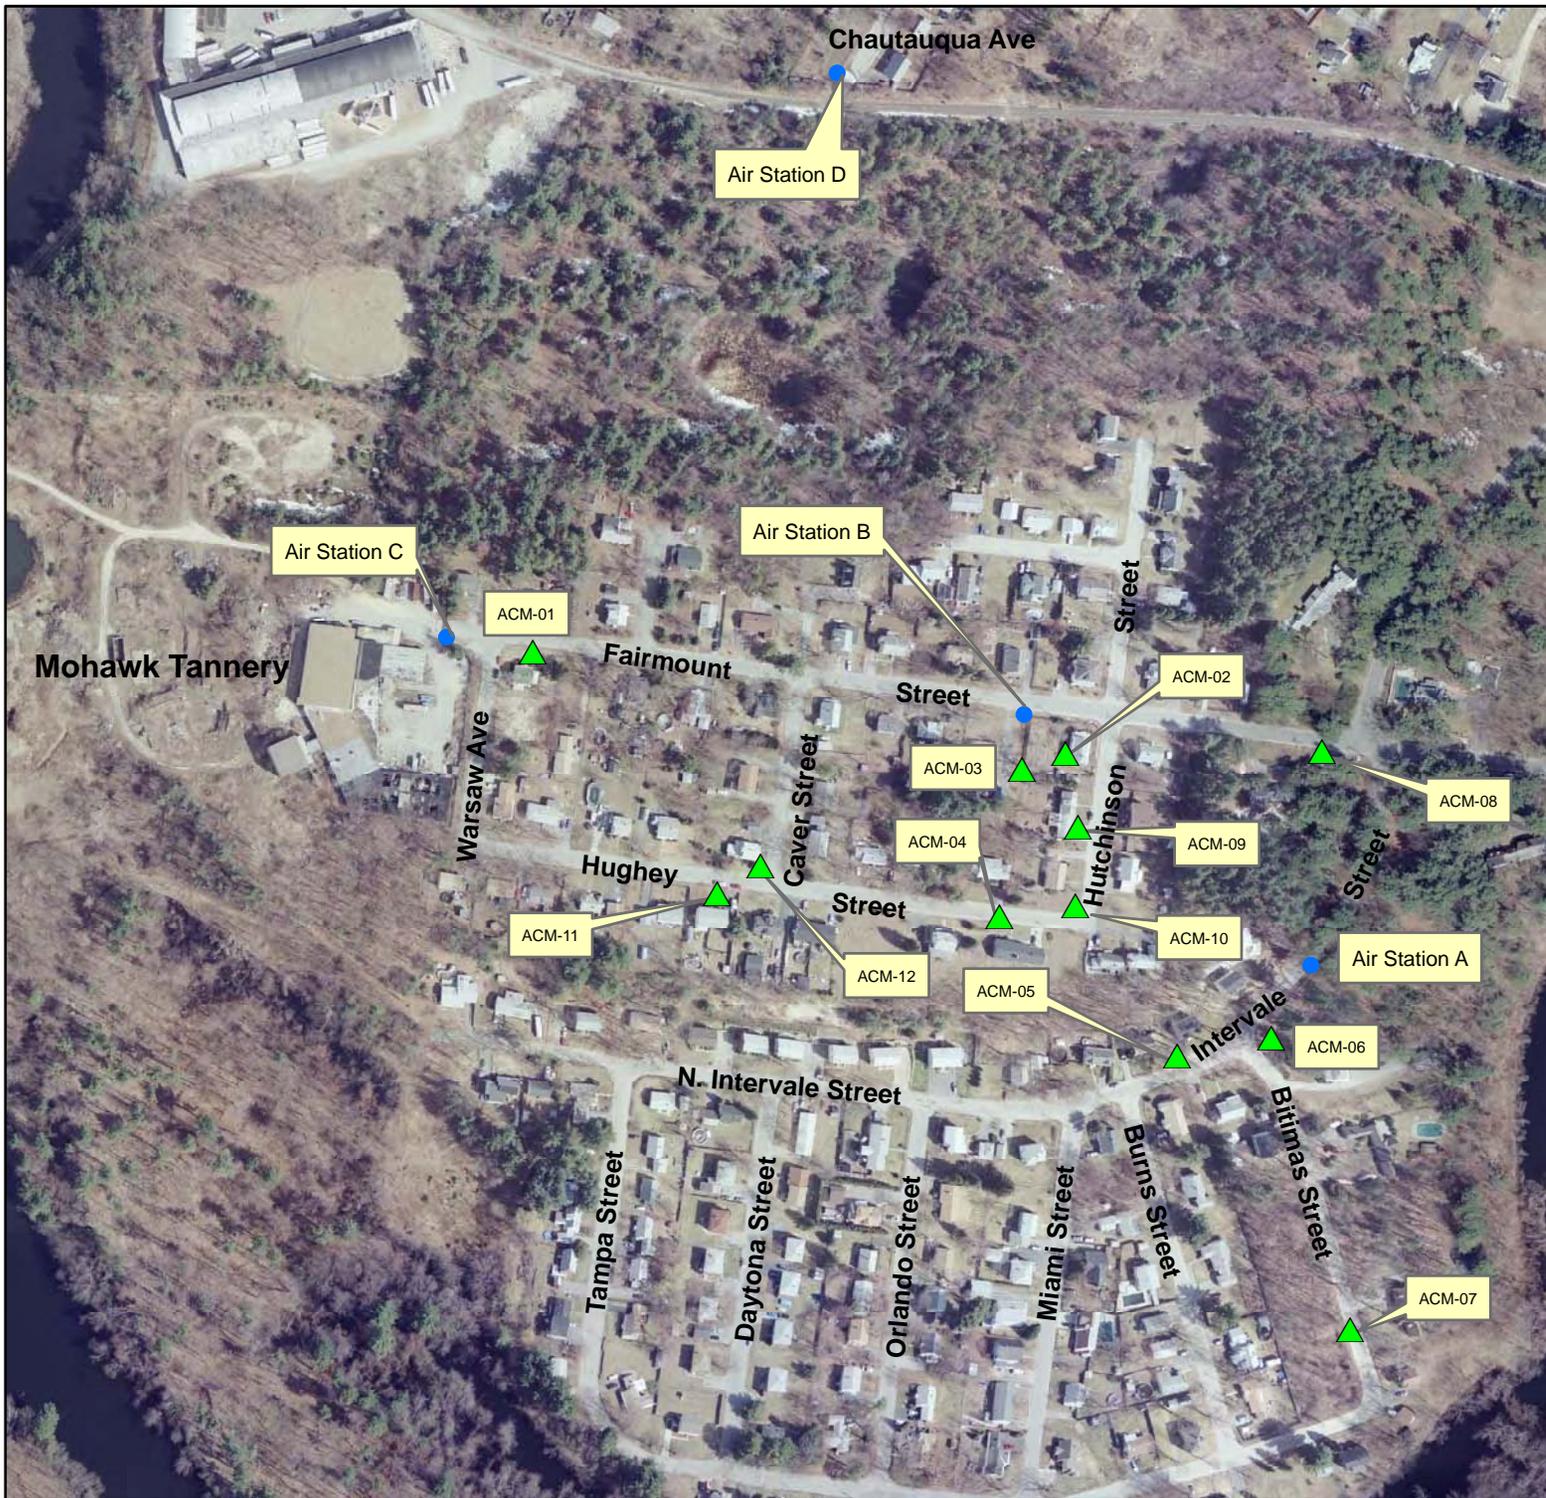
Site and Sample Location Diagram (Figure 2)

Figure 2
Site and Sample
Location Diagram
Mohawk Tannery ER
Fairmount Street
Nashua, New Hampshire

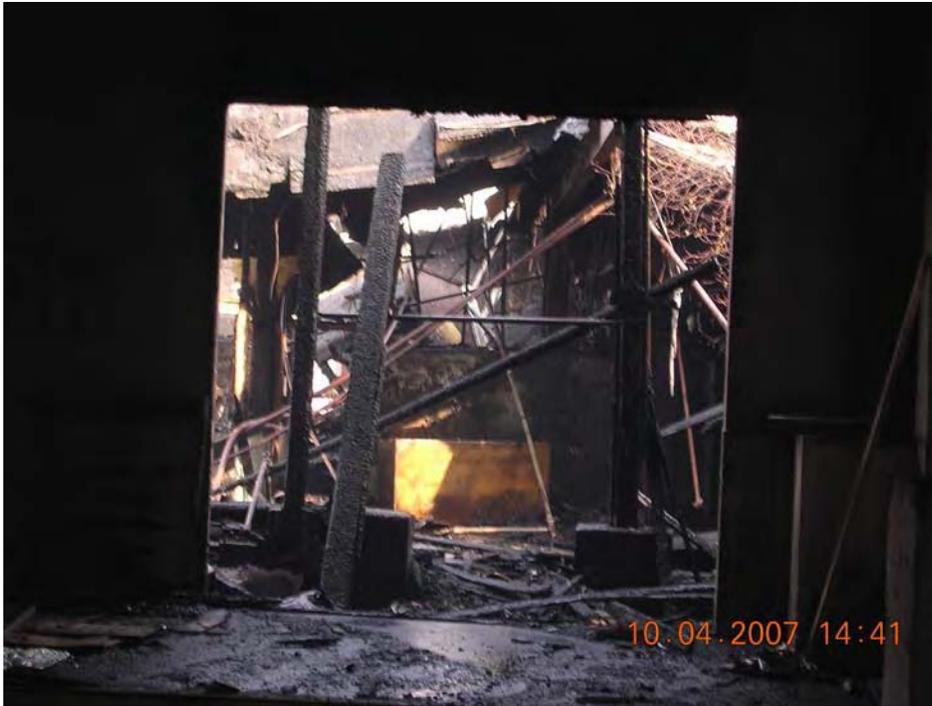
SCENE: View of the fire-damaged southwest portion of the site building. Photograph taken facing southeast.

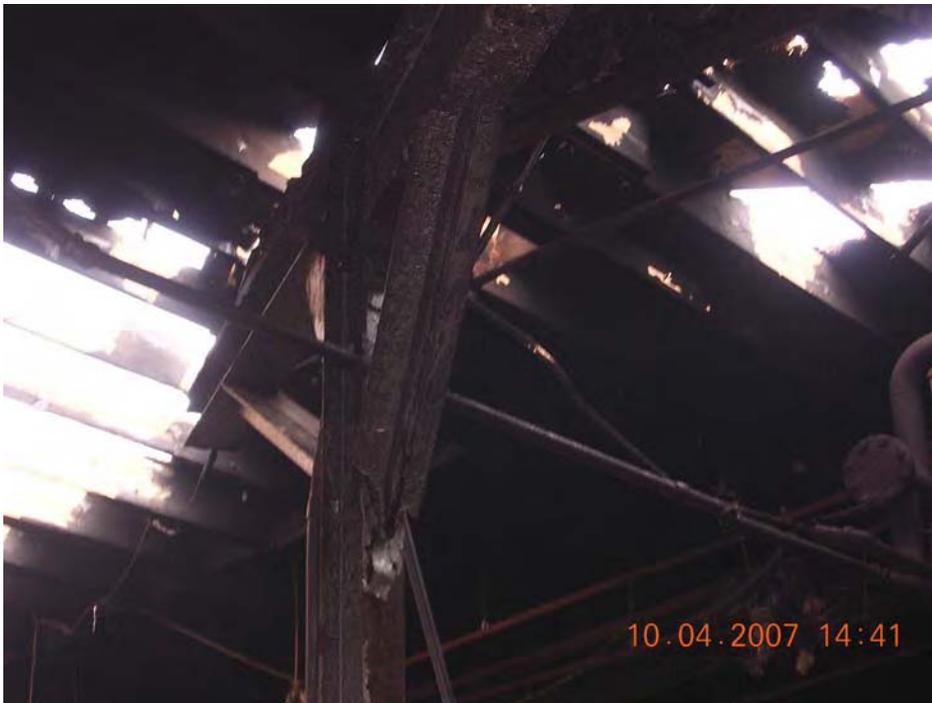
SCENE: View of the roof from which suspected asbestos-containing material was dispersed during the fire.

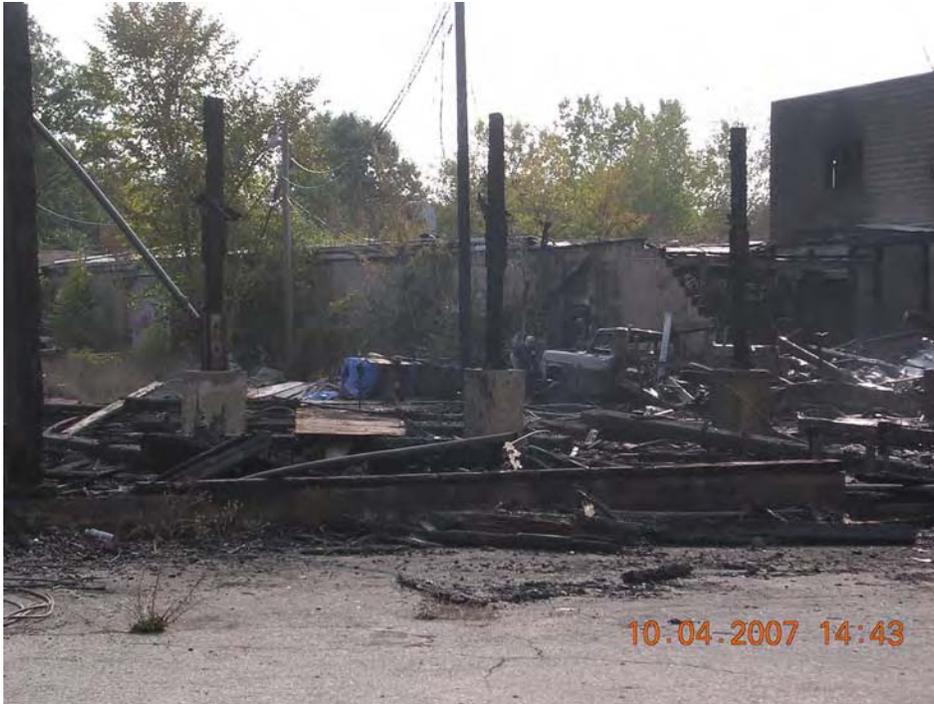
SCENE: View of the building remnants. Photograph taken facing southwest.

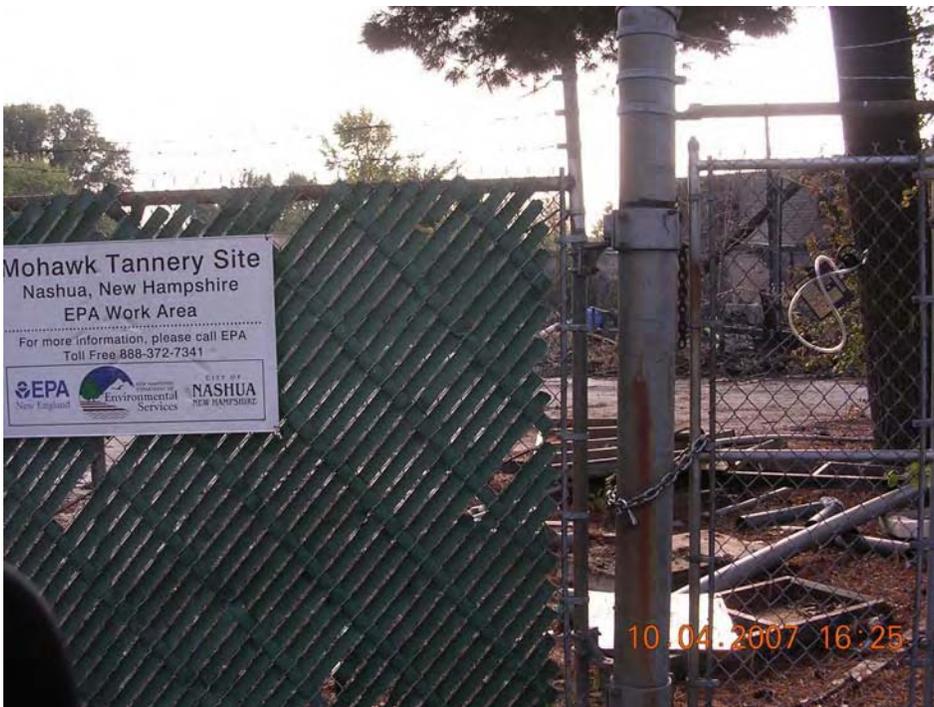
asbestos analysis at Air Station C, located downwind of the site on the perimeter chain-link fence surrounding the site.

SCENE: View of the entrance of the site and air sampling Station C. A typical air sampling station set up. Photograph taken facing west.

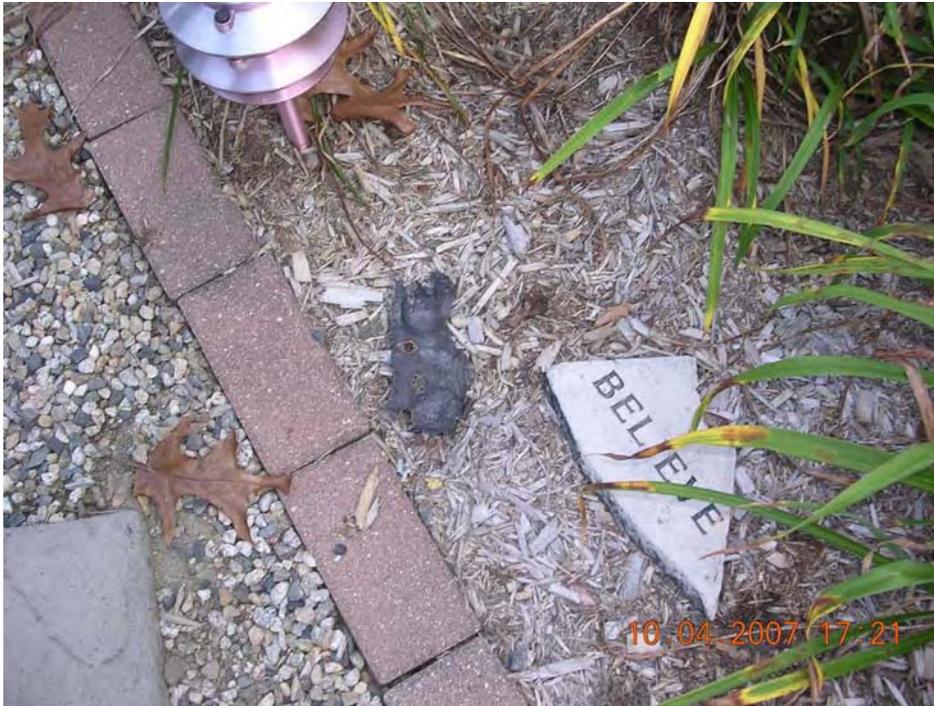
All asbestos results were non-detect (ND) for debris samples ACM-01 through ACM-12.

SCENE: View of suspected asbestos-containing material in a garden at a neighboring residence that was dispersed during the fire.

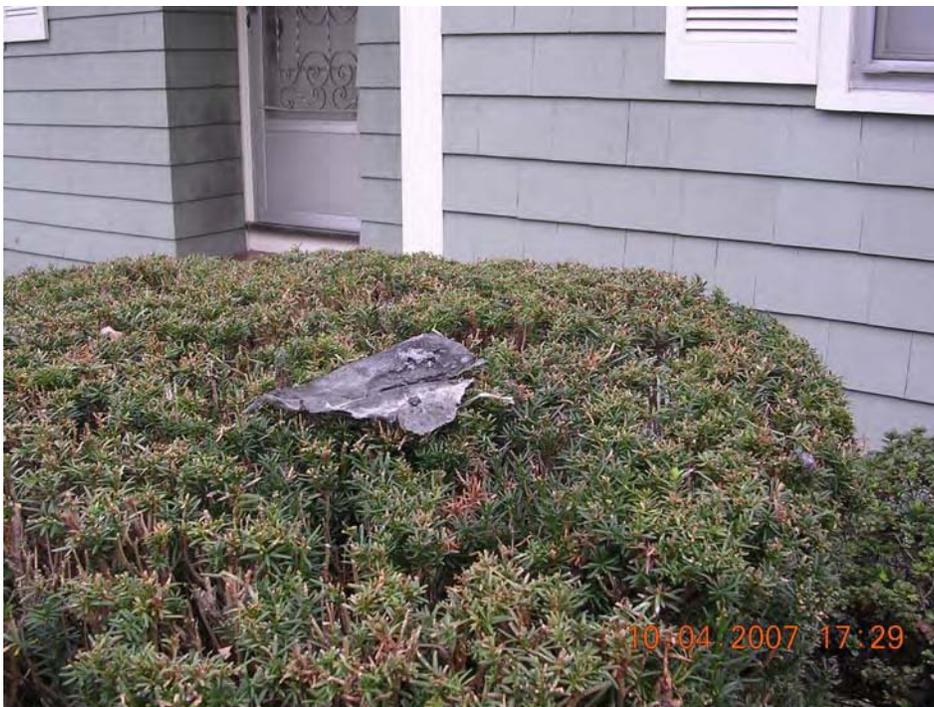
SCENE: View of suspected asbestos-containing material at a neighboring residence that was dispersed during the fire. Photograph taken facing northwest.
