**REMOVAL PROGRAM
AFTER ACTION REPORT
FOR THE
MOHAWK TANNERY SITE
NASHUA, HILLSBOROUGH COUNTY, NEW HAMPSHIRE
2 OCTOBER 2000 THROUGH 26 JANUARY 2001**

U.S. Environmental Protection Agency
Region I
Emergency Planning and Response Branch
One Congress Street, Suite 1100
Boston, Massachusetts 02114-2023

Roy F. Weston, Inc.
Superfund Technical Assessment and Response Team
37 Upton Drive
Wilmington, Massachusetts 01887

April 2001

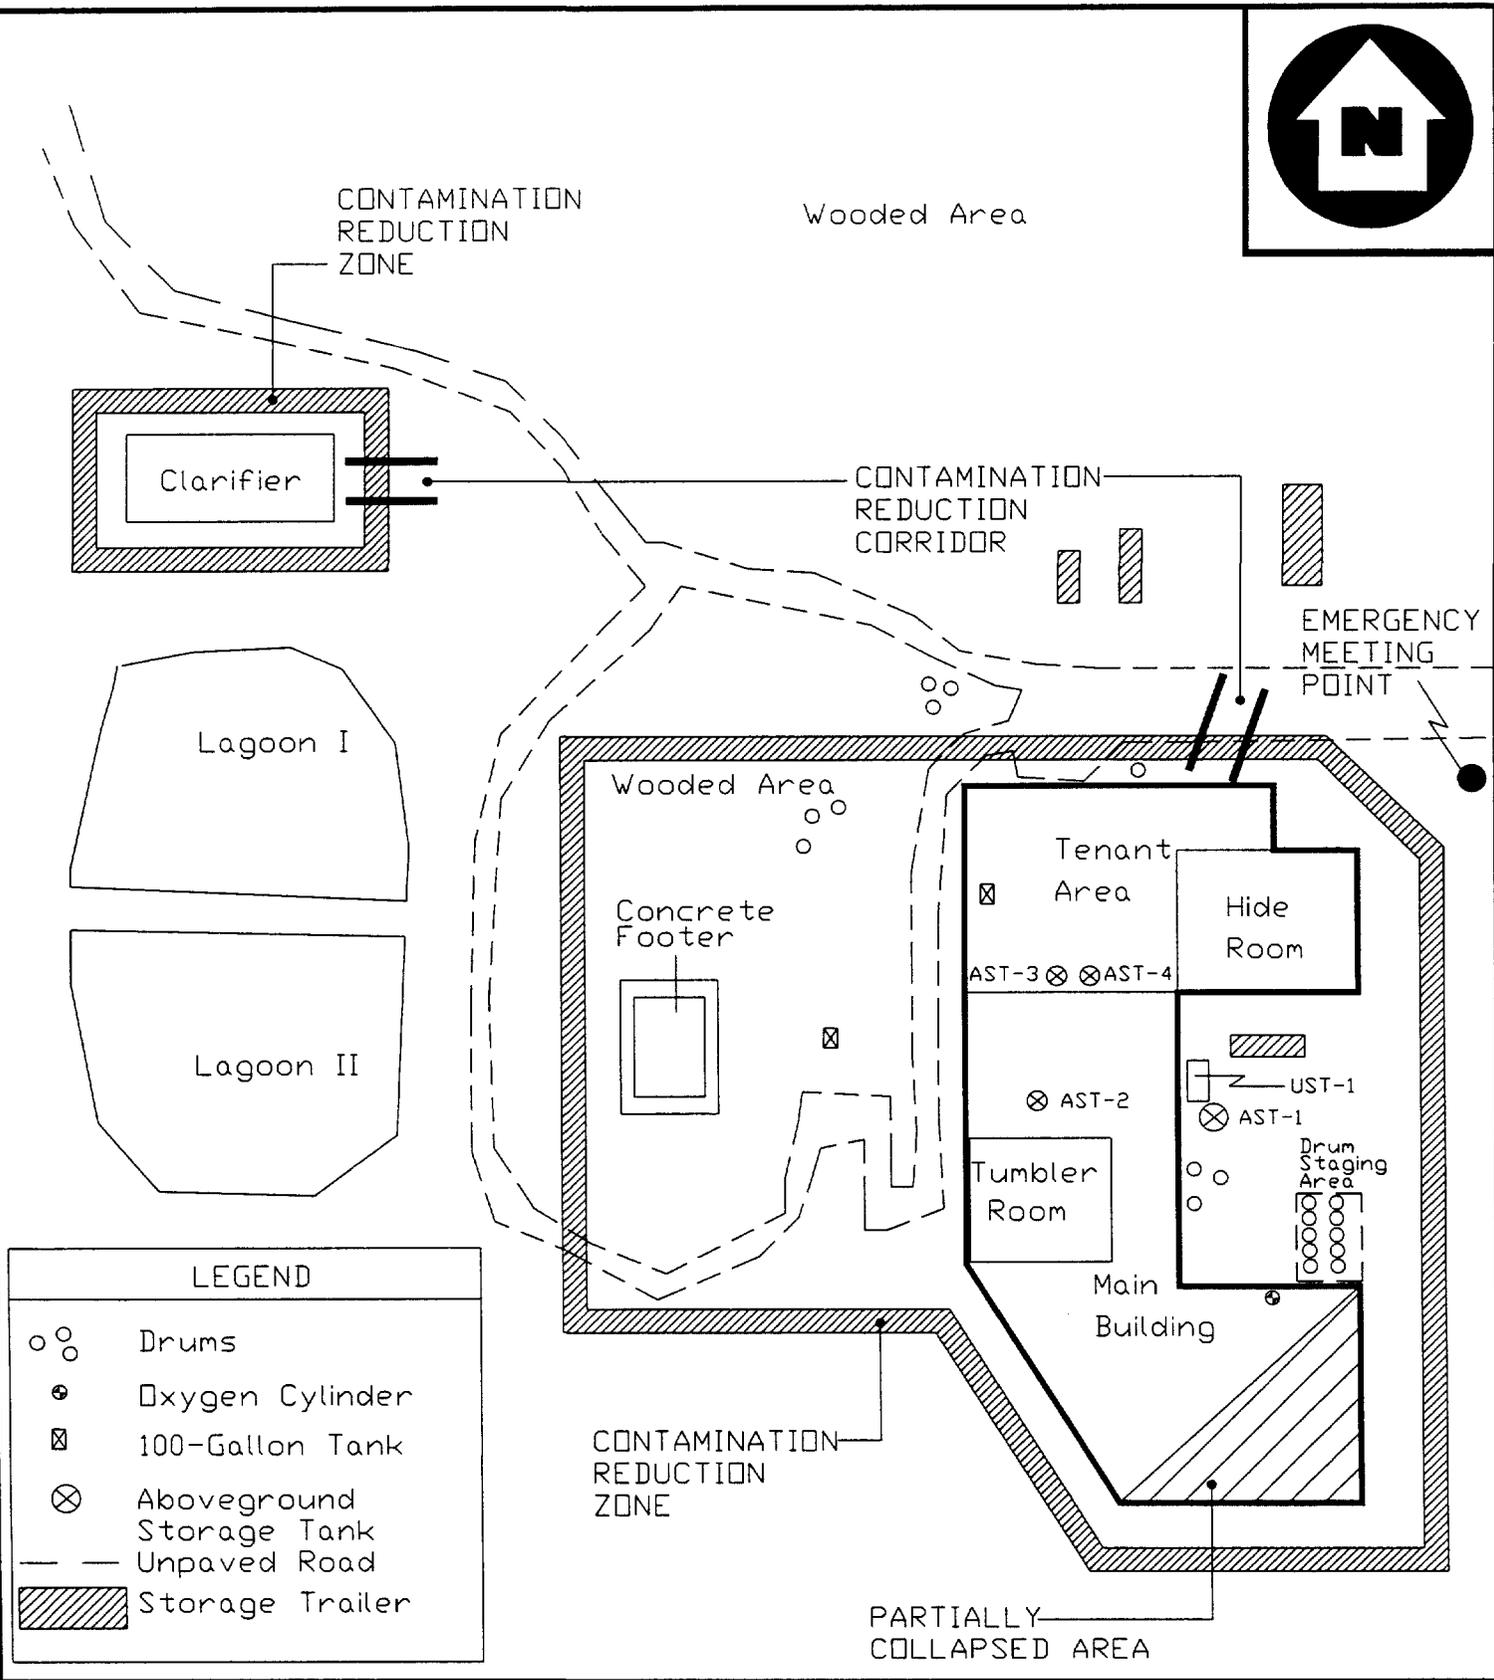
Site Diagram (Figure 2)

completed asbestos removal activities. ACM removal activities were conducted in the Main Building area. Some suspected ACM, primarily non-friable, was observed in the area identified in Figure 2 as the “partially collapsed area”. Due to the structural instability of this section, the material was not accessible and therefore not removed.

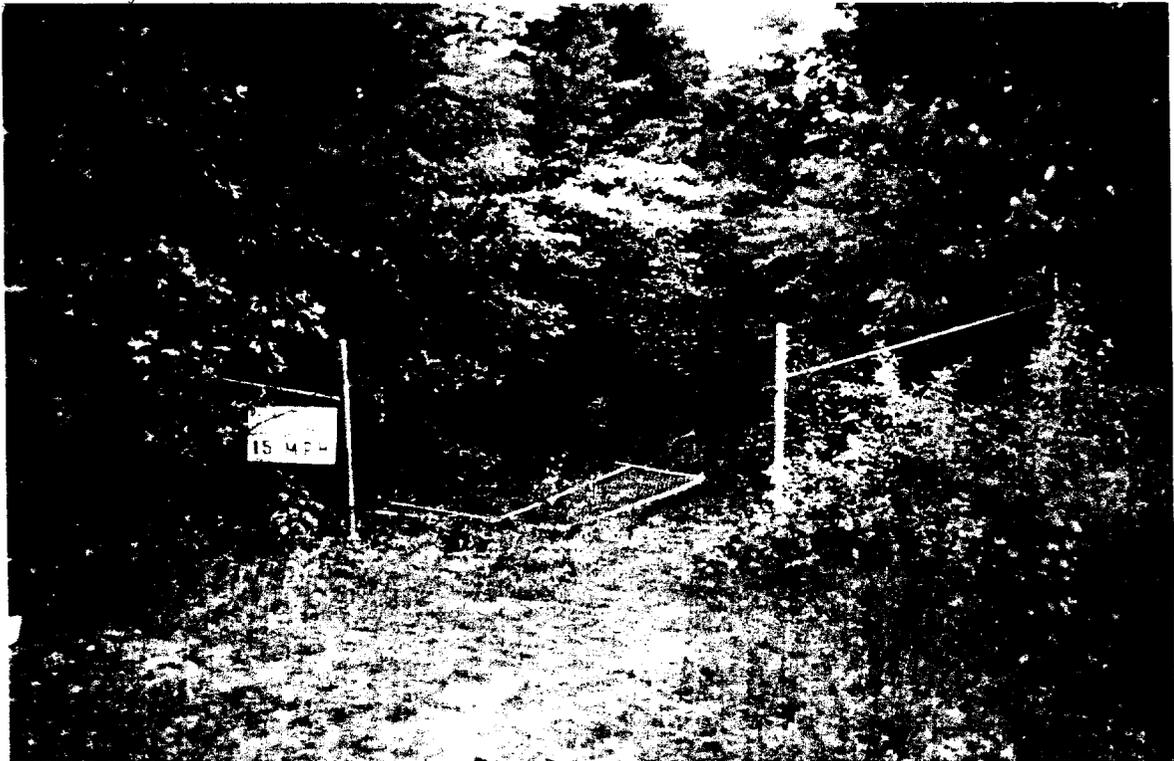
SCENE: View of the damaged north gate. Photograph taken facing north.
FRAME NUMBER: 08 **DATE:** 2 October 2000 **TIME:** 0840 **SKY CONDITION:** Cloudy
PHOTOGRAPH BY: Jeremy Picard **WITNESS(ES):** Gilberto Irizarry
CAMERA: Fuji **SETTING:** Automatic **FILM TYPE:** 35-mm **FILM ROLL:** 3828

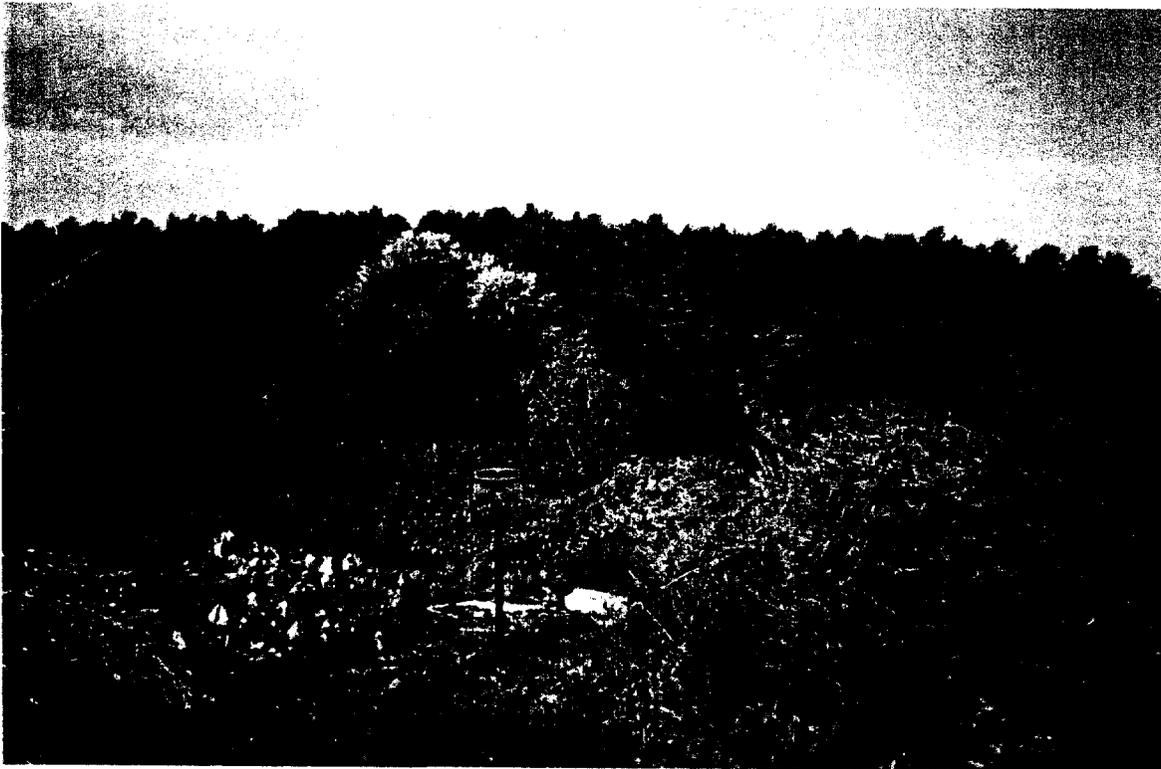
SCENE: View of "Warning" placards placed along the lagoon perimeter. Photograph taken facing west.

Site activities included clearing debris and brush from work areas to allow safe access to drums; posting signs along the perimeter of lagoons; repairing and placing locks and chains on the perimeter chain-link fence gates; and placing temporary overhead lights in the Main Building. START

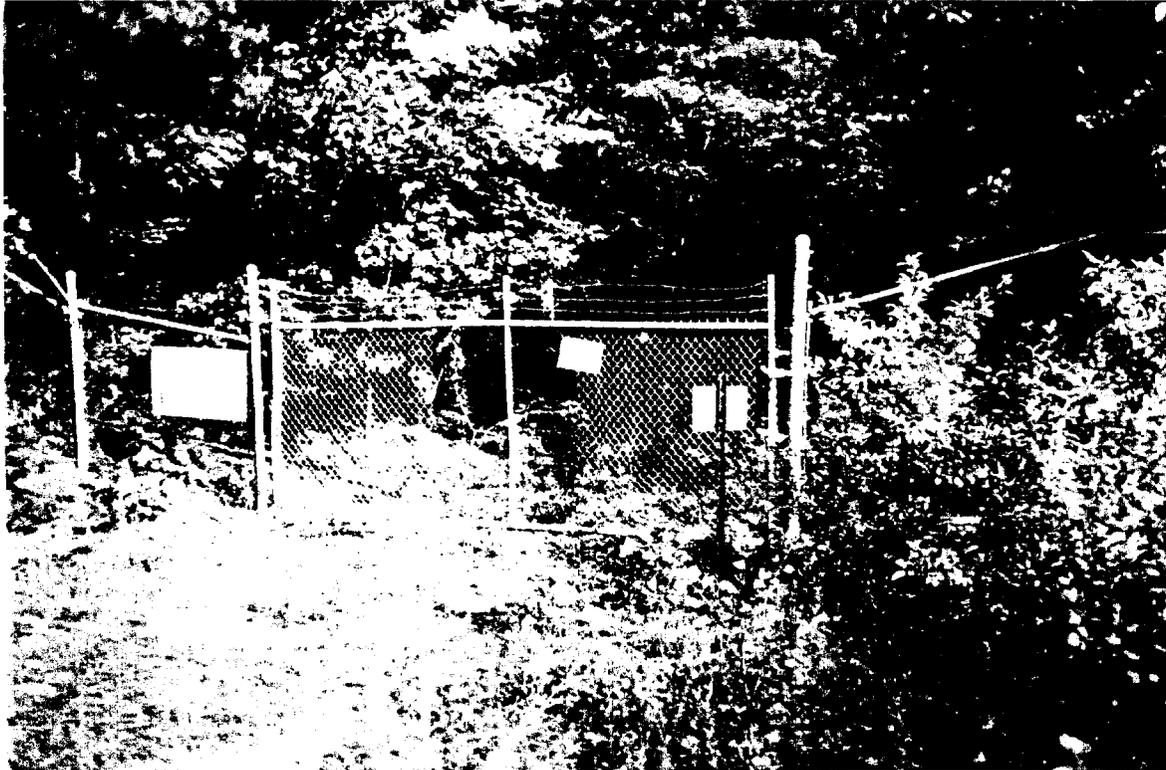
SCENE: View of the repaired north gate. Photograph taken facing north.

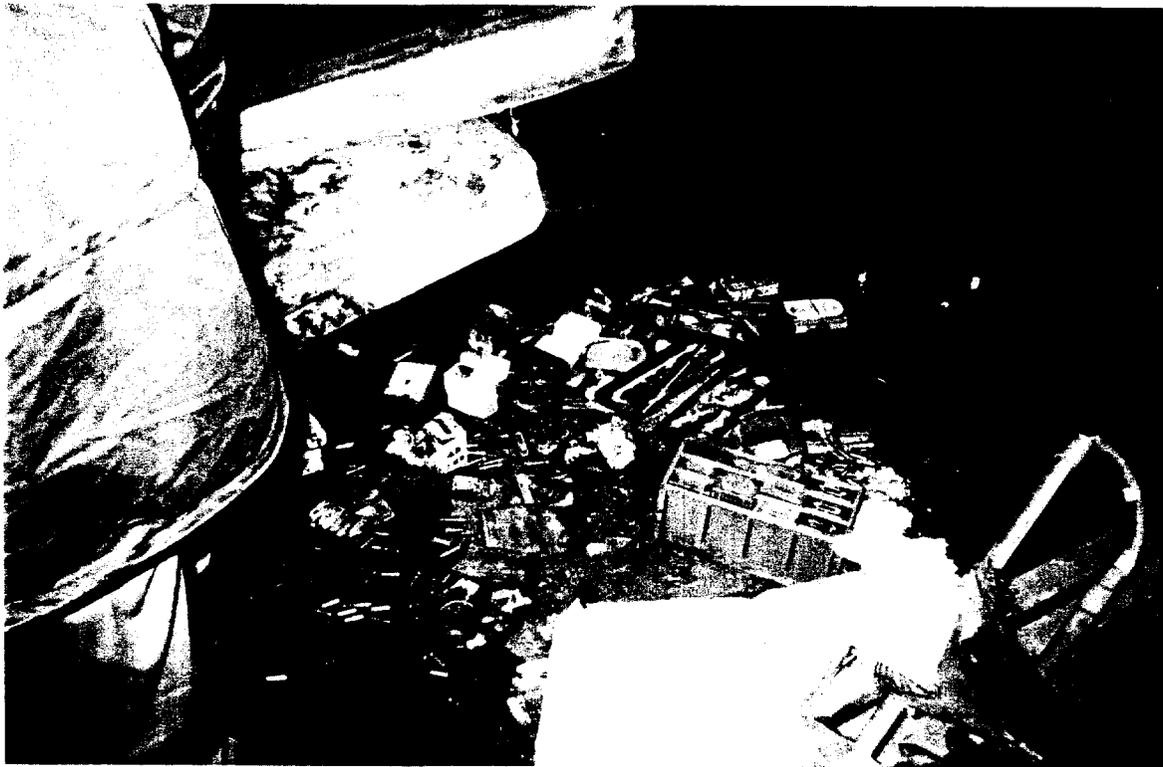
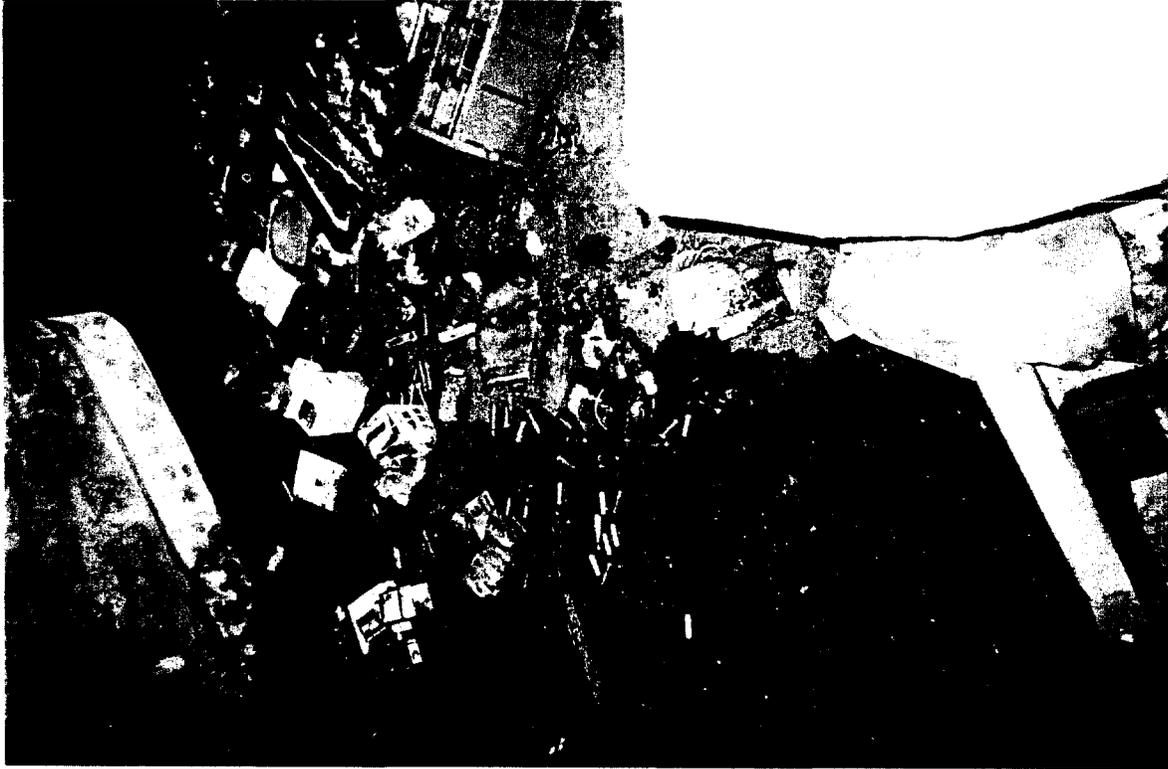
SCENE: View of munitions discovered in the Main Building.

Visitors to the site included the Nashua Police Department Hazardous Device Unit who mobilized to the site to remove black powder ammunition discovered in the Main Building during site activities, and IT Transportation and Disposal (T&D) Coordinator Gary Benham and IT Chemist Andy Schkuta who met the OSC to discuss the IT Sampling and Analysis Plan. In addition, EPA Remedial Project Manager (RPM) Neil Handler, NHDES representatives John Reagan and John Splendore, New Hampshire Department of Health and Human Services (NHDHHS) representative Dennis Pinski, and environmental consultants for the site owner, Mike Jordan of GeoSyntec Corporation (GeoSyntec), and Karl Touet of ERI, Inc., (ERI) visited the site and met with the OSC.

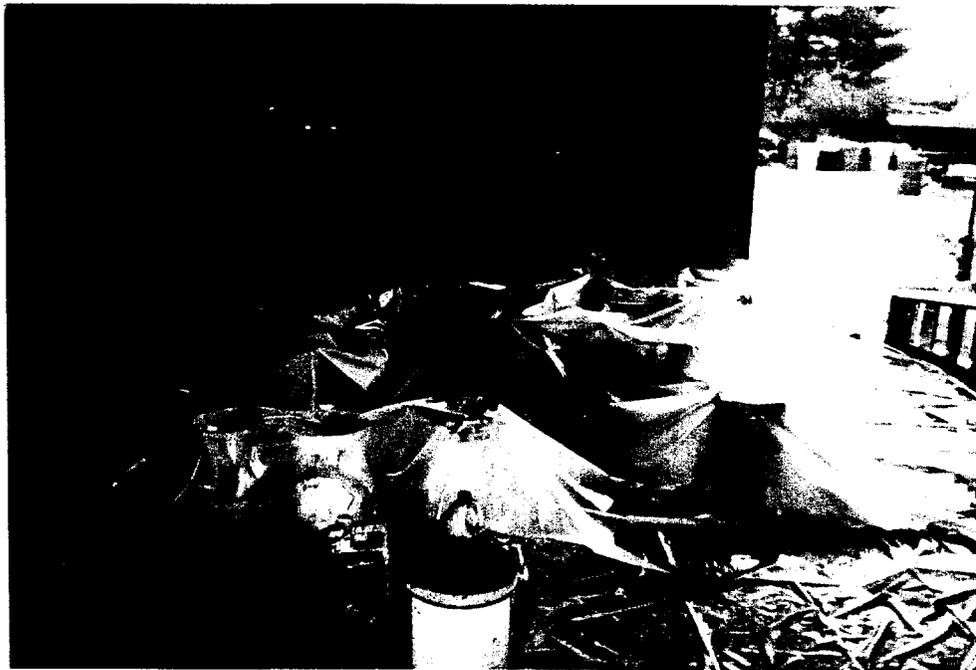
SCENE: View of approximately 360 chemical containers staged on and below a polyethylene liner. Photograph taken facing east.

The week's activities included mailing a Request for Proposal to subcontractors for asbestos removal; establishing an EZ and CRZ for the clarifier building; collecting approximately 360 chemical containers that were staged by wastestream on polyethylene sheeting in the Main Building, and covering the containers with polyethylene sheeting to protect them from a leaking roof; and overpacking drums located in the Hide Room into 15 85-gallon steel overpack and two 95-gallon polyethylene overpack drums. One sample was collected from each drum and stored for use by the IT Chemist for hazard categorization assessment of the drums.

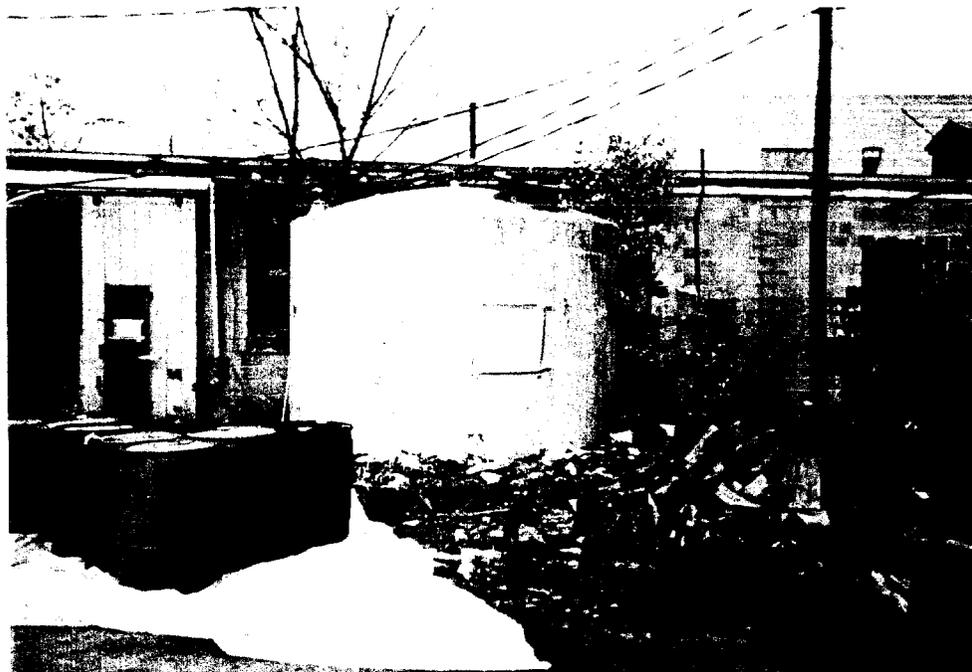
SCENE: View of AST-1 following the cutting of an access way into the tank and pumping of fluid into six 55-gallon polyethylene drums. Photograph taken facing west.

Amendment No. 2 to the HASP was issued to allow ERRS confined space entry (CSE) into AST-1 for decontamination. An estimated 490-gallons of caustic liquid was pumped from AST-1 into 10 55-gallon polyethylene drums with four additional 55-gallon polyethylene drums and one 55-gallon plastic lined steel drum used to contain decontamination water and waste debris. ERRS cleaned AST-1. START conducted continuous air monitoring during CSE activities with no levels above background observed on air monitoring equipment. The ERRS crew dismantled AST-1 using a partner saw and staged the debris beneath a polyethylene liner. While dismantling AST-1 a fill pipe from an underground storage tank (UST) was detected. The ERRS crew removed the fill cap the UST (UST-1). The tank depth was measured to be 8 feet and contained approximately 18-inches of suspected No. 2 fuel oil. START conducted continuous air monitoring during UST-1 investigation with a Combustible Gas Indicator/Oxygen (CGI/O₂) Meter, and noted a Lower Explosive Limit (LEL) of 10% and deficient O₂ in UST-1. The ERRS crew removed plywood and investigated the tumbler room area of the Main Building. Two 55-gallon fiber drums containing solid product, two empty 55-gallon steel drums, and six 5-gallon polyethylene buckets were discovered. The ERRS crew overpacked and transported the drums to the staging area. START conducted background perimeter air monitoring in preparation for asbestos removal activities. ERRS T&D Coordinator Benham conducted hazardous categorization assessment of drum samples.

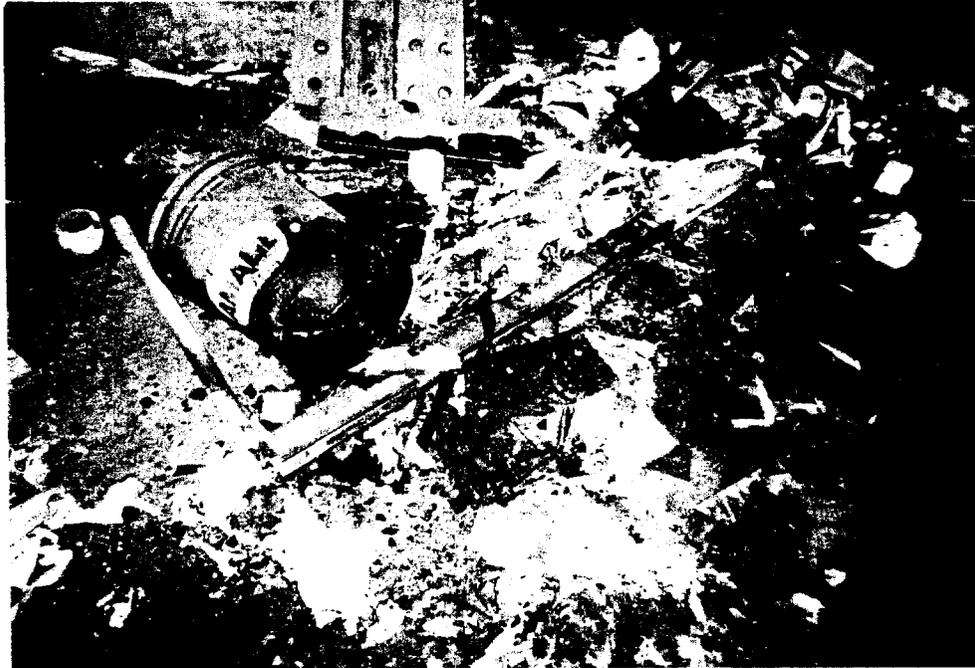
SCENE: View of 5-gallon container leaking oil. Container discovered in lower area of main building.

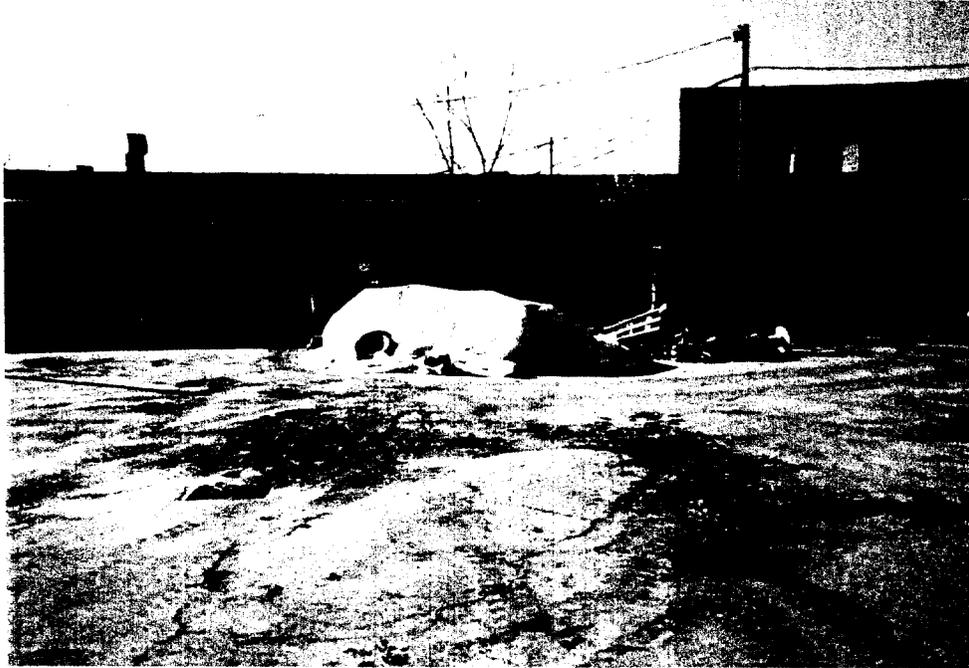
SCENE: View of dismantled AST-1 under polyethylene liner. Photograph taken facing west.

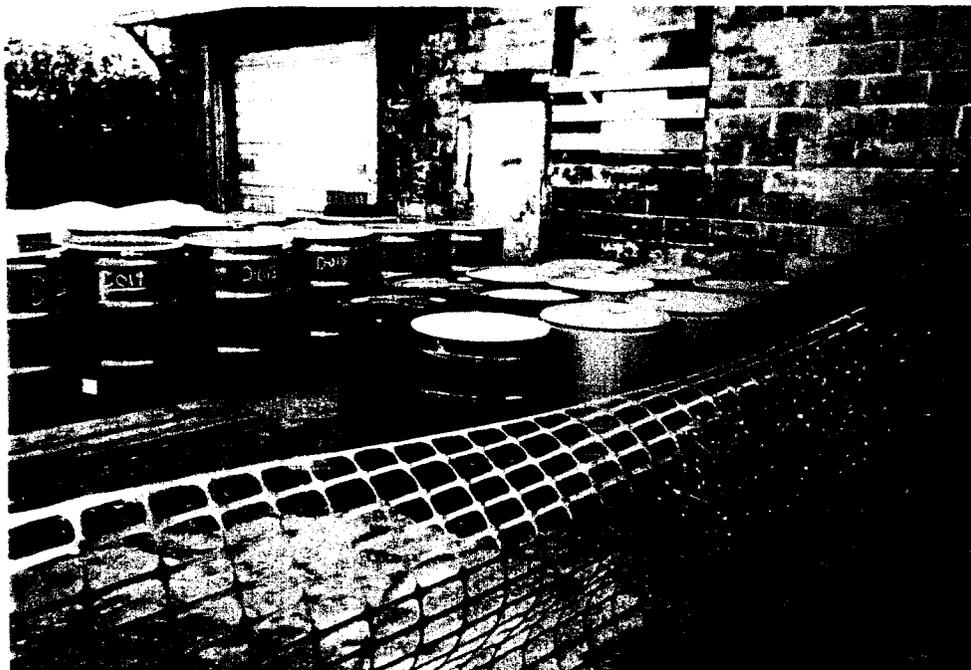
SCENE: View of 10 55-gallon polyethylene and one 55-gallon steel drums containing fluid and waste removed from AST-1. Photograph taken facing southeast.

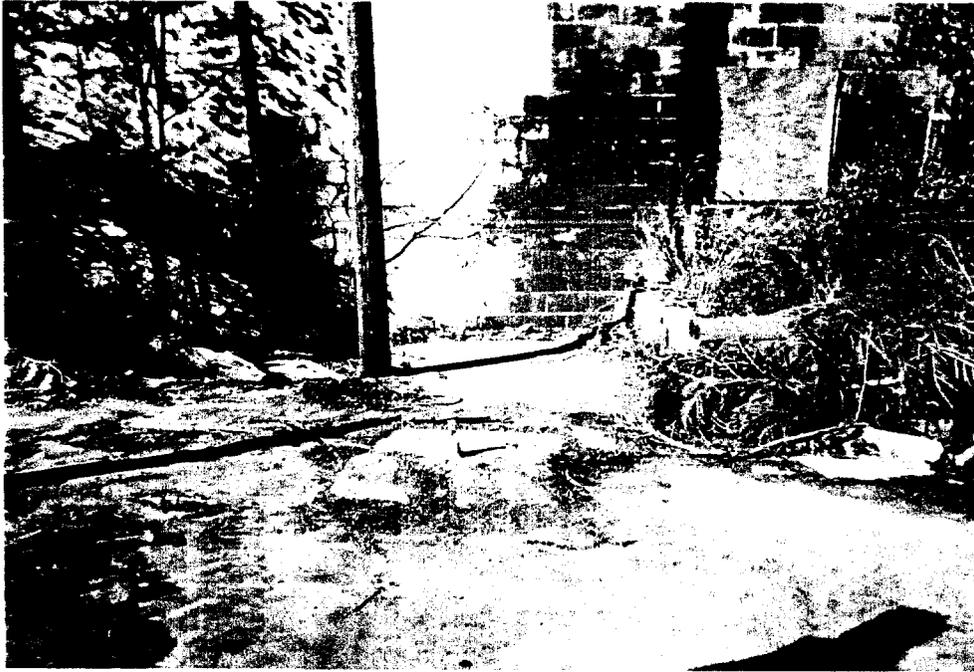
SCENE: View of UST-1 location. Area is located along main building just north of AST-1 Photograph taken facing west.

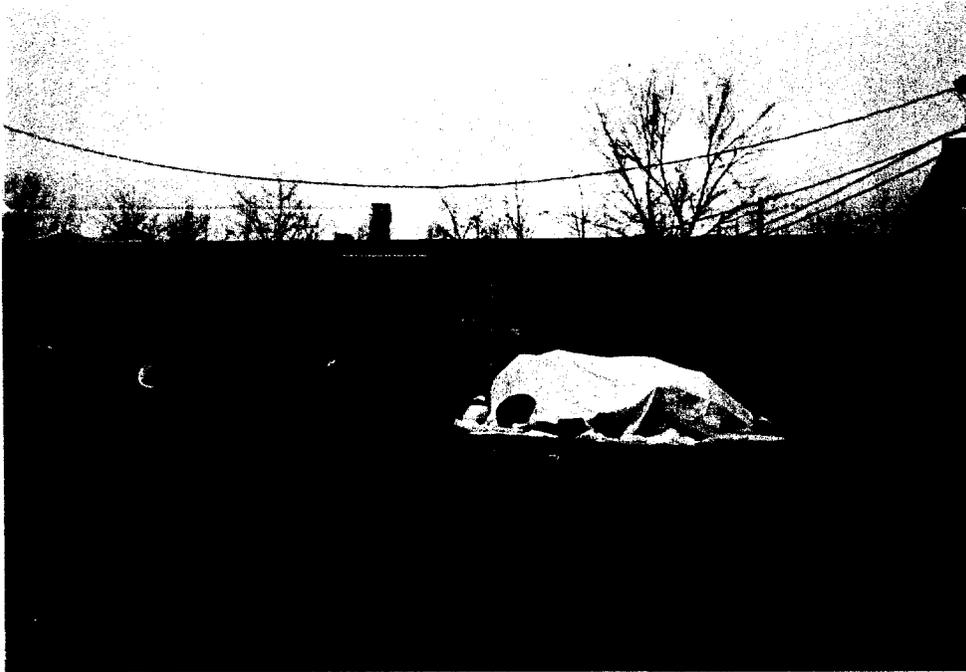
SCENE: View of the AST-1 rubble beneath a polyethylene liner. Photograph taken facing west.

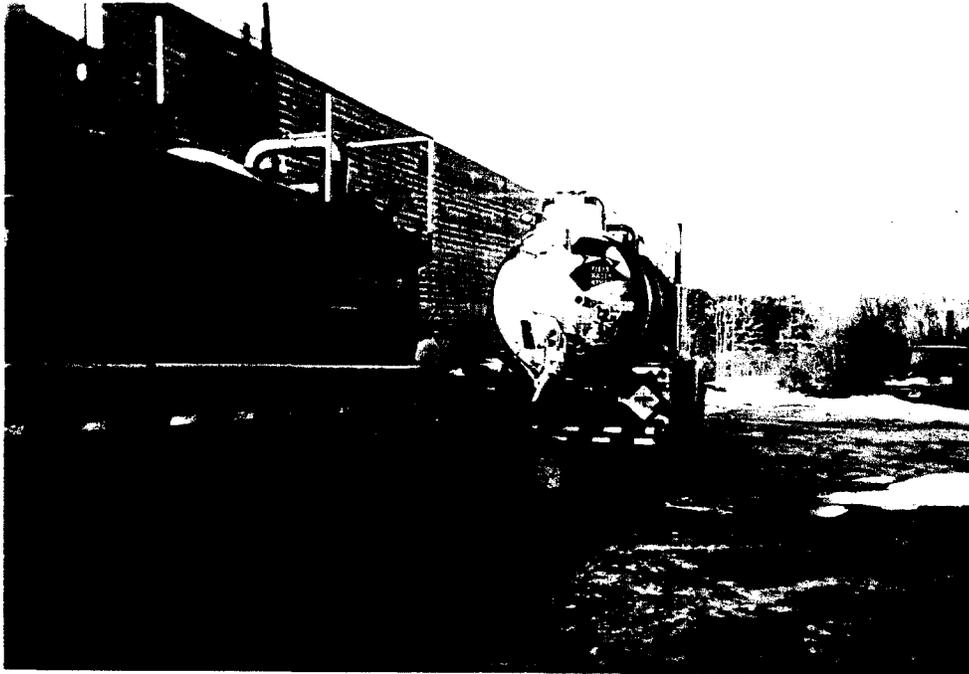
SCENE: View of Fleet Environmental Services, Inc. (FLEET) tanker trucks that hauled clarifier liquid off site for disposal. Photograph taken facing west.
