PROJECT FOR  
PERFORMANCE OF  
REMEDIAL RESPONSE ACTIVITIES AT  
UNCONTROLLED HAZARDOUS  
SUBSTANCE FACILITIES—ZONE 1

**SITE INSPECTION  
ATLAS TACK CORPORATION  
FAIRHAVEN, MASSACHUSETTS**

TDD NO. F1-8403-01A  
NUS JOB NO. 3519  
EPA SITE NO. MAD 001026319  
CONTRACT NO. 68-01-6699

August 31, 1984

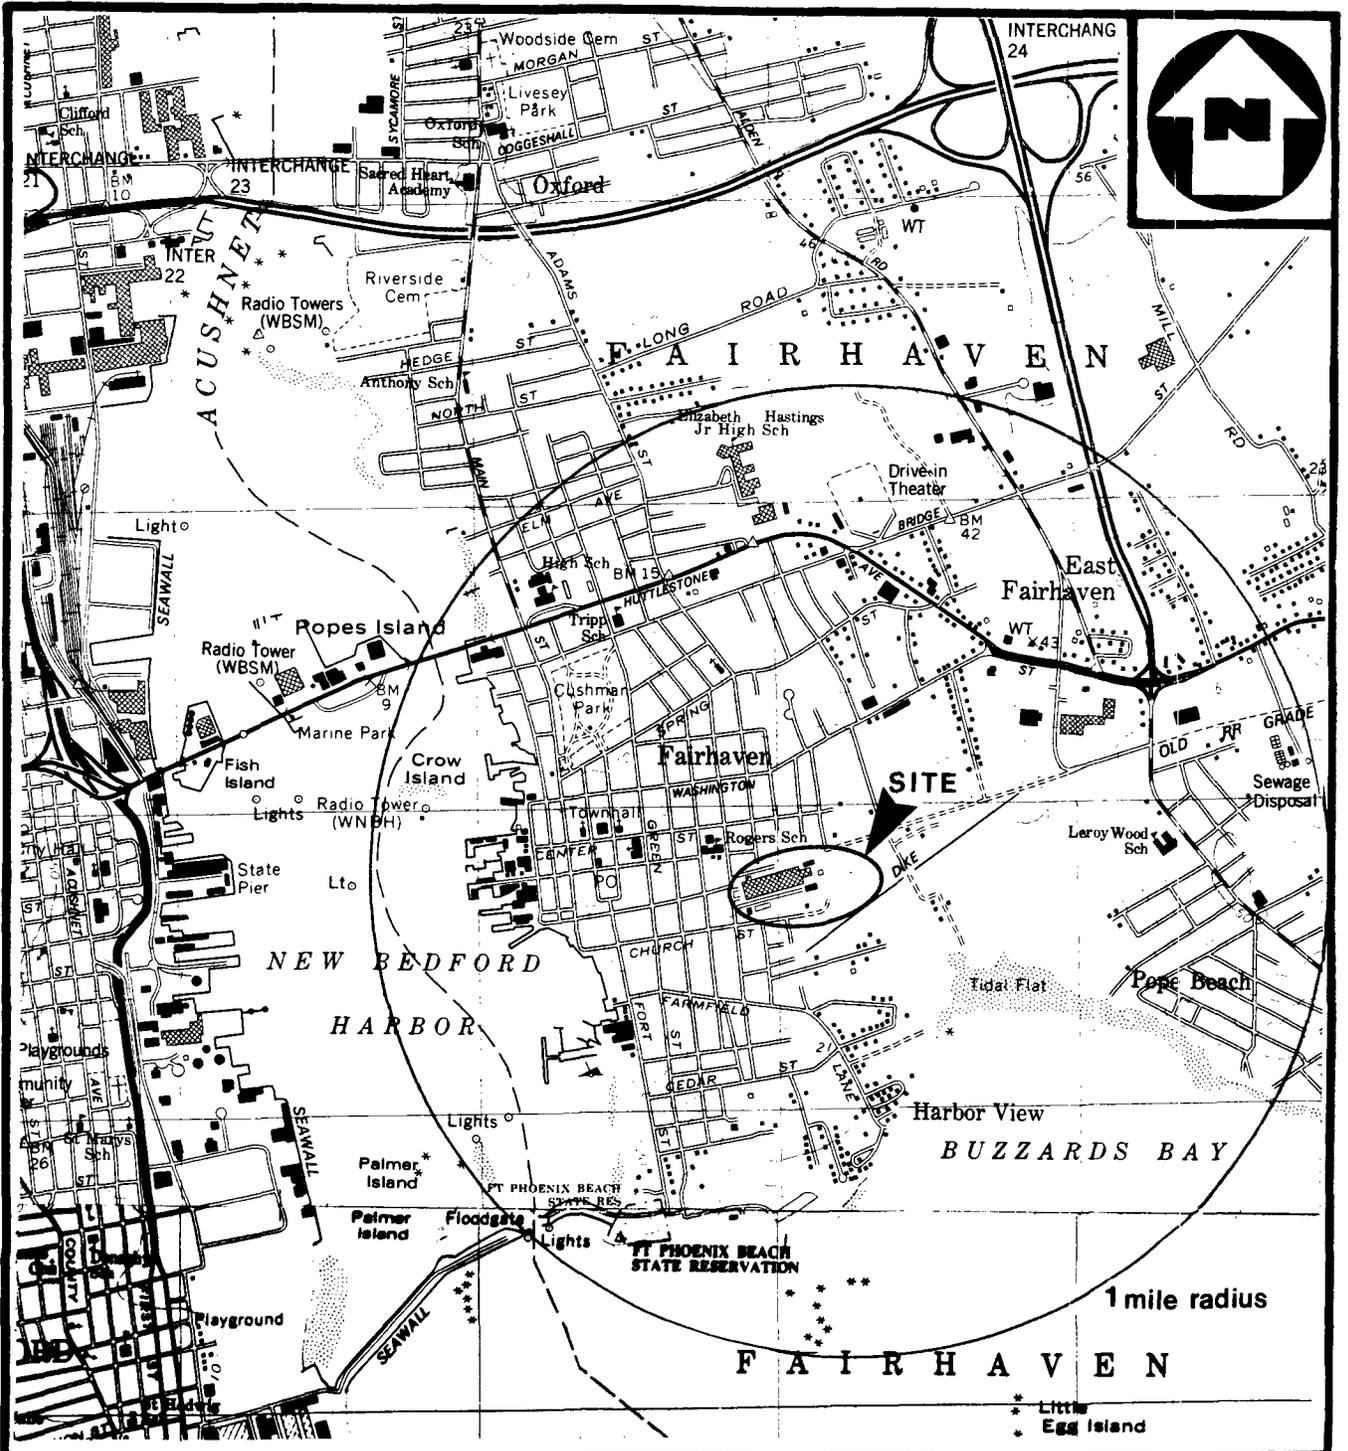
BASE MAP IS A PORTION OF THE U.S.G.S. NEW BEDFORD NORTH & SOUTH QUADRANGLES 7.5'SERIES, 1979 & 1977 ]

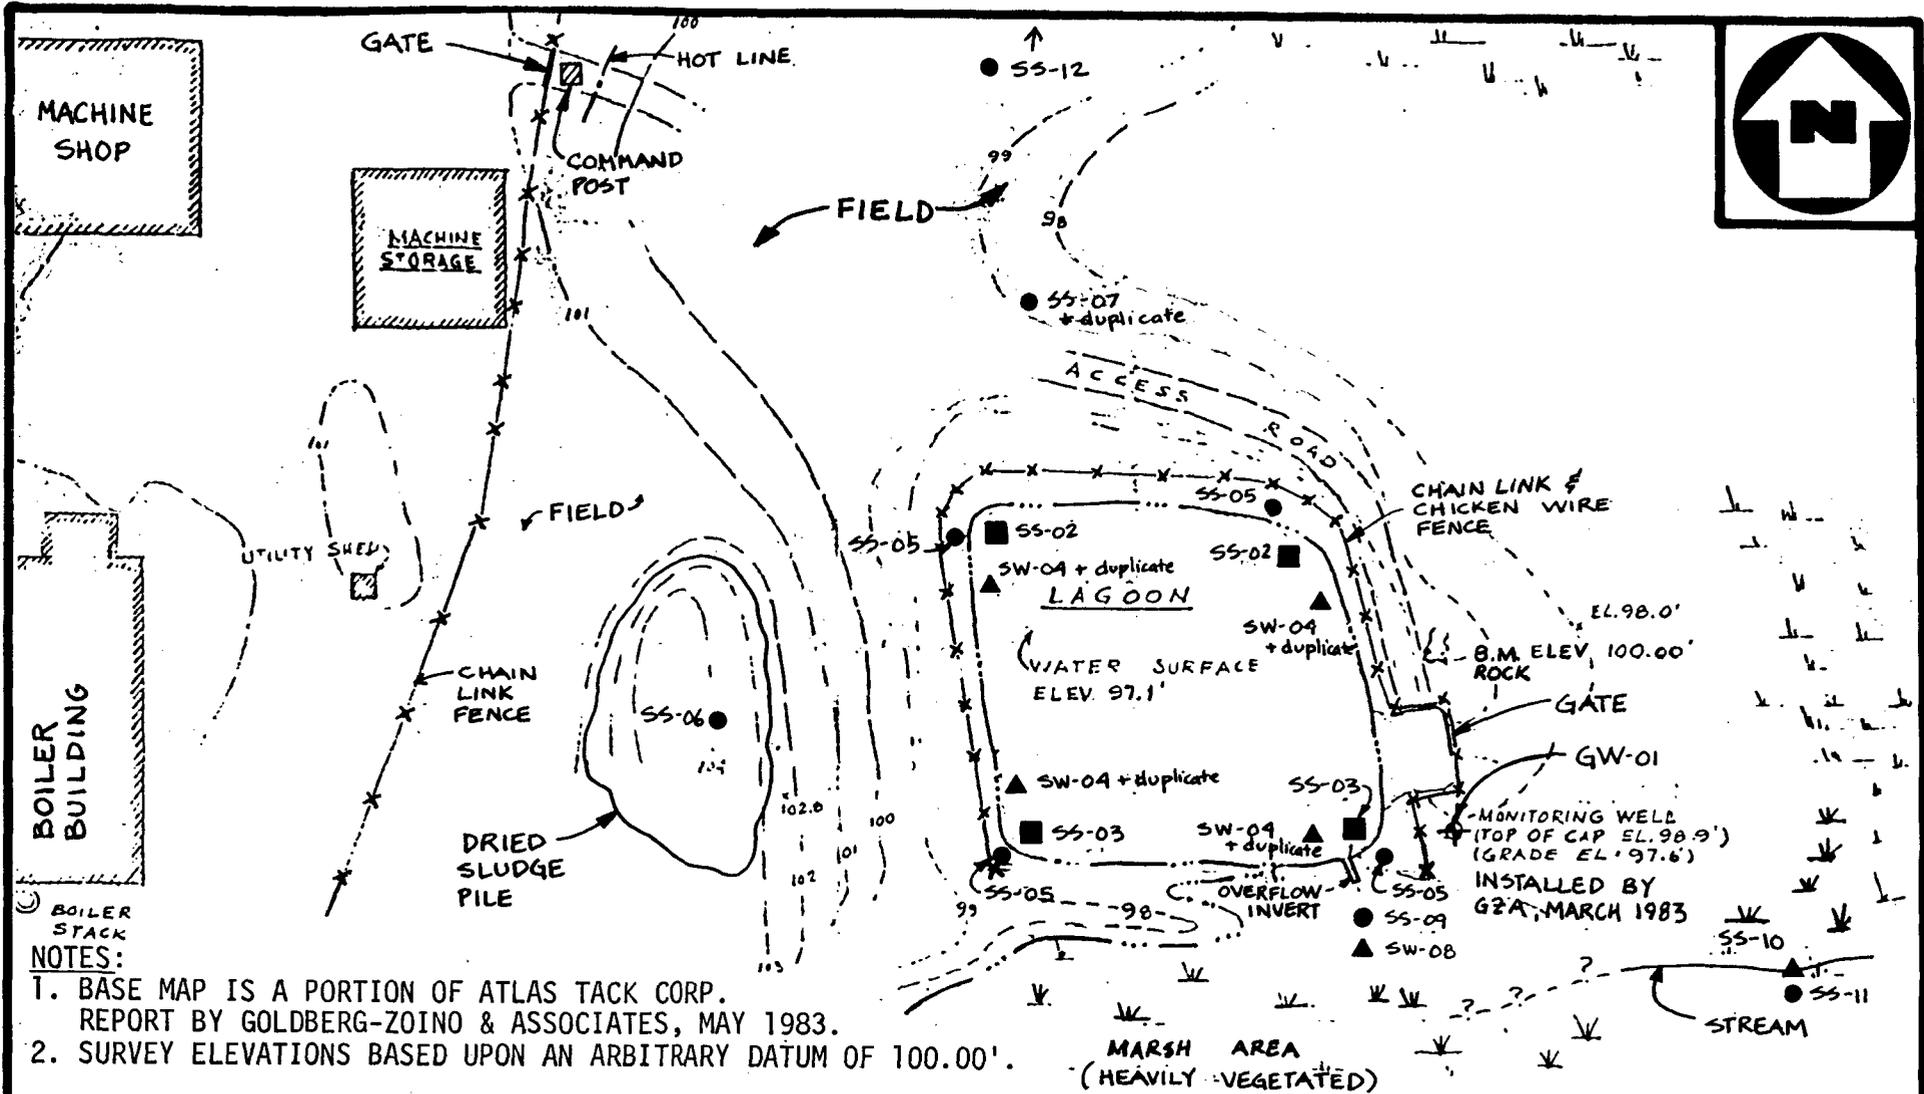
Following reconnaissance, NUS/FIT proceeded to conduct environmental sampling. All sampling was conducted in accordance with NUS/FIT Standard Operating Guidelines. A total of seventeen samples were collected by NUS/FIT at this site. These included one groundwater, two sludge, six soil, two sediment and six surface water samples, including blanks and duplicates (Figure 2).

1. BASE MAP IS A PORTION OF ATLAS TACK CORP. REPORT BY GOLDBERG-ZOINO & ASSOCIATES, MAY 1983.
2. SURVEY ELEVATIONS BASED UPON AN ARBITRARY DATUM OF 100.00'.

Sludge sample SS-03 was a composite of the SE and SW corners of the lagoon, the effluent area in contact with the wetland. Sludge samples were collected with a glass jar clamped to a stainless steel pole and composited in a stainless steel bowl. Samples were analyzed for metals, EP Toxicity and cyanide. Volatile analysis could not be performed on the sludge samples due to a lack of availability of the analysis slots at the contract laboratory.

Sediment and soil samples were collected by digging a few inches beneath the surface and placing the soil into the appropriate sample container. Composite and duplicate samples were mixed in a stainless steel bowl prior to filling containers. In addition to the two sediment samples, five soil samples were collected.
