TS-PIC-2005
May 1982

Historical Assessment of Aerovox-PCB Related Facility New Bedford, Massachusetts

prepared for
EPA Region 1

Judith M. Begley, Imagery Analyst
The Bionetics Corporation
Warrenton, VA 22186

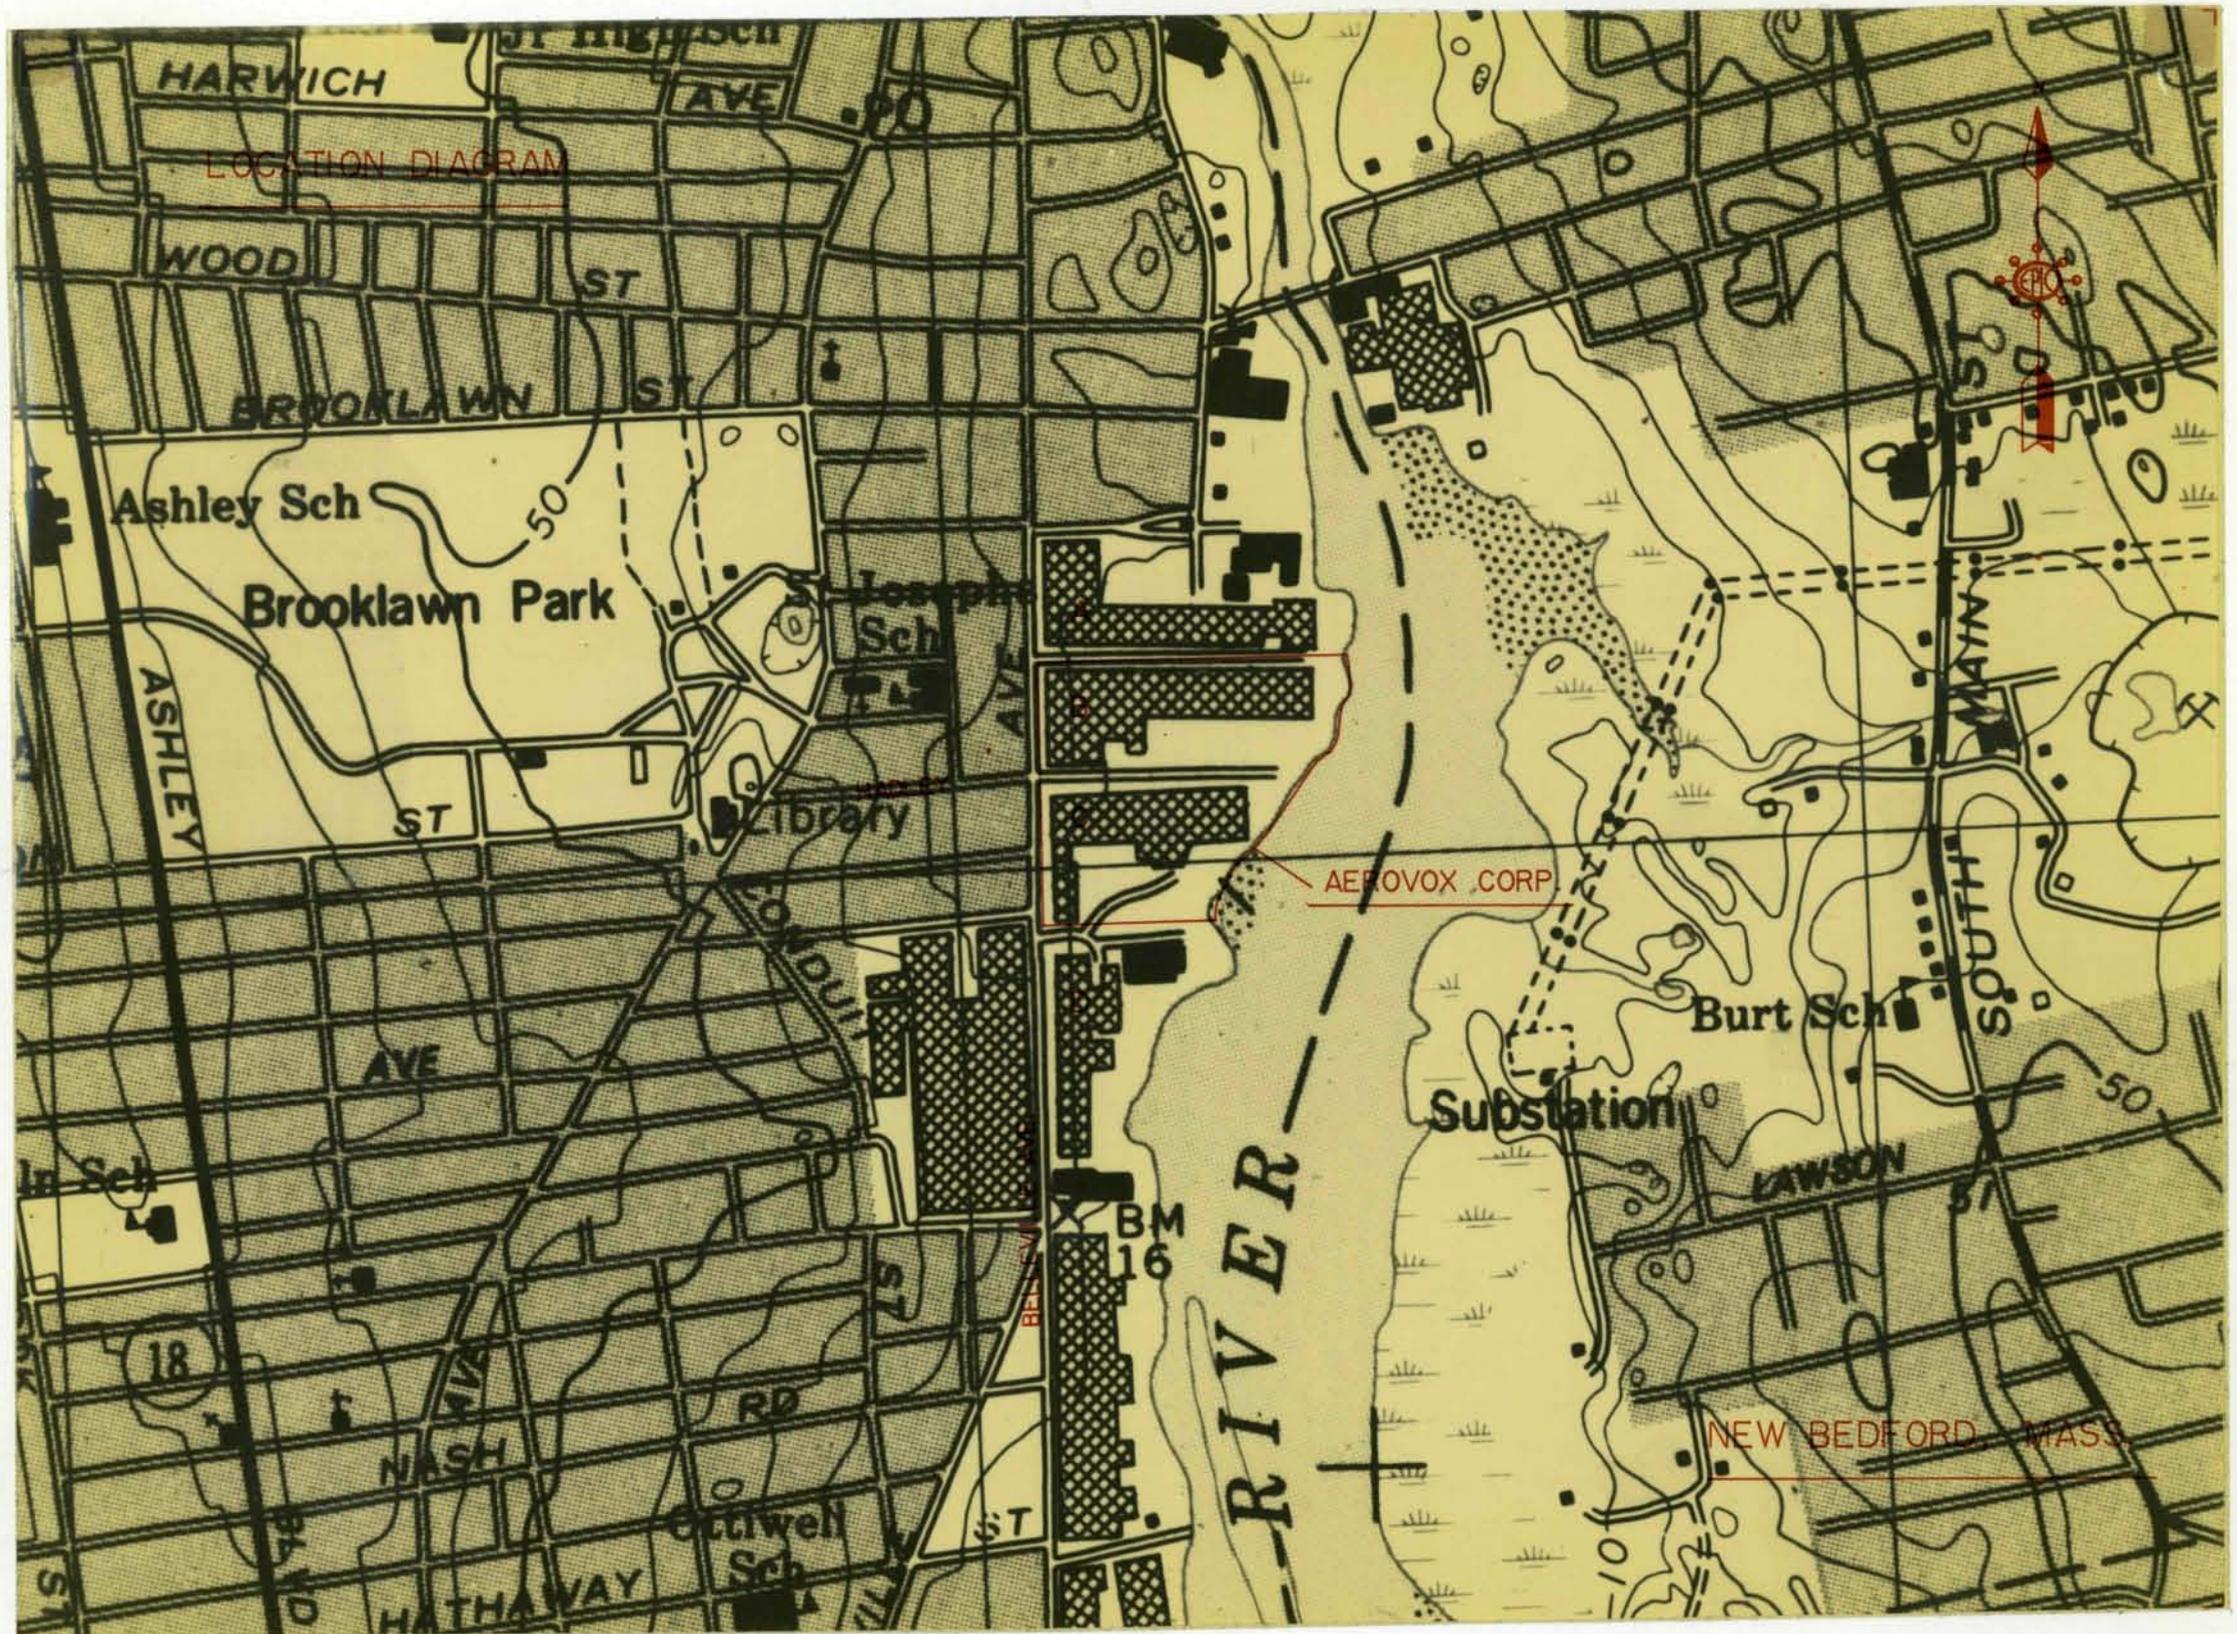
LOCATION DIAGRAM

Aerovox Corporation is located on the west bank of the Acushnet River in New Bedford, Massachusetts.

Building B on the Location Diagram (p. 4) was acquired by Aerovox Corporation prior to 1937 (see Sanborn map, page 6). Building C on the Location Diagram was acquired by Aerovox Corporation between 1950 and 1975 (see Sanborn map, page 10). In this report, the term "site" will refer to Buildings B and C and the lots they occupy.

The site is bounded by the Acushnet Process Company on the north (Building A on the Location Diagram) and by the Nonquitt Mill on the south (Building D on the Location Diagram). The site is bounded on the east by the Acushnet River and on the west by a residential area.

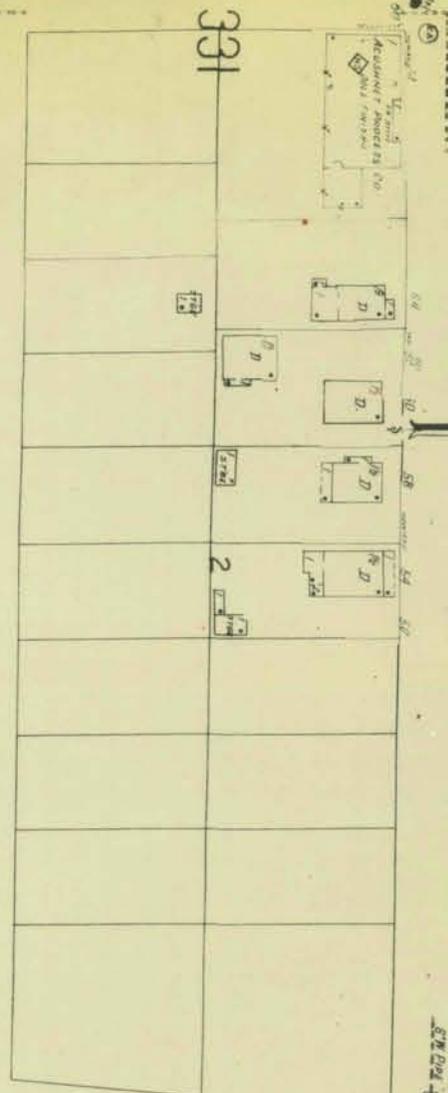
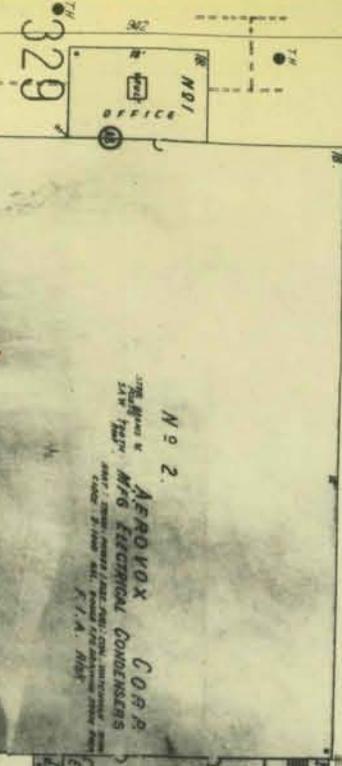
1924-1950

The second set of maps (pp. 8 - 9) is a revised version of the 1924 base maps. The revisions occurred at an unspecified time between 1924 and 1950. Building A is owned by Acushnet Process Company. Building B is now owned by Aerovox Corporation. Buildings C and D still belong to Nonquitt Mills. Buildings A, B and D do not change ownership again through the date of the most recent Sanborn map (1975).

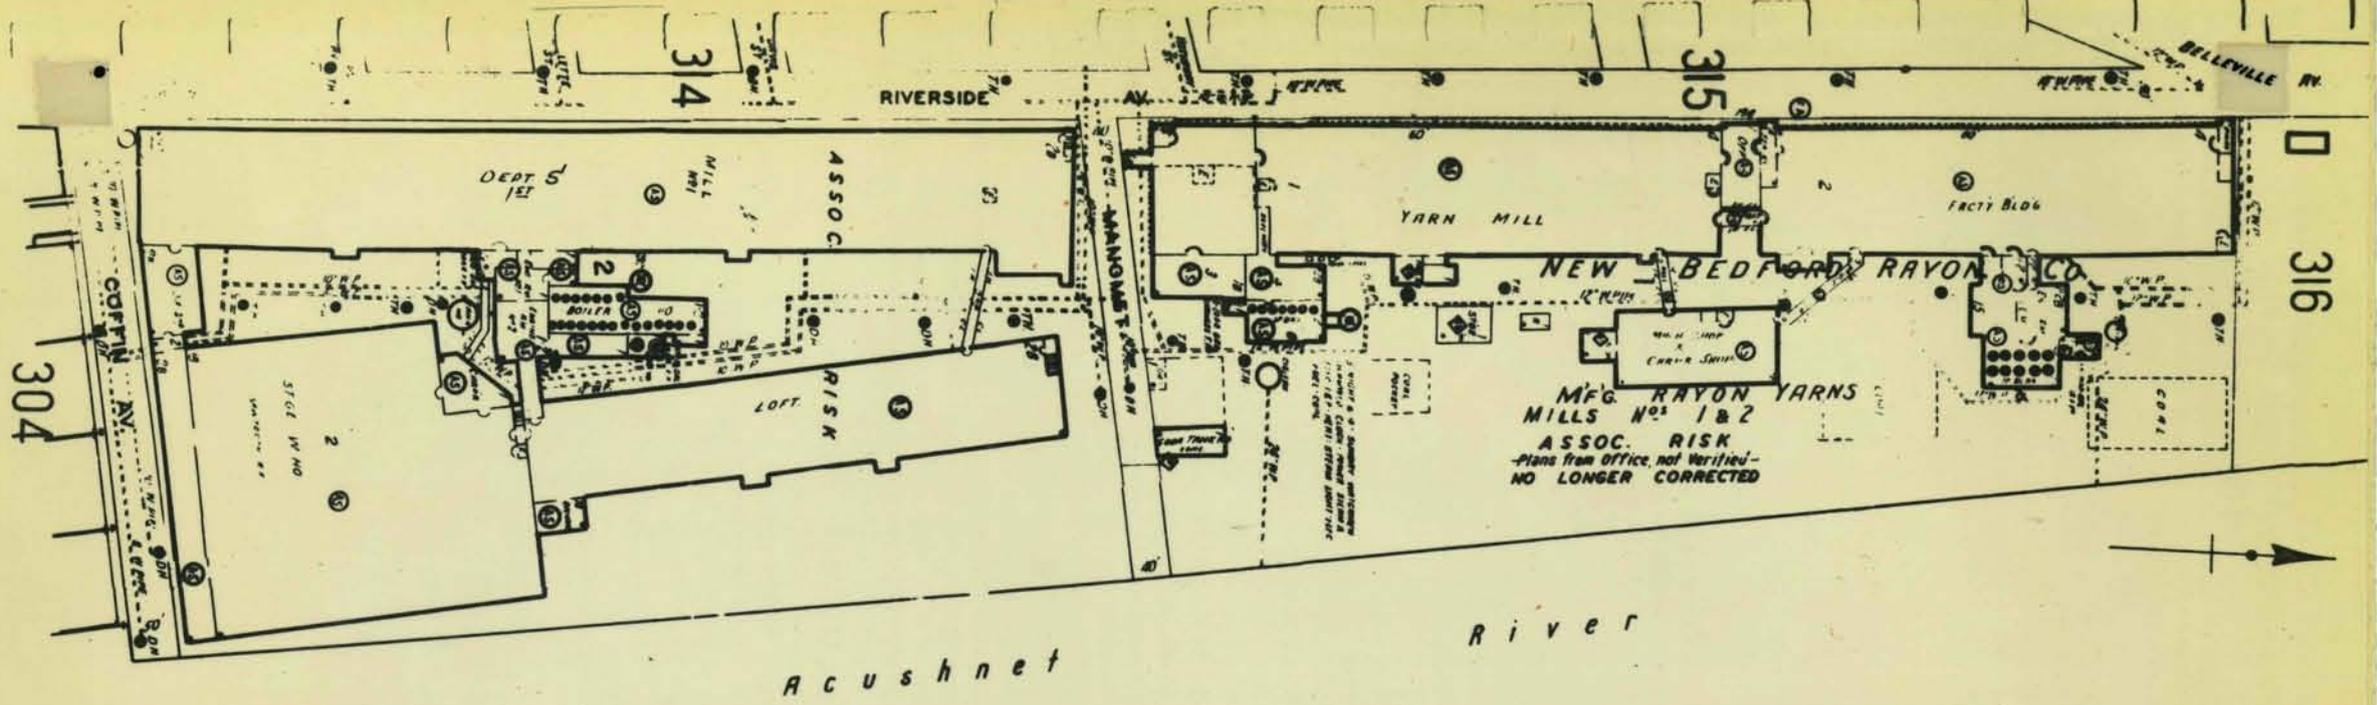
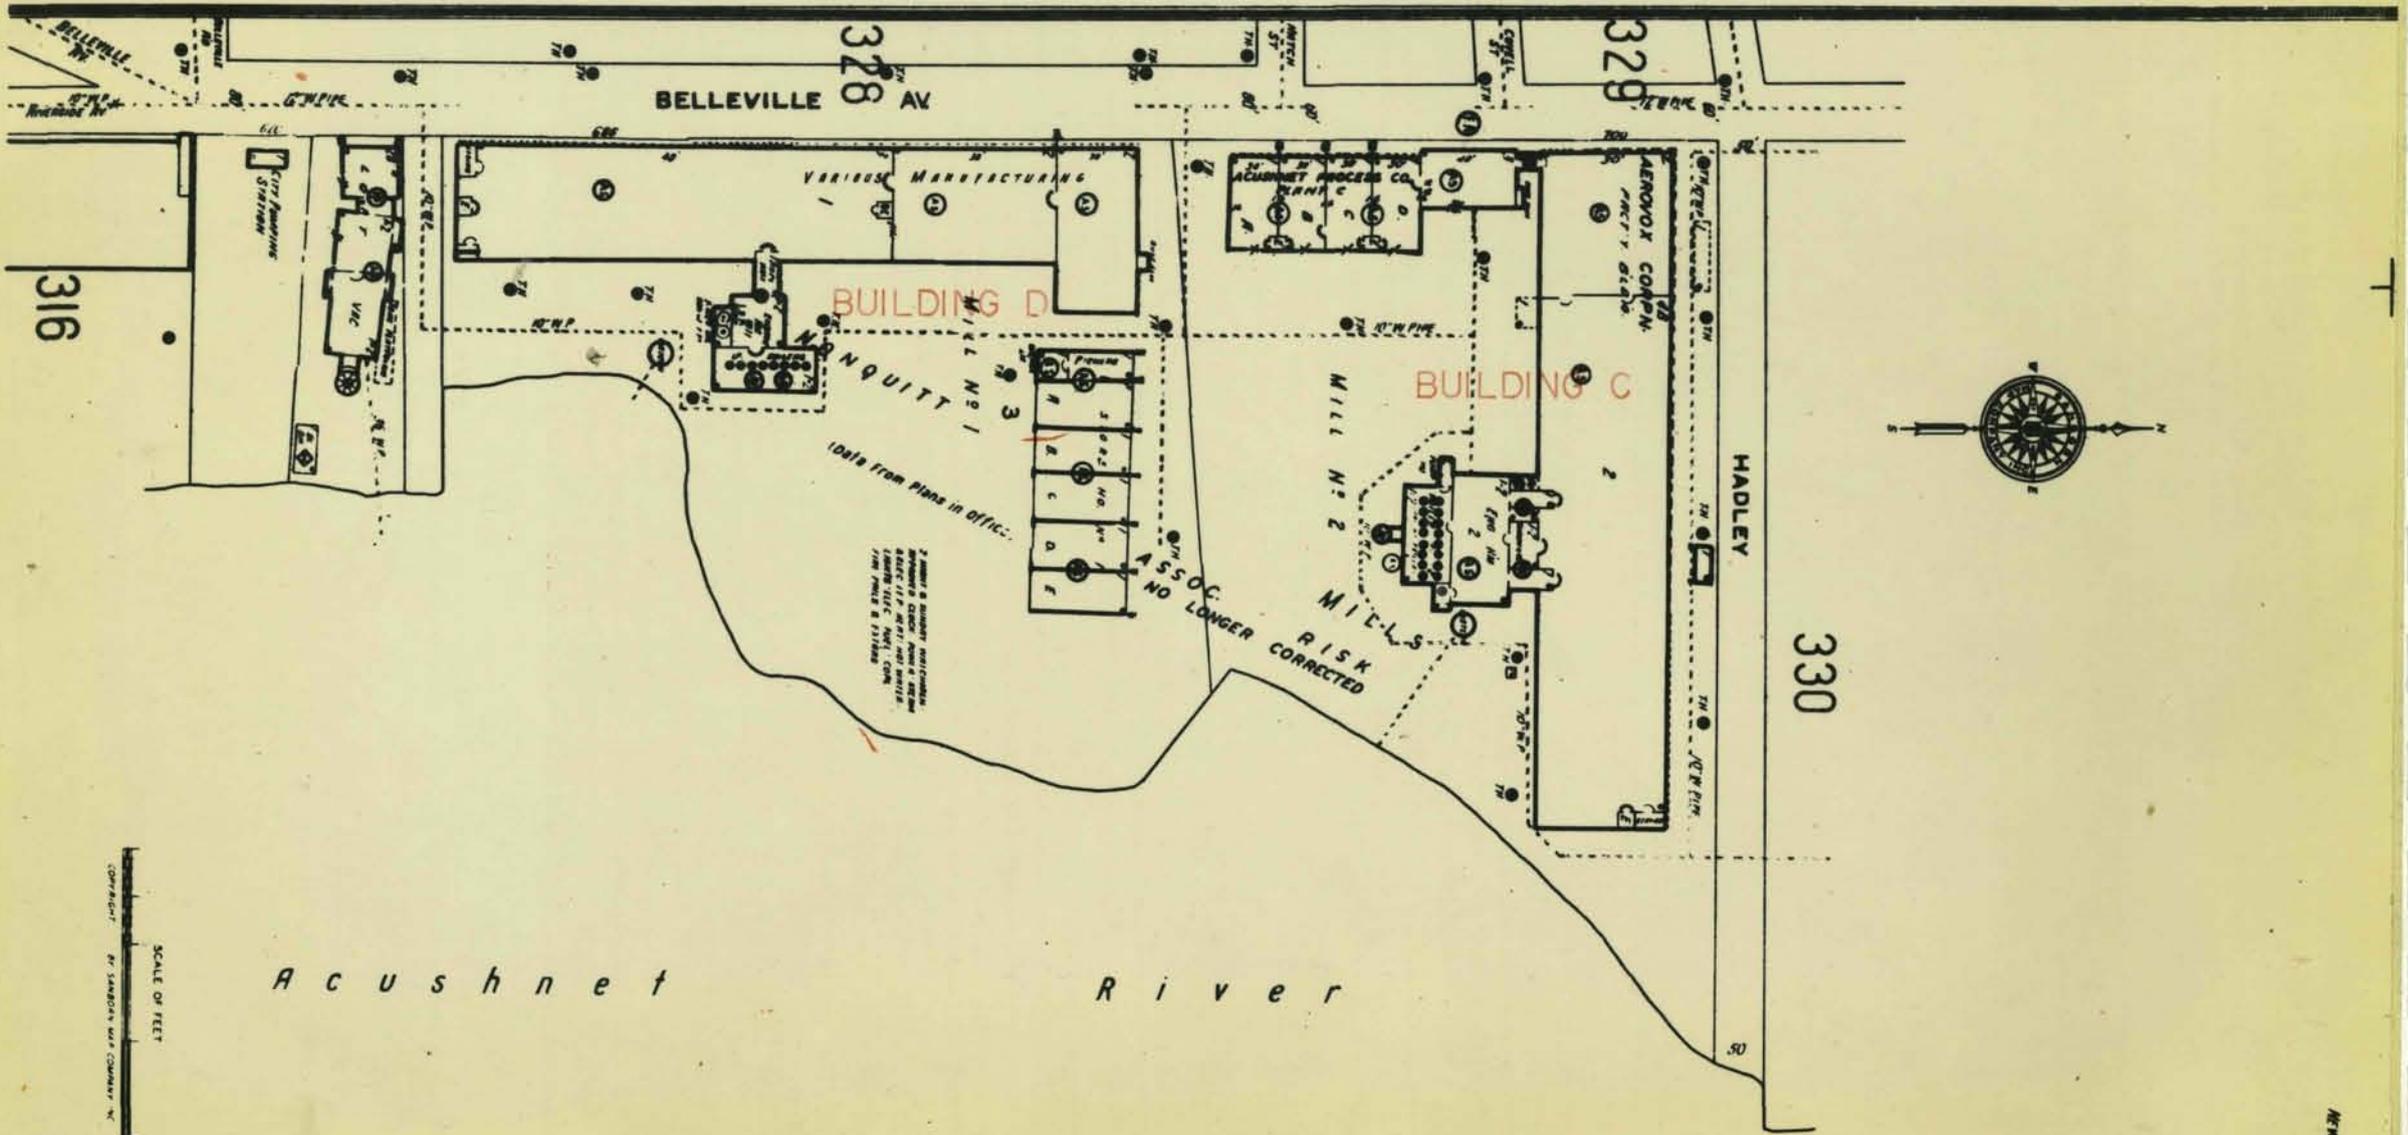
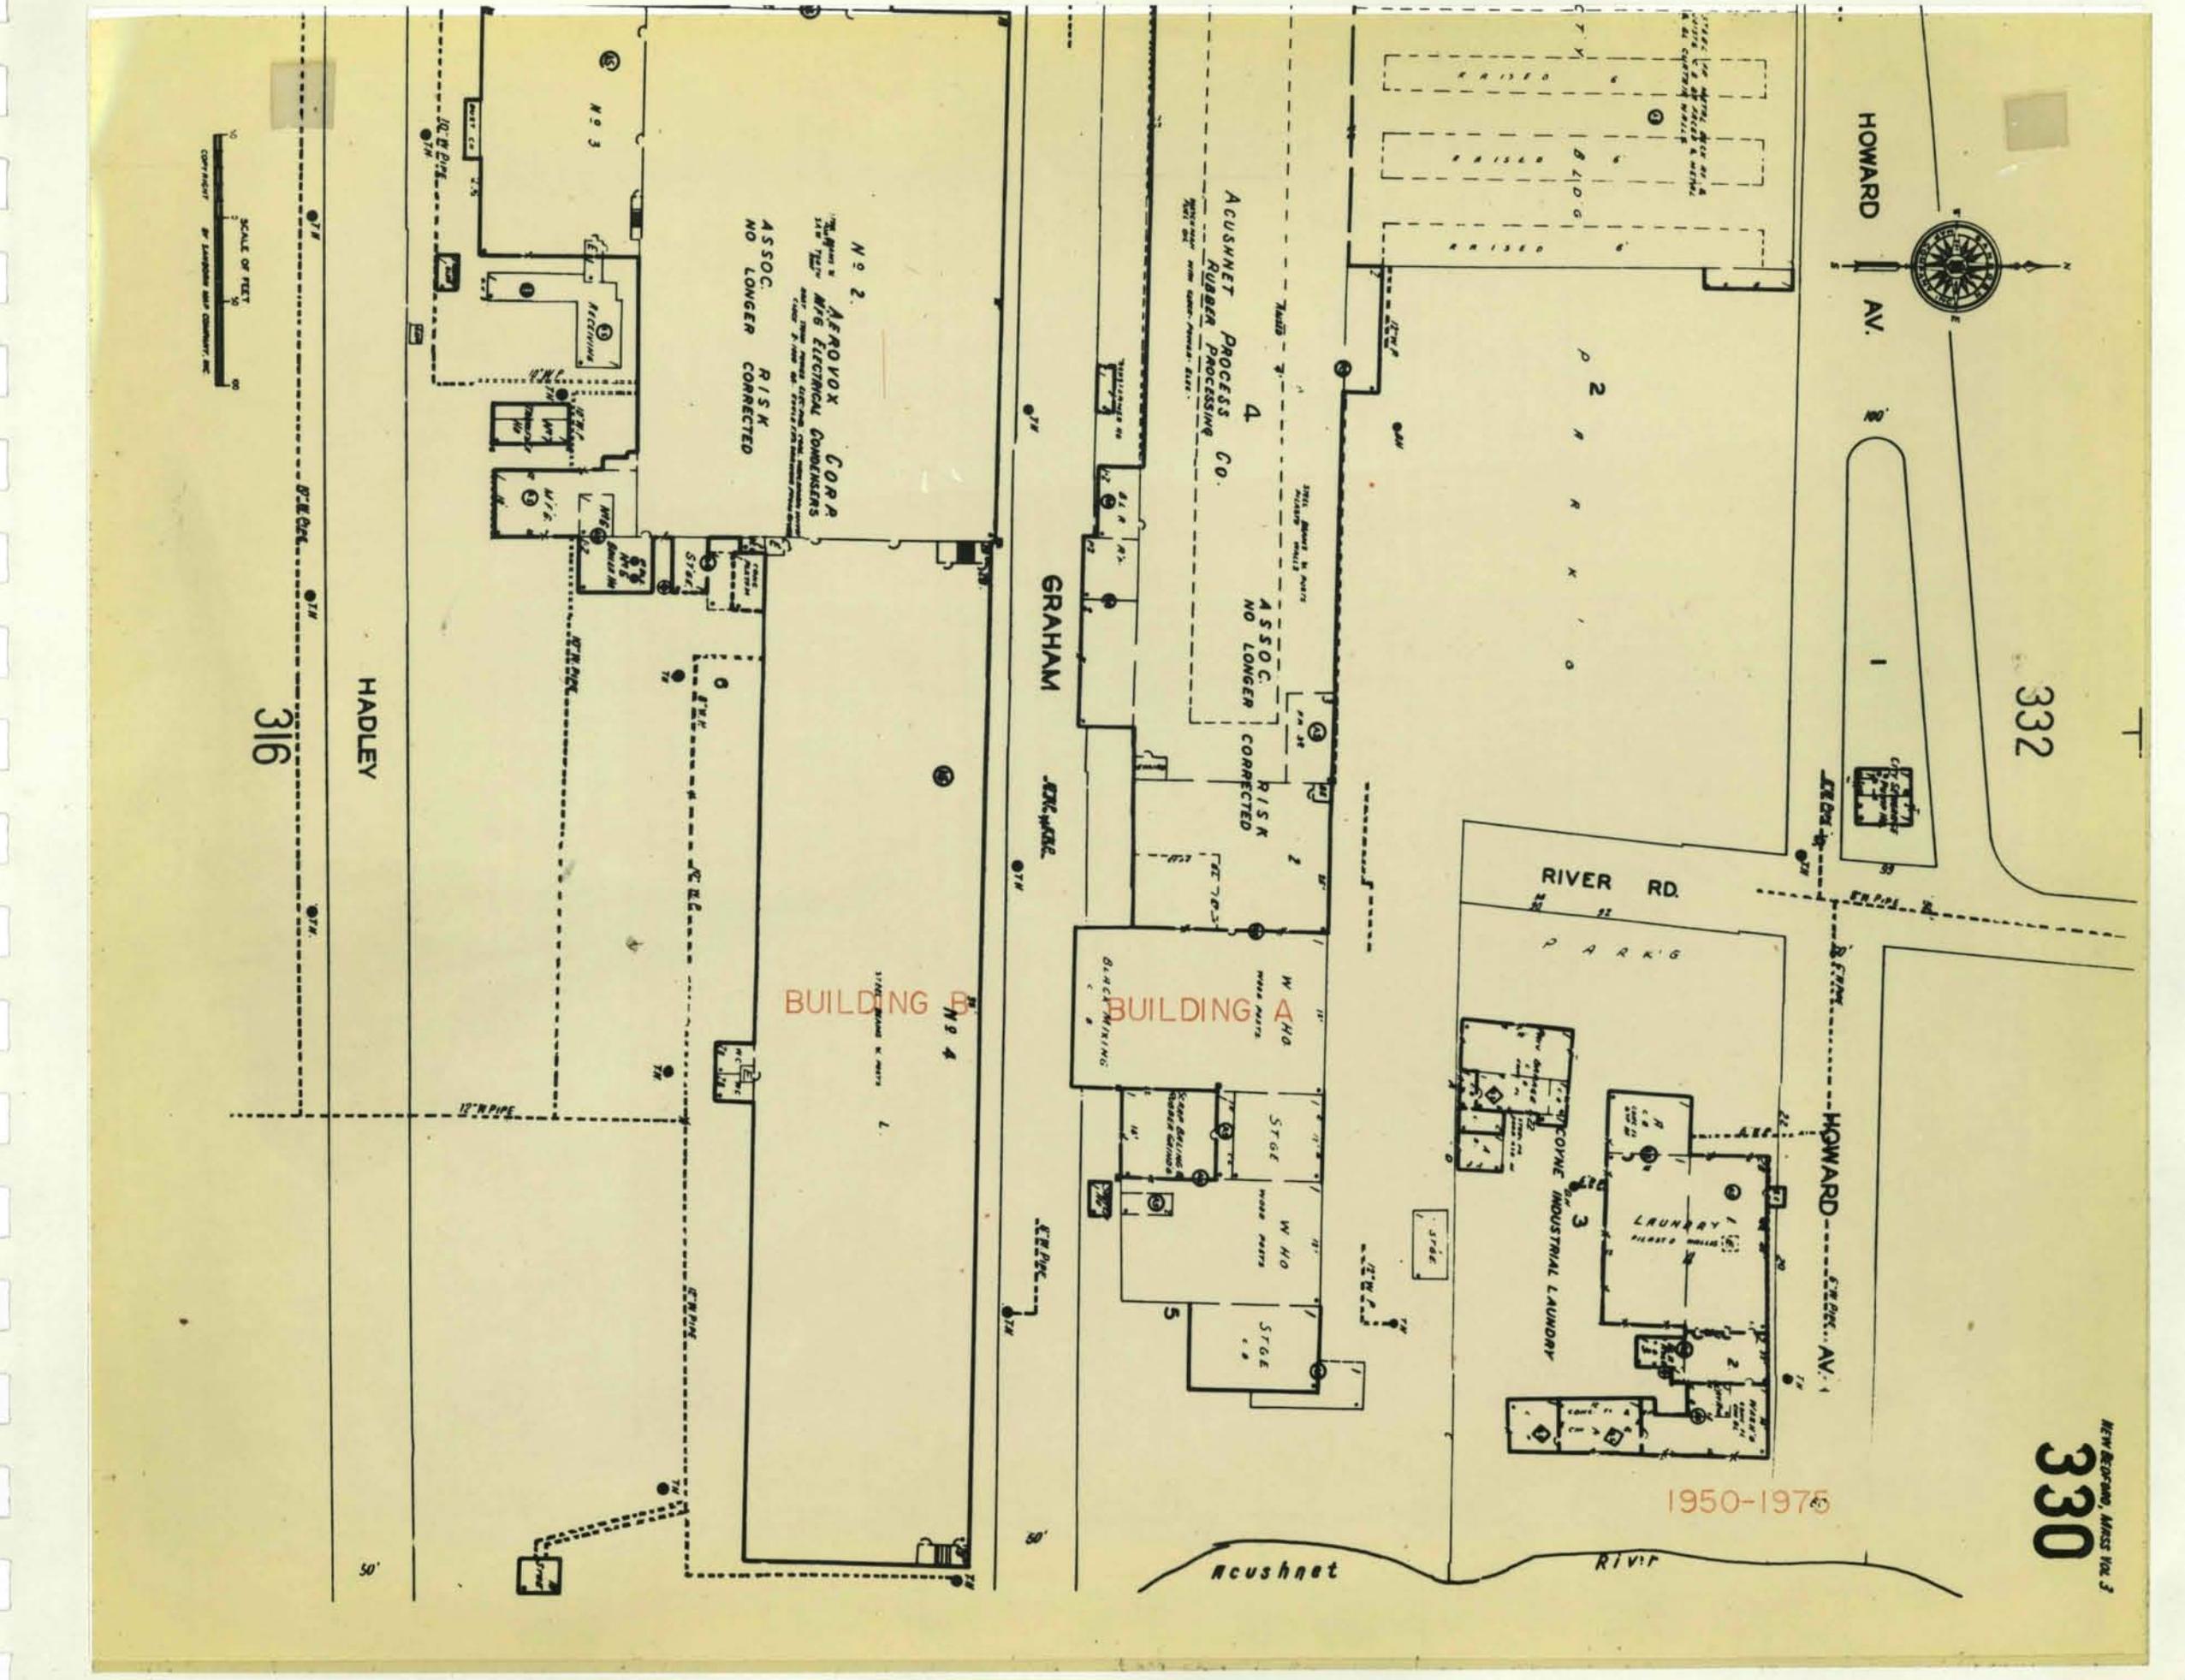
1950-1975

The third set of maps (pp. 10 - 11) reflects a second set of revisions that occurred sometime between 1950 and 1975. Building C is now owned by Aerovox Corporation.

These maps confirm that Building B was controlled by Aerovox Corporation between 1951 and 1974, the dates of the aerial photos presented later in this report. Building C was controlled by Aerovox Corporation for at least a portion of this period.**

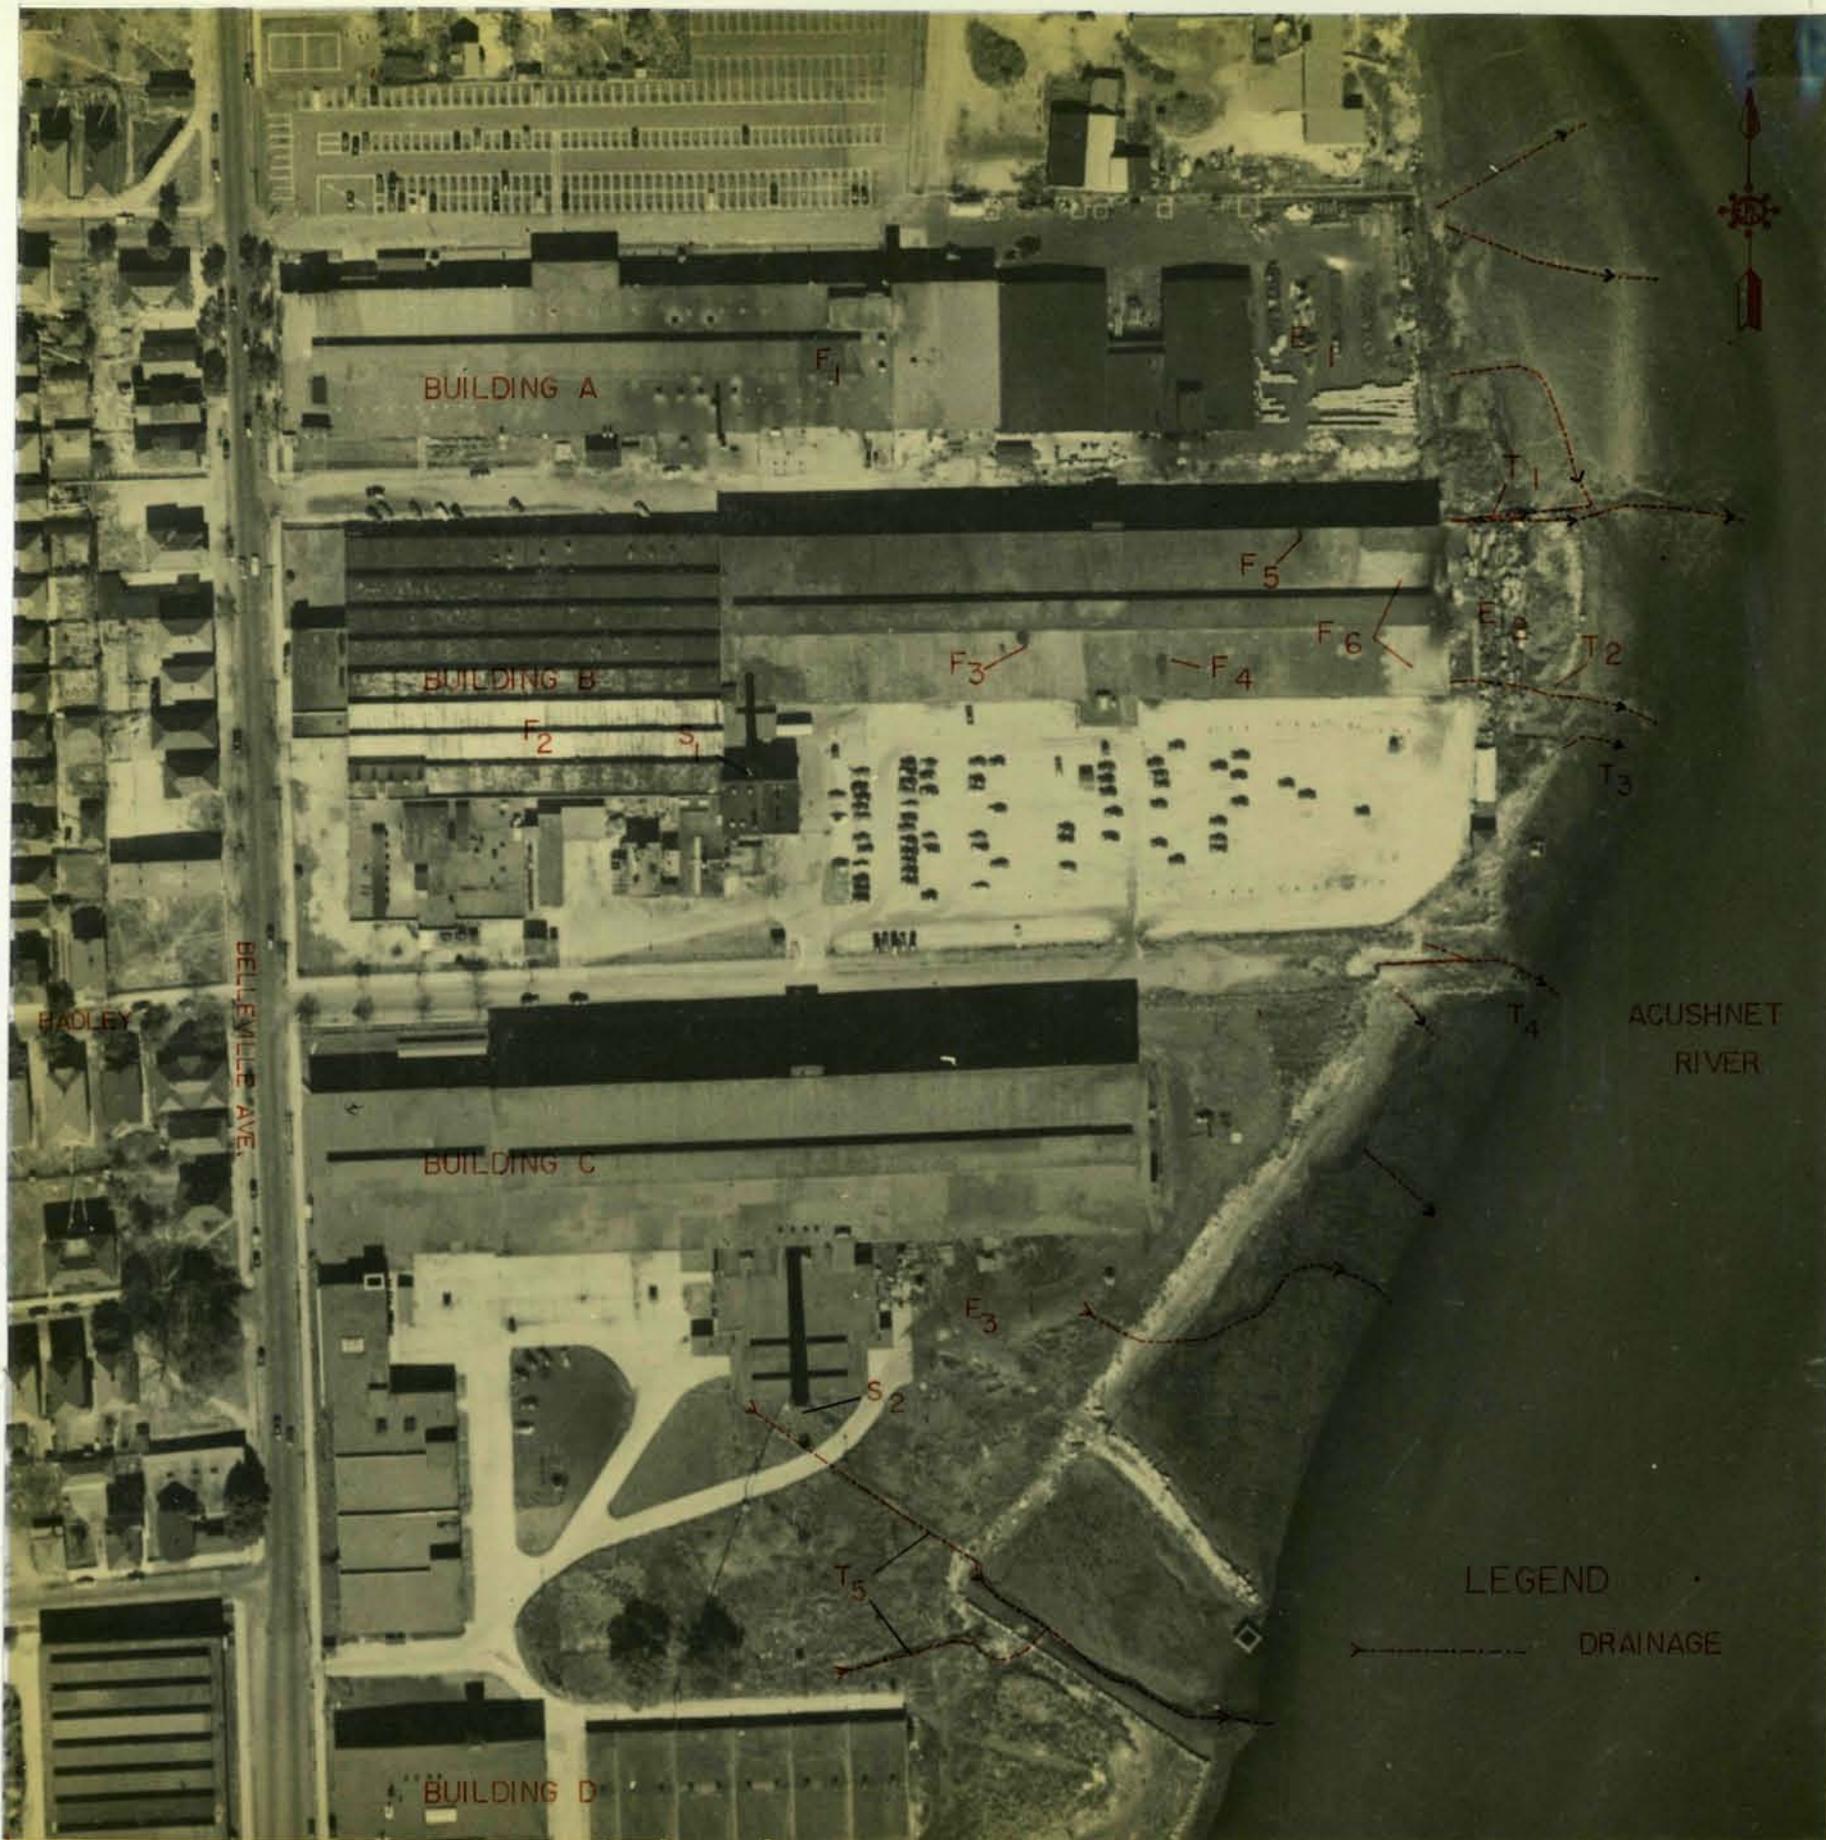
SEPTEMBER 28, 1951

Building B is owned by Aerovox Corporation by 1951 (see Sanborn map, p. 8).

Area E₁* is a paved lot containing neat rows of objects. Some dumping of refuse may have occurred along the southern edge of this Area.

Area E₂ appears to be an unpaved waste disposal area. It contains numerous objects, some of which are possibly drums and/or capacitors.

Area E₃ contains piled refuse.

Area E₂ exhibits a rocky dike along its eastern edge, which may have been constructed in preparation for filling.

S₁ and S₂ on the photo indicate smokestacks. They are present on this and all following photos.

F₁, and F₃ through F₅, indicate roof vents that may release airborne material from inside the buildings.

Area F₂ indicates the light tone of portions of the roof at the west end of Building B. This tone may be caused by settling particulates from the stack at S₁.

The roof of Building B is also discolored in Area F₆, but no obvious sources of airborne material are seen in the immediate vicinity.

The general drainage in the area of Aerovox Corporation flows from west to east, toward the Acushnet River. Aerovox Corporation is located on a relatively flat bank of the river. The level of water in the river is affected by tidal fluctuations in Buzzard's Bay (to the south), and large mud flats appear along the shoreline at low tide. Portions of these tidal flats are visible on this photo as a light-toned band along the shore. A number of drainage channels are cut into these flats.

T₁ and T₂ are trenches which emanate from Building B. T₁ is lined. The channel cut into the river bed offshore from T₁ is particularly well-defined.

T₃ is a rectangular, lined feature that is a possible liquid containment area or lined trench.

T₄ appears to be the point at which an underground pipeline empties into the harbor.

T₅ indicates two ditches which cut across the lot of Building C and converge just offshore. This channel in the river bed is also very well-defined.

There are no obvious signs of standing liquid or ground staining on the 1951 photo.

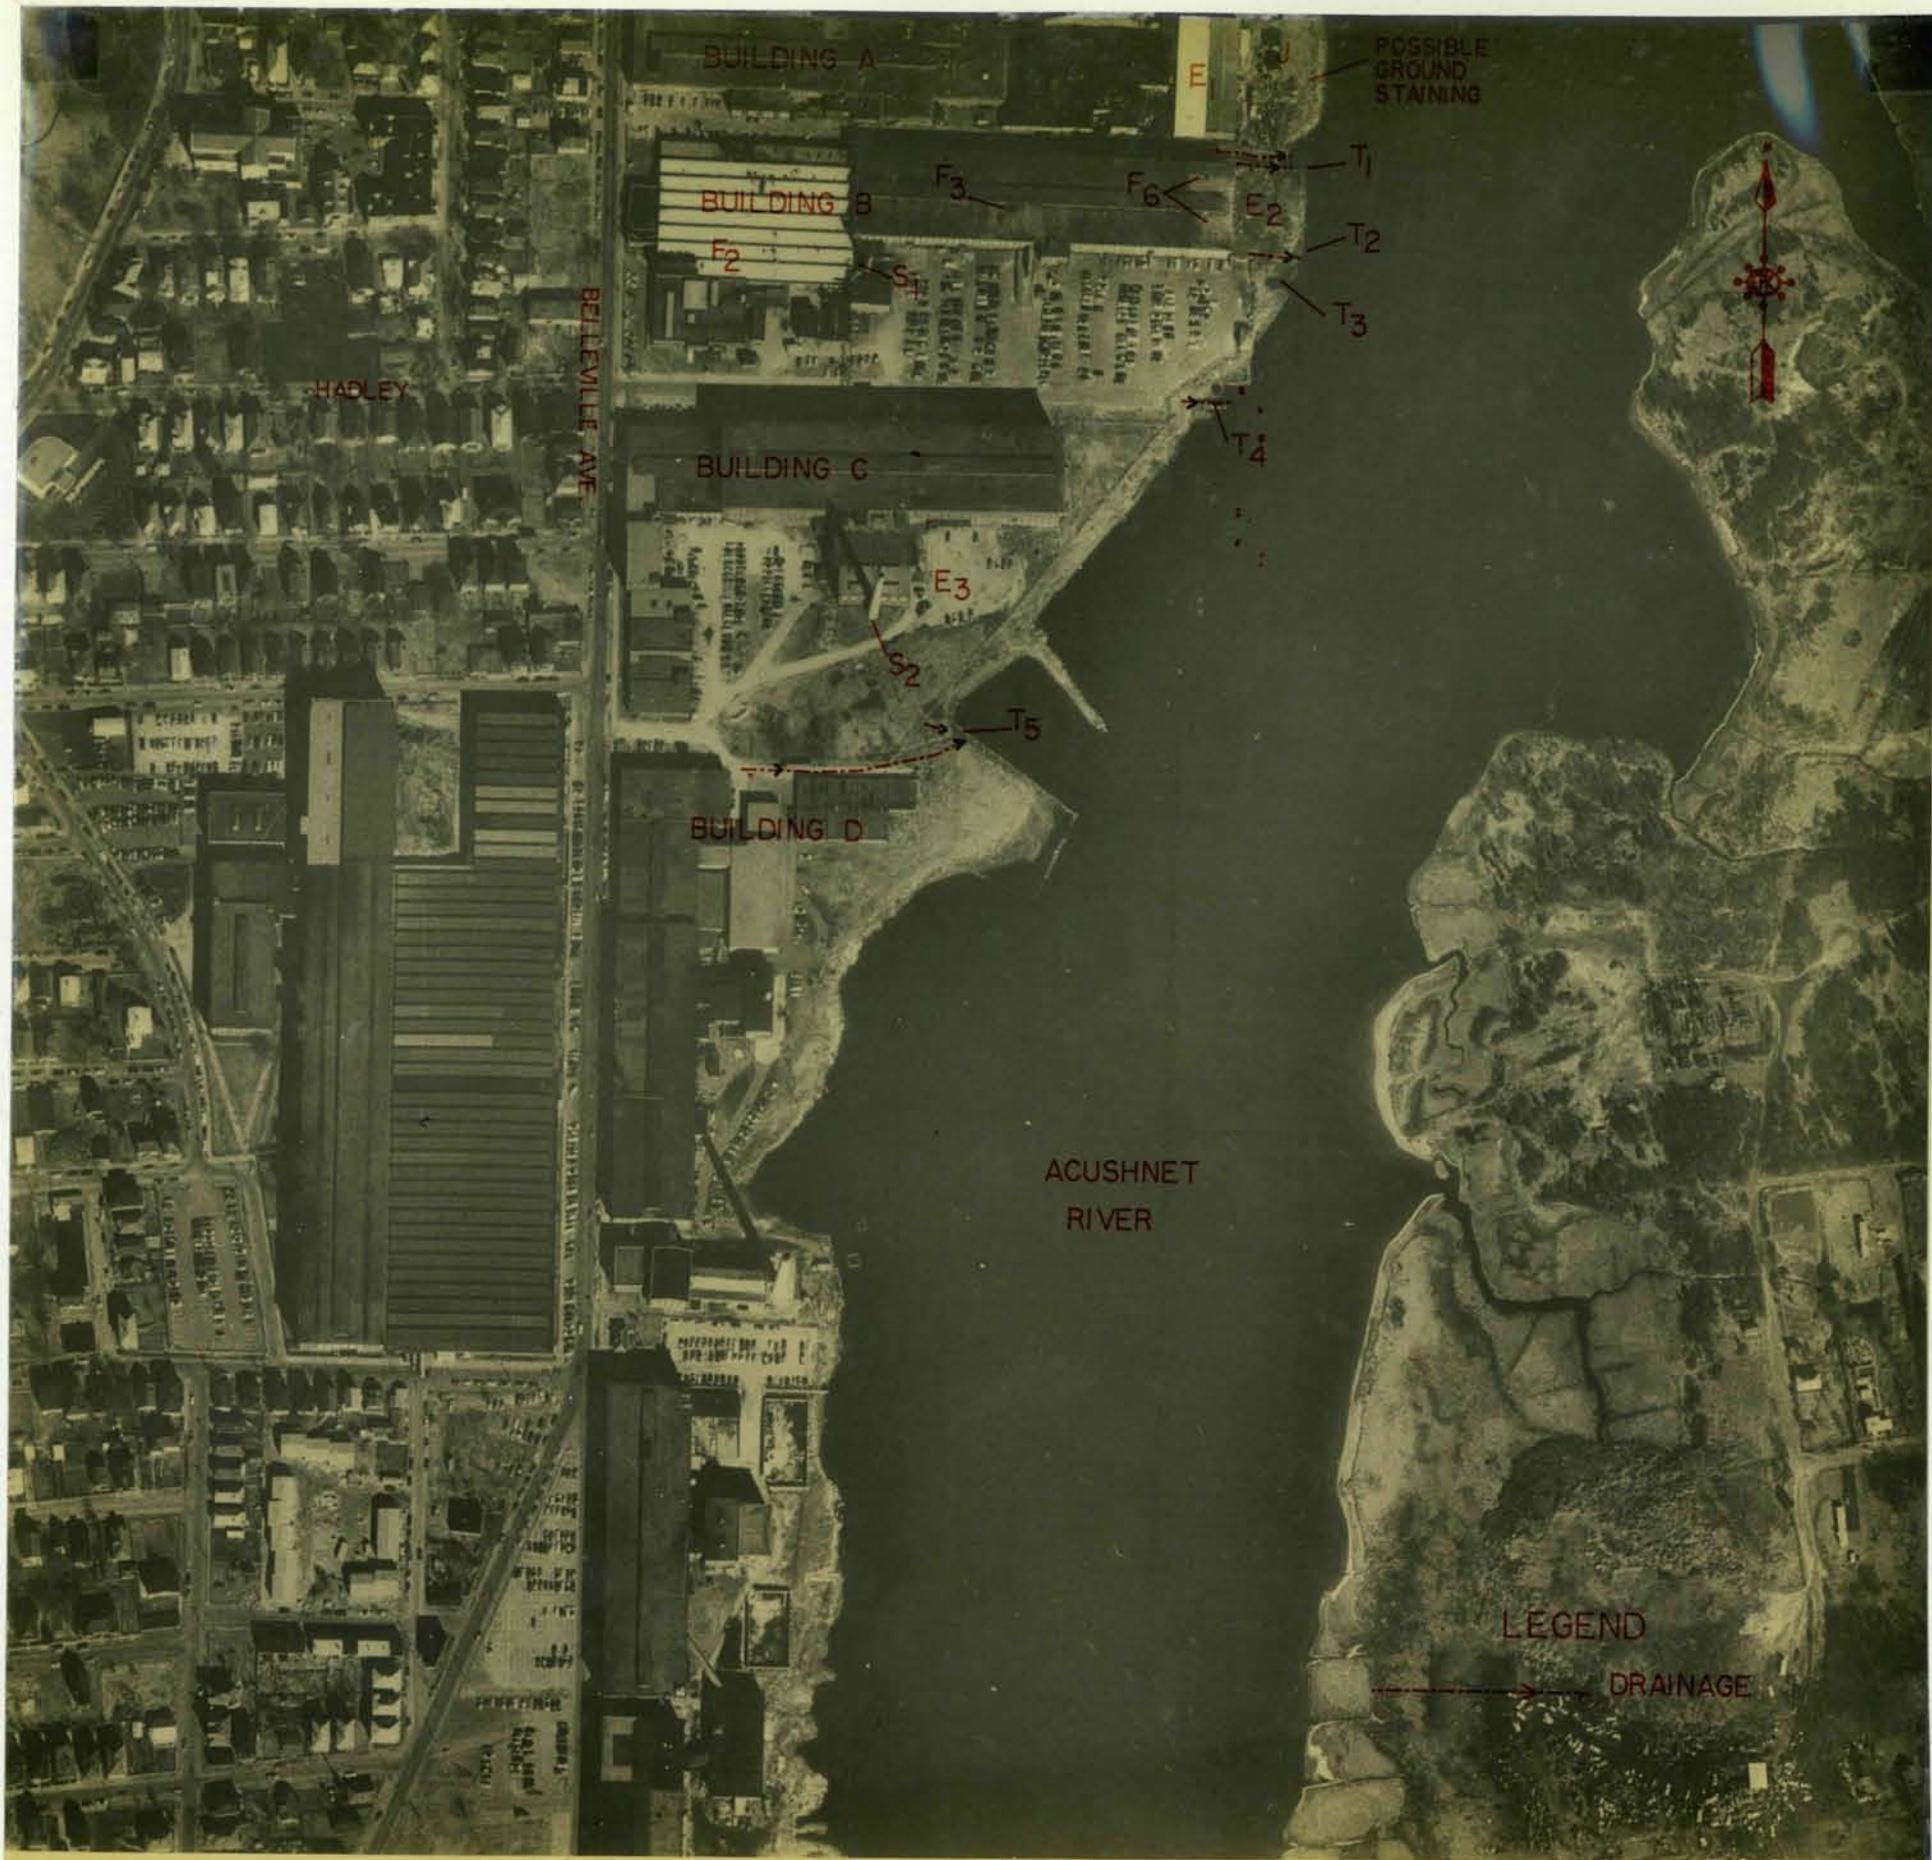
FEBRUARY 27, 1974

A building has appeared in Area E₁ since 1962.

Area E₂ contains mounded material, probable drums, and possible refuse. Additional filling has occurred since 1962.

Area E₃ is now a parking lot.

Discoloration of Building B's roof is still visible at Areas F₃ and F₆.

The light tone of the roof in Area F₂ is now very uniform. It is impossible to tell whether this is due to continued ash deposits from S₁ or to a new roof surface.

Both the lined trench and a natural channel are visible at T₁.

T₂, T₃ and T₄ are still visible.

At T₅, the long trench across the lot of Building C is no longer visible. An eroded cut still appears there in the bank of the river, but there are no signs of discharge into the river at this cut.

No obvious signs of standing liquid or ground staining appear on the 1974 photograph.
