TS-PIC-2005
May 1982

Historical Assessment of Aerovox-PCB Related Facility New Bedford, Massachusetts

prepared for
EPA Region 1

Judith M. Begley, Imagery Analyst
The Bionetics Corporation
Warrenton, VA 22186

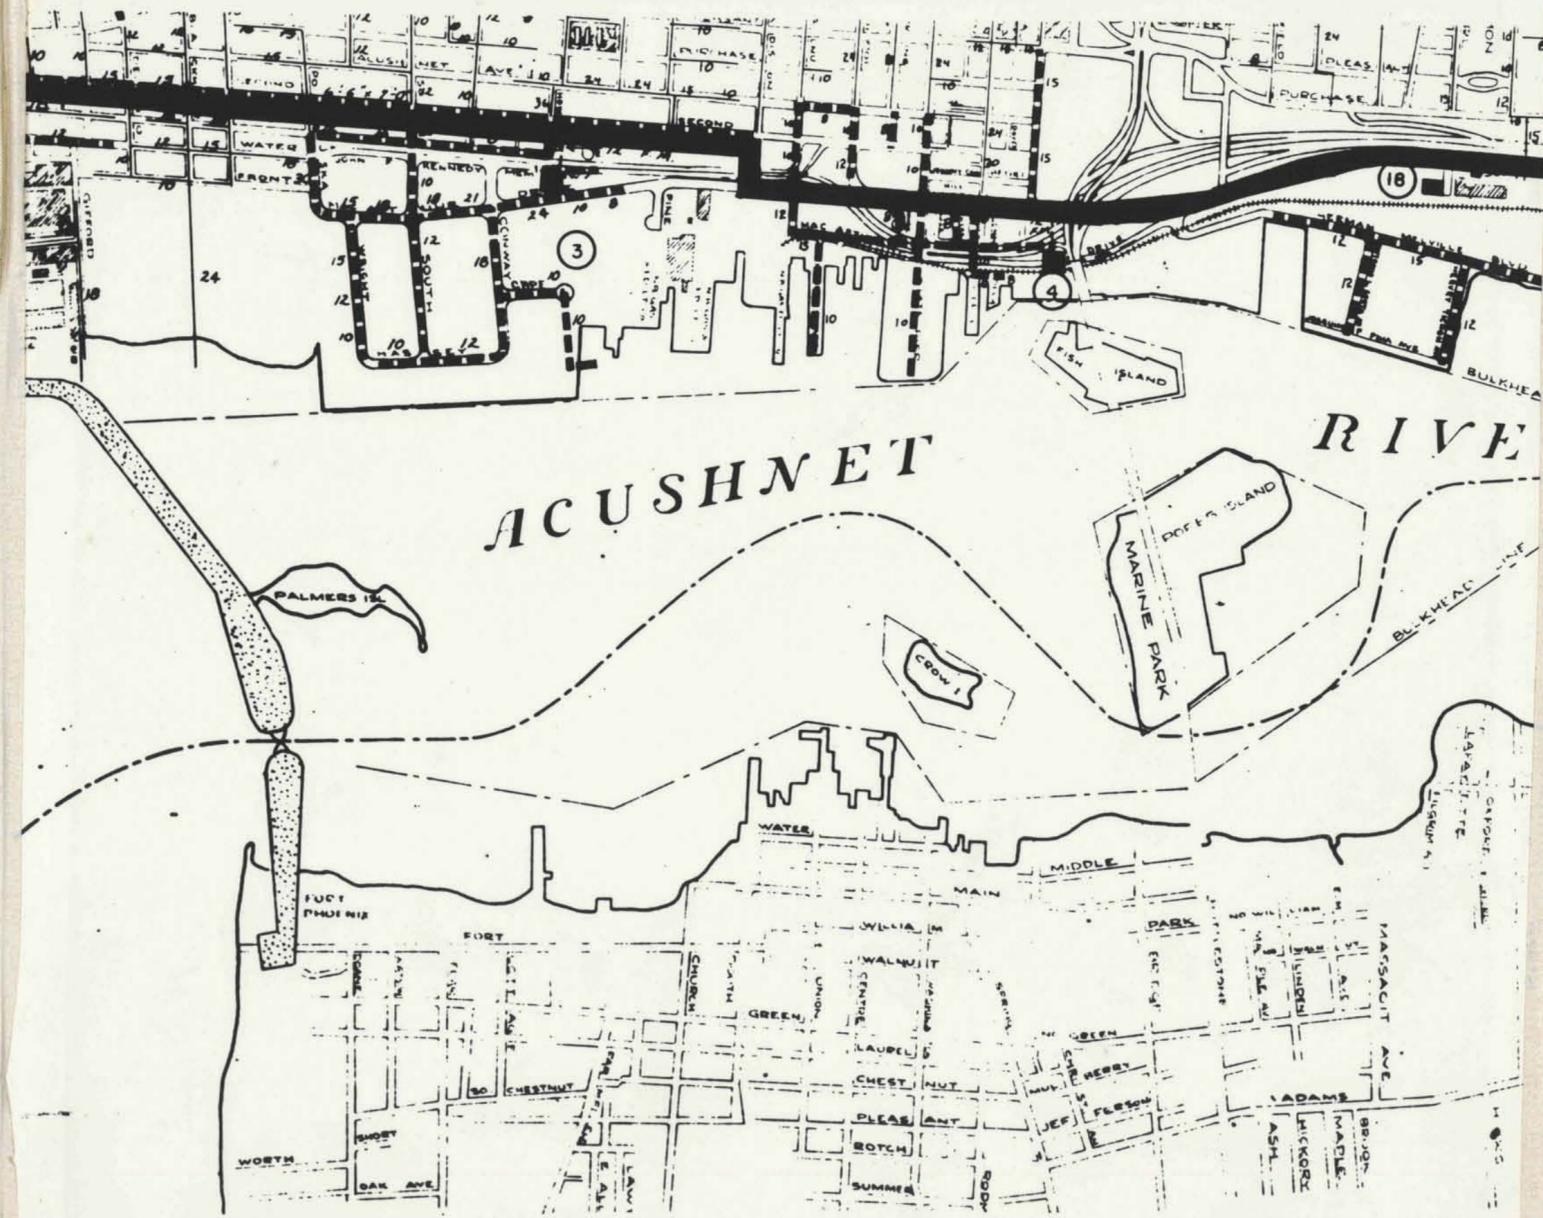
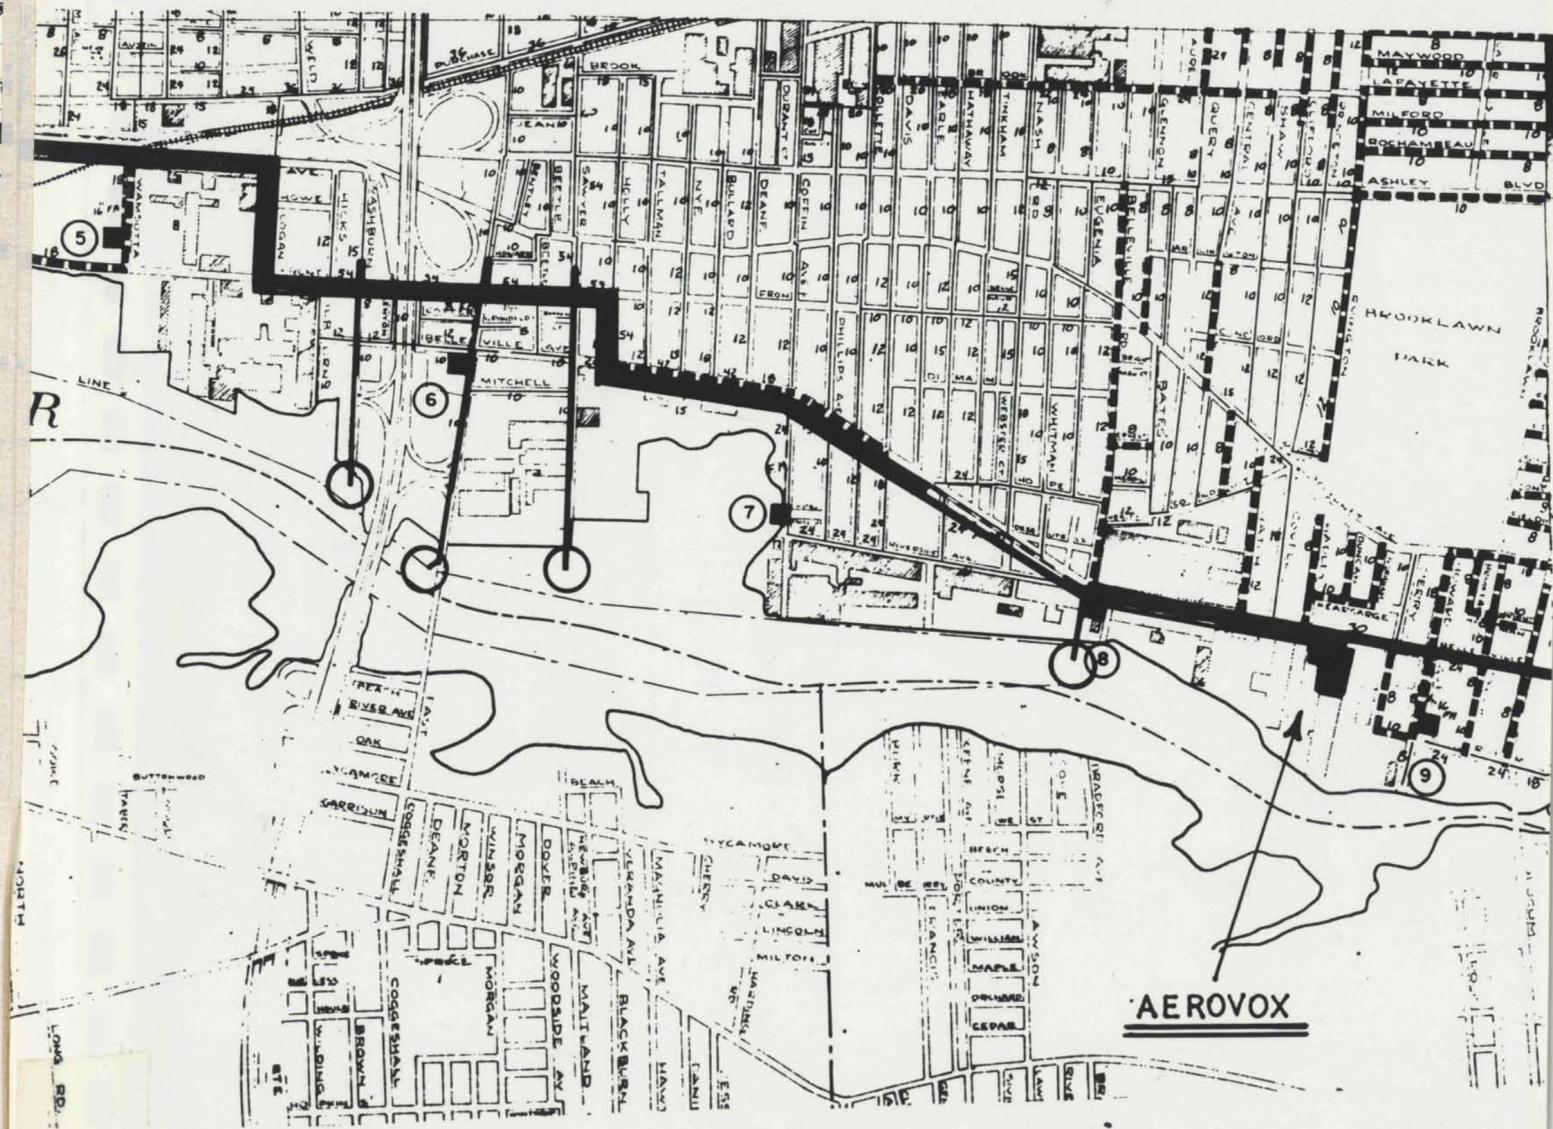
MUNICIPAL SEWER SYSTEM MAP

The main interceptor line provides a direct connection between Aerovox Corporation and the New Bedford Municipal Sewage Treatment Plant.

The combined sewage/storm sewer overflow outfalls are also shown on this map, running from the main line to the Acushnet River and Clark's Cove. When the sewer system is filled to maximum capacity, untreated wastewater is released through these lines.
