TS-PIC-2008  
June 1982

# Historical Analysis Municipal Wastewater Treatment, Clarks Cove, New Bedford, Massachusetts

prepared for  
EPA Region 1  
and OERR

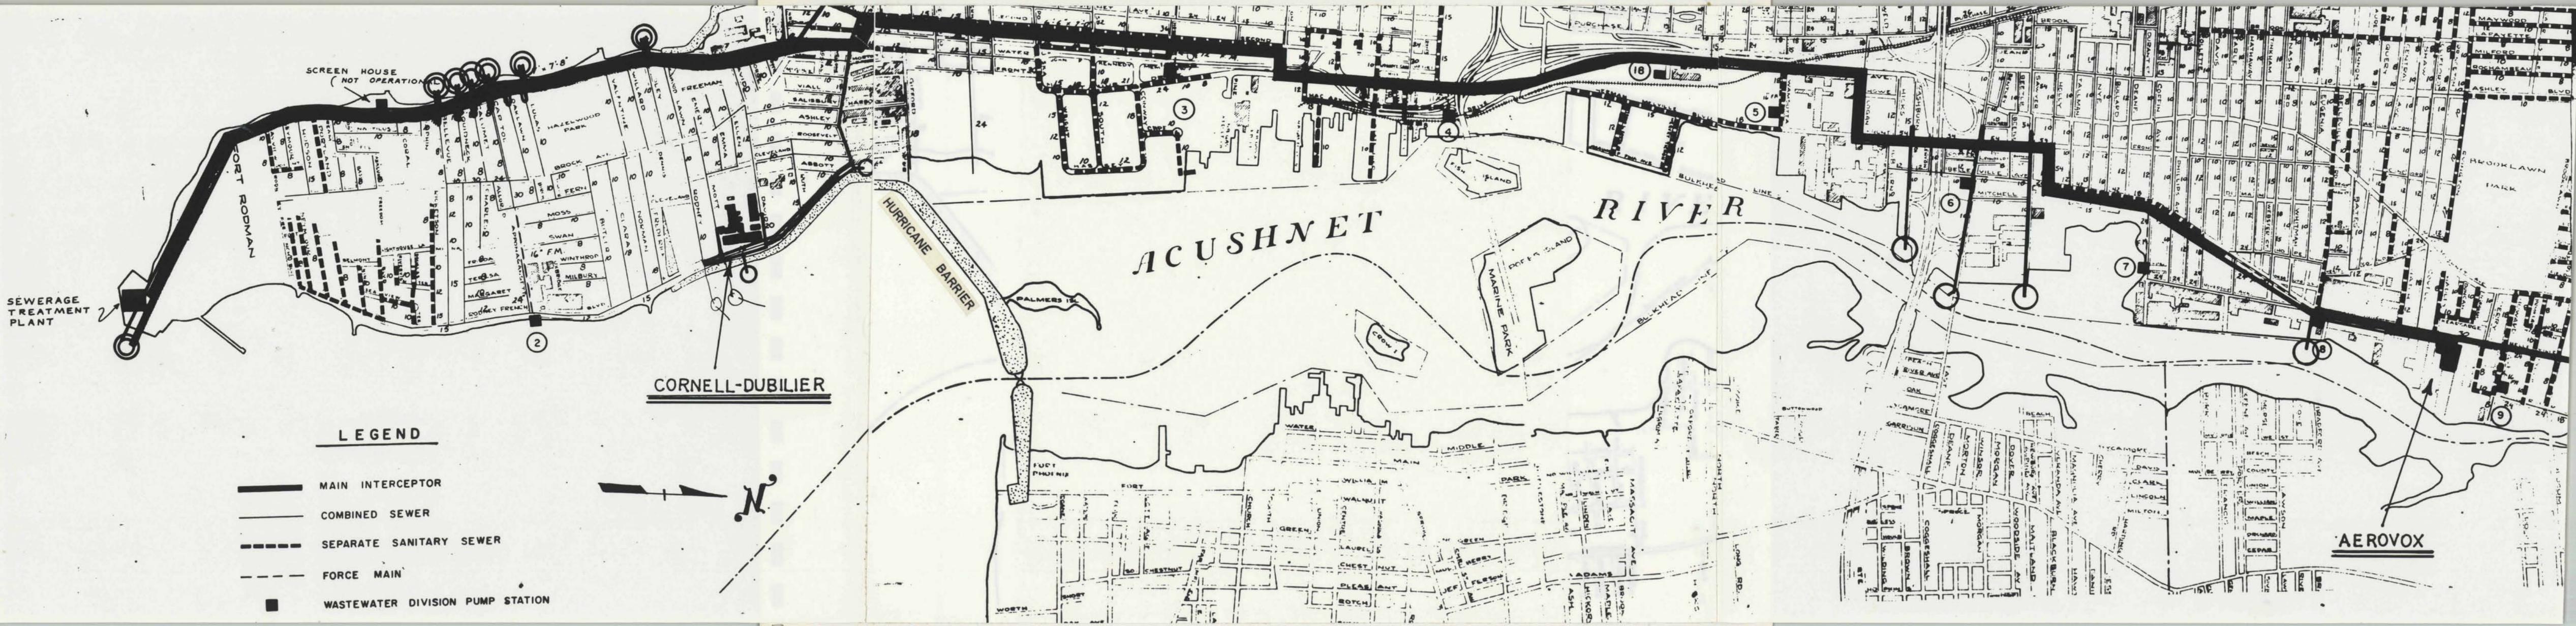
This map was provided to EPA by the City Engineering Office in New Bedford, Massachusetts.

According to this map both Aerovox Corporation and Cornell-Dubilier are linked to the Municipal Sewage Treatment plant by the sewage system.

Thirteen combined sewage/storm sewer overflow outfalls can be seen on this map. As the sewer system reaches its maximum capacity, untreated sewage may be released from these outfalls. Seven of the outfalls empty into New Bedford Harbor; four of these empty north of the hurricane barrier. The remaining six outfalls empty into Clarks Cove.

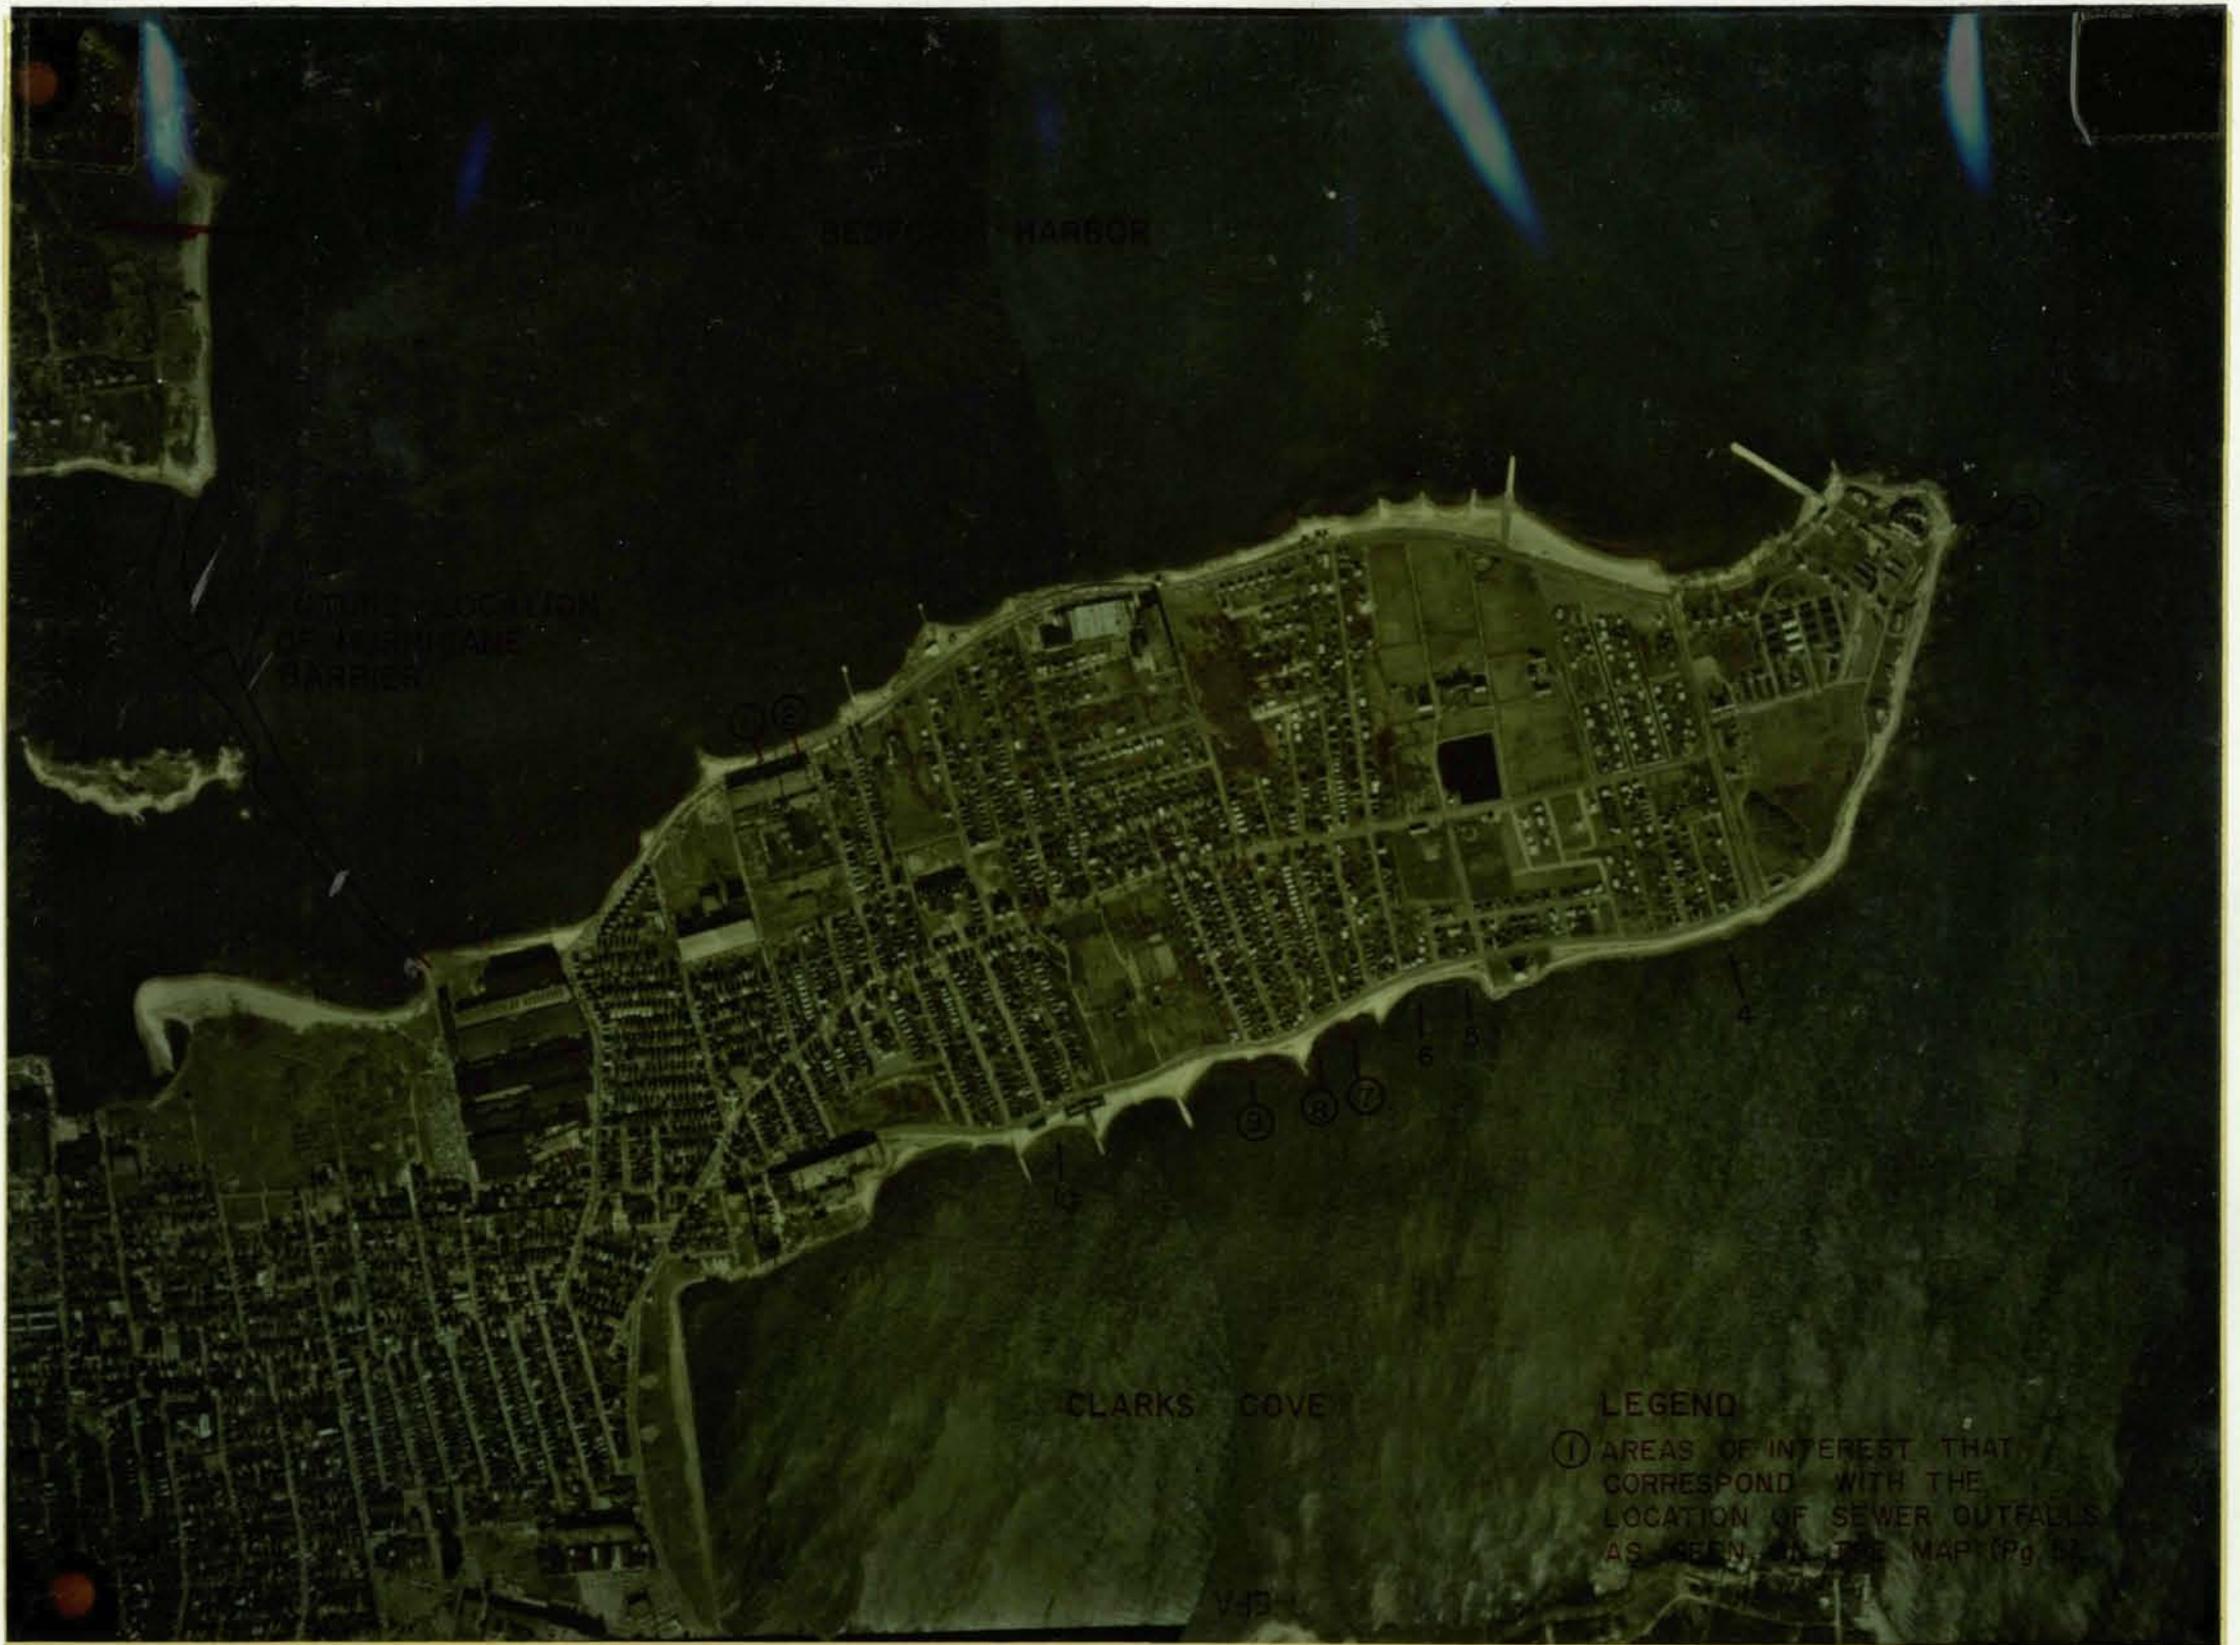
CLARKS COVE

The Municipal Sewage Treatment Plant had not yet been built at the time this photograph was taken.

Six of the ten possible outfalls labeled on the photograph are at the approximate location of those shown on the sewer system map (p. 5). The photograph does not indicate whether or not the underground main interceptor line and/or any of the storm sewer lines pictured on the map existed in 1962. Therefore, on the date of this photograph, no direct link can be established between Cornell-Dubilier and Aerovox and outfalls along the shore of Clarks Cove.

No outfall was visible on the north end of Clarks Cove along the seawall.

1. A small cut in the shore and faint discoloration of the water near the shore are seen here.
2. A small cut in the bank is visible here.
3. A large cut in the shore and offshore sediments appears here. This is probably a major outfall.
4. A possible pipe can be seen on the shore here.
5. A cut in the shore is visible here.
6. A possible pipe is visible here.
7. A small concrete abutment visible on the shore here may be an outfall point.
8. A small cut in the bank and slight discoloration of the water offshore are visible here.
9. A small concrete abutment is also visible here.
10. An object, possibly a section of pipe, and a possible channel in the offshore sediments can be seen here.

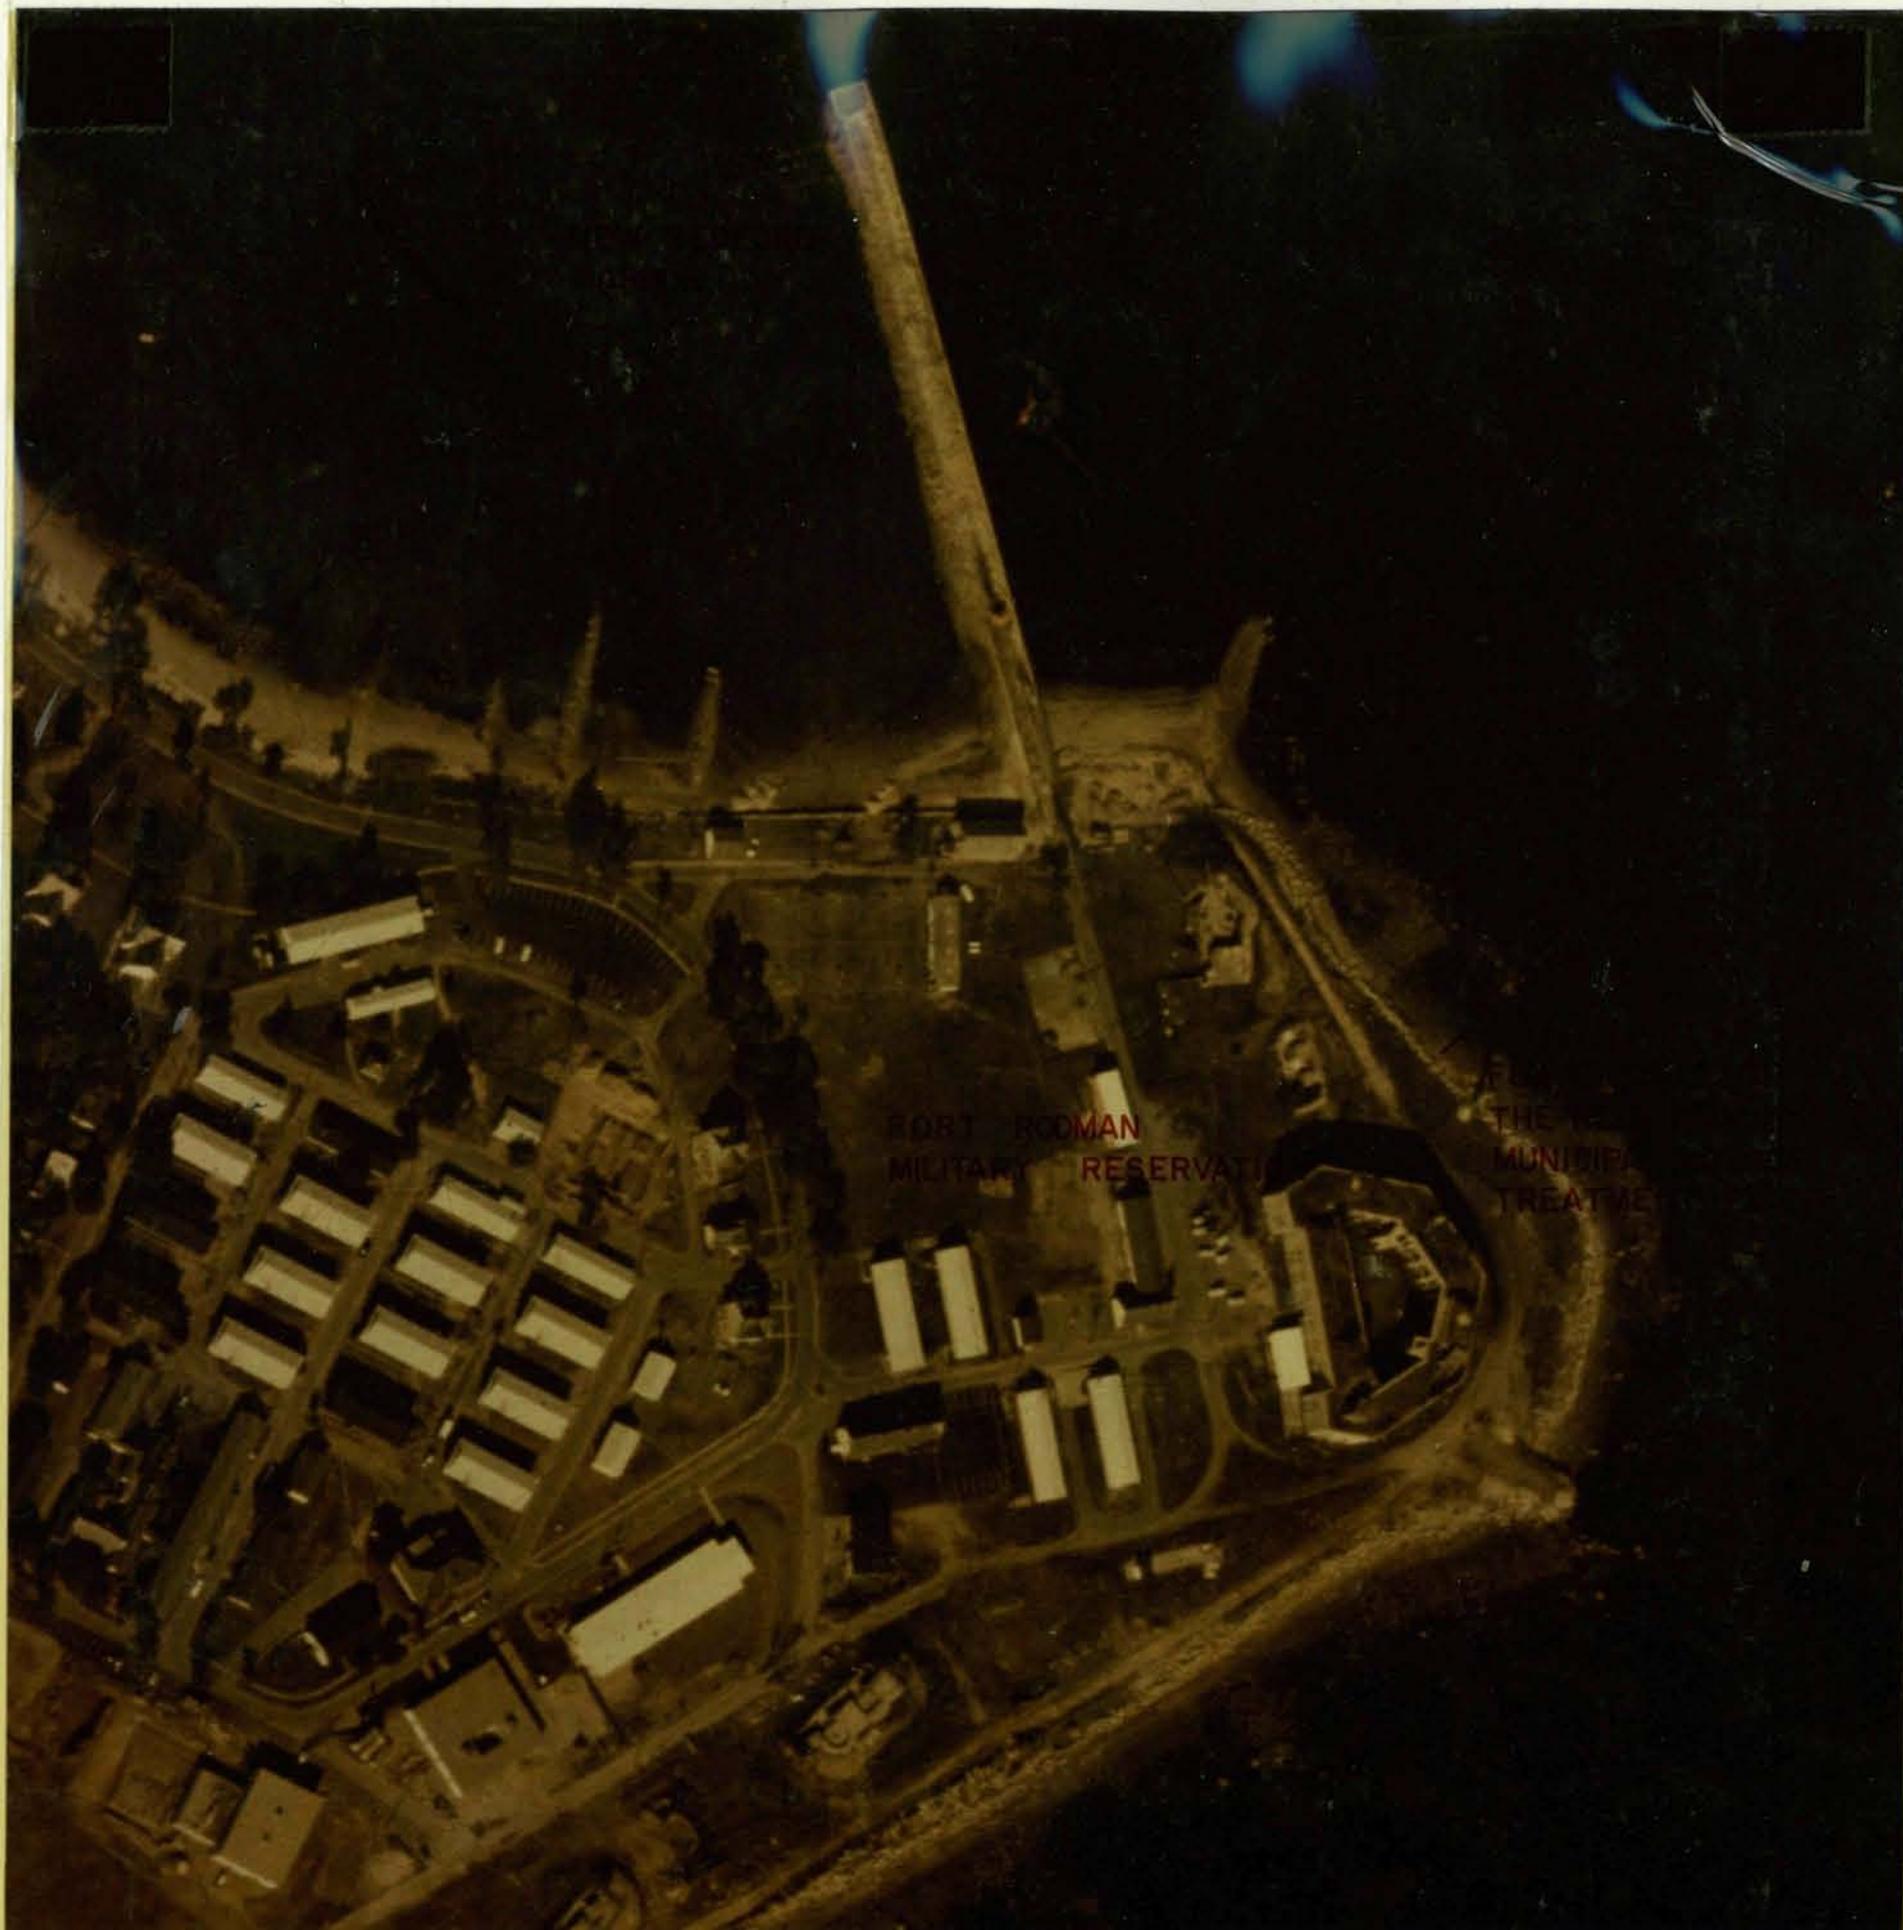
SEWAGE TREATMENT PLANT SITE

As of the date of the photography the New Bedford Municipal Sewage Treatment Plant has not been built. The future site of the plant is annotated on the photo.

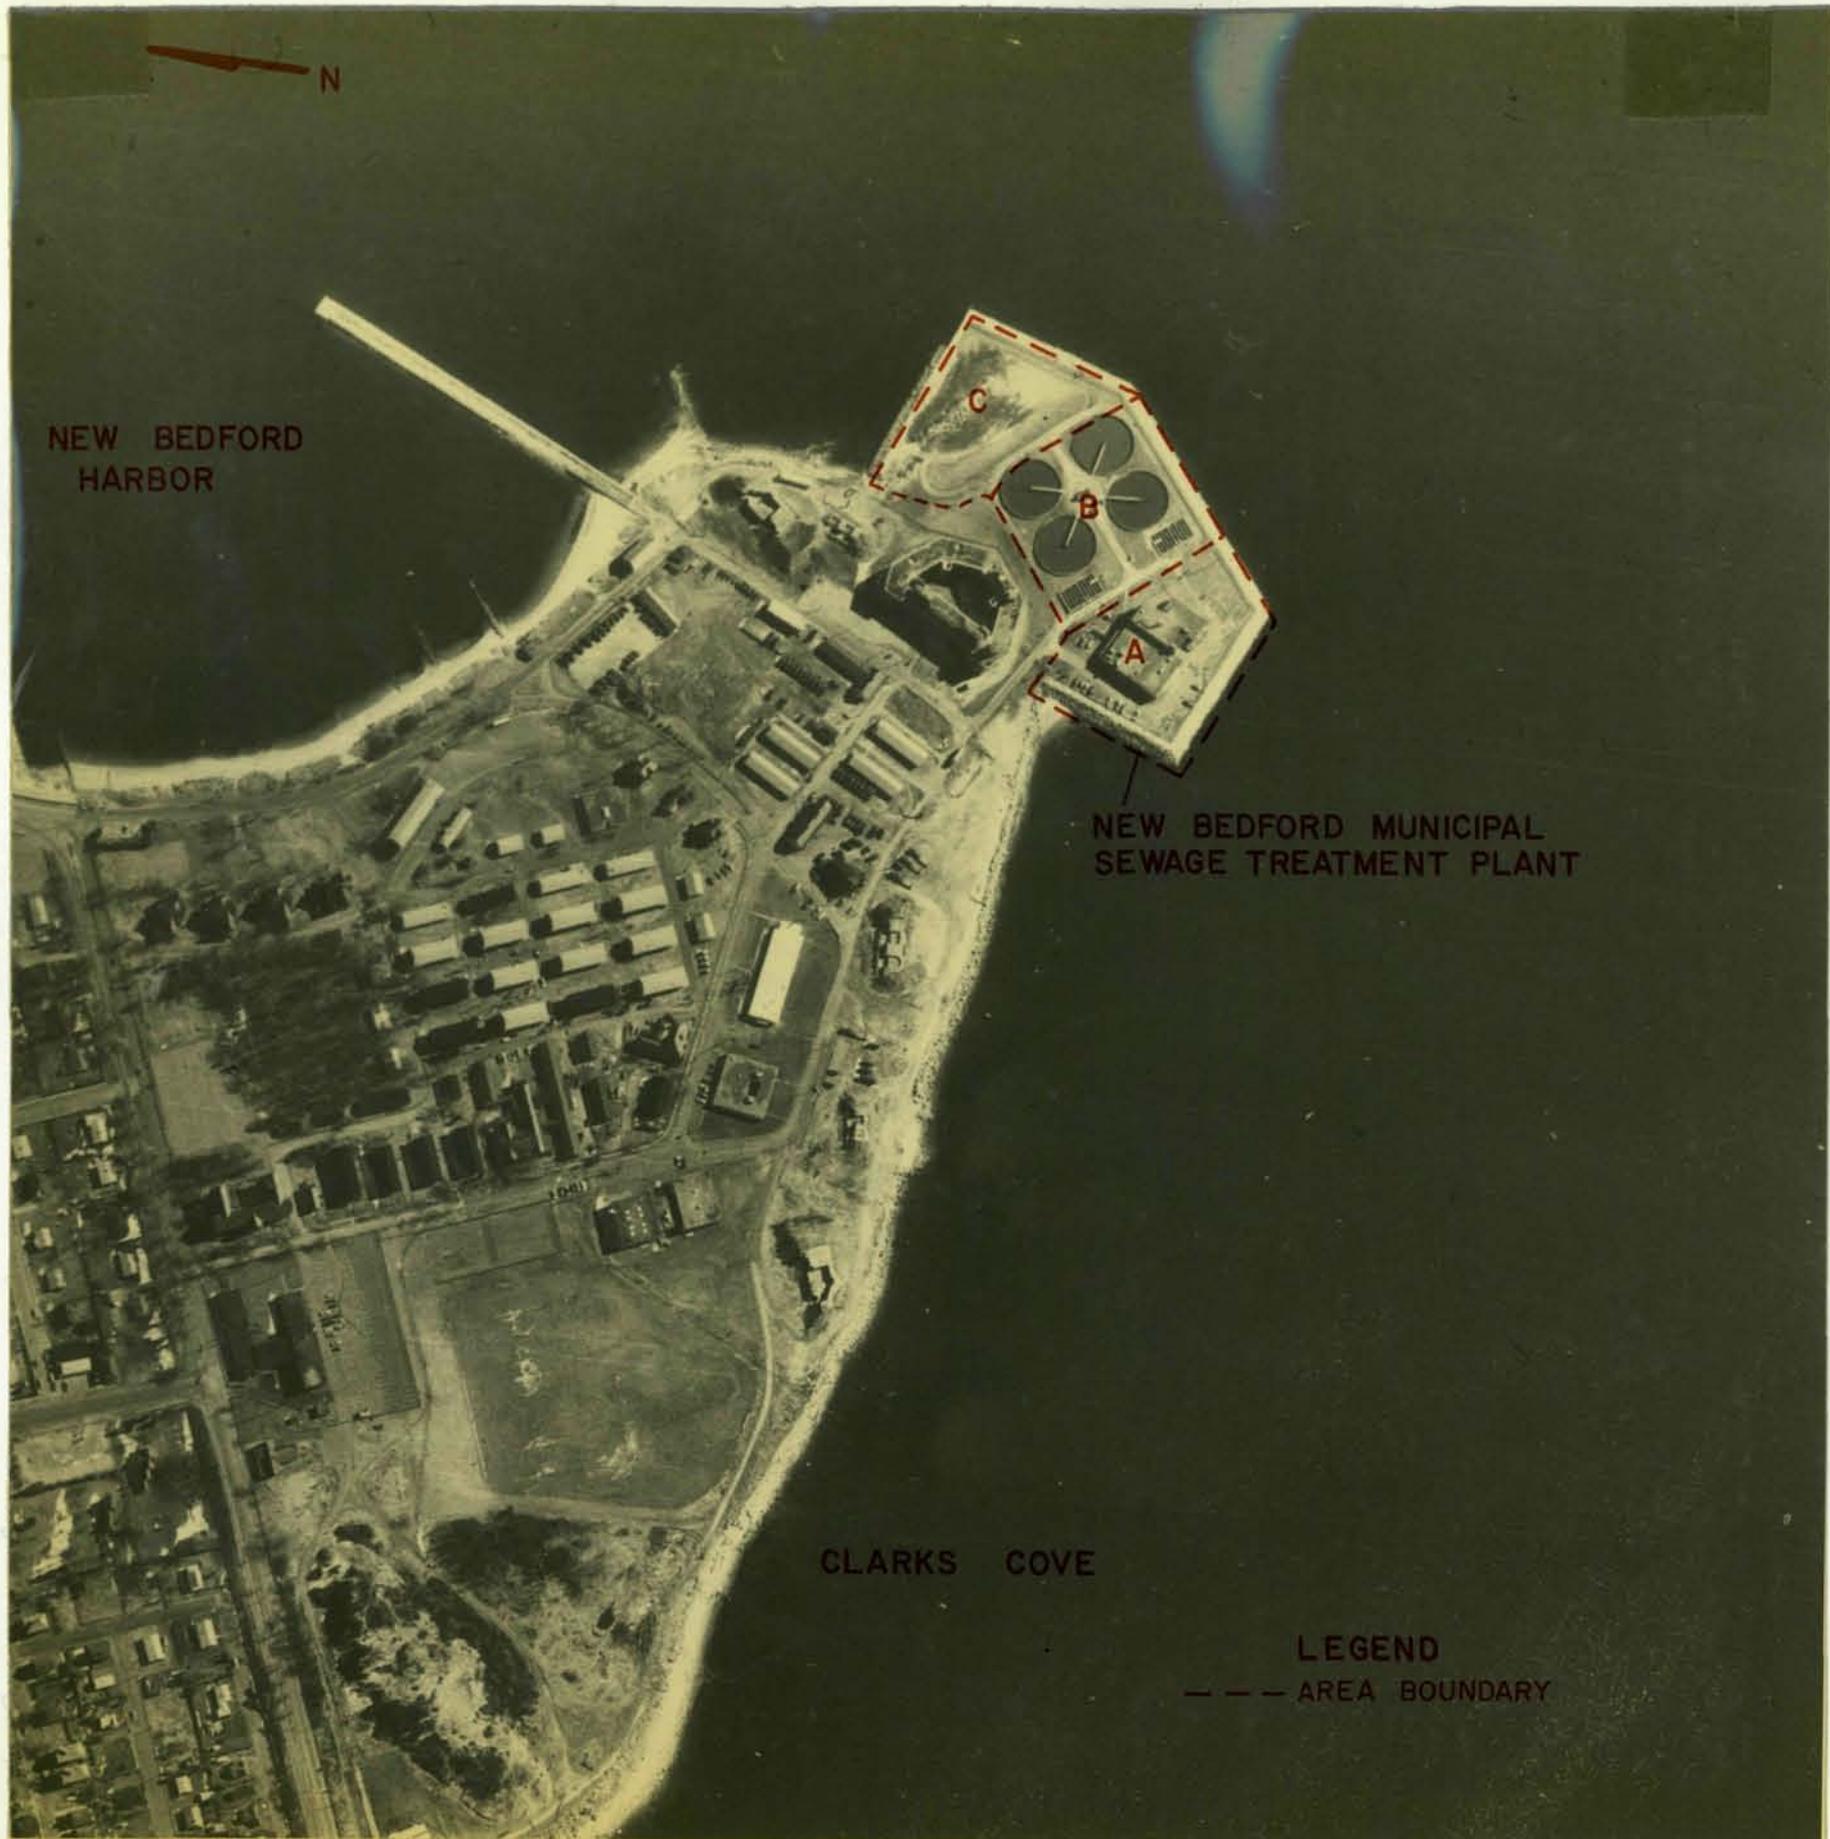
SEWAGE TREATMENT PLANT

The New Bedford Municipal Sewage Treatment Plant was constructed sometime between 1966 and 1974 (see photo, page 9). It is located on a piece of land that was constructed at the tip of the peninsula that separates Clarks Cove from New Bedford Harbor.

Area A contains one building. There is no sign of the incinerator that is supposedly on site to burn sludge (see Introduction).

Area B contains six tanks. The four large round tanks are probably clarifiers, and the two small rectangular tanks are probably chlorine contact basins.

Area C is a depression containing light-toned mounded material. A well-defined dirt road enters the area from the north.

No discoloration is visible in the water offshore from the plant. This may be due to the nature of the photography, however, rather than a lack of discharging.

It should be noted that this plant is small compared to sewage treatment plants that serve communities of comparable size to New Bedford. It possibly handles only a small portion of the city's wastewater. Or, perhaps, it is providing only minimal processing to a larger portion of the wastewater output of the city.

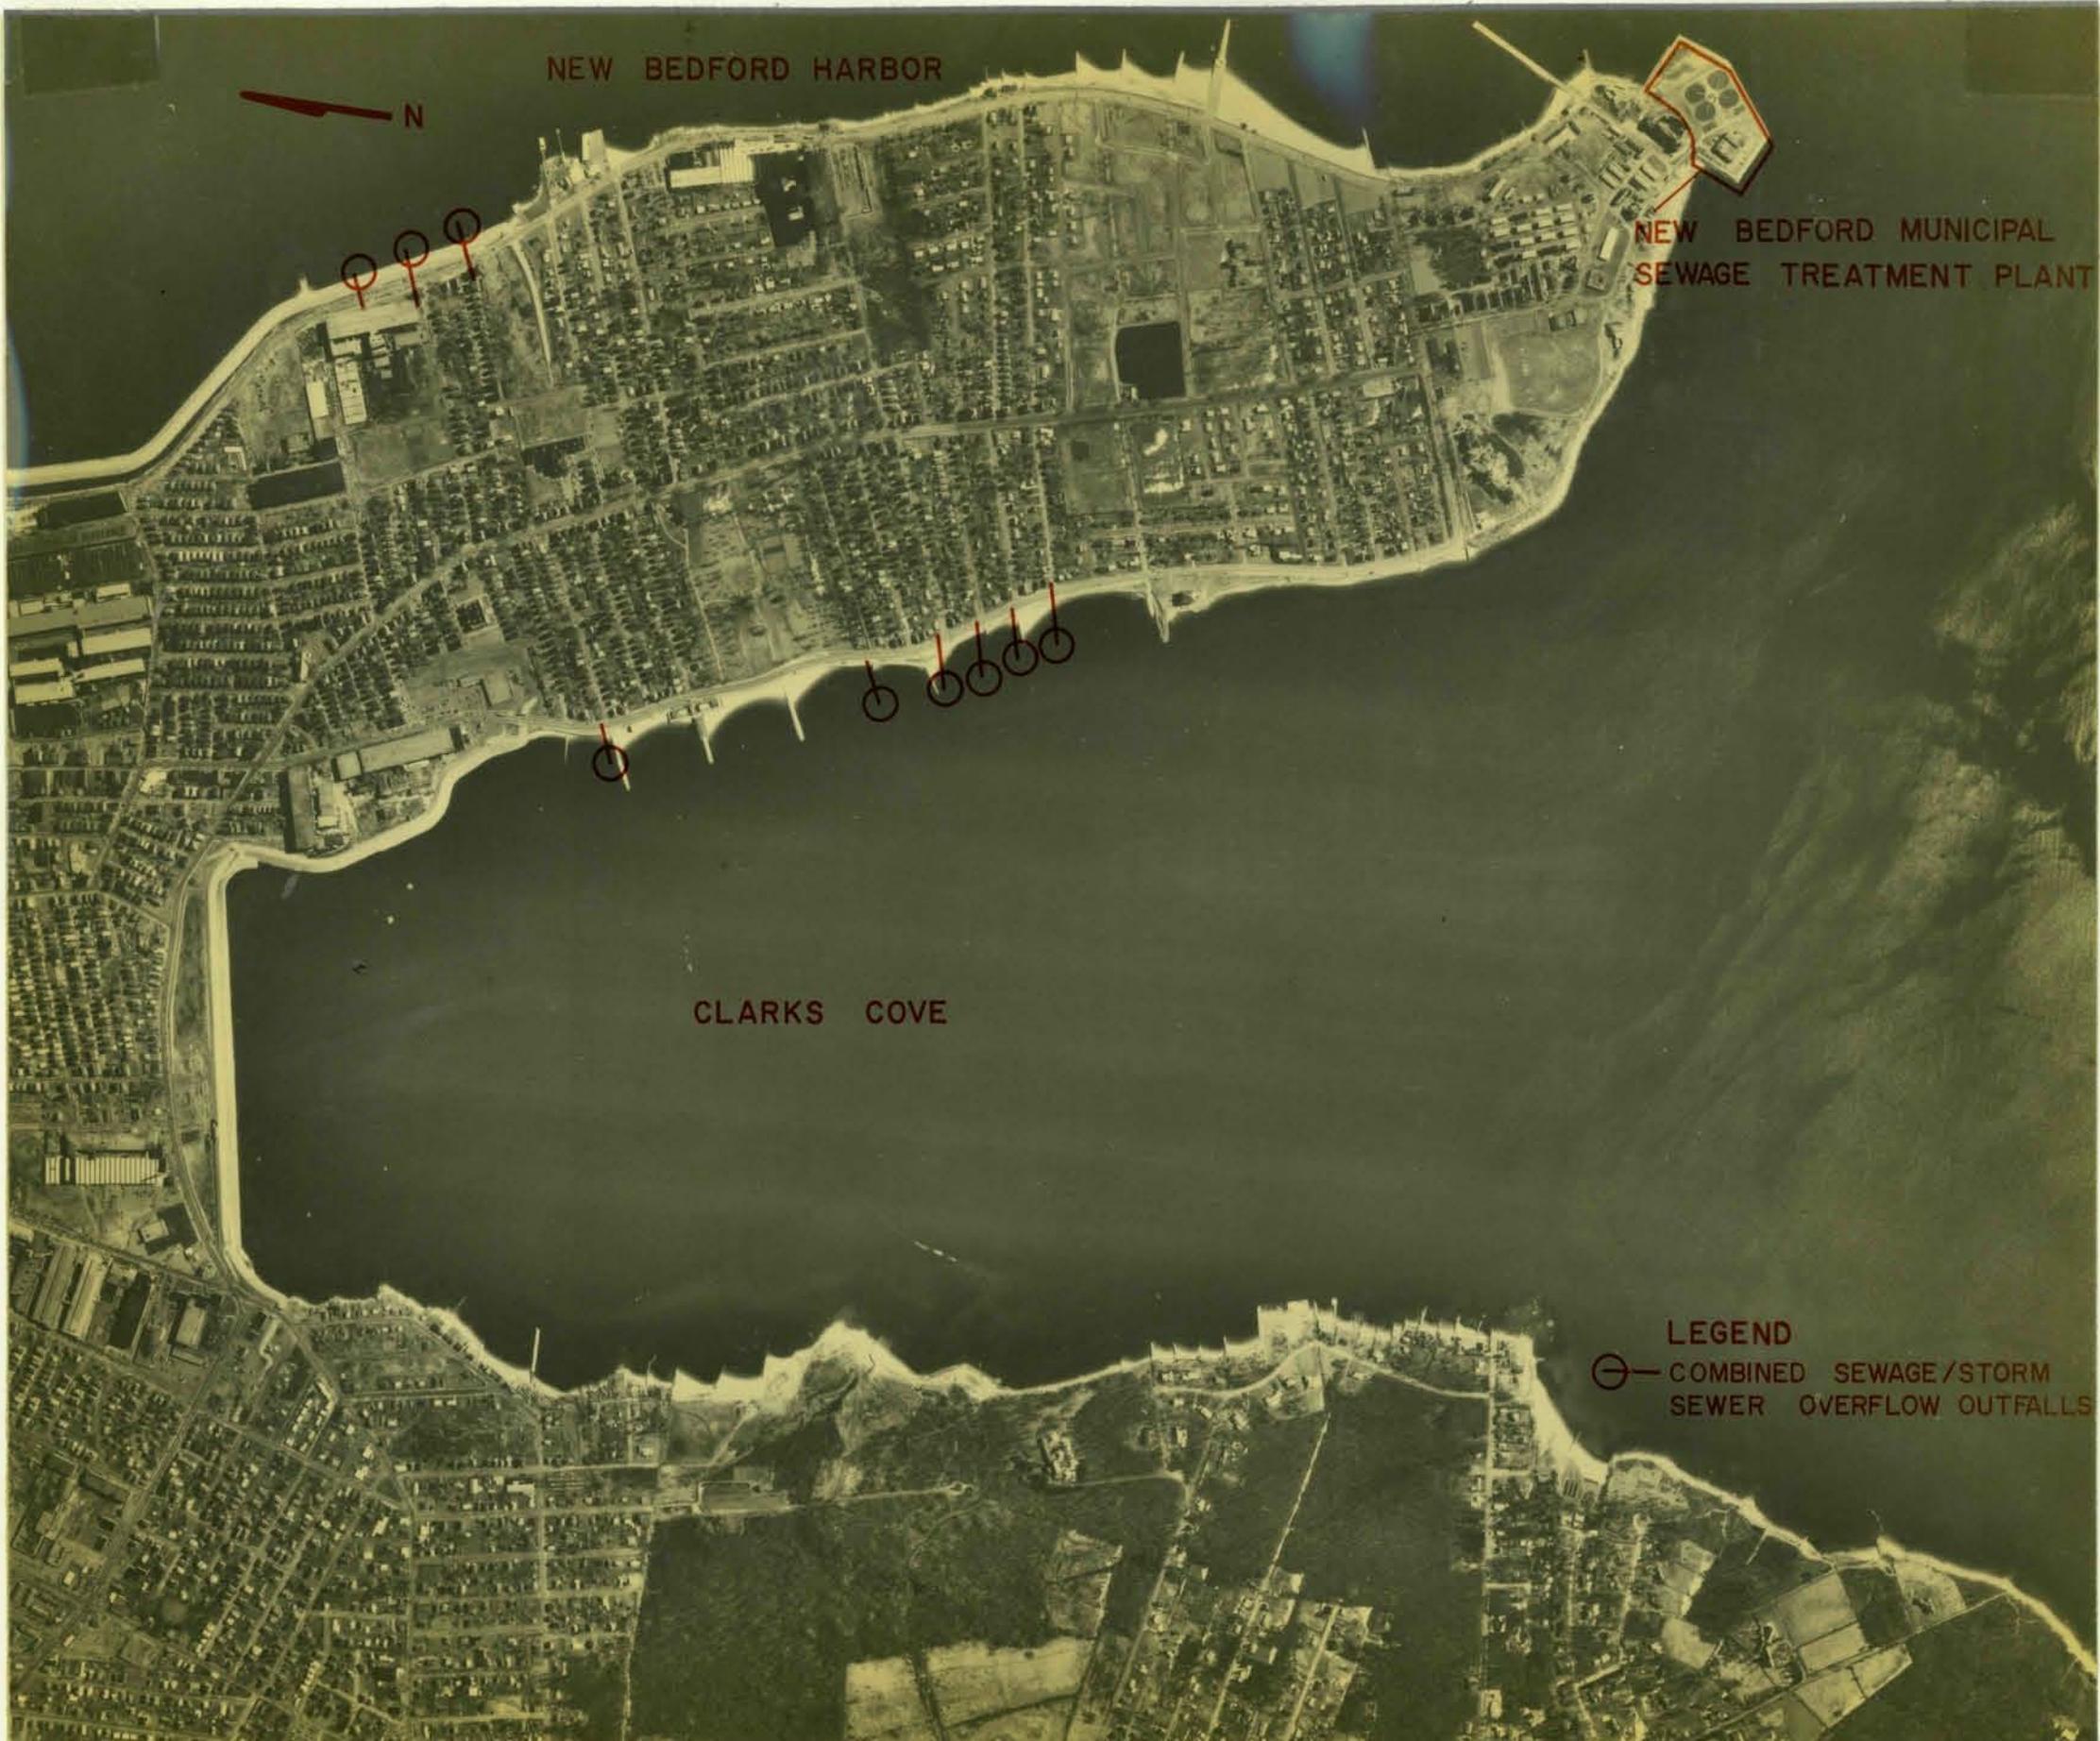
CLARKS COVE

This photograph shows the Sewage Treatment Plant, which has been built since 1966.

The overlay shows the location of nine of the combined sewer/storm sewer overflow outfalls shown on the Sewer System Map (p. 5). No plumes or discoloration can be seen in water at any of these outfalls. This may be due to the nature of the photography, however, rather than a lack of discharging.
