TS-PIC-86021  
December 1986

# Site Analysis Conrail Railyard New Bedford, Massachusetts

by  
Donald P. Fanelli, Imagery Analyst  
The Bionetics Corporation  
Warrenton, Virginia 22186

Historical aerial photography of the Conrail Railyard in New Bedford, Massachusetts, spanning the period from 1938 to 1985, was analyzed to document evidence of alleged PCB spills and illegal filling activities into the Acushnet River.

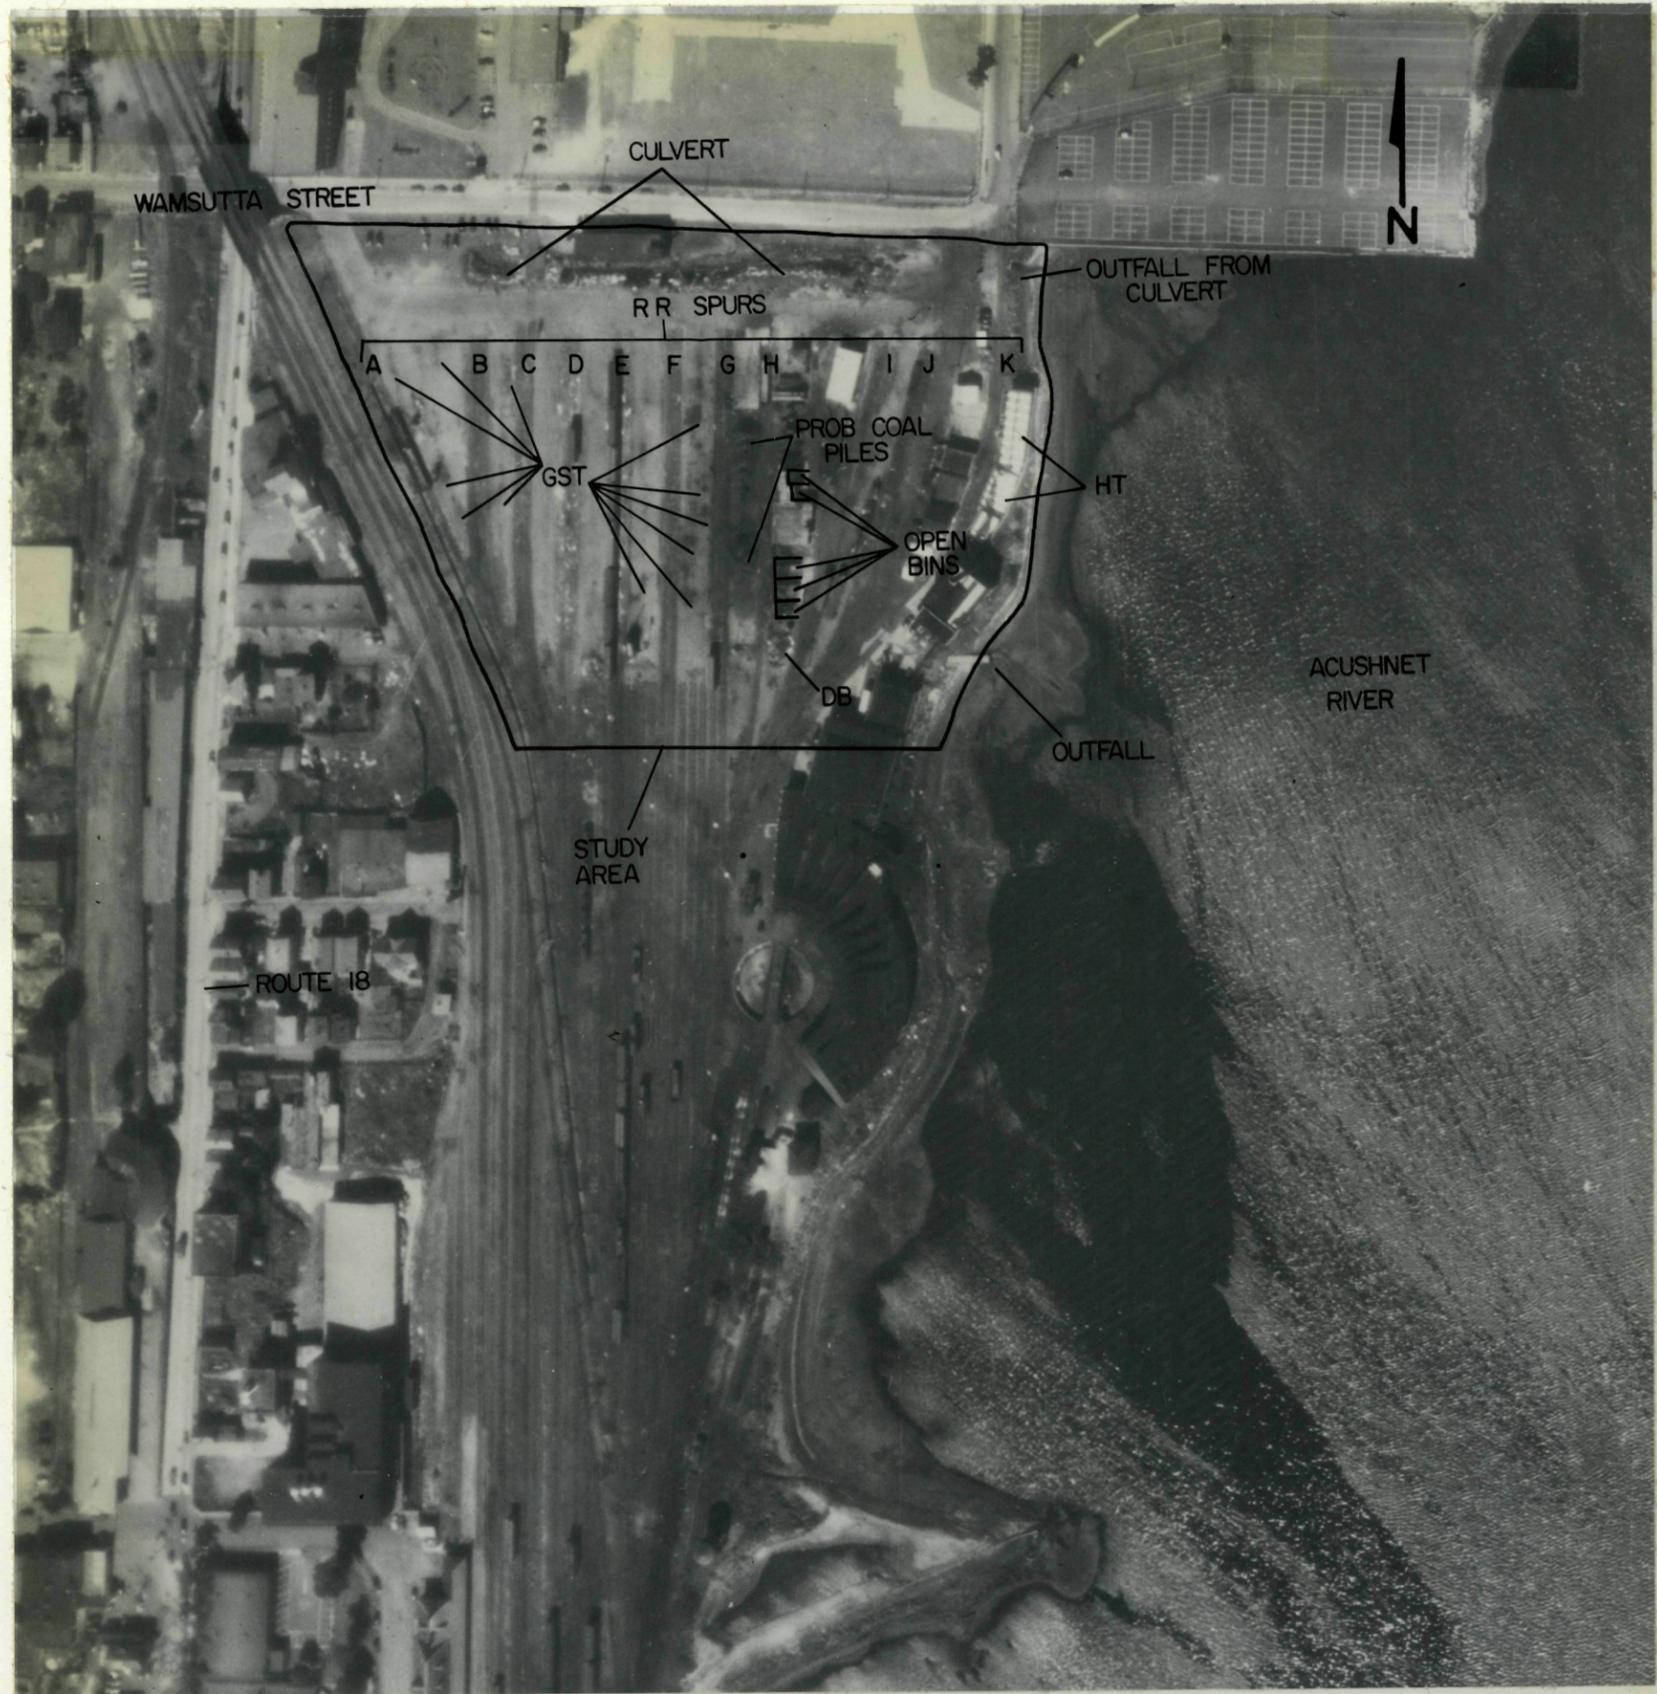
FIGURE 2  
CONRAIL RAILYARD

As requested by EPA Region 1, only the northern portion of the railyard, as outlined on Figure 2, was analyzed. The railroad spurs in the study area are lettered A-K (from west to east) for identification/location purposes.

An open, unlined culvert runs just south of and parallel to Wamsutta Street. This culvert is suspected of carrying PCB contamination from the railyard into the Acushnet River. No staining is evident within the culvert but light-toned material, probably debris (not annotated), appears along its entire length. The culvert's outfall to the Acushnet River is visible, as well as another outfall to the south. Light-toned material or debris (not annotated), similar to that seen in the culvert, is visible along spurs D and E.

Numerous very dark ground stains (GST) are visible between spurs F and G, with generally lighter stains between spurs E and F and spurs A and C. Uniform ground discoloration is seen along all spurs except A, D and E. The darkest discoloration is along spurs B, G and H. Two large, probable coal piles between spurs G and H probably contribute to the intensity of the discoloration along these two spurs.

Other potential sources of contamination within the study area include a series of horizontal tanks (HT), five open bins partially filled with dark-toned material (probably coal), and a pile of debris (DB).

No tank cars are present in the study area. Tank cars are visible in the railyard south of the study area, but none appear to be in the process of transferring their contents.

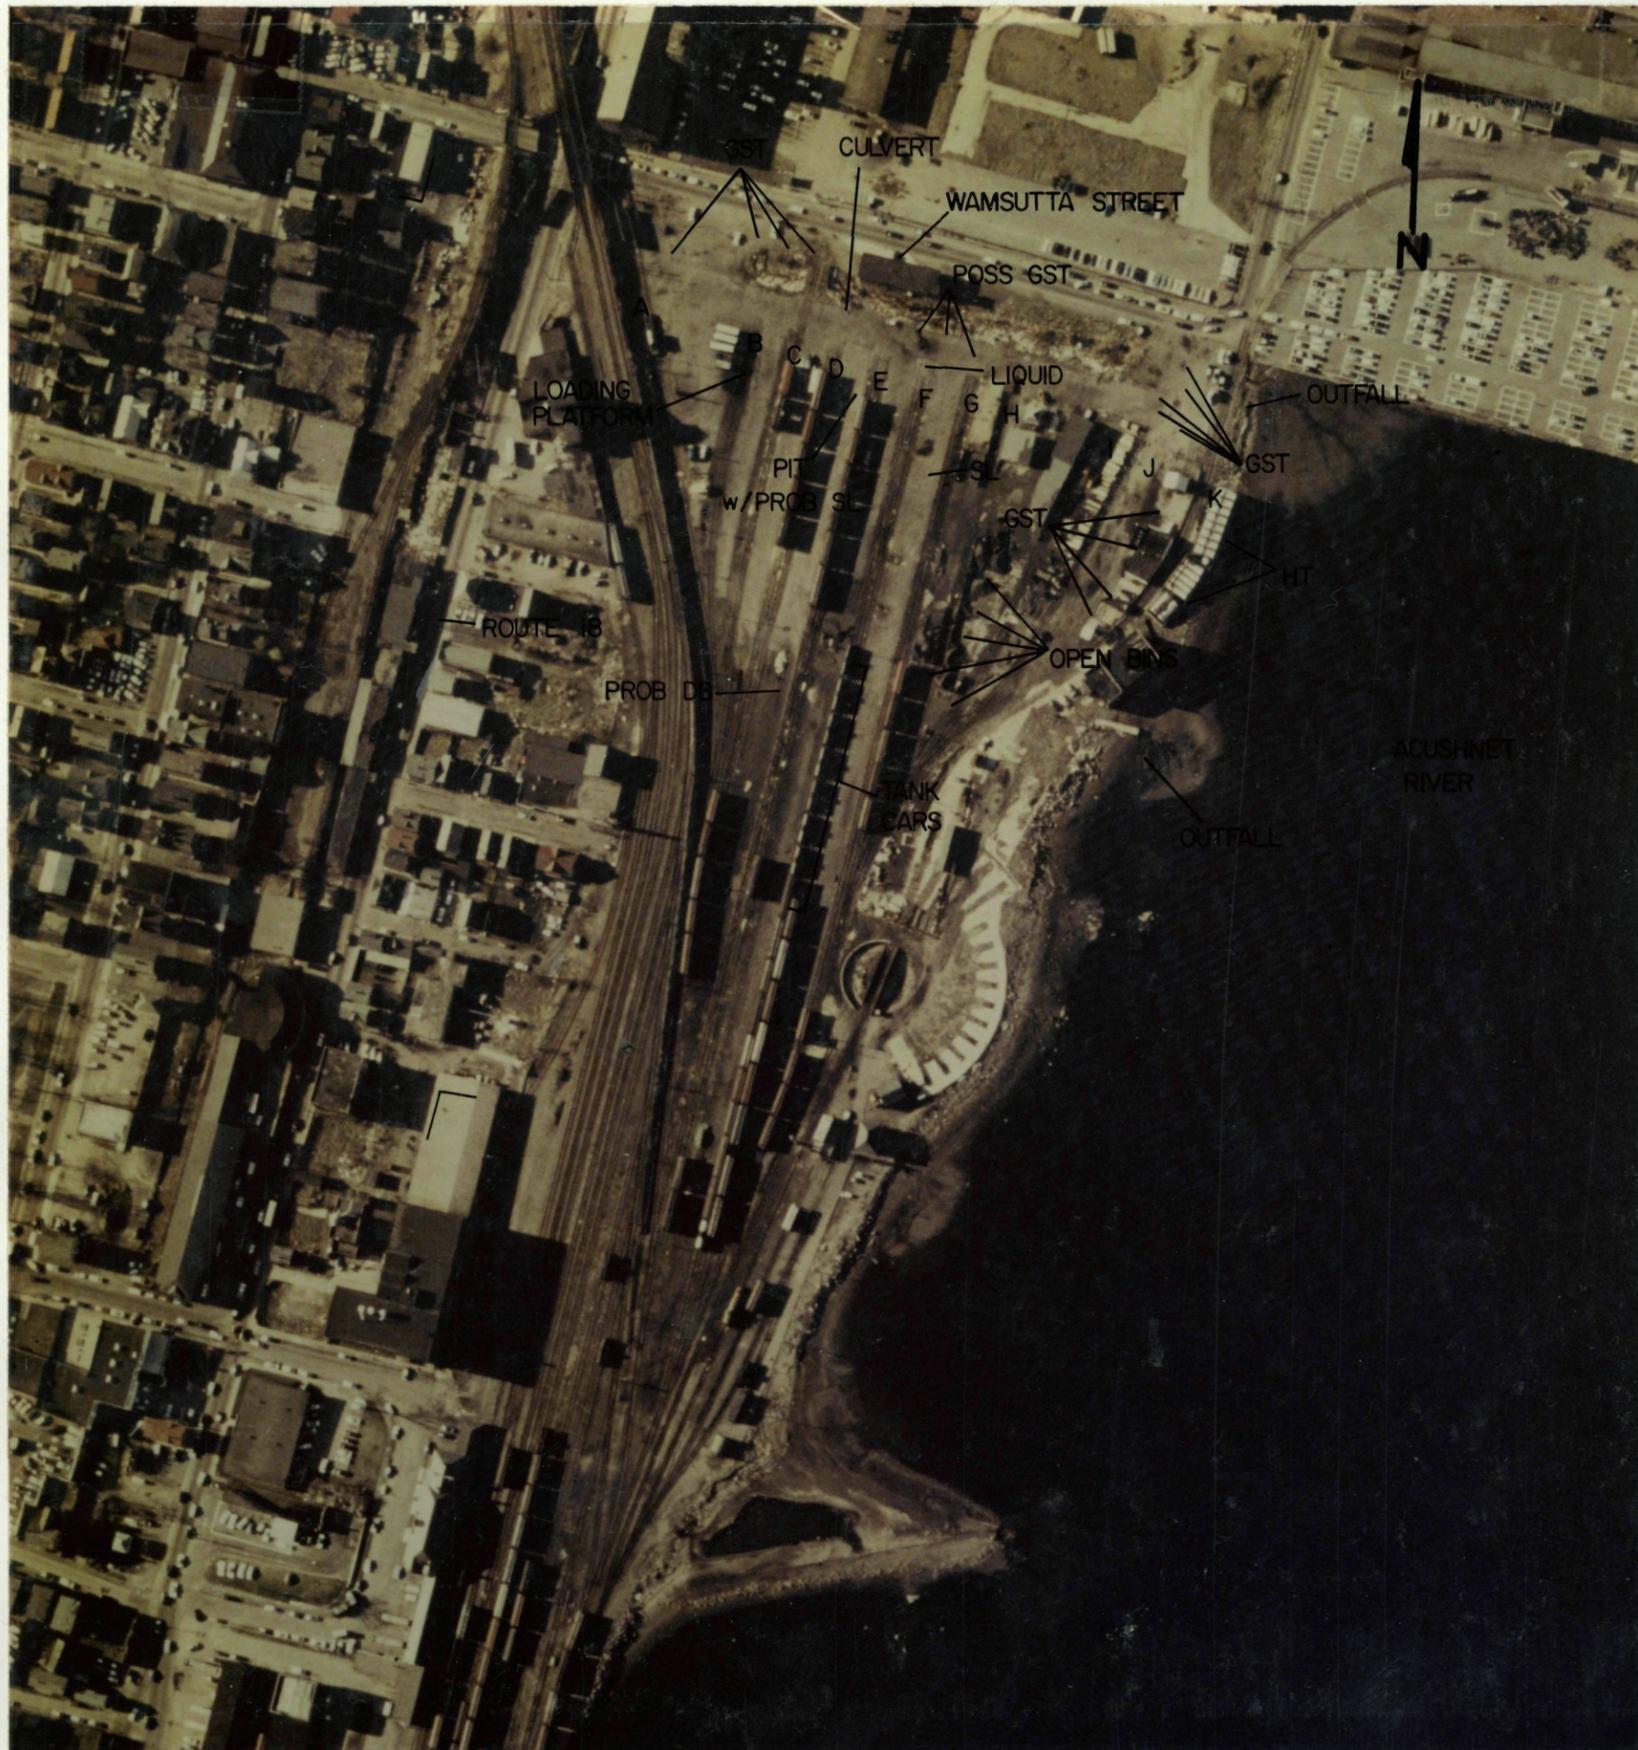
FIGURE 3  
CONRAIL RAILYARD

Light-toned probable debris (not annotated) is still visible all along the culvert. A pile of similar material is seen between spurs D and E. A black liquid appears to be flowing into the culvert from a small pool at the end of spur F. Possible ground stains are evident within the culvert near the point where the black liquid is entering it. A similar black pool of standing liquid (SL) is seen on the eastern side of spur F near its terminus. A string of seven tank cars is visible farther south on spur F. (All other cars in the study area are boxcars.)

Numerous black ground stains with an oil-sheen appearance are seen between spurs J and K. Similar ground stains appear in the northwestern section of the railyard between spurs A and C, both of which extend to Wamsutta Street.

The general pattern of ground discoloration is the same as in 1951, except that spur E is now discolored, and discoloration is visible only along the west side of spur C. The number of open bins has increased (not all are individually annotated), and all appear to be at least partially filled with coal. A loading/unloading platform has been added alongside spur B and is uniformly black in color.

A shallow pit with probable standing liquid was seen between spurs D and E on 1961 imagery. The probable liquid appears very dark-toned and is surrounded by a very light-toned material that rings the pit.

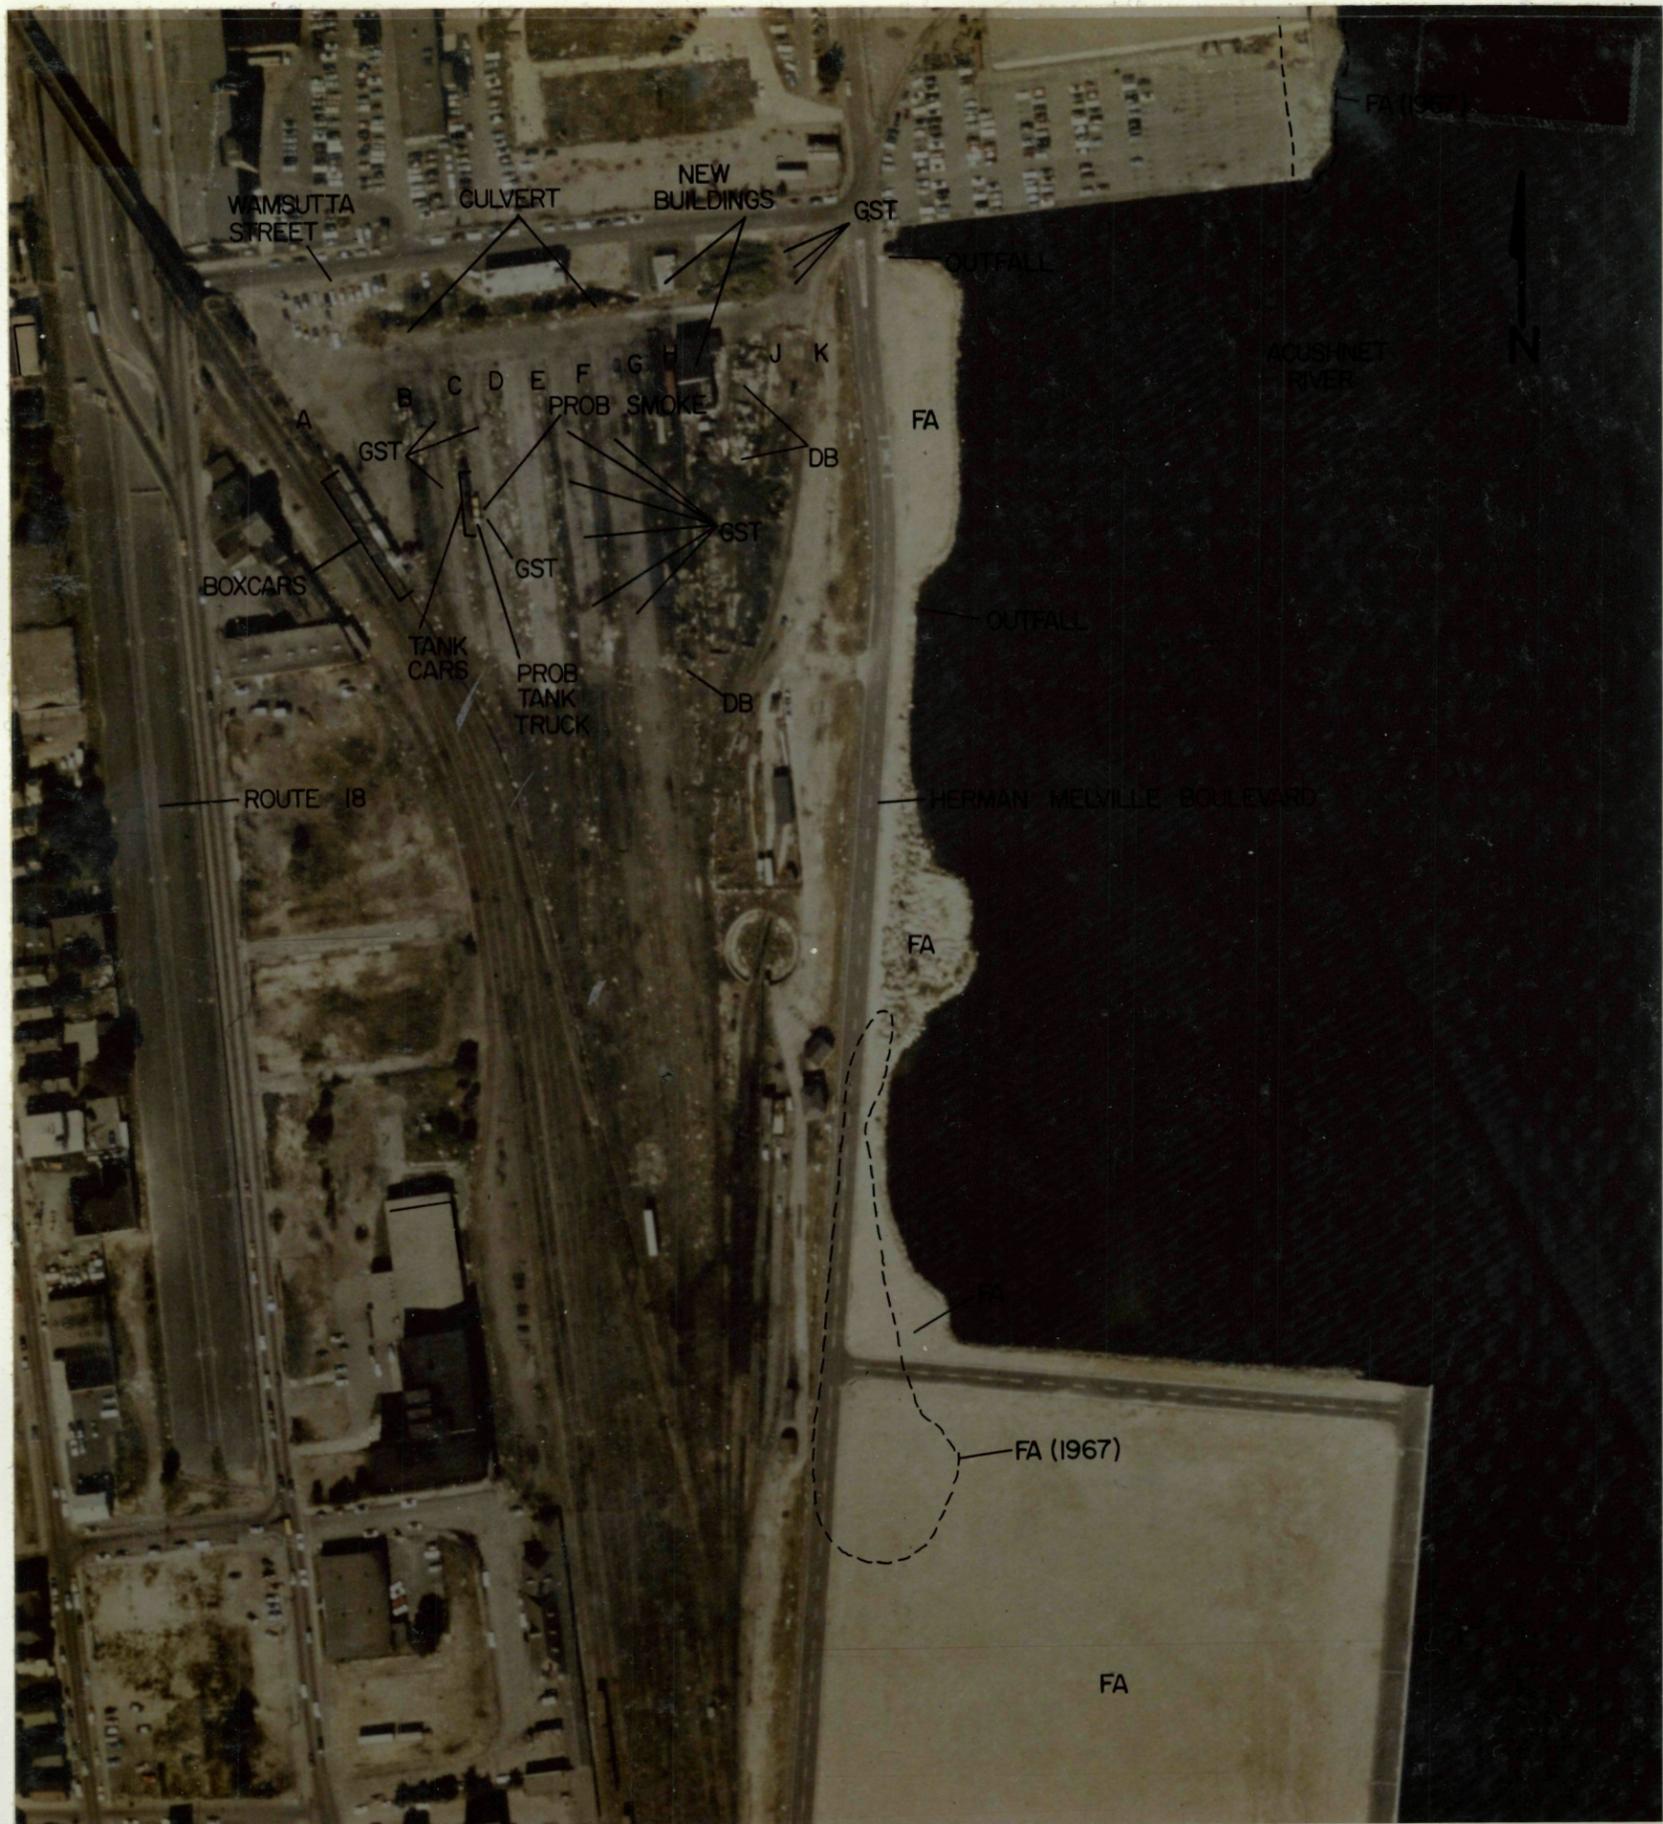
FIGURE 4  
CONRAIL RAILYARD

In general, activity in the northern portion of the railyard appears to have decreased significantly since 1967 (in which the level of activity was similar to that of 1962). (Imagery for 1967 was analyzed but not reproduced for this report.) Most of the buildings and features in this area, including the horizontal tanks and open bins, have been removed. Several mounds of debris and a new building are seen between spurs G and J. Another new building is visible north of spur H. Spur I appears to have been removed. White material, refuse or debris is scattered throughout the railyard.

The open portion of the culvert is mostly covered by vegetation and shows no evidence of significant ground staining. However, several dark ground stains are seen on an access road running over the culvert, near its outfall to the Acushnet River.

Ground stains are visible throughout the railyard, most notably between spurs B and D and spurs E and G. Ground discoloration is seen along the length of spurs B, C, E and F. Widespread ground discoloration is visible between spurs G and K. The probable coal piles seen in 1951, 1962 and 1967 are no longer present, but the ground discoloration in this area appears very similar to that seen in 1962 and probably is attributable to coal.

Two tank cars are seen on spur C. Alongside the southern tank car is a yellow probable tank truck (with a white cab). A dark ground stain lies next to the tank truck, on its eastern side. Probable smoke or steam rising near the rear of the truck suggests that a transfer of contents may be in progress.

Filling activity into the Acushnet River was first seen in two areas (FA) on 1967 imagery; their extent in 1967 is annotated on Figure 4. Herman Melville Boulevard has been constructed since 1967 and is a rough approximation of the shoreline prior to 1967. All of the light-toned area east of Herman Melville Boulevard and south of the culvert outfall, excluding the outlined 1967 fill areas, has been filled since 1967. The fill material is fairly uniform in color and is medium-textured.

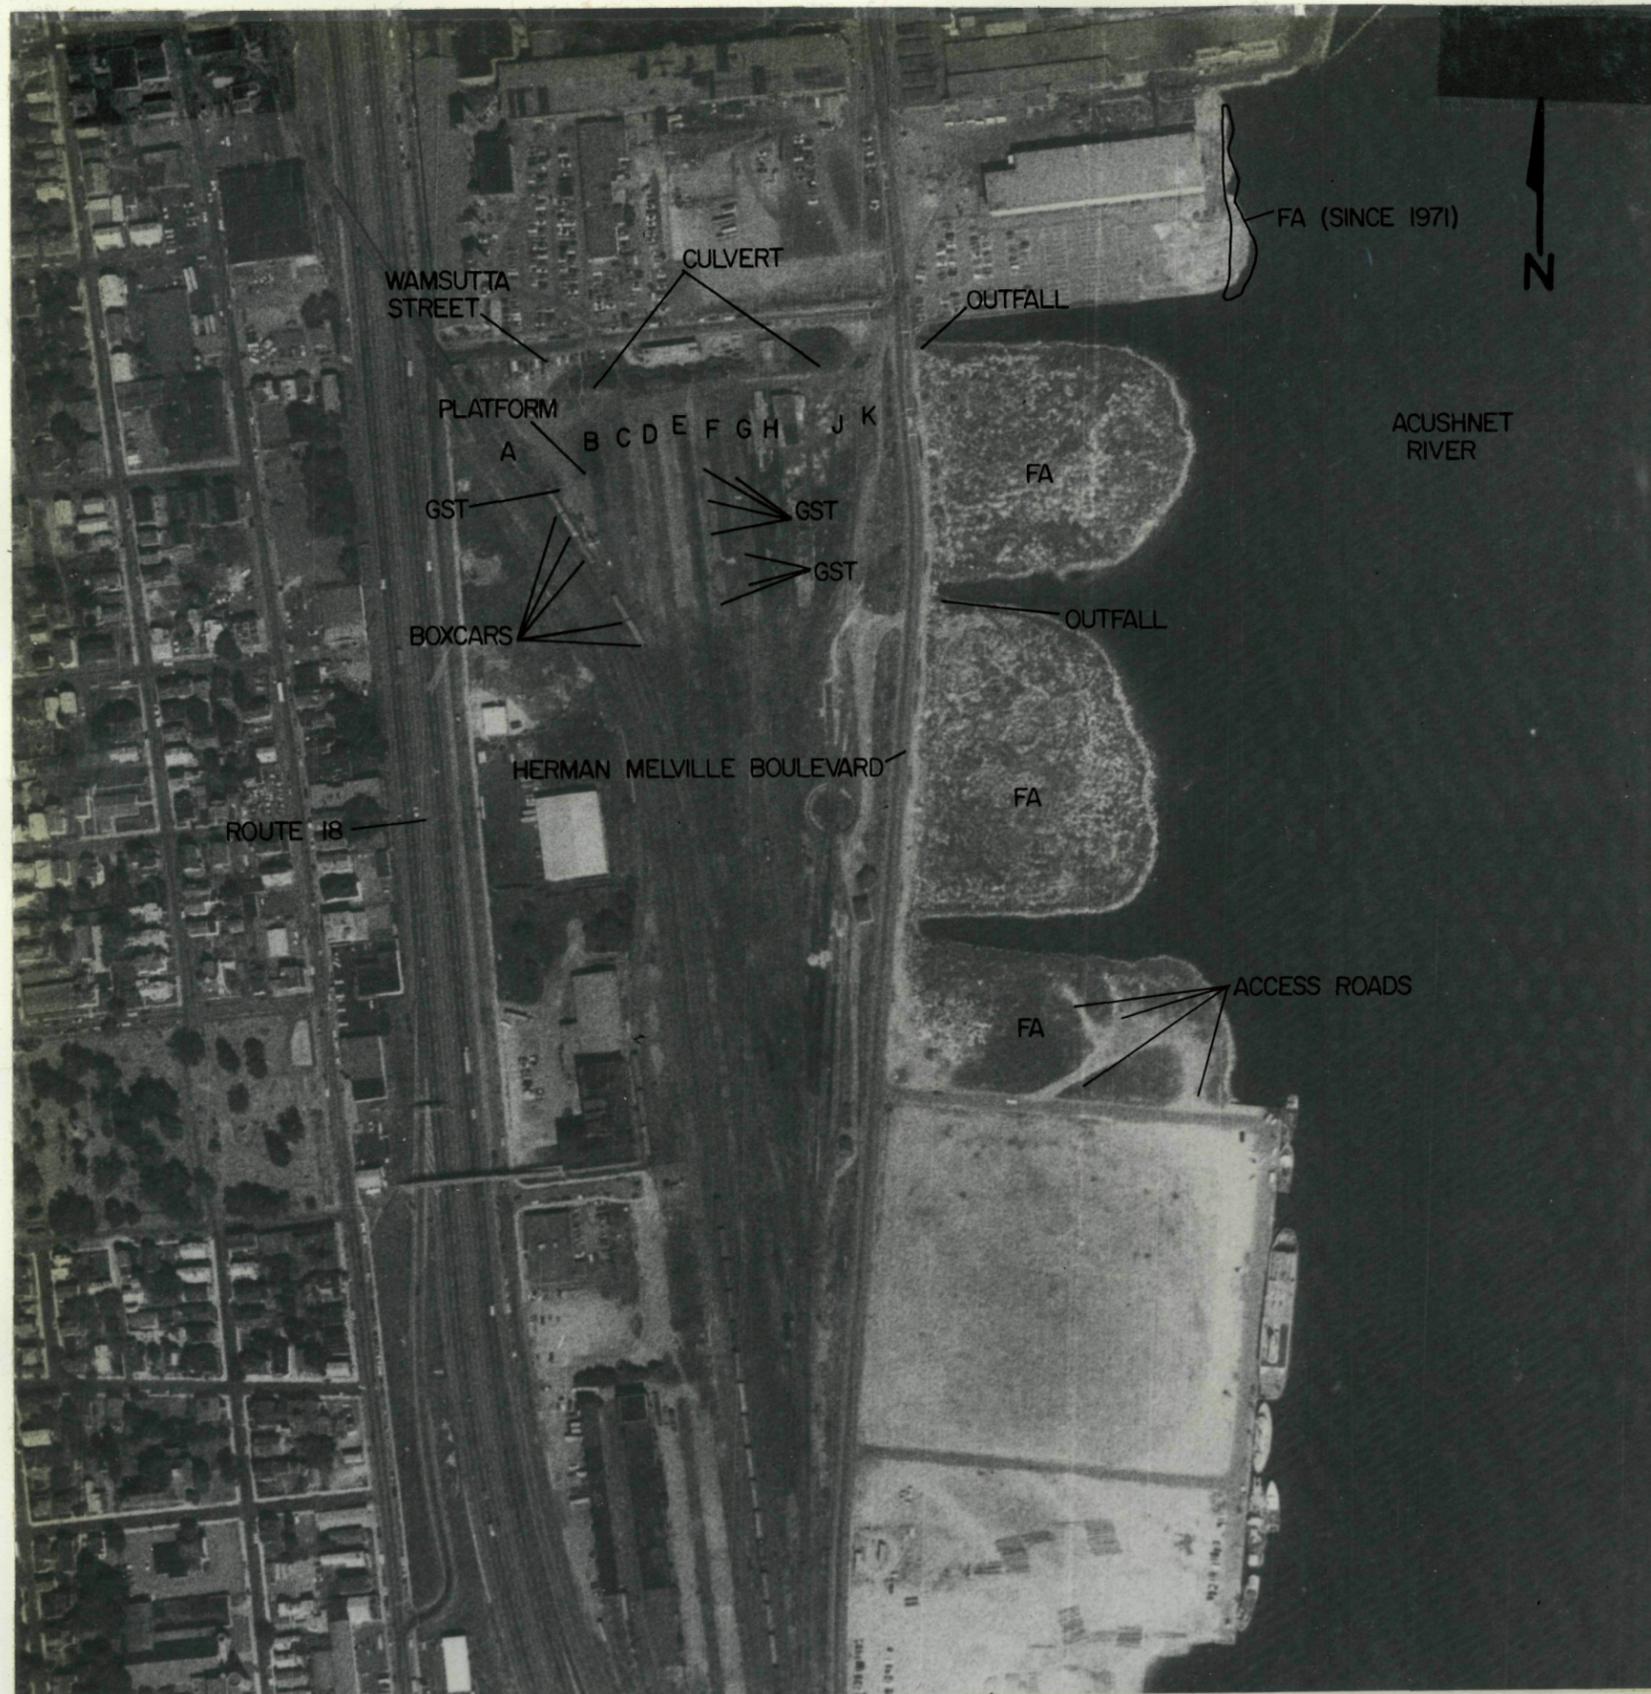
FIGURE 5  
CONRAIL RAILYARD

Very little evidence of activity is seen in the railyard. The culvert is obscured by vegetation.

Numerous ground stains are again seen between spurs E and G. A large, very dark stain is seen along spur A near several boxcars. All of the spurs show ground discoloration along their length; spur B is significantly darker than the rest, especially at its terminus (next to the platform). Most of the area between spurs G and K remains very darkly discolored.

Imagery for 1974 (not reproduced in this report) shows very little filling activity into the Acushnet River since 1971. From 1974 to 1980, however, significant filling activity has resulted in the formation of three fill area protrusions into the river. The two northernmost protrusions are covered with mottled, rough-textured material and do not appear currently active. The southernmost one has a more uniformly dark, finer-textured material and access roads that currently appear in use.

In the small fill area to the north, only a small amount of filling has occurred since 1971.

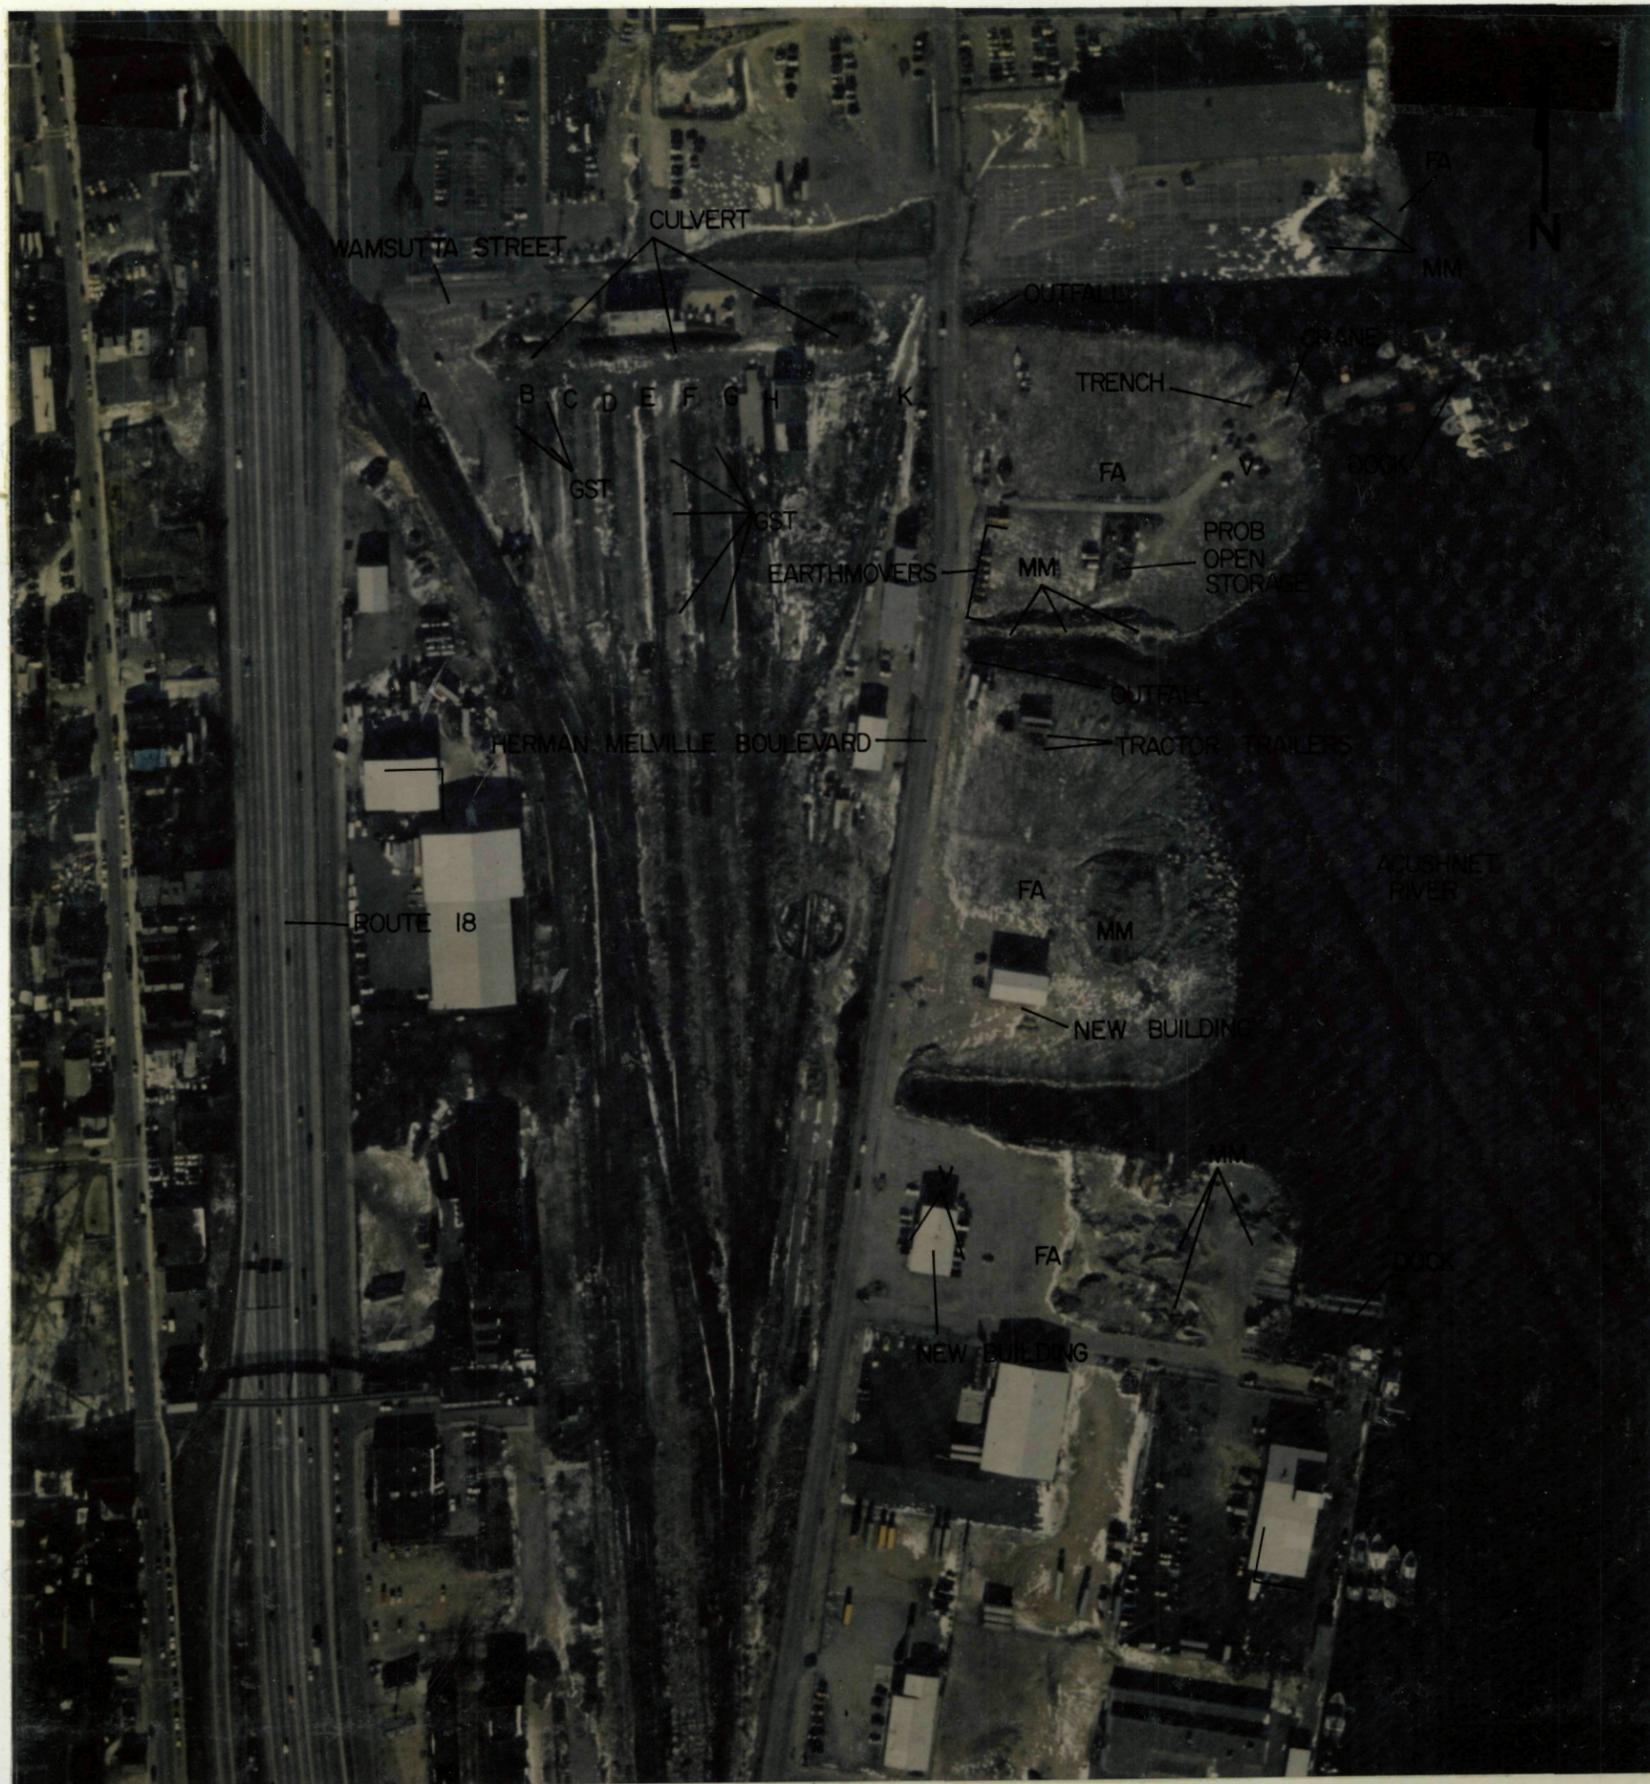
FIGURE 6  
CONRAIL RAILYARD

Again, very little evidence of activity is seen in the railyard. Patches of snow are scattered throughout the area. Spur J is not clearly visible and may have been removed. The culvert has been dug out and deepened, and is mostly obscured by shadow.

Significant ground staining is again visible between spurs E and G and near the terminus of spur B. The ground discoloration pattern along the spurs remains relatively unchanged from 1980.

The fill areas have not expanded any further into the Acushnet River since 1980; however, all show significant dumping and spreading of a dark grey, medium-textured material that completely covers their surfaces. Also visible on the fill areas are two new buildings, a trench, a probable open storage area, mounds of the grey material (MM), and numerous vehicles (V) including a crane, tractor trailers and earthmoving equipment. Two docks extend out from the fill areas. Eight boats are moored at the northern dock.
