Subject.: USACE CONTRACT NO. DACW33-94-D-0002
TOTAL ENVIRONMENTAL RESTORATION CONTRACT (TERC)
TASK ORDER No. 0024 – NEW BEDFORD
Final North of Wood St. After Action Report

**North of Wood St. After Action Report
Consolidated Response to Comments**

FIGURE 1-1
 NEW BEDFORD HARBOR SUPERFUND SITE
 NEW BEDFORD, MASSACHUSETTS
SITE LOCATION MAP
 FOSTER WHEELER ENVIRONMENTAL CORPORATION
 TERC PROGRAM

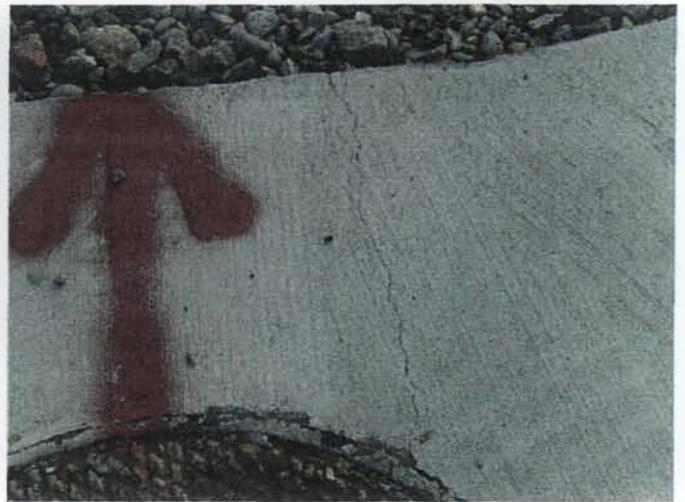
Photo # WS122402

Existing cracks in sidewalk/curb

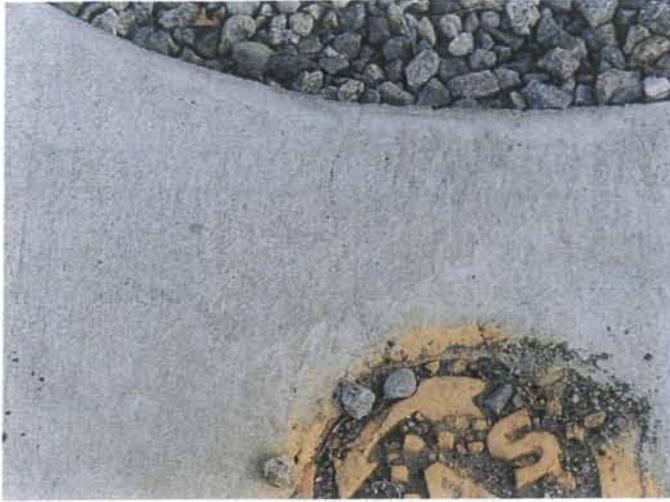
Existing cracks in sidewalk/curb
Photo # WS122403
12/24/02
JPK

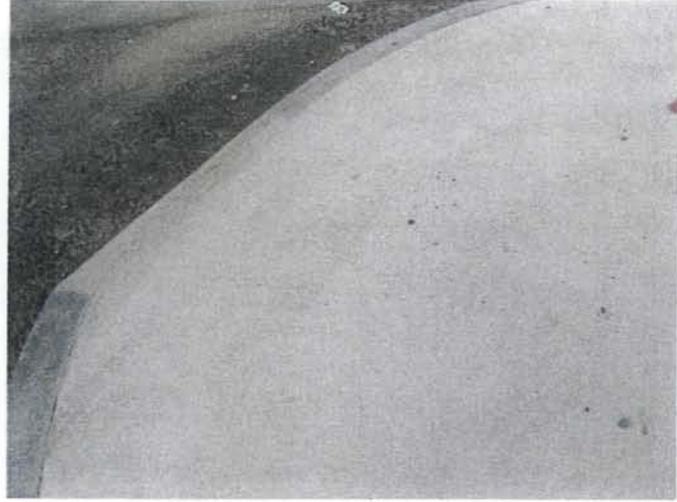
Existing cracks in sidewalk/curb
Photo # WS122404
12/24/02
JPK

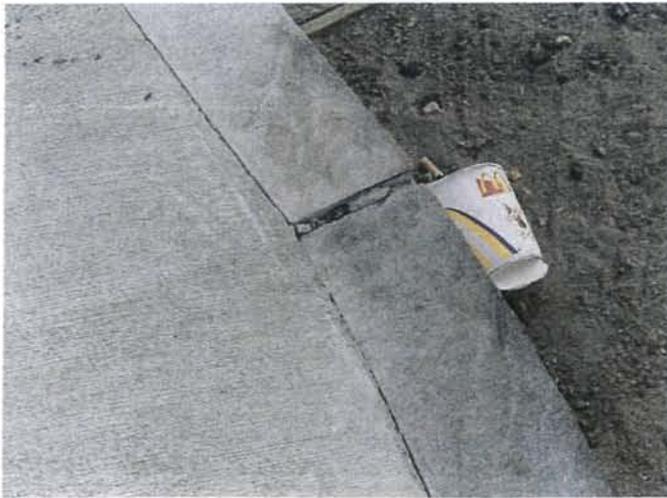
Existing cracks in sidewalk/curb
Photo # WS122405
12/24/02
JPK

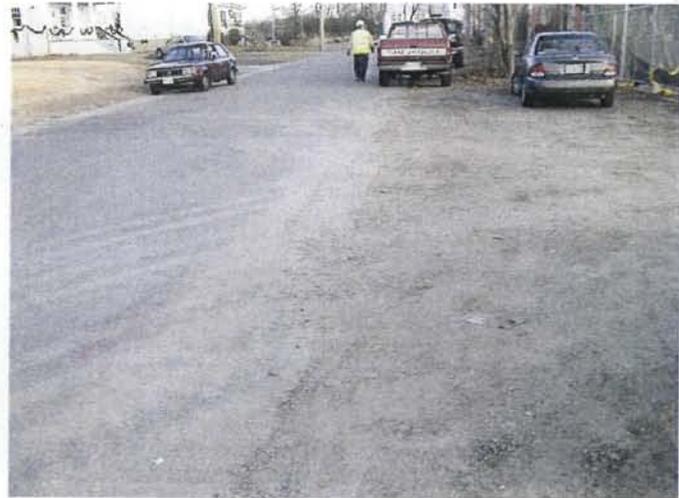
Conditions at substation access prior to construction traffic
Photo # WS122406
12/24/02
JPK

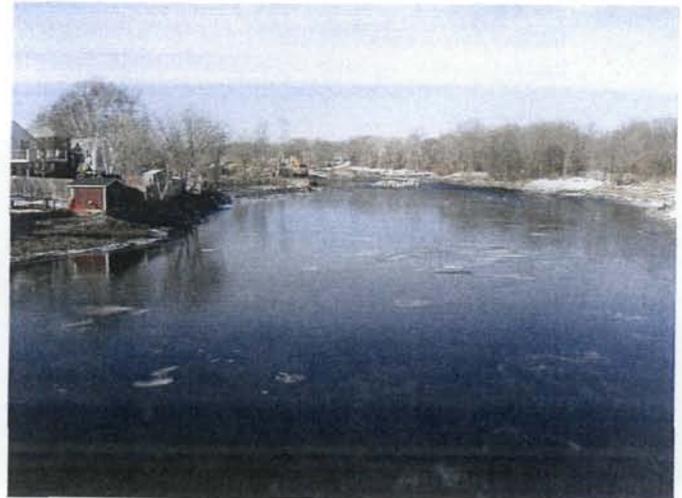
Photo # WS22501
2/25/03
JPK

Conditions after berms opened due to heavy rain

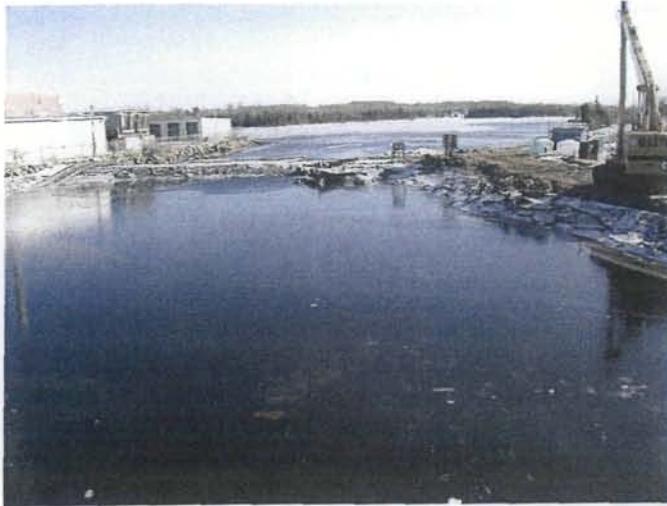
Conditions after berms opened due to heavy rain
Photo # WS22502
2/25/03
JPK

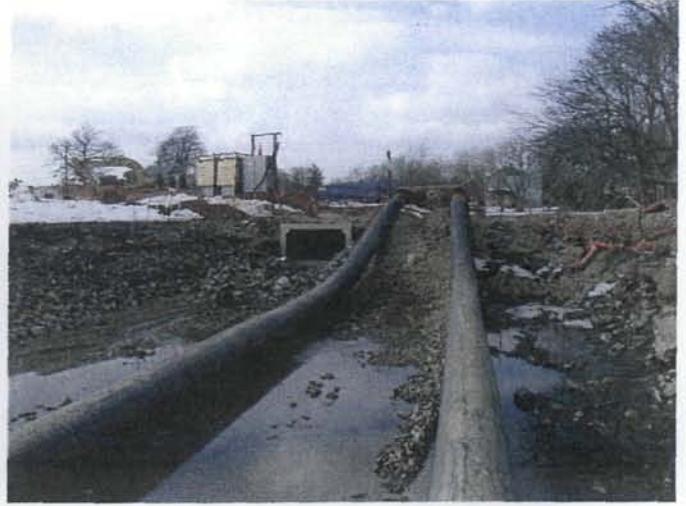
By-pass pumping system at North berm
Photo # WS30101
3/01/03
JPK

Due to high river flow rates in December 2002, the three 12-inch pumps at the North Berm were replaced with two 20-inch pumps providing a total pumping capacity of 40,000 gpm. The electrical power was upgraded to meet the power demands of the larger pumps.

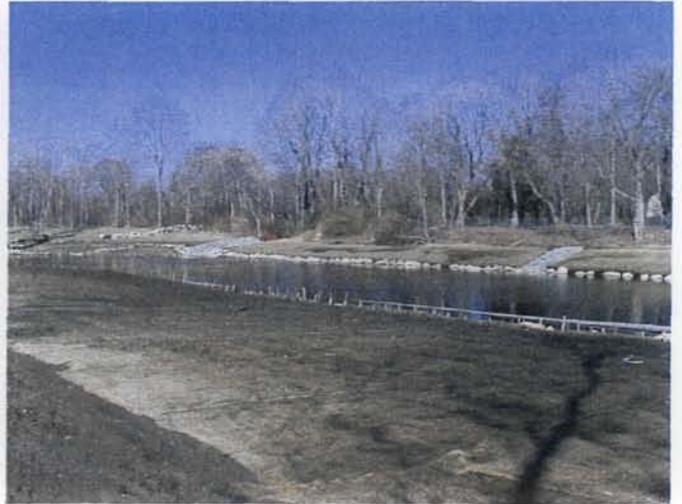
Photo # WS31903

Restored condition. Note: Water elevation = -0.5ft

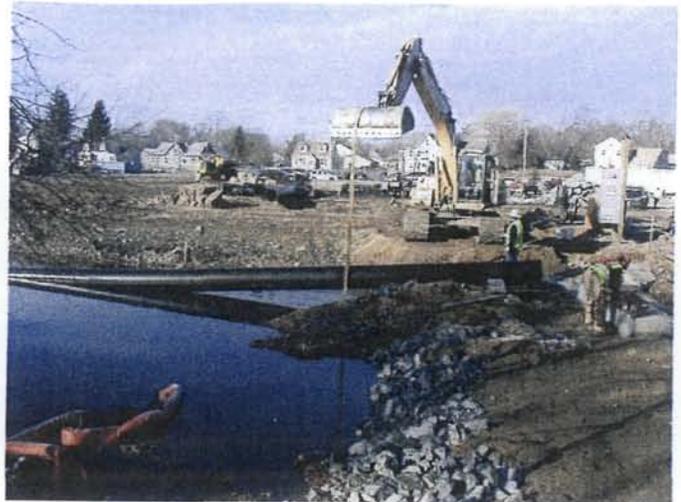
Removal of the by-pass piping from river
Photo # WS32005
3/20/03
JPK

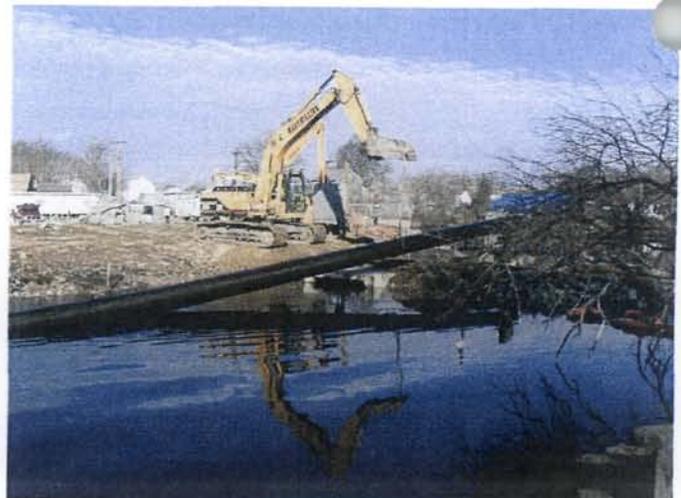
Removal of the by-pass piping from river
Photo # WS32007
3/20/03
JPK
