NEW BEDFORD MARINE
COMMERCE TERMINAL
FEDERAL RESOURCE
AREA ASSESSMENT

Re: Wetland Site Investigation –
Map 25A Parcels 48/49 & Map 31, Parcel 288
New Bedford, Massachusetts

USGS Map
 Wetland Report
 Land North of Gifford Street
 New Bedford, MA

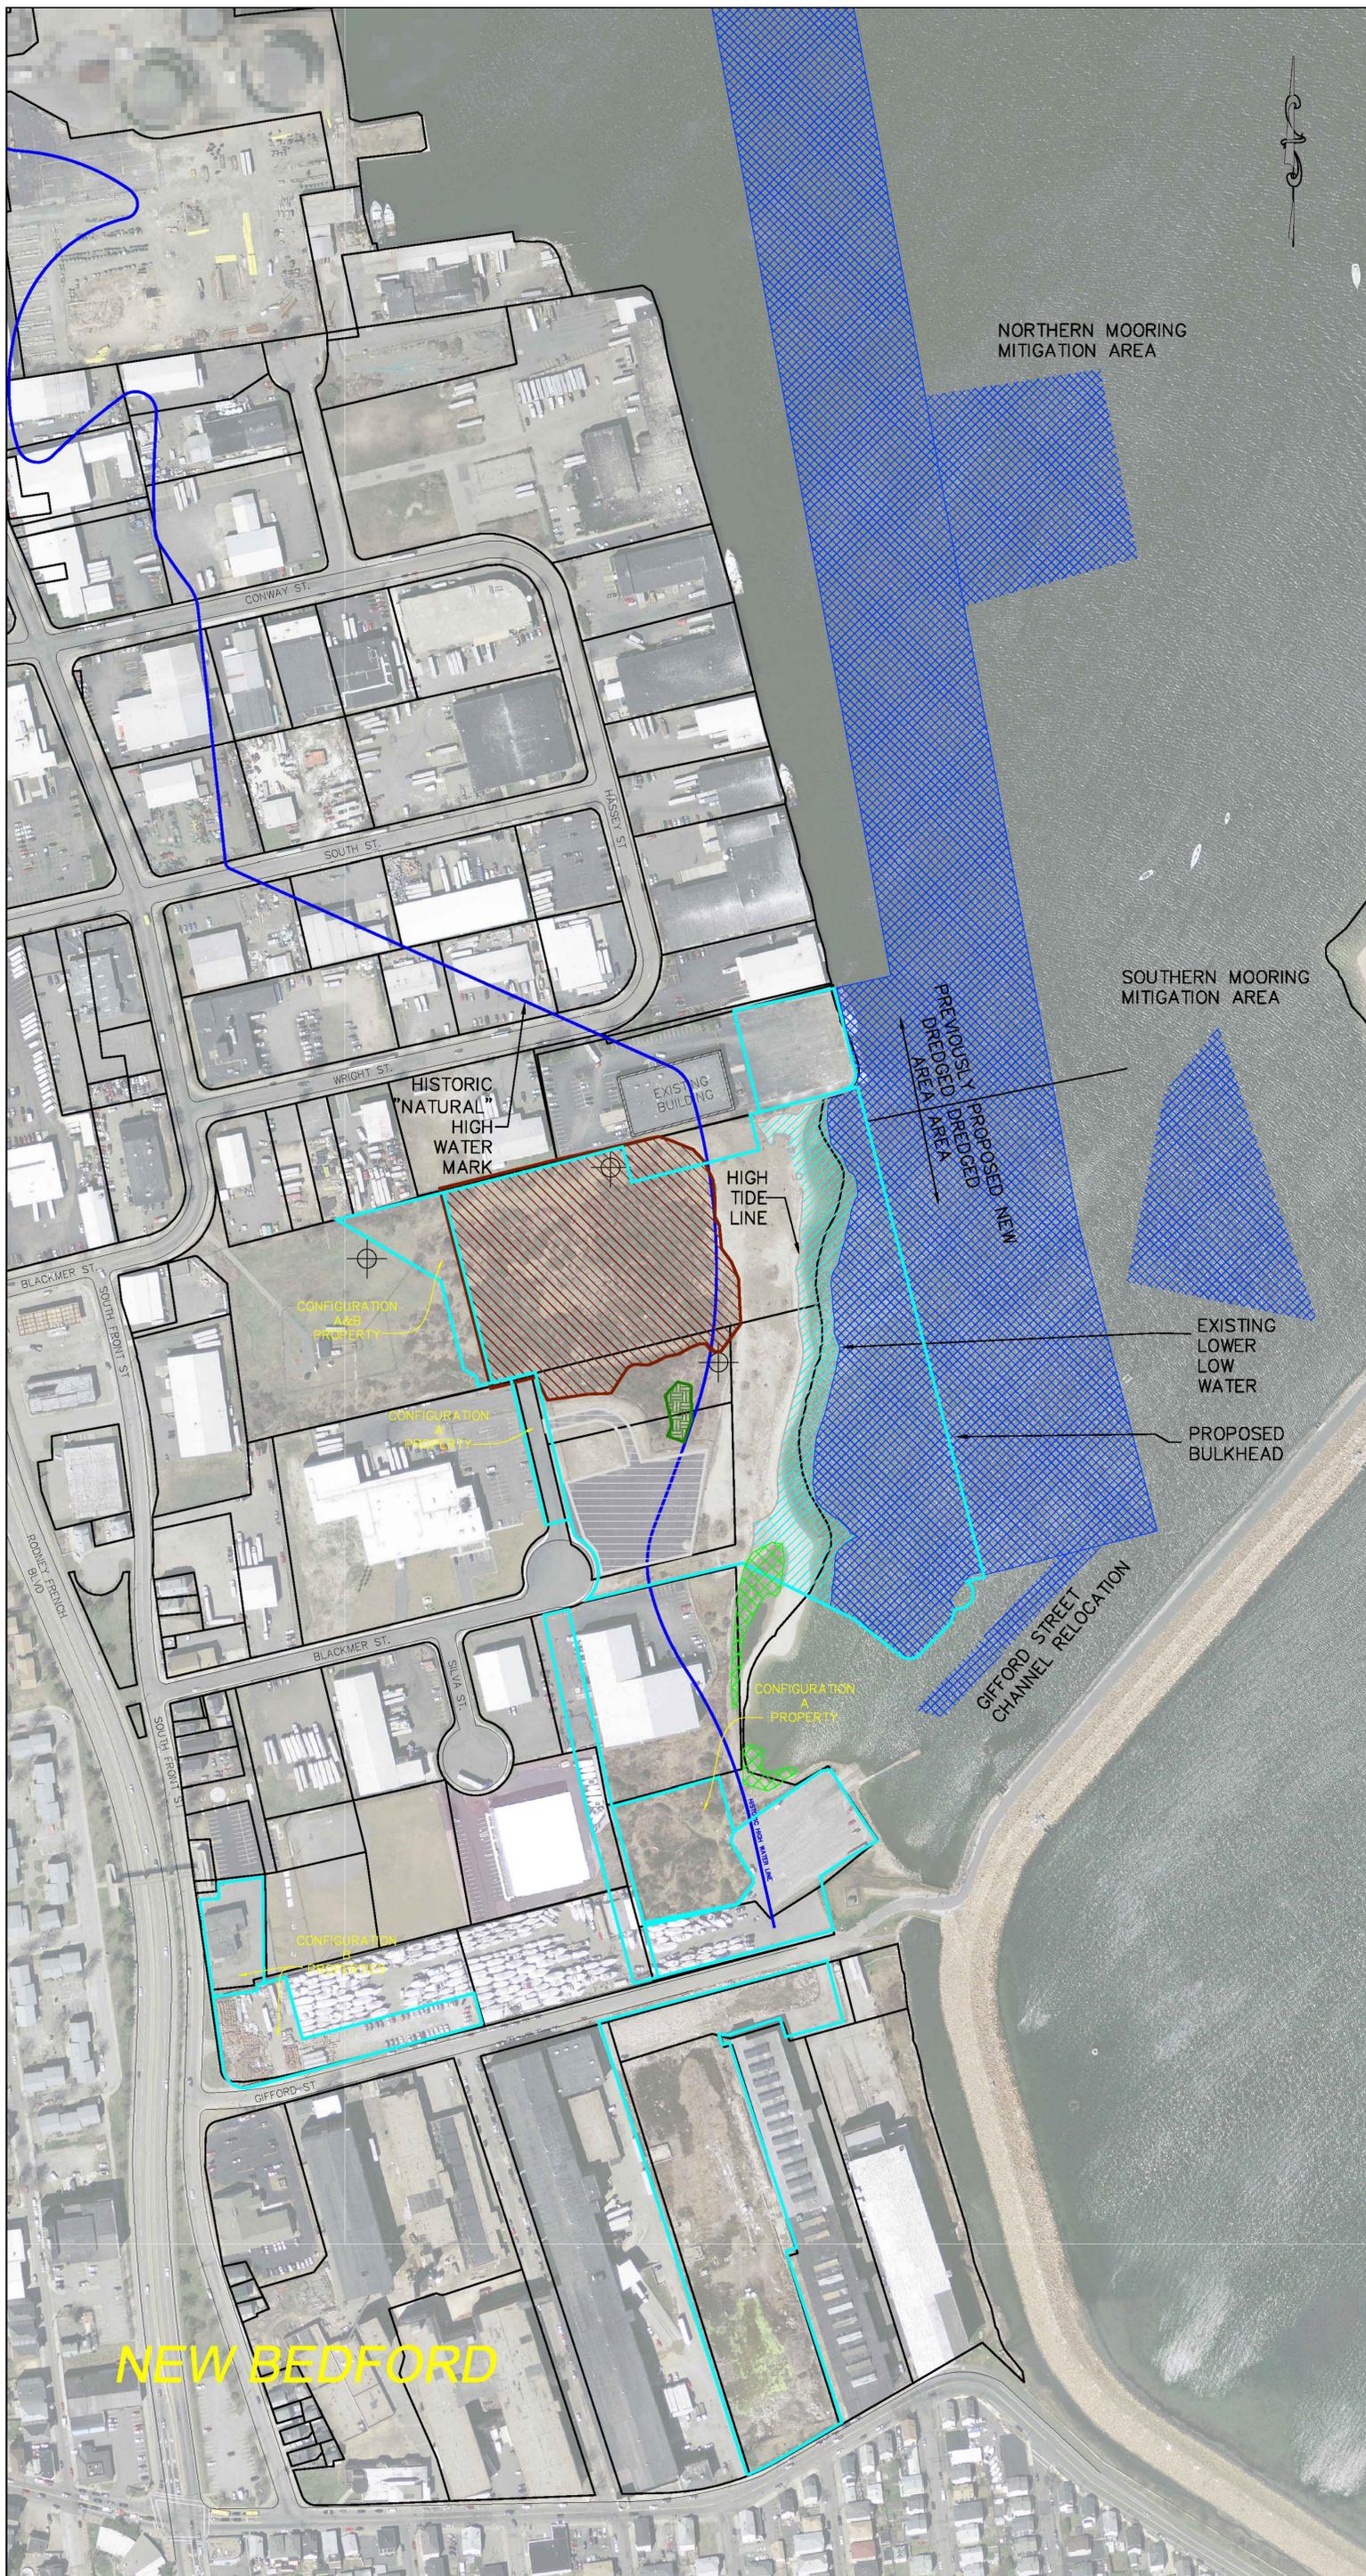
Date	3/24/10	Drawing No. FIG-5
Proj. Mgr.		
Design		
Check	CM	
Drawn	GCD	
Job. No.	6615	
Last Rev.	6/29/12

- PAVED CAP
- APPROXIMATE URBAN FILL
- ISOLATED WETLAND
- INTER-TIDAL
- SUB-TIDAL
- INTER-TIDAL SALT MARSH
- APEX TEST PIT
- PROPOSED FACILITY PARCEL

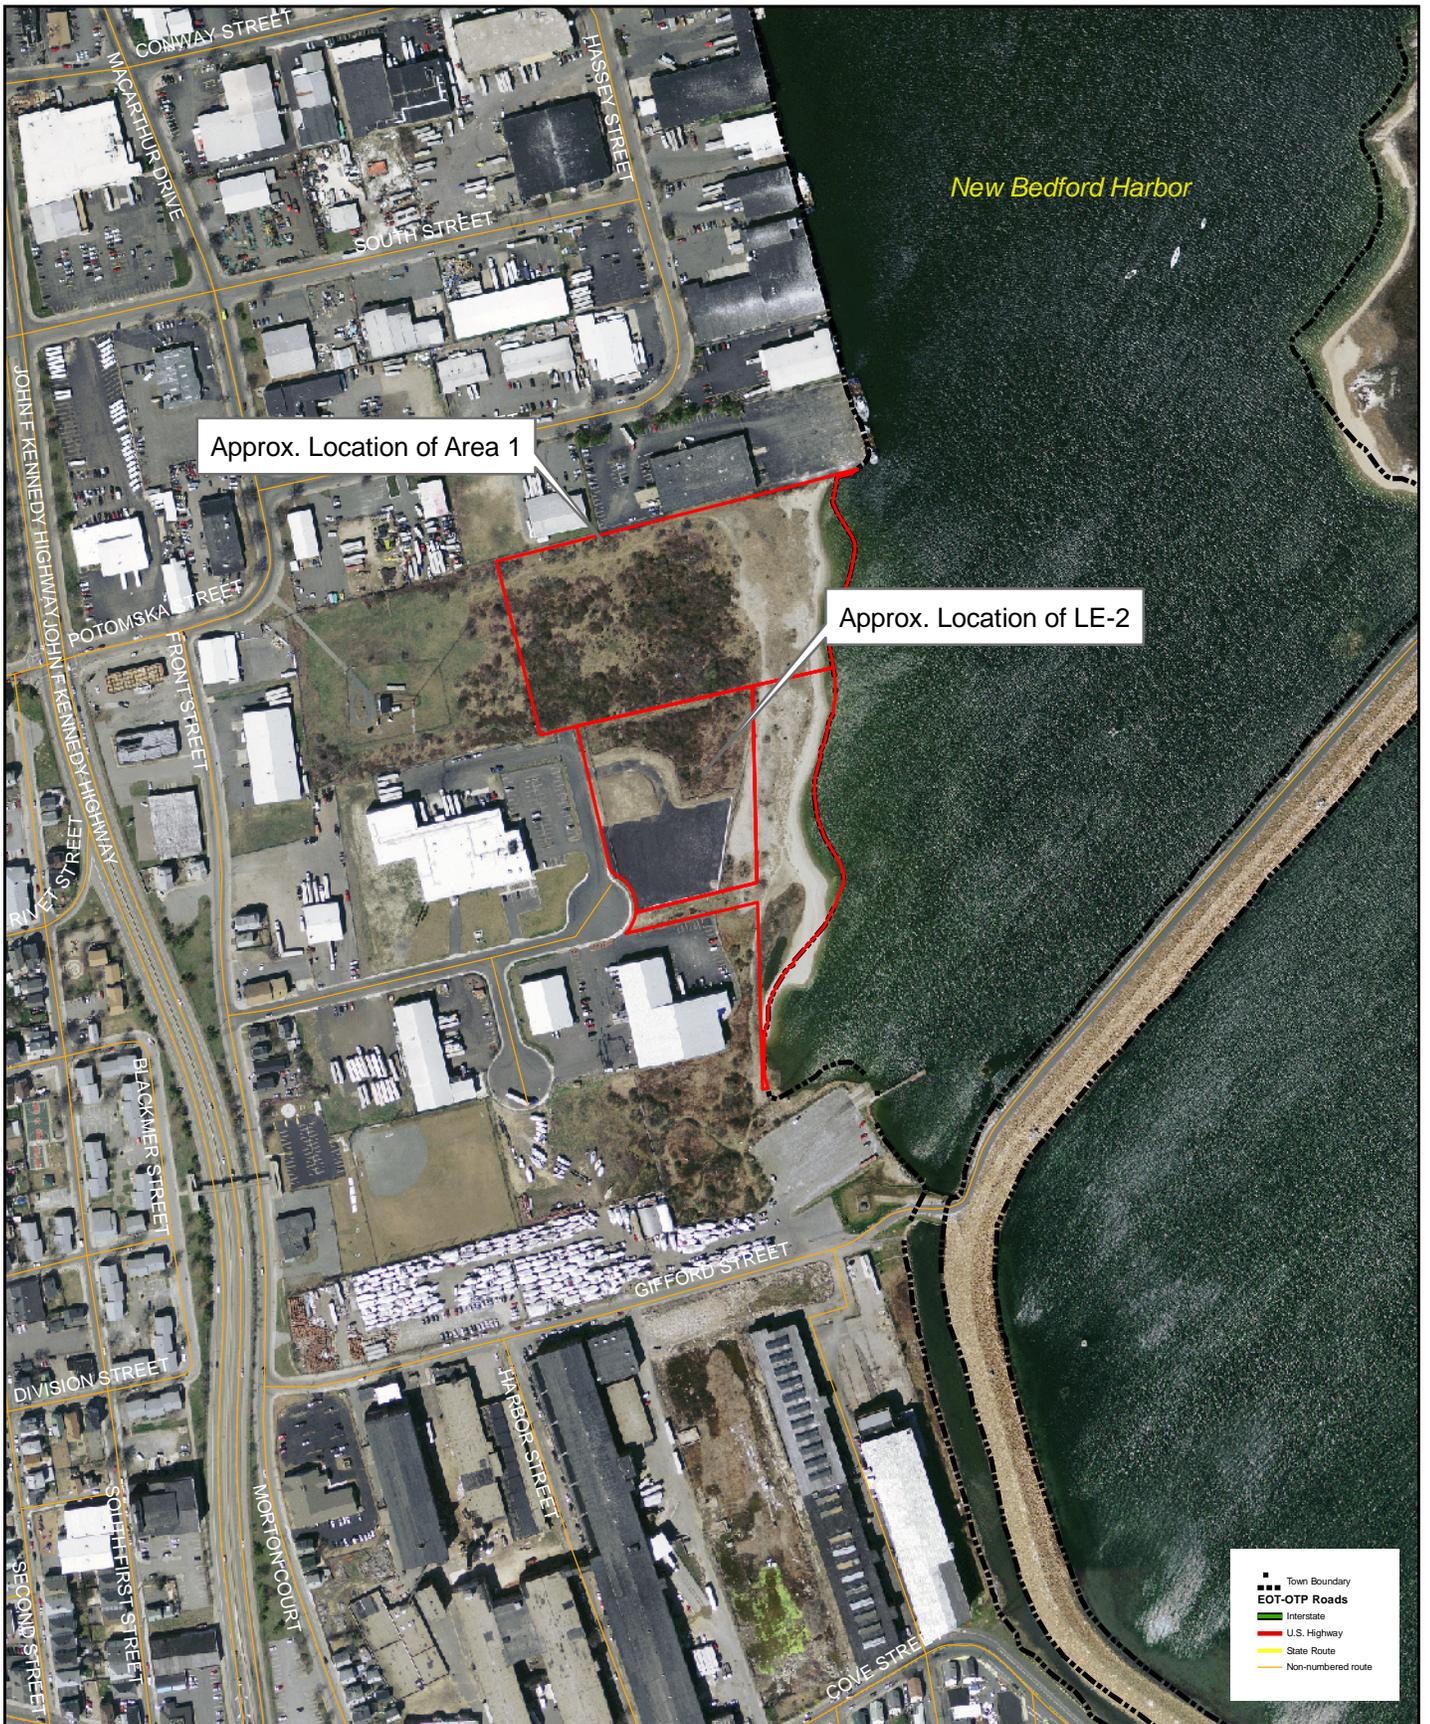
FIGURE 2
LUCAS ENVIRONMENTAL, LLC
 LAND DEVELOPMENT & PERMITTING

Aerial Map
Wetland Report
Land North of Gifford Street
New Bedford, MA

Collectively the properties are located along the western coastline of New Bedford Harbor, north of Gifford Street (See Figure 1 – USGS Map and Figure 2 – Aerial Map). The properties are currently undeveloped but show evidence of previous land use and development. Representative photographs of the site and surrounding areas have been included in this report.

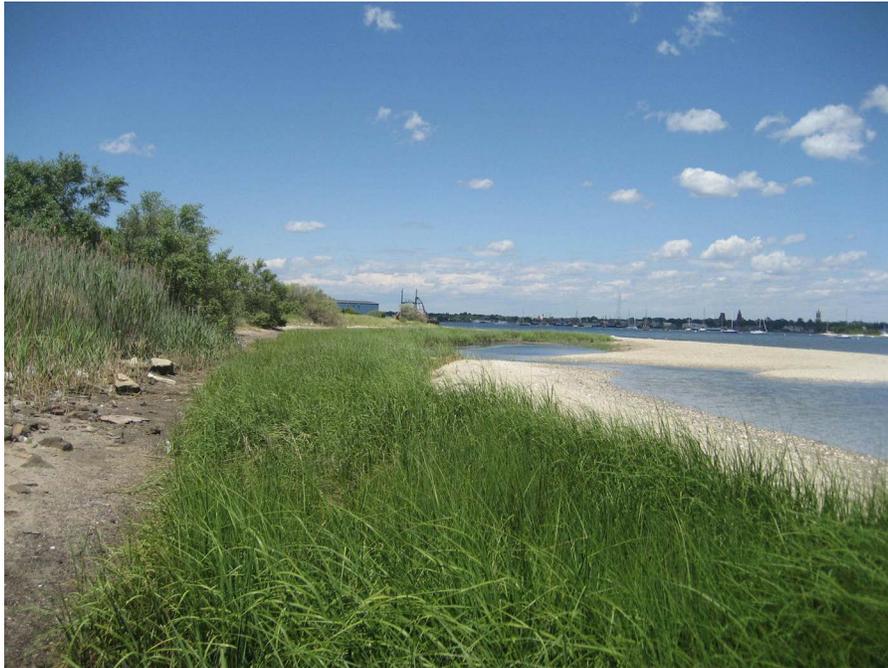
Photograph 1: View of Salt Marsh 1 looking north during high tide.

Salt Marsh 1 and 2 are two separate salt marshes located along the shoreline. Salt Marsh 1 was delineated using survey flagging numbered sequentially from SM 1-1 to SM 1-19 and Salt Marsh 2 was delineated sequentially SM 2-1 to SM 2-12. Both salt marsh areas are vegetated with salt marsh cord grass (*Spartina alterniflora*) and traces of glasswort (*Salicornia virginiana*).

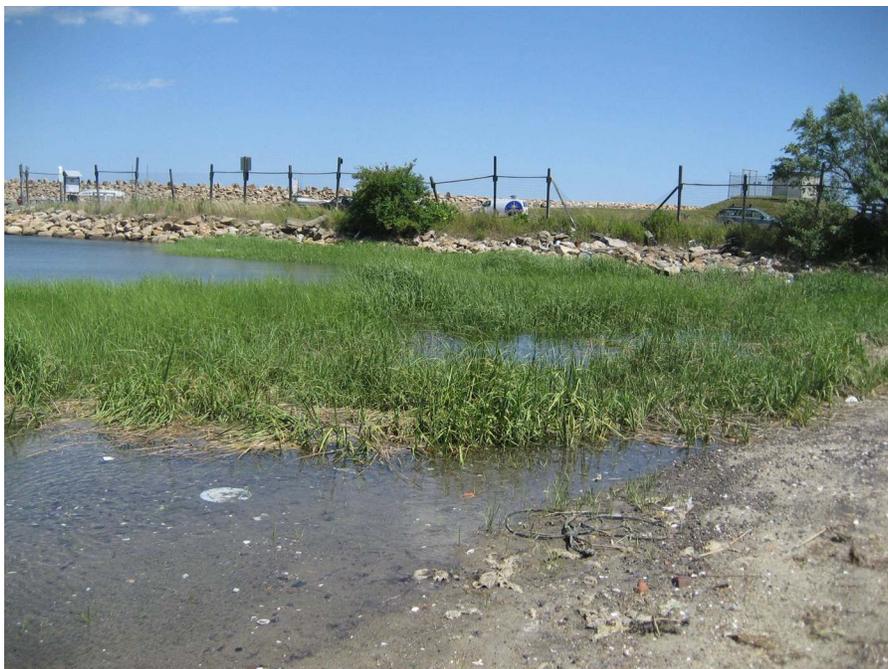
Photograph 2: View of Salt Marsh 2 north of parking lot looking south during high tide.

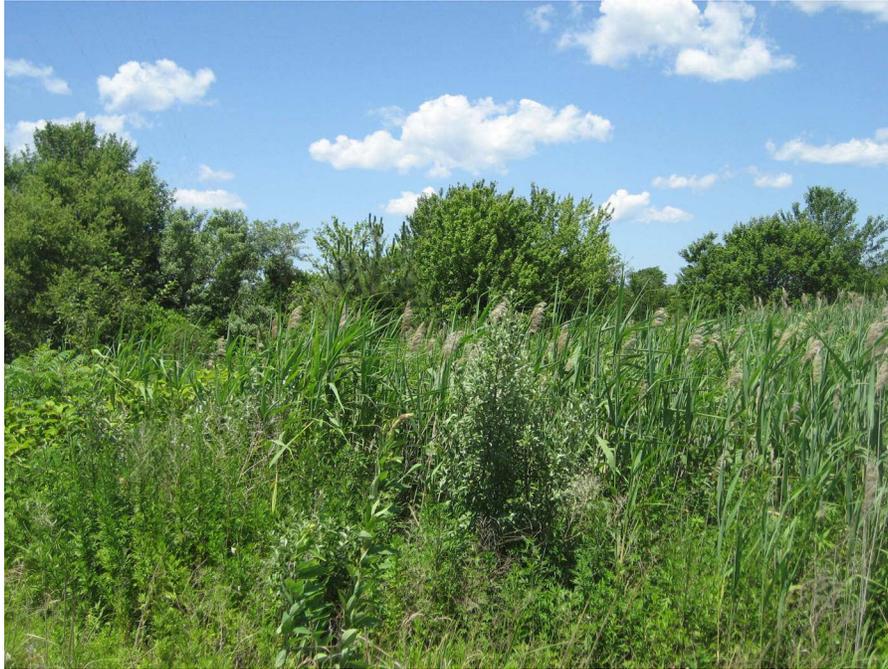
Photograph 3: Isolated Vegetated Wetland LE-2 on Parcel 49.

LE2 – is an isolated wetland located north of the existing paved area on Parcel 49. The wetland was delineated using survey flagging numbered sequentially from LE2-1 to LE2-12. The wetland area is a shallow depressional feature which has been highly disturbed and altered by previous land uses. Soils consist of disturbed urban fill with varying degrees of morphological development. The wetland is vegetated by a monoculture of common reed. The delineation of this wetland feature is limited to the areas where common reed and evidence of hydrology is present. There is a clear break in vegetation between the wetland and the upland field species staghorn sumac, oriental bittersweet, pitch pine, red cedar, multiflora rose, common milkweed, thistle, black swallow-wort, and goldenrod.

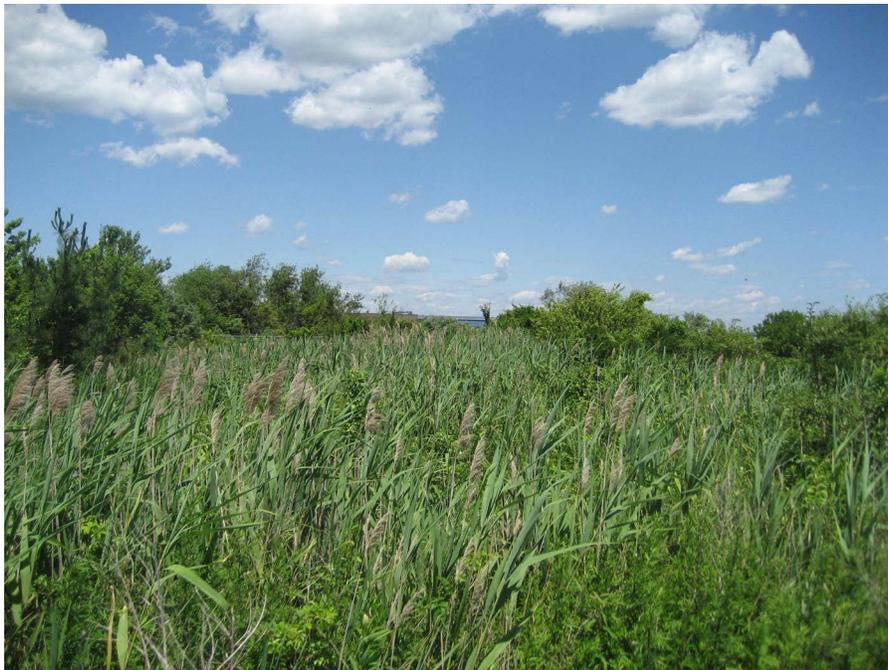
Photograph 4: Isolated Vegetated Wetland LE-2 on Parcel 49 looking north.

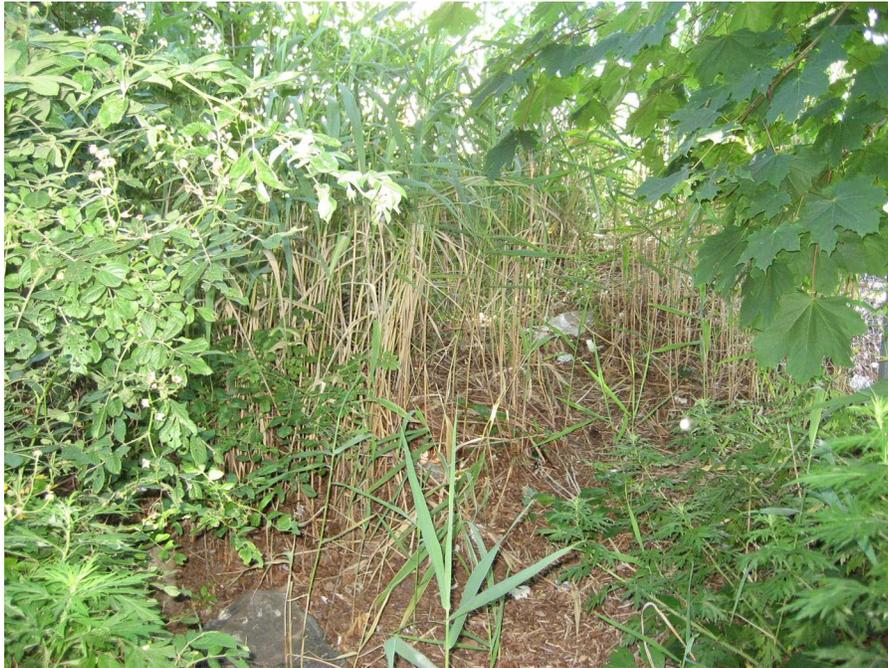
Photograph 5: View of first area near northern edge of Parcel 288. Area dominated by upland species common ragweed, multiflora rose, Norway maple, and autumn olive.

As stated above, the area identified as an isolated wetland along the northern limit of Parcel 288 was investigated to determine if it meets the federal definition of a wetland. Jurisdictional wetlands are defined by the 1987 Corps of Engineers Wetlands Delineation Manual as “those areas that are inundated or saturated by surface or ground water at a frequency and duration sufficient to support, and that under normal circumstances do support, a prevalence of vegetation typically adapted for life in saturated soil conditions”. The USACE Wetland Delineation Manual goes on to identify wetlands based on a three-factor approach involving indicators of hydrophytic vegetation, hydric soil, and wetland hydrology. Hydrophytic vegetation is present when the plant community is dominated (>50%) by species that can tolerate prolonged inundation or soil saturation during the growing season.

LE established a data plot at the center of the area and completed a Wetland Determination Field Form to document vegetation, soils and hydrology. The area lacks a predominance of hydrophytic vegetation and is dominated by species suited for upland conditions such as autumn olive, ragweed, Norway maple (*Acer platanoides*) and multiflora rose. There was no evidence of wetland hydrology in or near the area. The soil within this area lacked indicators of hydric soil, however they consist of urban fill which any lack morphological development. Since the soils are unreliable to indicate hydric conditions, vegetation and hydrology was used to make the final determination.

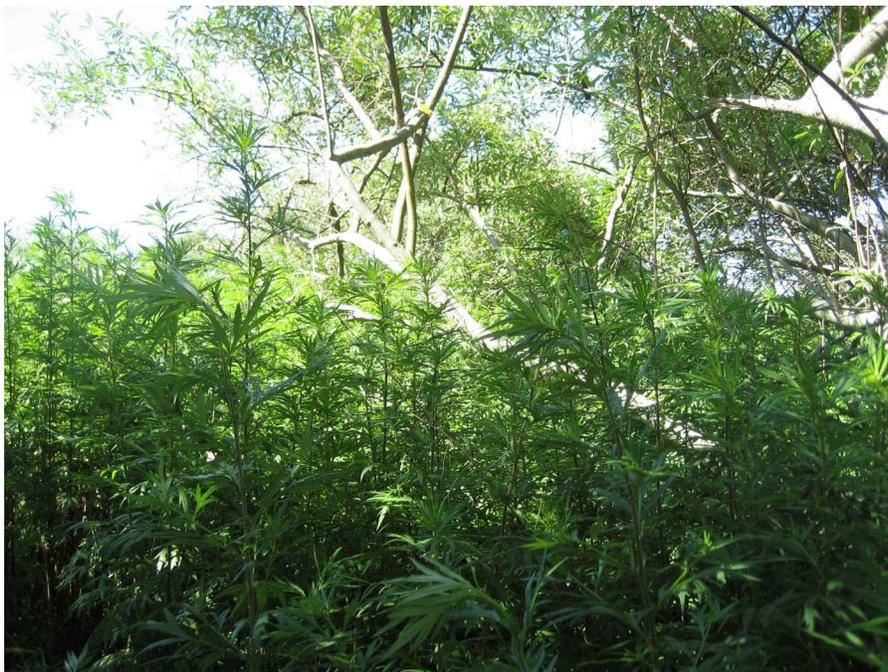
Photograph 6: View of first area near northern edge of Parcel 288.
