July 2, 2012

Re: Wetland Site Investigation –
Map 25A Parcel 48
New Bedford, Massachusetts

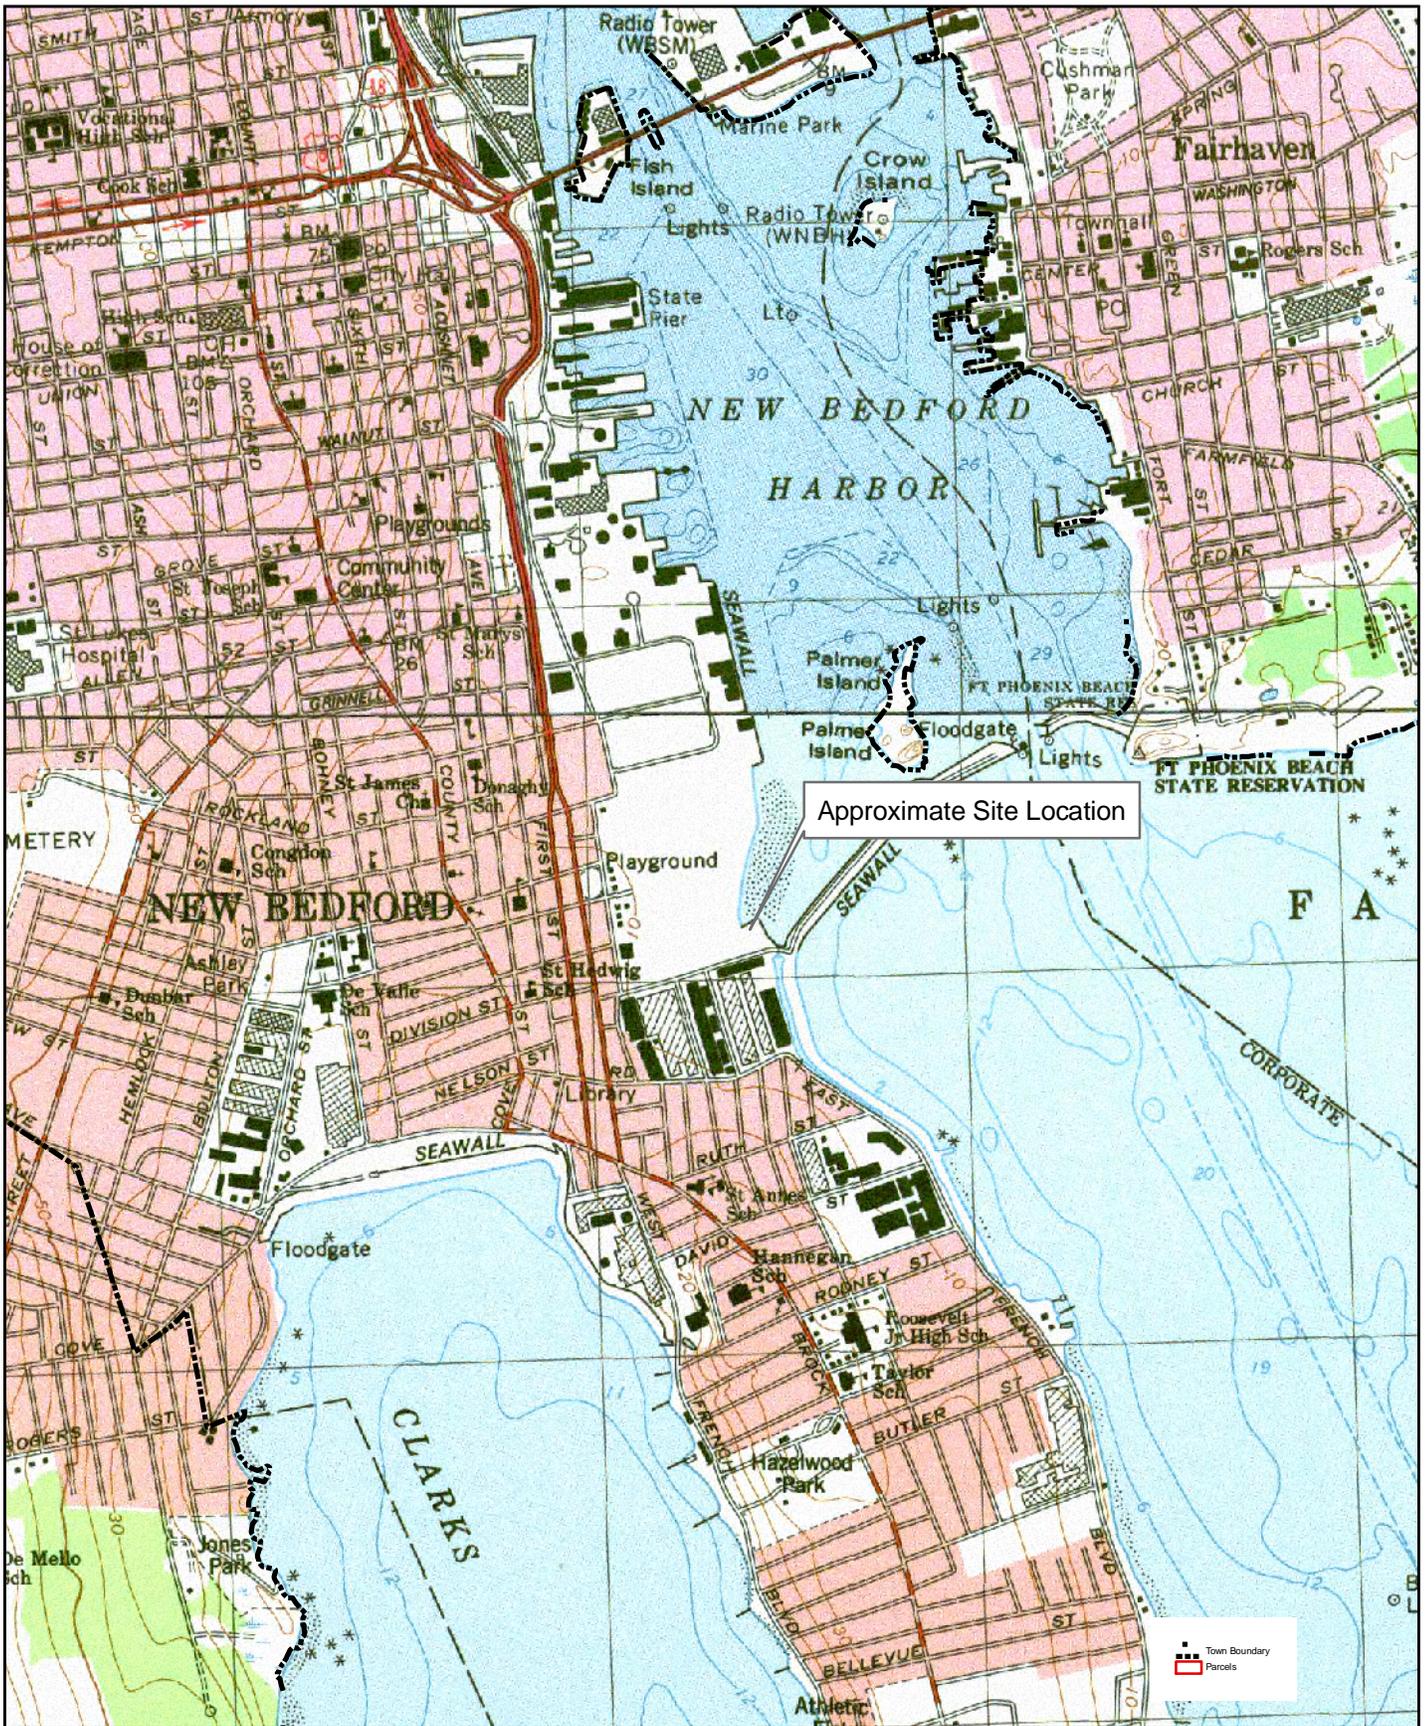
FIGURE 1
LUCAS ENVIRONMENTAL, LLC
 LAND DEVELOPMENT & PERMITTING

The property is located along the western coastline of New Bedford Harbor, north of Gifford Street (See Figure 1 – USGS Map and Figure 2 – Aerial Map). The property is currently undeveloped but shows evidence of previous land use and development. Representative photographs of the site and surrounding areas have been included in this report.

USGS Map
Wetland Report
Land North of Gifford Street
New Bedford, MA

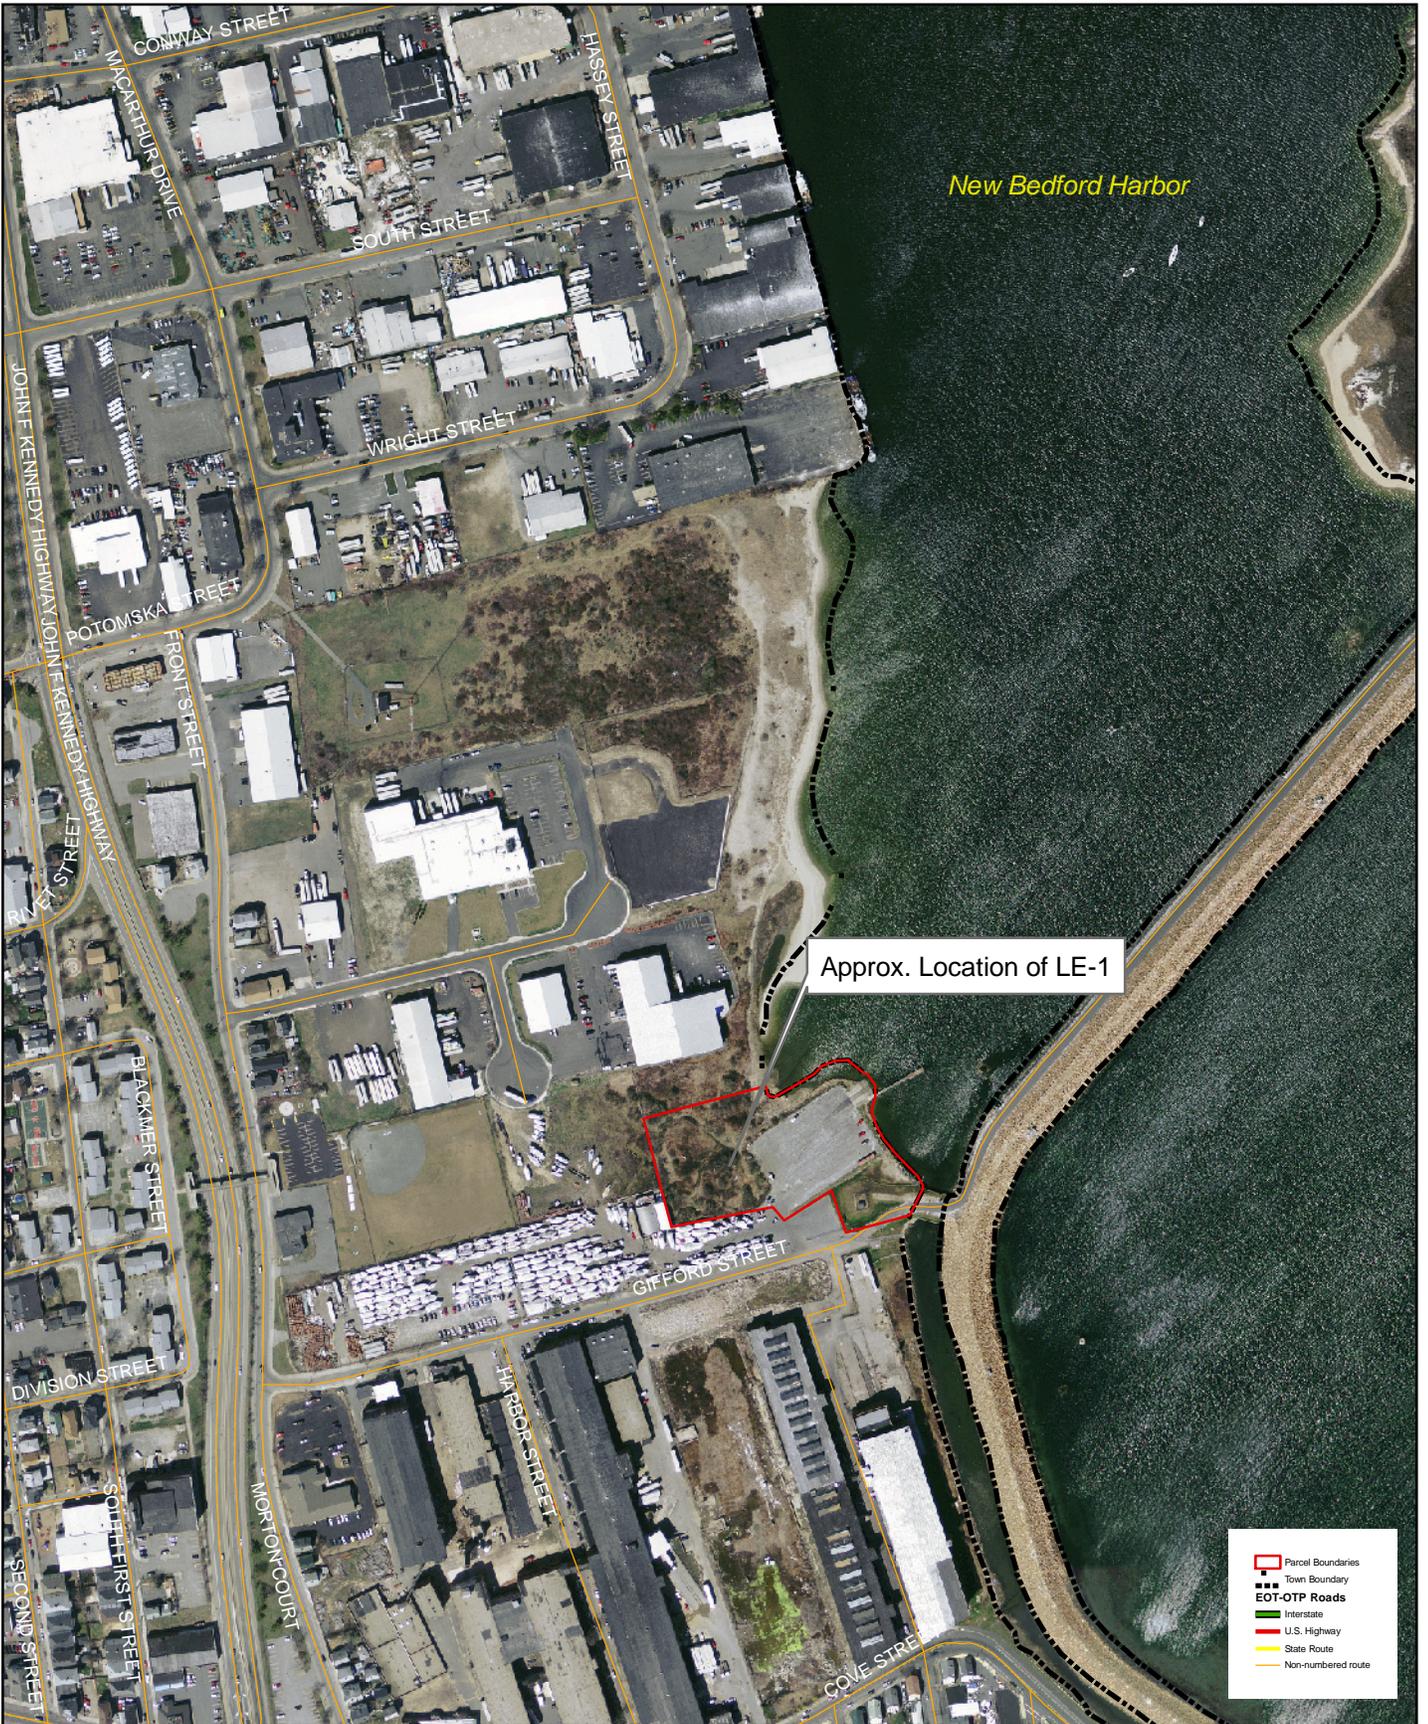
FIGURE 2

Aerial Map
Wetland Report
Land North of Gifford Street
New Bedford, MA

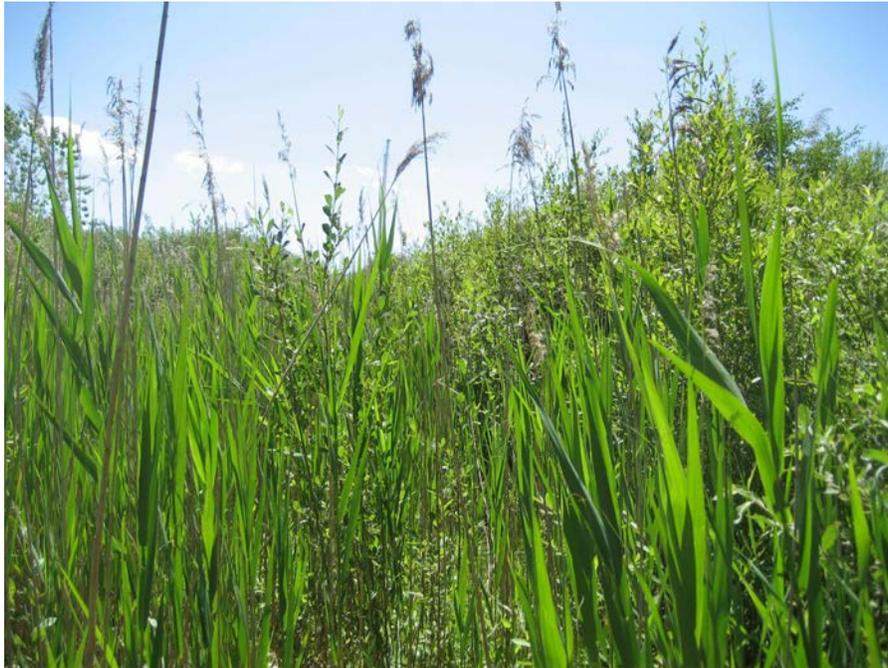
LE1 – is an isolated vegetated wetland located on Parcel 48 and was delineated using survey flagging numbered sequentially from LE1-1 to LE1-36. The area is highly disturbed and impacted from its

previous use as a racecourse but has since developed wetland conditions. The wetland is best characterized as a scrub shrub and emergent wetland vegetated with a dense mix of pussy willow (*Salix discolor*), common reed, soft rush (*Juncus effuses*), broom sedge (*Carex scoparia*), and fox sedge (*Carex vulpinoidea*). Soils within the wetland are highly disturbed and consist of compacted urban fill however redoximorphic features (concentrations and reductions) can be observed at or near the surface. There is no apparent hydrologic connection to another wetland. The upland fringe area is vegetated with a dense mix of autumn olive, Norway maple, quaking aspen and ragweed.

Photograph 1: Isolated Vegetated Wetland LE-1 on Parcel 48.

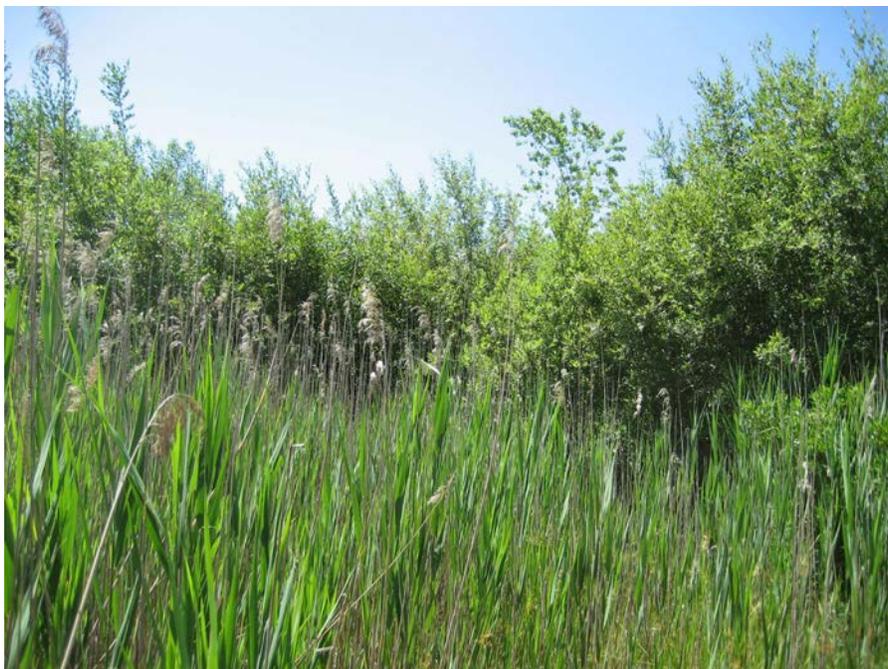
Photograph 2: View of Isolated Vegetated Wetland LE-1 – wetland dominated by willow and common reed.
