RE: Phase I Environmental Site Assessment
Town of Cumberland Tax Assessor's Map Plat 14, Lots 2 and 4 and Plat 15, Lot 1
Cumberland, Rhode Island

**Phase I Environmental Site Assessment
Plat 14 Lots 2 and 4, Plat 15 Lot 1
Berkeley Commons/River Run Development
Cumberland, Rhode Island**

June 2003
Version: FINAL
EA Project No. 61776.01.0001

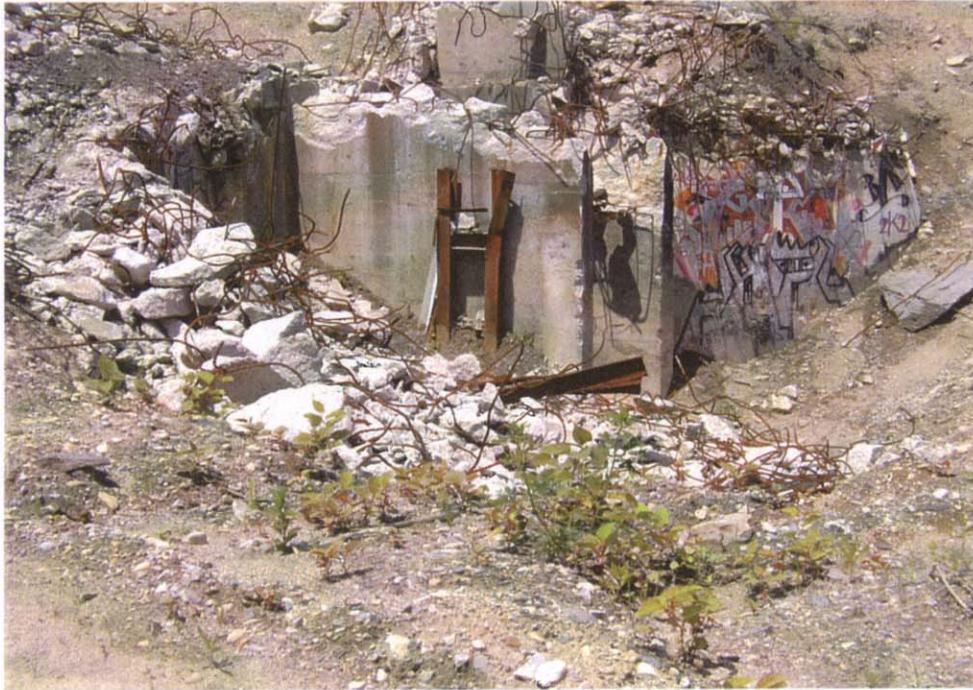
Photo 1: Remnants of the reinforced concrete material crusher foundation.

There are currently no buildings on the site. On the Plat 15 side of the development, site development was limited to a reinforced concrete base for the material crusher (Appendix A, Photo 1) and a scale house. On the Plat 14 side of the site, the Admiral Inn (since demolished) was located on the eastern site portion, abutting Mendon Road. This structure was not part of the sand and gravel operations, and the lot was transferred to the current site owner in 1993. Aerial photographs from 1939, 1951, 1965, 1972, 1972-1974, 1981, and 1992 all show no additional development on the site.

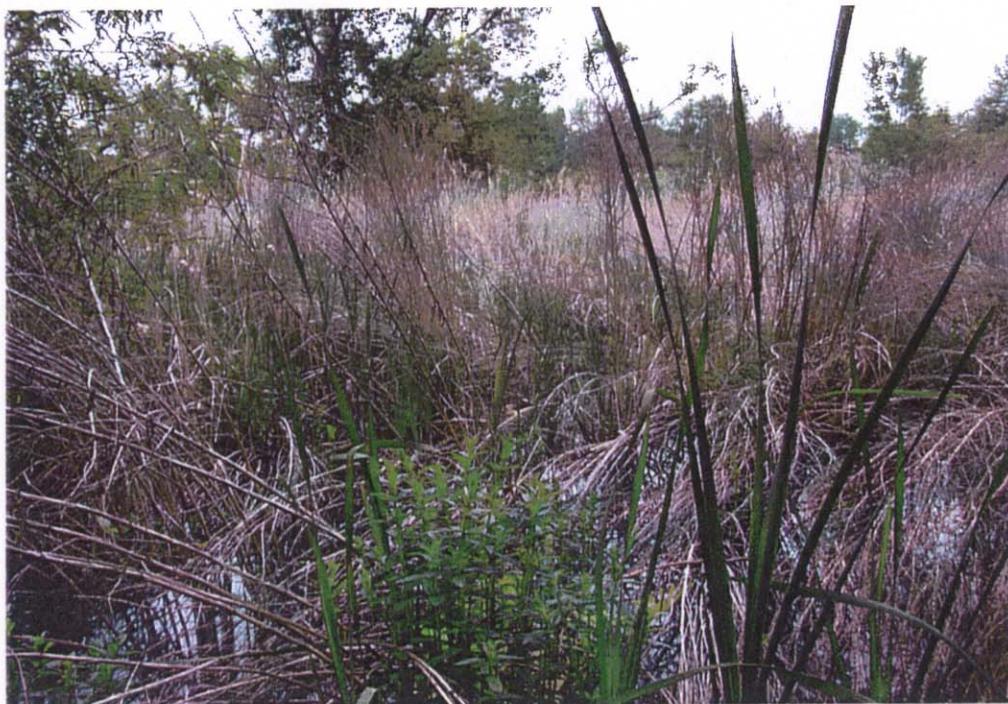
Photo 3: Vegetation in wetland south of the site.

The site is located in the Town of Cumberland, Providence County, Rhode Island. The site is located on locally variable terrain approximately 115 ft above mean sea level. According to the Federal Emergency Management Agency flood insurance rate map, the southern portion of the site is located within the 100-year flood zone. Drainage patterns in the area of the site are generally to the south and southwest, toward wetlands and New River. National Wetlands Inventory maps indicate wetlands on the site (Appendix A, Photo 3).

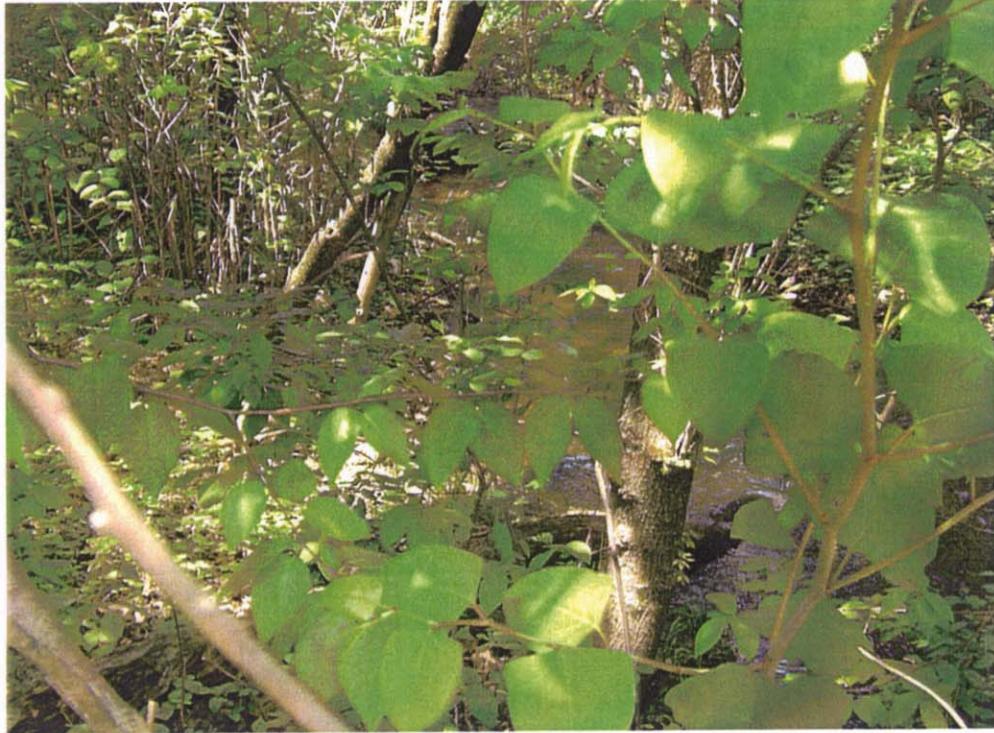
Photo 5: Monastery Brook just upstream of the culvert under the access road.

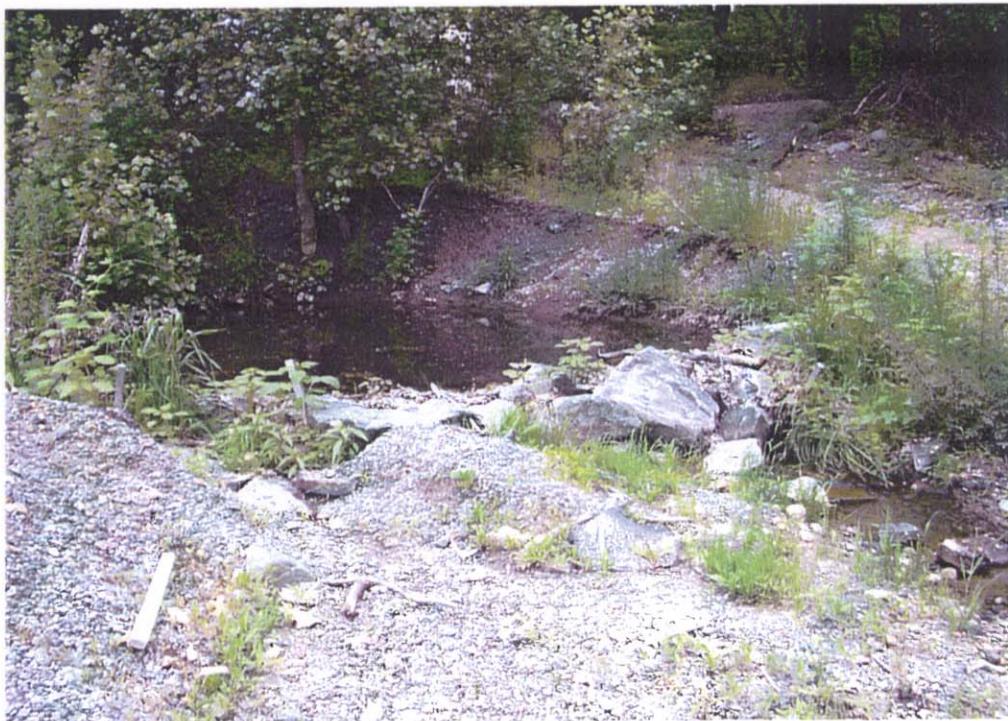
Photo 6: Retention pond for stormwater runoff from residential development to the north.

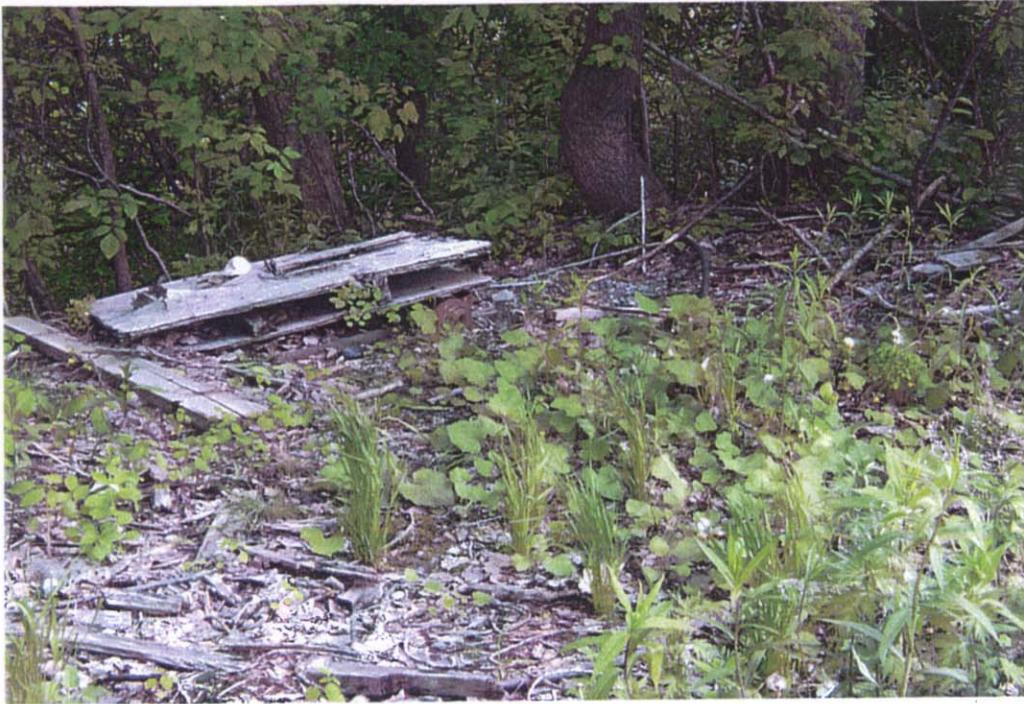
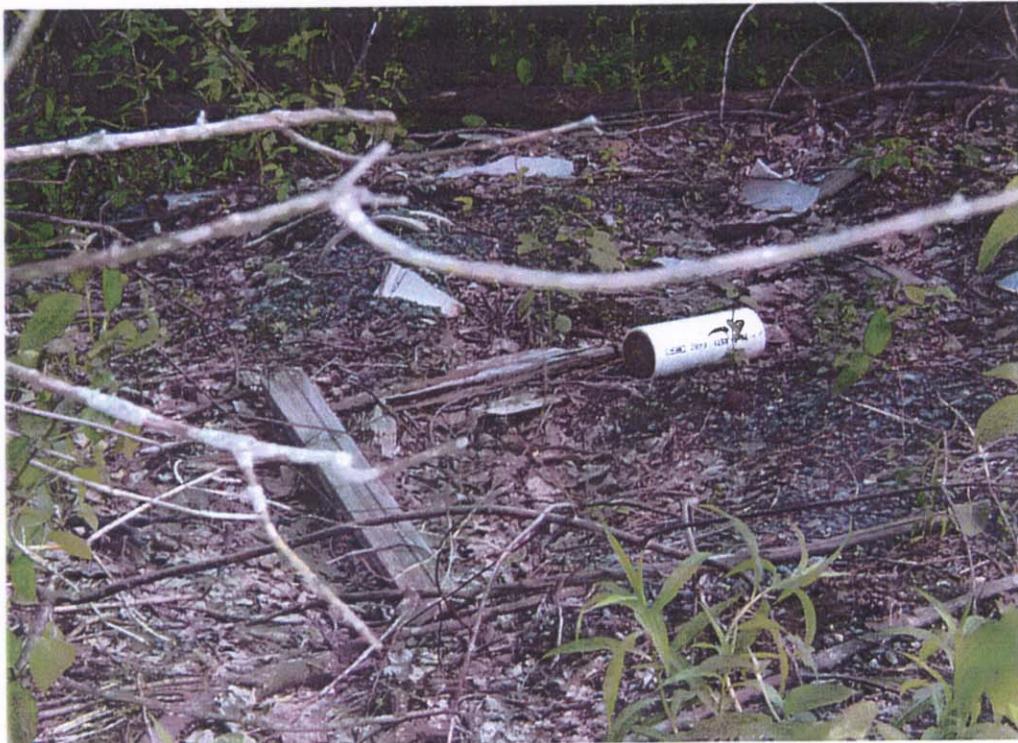
During the site inspection, isolated examples of small-scale solid waste dumping were observed at the site (Appendix A, Photos 7 and 8). No indication was found of environmental impacts from this non-hazardous waste disposal. The site representative indicated that this dumping was conducted without the knowledge or permission of the site owners.

Photos 7 and 8: Miscellaneous debris along southern edge of Plat 14.
