**RE: Remedial Action Construction Completion Report
Pine Street Canal Superfund Site, Burlington, Vermont**

REMEDIAL ACTION
CONSTRUCTION COMPLETION
REPORT

Pine Street Canal Superfund Site
Burlington, Vermont

The Johnson Company, Inc.
100 State Street, Suite 600
Montpelier, Vermont 05602

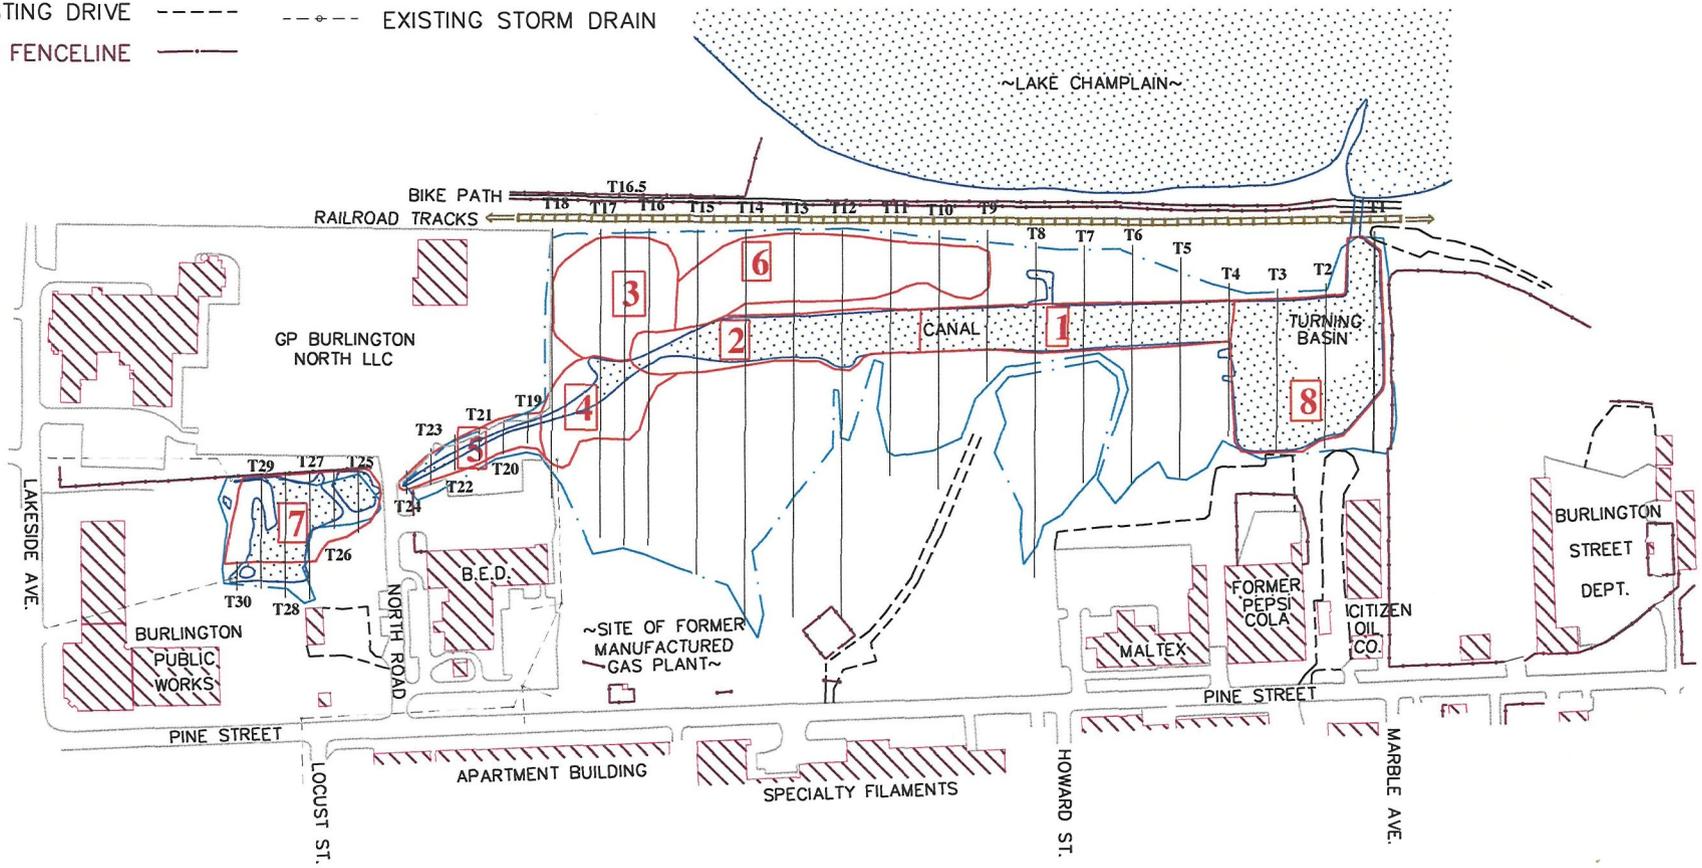
FIGURE 1
STUDY AREAS & TRANSECT LOCATIONS
PINE STREET CANAL SITE, BURLINGTON, VT

During the course of completing the remedial investigations and risk assessments, the Site was broken down into “study areas” with east-west transects every 100 feet for convenience. The transects, which run east-west, were originally established for the Additional Remedial Investigation on a 100-foot spacing, and are numbered from north to south starting with T1 and ending with T30. Locations between transects are connoted by the nearest transect to the north plus the distance from that transect. Positions along a transect are called transect nodes and are connoted by E (east) or W (west) followed by the number of feet from the west end of the transect. For example, T7+20E53 is a location 20 feet south of T7 and 53 feet east of the west

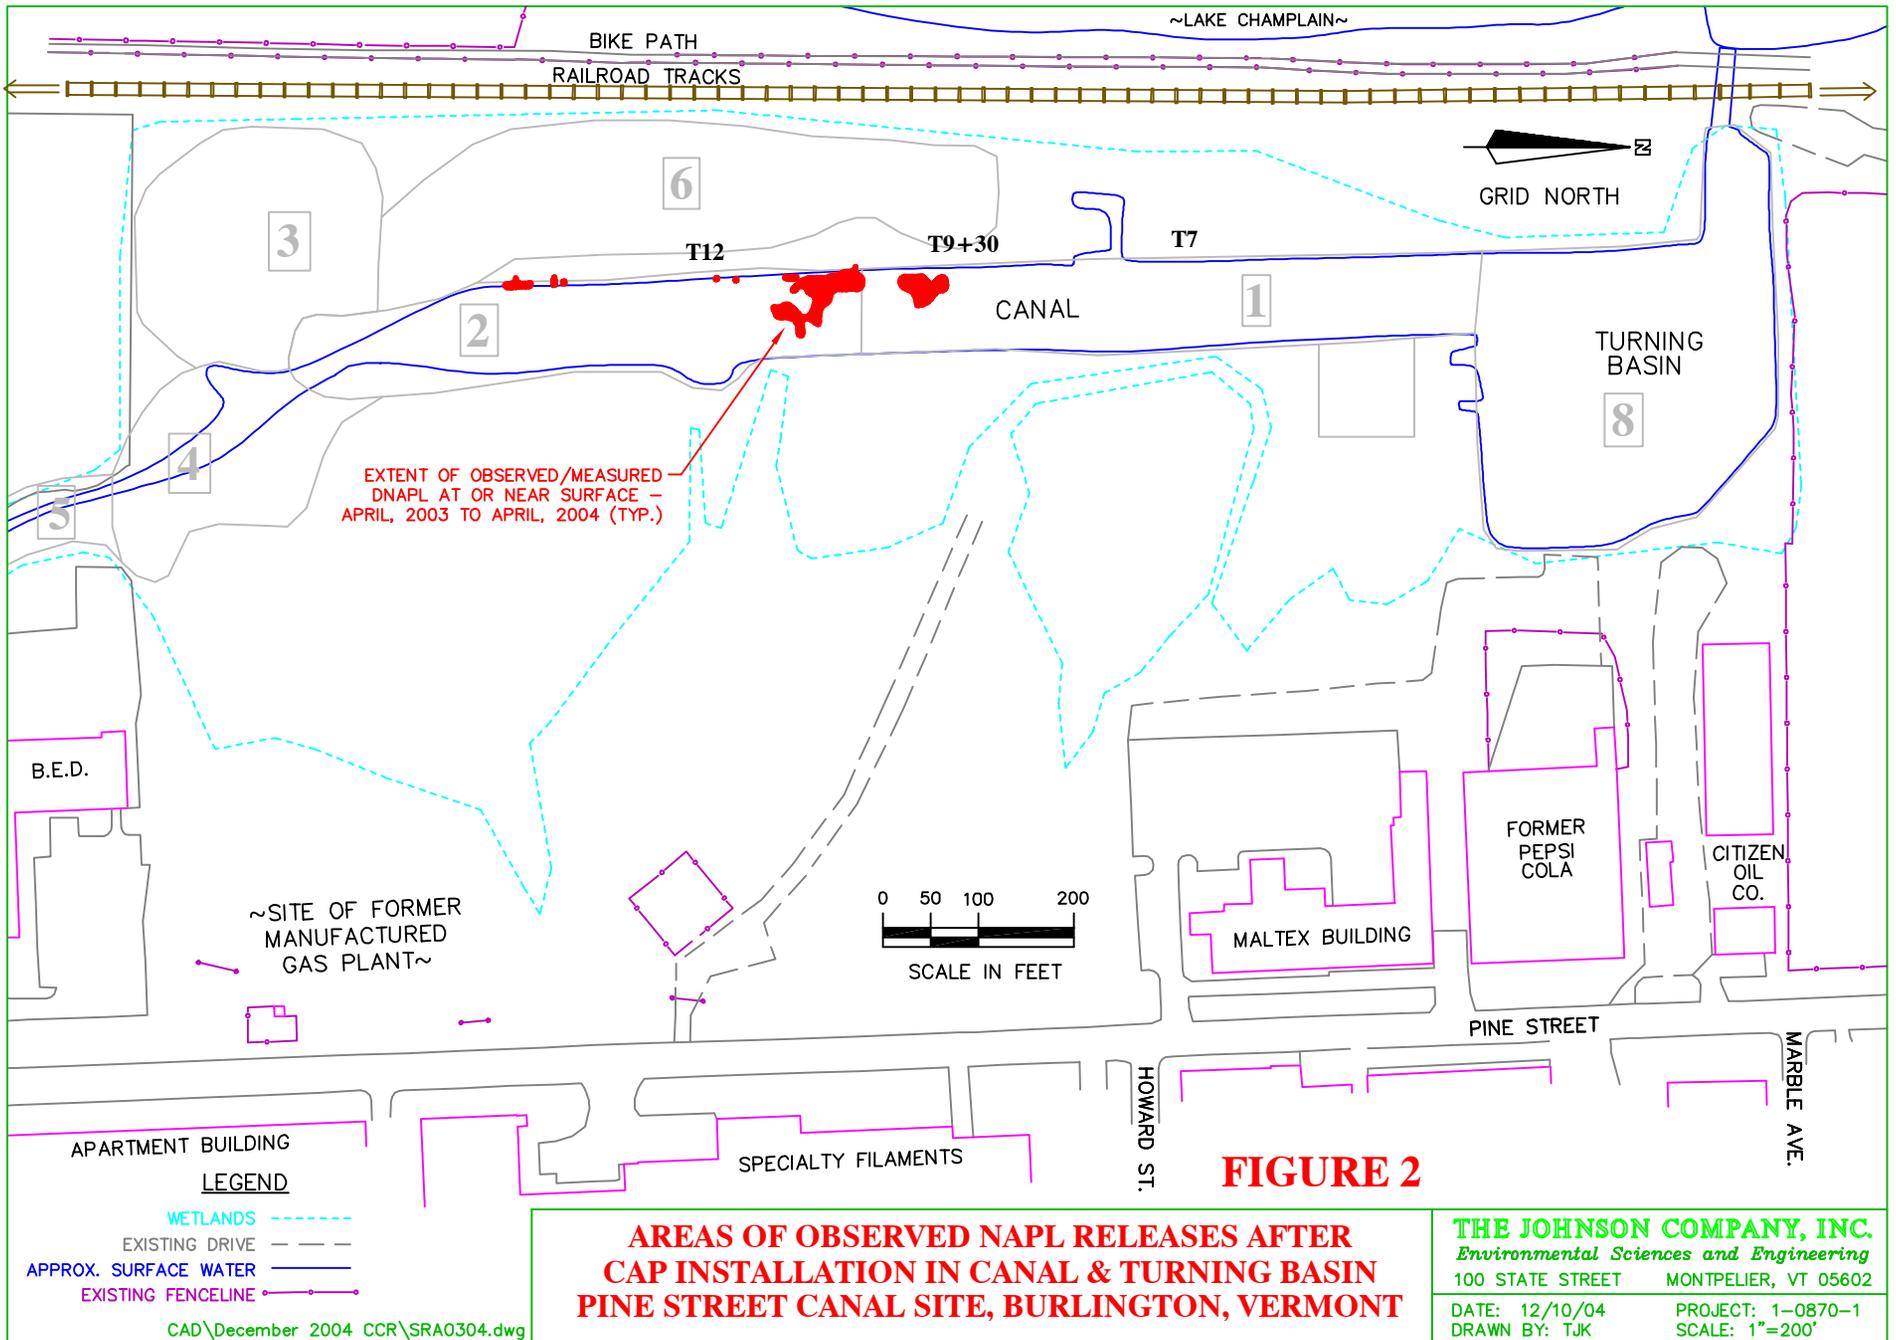
FIGURE 2

All areas where NAPL was observed in the shallow (less than 2 fbs) soils, at the ground surface, or in measurable thickness on the Canal cap surface are shown on Figure 2.

**AREAS OF OBSERVED NAPL RELEASES AFTER
CAP INSTALLATION IN CANAL & TURNING BASIN
PINE STREET CANAL SITE, BURLINGTON, VERMONT**

Following completion of the Canal Cap in March 2003, during a site visit on April 28, 2003, a seep of light non-aqueous phase liquid, or LNAPL (i.e., sheens and small black globules floating on the water surface) was observed in the Canal associated with gas bubbles and located just west of the western cribbing (beyond the edge of the cap) at approximately Transect T10+50. The frequency of visual monitoring was increased, and additional similar LNAPL and bubble release locations were observed along the western cribbing between transects T11+20 and T9+75, and near the center of the Canal between approximately Transects T10+50 and T11+30, during the summer of 2003. Sorbents, booms, and sweeps were installed to contain the NAPL, and weekly removal of accumulated sheens and LNAPL was performed during the summer and autumn 2003.

In August, 2003, another NAPL release area was observed during a site walkover. This release area was located west and adjacent to the western edge of the Canal from Transects T13+98 to T14+10, and five to ten feet west of the west cribbing. This area consisted of four ponded, locally low areas (one to two feet below the surrounding ground surface) west of the berm placed over the cribbing in that area. The four ponded areas, which were all isolated from surface water in the Canal and in Area 6 to the west, ranged from less than one square foot to about 15 square feet in size and contained DNAPL, water and LNAPL. On August 20 approximately 105 gallons of NAPL was bailed from the deepest pool (at T14+05, 5' west of the cribbing) and placed into two drums. Observations of the liquid levels in the four pools during bailing indicated that they were interconnected via macropores. While bailing out the NAPL from the largest pool, the NAPL levels dropped in all of the other pools. It appears that the macropores were related to an old tree stump in the immediate vicinity which had rotted in place.

DNAPL was observed in the top inch or two of five of the 28 cap sand cores. These five cores were collected along the west bank generally between Transects T10+00 and T11+00, and in the two cores near the center of the Canal circa T11+00. No NAPL was present in the lower portions of the cores. The cores indicated that DNAPL was present on the cap surface in local areas in portions of the center of the Canal and along the western bank at thicknesses up to 0.1 foot. The DNAPL probing indicated that the DNAPL pools on the cap surface near the center of the Canal were local in extent, being generally less than four feet in diameter, and were located in local low depressions in the cap surface. Probing near the west bank at Transects T10+00 and T11+00 indicated that the DNAPL was present on the cap surface from between eight and 16 feet from the Canal cribbing.

In November 2003, the cap surface in the Canal was again probed for the presence of DNAPL, and underwater videos were recorded showing methane gas vents, DNAPL, and the cap surface in general. Methane gas vents were observed at several locations. In many instances the gas vents were not associated with observations of DNAPL on the cap surface. In other cases, small globules of DNAPL were observed lying on the cap surface in close proximity to the vents. In some low areas of the cap surface, contiguous pools of DNAPL up to one foot thick were observed on the cap surface. Additional probing and monitoring of the extent and thickness of DNAPL on the cap surface was performed in January and April of 2004. No increase in thickness or areal extent of the DNAPL was observed when compared to the November 2003 results.

During construction of the West Bank Cap on June 21, 2004, DNAPL globules were observed on the subaqueous cap adjacent to the construction. These small globules appeared to have been expelled from the Canal cribbing near Transect T10+70. There was 2-3 inches of sand over the cribbing at the time, with active cap placement occurring in the vicinity using tracked skid-steer loaders. The DNAPL globules would appear on the cap surface, and then detach and roll downhill to lower areas of the cap in the Canal. There was no visible residue left by the DNAPL in or on the sand cap. The rate of formation of these globules decreased and finally stopped a few hours after the disturbance from construction ceased.

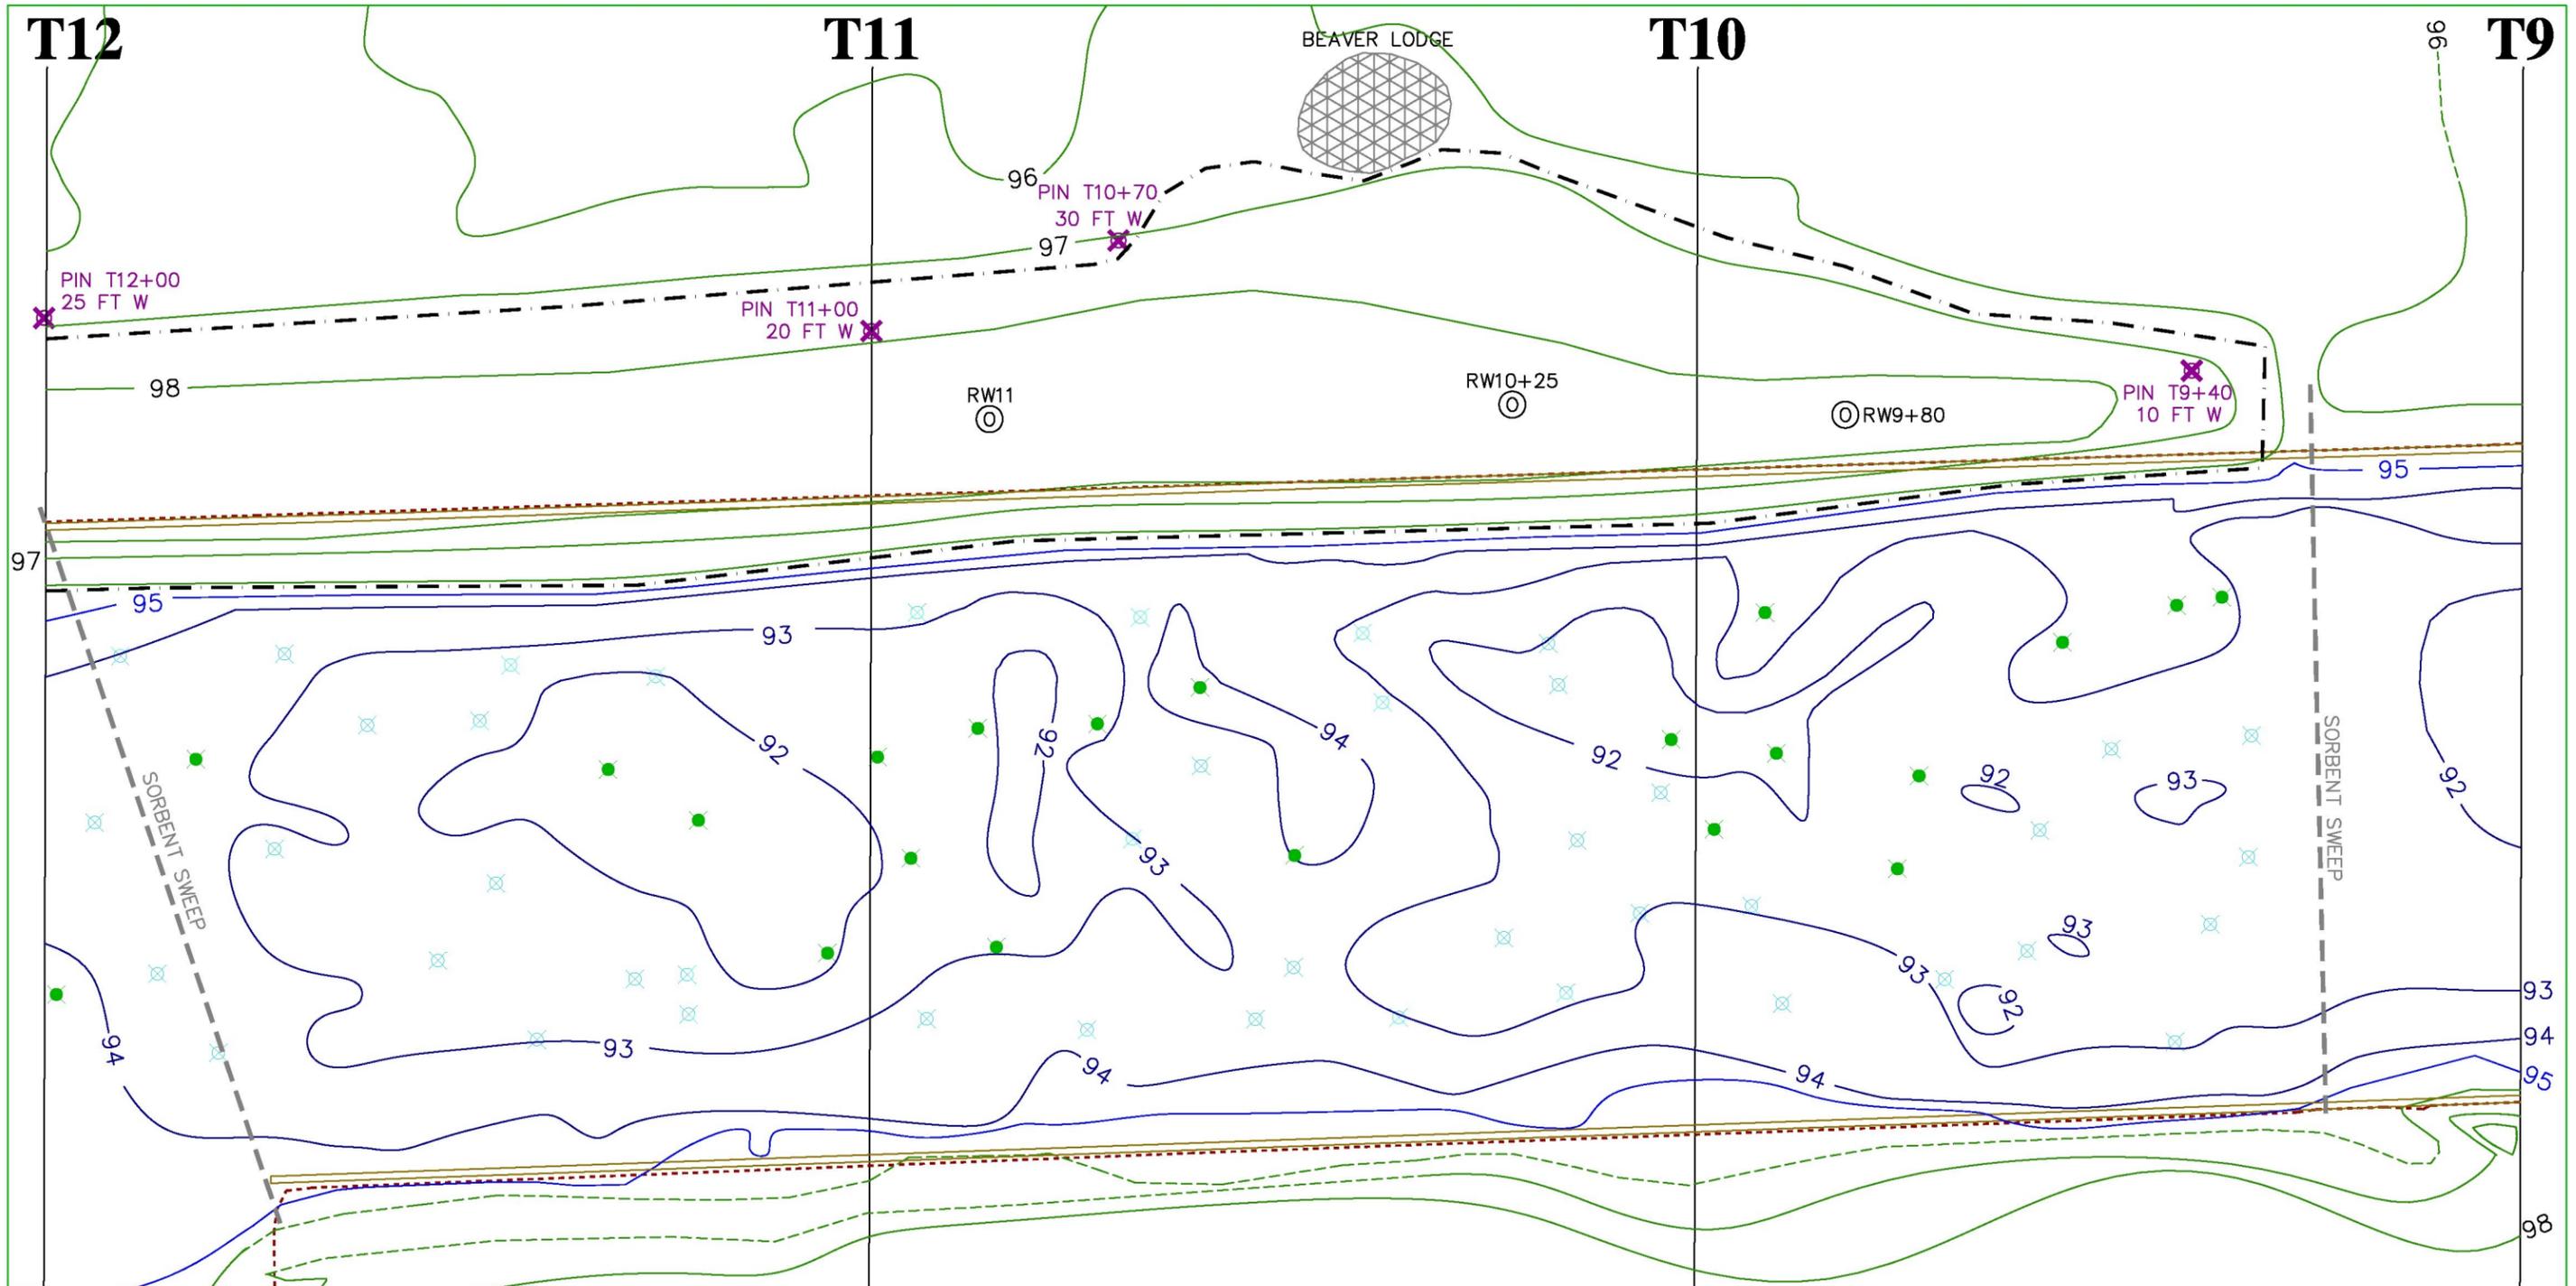
Probing for DNAPL on the Canal cap between Transects T9+30 and T12+00 (following the same methods for probing this area during pre-construction monitoring) was conducted on August 24, 2004 following completion of the swabbing and mopping of residual accumulations. The probing was conducted using a ten-foot long PVC pipe with a cloth survey tape attached. A 12-inch strip of sorbent pad was attached to the pipe with Zipties™. The pipe was gently inserted into the water to the cap surface, and then removed for visual inspection. The highest point on the sorbent at which NAPL was observed was recorded as the DNAPL thickness. This method allows detection of DNAPL thickness down to approximately 0.01 feet. Any observations of sheens or NAPL released to the water surface during the probing were noted. The location of each probe test was determined using a Trimble sub-meter global positioning system.

<ul style="list-style-type: none"> PROBE OF CAP SURFACE IN CANAL WITH NO EVIDENCE OF DNAPL PROBE OF CAP SURFACE IN CANAL WITH SPOTS OF DNAPL DETECTED ON PROBE FABRIC SURVEY MONUMENT LOCATION NAPL OBSERVATION WELL LOCATION PINS FOR CONSTRUCTION 	<ul style="list-style-type: none"> WOODEN CRIBBING 1' SURFACE CONTOUR 5' SURFACE CONTOUR 1' BATHYMETRIC CONTOUR 5' BATHYMETRIC CONTOUR EXTENT OF CAPPED AREA IN CANAL EXTENT OF WEST BANK CAP
---	---

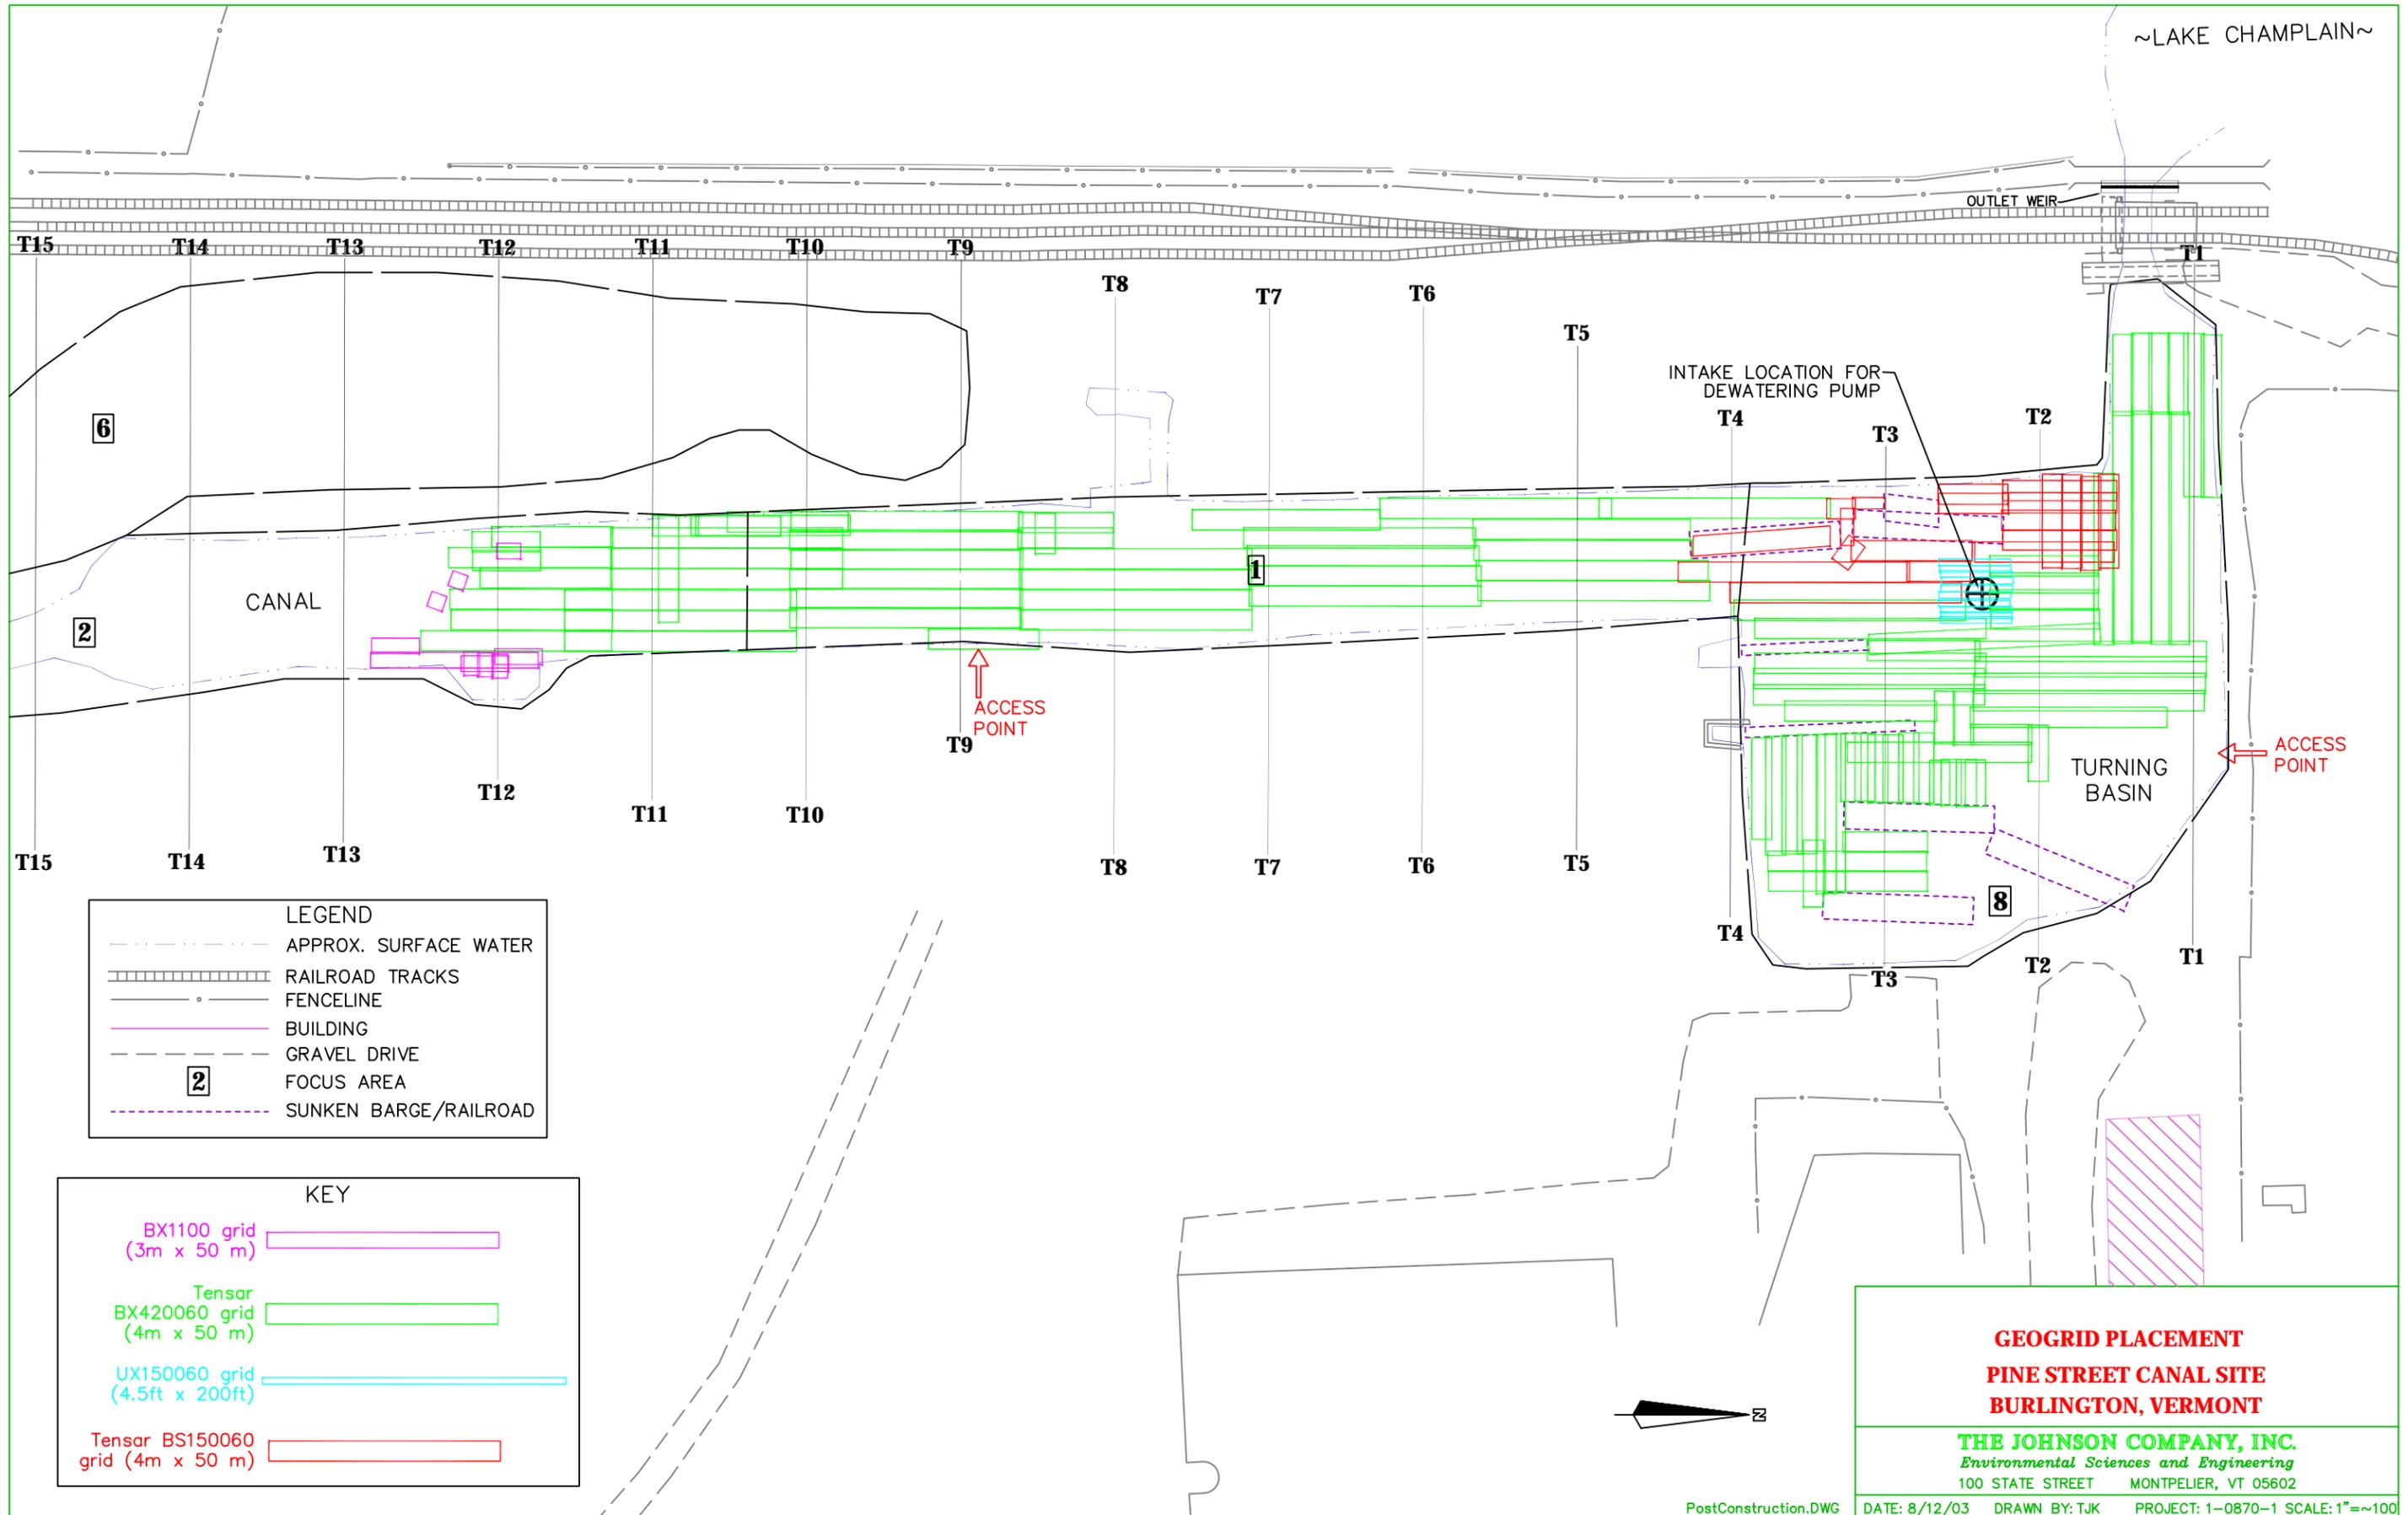
GEOGRID PLACEMENT
PINE STREET CANAL SITE
BURLINGTON, VERMONT

Following dewatering, woody debris was removed from the sediment surface. All woody debris sticking above the sediment surface was cut off and removed. Portions of the wood which had not contacted the contaminated sediments were cut into short lengths and burned or placed along the banks of the Canal and Turning Basin at elevations above 96 ft NGVD. Debris which was contaminated with tar or oil was collected, temporarily stored in roll-offs, and ultimately transported off-site for disposal at a licensed facility. After debris removal was complete, geotextile was manually placed directly onto the existing sediment in the Canal lengthwise down the Canal from approximately Transect T13 to approximately T4+50, leaving 2 to 3 foot pleats on each side of the Canal to account for settlement after cap placement. Geotextile was also placed on the sediments in the Turning Basin to facilitate the construction of the cap there, as dictated by field conditions. In the 150' area from the end of the Area 2 waterway northward (an initial test area to demonstrate the feasibility of capping the sediments in a dewatered state), field connections of the geotextile joints were either sewn or fastened mechanically with a minimum one foot of overlap. For the remainder of the Canal, connections were field sewn. Geotextile seams in the Turning Basin were not sewn or attached, but were overlapped a minimum of two feet and for much of the Turning Basin area, a second layer of geotextile panels were placed over and perpendicular to the first layer. Geogrid was placed over the geotextile in the Canal generally parallel to the cribbing, and in some portions of the 150' test area and the Turning Basin. Adjacent geogrid edges were secured with Zipties® with a minimum of one foot of Geogrid overlap. The actual locations of the placed geotextile and geogrid panels are presented in Figures included in Appendix 2.

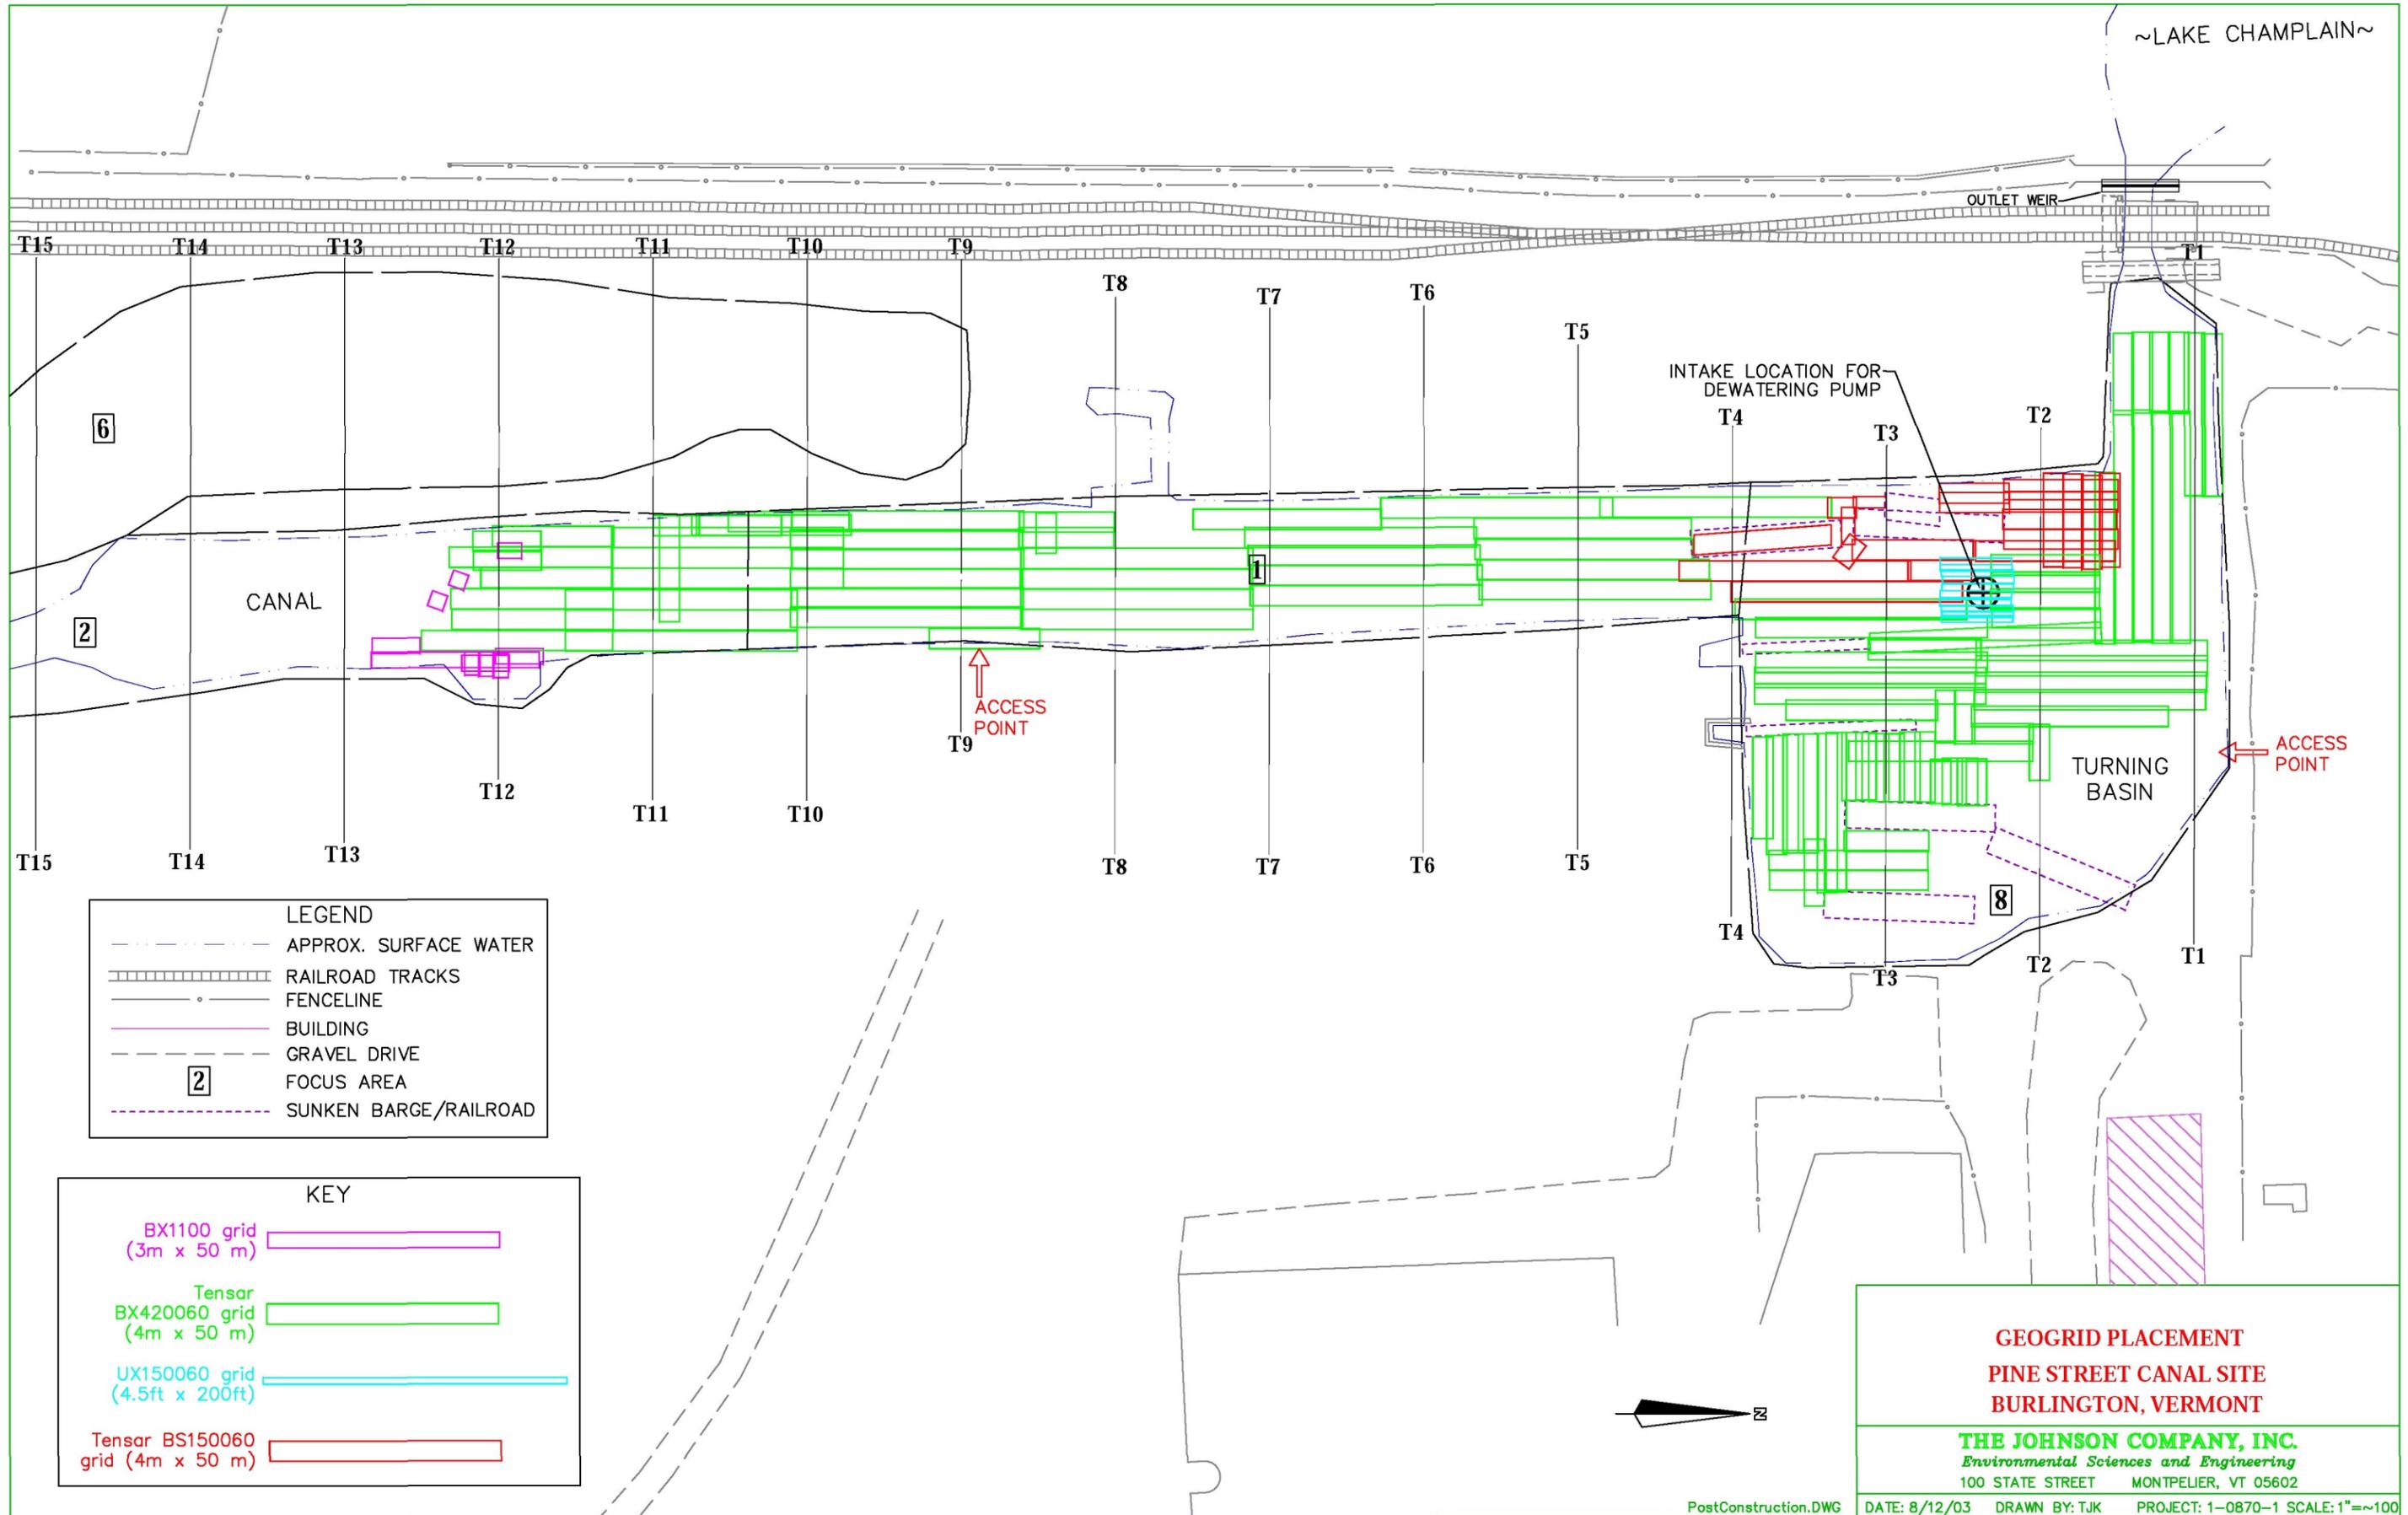
GEOGRID PLACEMENT
PINE STREET CANAL SITE
BURLINGTON, VERMONT
