**PHOTODOCUMENTATION OF HISTORIC CANAL CRIBWORK IDENTIFIED
DURING CONSTRUCTION OF THE PINE STREET CANAL WEIR,
BURLINGTON, CHITTENDEN COUNTY, VERMONT**

John G. Crock, Ph.D.

**CONSULTING ARCHAEOLOGY PROGRAM
UNIVERSITY OF VERMONT
112 University Heights
Burlington, VT 05405**

November 19, 2001

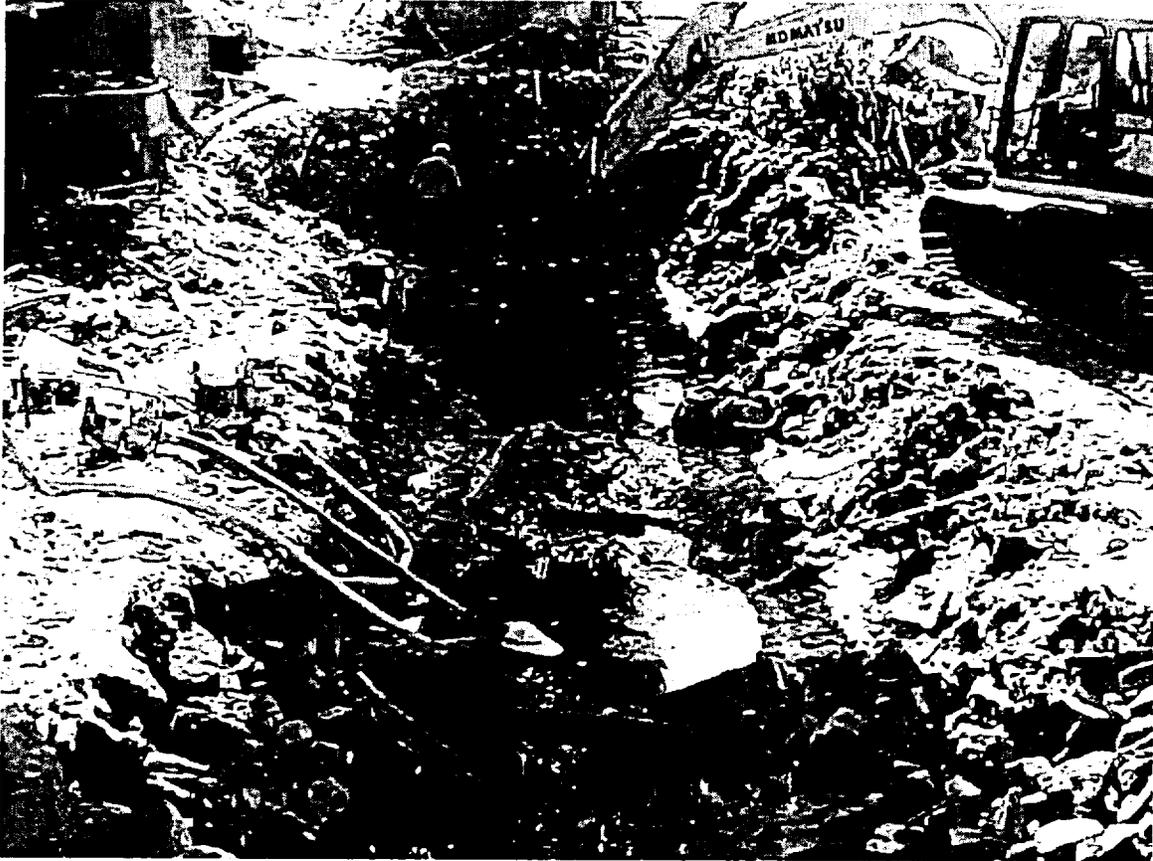
Figure 1. Excavation for weir footing, facing south. Note cut timbers representing the south canal wall to left of workman, cut timbers representing the north canal wall below pumps in foreground, and displaced timbers within excavation trench (photo courtesy of John Hunt, *de maximis*).

According to Thor Helgason, Project Coordinator for *de maximus, inc.*, the disturbance of the buried architectural features occurred when “during excavation for the weir footing, a concrete step or sill was found cast into the northern railroad bridge abutment (Figure 1). The concrete step appeared to have been cast on top of wooden cribbing, which extends from the edge of the bridge abutment at least 12 feet. Within the weir footing excavation, the cribbing was composed of square 10-inch timbers (in the east-west direction), connected by notches to round, notched logs extending about 6 feet in a north-south direction, similar to Lincoln Logs. The top of the cribbing is at elevation 93, which is about 6 inches above the proposed top of weir footing elevation. The cribbing was filled with 1-foot diameter, angular stone. At the edge of the weir footing excavation, the cribbing was cut and left in place (Figure 2). The cribbing does not appear on the design drawings for the railroad bridge and it may or may not have been associated with construction of the bridge.”

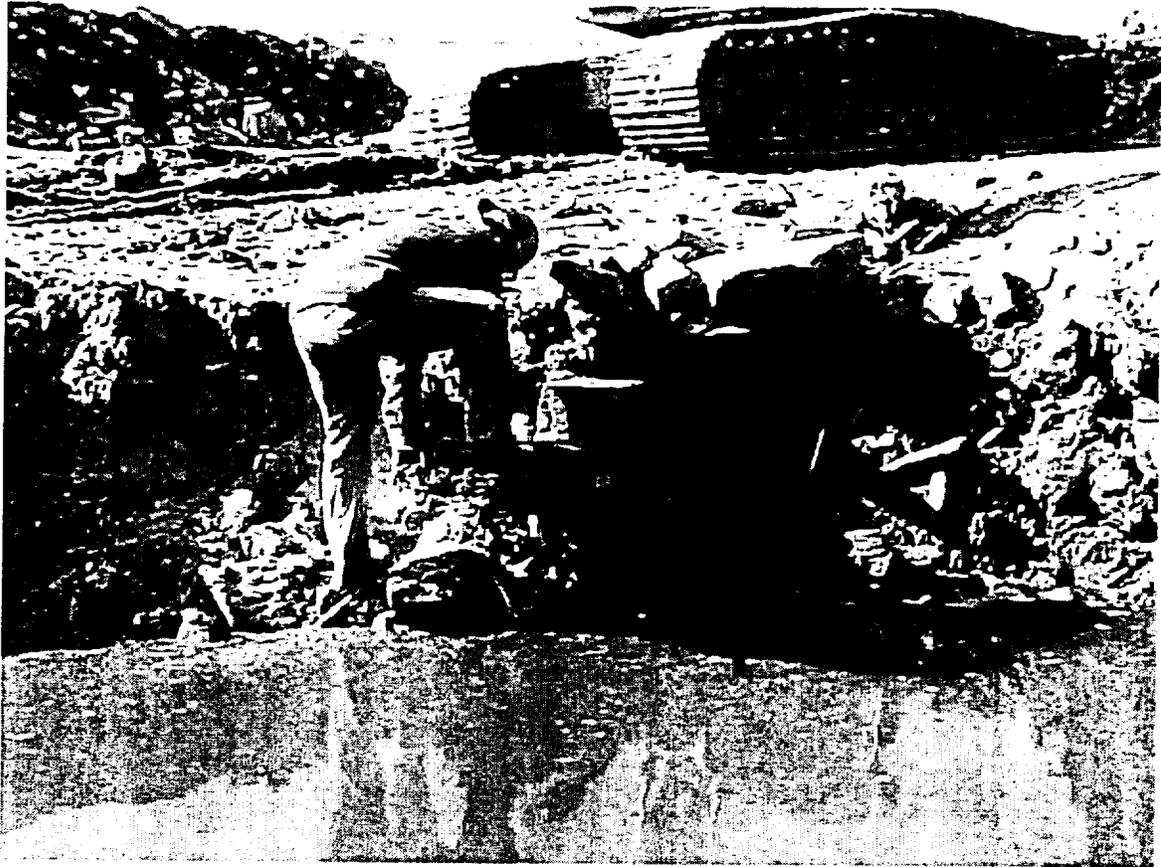
Figure 2. Cutting of north canal wall timbers at the northwest corner of weir footing excavation (photo courtesy of John Hunt, *de maximis*).

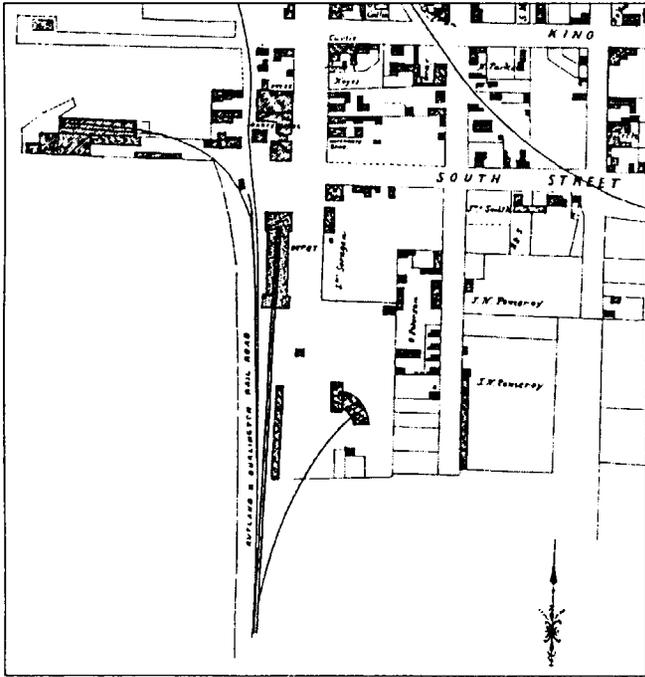
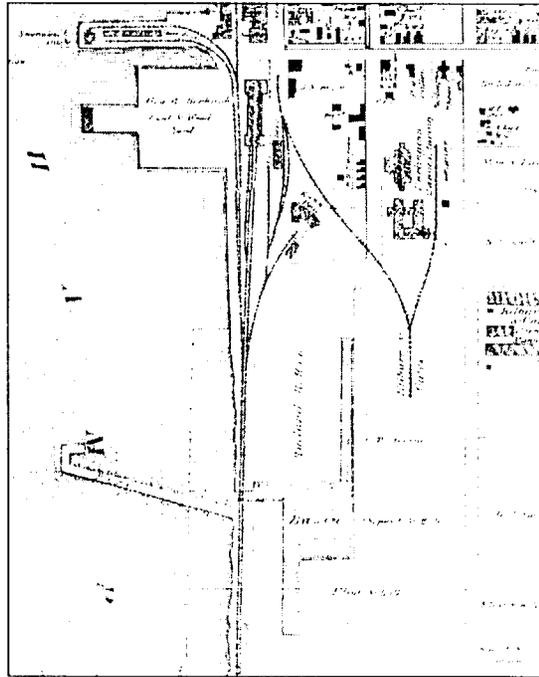
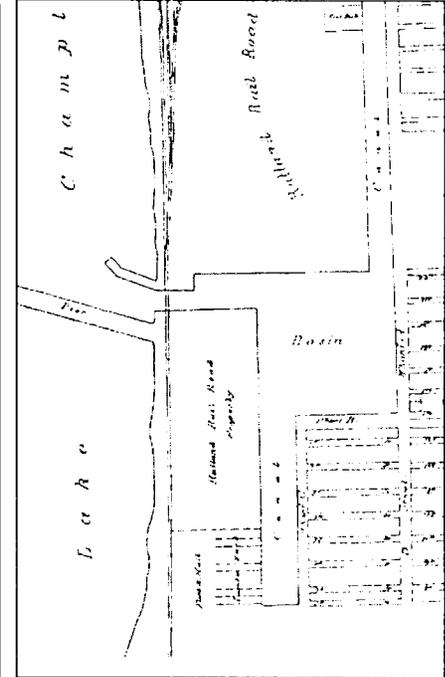
Figure 3. Historic maps showing the development of the barge canal and piers/breakwaters between 1853 and 1869.

Pre-Canal (Presdee and Edwards 1853)

Canal with south pier (Beers 1869)

Canal with south pier and first stage of north pier (Sanborn 1869)

Based on the earliest available historic maps, the cribwork for the interior of the canal and the southern pier were completed by 1869, and for the northern pier by 1872. The maps do show an evolution of the northern pier and shoreline between 1869 and 1890. The progression goes from no pier (Beers 1869) to a short pier (Sanborn 1869), then a full length pier (Pichot 1872), then infilling to the north of the north pier (UVM 1886). The 1886 map showing infilling suggests a collapse of cribwork in this area, sedimentation of the “cove”, or simply low water conditions at the time the 1872 map was prepared (see Figure 4). The 1890 map depicts a more irregular shoreline than apparently existed earlier and seems to provide evidence of erosion along this portion of the waterfront and/or a general lack of maintenance. By this time in Burlington history, the lumber boom was definitely on the decline and resources may not have been as readily available for the upkeep of the waterfront cribwork and the cribwork around the canal. The 1890 map does show the addition of structures on the filled in area north of the canal mouth, however. These were likely associated with the railroad and the operation of the drawbridge. More recent Sanborn *Insurance Maps of Burlington, Vermont* from 1894 onward do not show the piers and also depict an irregular shoreline (Sanborn 1894; 1900; 1926). While the piers may have been outside the area of focus for these maps, it is also likely that they already had substantially degraded by the late 19th century.

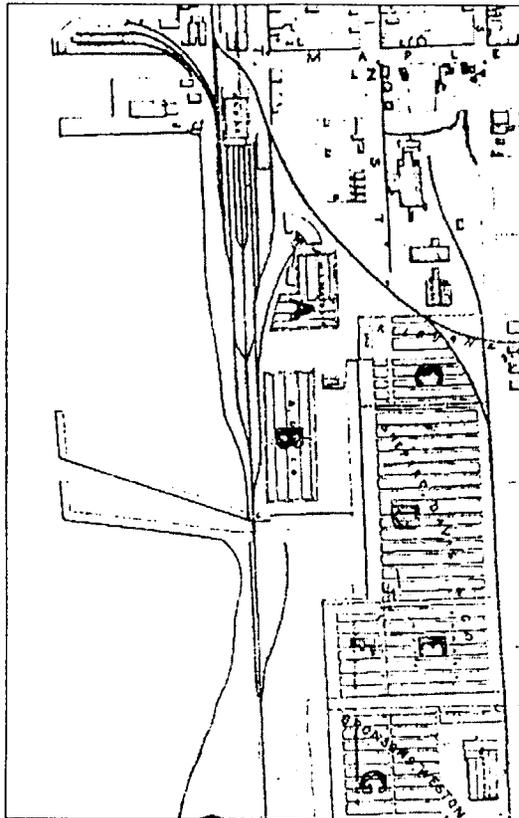
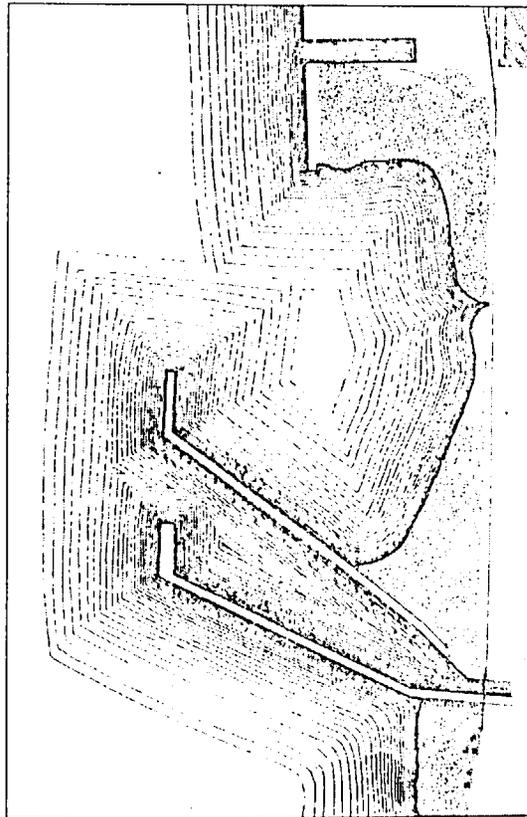
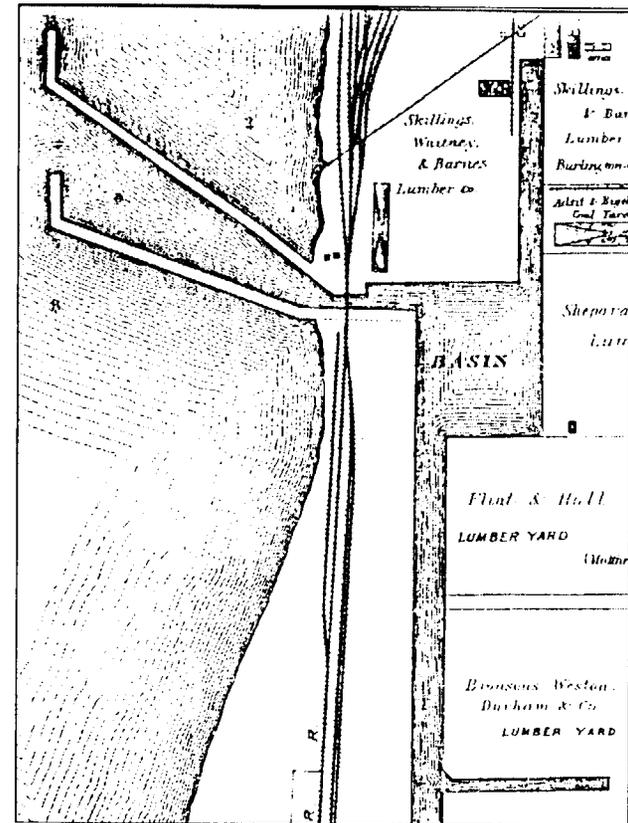
Figure 4. Historic maps showing development of the barge canal and waterfront from 1872 through 1890.

Canal with two piers (Pichot 1872)

Infilling and/or erosion north of north pier (UVM 1886)

Structures on infilled area just north of canal mouth, west of tracks (Hopkins 1890)

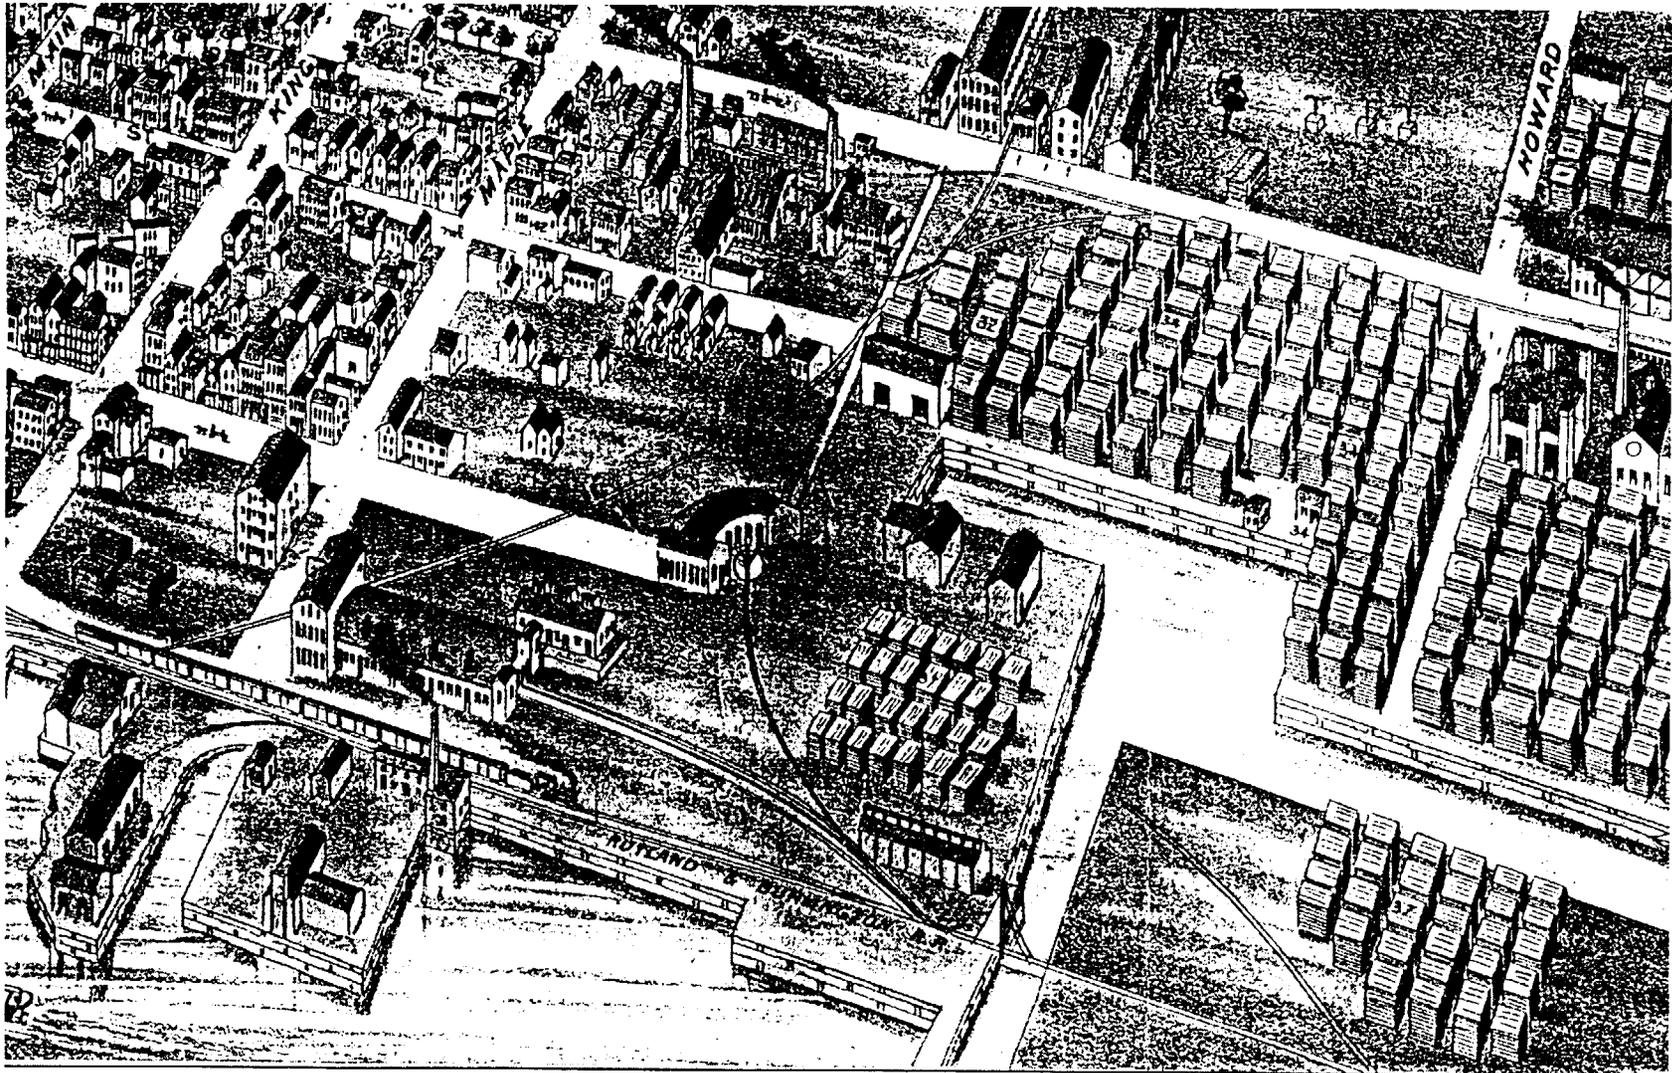
Figure 5. Close-up of Meilbek's 1877 *Birds Eye View of Burlington and Winooski, Vt.* Note cribwork along waterfront and canal.
