Inspection and photodocumentation of exposed architectural features associated with the historic Pine Street Barge Canal in Burlington, Vermont, revealed evidence of cribwork along the original canal mouth and pier/breakwaters that once extended westward from the canal mouth into Lake Champlain. The exposures resulting from the construction disturbance, combined with rare low lake levels provided a unique opportunity to study canal and pier construction (Figure 14). The exposed features at the mouth and along the south pier were originally constructed in 1868, those around the north pier were constructed in 1869 and apparently enhanced in the decade that followed. Construction of wooden retaining walls involved edge-fastened exterior walls of square timbers (likely hemlock), tied into parallel interior walls with round log “dead man” cross members. This configuration produced compartments measuring roughly 6 feet square that were then filled with large boulders and rocks. Both wooded peg dowels and iron rod fasteners were employed, with the latter likely associated with more recently constructed sections. Several exposed vertical fasteners tilted outward toward the canal channel, i

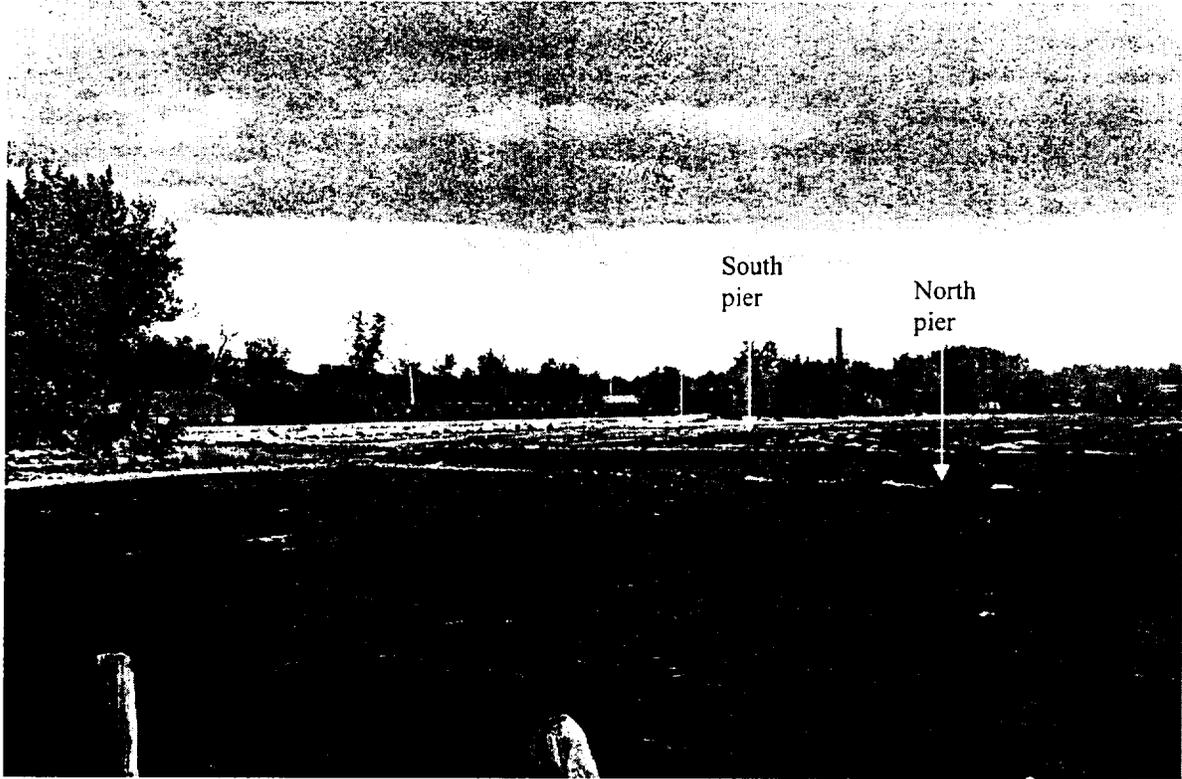
Figure 6. View of exposed canal pier ruins during unusually low lake levels, facing southwest.

93 ft ) which fortuitously exposed the piers which are usually submerged (Figure 6) and wooden structural members within them (Figure 7).

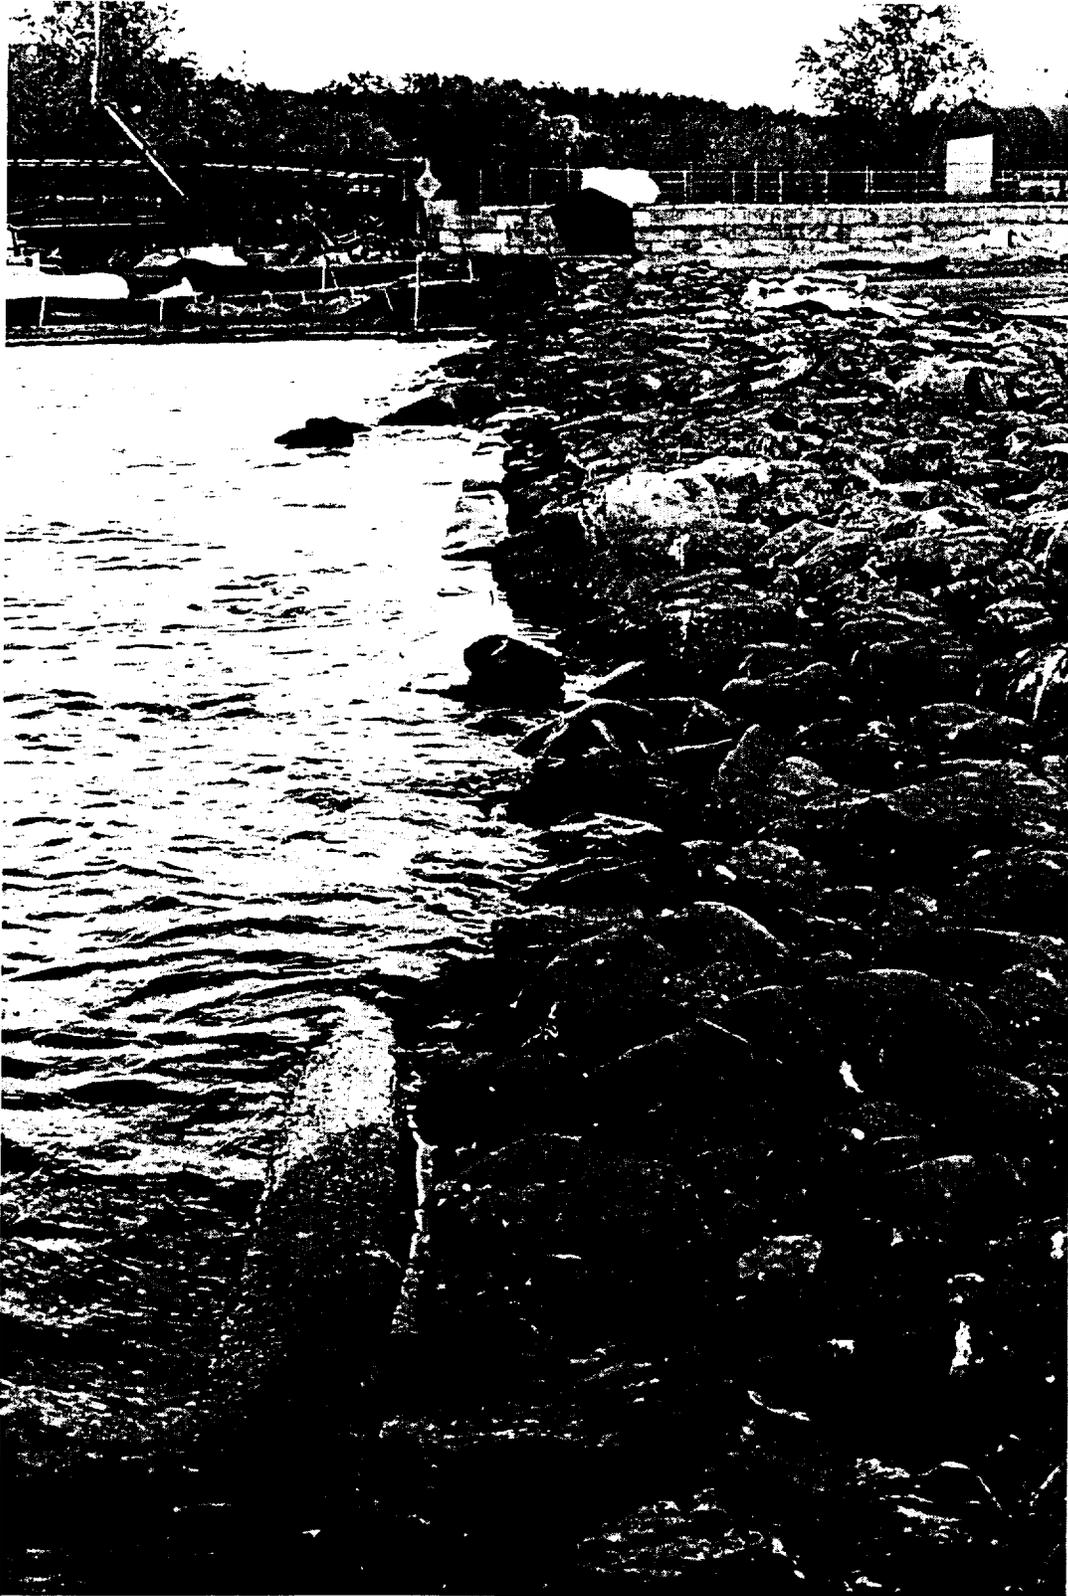
Figure 7. South pier facing west toward canal mouth. Note exposed interior wall cribbing.

Based on the exposed evidence, the cribwork retaining walls that formed the interior of the canal, the edge of the waterfront, and the borders of the piers, all were constructed using an edge fastening technique, much like that used in the construction of the canal boats themselves (e.g., see Kane et al. 2001). The vertical retaining walls were anchored by perpendicular “dead men” that extended back, away from the vertical walls (Figure 8). Exposures provided by the weir footing excavation and along the piers indicate that, around the canal mouth and along the piers, the perpendicular “dead men” were connected to interior retaining walls that ran parallel to exterior walls (Figure 9). The configuration of walls and cross member “dead men” formed individual compartments that were filled with boulders, large rocks and sediment. As first noted by *de maximis* personnel, exposures revealed that the cross members were often notched to interlock timbers (Figure 10). Most of the exposed cross members visible were round logs as opposed to the larger, 10-12 inch square timbers utilized for the exterior walls and some interior walls. Exposures also revealed that the edge fastening of square timbers was accomplished using 2 in diameter vertical wooden dowels (Figures 11 and 12) as well as iron fasteners (Figure 13). Iron fasteners were only identified in association with the north canal wall, however, perhaps indicative of the more recent construction and renovation dates for the north pier.

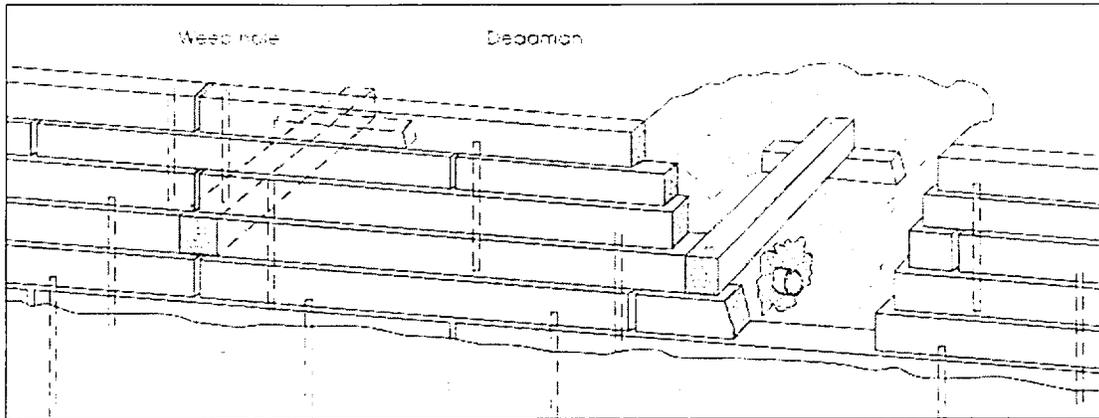
Figure 8. Schematic sketch showing a standard edge fastened retaining wall with perpendicular “dead man” anchors (Hufnagel 2000:403).

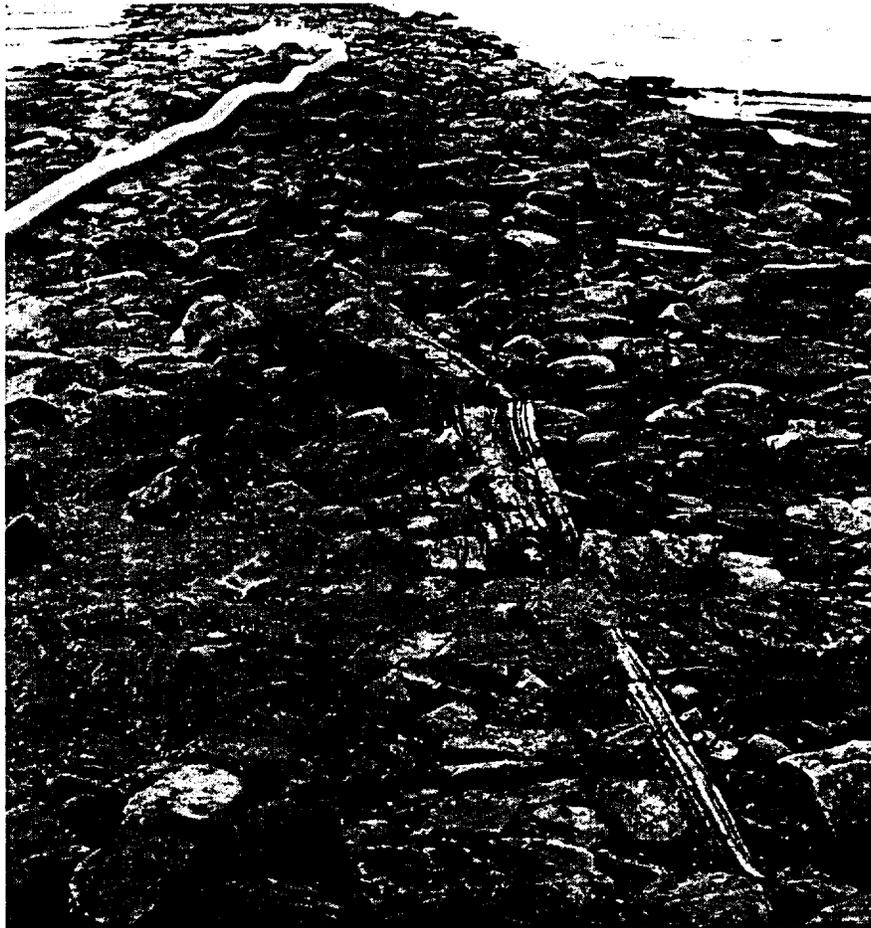
Figure 9. South pier facing west. Note exposed timbers representing interior wall into which outer walls were tied.

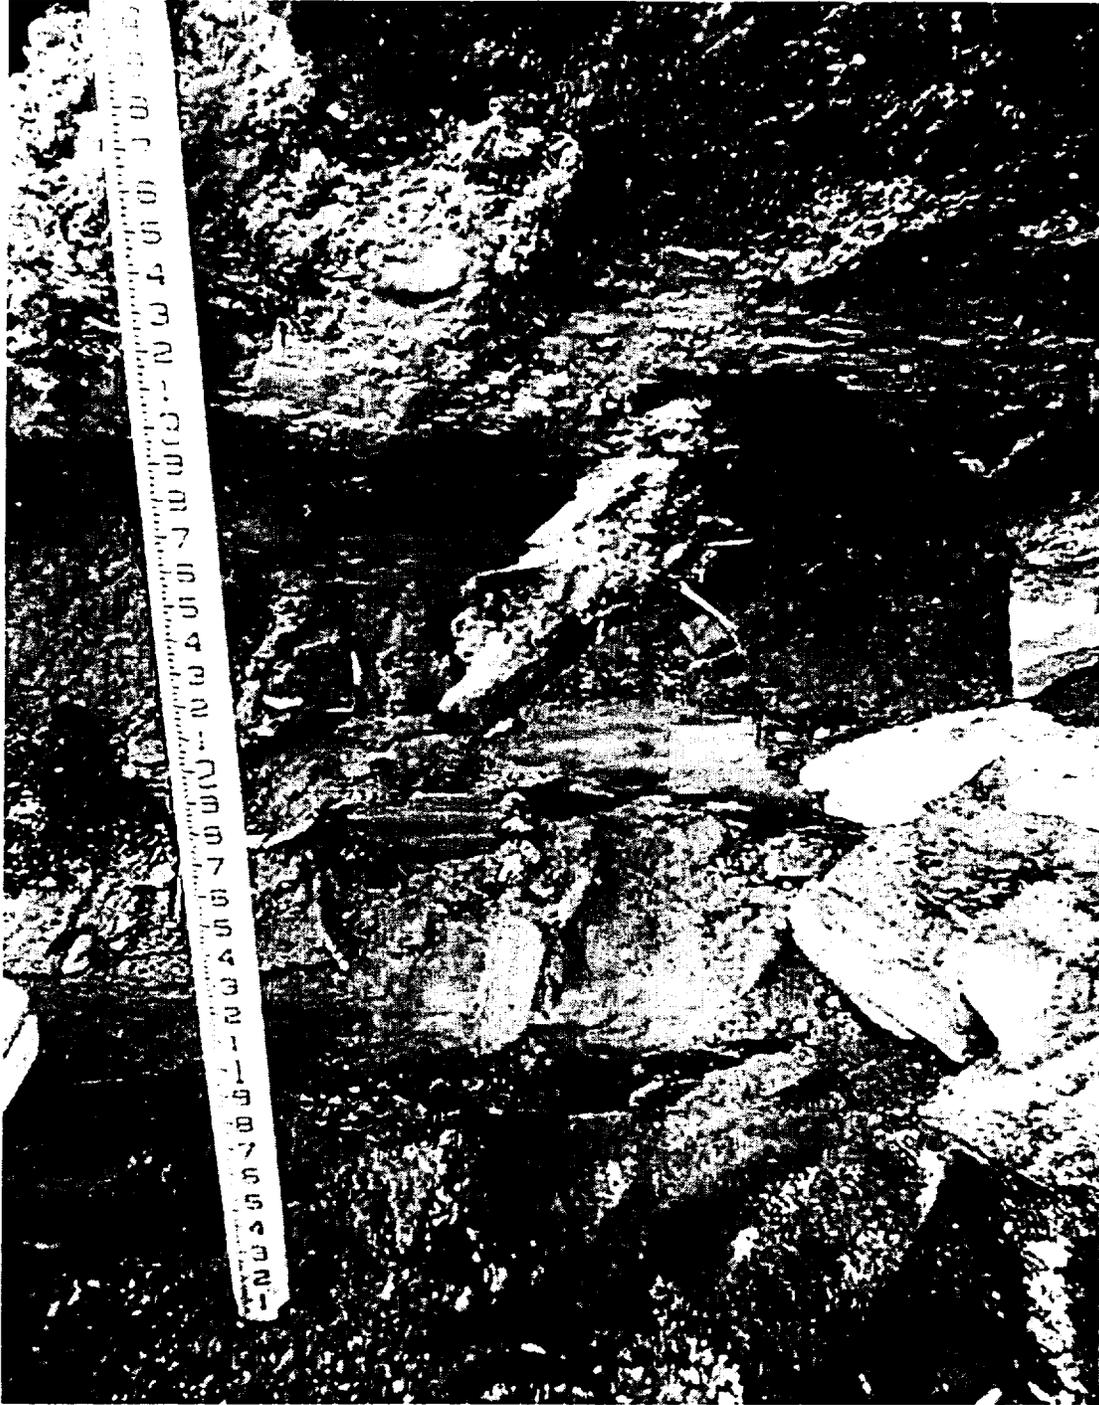
Figure 10. View of interior north wall, north of original canal mouth, facing north. Note notched log and stacked round logs forming interior wall cribbing.

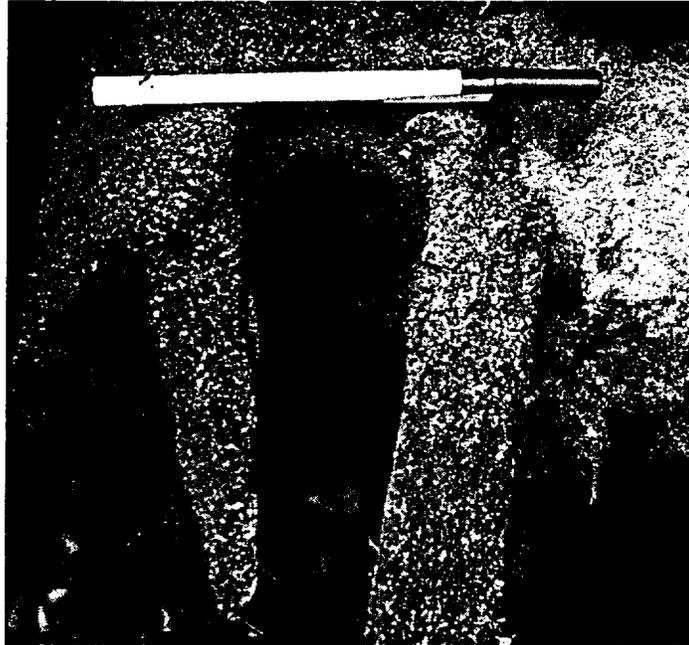
Figure 11. View of 2 inch diameter bore hole drilled to accommodate vertical wooden dowel fasteners.

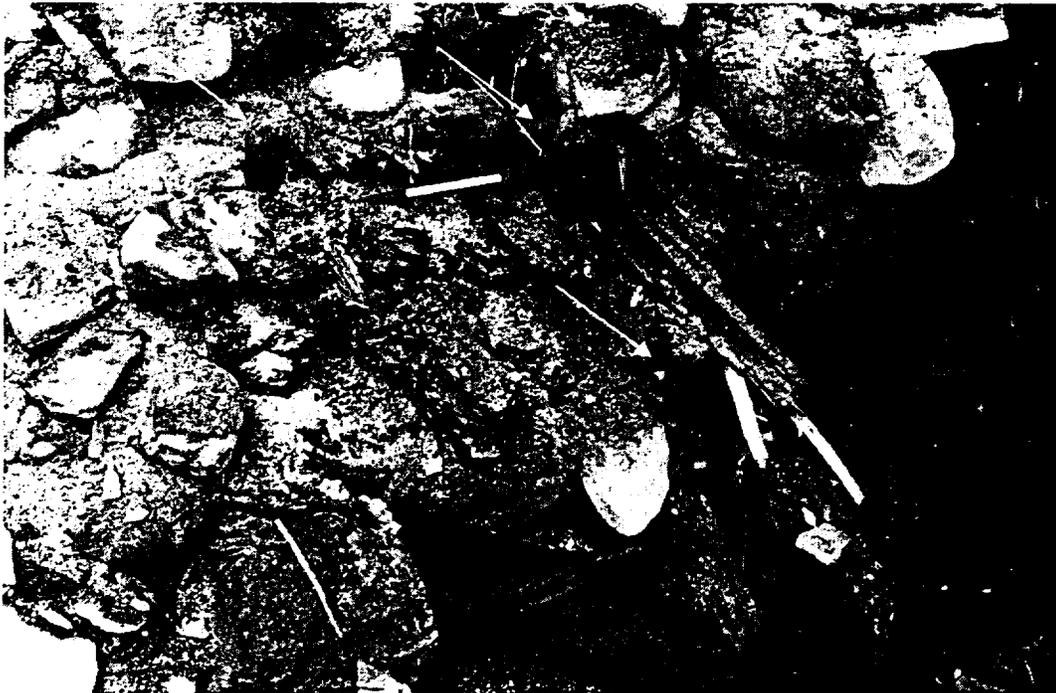
Figure 12. Northern side of canal mouth, facing northeast. Note vertical wooden dowels used to fasten horizontal cribbing and slight angling of dowels toward camera evidencing an outward bulge to the original northern canal wall

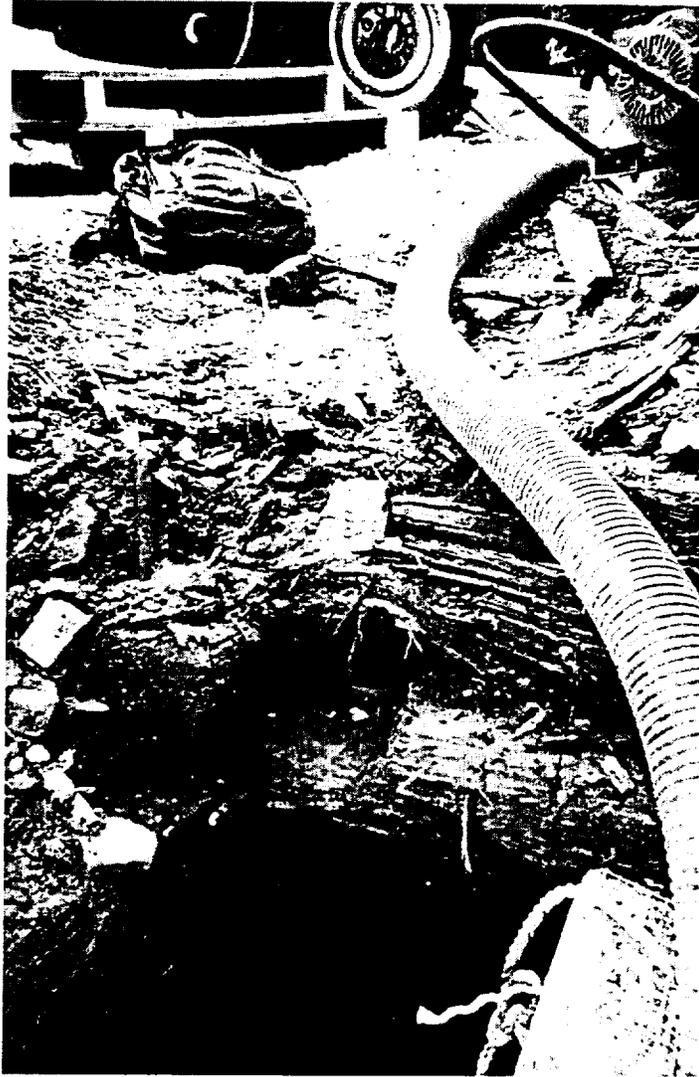
Figure 13. View of inside corner of northwest canal mouth. Note interlocking timbers and vertical iron rod used to fasten horizontal timbers.
