# Preliminary Closeout Report

## ROSE HILL REGIONAL LANDFILL SITE South Kingstown, Rhode Island

September 2008

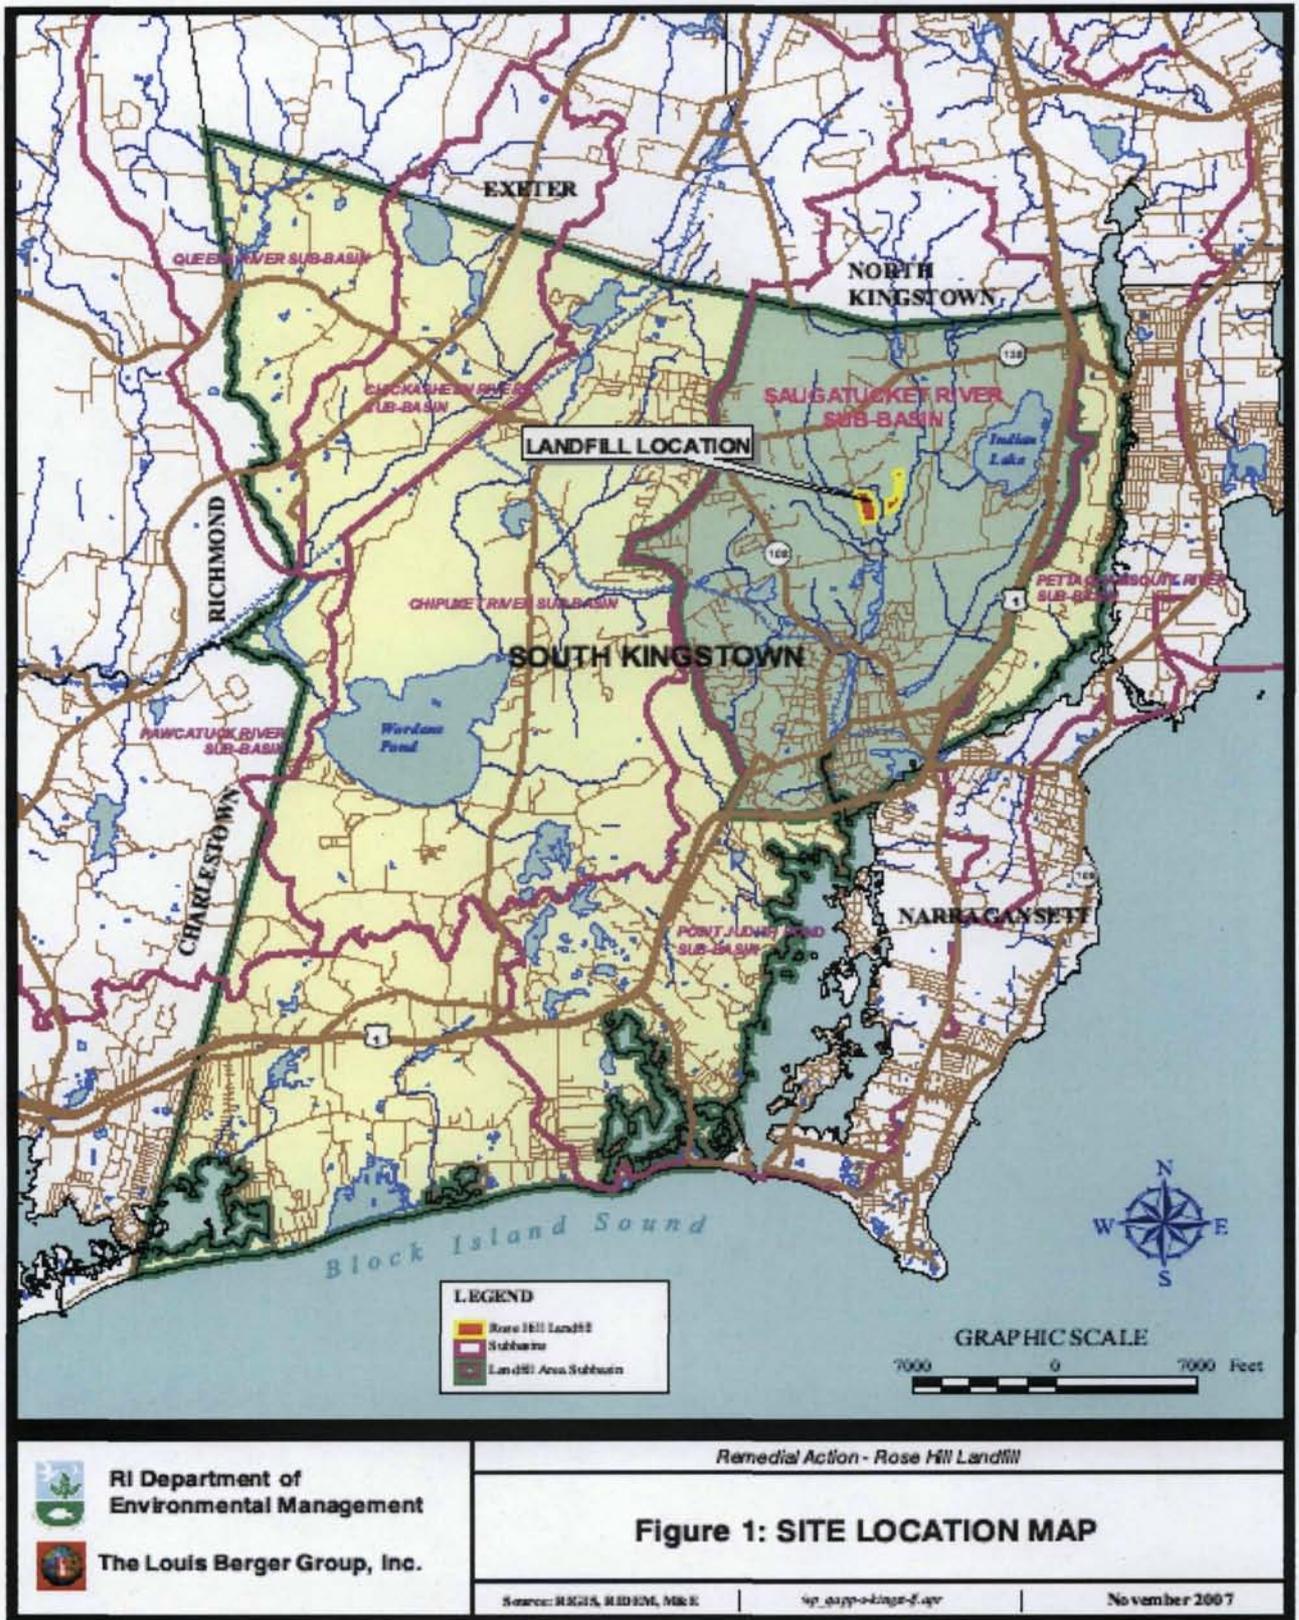
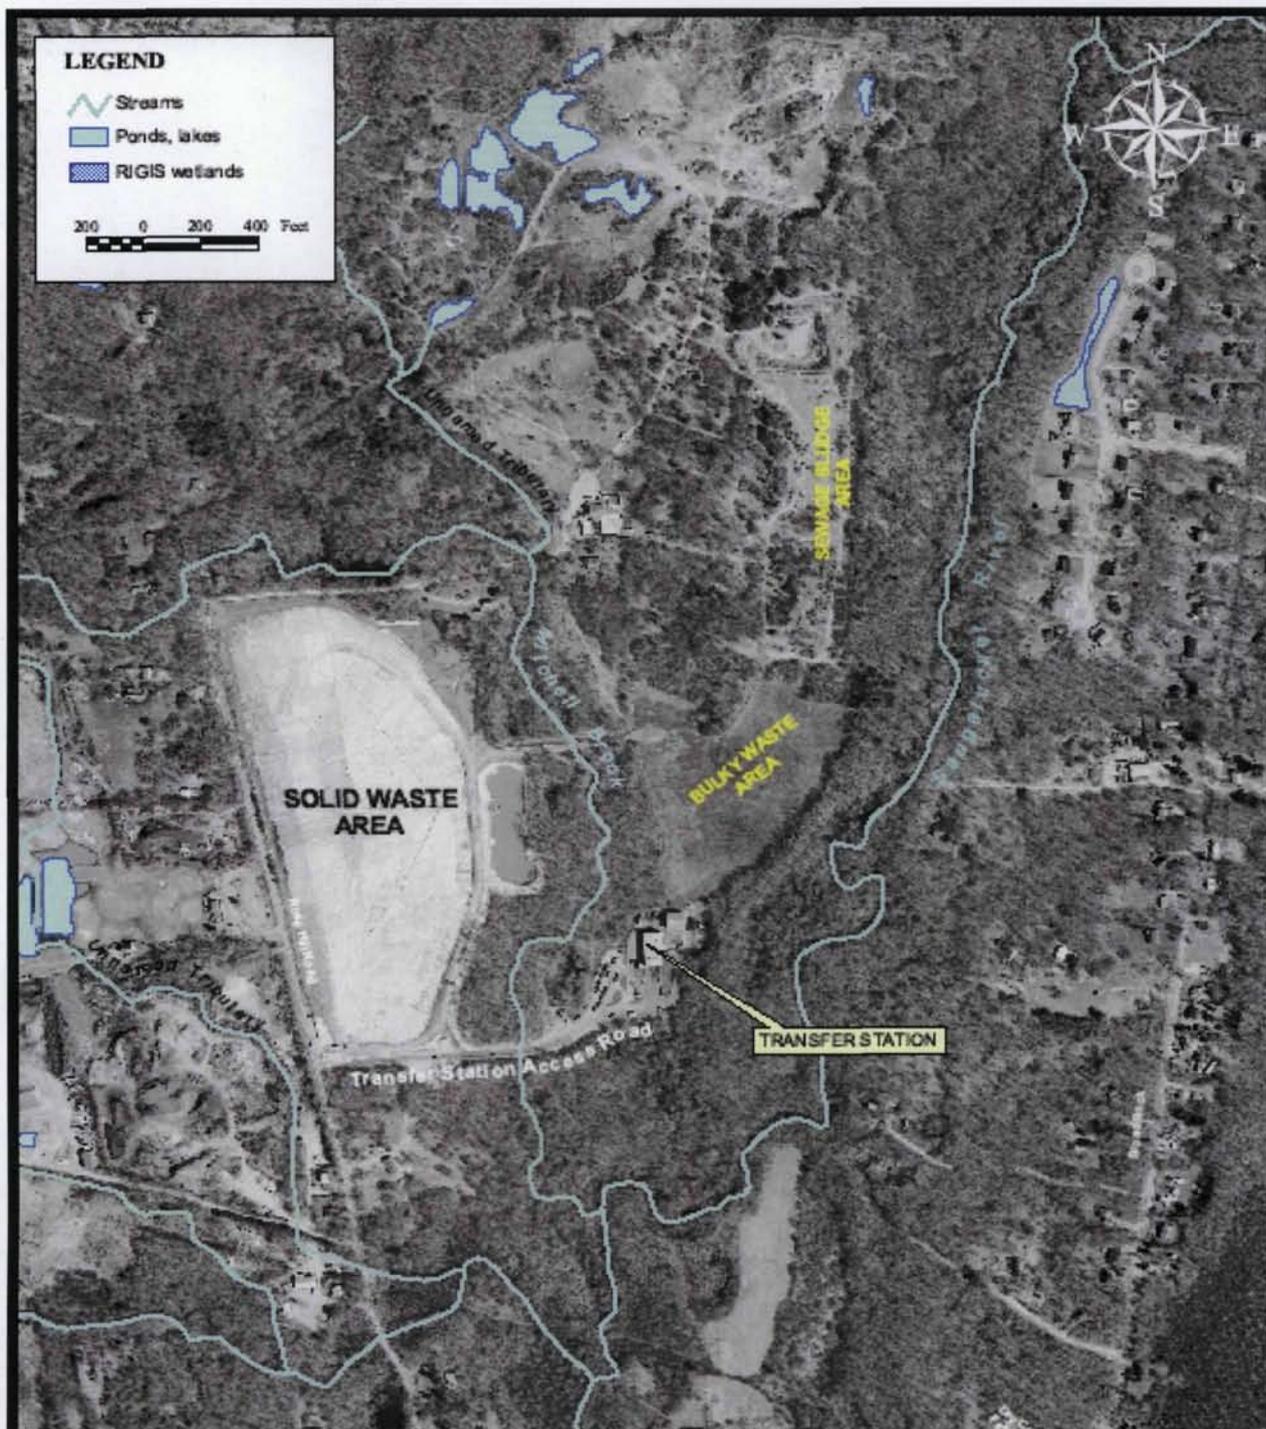
**Figure 2: SITE AERIAL EXISTING FEATURES MAP**

The Site is located in an abandoned sand and gravel quarry and encompasses approximately 70 acres. As shown in Figure 2, the Site consists of three separate and inactive disposal areas or landfills, referred to herein as the Solid Waste Area (SWA), the Bulky Waste Area (BWA) and the Sewage Sludge Area (SSA).

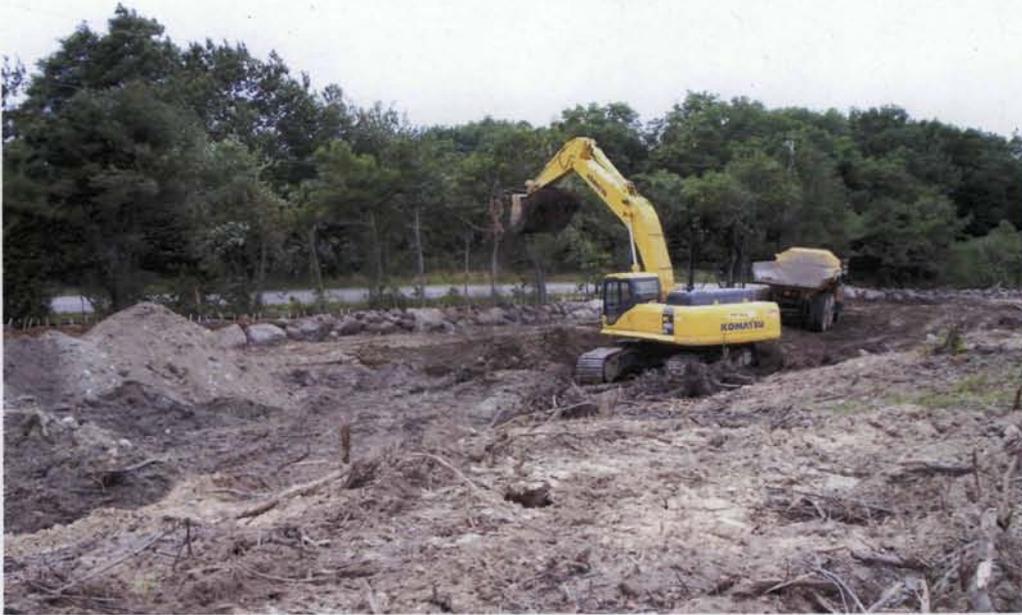
**Grubbing and site prep at Solid Waste Area along Rose Hill Road (Phase 1)**

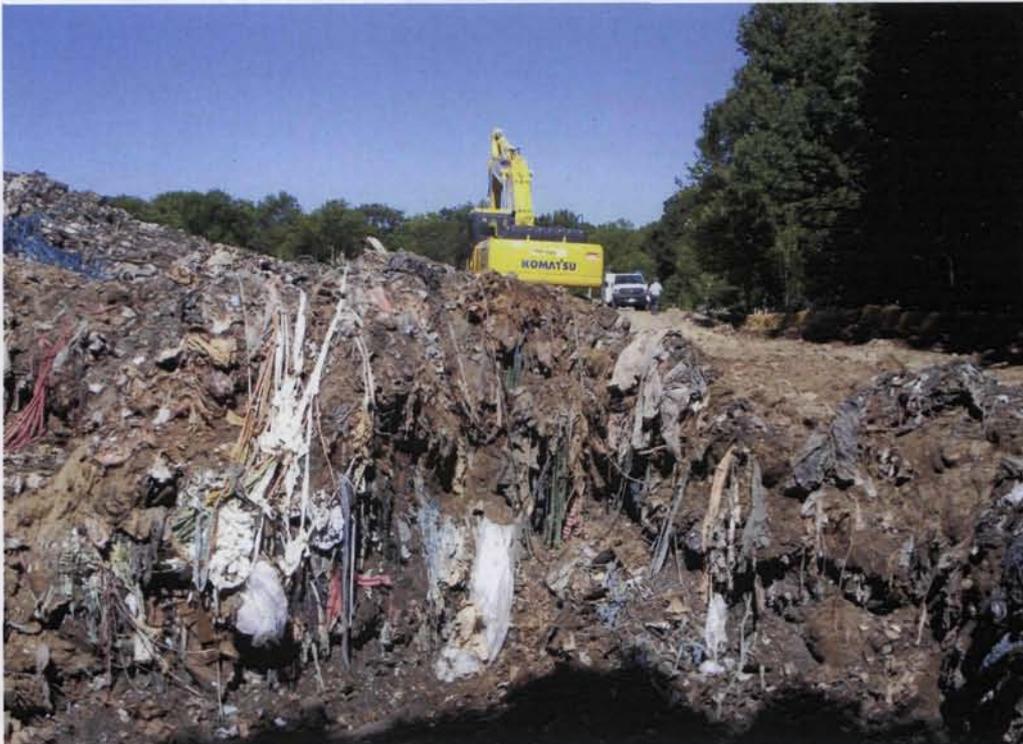
**Waste removal for consolidation underway at Bulky Waste Area (Phase 1)**

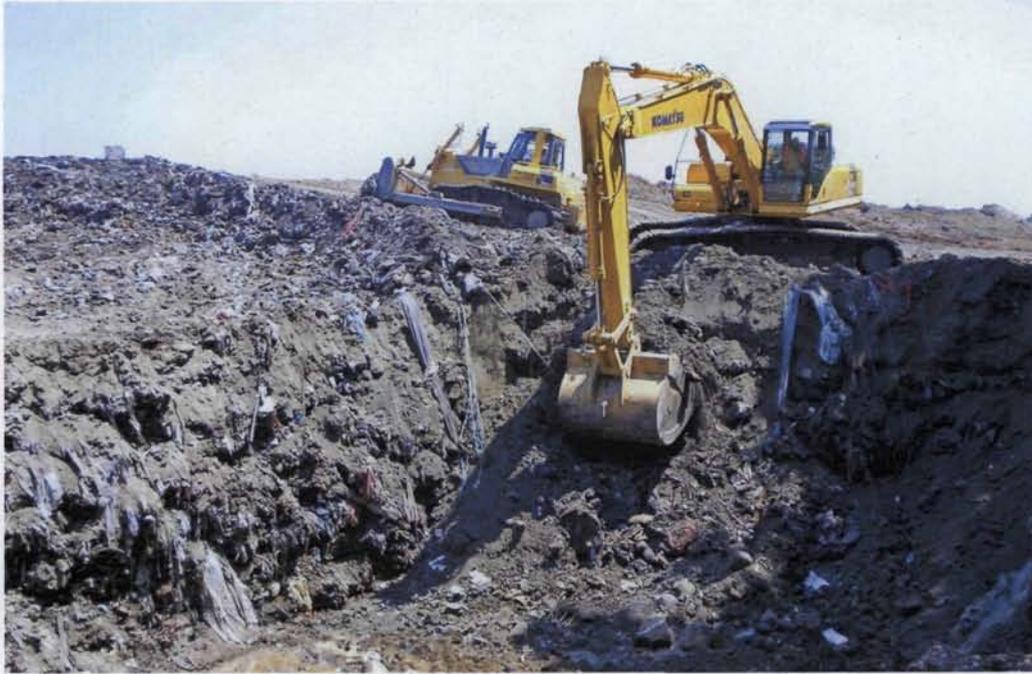
**Waste contouring and consolidation on the Solid Waste Area (Phase 1)**

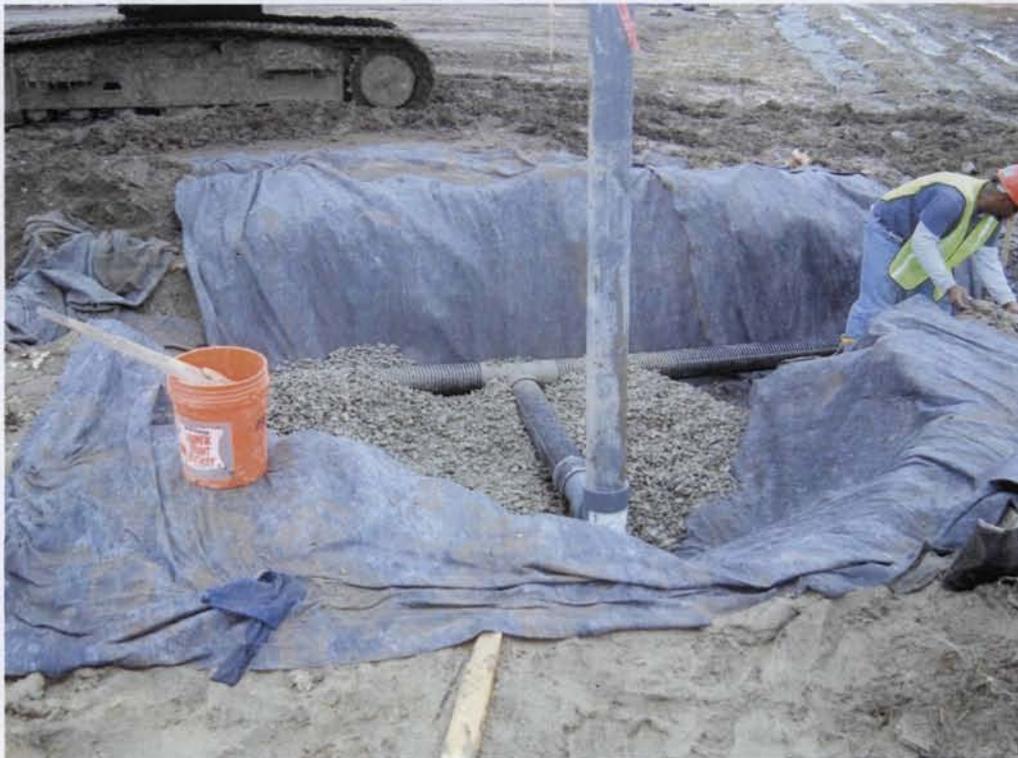
**Laying the LFG gas collection pipe network (Phase 2)**

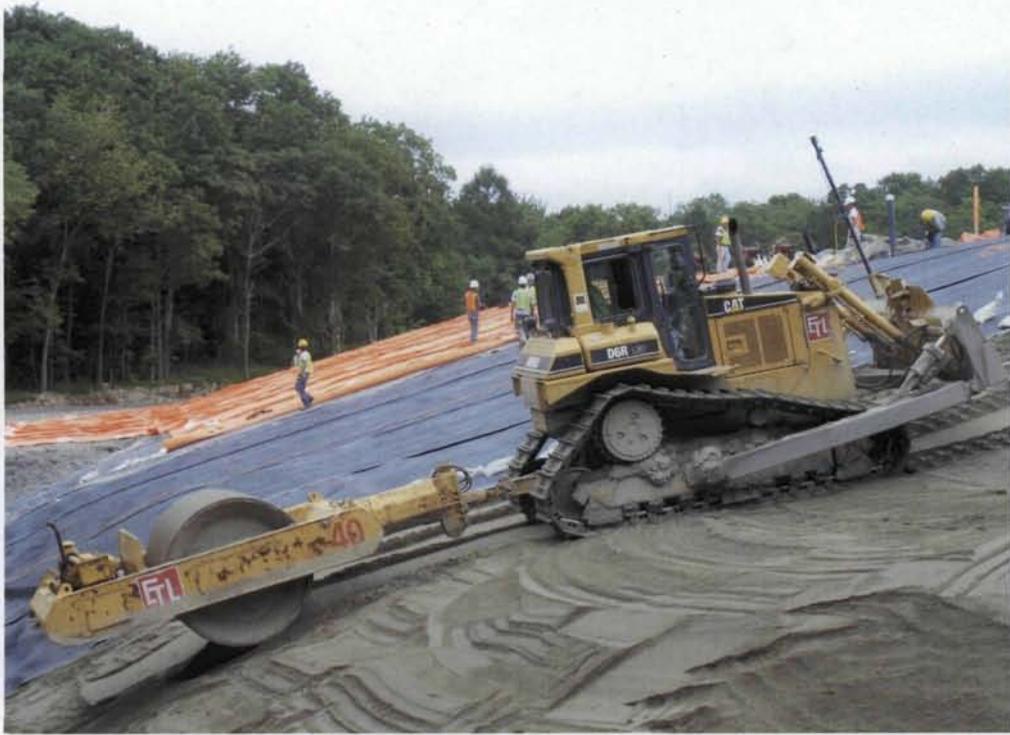
**Sequencing the cap installation on the slopes (Phase 2)**

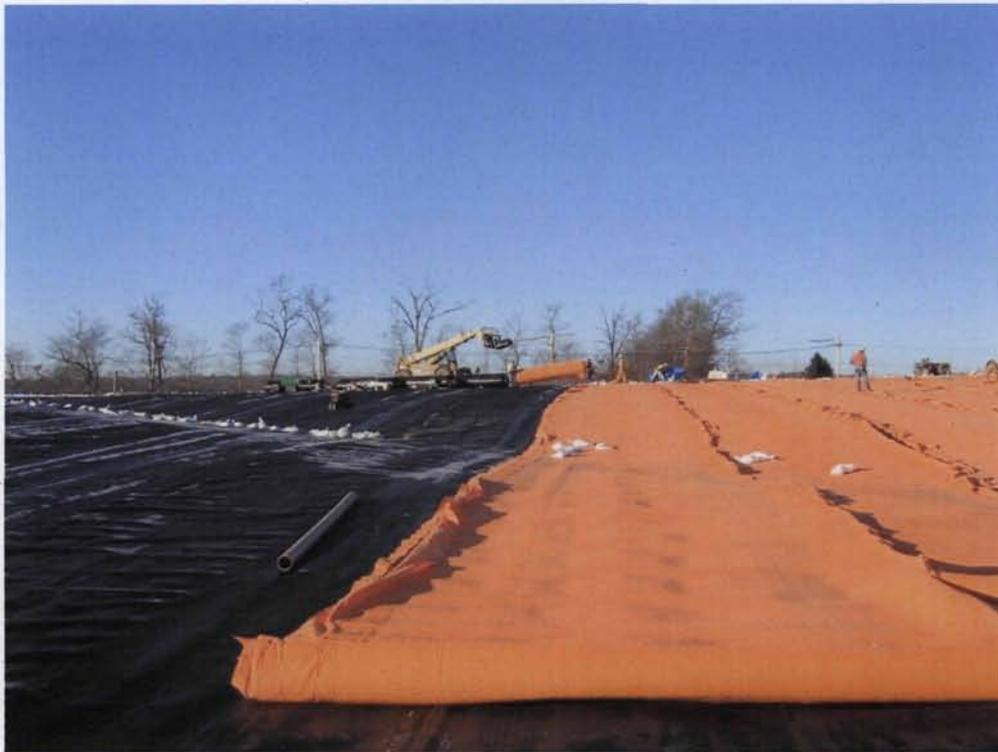
**Capping sequence along top of slope of Solid Waste Area (Phase 2)**

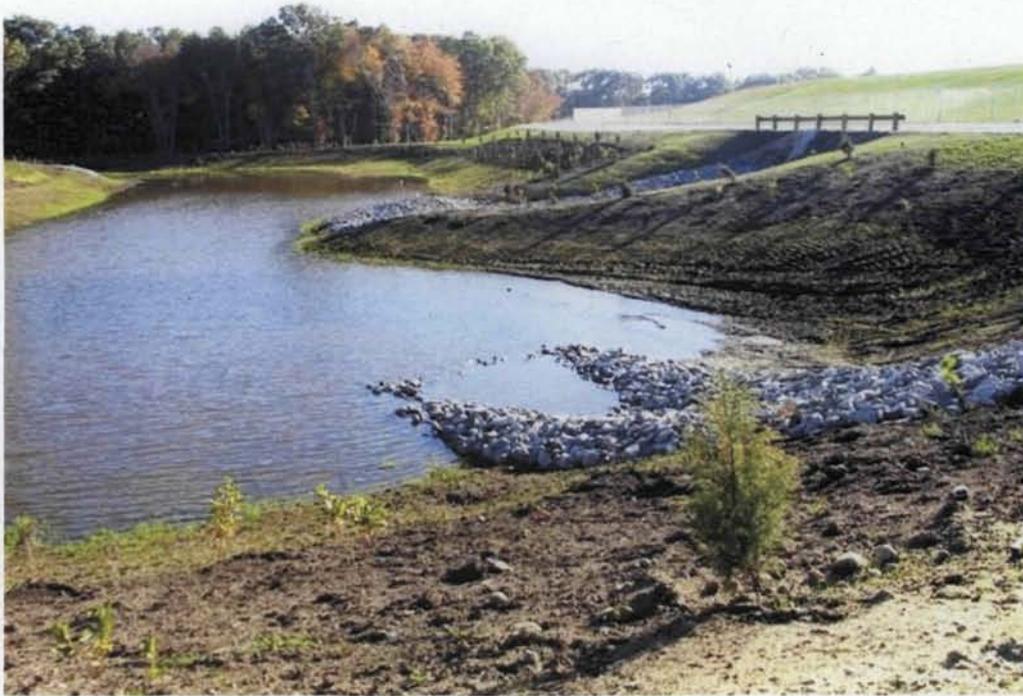
**View of south pond/wetland complex shortly after restorative planting. Pond will act as a storm water retention basin and on-site wetland habitat.**

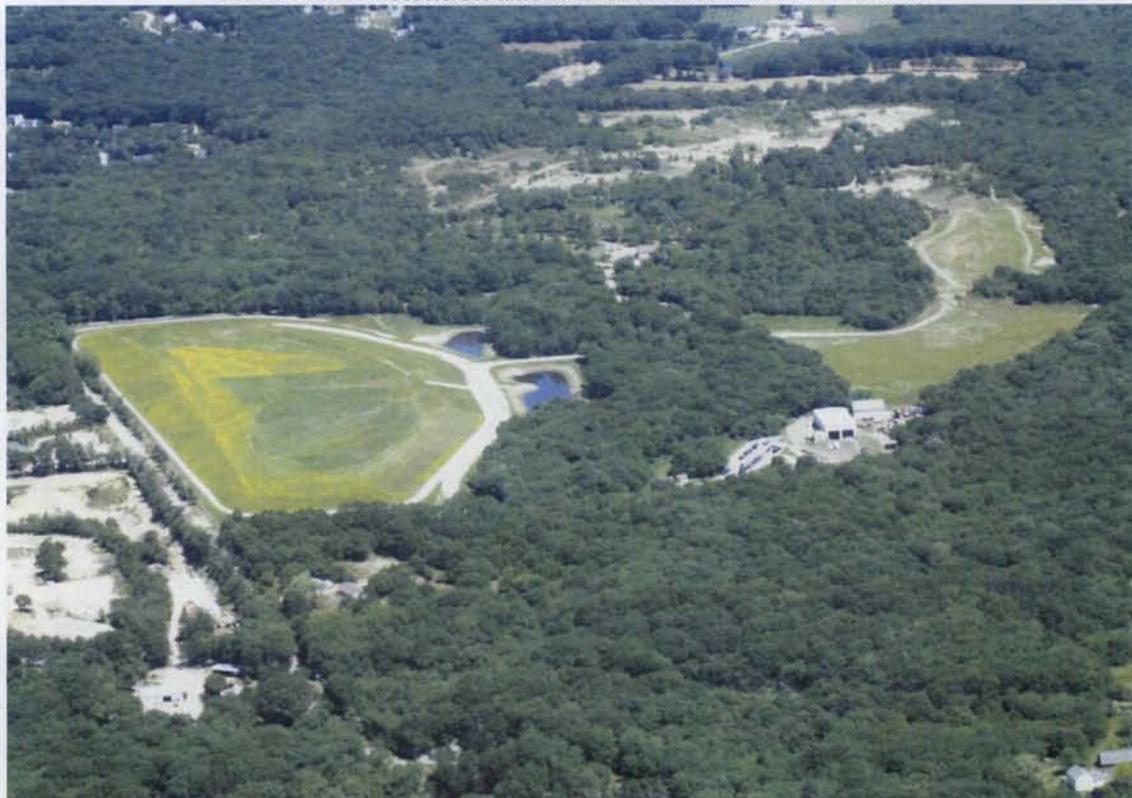
**Aerial photo taken June 2008 showing SWA, BWA and SSA completed; cover crops taking hold. Operating solid waste transfer station in center right of photo.**
