# Final Data Evaluation Report

## Scovill Industrial Landfill Superfund Site Waterbury, Connecticut

Remedial Investigation / Feasibility Study  
EPA Task Order No. 0018-RI-CO-017F

**Nobis Engineering, Inc.**

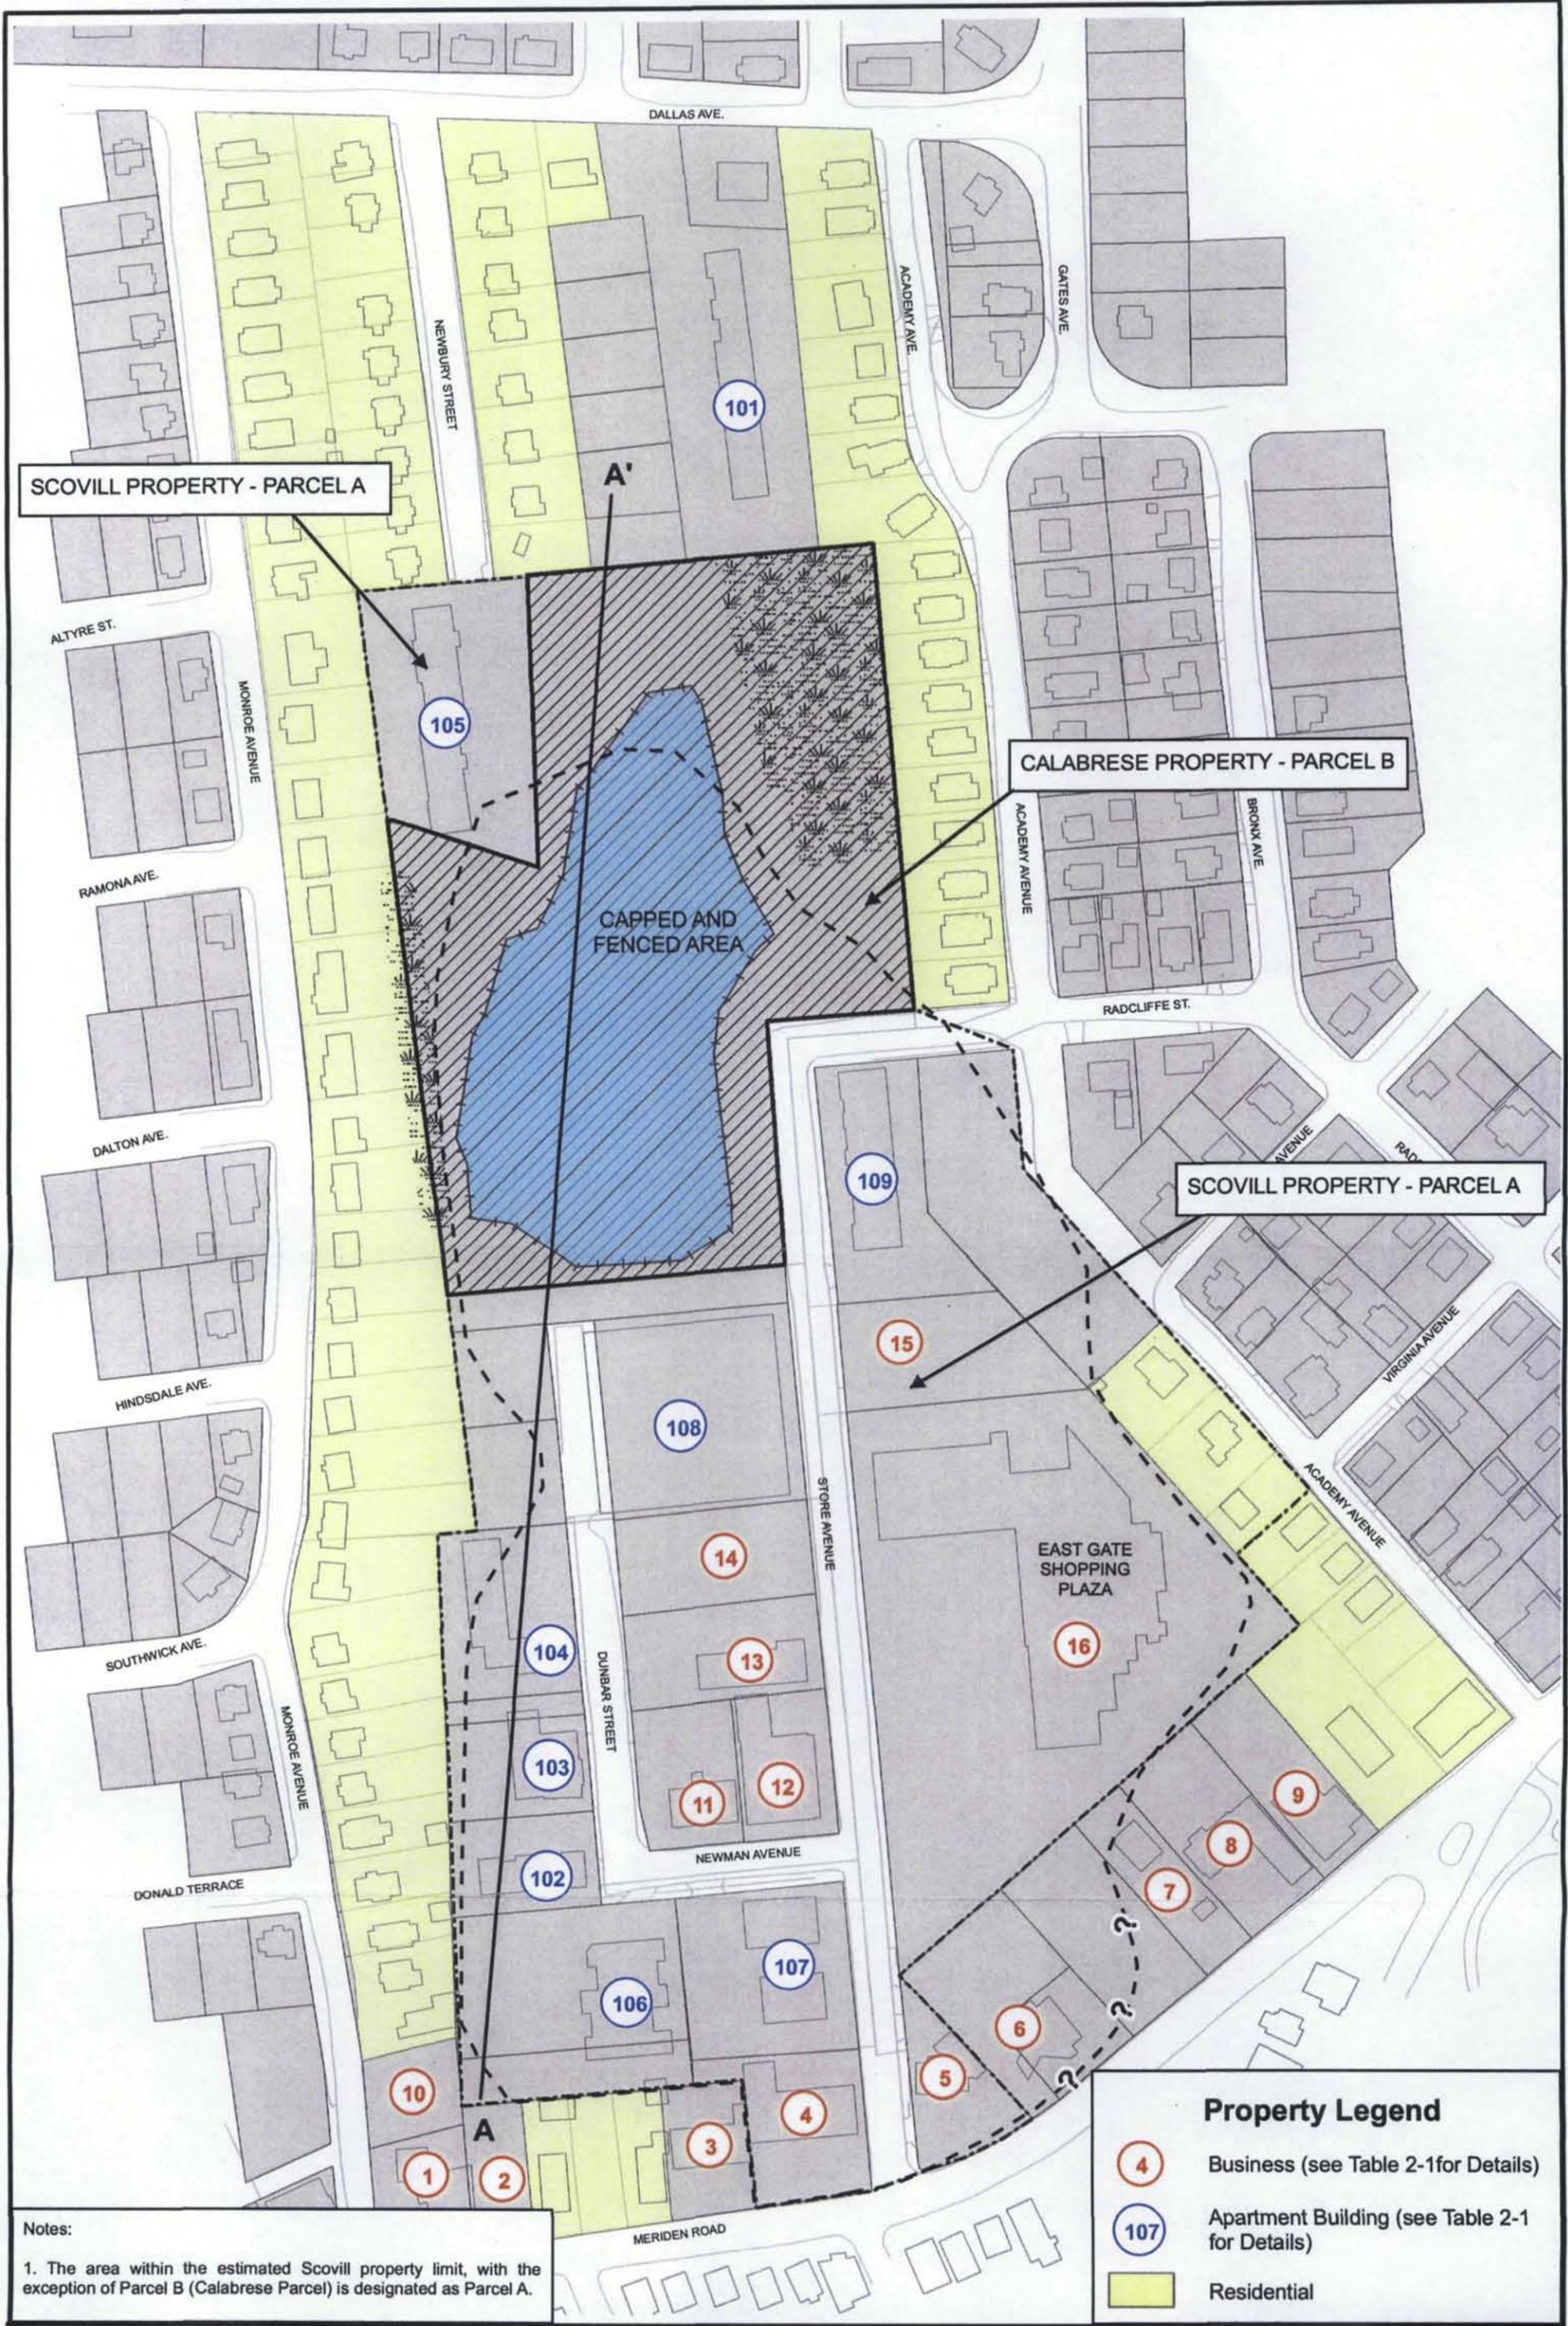
**FIGURE 2-2**  
 SITE LAYOUT WITH  
 CROSS-SECTIONAL TRANSECT  
 SCOVILL INDUSTRIAL LANDFILL  
 WATERBURY, CONNECTICUT

SCOVILL PROPERTY - PARCEL A

CALABRESE PROPERTY - PARCEL B

department store, cab service, medical office, car repair shop, and a shopping mall (East Gate Shopping Plaza). The remaining 7-acre parcel is undeveloped and was in the initial stages of development by Calabrese Construction, Inc. before the Site was designated as a Superfund Site on the National Priorities List. For RI purposes, the 23-acre developed parcel will be referred to as the Scovill parcel or Parcel A, while the 7-acre parcel will be referred to as the Calabrese parcel or Parcel B (Figure 2-2). Note that the limit of landfilling activities underlies both parcels.

The Site was used by the Company as a landfill (see Figure 2-2 for estimated limits) from 1919 until the mid-1970s for disposal of ash, cinder, demolition debris, and other wastes generated by the nearby Company facility. The Company began operations in the early 1800s along Mill Street in Waterbury and continued manufacturing through the 1980s. Manufacturing was conducted at other locations in Waterbury, including an 87-acre parcel located southwest of the Site. In 1997, the Company moved its corporate headquarters from Waterbury to Georgia.

Once filling was completed in the southeastern portion of the Site, the Company subdivided the property and sold it to developers. As the wetlands and the stream valley were filled, those portions of the property were subdivided and were also sold to developers. Ponding of water in the drainage running between Monroe Avenue and Newbury Street, as well as just west of Dunbar Street, reflects the overall Site drainage pattern developed by Carrington Brook that persists today despite filling operations. Most of the development appears to have occurred between the mid-1950s and the mid-1970s. By the mid-1990s, approximately 23 of the 30 acres had been developed. An index of the current businesses and apartment buildings is listed on Table 2-1 and displayed on Figure 2-2.

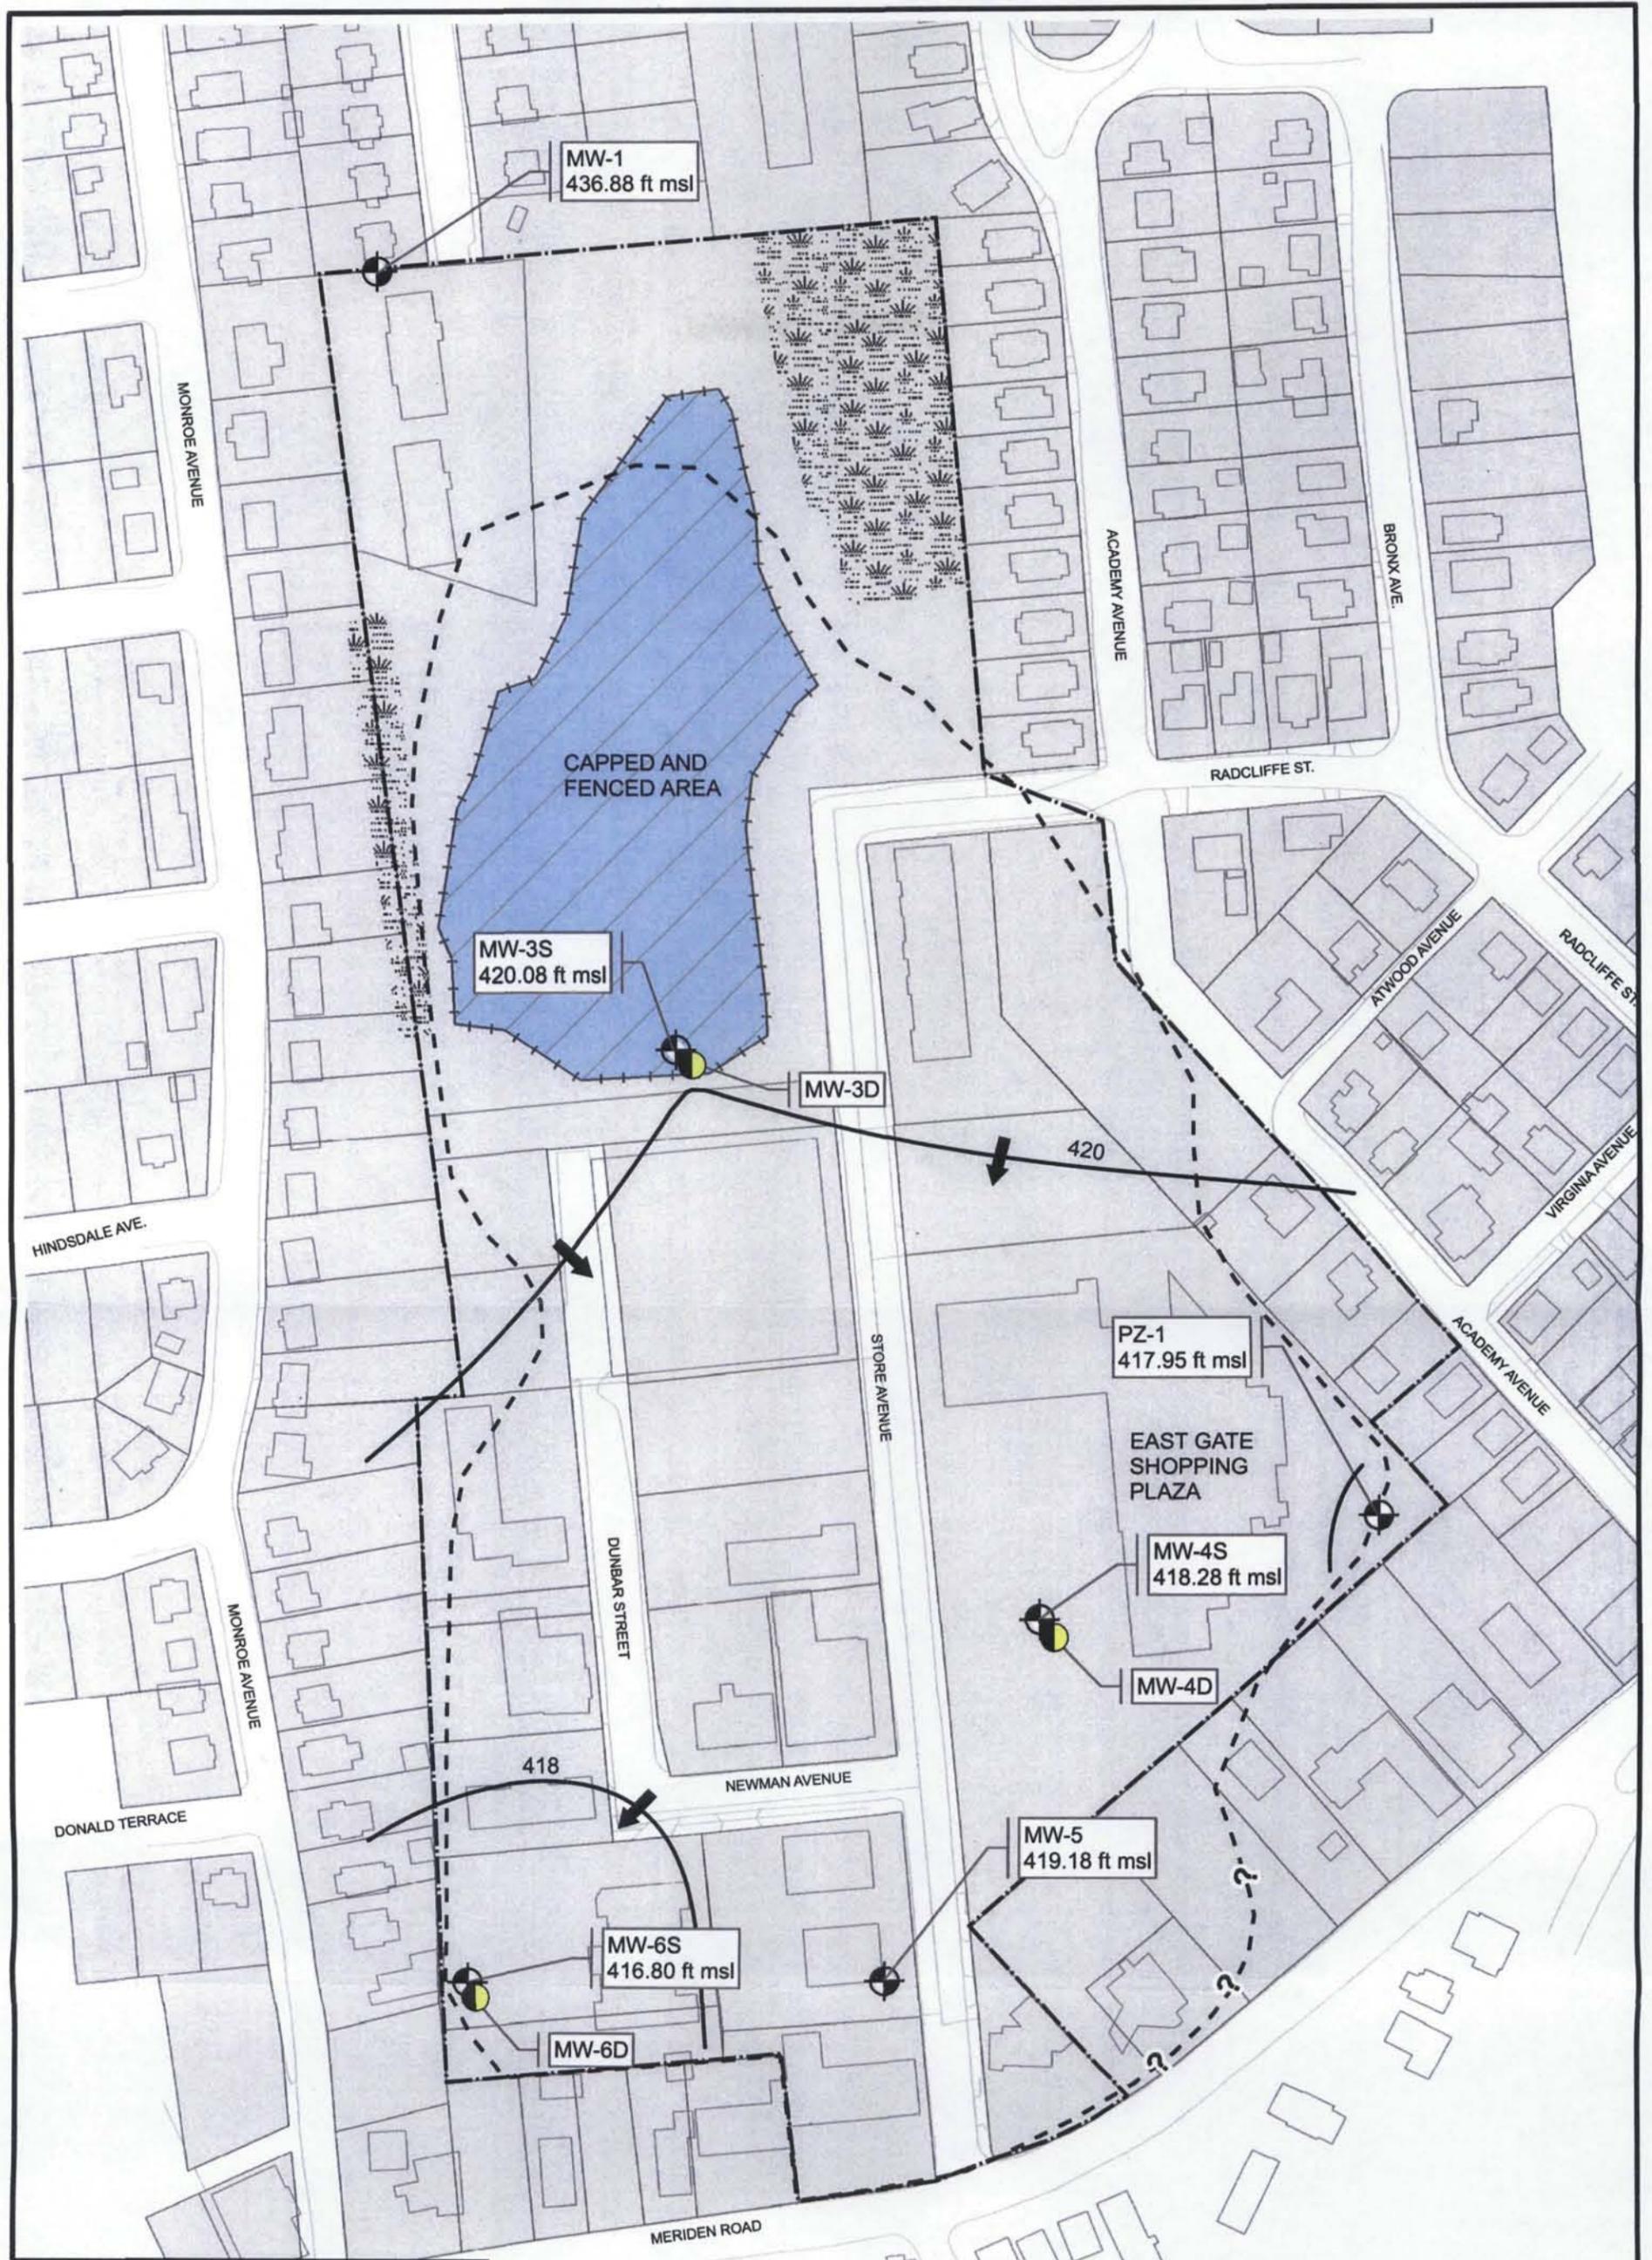
**FIGURE 2-3**  
**OVERBURDEN GROUNDWATER CONTOURS - JUNE 3, 2008**  
**SCOVILL INDUSTRIAL LANDFILL**  
**WATERBURY, CONNECTICUT**

1. S denotes shallow well; D denotes deep well.
2. Only shallow well elevations were used to produce groundwater contours.

Eight shallow and deep overburden groundwater monitoring wells were installed at five different locations at the Site in 2004 as part of the Phase IIA activities. Table 2-2 summarizes construction details for the wells based on Phase IIA field notes. Table 2-3 shows the calculated groundwater elevations from 2004 and 2008 using the recent survey data. The wells were surveyed in June 2008 and groundwater flow is generally from the topographic highlands to the east and west of the Site and converges to the south as shown on Figure 2-3. This is the same general direction as regional flow towards the Mad and Naugatuck Rivers (Figure 2-1). The estimated horizontal hydraulic gradients for the area are approximately 0.02 ft/ft in both the

shallow and deep overburden. Based on calculations using groundwater elevations from well couplets MW-3S/D, MW-4S/D, and MW-6S/D, vertical gradients appear to be minimal and not suggestive of any significant vertical water movement between the shallow and deep portions of the overburden. Calculated vertical gradients from the June 3, 2008 groundwater elevation data are 0.00 (neutral), -0.01 (slightly up), and 0.08 (slightly down) ft/ft for MW-3S/D, MW-4S/D, and MW-6S/D, respectively.

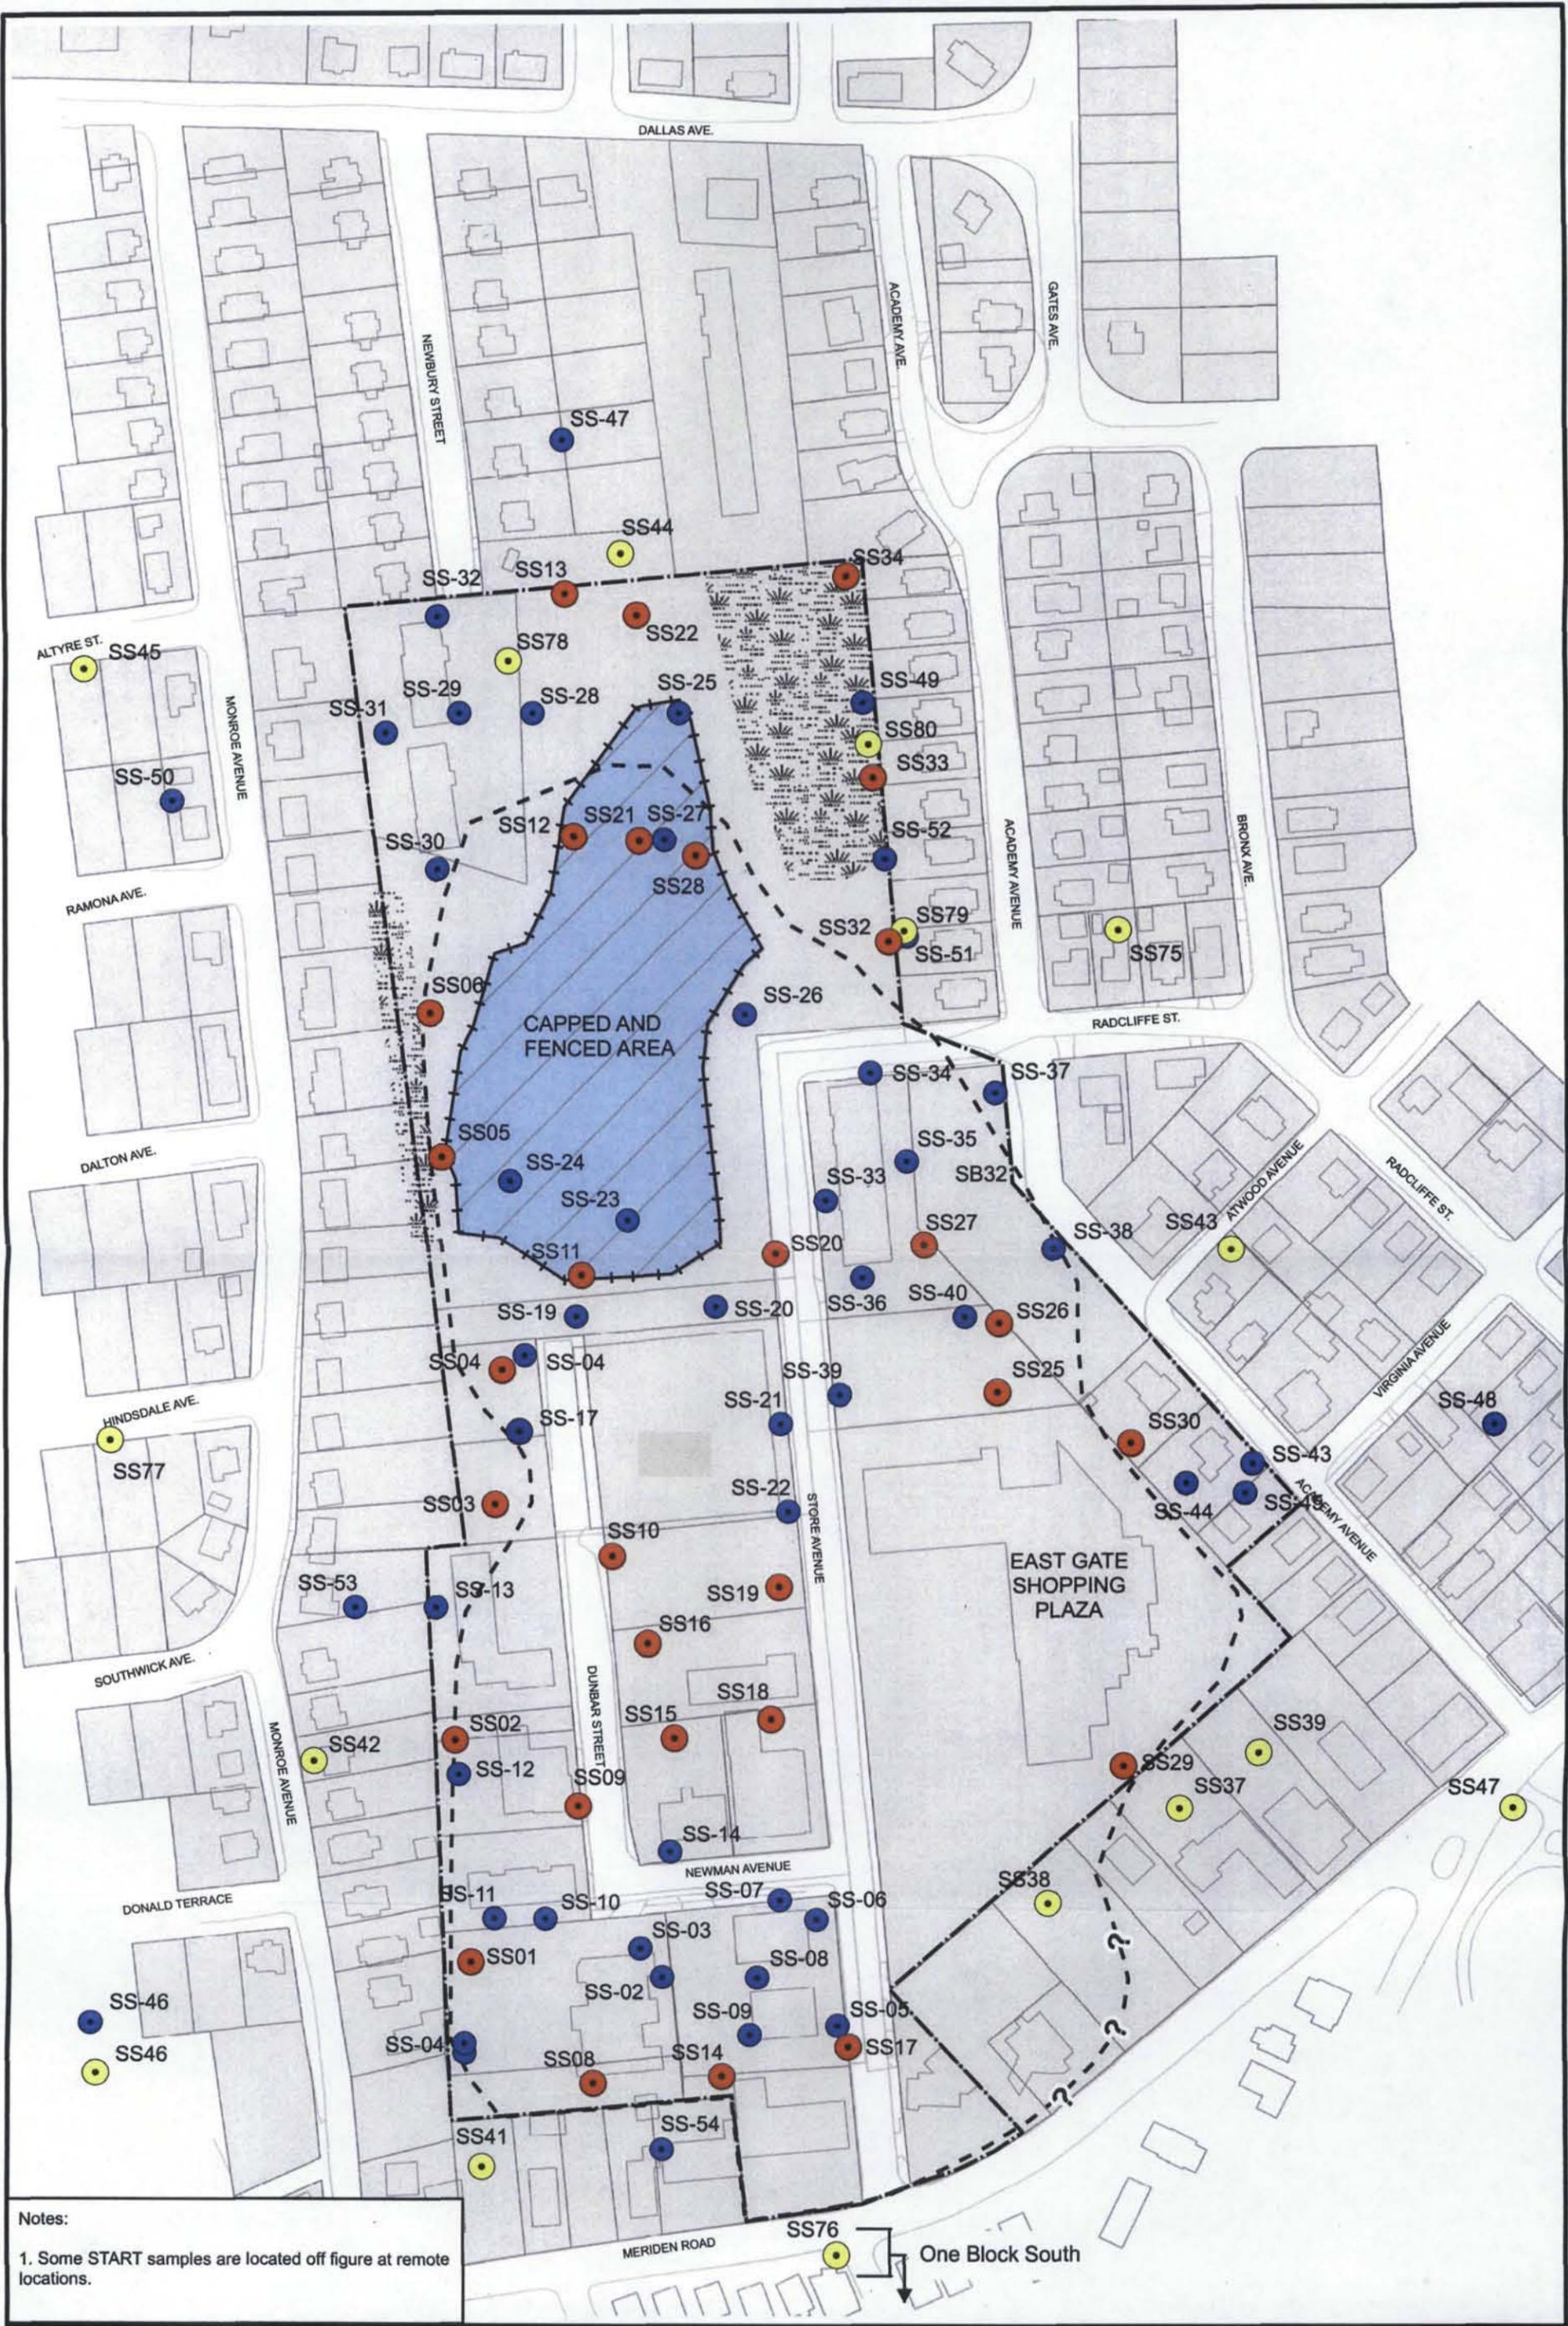
Notes:  
 1. Some START samples are located off figure at remote locations.

In April 1999 the START program collected 124 surface and shallow subsurface soil samples throughout the Site and in the surrounding environs from 0 to 6 inches and 6 to 24 inches bgs at each location (i.e., 2 samples per location). An additional 52 surface soil samples were collected from locations during the Phase I and Phase IIA programs (Figure 3-1). Samples were taken from approximately 0 to 3 inches bgs and analyzed for volatile organic compounds (VOCs), semi-volatile organic compounds (SVOCs), pesticides, PCBs, metals, and dioxins for select samples (M&E/FWENC, 2003 and M&E/TtEC, 2005).

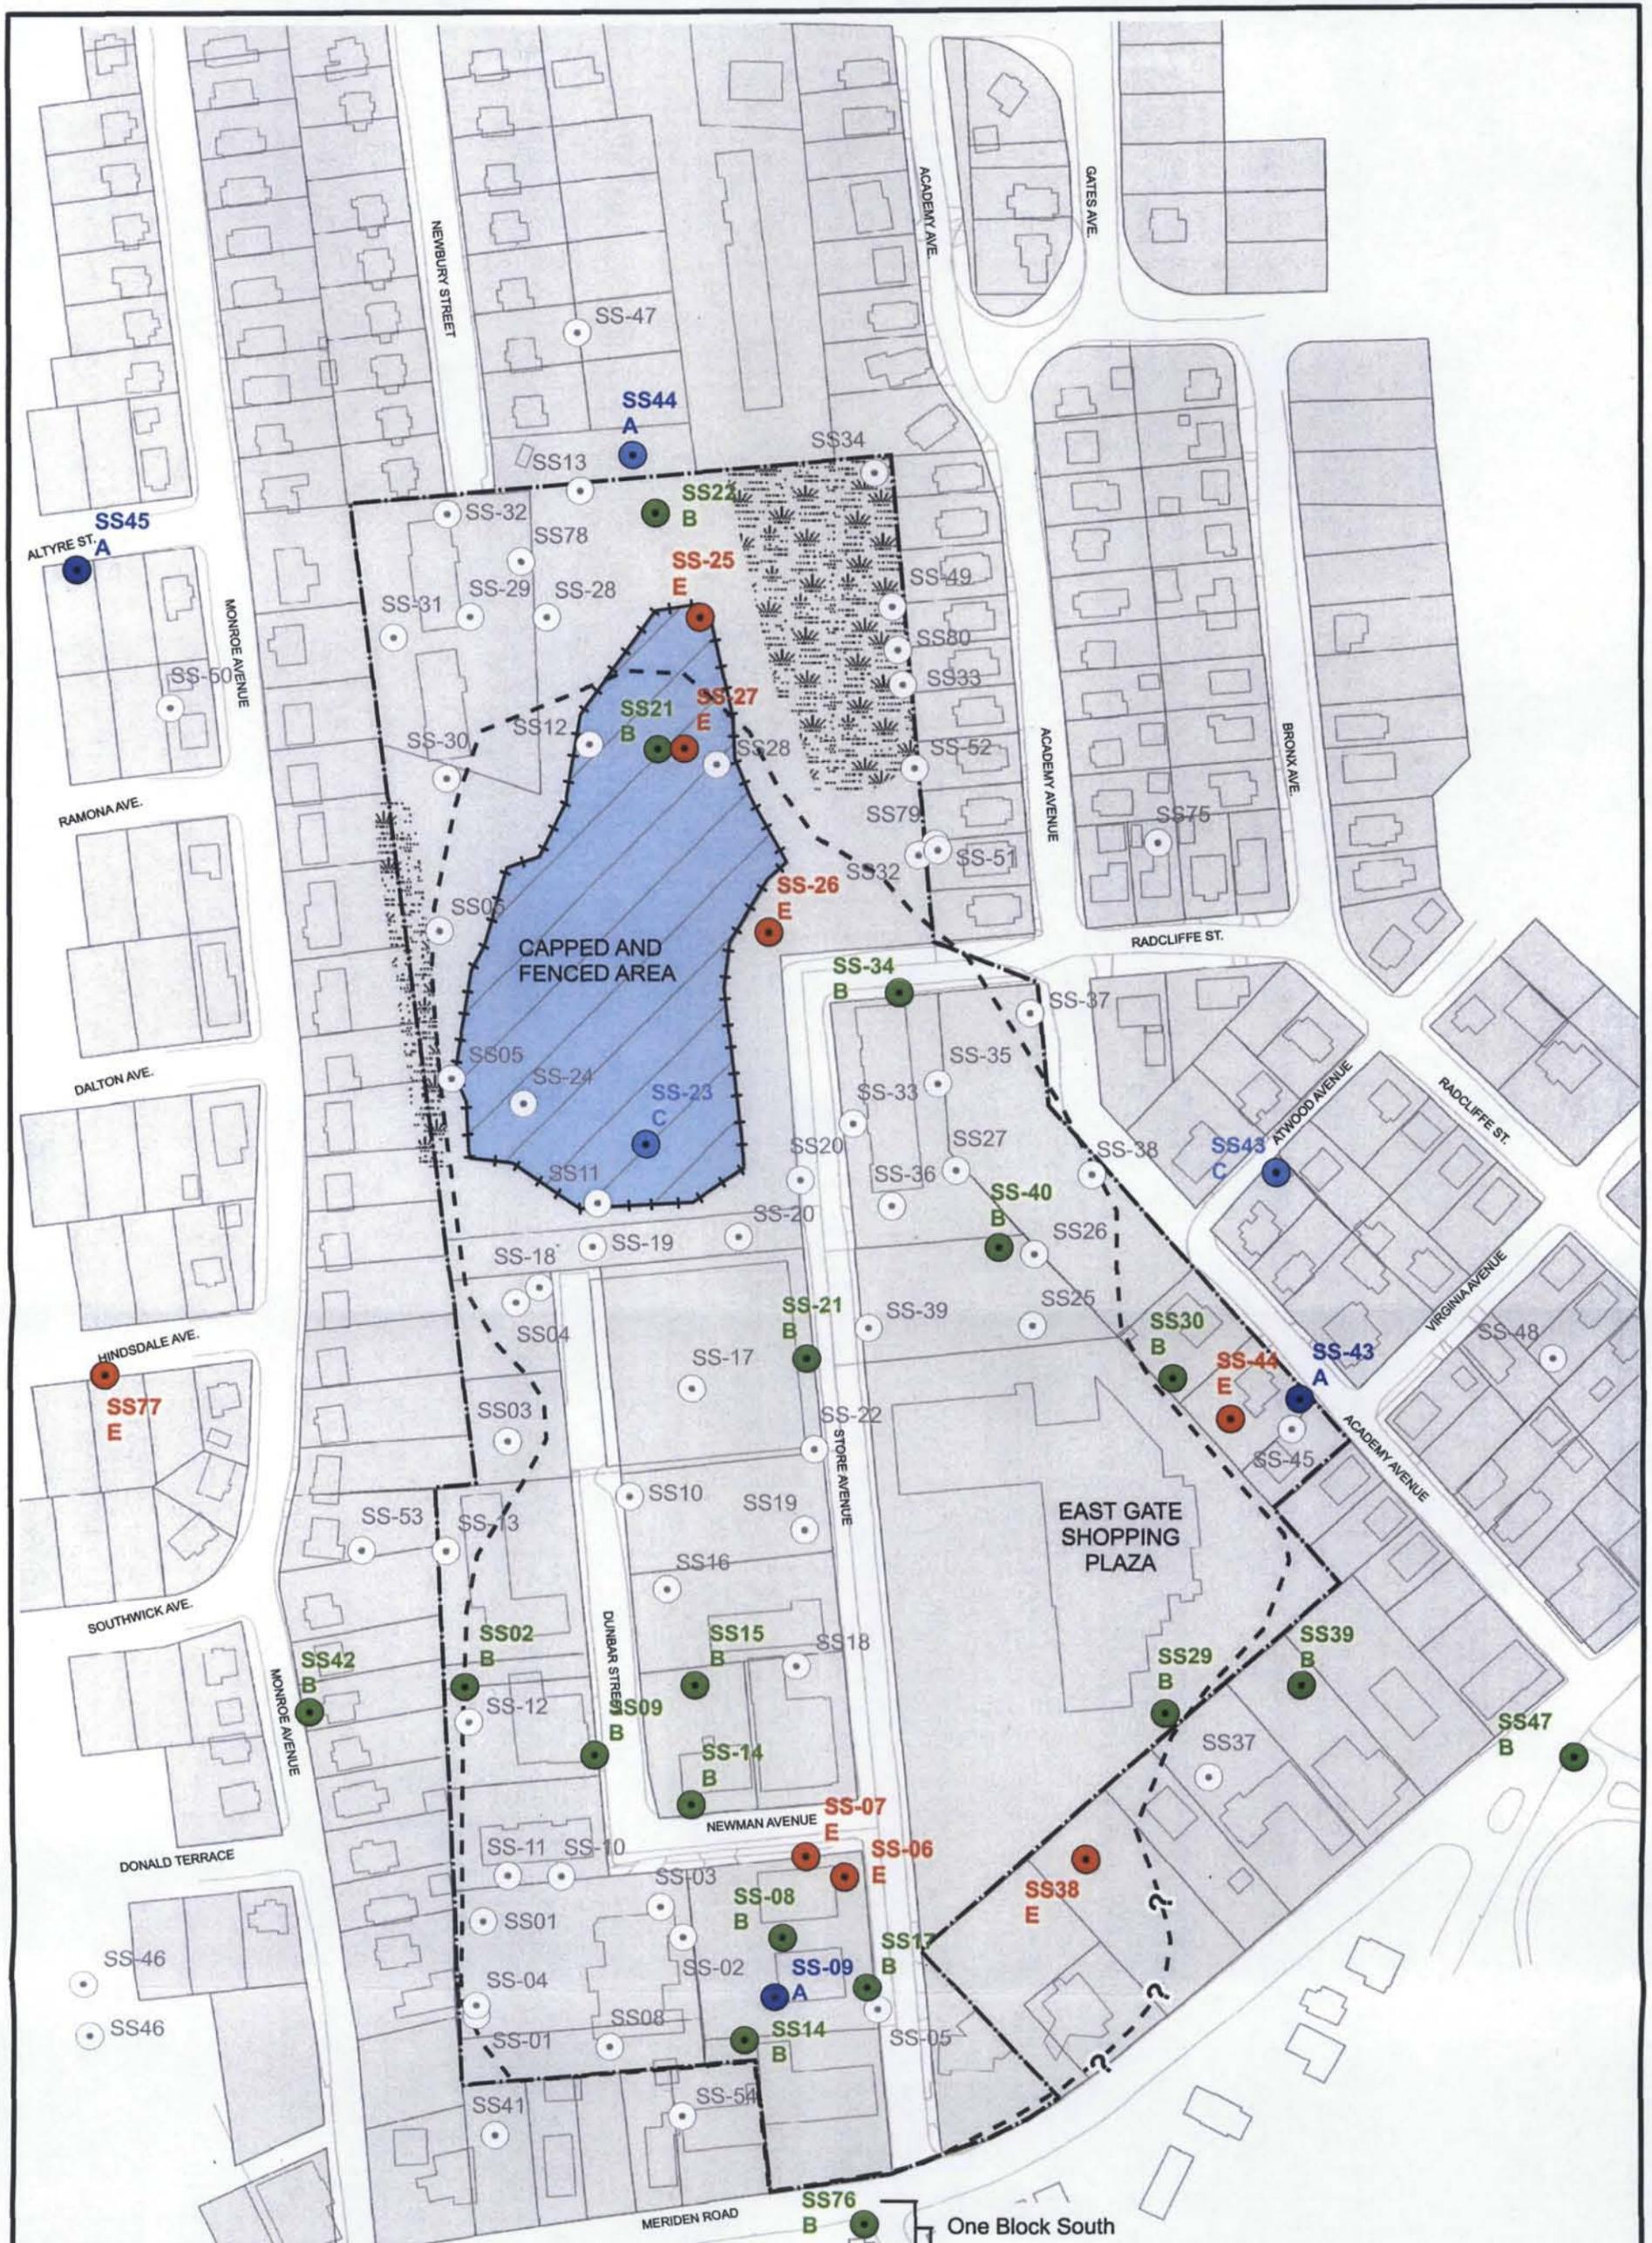
**FIGURE 3-2**  
 SURFACE SOIL  
 RES DEC EXCEEDANCES  
 SCOVILL INDUSTRIAL LANDFILL  
 WATERBURY, CONNECTICUT

1. START location names are denoted with a hyphen (e.g. SS-54). Phase I/IIA location names do not contain a hyphen (e.g. SS17).
2. Locations depicted in light gray indicate all analytical results were below the CTDEP RES DEC.

Figure 3-2 depicts the distribution of surface soil concentrations exceeding CTDEP's Residential Direct Exposure Criteria (ResDEC) for individual compound classes (e.g., PAHs). Results from these samples did not identify any VOCs above CTDEP ResDEC. Multiple samples identified PAHs exceeding the CTDEP ResDEC in soils collected from the properties of the Store Avenue Apartments, the Agricare property, the 119 East Elderly Housing Apartments, 55 Academy Avenue, the child day care facility on Store Avenue, the Laur-Ray Apartments, and the Calabrese property. The most frequently encountered PAHs exceeding criteria included benzo(a)anthracene, benzo(b)fluoranthene, benzo(k)fluoranthene, and benzo(a)pyrene. These chemicals are not uncommon in urban areas.

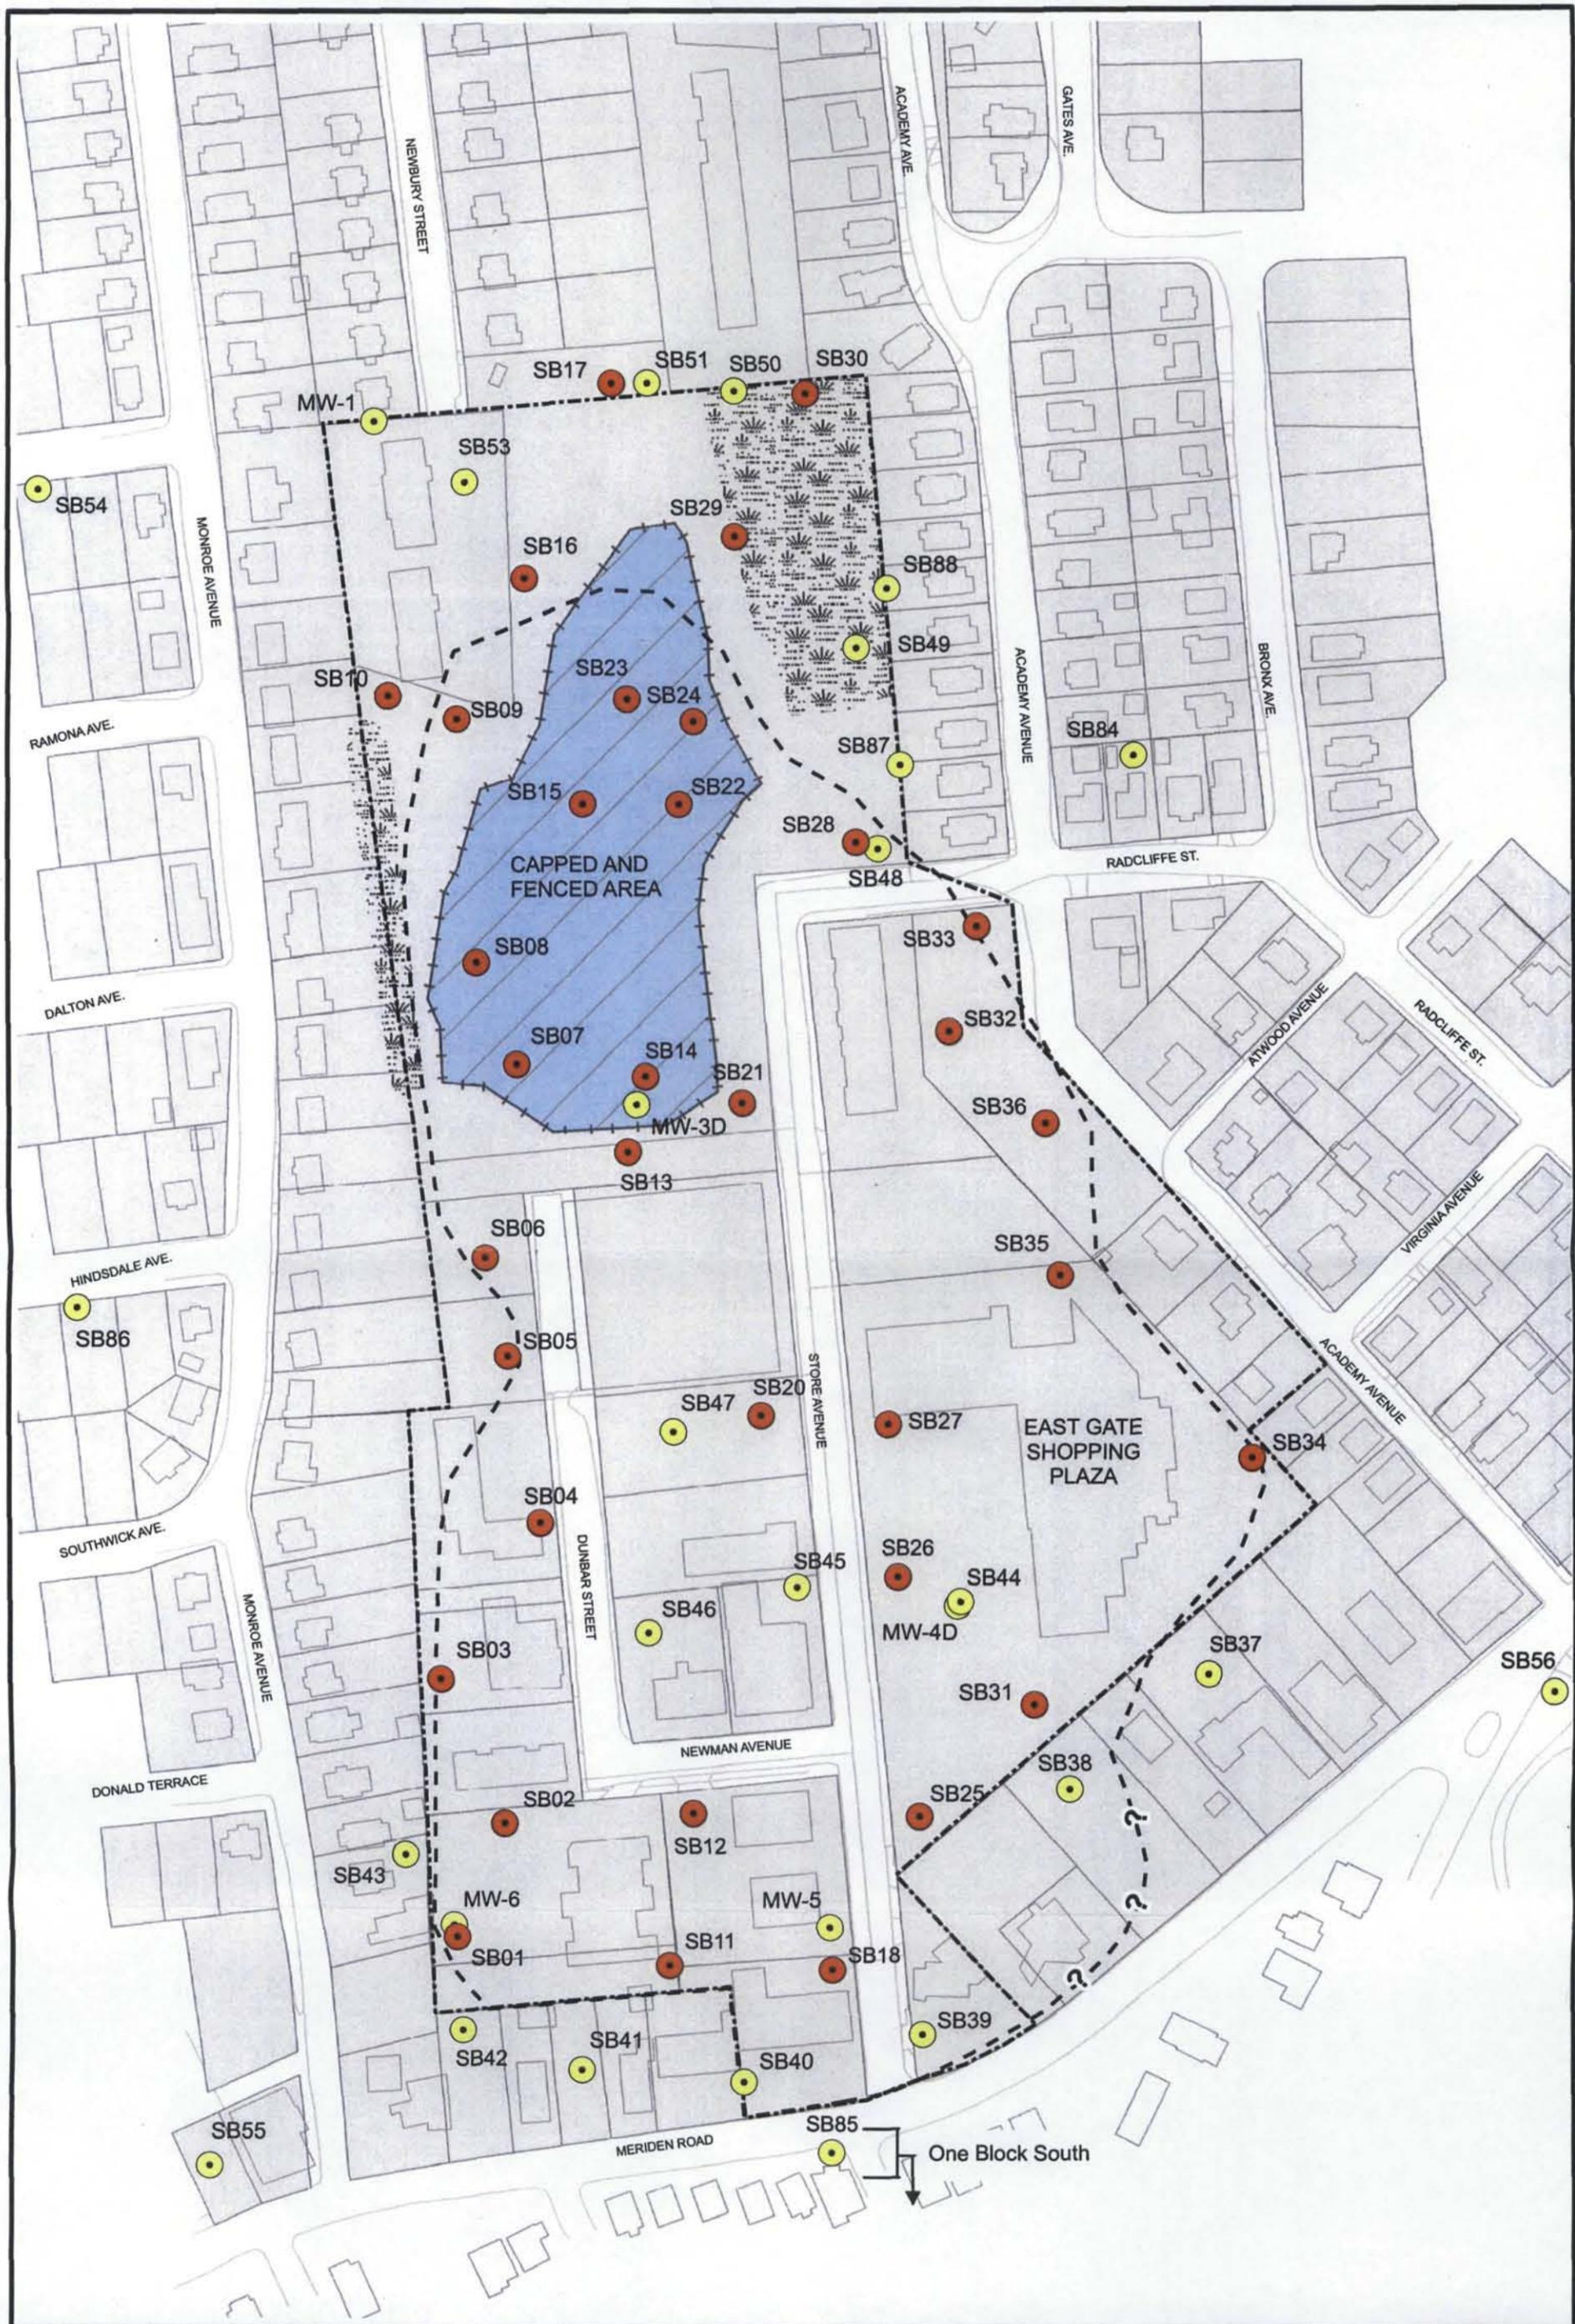
**FIGURE 3-3**  
**SUBSURFACE SOIL**  
**SAMPLE LOCATIONS**  
**SCOVILL INDUSTRIAL LANDFILL**  
**WATERBURY, CONNECTICUT**

- Phase I Subsurface (> 2 ft bgs) Sample Locations
- Phase IIA Subsurface (> 2 ft bgs) Sample Locations
- Limit of Former Scovill Property
- Existing Structure
- - - Fence Line
- - - Estimated Limit of Landfill
- ▨ Wetland Area (Approximated)
