# Final Data Evaluation Report

## Scovill Industrial Landfill Superfund Site Waterbury, Connecticut

Remedial Investigation / Feasibility Study  
EPA Task Order No. 0018-RI-CO-017F

**Nobis Engineering, Inc.**

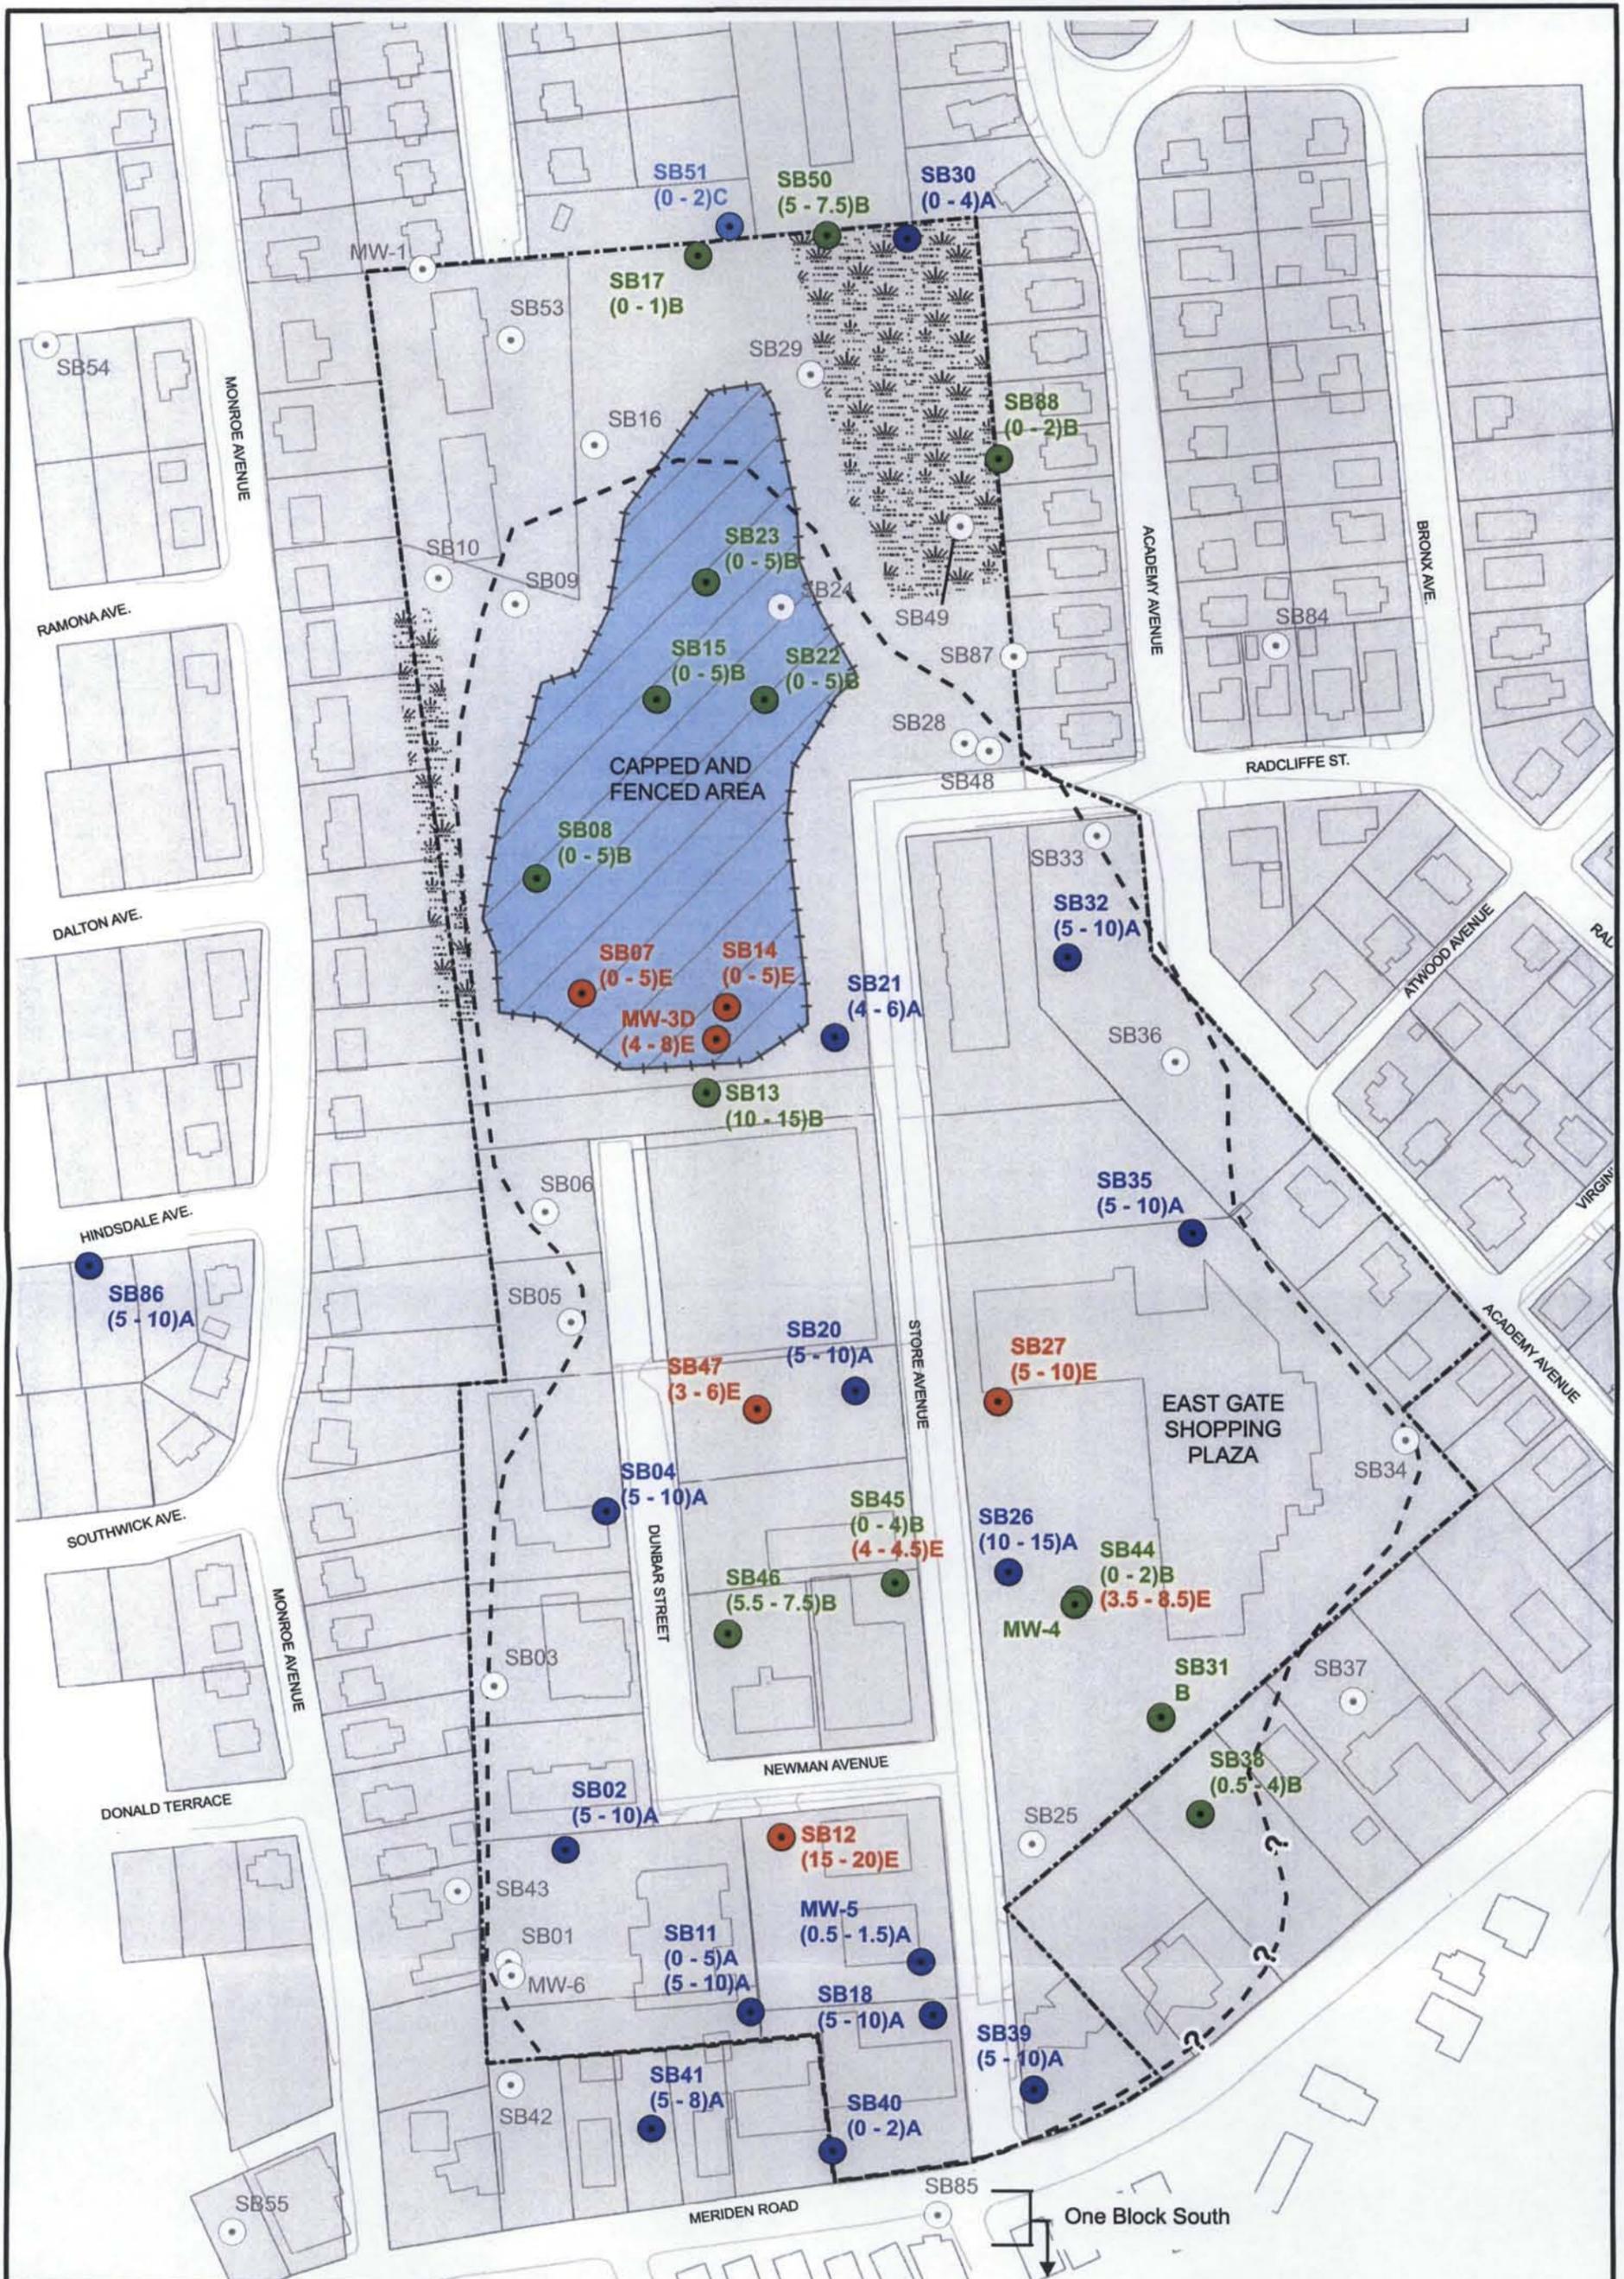
**FIGURE 3-4**  
 PHASE I/IIA SUBSURFACE SOIL RES DEC EXCEEDANCES SCOVILL INDUSTRIAL LANDFILL WATERBURY, CONNECTICUT

Notes:  
 1. Locations depicted in light gray indicate all analytical results were below the CTDEP RES DEC.

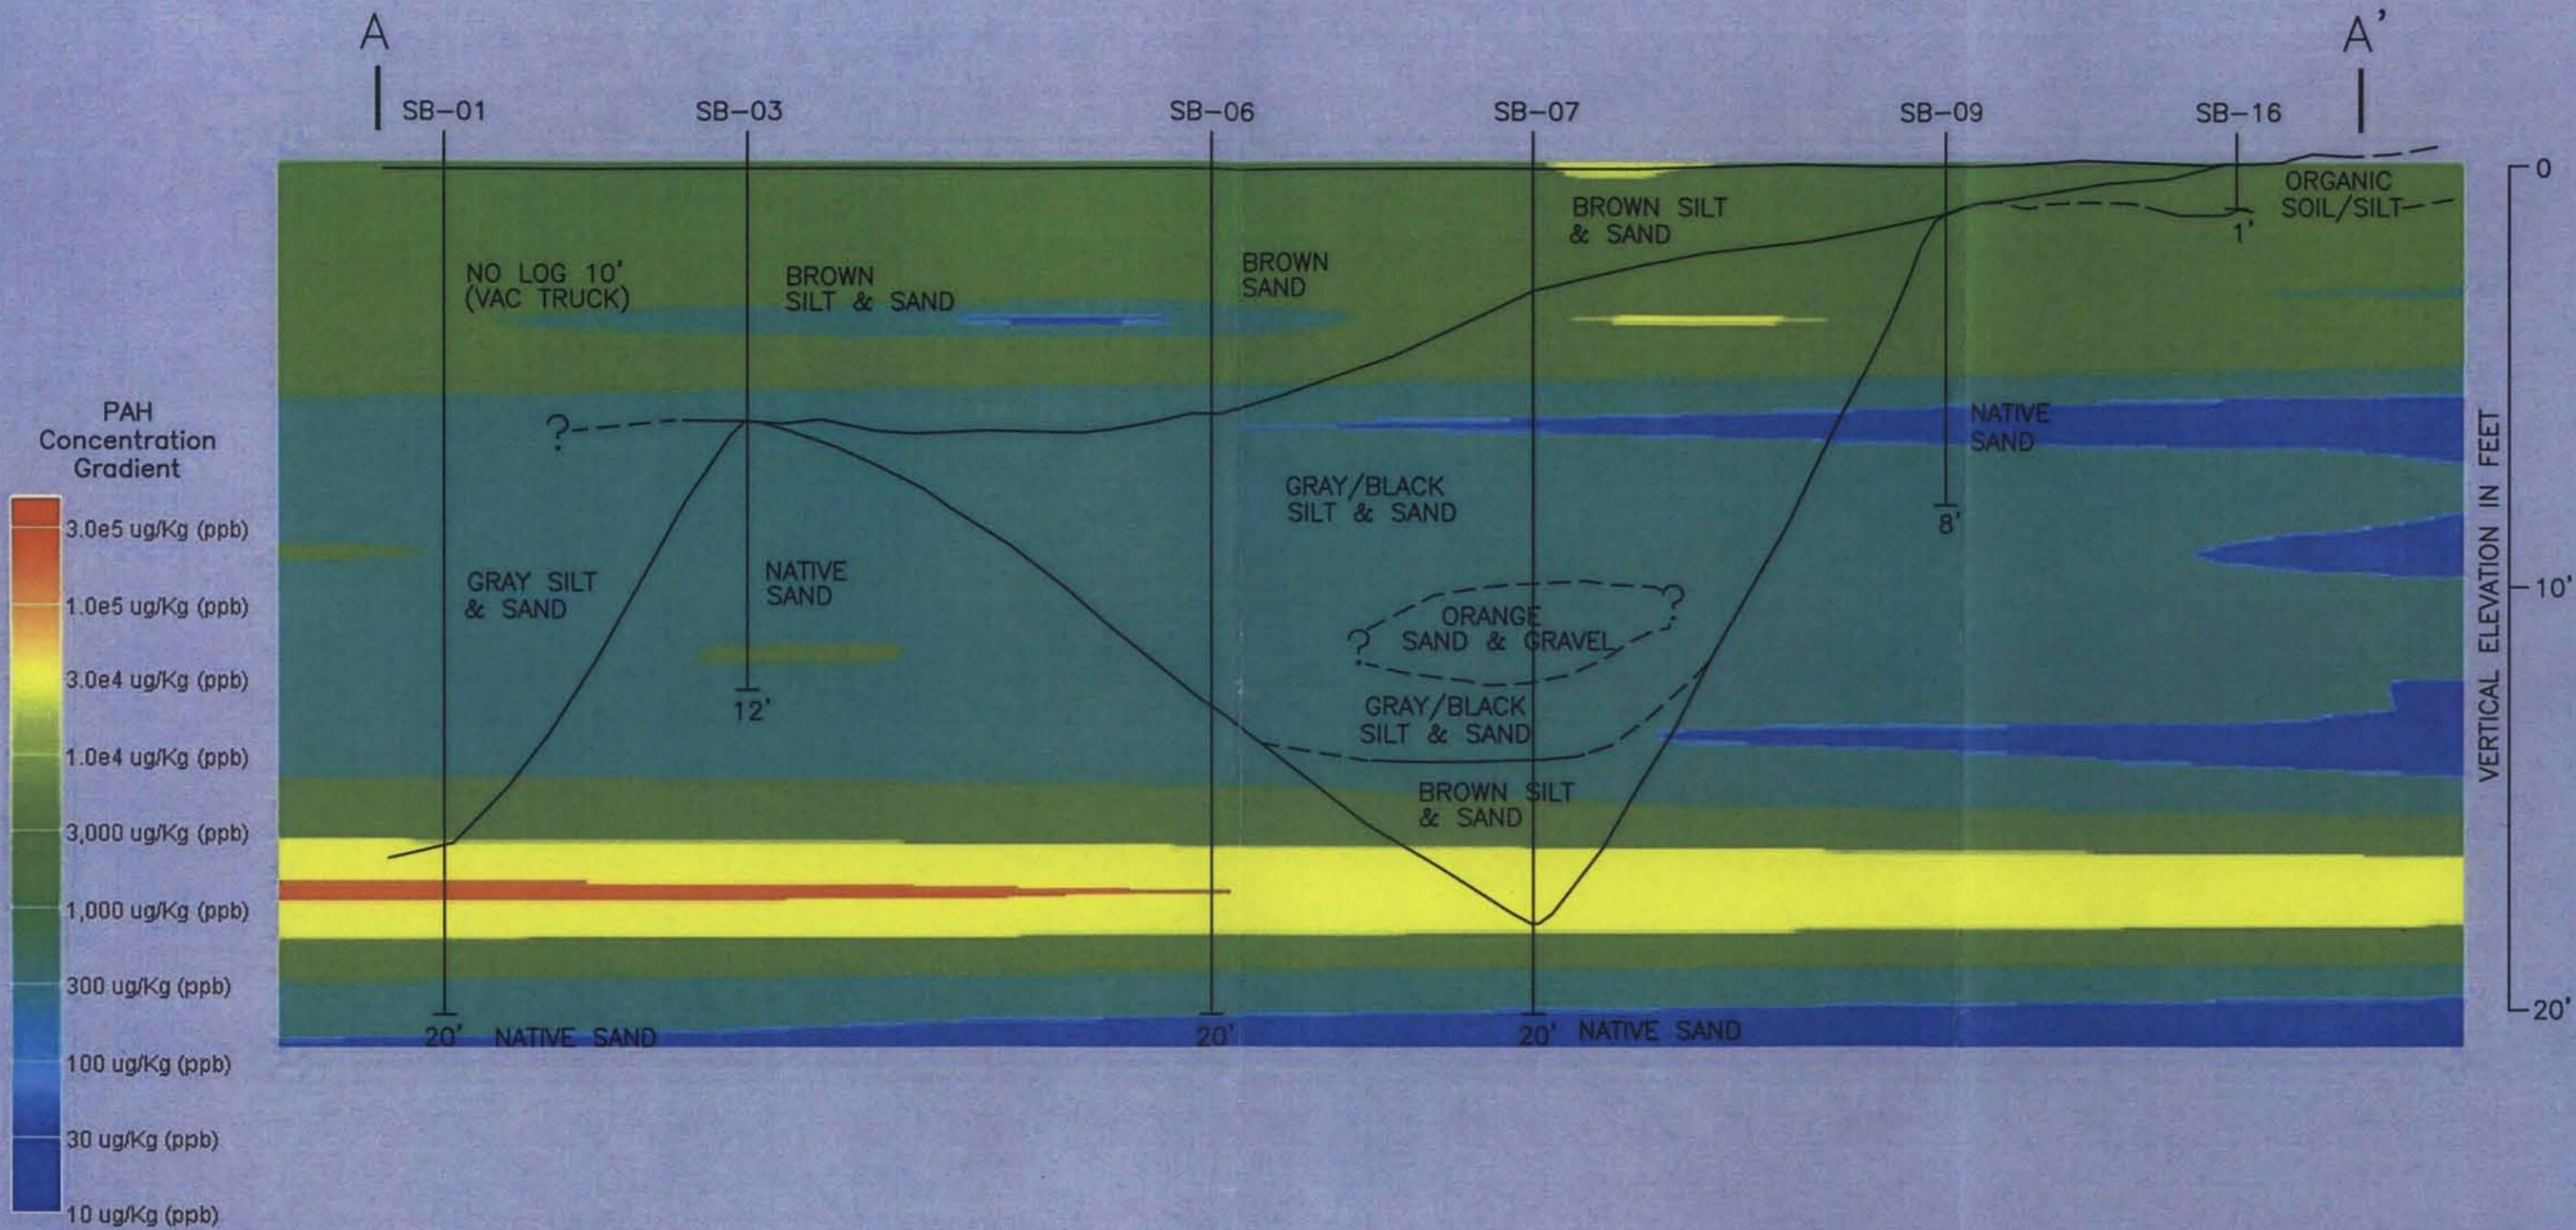
ESTIMATED DISTRIBUTION OF PAH  
 ALONG GEOLOGIC CROSS-SECTION A-A'  
 SCOVILL INDUSTRIAL LANDFILL SITE  
 WATERBURY, CONNECTICUT

Notes:  
 1) Graphics from Metcalf&Eddy/Foster Wheeler Environmental Corp., 2003  
 2) ug/Kg = micrograms per kilogram

As previously stated, PAH and metal contamination is unevenly distributed across the Site with some localized areas of high concentrations. For PAHs, as shown on Figure 3-5, locally higher concentrations, relative to surrounding areas, occur at 0-5 ft bgs and at approximately 15 ft bgs. For copper, as shown on Figure 3-6, samples with higher concentrations are found at various depths and at several locations across the area. Along the cross section, elevated concentrations of copper are generally localized and discontinuous (M&E/FWENC, 2003).

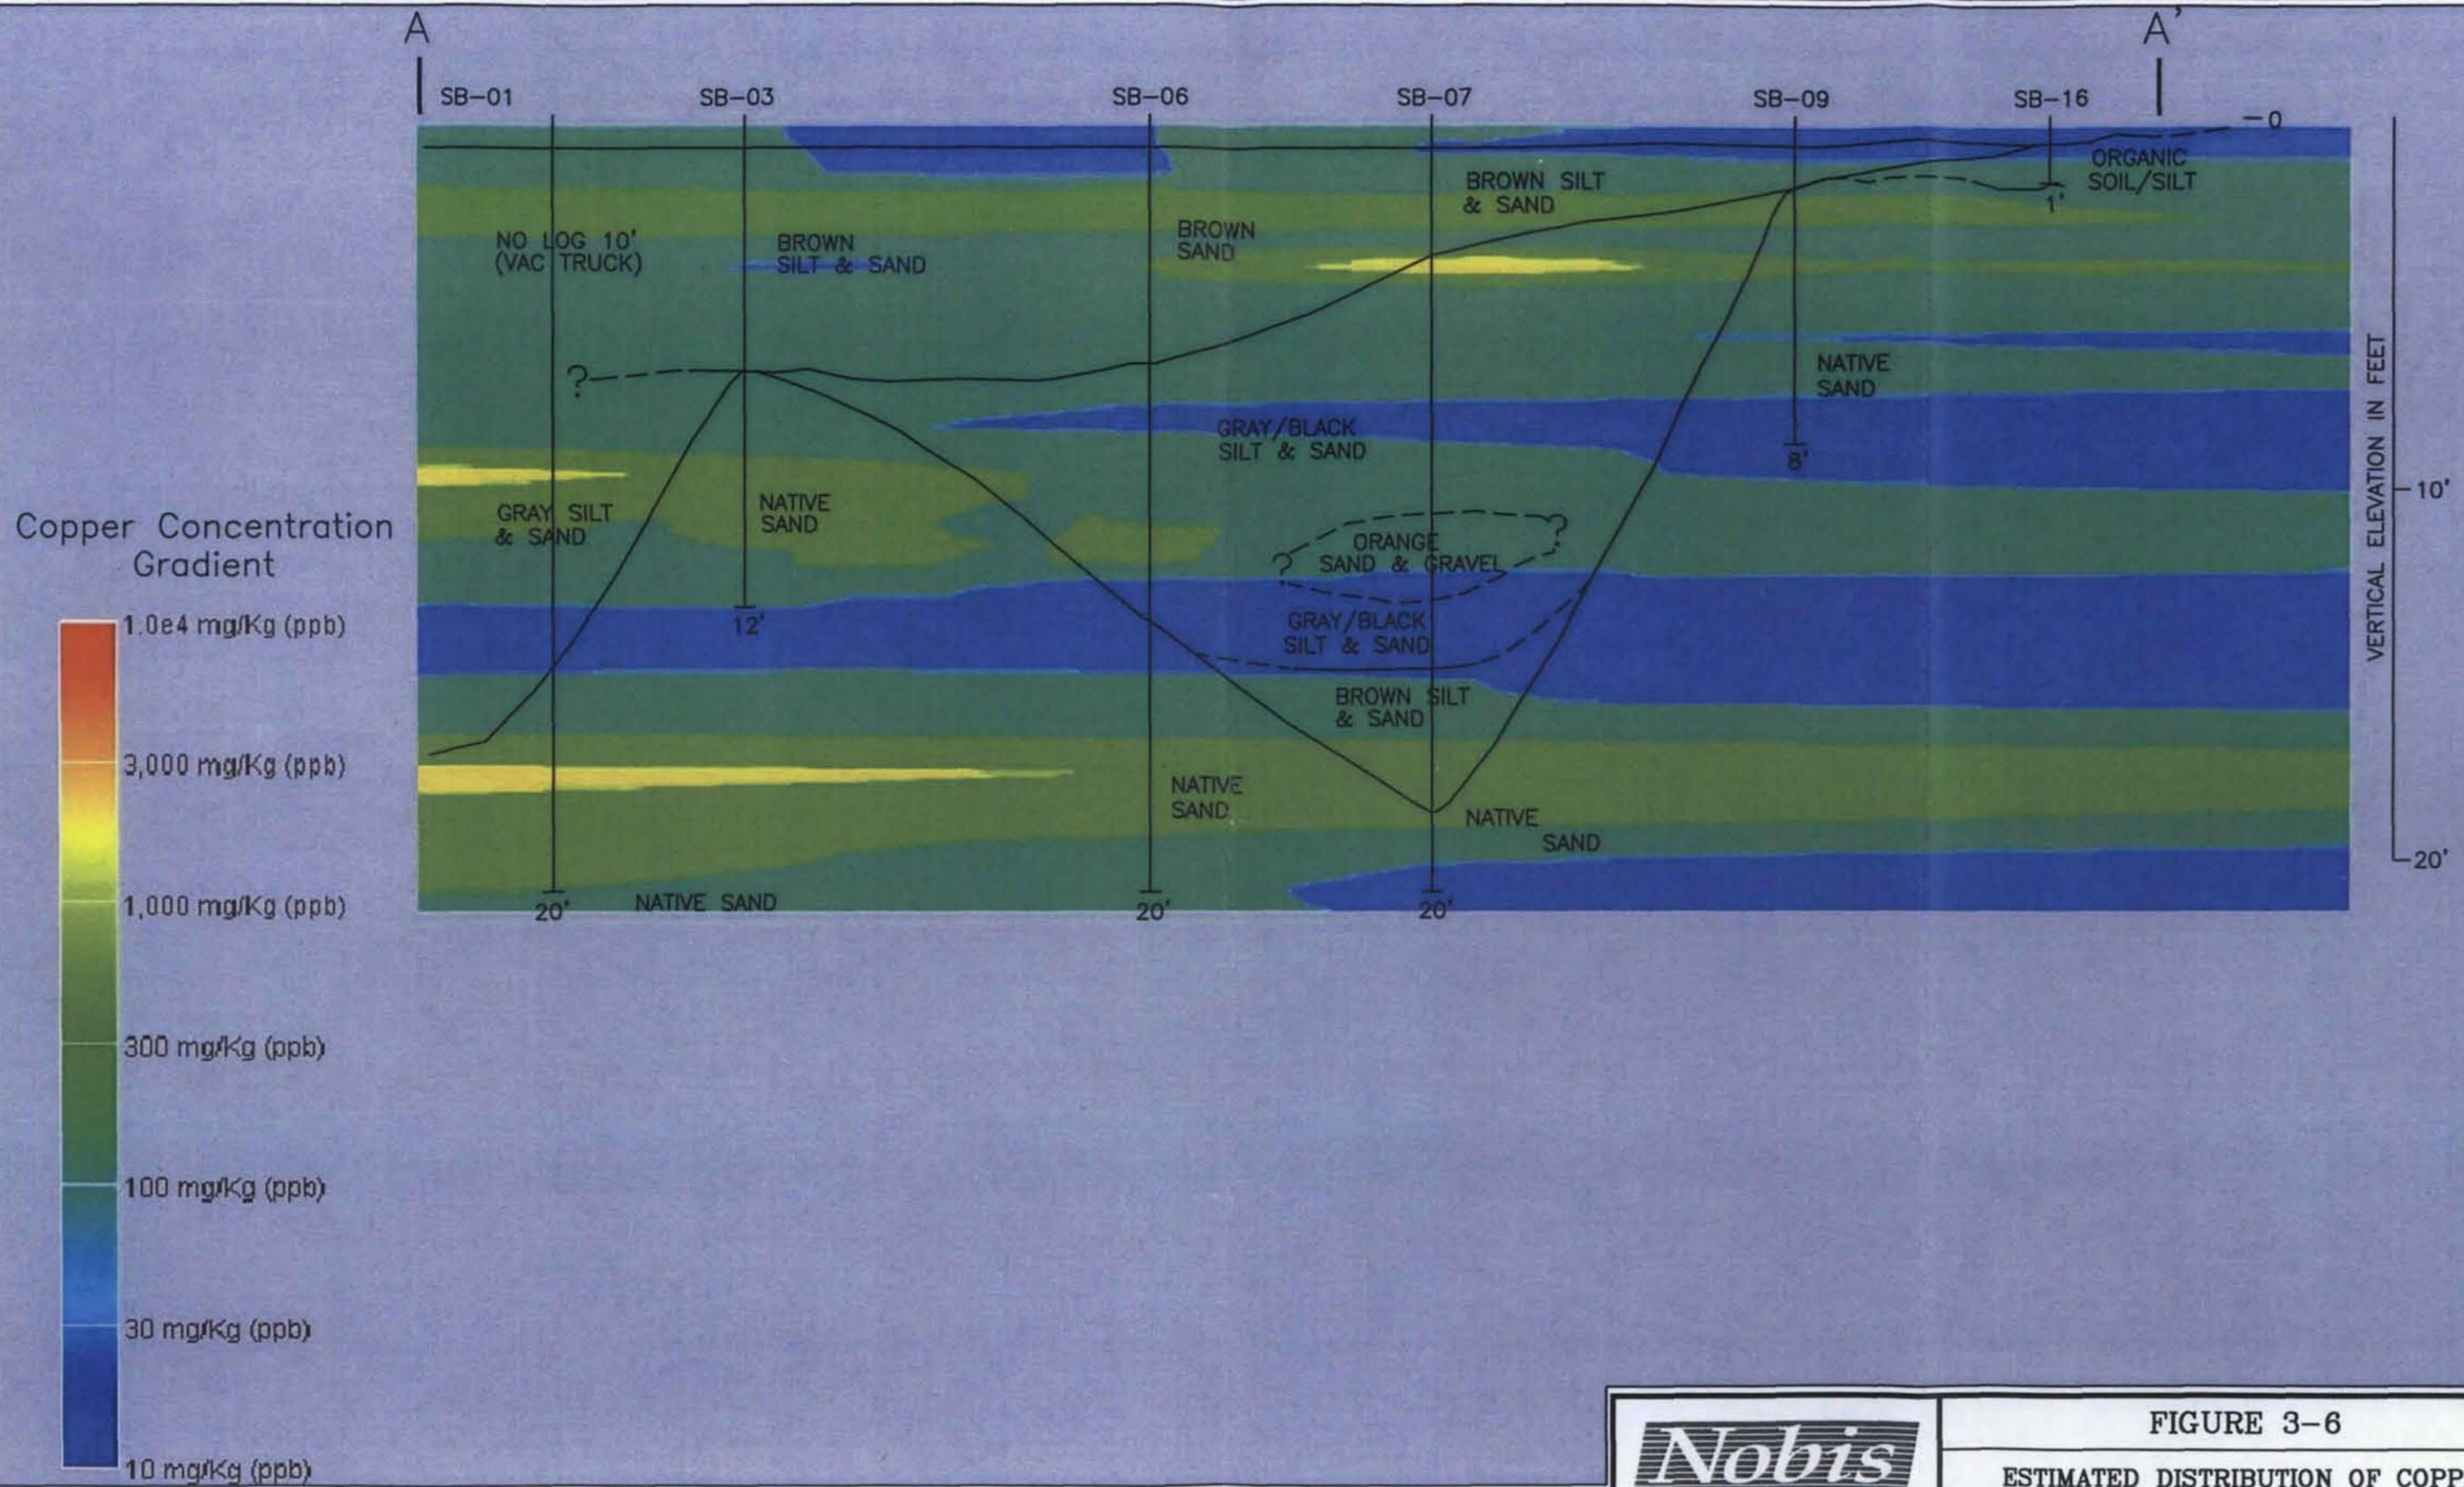
ESTIMATED DISTRIBUTION OF COPPER  
 ALONG GEOLOGIC CROSS-SECTION A-A'  
 SCOVILL INDUSTRIAL LANDFILL SITE  
 WATERBURY, CONNECTICUT

Notes:  
 1) Graphics from Metcalf&Eddy/Foster Wheeler Environmental Corp., 2003  
 2) mg/Kg = milligrams per kilogram

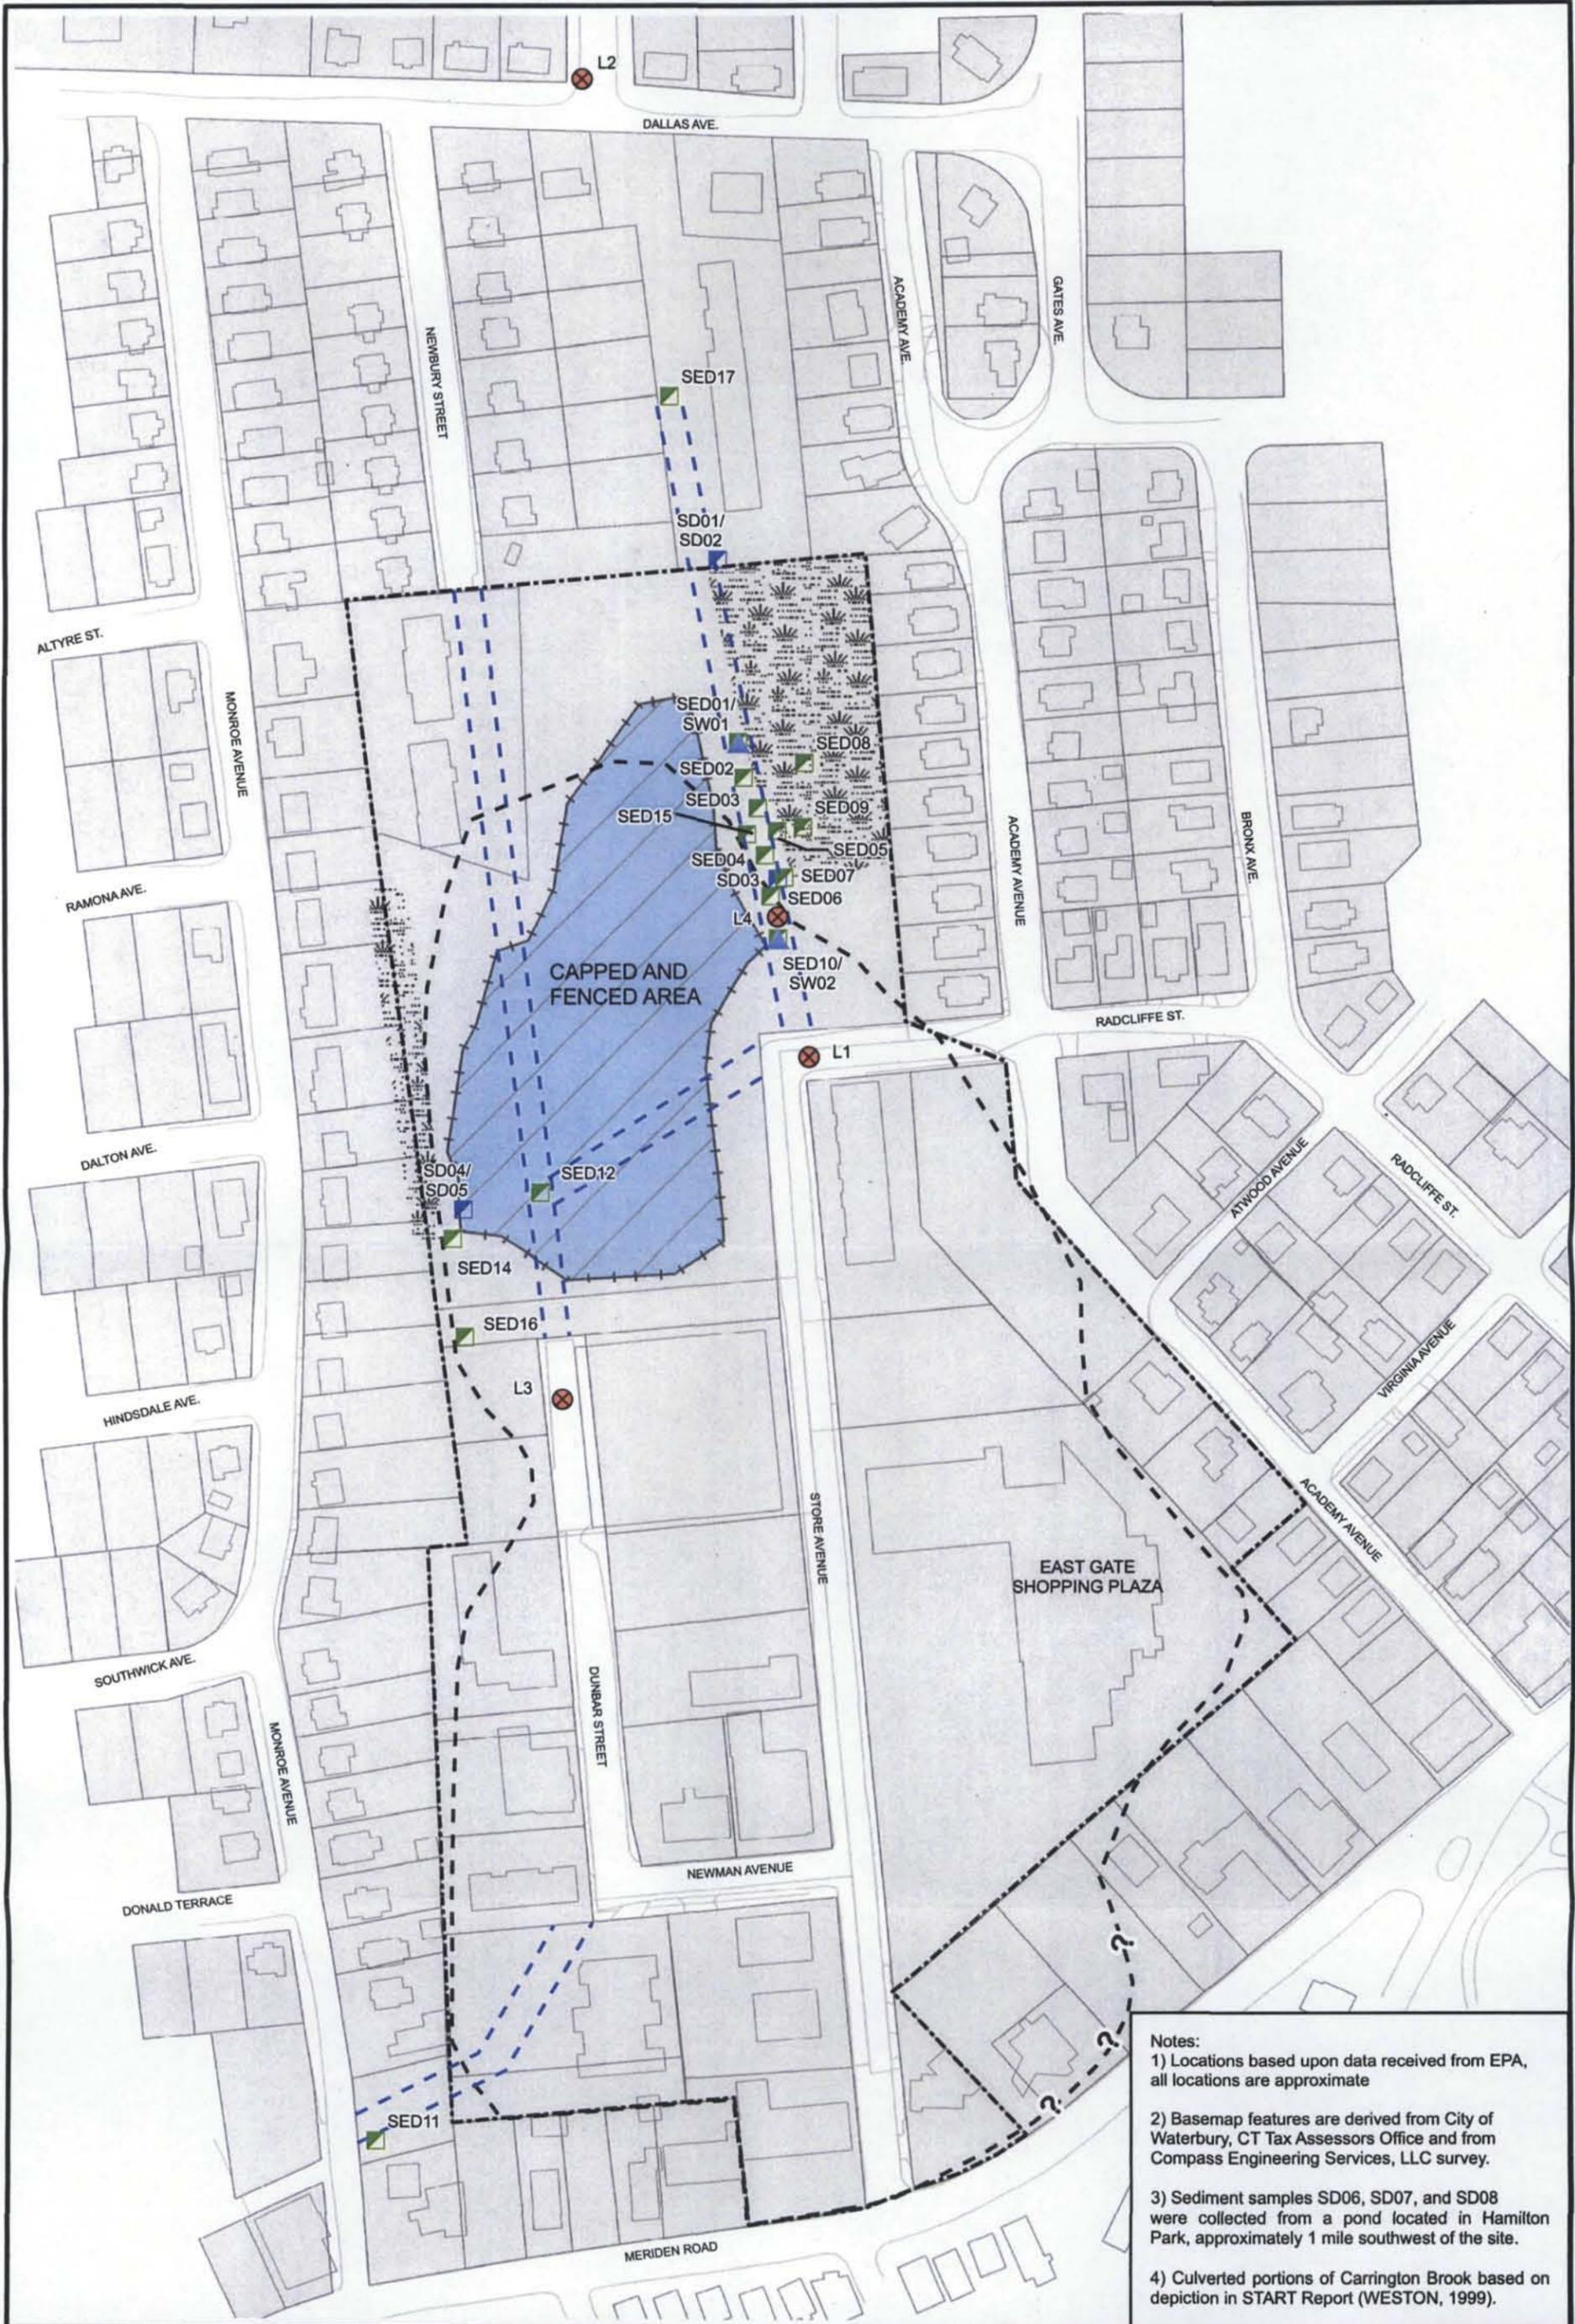
**FIGURE 3-7**  
**SURFACE WATER & SEDIMENT**  
**SAMPLE LOCATIONS**  
**SCOVILL INDUSTRIAL LANDFILL**  
**WATERBURY, CONNECTICUT**

Notes:  
 1) Locations based upon data received from EPA, all locations are approximate  
 2) Basemap features are derived from City of Waterbury, CT Tax Assessors Office and from Compass Engineering Services, LLC survey.  
 3) Sediment samples SD06, SD07, and SD08 were collected from a pond located in Hamilton Park, approximately 1 mile southwest of the site.  
 4) Culverted portions of Carrington Brook based on depiction in START Report (WESTON, 1999).
